Building and Timber Pest Inspection Report

Inspection Date: Fri, 23 Jan 2026

Property Address: 13/12a russel St, Strathfield NSW 2135,
Australia

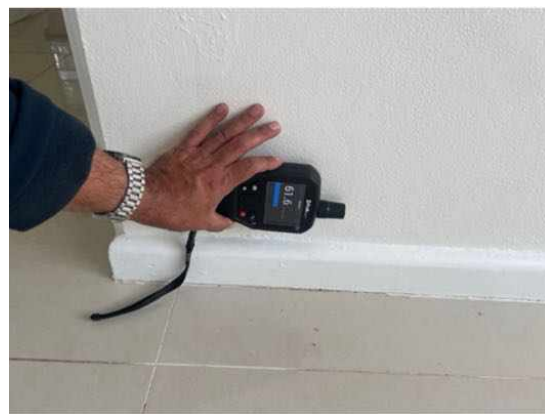
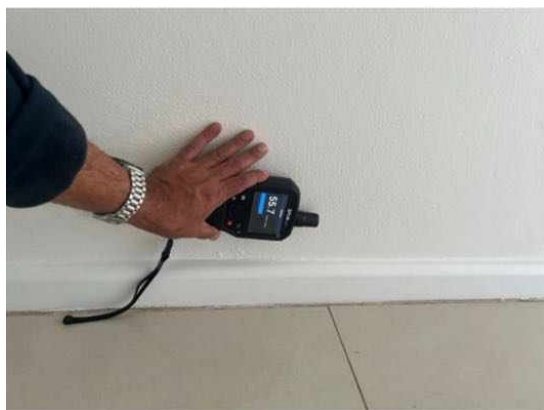
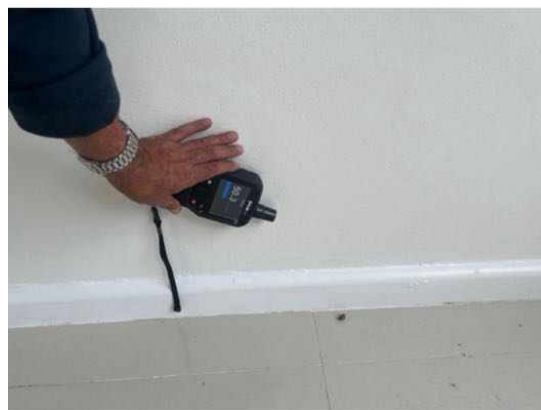
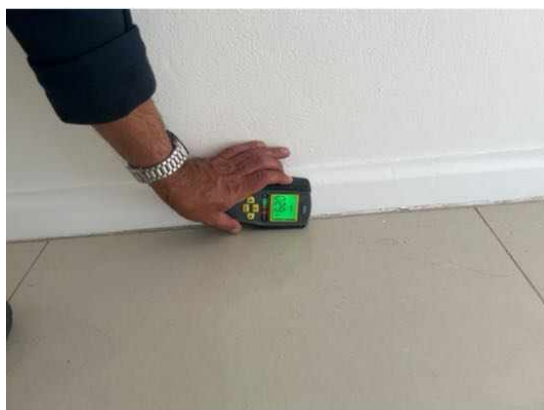
Finding: Elevated Moisture Bathroom & Back of shower

Information: Elevated moisture levels were detected to tiled surfaces in bathroom/shower areas. This may be due to porous or missing grout, cracked tiles or recent use, however the possibility of waterproofing membrane failure or plumbing leaks cannot be excluded. Persistent moisture ingress can lead to concealed damage, including timber rot and mould growth. The back of shower area also showed slightly elevated moisture in the walls and skirting also presented elevated moisture readings above typical thresholds.

Further investigation by a licensed plumber and/or waterproofing contractor is recommended as soon as possible.

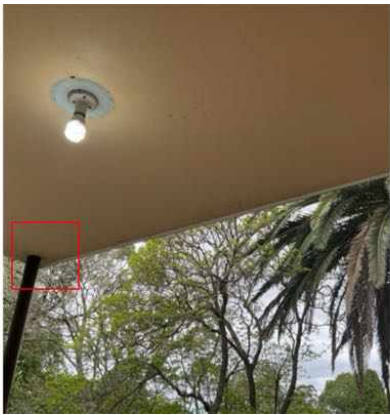
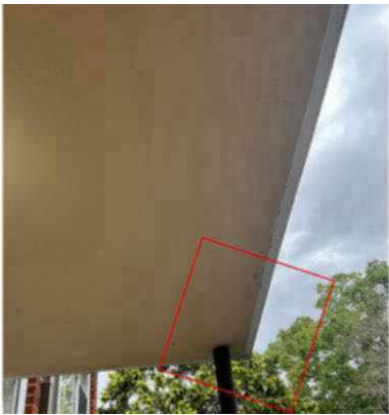
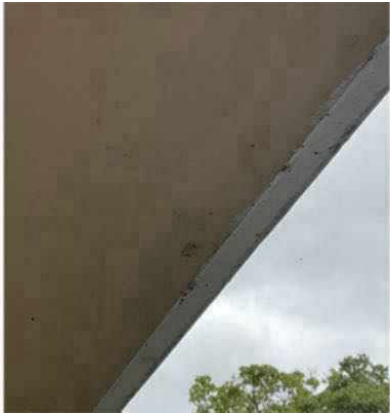
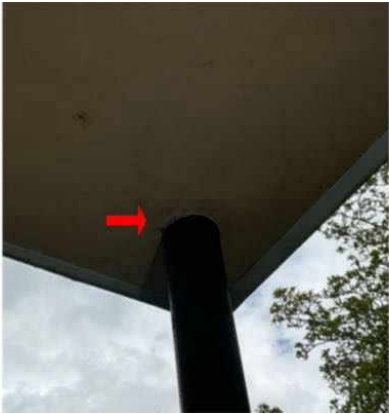
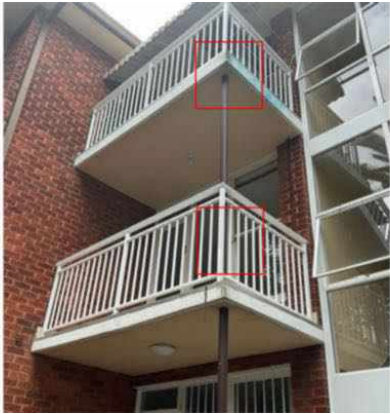
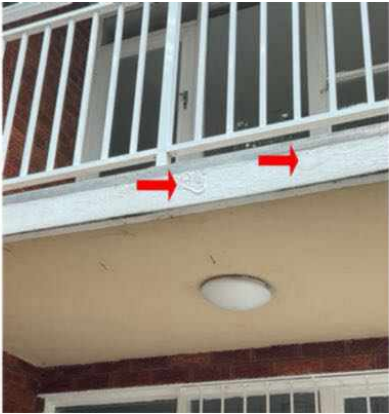
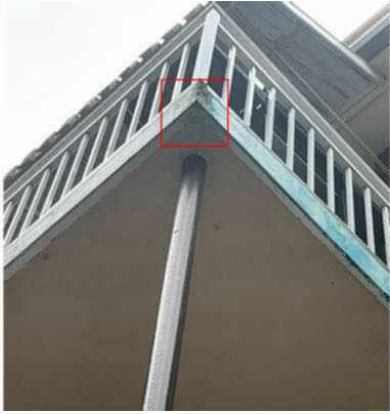
Finding 3.02

Building:	Main Building
Location:	Balcony
Finding:	Balcony Elevated Moisture - Strata
Information:	Elevated moisture was recorded at the base of the balcony above and tiles, with associated minor staining consistent with water exposure. While no internal damage was visible at the time of inspection, balconies in multi-unit dwellings are high-risk areas for waterproofing failure, which can lead to leaks into adjoining units and significant rectification costs. Further investigation by a licensed waterproofing contractor is strongly recommended.

Depending on the strata plan, this area may form part of the common property, in which case remedial responsibility may rest with the owners corporation (strata). Purchasers should seek clarification from the strata manager and legal adviser prior to purchase.

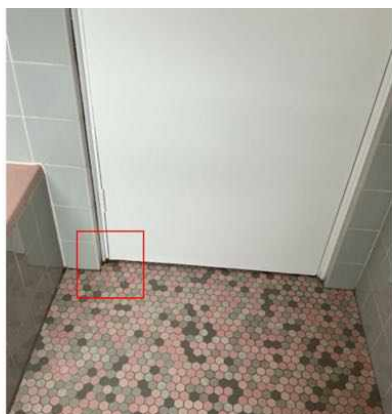
Finding 3.03

Building:	Main Building
Location:	All Internal Areas
Finding:	Wet-Area Door Jamb – Moisture Staining / Decay
Information:	Minor moisture staining and early signs of deterioration were observed at the base of the wet-area door jamb and architraves. This is commonly due to water splashing or moisture tracking from the bathroom floor into adjacent joinery. At the time of inspection, the condition appears superficial and non-structural, consistent with general wear typical of wet-area use.

It is recommended that the door junctions be resealed with a suitable moisture-resistant sealant and that ventilation and drainage within the bathroom be maintained to reduce further dampness. Where timber swelling or decay has progressed, localised repair or replacement using moisture-resistant materials (H3-treated or equivalent) should be undertaken.

For information only — further inspection by a licensed carpenter or waterproofing contractor is recommended to confirm the extent of deterioration and verify whether remedial sealing or minor replacement works are warranted.

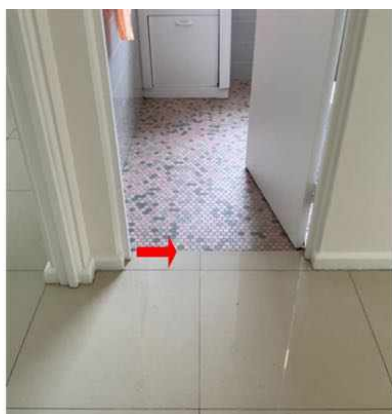
Finding 3.04

Information: The bathroom floor is at the same level as the adjoining timber flooring. This configuration is typical in modern apartments and is permitted where compliant waterproofing and floor falls are provided. No evidence of moisture damage was observed at the time of inspection; however, waterproofing performance cannot be confirmed without invasive inspection.

Care should be taken to avoid excessive water migration beyond the bathroom during use.

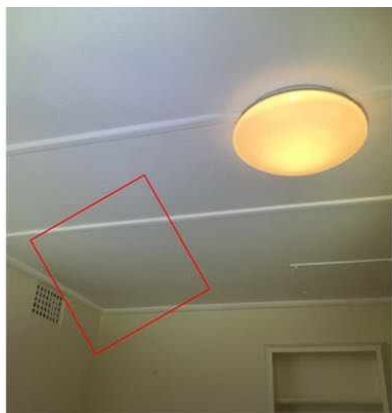
Finding 3.05

Finding: Water Staining - Humidity or Ventilation

Information: The ceiling surface shows peeling paint and water staining on the walls faint commonly consistent with humidity-related staining, often found in bathroom or wet areas with insufficient ventilation. While there is no visible sagging or major water damage, the pattern suggests prolonged moisture exposure, possibly due to steam

accumulation or minor condensation issues. According to AS 4349.1–2007 (Appendix C), this would be classified as a minor defect unless further deterioration or active leaks are found. Recommend improving mechanical or natural ventilation, cleaning the surface with mould treatment, and monitoring for recurrence.

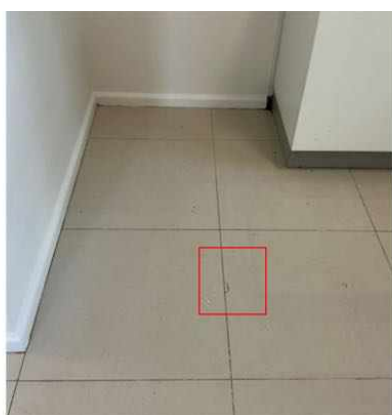
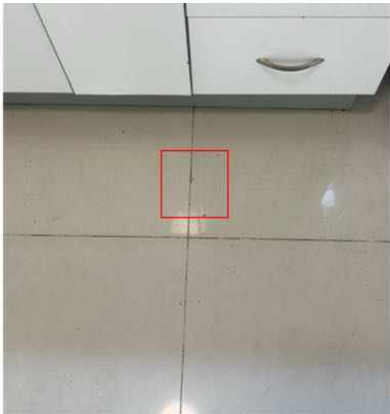
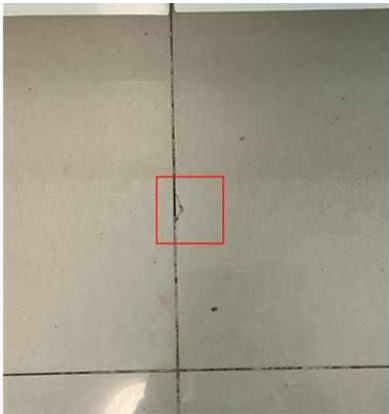
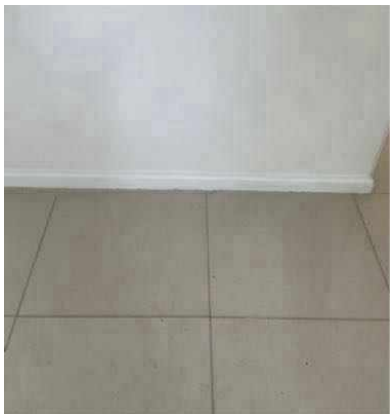
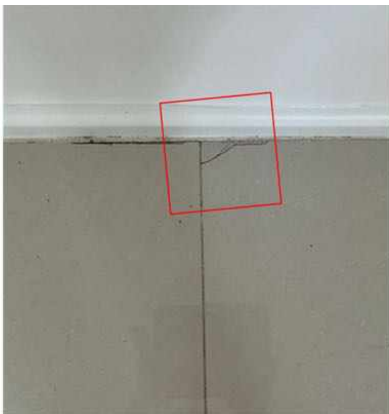
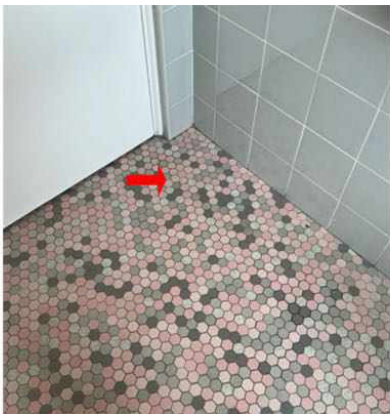
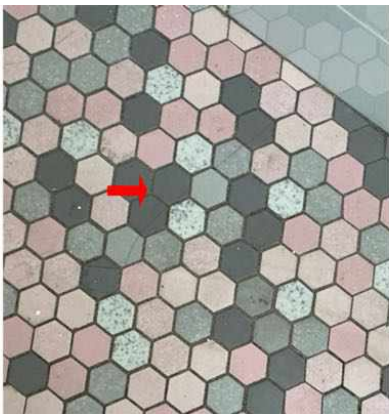
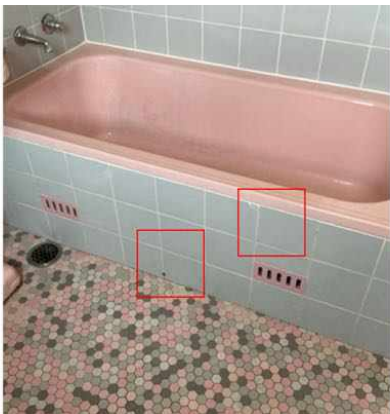
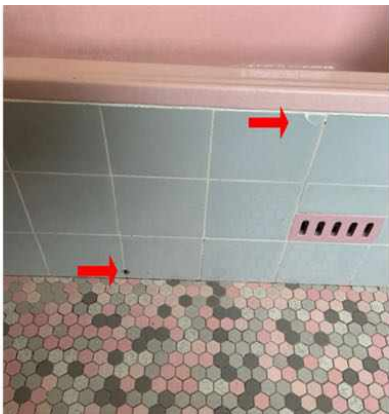
Finding 3.06

Building: Main Building
 Location: All Internal Areas - Kitchen, bedroom left
 Finding: Tiles - Cracked or damaged to some areas
 Information: Cracking was evident to the tiling in this area at the time of inspection. While the cracking appears to be minor, this area is frequently exposed to water, allowing potential for water penetration into adjoining sections of walls or flooring.

If left unmanaged, water penetration to these areas may lead to subsequent water damage, which is likely necessitate repair work to affected building elements.

A tiling contractor should be appointed to ensure that no further water damage occurs. The re-application of silicone and grouting throughout remaining tile work is also advised, to further protect the area against water penetration.

Where water penetration has led to water damage, appointment of a relevant tradesperson may be required to repair damaged building elements.

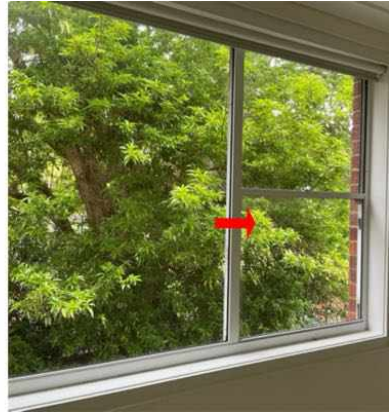
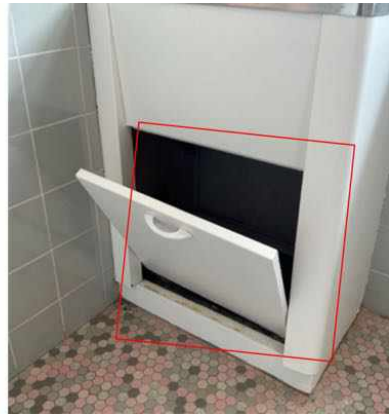
Building:	Main Building
Location:	All Internal Areas - Kitchen, bedroom
Finding:	Building element - Damaged - Switch cracked kitchens, cupboard broken kitchen ,

Information: bench top cracked , lounge sliding door noisy when sliding , possible missing fly screen , Laundry door damaged and corroded inside
Breakage occurs generally when the building materials have either aged and decayed, or as a result of damage (accidental or deliberate).

Repair and/or replacement of broken elements is advised to ensure that additional secondary defects do not arise as a consequence. Such works are necessary, as all building elements play a key role in the operation and function of the overall structure and its performance.

A relevant tradesperson should be appointed to repair or replace the affected building element prior to any subsequent damage being caused.

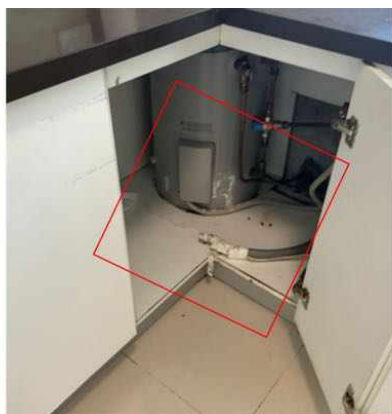
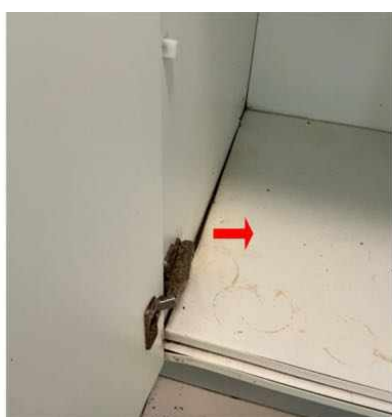
Finding 3.09

Building:	Main Building
Location:	All Internal Areas - kitchen
Finding:	Building element - Damaged - Kitchen cabinet base moisture damaged
Information:	Breakage occurs generally when the building materials have either aged and decayed, or as a result of damage (accidental or deliberate).

Repair and/or replacement of broken elements is advised to ensure that additional secondary defects do not arise as a consequence. Such works are necessary, as all building elements play a key role in the operation and function of the overall structure and its performance.

A relevant tradesperson should be appointed to repair or replace the affected building element prior to any subsequent damage being caused.

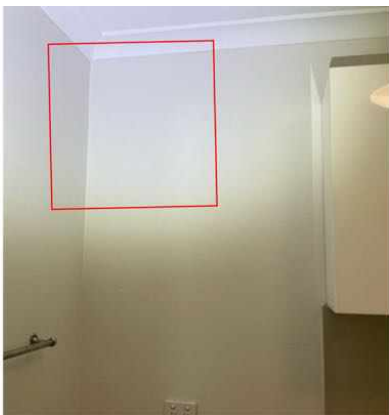
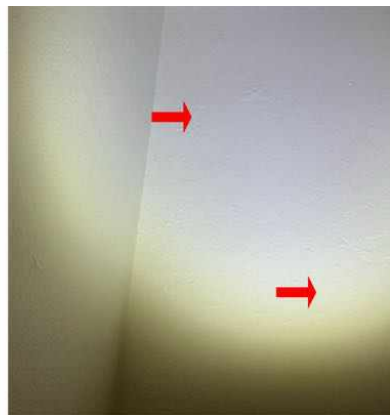
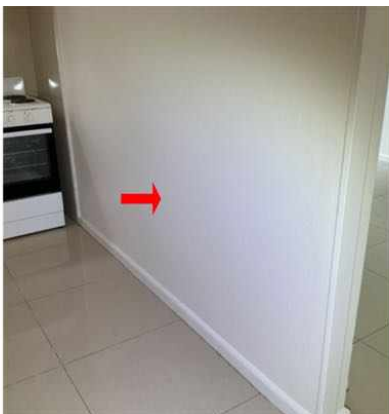
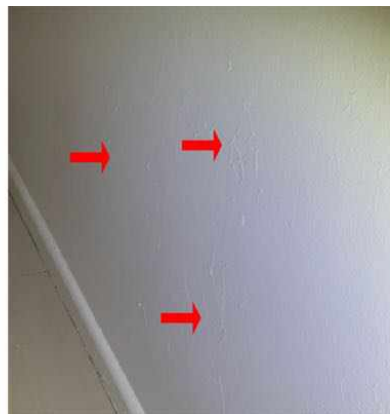
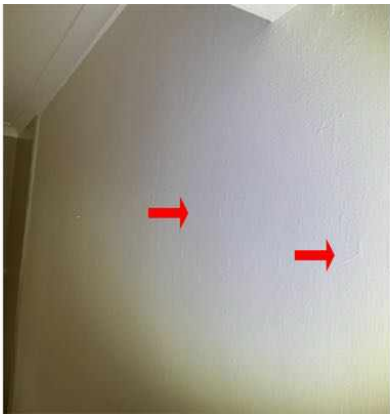
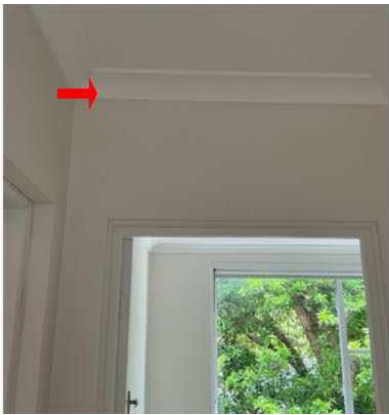
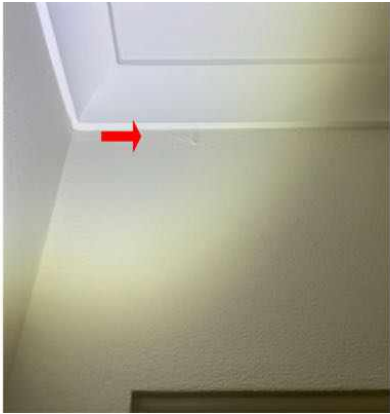
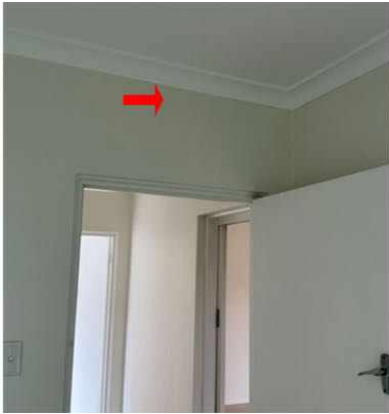
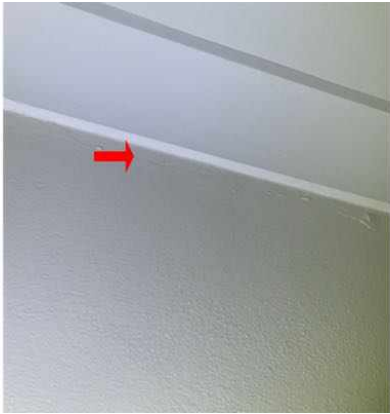
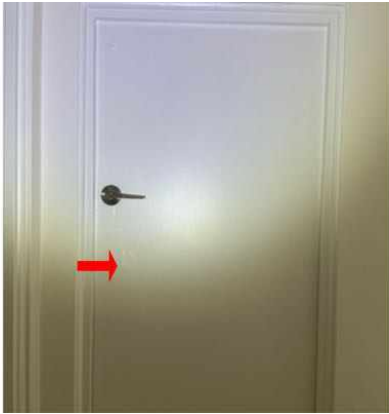
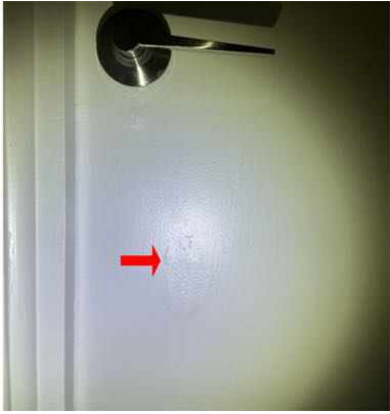
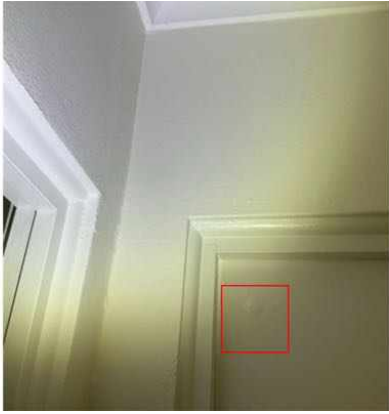
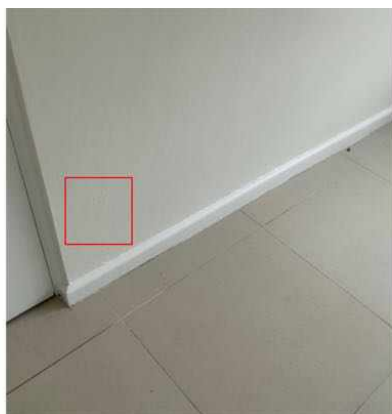
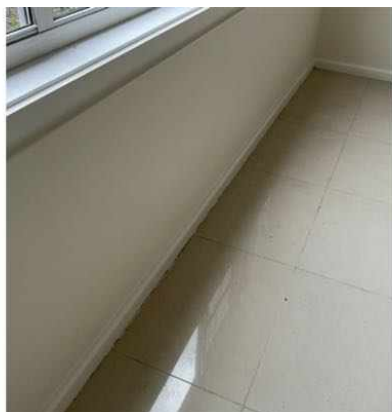
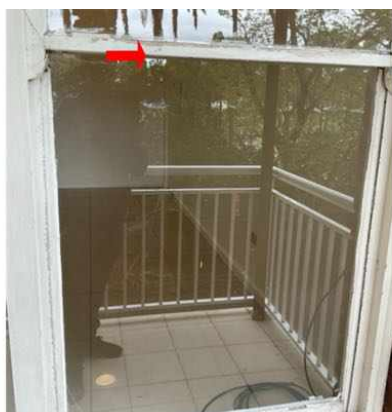
Finding 3.10

Building:	Main Building
Location:	All Internal Areas
Finding:	Paint finish and hairline cracking
Information:	The paint finish in this area was identified as being incomplete at the time of inspection including some hairline minor cracking.

Whilst incomplete or missing paint finish is generally an appearance defect, it can also lead to the development of secondary building defects over time. Incomplete areas of paint finish expose the area to moisture, potentially accelerating the deterioration of underlying building materials.

Incomplete paint finishes should be sanded back, filled, leveled and painted, as applicable. Where inadequate or missing paint protection has led to the deterioration of the associated building element, repair and/or replacement of this building element may be required.

A painting contractor should be appointed as soon as possible to perform necessary works to aid the appearance of the affected area and to ensure the area is protected

against further deterioration. Alternatively, the homeowner following manufacturer instructions may perform these works.

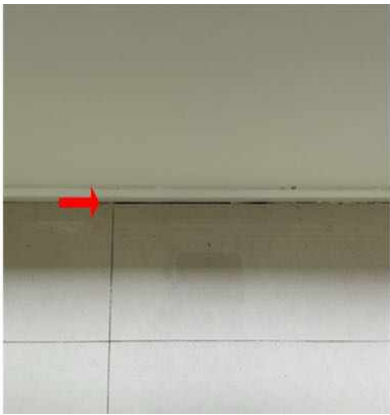
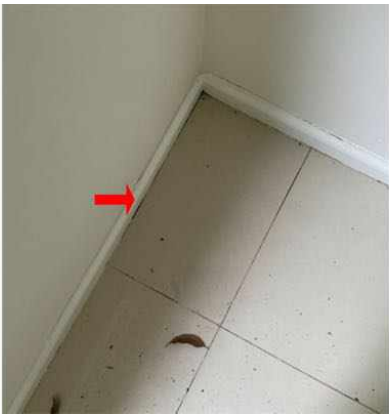
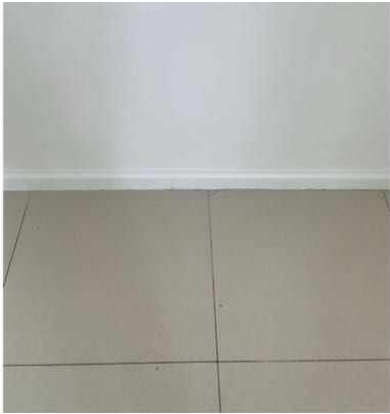
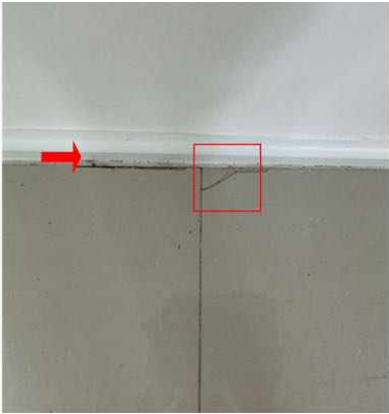
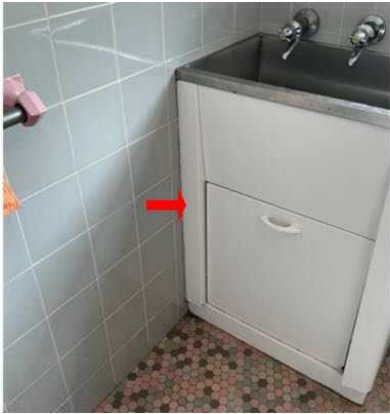
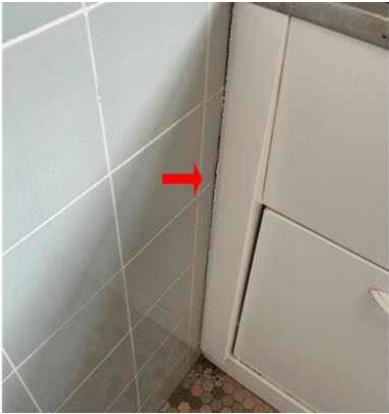
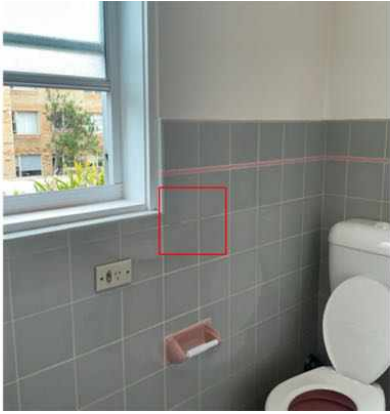
Finding 3.11

Building:	Main Building
Location:	All Internal Areas - Kitchen cabinet base, bedrooms , lounge
Finding:	Sealant and grouting - Missing or degraded
Information:	It was noted on inspection that sealant or grout is degraded. There is also evidence of poor workmanship and excessive use of sealant. Silicone should never be used as a first line of defence against waterproofing. Further inspection by a licensed waterproofing contractor is highly recommend

Different materials and floor areas move at different rates, generally causing cracking to grout or sealant at this point. A flexible sealant is required to allow for expected expansion and contraction, while keeping the joint water tight and protective of all

There appears to be excessive mould to the sealant and grout which will likely require scraping out and replacement.

Flexible and mould resistant materials should be applied to affected areas to prevent any subsequent water damage that is likely to occur. Regular maintenance and replacement of damage or missing or damaged sealant and grout is highly recommended to the wet areas, as this is a regular wear and tear defect. Sealant and grouting in areas that come into regular contact with water should be maintained for the long term care of your property.

A sealant specialist or tiling contractor should be appointed to complete these works as soon as possible

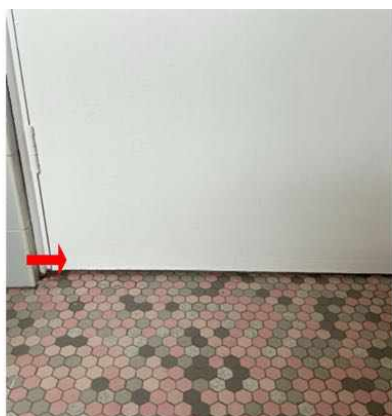
Finding 3.12

Building:	Main Building
Location:	Bathroom
Finding:	Delamination of timbers
Information:	Delamination is one means by which composite materials (e.g. layered timber composites) may fail over time. In laminated materials, repeated cyclic stresses may lead to the formation of mini-structures of separate layers, with significant loss of mechanical toughness. Water penetration or the presence of excessive moisture also generally contributes to delamination.

Where building materials have become delaminated, they lose their structural strength, and are likely to have a variety of appearance and serviceability defects as a result.

Delamination of timbers may be repaired where the area affected is minor and/or easily accessible, by gluing and screwing layers back together. However, this is an interim repair, and where delamination has occurred, the client should plan for the replacement of affected timbers sooner than would otherwise be expected.

All timber structures affected by delamination should be replaced as soon as possible to avoid any further damage. Repair and replacement estimates should be sought from a registered builder or qualified carpenter.

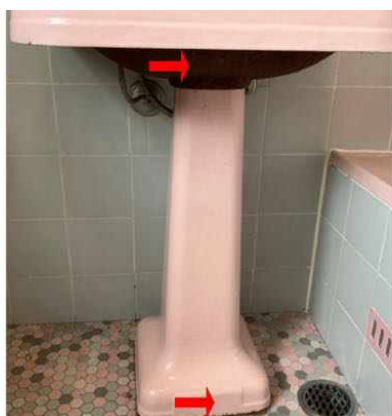
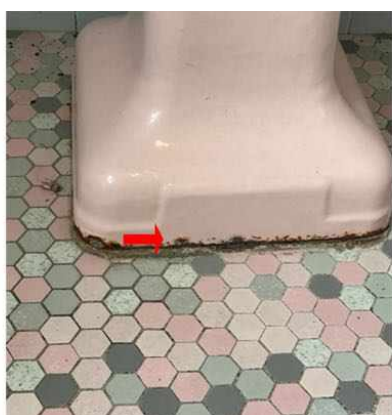
Finding 3.13

Building:	Main Building
Location:	Bathroom
Finding:	Building element - Rusted or corroded - Wash Basin
Information:	This building element shows evidence of rusting and corrosion, which is likely to have developed as a result of excessive exposure to moisture and or inadequate coatings.

As surface rust provides no protection to the underlying iron, the deteriorating condition is likely to worsen if not addressed in the short-term future.

Where possible, the use of galvanized (treated) metals or aluminium coated metals aid in rust prevention, as does regular general maintenance. Rust formation can be controlled with coatings, such as paint, that isolate the iron from the environment.

Rusting and corrosion should be managed by ideally removing or limiting the affected surface from exposure to moisture. A registered builder may be appointed to replace any building elements that have been severely affected by rust or water damage.

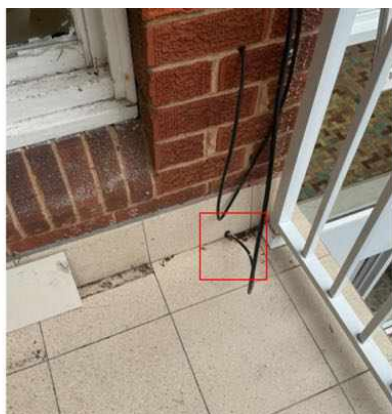
Building:	Main Building
Location:	Balcony
Finding:	Installation - substandard or incomplete (Hole not sealed, possible moisture ingress)
Information:	The installation of this building element appears to have been completed to a substandard level of workmanship or is incomplete. Generally substandard repairs or installation are related to poor workmanship, the use of inappropriate materials, or a failure to complete installation to a suitable standard.

Where installation is substandard and/or incomplete, the client should contact the responsible trade to undertake rectification. Unfinished and substandard building works are likely to degrade more quickly and may create potential for secondary defects to associated building elements.

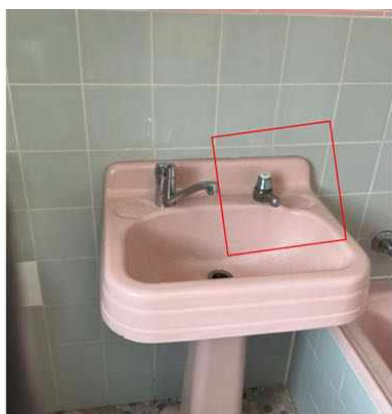
Finding 3.16

Building:	Main Building
Location:	Bathroom
Finding:	Building element - Damaged - Tap head missing
Information:	Breakage occurs generally when the building materials have either aged and decayed, or as a result of damage (accidental or deliberate).

Repair and/or replacement of broken elements is advised to ensure that additional secondary defects do not arise as a consequence. Such works are necessary, as all building elements play a key role in the operation and function of the overall structure and its performance.

A relevant tradesperson should be appointed to repair or replace the affected building element prior to any subsequent damage being caused.

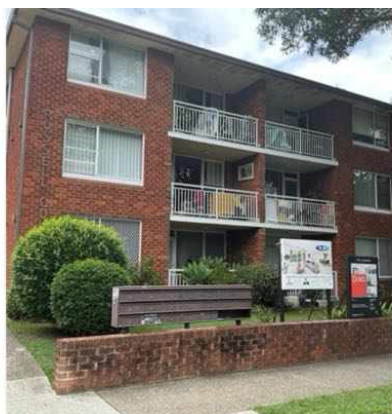
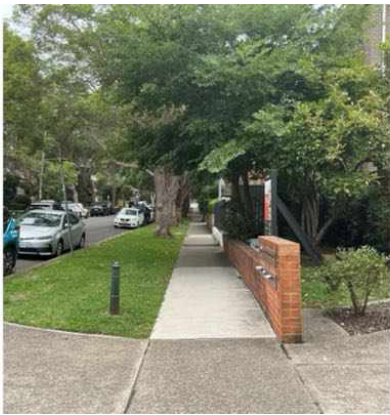
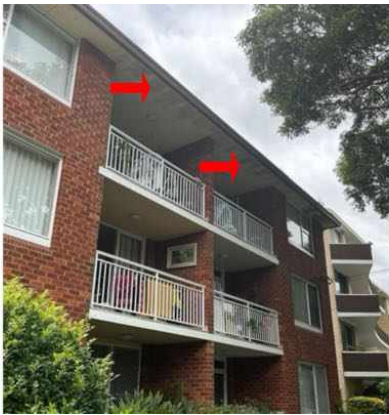
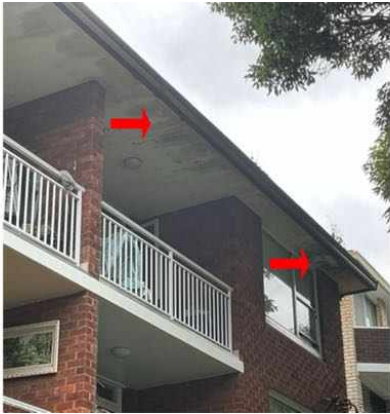
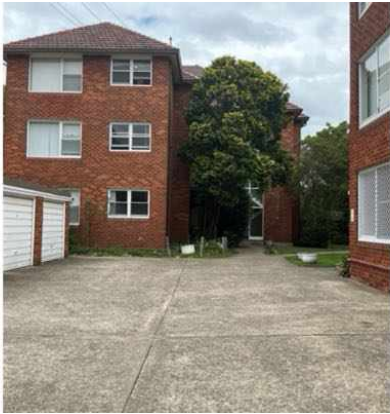
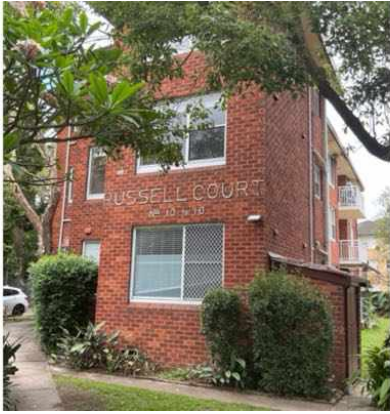
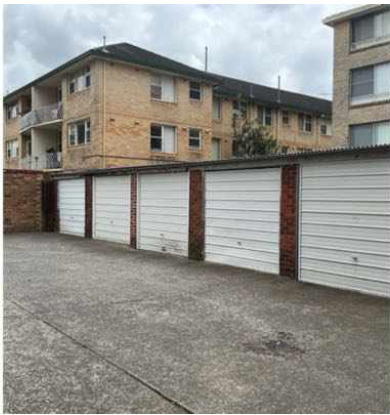
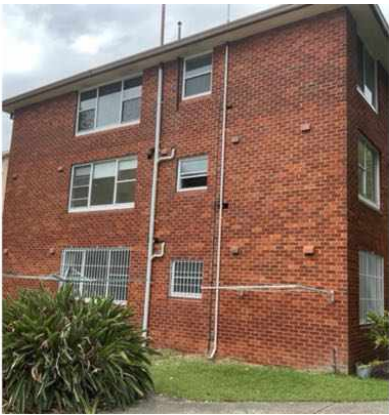
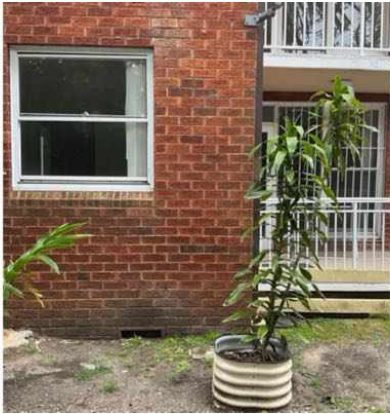
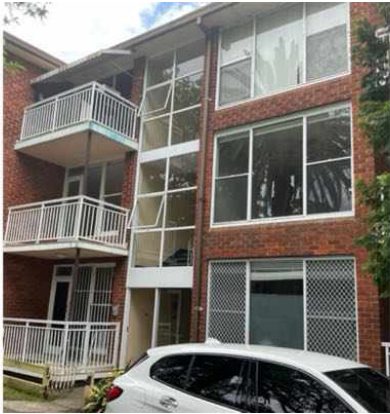
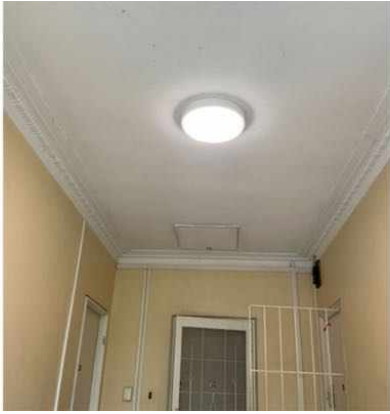
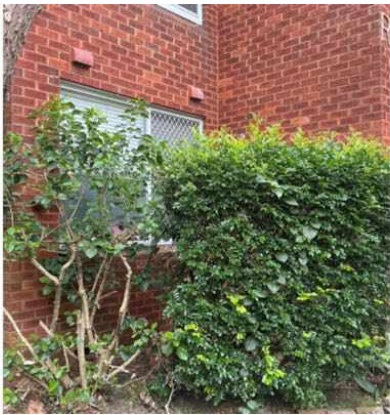
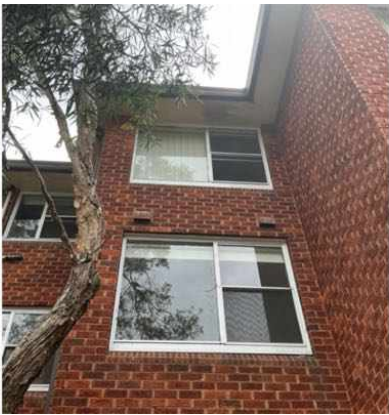
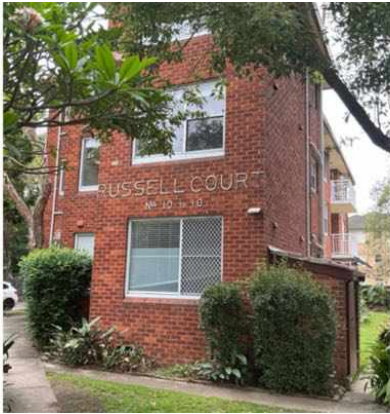
Building: Main Building
Location: All External Areas
Finding: Additional Photos - Obstructions and Limitations
Information: These photographs are an indication of the obstructions and limitations which impeded full inspection of the property at the time of inspection. These obstructions can hide an array of defects and should be removed to allow full inspection to be carried out. A re-inspection is recommended once the areas are made accessible.

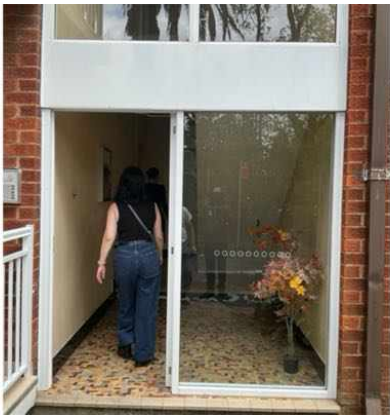
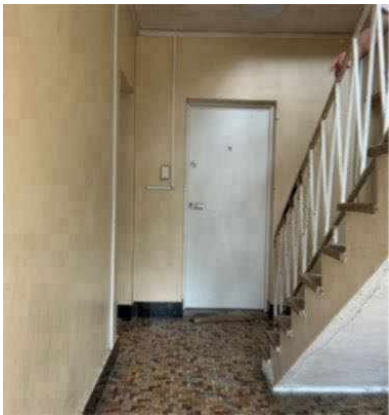
Building: Main Building
Location: All Internal Areas
Finding: Additional Photos - Obstructions and Limitations
Information: These photographs are an indication of the obstructions and limitations which impeded full inspection of the property at the time of inspection. These obstructions can hide an array of defects and should be removed to allow full inspection to be carried out. A re-inspection is recommended once the areas are made accessible.
