Building and Timber Pest Inspection Report

Inspection Date: Fri, 13 Mar 2026

Property Address: 3 Seaforth St, Bomaderry NSW 2541,
Australia

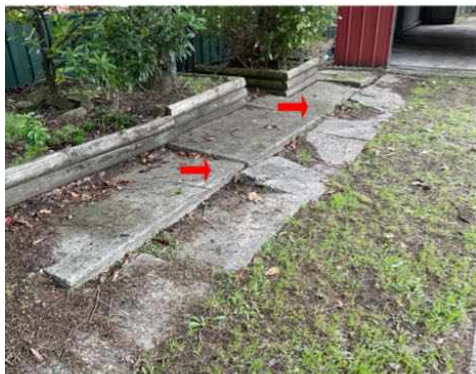
Building:	Building 1
Location:	Driveway
Finding:	Crack in concrete slab - Category 4
Information:	A crack coded as Category 4 was identified in the slab. A Category 4 crack is described as a crack that appears as a gap in the slab, with disturbing curvature or change in level affecting the slab.

The approximate width of the crack or gap is 4mm-10mm or a change in offset of

greater than 25mm when a 3m straight edge is placed over the defect.

Category 4 cracking to slabs exceeds allowable Standards and Tolerances, and are therefore considered as major defects that require rectification.

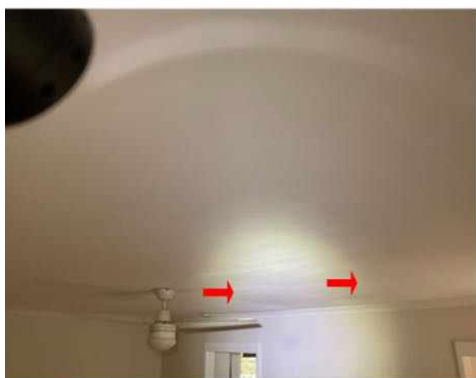
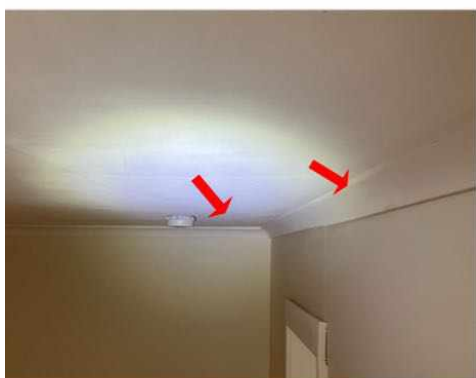
Finding 3.01

Building:	Building 1
Location:	Pictured areas
Finding:	Ceiling - Sagging/deflection evident
Information:	The ceiling in the loungeroom was found to have minor sagging and cracking evident at the time of inspection. Sagging to the fixed ceiling structure generally indicates that the building materials have swollen, due to contact with water, or that fixings (e.g. nails or glue) have become loose and require reattachment.

No moisture was evident in the roof void above this area and this appears to be minor in nature required refixing in place.

Where minor sagging is evident, comparatively minor works, such as re-gluing of ceiling sheets, may be required. Such works may be performed by relevant tradespeople, such as plasterers and painters.

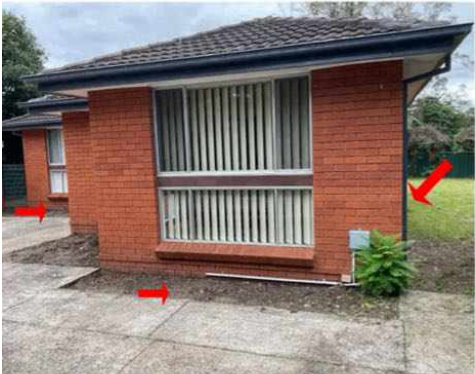
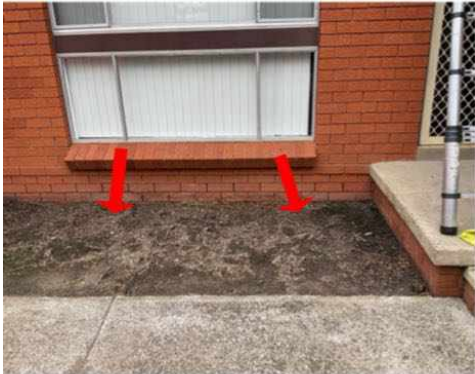
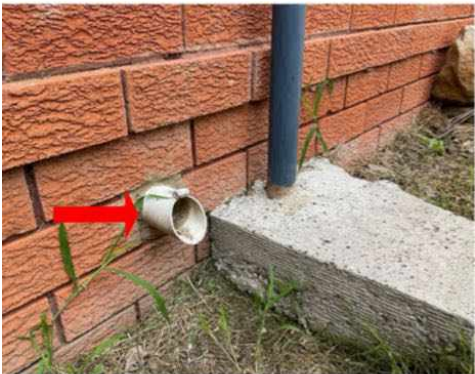
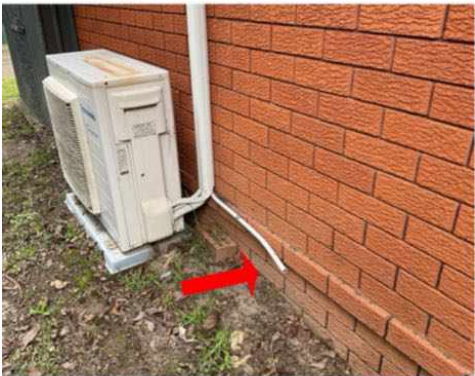
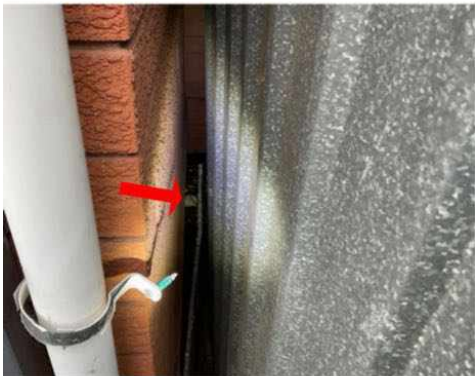
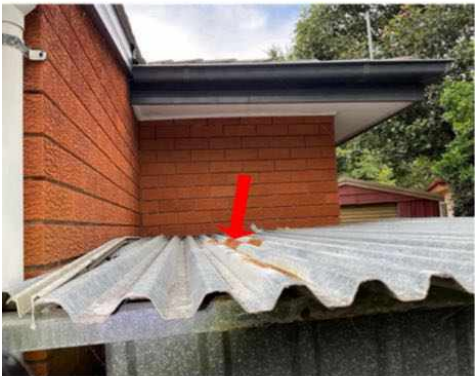
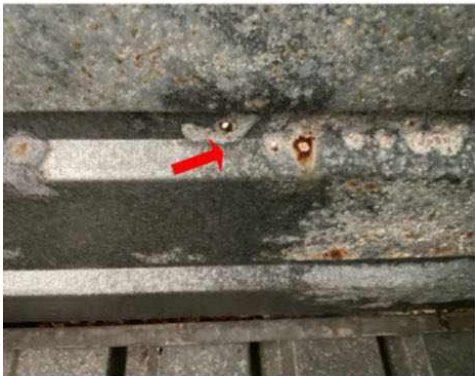
Finding 3.02

Building:	Building 1
Location:	Walls, shed,
Finding:	Site drainage - Inadequate
Information:	The site drainage in these areas was found to be inadequate at the time of inspection, creating potential for subsequent water damage to associated building elements.

The bathroom and laundry floor wastes, air conditioner and hot water system overflows all run against the house walls. The front shed roof has no fall resting this roof.

Where site drainage is inadequate, installation of an Agricultural (Aggie) Drain may be required. A qualified plumber should be appointed to further inspect the property and perform any remedial works as necessary. Secondary defects are likely to occur if left

unmanaged.

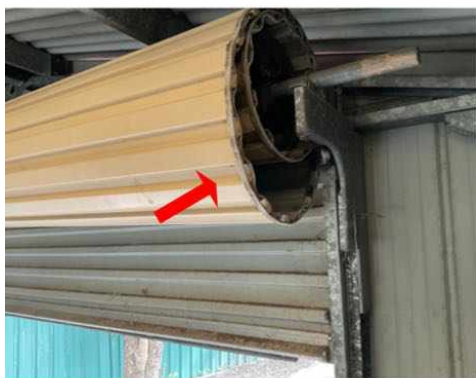
Finding 3.03

Building:	Building 1
Location:	Garage
Finding:	Doors appear non operational
Information:	These pictured doors did not work at the time of the inspection. The front door would not work with the button or remote. The rear manual door is unravelling.

Repairs of these doors is advised to improve the operational state of the associated doors and for security.

A garage door contractor should be appointed to repair these doors as soon as possible.

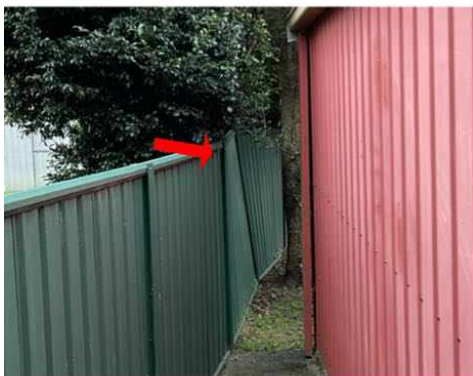
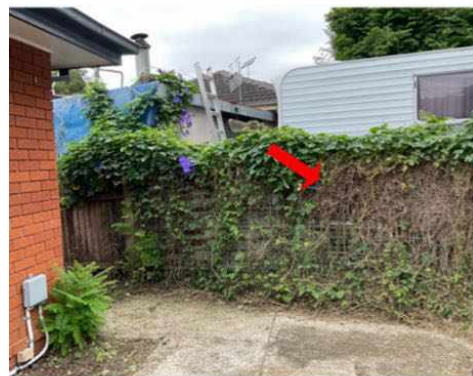
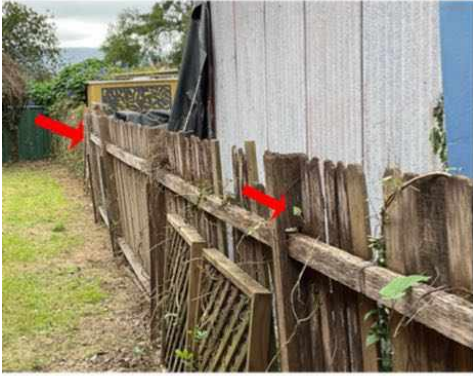
Building:	Building 1
Location:	Pictured fences
Finding:	Fences damaged - leaning
Information:	Evidence of damage to the pictured fences was identified at the time of the inspection. The likely cause of these fences leaning is not enough concrete used in the post footings, wood bora and wood rot to the right timber fence. If left unmanaged these fences will deteriorate further. It is suggest a fencing contractor be engaged for rectification when convenient.

The cost of repairing fences is often shared between neighbours.

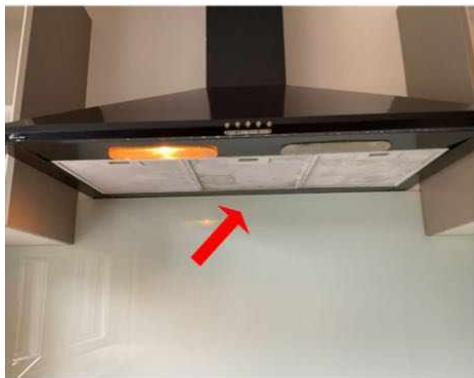
Building:	Building 1
Location:	Rear Roof cavity
Finding:	Rangehood and rangehood ducting damaged
Information:	The rangehood ducting was found to be damaged in the roof cavity, possibly by rodents. This will mean the rangehood is not functioning effectively and exhaust gases from cooking can create a potential fire risk if not replaced. This is a relatively simple job. The rangehood was also not operating with only one light working.

It is highly recommended that a skilled handy person or A/c installer be appointed to reconnect the ducting in order to prevent a loss of air into the roof void.

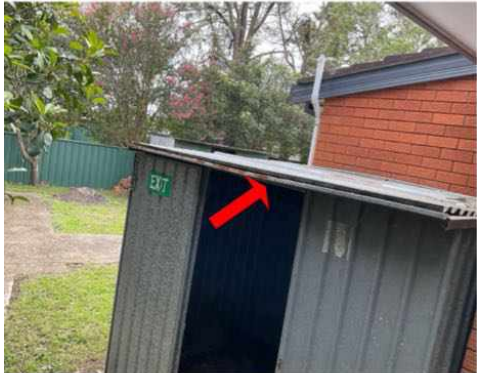
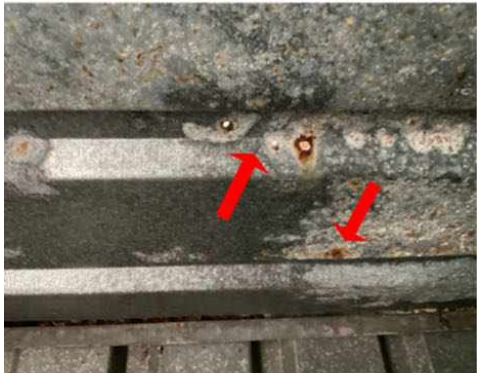
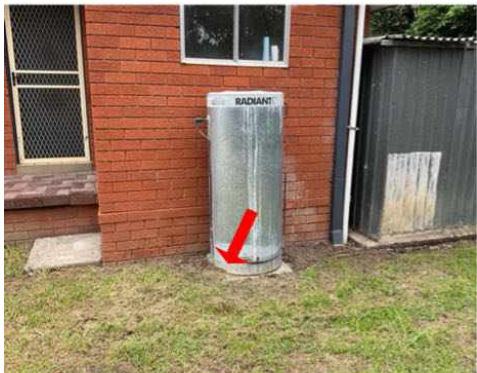
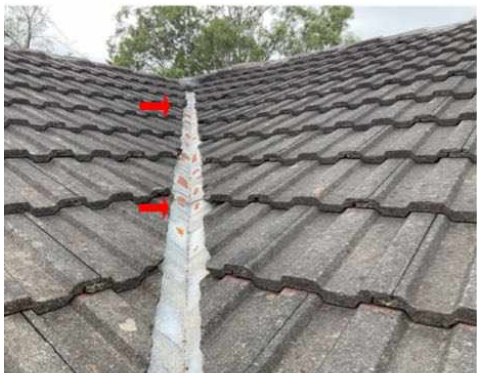
Finding 3.08

Building:	Building 1
Location:	Pictured sheds, water tank, roof valleys
Finding:	Areas rusted or corroded
Information:	These areas shows evidence of rusting and corrosion, which is likely to have developed as a result of excessive exposure to moisture and or inadequate coatings.

As surface rust provides no protection to the underlying iron, the deteriorating condition is likely to worsen if not addressed in the short-term future.

Where possible, the use of galvanized (treated) metals or aluminium coated metals aid in rust prevention, as does regular general maintenance. Rust formation can be controlled with coatings, such as paint, that isolate the iron from the environment.

Rusting and corrosion should be managed by ideally removing or limiting the affected surface from exposure to moisture. A registered plumber or skilled handy person should be appointed immediately to repair or replace these areas that have been severely affected by rust or water damage.

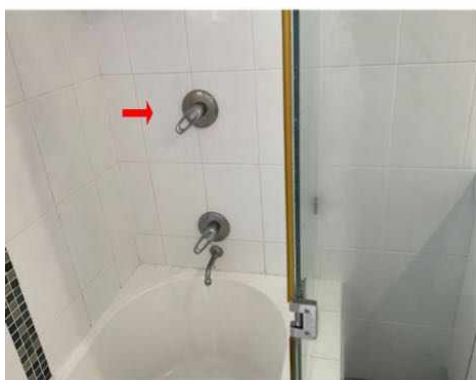
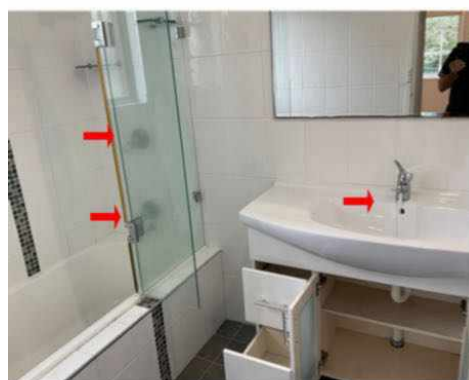
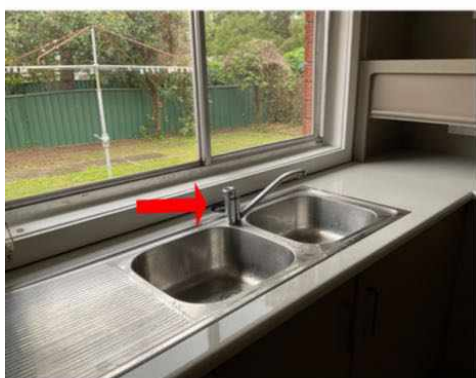
Finding 3.09

Building: Building 1
Location: Bathroom & kitchen
Finding: Taps - Water hammer
Information: Many taps shows evidence of water hammer being present. Water hammer, a pressure surge resulting when a fluid is forced to suddenly change direction, is a common defect in plumbing fittings, particularly those that are aged and not frequently maintained. Water hammer is generally caused by factors that create high water pressure in the affected plumbing fixture, usually evidenced by a faint banging noise during operation of the affected tap.

Although water hammer is generally considered to be a minor defect, subsequent damage such as erosion of tap hardware and/or water damage to associated building elements is likely to occur if left unmanaged.

A licensed plumber should be appointed as soon as possible to replace any affected tap hardware and perform any remedial works as necessary. Please be advised that the appointment of a cabinet maker or qualified carpenter may be necessary if water damage to associated building elements has occurred.

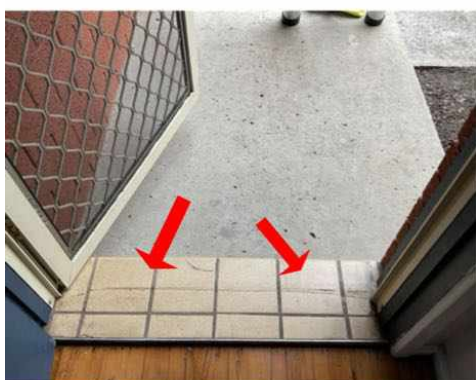
Finding 3.10

Building: Building 1
Location: Porches

Finding: Tiles cracked
 Information: Cracked tiles were evident in these pictured areas at the time of inspection. It is suspected that this cracking has occurred as a result of minor settlement or impact damage.

Cracked tiles throughout the household detract from the overall appearance of the affected areas. In wet areas of kitchens and bathrooms, it can lead to water damage of adjoining walls and floors.

Replacement of cracked tiles is recommended as soon as possible. A tiling contractor may be appointed to perform these works. Where cracks become more numerous, contact a licensed building inspector for further investigation.

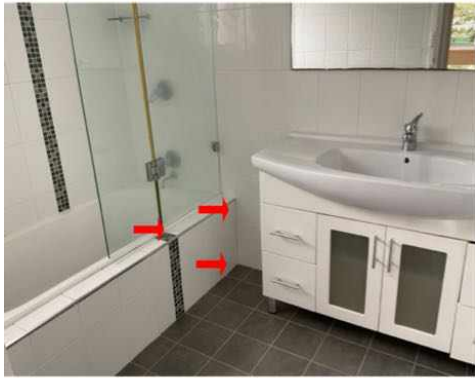
Finding 3.11

Building: Building 1
 Location: Bathroom
 Finding: Sealant and grouting - Missing or damaged
 Information: It was noted on inspection that sealant or grout is degraded to these pictured wet areas.

Different materials and floor areas move at different rates, generally causing cracking to grout or sealant at this point. A flexible sealant is required to allow for expected expansion and contraction, while keeping the joint water tight and protective of all associated building materials.

Flexible and mould resistant materials should be applied to affected areas to prevent any subsequent water damage that is likely to occur. Regular maintenance and replacement of damage or missing or damaged sealant and grout is highly recommended to the wet areas, as this is a regular wear and tear defect. Sealant and grouting in areas that come into regular contact with water should be maintained for the long term care of your property.

A sealant specialist or tiling contractor should be appointed to complete these works as soon as possible

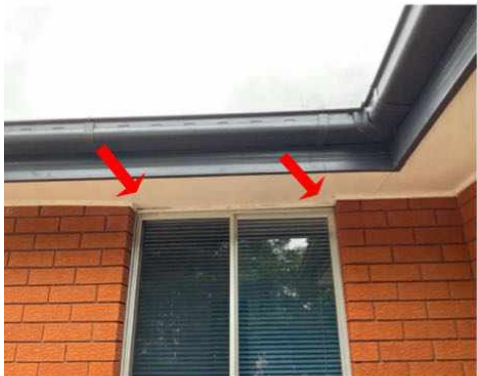
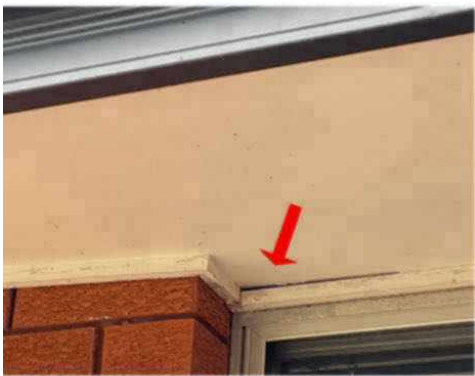
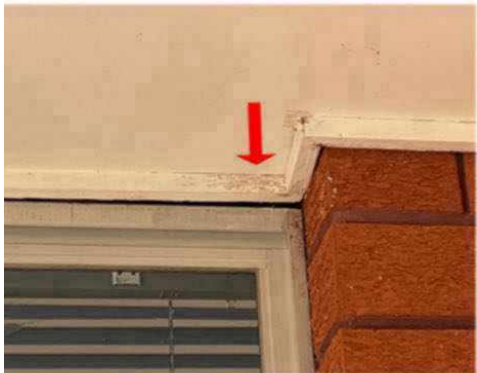
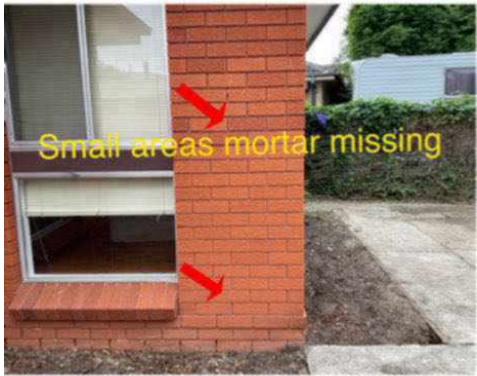
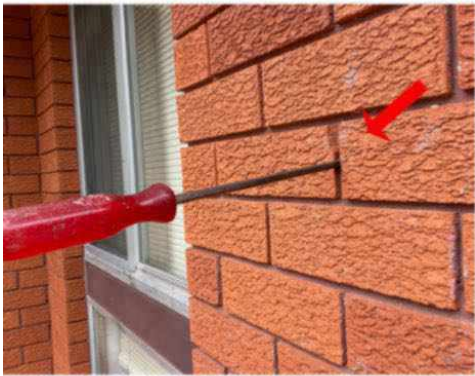
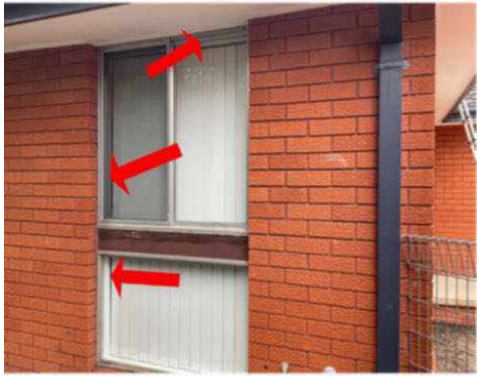
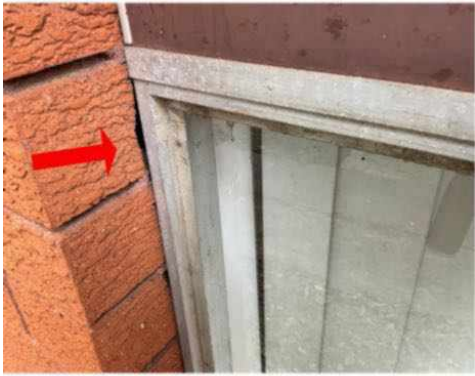
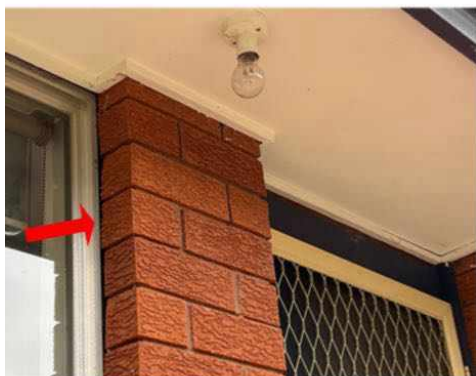
Finding 3.12

Building: Building 1
 Location: Pictured Areas
 Finding: Sealant (external) - Missing.
 Information: It was noted on inspection that areas of external sealant was missing to small areas of the external walls and many windows.

Flexible sealants should be applied to these affected areas to prevent any subsequent water damage that is likely to occur.

A sealant specialist or skilled handy person should be appointed to complete these works as soon as possible

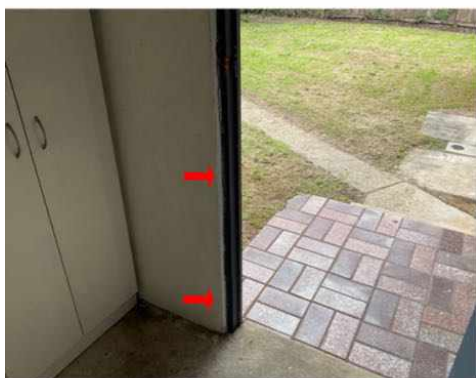
Finding 3.13

Building:	Building 1
Location:	Lounge Room, laundry
Finding:	Cracking - minor
Information:	Although fine cracks are quite noticeable, they are often only considered to be an appearance defect, and usually do not indicate any structural damage. Generally, the cause of a fine crack is indicative of a separation between building materials and finishes (e.g. paint, plaster, etc.) along joins.

Cracking of this nature can generally be repaired with minor sanding, filling and/or repainting. This cracking also requires additional screws to stop the minor sagging evident. Such works should be performed by a plasterer, carpenter or skilled general handyman.

Monitoring of all cracking should be conducted frequently. Always contact a building inspector should cracks widen, lengthen, or become more numerous.

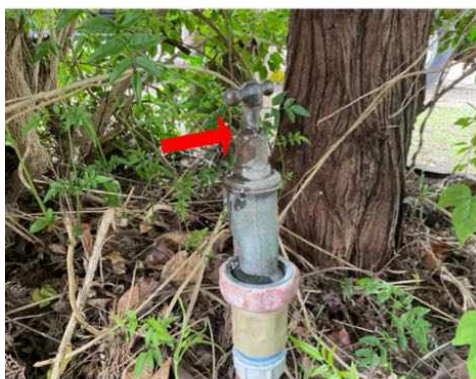
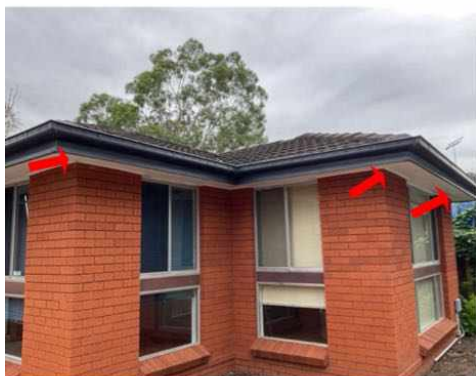
Finding 3.14

Building:	Building 1
Location:	Pictured external areas
Finding:	Building elements - Damaged

Information: Evidence of minor missing or damaged areas was identified at the time of the inspection. These include -

1. The front yard and kitchen taps are leaking when turned on.
2. Some eave areas appear to have been constructed out of level.
3. Testing stoves in not in the scope of NSW building reports, this stove has a missing knob.

A carpenter and plumber would be the trades responsible for rectification of these areas when convenient.

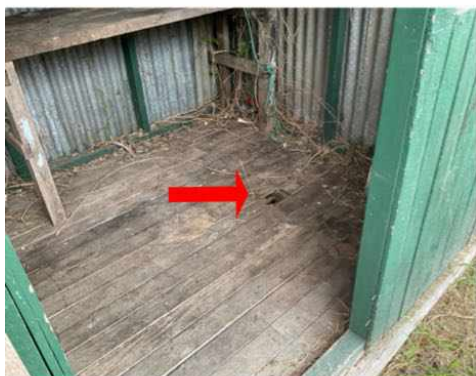
Finding 3.15

Building: Building 2
 Location: Pictured shed areas
 Finding: Wood rot
 Information: The building shows evidence of wood rot. Wood rot, also known as Fungal Decay, occurs when timbers and other cellulose building materials are exposed to damp conditions on an ongoing basis. This could be the result of exposure to weathering over a prolonged period of time, or the attraction of excessive moisture from other abutting building materials.

Early intervention and regular maintenance, particularly of exterior timbers, will prolong the useful life of these building elements. Prior to any works being performed, the cause of the moisture that has created the visible wood rot should be identified and addressed in a suitable manner. Replacement of affected timbers may then be a necessary step in protecting surrounding building elements from such deterioration.

A qualified carpenter or registered builder may also be required to replace affected building materials.

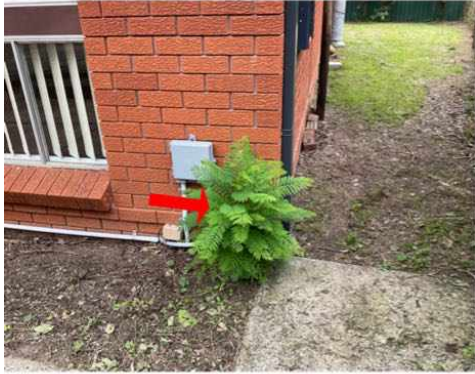
Building: Building 1
 Location: Yard - front
 Finding: Bridging - Vegetation
 Information: Where vegetation obstructs inspection of building elements, also known as bridging as it provides a bridging point for the access of termites, full inspection can not be achieved. Consequently moisture or dampness may be present and the areas becomes conducive to termite activity. Plants against or very close to buildings provide cover, shade and can provide an environment that is attractive to termite infestation.

The removal and replanting of species that do not provide "cover" or cutting back of existing vegetation will assist greatly in preventing Bridging from occurring.

The removal of any such materials that may be conducive to termite activity should be carried out as soon as possible and arrange re inspection to minimize the risk of termite attack.

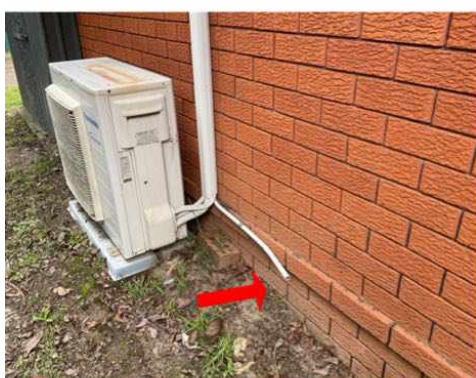
Building:	Building 1
Location:	Pictured external wall areas
Finding:	Overflows - Not plumbed for drainage
Information:	The pictured overflow pipes are not plumbed or connected to suitable drainage, which has resulted in the surrounding area becoming excessively damp.

These damp conditions can lead to secondary defects such as rot, rust or corrosion of associated building elements, the formation of fungal decay, or even the creation of potential slip hazards. When coupled with poor site drainage, pooling of water may also attract termite activity to this area. It is highly recommended that a qualified plumber be appointed to install adequate drainage to these areas. These works will ensure that the area remains dry and free of any secondary defects.

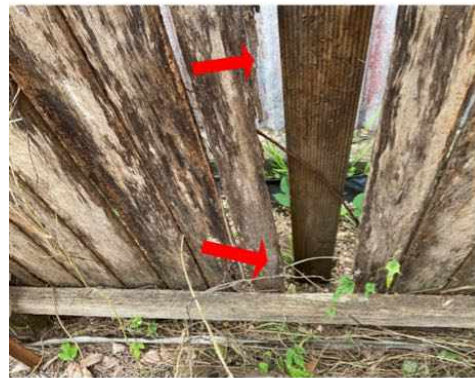
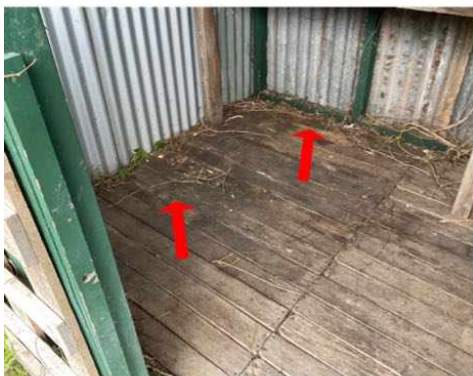
Finding 7.01

Building:	Building 1
Location:	Shed, fence, subfloor areas
Finding:	Fungal decay - present (localised)
Information:	Fungal decay also known as wood decay or wood rot generally refers to the deterioration of timber elements when in contact with excessive levels of moisture for a

The development of fungal decay is accelerated by temperatures from 5degreeC to 40degreeC as well as the presence of oxygen. Generally fungal decay develops on timber elements that are in use in an external environment which are exposed to rain penetration.

Note - See ALL wood rot photos, all these show fungal decay.

In this case, the affected timber elements are in a decaying state and will need removal or replacement by a carpenter or licensed builder.

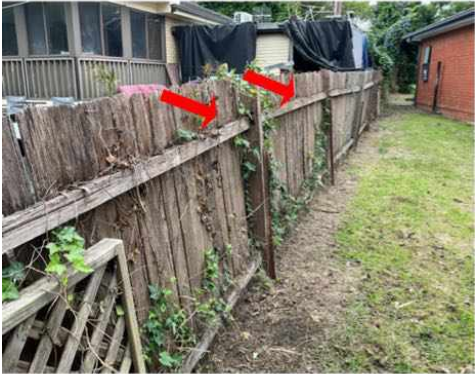
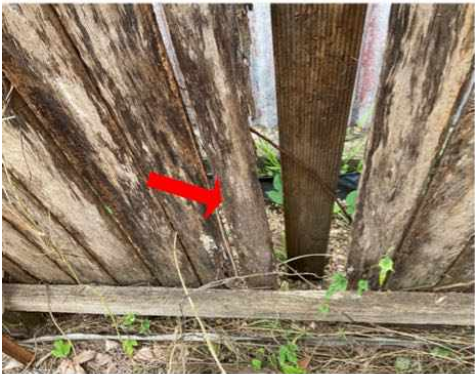
Finding 8.01

Building:	Building 1
Location:	Pictured fences
Finding:	Evidence of wood borer activity identified
Information:	Wood borers small beetles that colonise in exposed timber elements are a common timber pest that are regularly mistaken for termites. Although wood borer activity is generally not detrimental to the affected timber they may lead to serious damage and

necessitate replacement of certain building elements if left unattended.

As no live wood borer activity was identified treatment is not required at this time. Replacement of affected timbers may be considered by the client for superficial reasons.

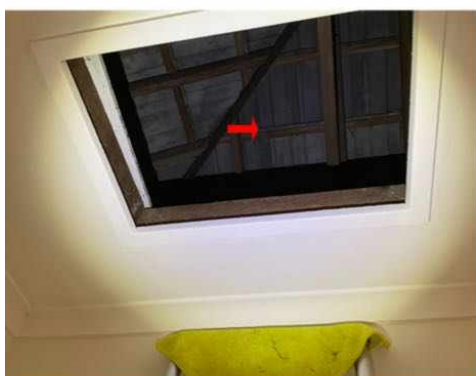
Although not a requirement at the time of construction, replacement of any missing building element is advisable (although this can be quite expensive to do after the time of construction). Where sarking is missing, regular inspections of the roof tiles for cracking and potential moisture penetration is required.

Sarking may be retrospectively fitted by a registered builder at the discretion of the client.
