Building and Timber Pest Inspection Report

Inspection Date: Tue, 3 Mar 2026

Property Address: 56 Queensville St, Kingsville VIC 3012,
Australia

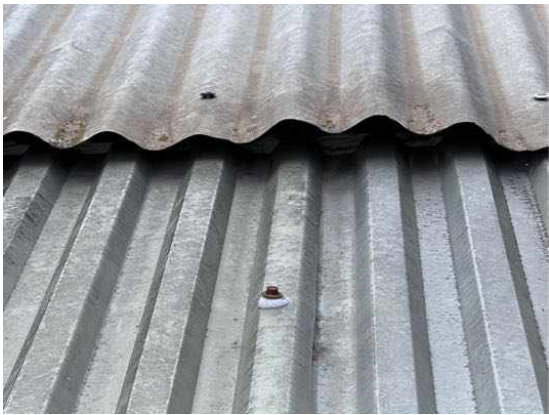
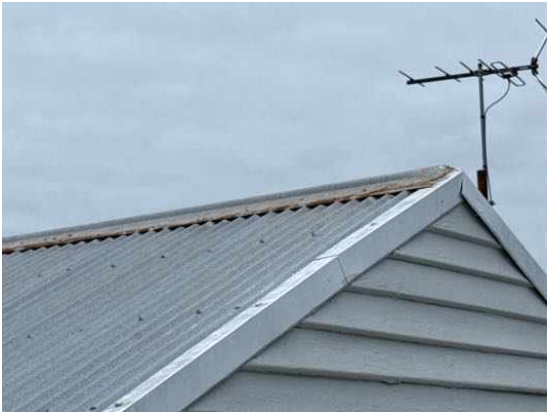
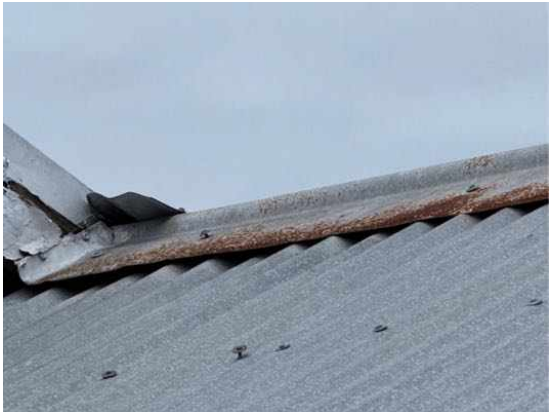
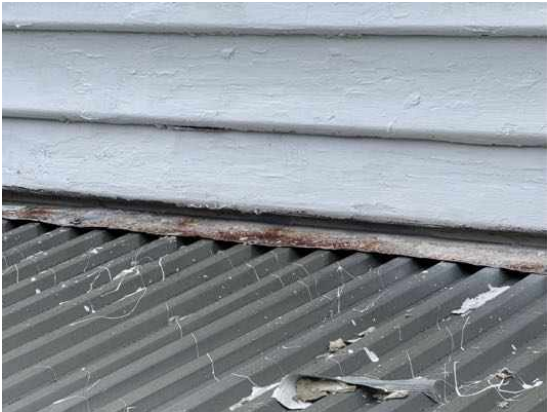
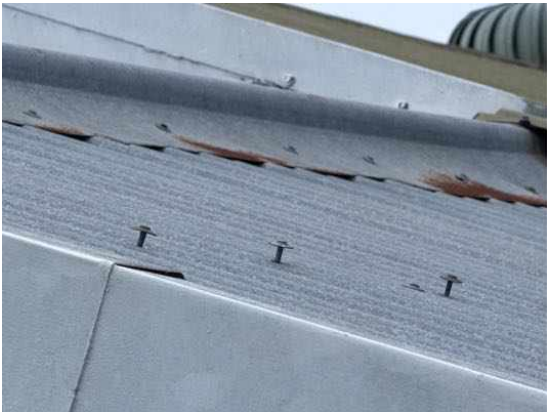
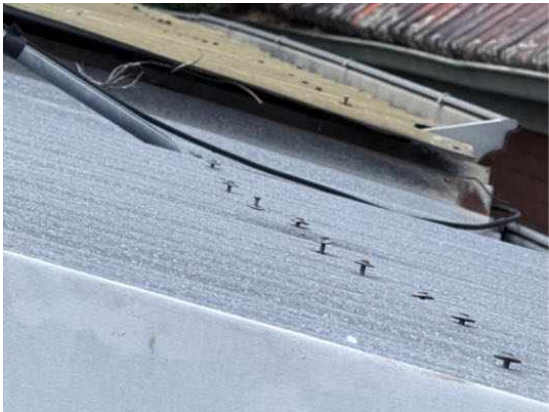
Building:	Main Building
Location:	Roof Void
Finding:	Roofing Deterioration – Loose Fixings, Rusted Flashings & Drainage Concerns (Moderate to Major)
Information:	During the inspection, multiple defects were observed to the metal roof covering and associated flashings. Significant corrosion is present to several flashings, particularly at abutments and transitions. In some areas, corrosion has progressed beyond surface oxidation, indicating material thinning which may compromise long-term weatherproofing performance.

Roofing screws were found to be loose and/or partially lifted at numerous locations. Several fixings appear inadequately seated, and some roof sheets exhibit minor movement, suggesting reduced wind uplift resistance and compromised fixing integrity. Over time, this condition increases the likelihood of water ingress through enlarged penetrations and deteriorated neoprene washers.

Sections of the roof sheeting were observed to be inadequately secured, and minor lifting was evident along sheet laps. This condition, combined with loose fasteners, may allow capillary action or wind-driven rain to penetrate beneath the sheets.

Gutters were observed to be holding/pooling water, indicating inadequate fall or possible minor deformation. Persistent ponding accelerates corrosion, particularly at

Internally, no active water ingress was detected at the time of inspection. However, some ceiling areas show evidence of prior patch repairs, which may indicate historical leaks that have since been addressed cosmetically. Recently painted ceilings can obscure moisture staining, and absence of visible leakage at the time of inspection does not eliminate future risk.

While no active internal leaks were noted, the cumulative effect of corroded flashings, loose fixings, minor sheet movement, and gutter ponding presents an elevated risk of future water ingress, especially during prolonged or wind-driven rainfall events.

- Re-secure or replace loose roofing screws with appropriate cyclone-rated fixings and new neoprene washers.
- Replace heavily corroded flashings.
- Assess and rectify sheet fixing integrity and laps.
- Correct gutter fall and ensure free drainage.

If corrosion is widespread, partial re-roofing or staged replacement may need to be considered in the medium term to prevent progressive deterioration.

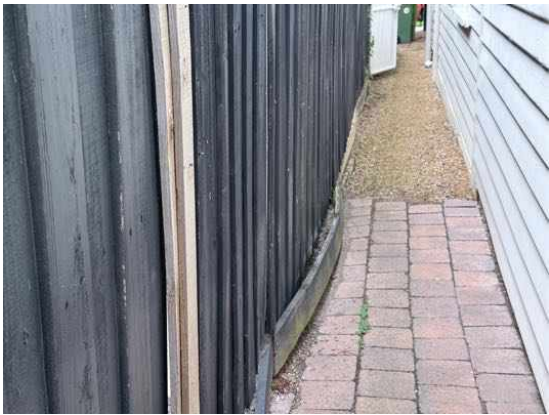
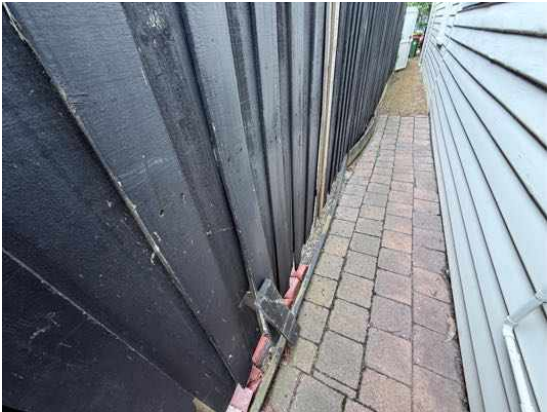
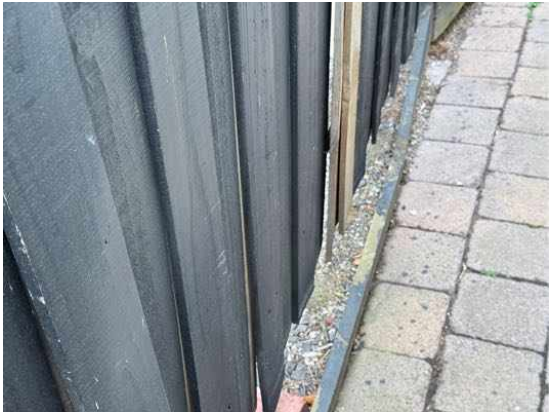
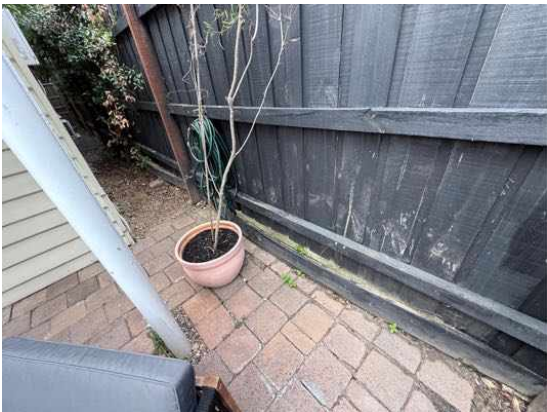
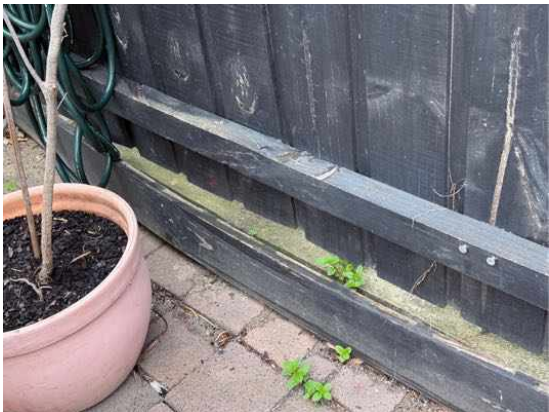
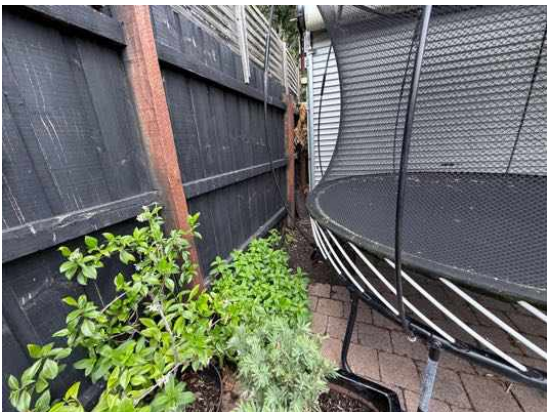
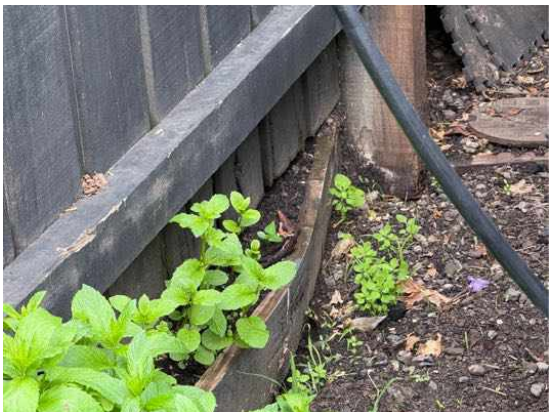
Building:	Main Building
Location:	Yard
Finding:	Timber Boundary Fence Deterioration
Information:	The timber boundary fence was observed to be deteriorating in sections, with visible warping, splitting and separation of palings. Some boards appear weathered and loosely fixed, and minor distortion is evident along the lower rail. While the fence remains generally standing at the time of inspection, continued exposure to weather and moisture may result in progressive weakening and potential instability over time.

Maintenance and selective replacement of damaged palings/rails is recommended in the short to medium term to prevent further deterioration and to maintain adequate boundary support and presentation.

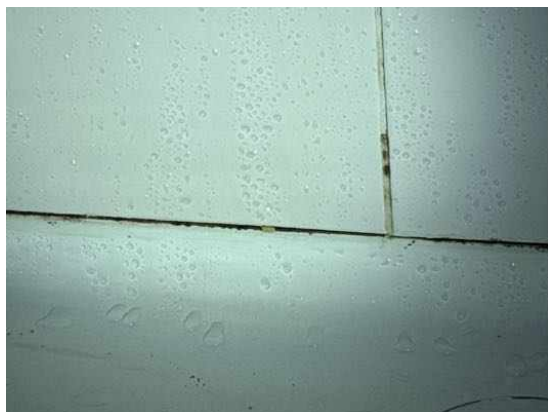
Finding 3.02

Building: Main Building
Location: Bathroom
Finding: Sealant or Grout- degraded/ fine cracks (moderately significant)
Information: It was noted on inspection that sealant or grout is degraded or cracked to the tiled shower alcove and or other areas of the bathroom.

Different materials and floor areas move at different rates, generally causing cracking to grout or sealant at this point. A flexible sealant is required to allow for expected expansion and contraction, while keeping the joint water tight and protective of all associated building materials.

There appears to be excessive mould to the sealant and grout which will likely require scraping out and replacement.

Flexible and mould resistant materials should be applied to affected areas to prevent any subsequent water damage that is likely to occur. Regular maintenance and replacement of damage or missing or damaged sealant and grout is highly recommended to the wet areas, as this is a regular wear and tear defect. Sealant and grouting in areas that come into regular contact with water should be maintained for the long term care of your property.

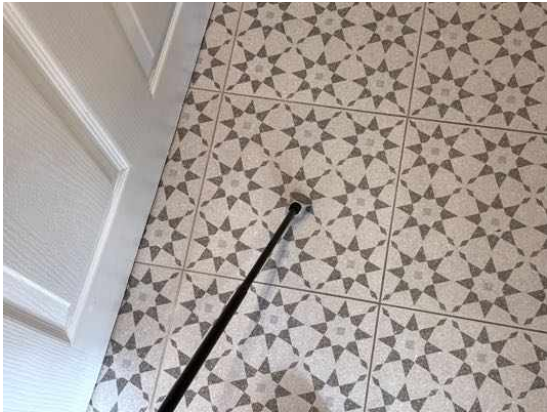
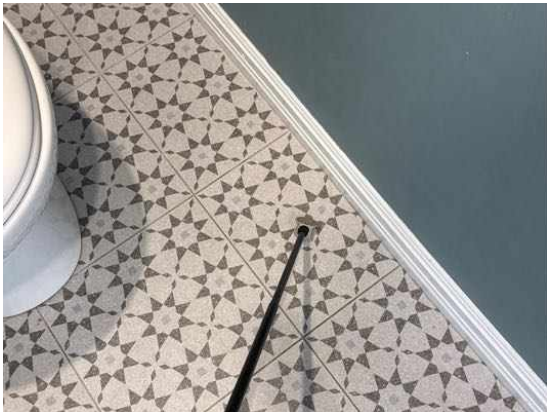
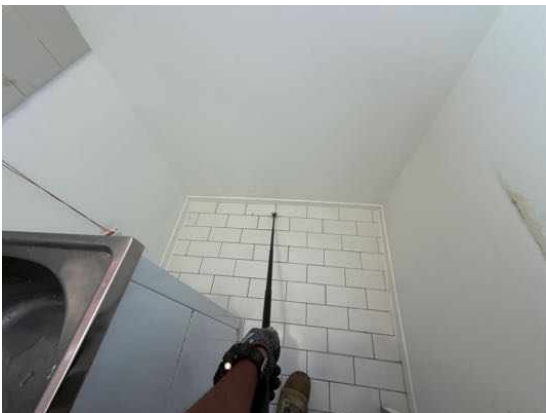
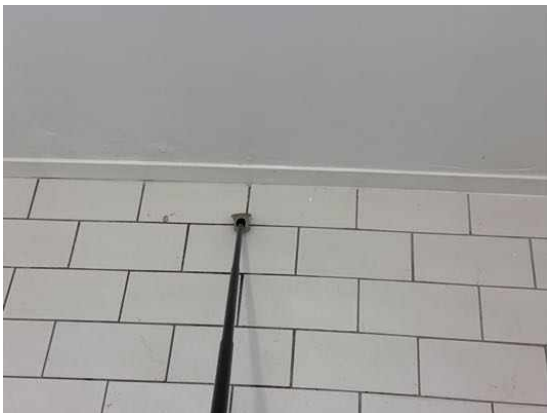
Building:	Main Building
Location:	Some Internal Areas
Finding:	Tiles - Drummy
Information:	Drummy tiled areas were identified at the time of inspection. The term 'drummy' refers to tiles that have become detached from their fixing, despite otherwise being in relatively good condition. Such defects are generally caused by physical or moisture damage to the area. Drummy tiled areas may also be a direct result of poor workmanship during the construction process.

Tiled areas may swell and shrink with changes in air humidity if the area has sustained moisture damage. Any exposure to moisture is capable of causing tiled areas to become drummy and/or cracked over a prolonged period of time. Drummy tiled areas generally require removal and replacement of affected tiles, with adequate sealant and grouting.

Specialist trades are available for these types of services. A registered builder may be required to undertake works if damage is extensive or if secondary building defects have resulted. Otherwise, it is advised that a tiling contractor be appointed to perform works as necessary. Immediate action is recommended to ensure that no further damage is sustained in the affected area.

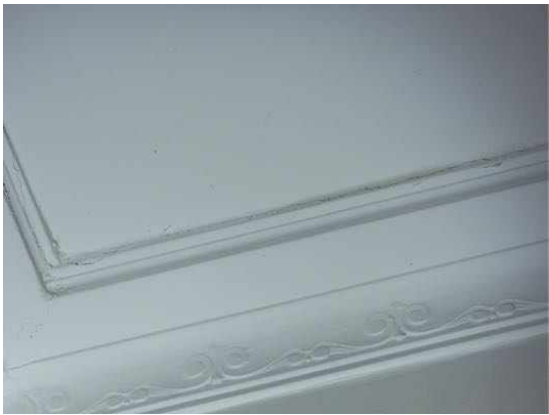
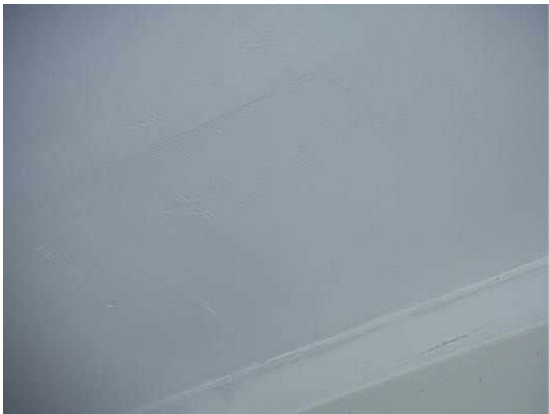
Finding 3.06

Building: Main Building
Location: Some Internal Areas
Finding: Cracking - Damage Category 1 - Fine (up to 1mm)
Information: Although fine cracks are quite noticeable, they are often only considered to be an appearance defect, and usually do not indicate any structural damage. Generally, the cause of a fine crack is indicative of a separation between building materials and finishes (e.g. paint, plaster, etc.) along joins.

Cracking of this nature can generally be repaired with minor sanding, filling and/or repainting. Such works should be performed by a qualified painter or a general handyman.

Monitoring of all cracking should be conducted frequently. Always contact a building inspector should cracks widen, lengthen, or become more numerous.

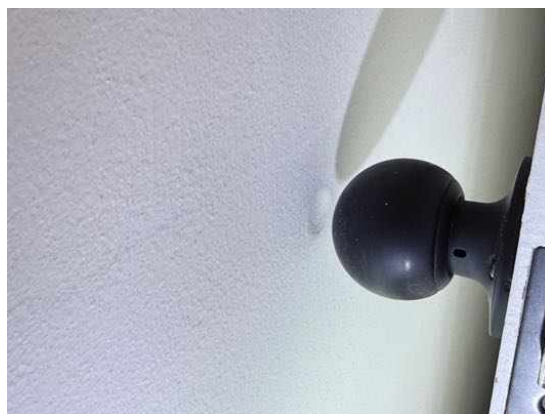
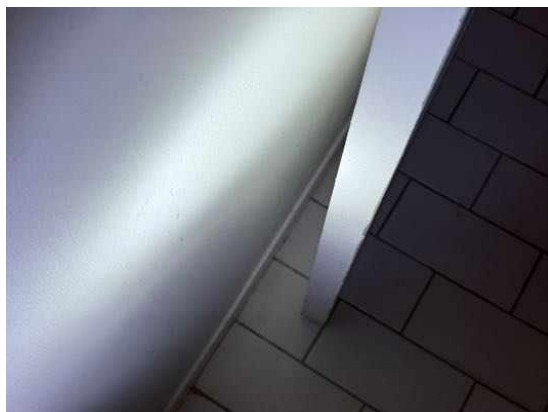
Building: Main Building
 Location: Laundry
 Finding: Door stop - Missing
 Information: The door stop is missing or is inadequate to stop the door handle from damaging the wall. Although some building elements may seem irrelevant or unnecessary, all building elements play a key role in the operation and function of the overall structure and its performance.

Re-installation or replacement of the door stop is advised as soon as possible to prevent any subsequent damage to the door or associated structures. A general handyman may be appointed to perform these works at client discretion.

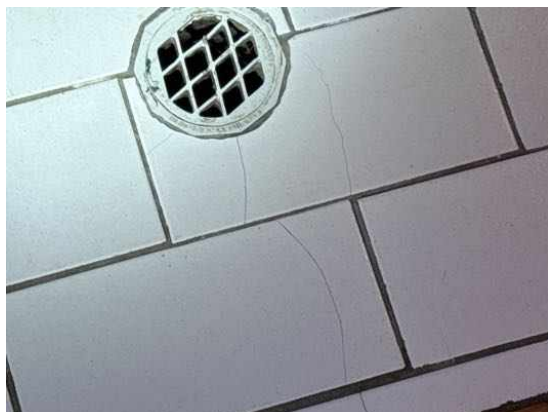
Finding 3.10

Building:	Main Building
Location:	Bathroom
Finding:	Cracked floor tiles
Information:	Cracking in the floor tiles was evident in this area at the time of inspection. It is suspected that this cracking has occurred as a result of minor settlement or shrinkage of the slab.

Cracked tiles throughout the household detract from the overall appearance of the affected areas however it is unlikely to create or lead to any secondary defects.

While not considered a matter of urgency, replacement of cracked floor tiles is recommended at the clients discretion. A tiling contractor may be appointed to perform these works. Where cracks become more numerous, contact a licensed building inspector for further investigation.

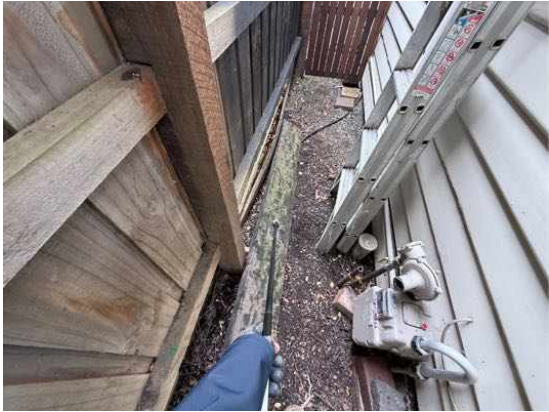
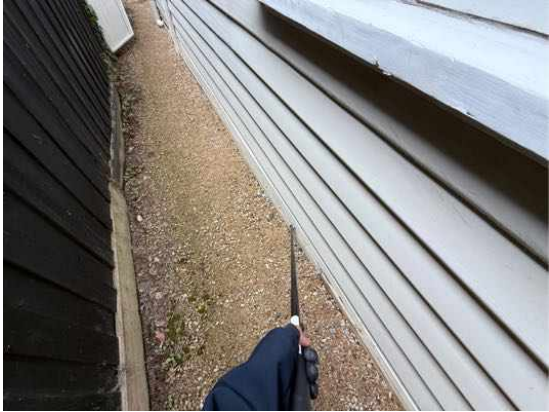
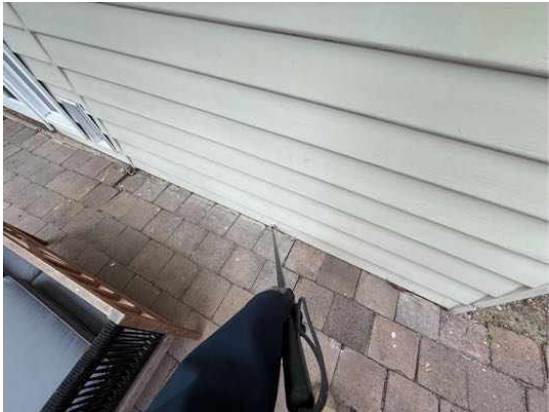
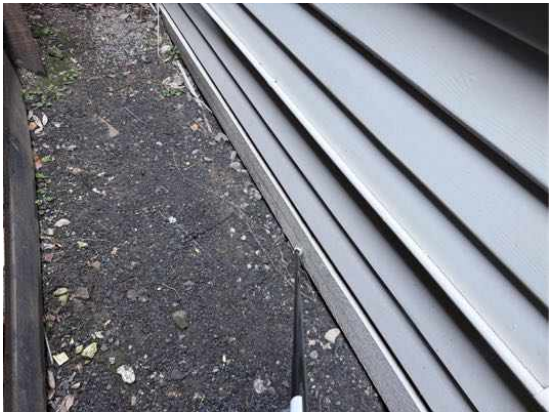
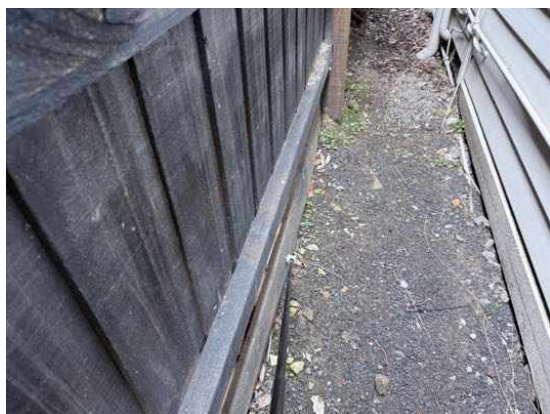
Building:	Main Building
Location:	All External Areas
Finding:	In ground contact
Information:	Any timbers in direct ground contact provide opportunity for concealed termite entry and are likely to be subject to premature rot and decay as the soil retains moisture or damp conditions against the timbers.

Remove untreated timber that is in direct contact with external grounds. Consider replacement with more durable materials i.e. treated timber or non timber elements. Frequent pest inspections are advised to readily identify any termite activity in these areas.

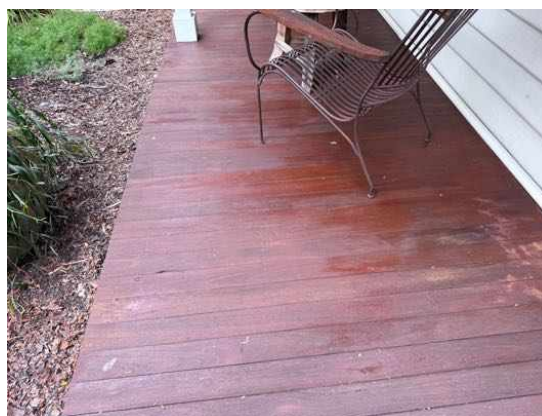
Finding 6.04

Building: Main Building
 Location: Entry
 Finding: Timber deck- High conducive condition.
 Information: We are unable to inspect under the timber deck if its in close proximity to the ground.

Where we are unable to inspect timber structures, decks and subfloor areas the risk of undetected termite activity is rated as extremely High.

We strongly recommend the purchaser prioritise a termite treatment by a Licensed Pest Controller to protect and maintain the asset as it is a timber structure.

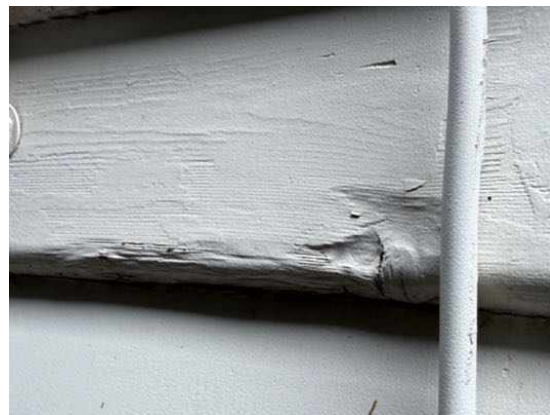
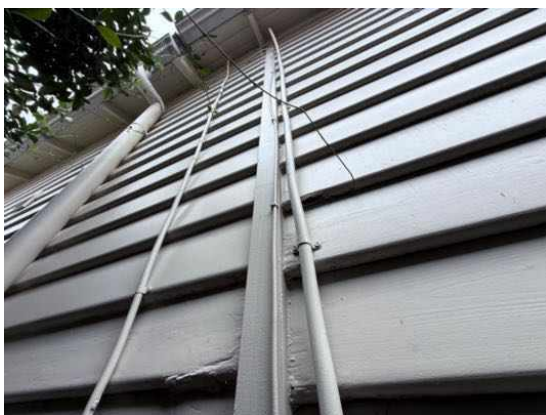
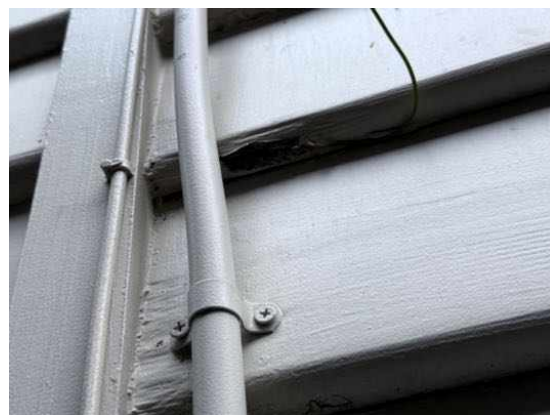
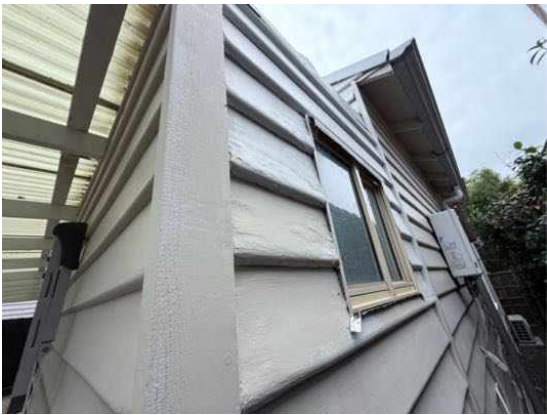
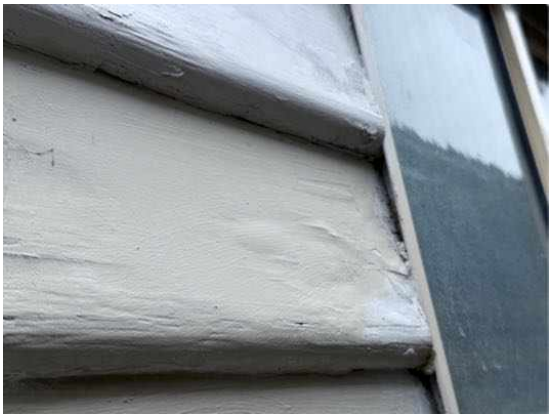
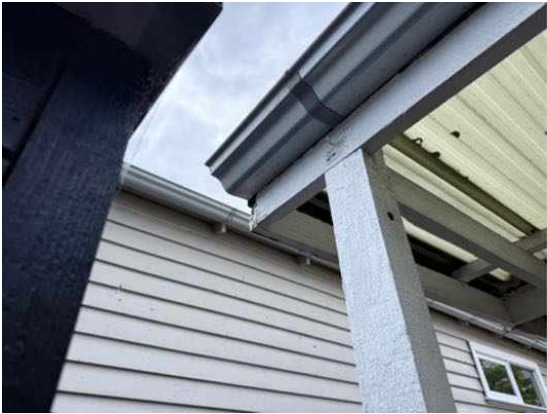
Finding 7.01

Building: Main Building
 Location: All Areas
 Finding: Wood rot
 Information: These building elements shows evidence of wood rot. Wood rot, also known as Fungal Decay, occurs when timbers and other cellulose building materials are exposed

to damp conditions on an ongoing basis. This could be the result of exposure to weathering over a prolonged period of time, or the attraction of excessive moisture from other abutting building materials. Contributing factors also include poor air ventilation in the area.

Wood rot is often associated with general damp problems and is evidenced by a 'musty' smell or mould and mildew occurring on surfaces. If left unmanaged, damp conditions can lead to further health problems and the decay of timbers will continue.

Early intervention and regular maintenance, particularly of exterior timbers, will prolong the useful life of these building elements. Prior to any works being performed, the cause of the moisture that has created the visible wood rot should be identified and addressed in a suitable manner. Replacement of affected timbers may then be a necessary step in protecting surrounding building elements from such deterioration.

A qualified plumber may be appointed to assess the cause of excessive moisture and to provide advice on any remedial works as required. A qualified carpenter or registered builder may also be required to replace affected building materials.

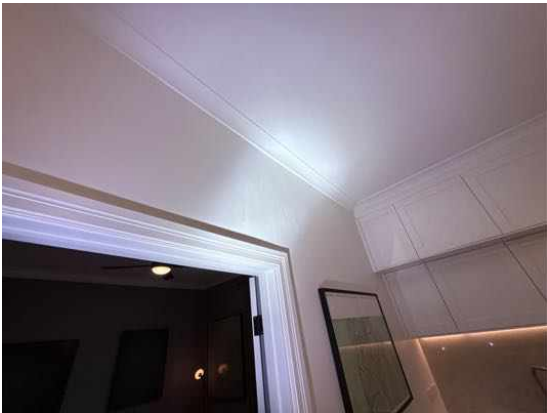
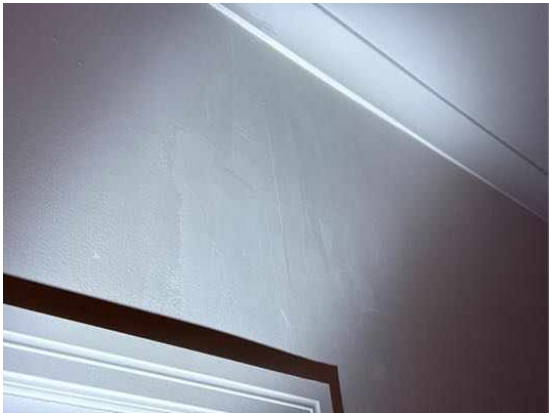
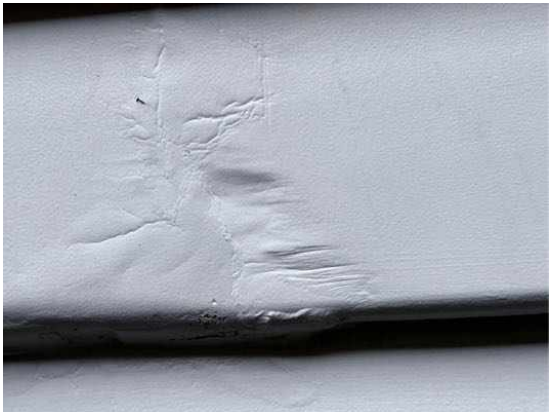
Building: Main Building
Location: All Areas
Finding: Evidence of recent renovations.
Information: Whenever a property is refurbished, majority of the defects if present could get obscured beneath the revamped work. The same can be said for this property as well. Some fine cracks are filled over, walls have been painted etc. It is difficult to pinpoint on any particular defects present below such layers.

Once the property is occupied, all areas should be monitored for a period of 12-24 months to lookout for any arising defects. If staining or cracking is noticed extensively in that period, always consult your building inspector.
