Building Inspection Report

Inspection Date: Fri, 13 Mar 2026

Property Address: 13/59 Henry St, Pakenham VIC 3810,
Australia

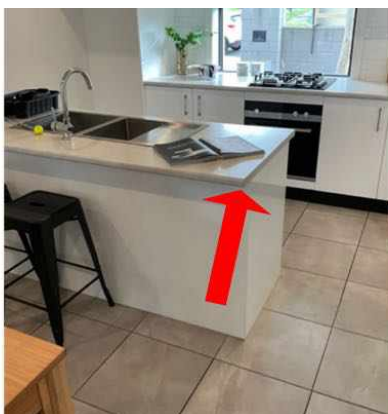
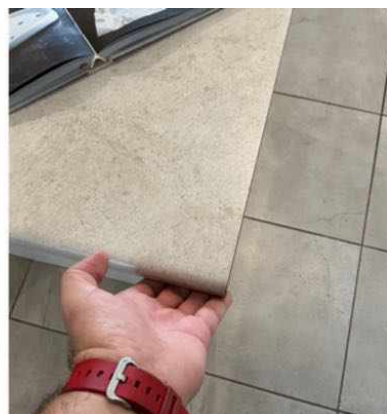
Defects 3.01

Building: Main Building
Location: Kitchen
Finding: Loose Kitchen Benchtop
Information:

At the time of inspection, a section of the kitchen benchtop was found to be insufficiently secured to the cabinetry below. When upward pressure was applied from one side, the benchtop was observed to lift, indicating that the fixing or bonding between the benchtop and the supporting cabinet structure is inadequate.

If left unaddressed, a loose benchtop may continue to move during normal use, which can lead to further loosening of fixings, potential cracking of the benchtop material, damage to surrounding cabinetry, or possible injury if the benchtop shifts unexpectedly.

It is recommended that a qualified cabinet maker be engaged to inspect the installation and securely refix the benchtop to the supporting cabinetry using appropriate fixings and bonding methods to ensure the benchtop is stable, properly supported, and safe for ongoing use.

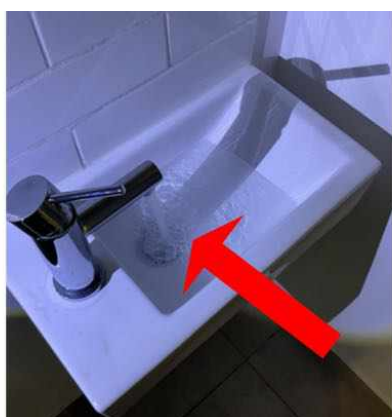
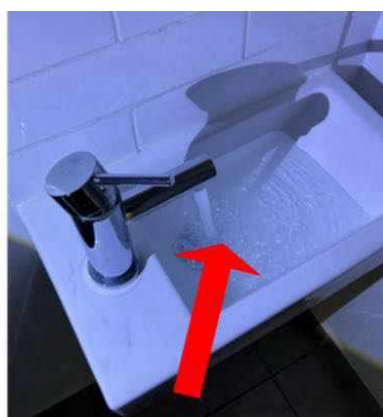
Defects 3.02

Building: Main Building
 Location: Powder Room
 Finding: Slow Drainage Issue at powder room Vanity Unit Mixer Tap
 Information: Upon visual inspection, it was noted that the mixer tap in the powder room's vanity unit was experiencing slow drainage when in use. Water was observed to accumulate in the sink, indicating that the drainage system is not functioning effectively. This issue suggests a possible blockage or restriction within the drainage pipes that may require further investigation.

It is recommended that a licensed plumber be engaged to inspect the drainage system and identify the cause of the slow drainage. Prompt action will ensure the issue is resolved effectively, restoring the proper function of the mixer tap and preventing potential long-term damage.

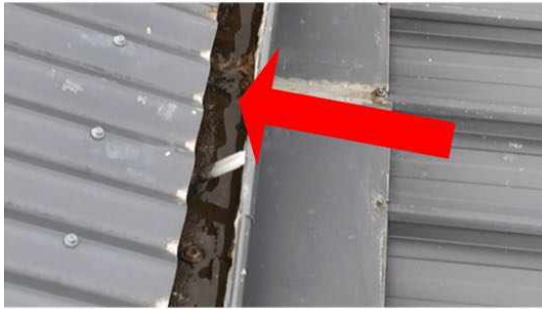
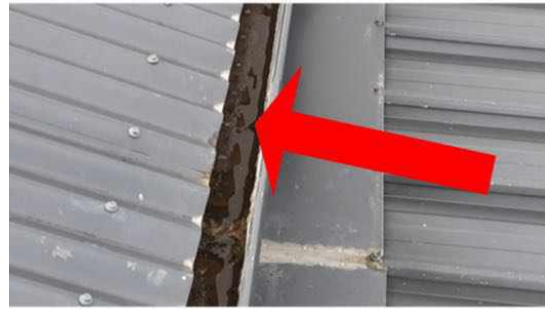
Defects 3.03

Building: Main Building
 Location: Gutters
 Finding: Gutters - Water pooling
 Information: Water was found to be pooling in sections of the roof guttering. This is generally a secondary defect caused by blocked or partially blocked gutters. Such blockages and subsequent water pooling are likely to lead to rust and water damage to associated structures if left unattended.

Any areas of guttering that shows evidence of water pooling should be checked for partial or full blockages and any secondary damage that may have occurred as a result. Depending on the extent of the damage, building elements may require repair and/or replacement to ensure adequate roof drainage and function of exterior plumbing system.

A roofing plumber should be appointed as soon as possible to rectify this issue. It is highly advised that all gutters be maintained on a frequent basis to ensure the condition of roof plumbing.

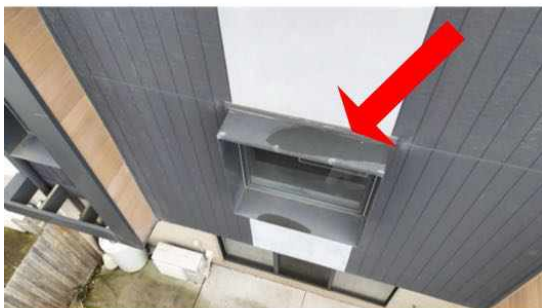
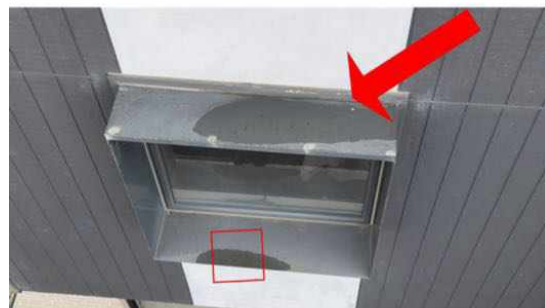
Defects 3.04

Building: Main Building
 Location: Rear Elevation
 Finding: Water Ponding on Window Head Flashing – Rear Elevation
 Information:

At the time of inspection, water ponding was observed on the metal head flashing above the window located at the rear elevation of the building. The horizontal flashing surface appears to have insufficient fall, allowing rainwater to accumulate rather than draining away effectively.

If left unaddressed, prolonged water ponding may accelerate deterioration of the metal flashing and increase the risk of water tracking behind the cladding or window frame. Over time, this may lead to moisture intrusion into the wall assembly and potential damage to internal building elements.

It is recommended that a qualified builder or cladding specialist be engaged to inspect the flashing installation and modify or reinstall the head flashing to provide an adequate fall for proper drainage. Any associated sealing and weatherproofing around the window should also be reviewed and rectified as required to maintain the integrity of the external building envelope.

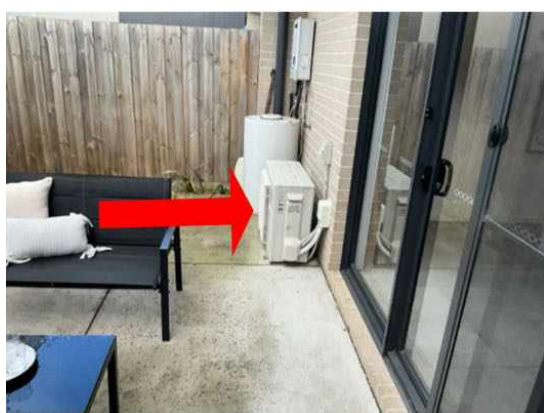
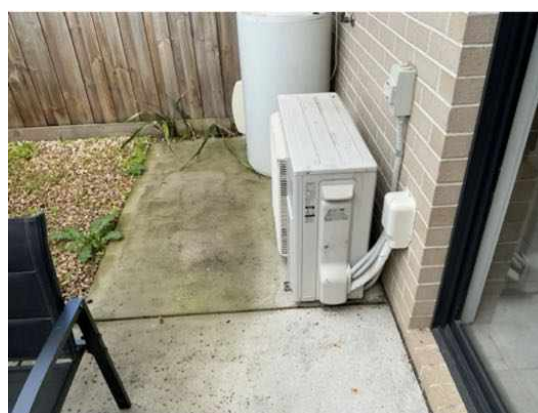
Defects 3.05

Building:	Main Building
Location:	All External Areas
Finding:	AC Overflow - Not plumbed to suitable drainage
Information:	Upon inspection, it was found that the AC overflow is not plumbed or connected to suitable drainage. This could lead to the surrounding area becoming excessively damp, which in turn may cause secondary defects such as rot, rust, corrosion of associated building elements, and the formation of fungal decay. In addition, prolonged damp conditions could create potential slip hazards. Poor site drainage may exacerbate the issue, potentially attracting termite activity to the area.

We recommend that a licensed plumber be appointed to properly plumb the AC overflow and connect it to suitable drainage. This will help ensure that the area remains dry and free from secondary defects.

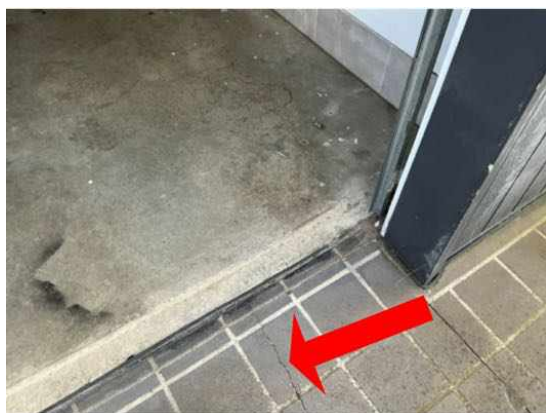
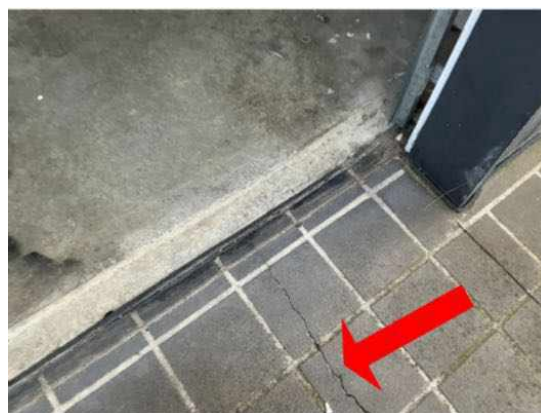
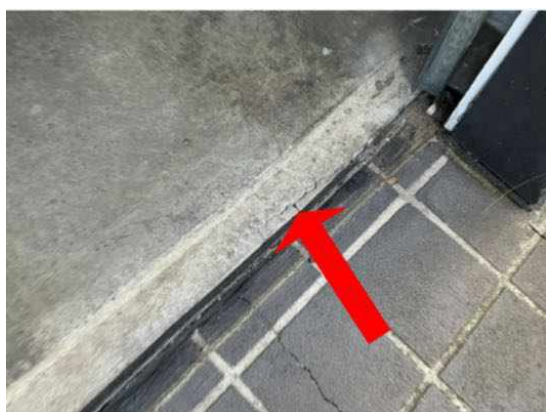
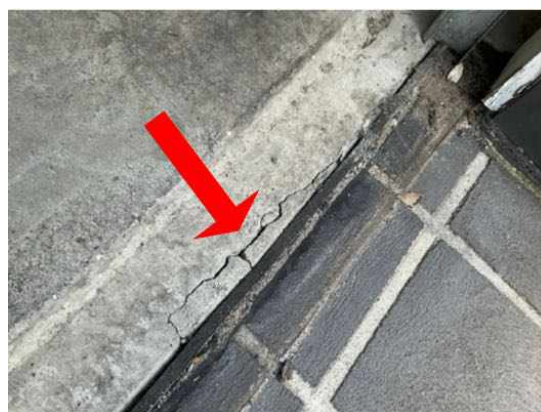
Defects 3.06

Building:	Main Building
Location:	External Paving
Finding:	Cracking - External Concrete Paving Damage Category 2 - Distinct (less than 3mm)
Information:	Distinct cracks were identified in external concrete paving and the garage concrete floors. Distinct cracks are generally found in older concrete paving, and may also present as a trip hazard as consequence of an uneven or curved surface.

General age and expected deterioration of the paved areas is a common cause of this type of cracking. However, expansion and contraction of the slab may also have occurred due to environmental factors. Such factors include variable moisture and weather conditions, the presence of trees and their roots having a settling or lifting affect on the soil, or the effect of load bearing, e.g. heavy vehicles over a sustained period of time.

Cracking to this degree may also be due to poor original installation of the concrete. Factors such as poor compaction of the sub surface and/or inadequate reinforcing of the slab may create cracking and other secondary defects.

Repairs are likely to be required to prevent further cracking and to reduce hazards associated with cracking, such as tripping. Monitoring of all cracking should be conducted frequently. Always contact a building inspector should cracks widen, lengthen, or become more numerous.

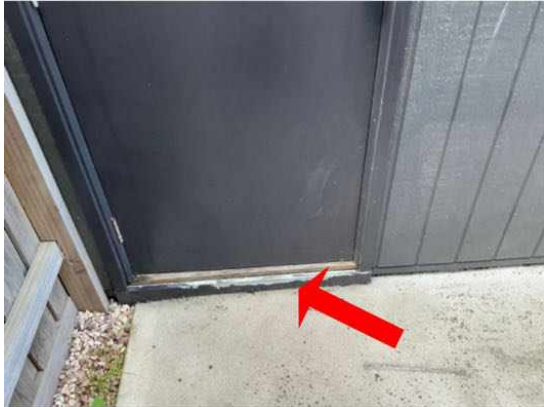
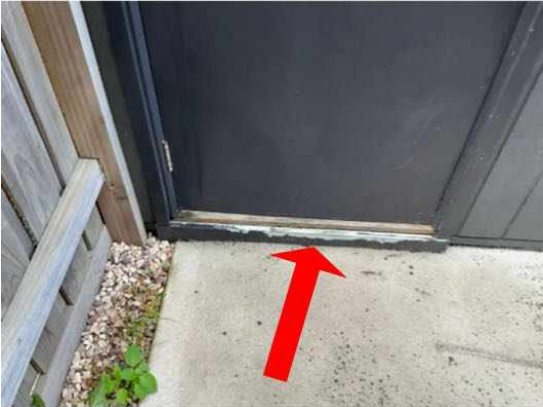
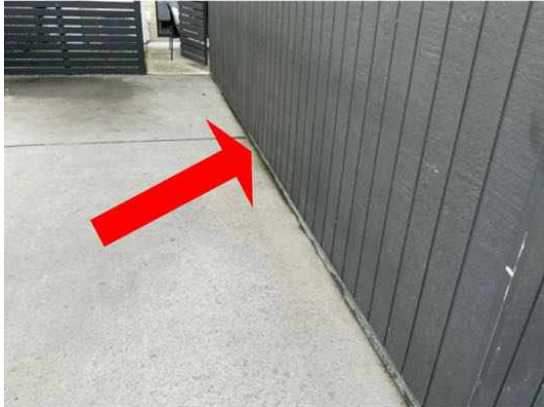
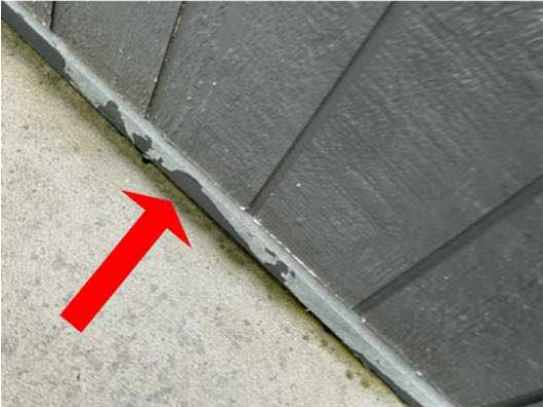
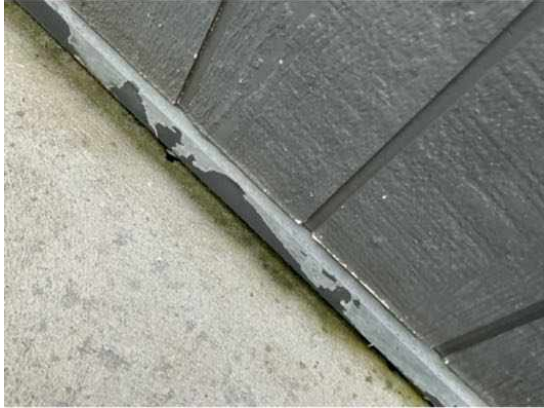
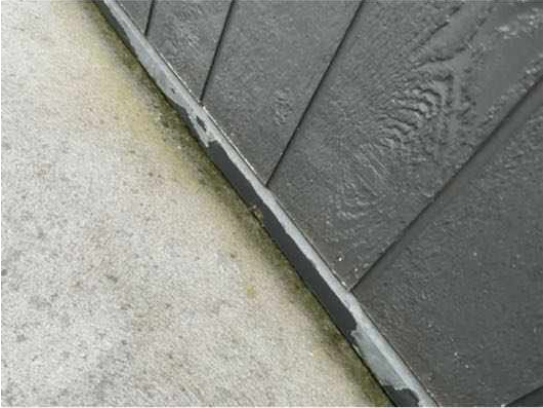
Defects 3.07

Building: Main Building
 Location: Garage exterior
 Finding: Moisture Exposure at Base of Garage External Cladding
 Information:

At the time of inspection, the external wall cladding to the garage was observed to terminate very close to the adjacent concrete paving, with signs of moisture-related deterioration noted at the lower edge of the cladding/base trim. The photos also indicate localised surface breakdown and deterioration to the bottom section, consistent with ongoing exposure to moisture. Based on the observed configuration, rainwater may pond or remain trapped along the base of the wall during wet conditions, increasing the likelihood of repeated wetting to the cladding base.

If this condition is allowed to continue, prolonged moisture exposure at the bottom of the cladding may lead to further deterioration of the cladding or base trim material and may increase the risk of moisture ingress into adjacent wall components. The bottom sill/threshold area of the garage access door also appears to have deteriorated, which

may be related to the same moisture exposure and poor drainage conditions at the base of the wall.

It is recommended that a registered builder assess the base of the garage external wall cladding and the adjacent paving levels/drainage arrangement to determine whether water is ponding against the wall and to provide appropriate rectification. Rectification may include improving drainage or surface falls away from the wall, maintaining suitable clearance between the cladding and paving, and repairing or replacing the deteriorated lower cladding/base trim and the affected bottom door sill/threshold as required.

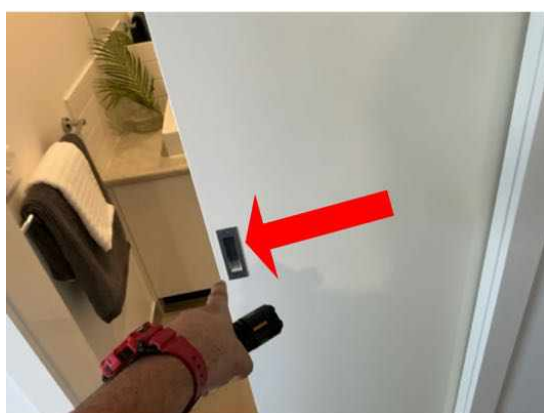
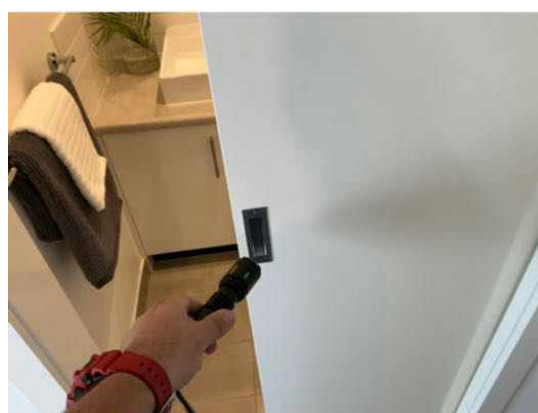
Defects 3.08

Building: Main Building
 Location: Bedroom - Master
 Finding: Door - Stiff to slide
 Information: The sliding door to the master ensuite was difficult to slide along the associated tracks at the time of the inspection. Restricted function of the affected door may pose as a potential safety hazard if required for emergency egress from the building.

Generally, factors such as general age of the building element and a lack of maintenance are the usual causes for this type of defect.

Replacement of door hardware or tracks may be required, as well as minor repairs and cleaning. A registered builder or general handy person will be required to repair the affected doors.

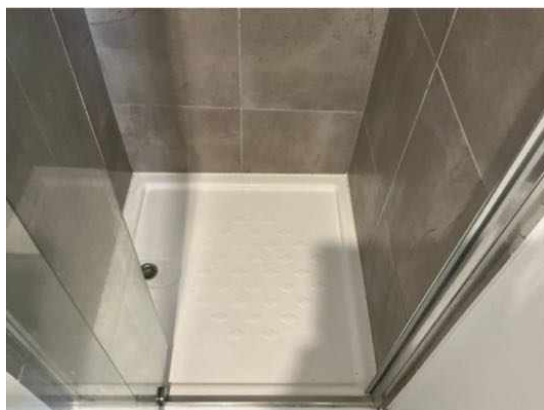
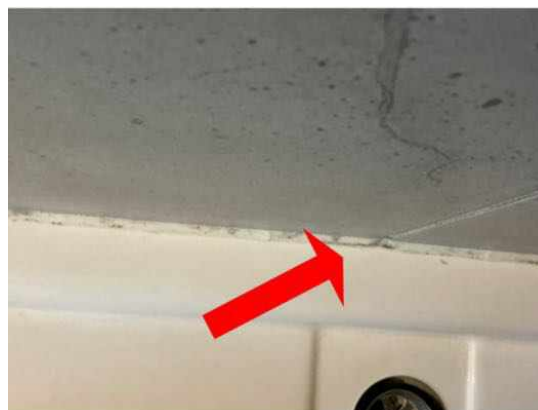
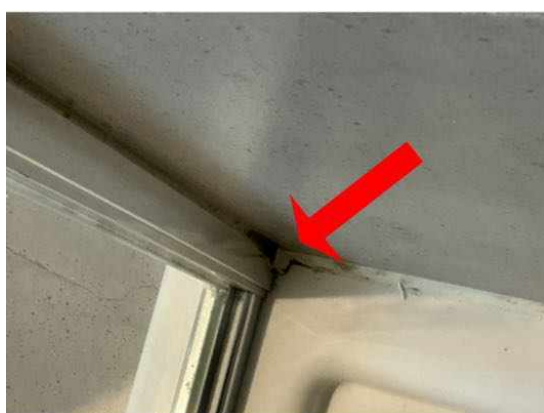
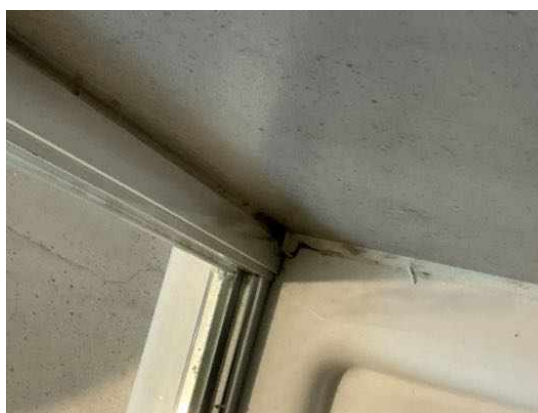
Defects 3.09

Building: Main Building
 Location: Ensuite - Master
 Finding: Sealant and grouting - Deteriorated
 Information: It was noted on inspection that sealant or grout is degraded to the tiled shower alcove and or other areas of the bathroom.

Different materials and floor areas move at different rates, generally causing cracking to grout or sealant at this point. A flexible sealant is required to allow for expected expansion and contraction, while keeping the joint water tight and protective of all associated building materials.

Flexible and mould resistant materials should be applied to affected areas to prevent any subsequent water damage that is likely to occur. Regular maintenance and replacement of damage or missing or damaged sealant and grout is highly recommended to the wet areas, as this is a regular wear and tear defect. Sealant and grouting in areas that come into regular contact with water should be maintained for the long term care of your property.

A sealant specialist or tiling contractor should be appointed to complete these works as soon as possible

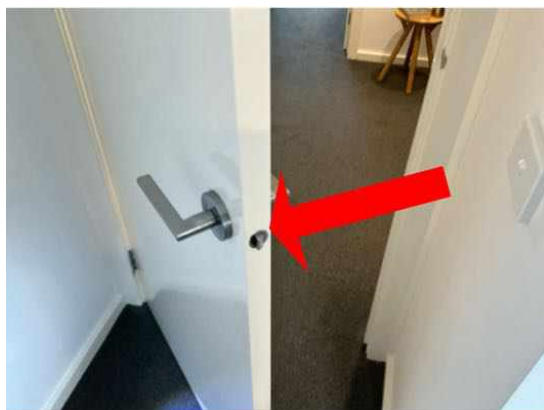
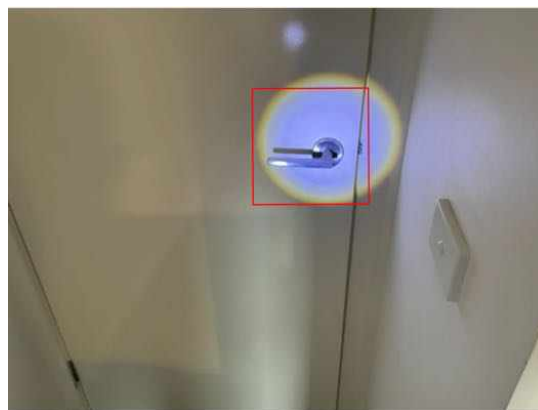
Defects 3.10

Building:	Main Building
Location:	Bedroom 2
Finding:	Door handle - Not latching
Information:	It was noted that the door in 2nd bedroom was not latching during operation at the time of inspection. Whilst detracting from the functionality of this building element, this minor defect may also be a security risk, and may therefore have serious implications if left unattended.

It is suspected that this defect has occurred due to minor issues with the associated hinges. Such damage is identified as general wear and tear, which is expected for building elements of this age.

A qualified carpenter or general handyperson may be appointed to perform rectification works as necessary, at client discretion. If left unattended, further functional impairment is likely to occur.

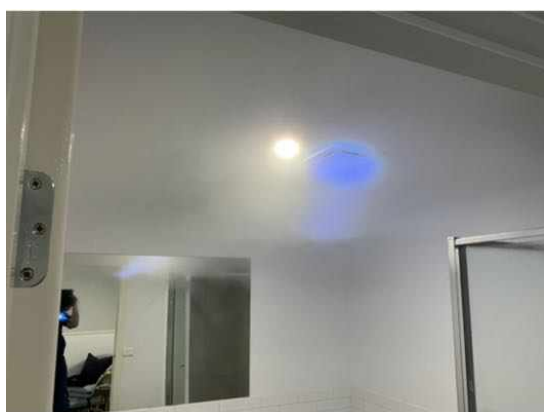
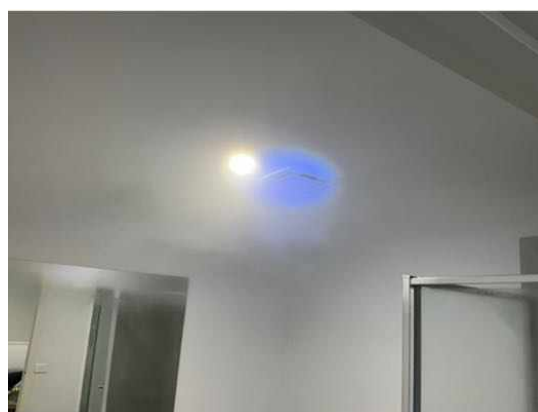
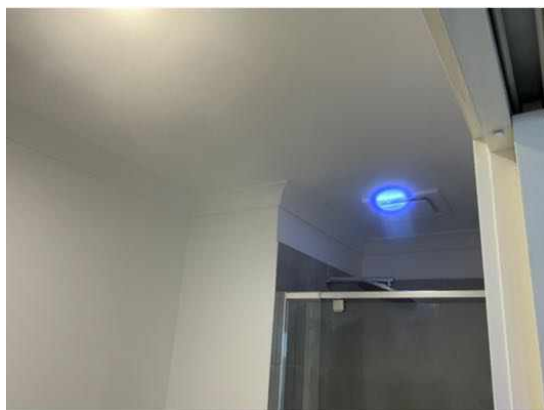
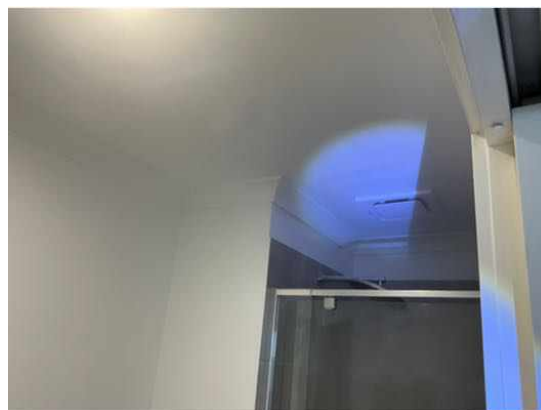
Defects 3.11

Building: Main Building
 Location: Bathrooms
 Finding: Bathroom Exhaust Fans – Insufficient Ventilation Capacity
 Information:

At the time of inspection, the exhaust fans installed in both bathrooms were tested and found to be operational. However, when the showers were run for an extended period using hot water, the fans appeared unable to adequately extract the steam generated, resulting in significant condensation and fogging within the bathrooms.

Insufficient ventilation capacity can allow excessive moisture to accumulate on wall and ceiling surfaces. If this condition persists over time, it may contribute to elevated humidity levels within the bathroom areas, which can promote the development of mould, deterioration of finishes, and potential moisture-related damage to surrounding building materials.

It is recommended that a licensed electrician be engaged to assess the existing bathroom exhaust fans and consider upgrading them to higher-capacity ventilation units suitable for the size of the bathrooms. The upgraded system should be capable of effectively removing steam and moisture to maintain adequate ventilation and reduce the risk of mould growth.

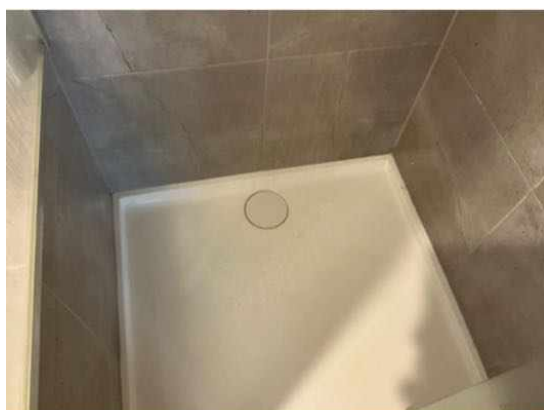
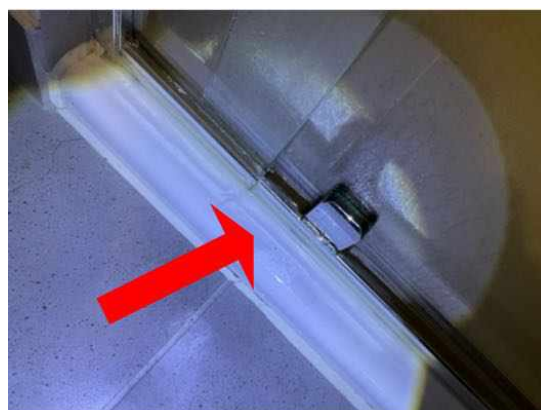
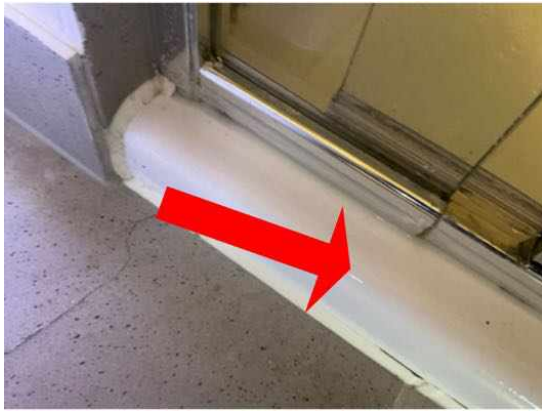
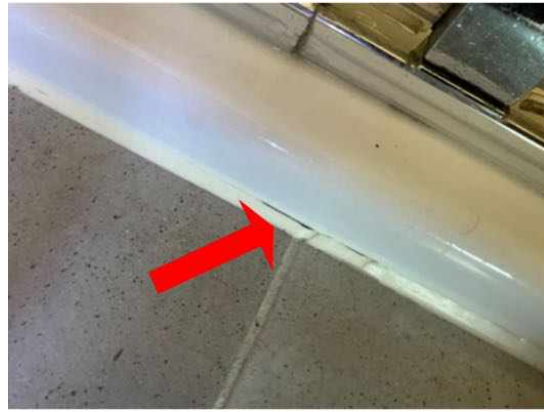
Defects 3.12

Building: Main Building
 Location: Bathroom 2
 Finding: Minor Water Escape at Shower Door
 Information:

At the time of inspection, the upstairs main bathroom shower was tested and found to be functioning as intended. However, a small amount of water was observed passing beneath the glass shower screen door and accumulating on the bathroom floor outside the shower during use.

Over time, repeated water escaping from the shower area may lead to ongoing moisture on the bathroom floor and could contribute to deterioration of nearby finishes or the potential for mould development if not addressed.

It is recommended that a handyman or shower screen installer install a more effective shower door water strip (weather trim) to improve water containment within the shower enclosure. In addition, the silicone sealant at the base of the shower screen externally should be topped up where required to close minor gaps and improve watertightness.

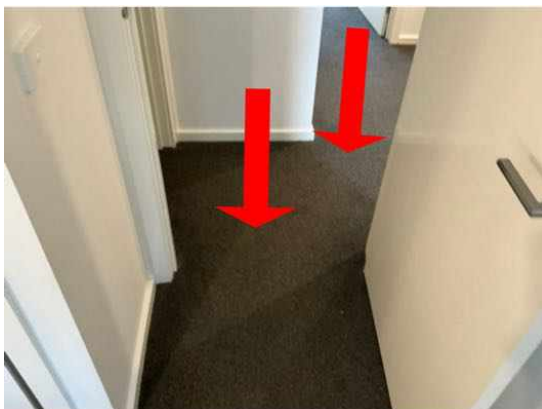
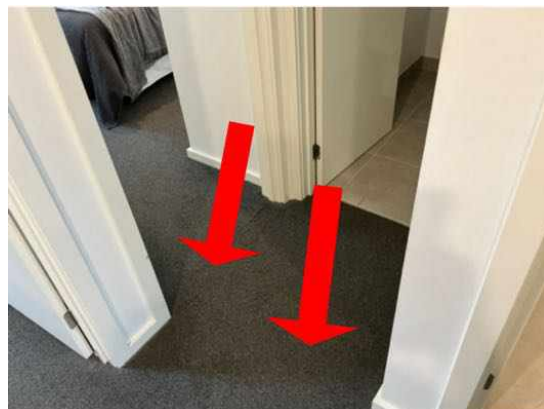
Defects 3.13

Building: Main Building
 Location: Upstairs floor
 Finding: Squeaky Floor – Upstairs Hallway Area
 Information:

At the time of inspection, the flooring in the upstairs area between the general bathroom and the third bedroom was found to produce squeaking and minor movement noise when walked on.

This condition is commonly associated with timber-framed upper floors in double-storey dwellings and is typically caused by minor movement or friction between the flooring sheets and the floor joists due to inadequate or loosened fixings over time. The issue is generally considered a nuisance rather than a structural concern.

If rectification is desired, a qualified carpenter can be engaged to investigate the affected area. This typically involves lifting the floor covering (such as carpet) and re-securing the flooring sheets to the joists using appropriate screws or fixings to reduce movement and associated noise.

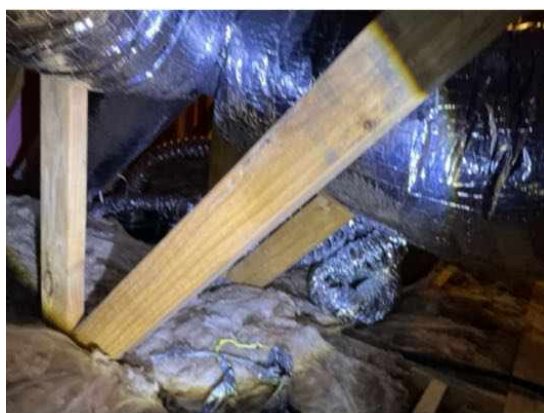
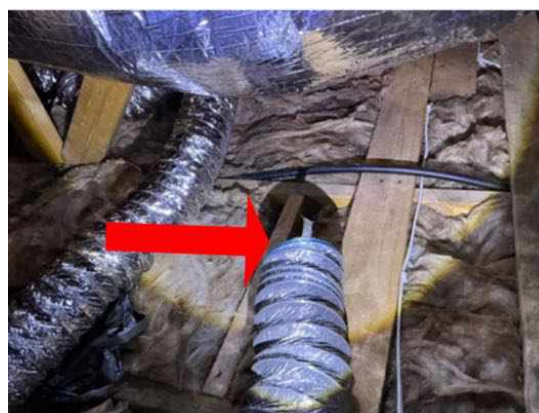
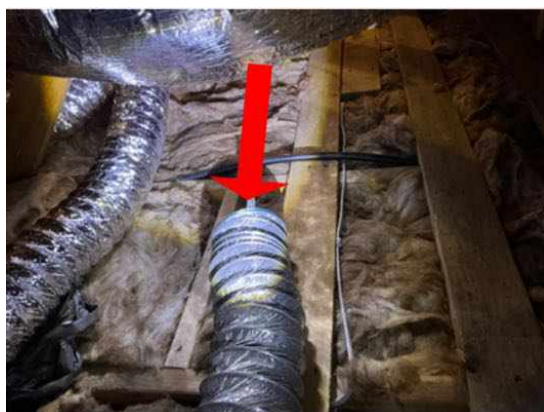
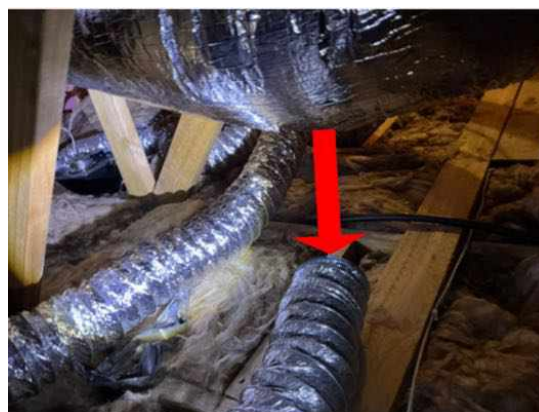
Defects 3.14

Building: Main Building
 Location: Roof Void

Information: The exhaust fans installed in the bathrooms were observed to be discharging directly into the roof cavity rather than being ducted to the external atmosphere. This configuration does not comply with best practice ventilation standards, as it allows moist air to accumulate within the roof space.

Prolonged moisture build-up in the roof cavity can lead to elevated humidity levels, which may contribute to mould growth, timber decay, and potential damage to insulation or other roof components over time.

It is recommended that a licensed ventilation specialist or electrician be engaged to install compliant ducting that vents the exhaust air to the outside of the building, in accordance with current building regulations and ventilation standards.

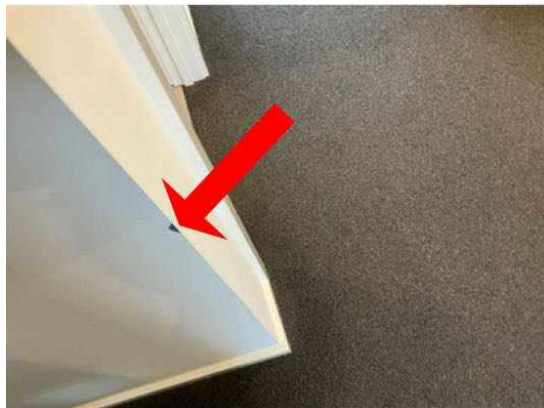
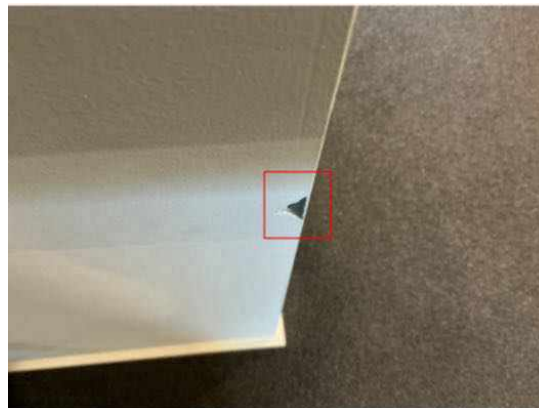
Defects 3.15

At the time of inspection, minor paint chipping was observed on the external wall corner located outside the general bathroom.

This condition appears to be cosmetic in nature and does not currently indicate a

structural concern. However, chipped paint may affect the overall appearance of the wall surface.

If desired, the affected area can be repainted by a painter to restore the appearance and maintain the finish of the external wall surface.

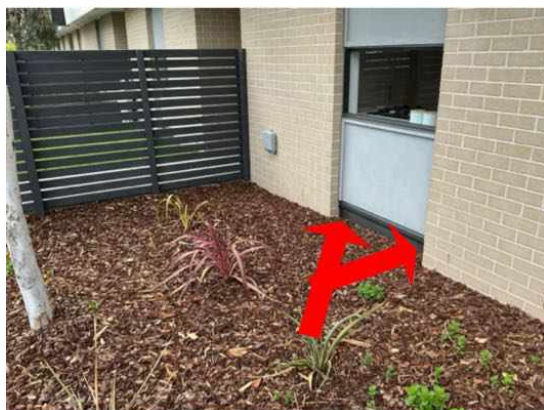
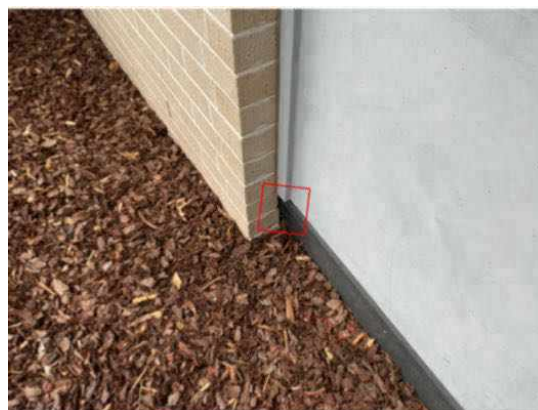
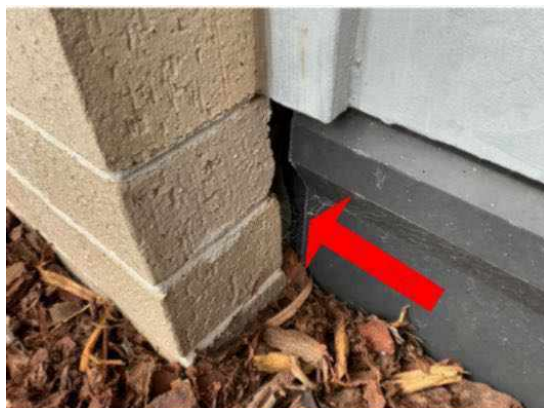
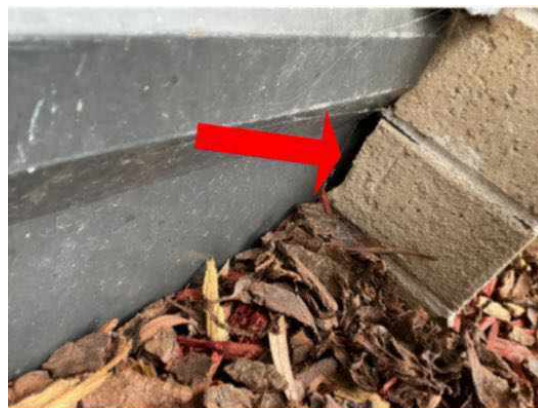
Defects 3.16

Building: Main Building
Location: Front Elevation
Finding: Gap at Base of Front Exterior Wall
Information:

At the time of inspection, a gap was observed at the base of the front exterior wall where the brick veneer meets the adjacent cladding and plinth area. The junction between these materials appears to have an opening that has not been properly sealed.

If left unaddressed, such gaps may allow pests, debris, and moisture to enter the wall cavity, which may increase the risk of pest activity or moisture-related issues over time.

It is recommended that a qualified builder or appropriate tradesperson seal the opening using a suitable external-grade sealant or filler to close the gap and improve protection of the wall cavity.

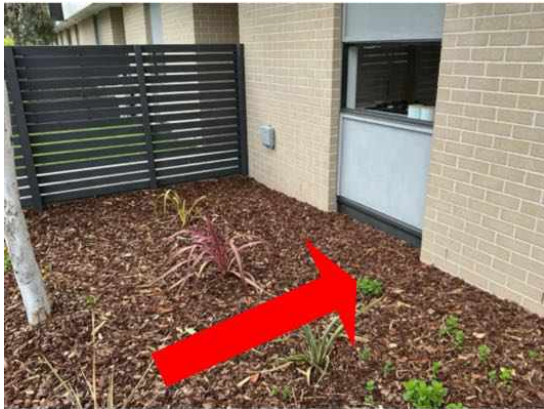
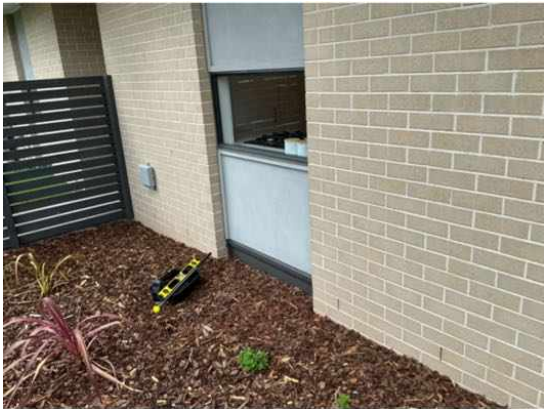
Defects 3.17

Building:	Main Building
Location:	Front Elevation
Finding:	Site drainage - Inadequate
Information:	The site drainage in the front elevation was found to be inadequate at the time of inspection, creating potential for subsequent water damage to associated building elements.

It is important that water does not lie against the base of walls; surrounding paths and ground levels should be sloped to drain water away from walls. Downpipes should not discharge stormwater onto lower walls or plinths. Stormwater should be carried away by large, regularly cleaned drains. Ground levels may need to be lowered to expose a buried DPC.

Where site drainage is inadequate, installation of an Agricultural (Aggie) Drain may be required. A qualified plumber should be appointed to further inspect the property and perform any remedial works as necessary. Water damage and secondary defects are likely to occur if left unmanaged.

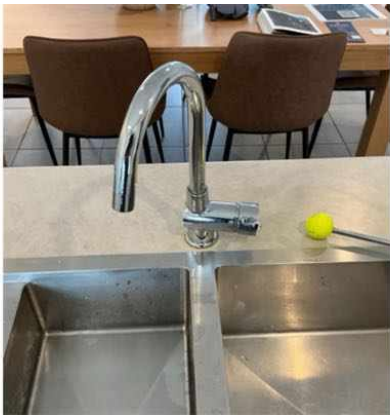
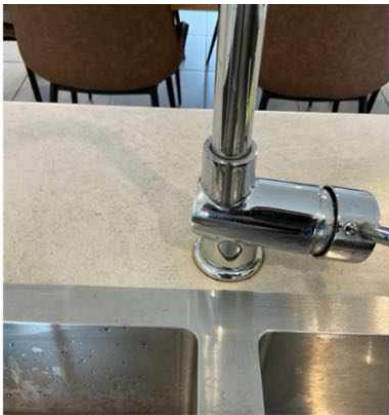
Defects 3.18

Finding: Tap - Loose

Information: The kitchen tap has deteriorated with age, and is consequently loose. This tap being loose creates potential for water leaks and subsequent water damage to the surrounding area.

Where taps or spouts are loose, a qualified plumber should be appointed to re-fix the plumbing fitting.

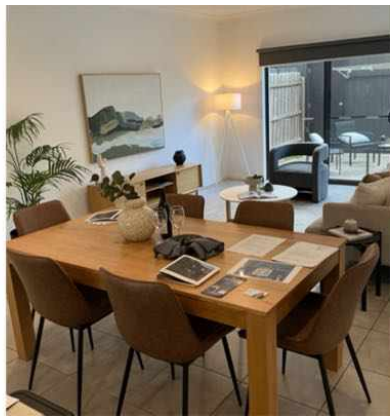
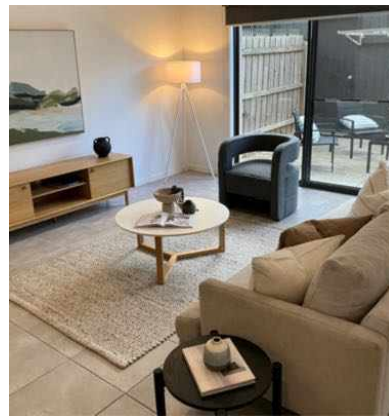
Building: Main Building
 Location: All Internal Areas
 Finding: Obstructions and Limitations - Interior
 Information: These photographs are an indication of the obstructions and limitations which impeded the inspection of the internal areas of the property at the time of inspection. These obstructions can hide an array of defects and should be removed to allow full inspection to be carried out. A re-inspection is recommended once the areas are made accessible.

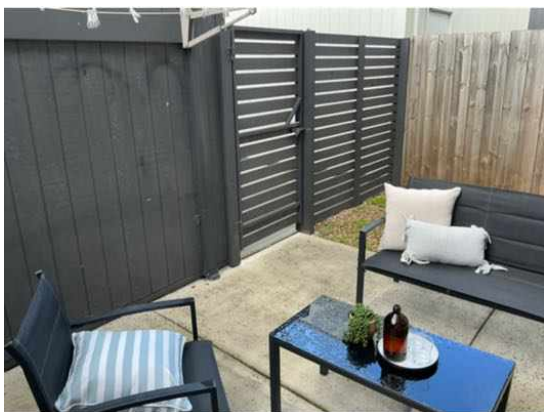
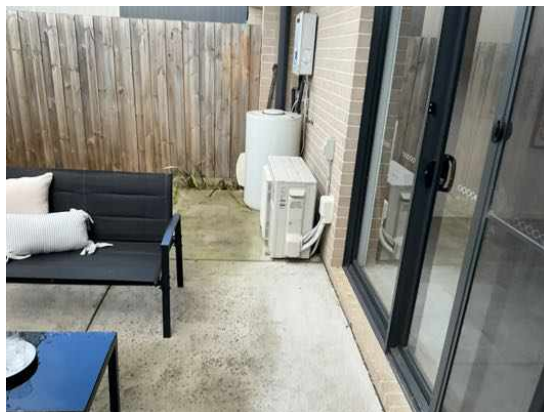
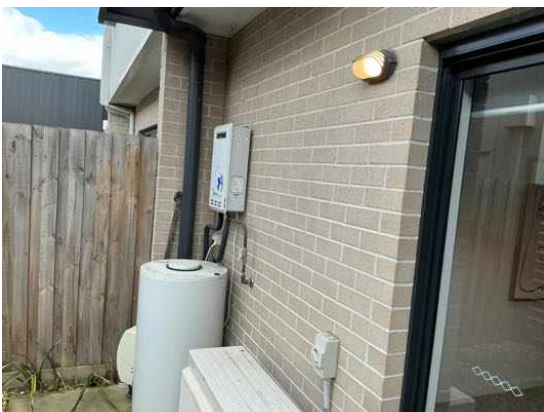
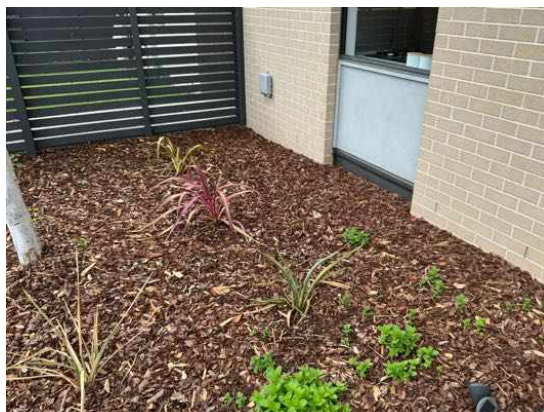
Building: Main Building
 Location: All External Areas
 Finding: Obstructions and Limitations - Exterior
 Information: These photographs are an indication of the obstructions and limitations which impeded the inspection of the external areas of the property at the time of inspection. These obstructions can hide an array of defects and should be removed to allow full inspection to be carried out. A re-inspection is recommended once the areas are made accessible.

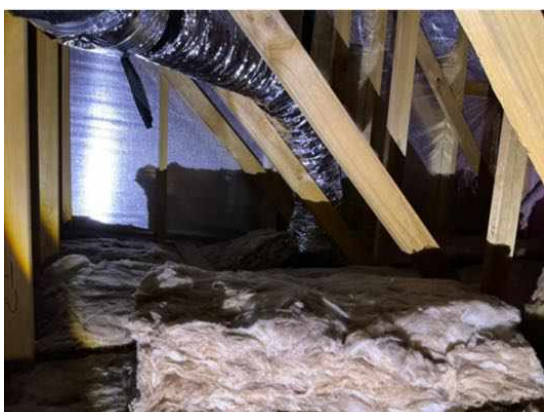
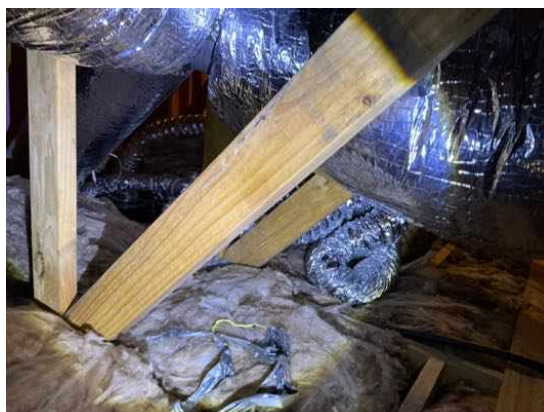
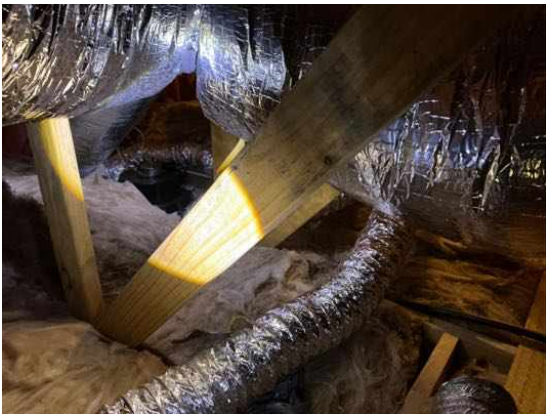
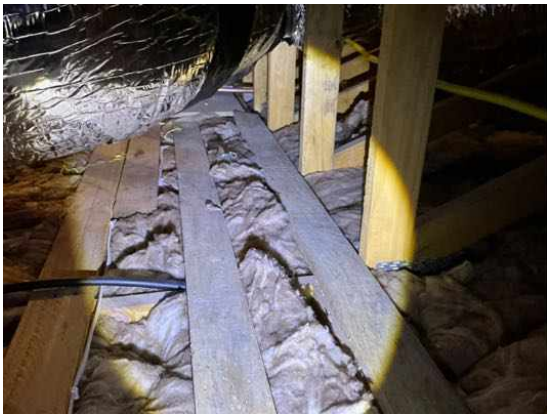
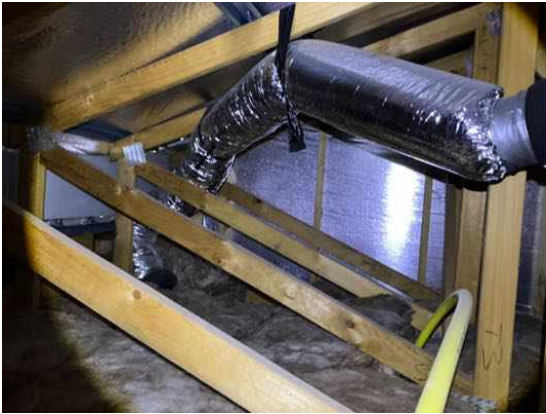
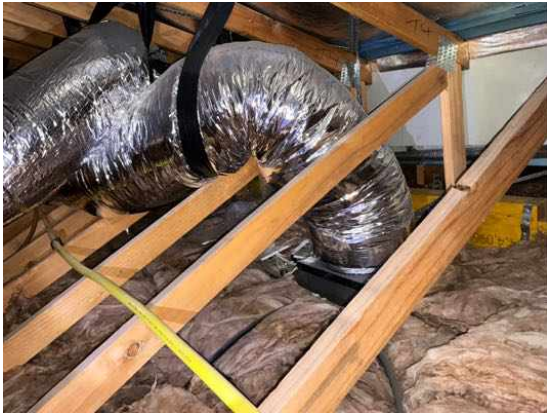
Building: Main Building
Location: Roof Void
Finding: Obstructions and Limitations - roof cavity
Information: These photographs are an indication of the obstructions and limitations which impeded the inspection of the roof cavity area of the property at the time of inspection. These obstructions can hide an array of defects and should be removed to allow full inspection to be carried out. A re-inspection is recommended once the areas are made accessible.
