Building and Timber Pest Inspection Report

Inspection Date: Thu, 12 Mar 2026

Property Address: 3 Mckevitte Ave, East Hills NSW 2213,
Australia

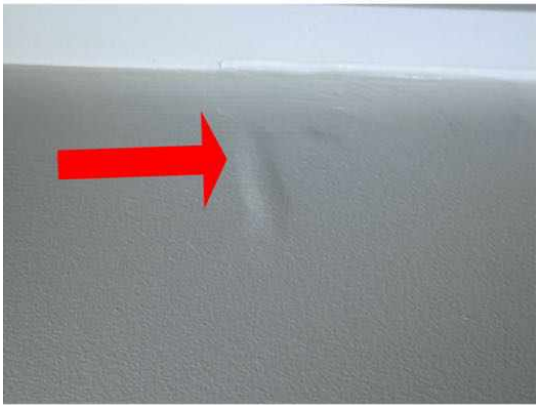
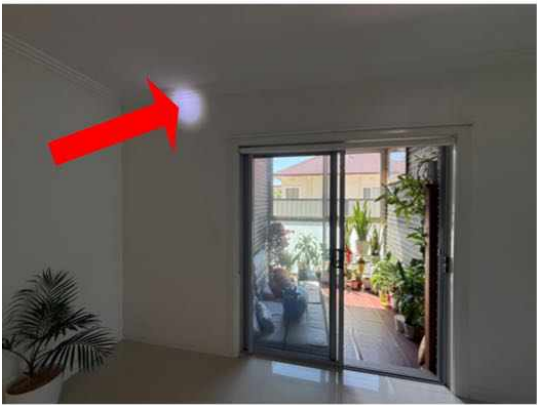
Building:	Main Building
Location:	All Internal Areas
Finding:	Paint finish - Substandard, Wear and Tear
Information:	The paint finish in this area was found to have been completed to a substandard level or wear and tear as the normal deterioration of a property from ordinary, everyday use. Exposure to the elements, time, as well as day to day living can cause fair wear and tear.

If this applies, further areas of poor and incomplete finishes could develop over time. Furthermore, substandard, wear and tear paint finishes in areas exposed to moisture, e.g. external areas or wet areas, could lead to deterioration of underlying building materials.

Substandard, wear and tear paint finishes should be sanded back, filled, leveled and repainted, as applicable. Where inadequate paint protection has led to the deterioration of the associated building element, repair and/or replacement of this building element may be required.

A painting contractor should be appointed as soon as possible to perform necessary works to aid the appearance of the affected area and to ensure that the area is protected against further deterioration. Alternatively, the homeowner following manufacturer instructions may be able to provide this service.

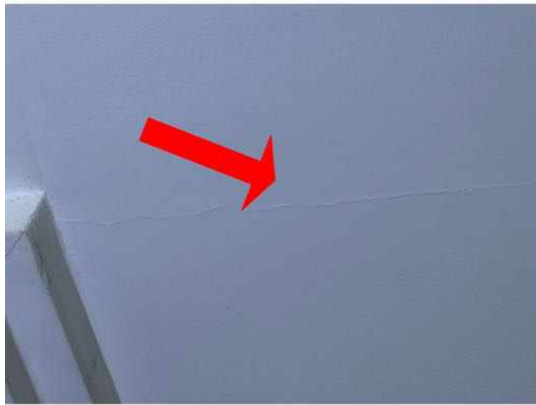
Building:	Main Building
Location:	All Internal Areas
Finding:	Cracking - Damage Category 1 - Fine (up to 1mm)
Information:	Although fine cracks are quite noticeable, they are often only considered to be an appearance defect, and usually do not indicate any structural damage. Generally, the cause of a fine crack is indicative of a separation between building materials and finishes (e.g. paint, plaster, etc.) along joins.

Cracking of this nature can generally be repaired with minor sanding, filling and/or repainting. Such works should be performed by a qualified painter or a general handyman.

Monitoring of all cracking should be conducted frequently. Always contact a building inspector should cracks widen, lengthen, or become more numerous.

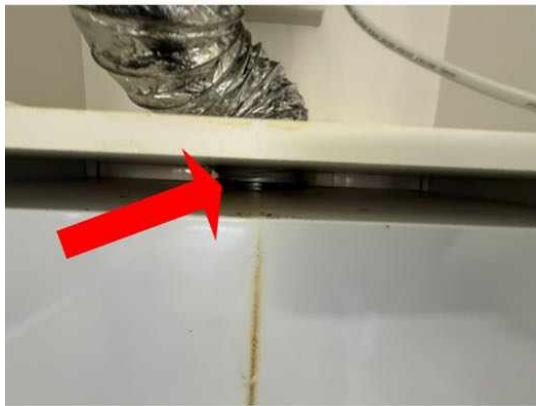
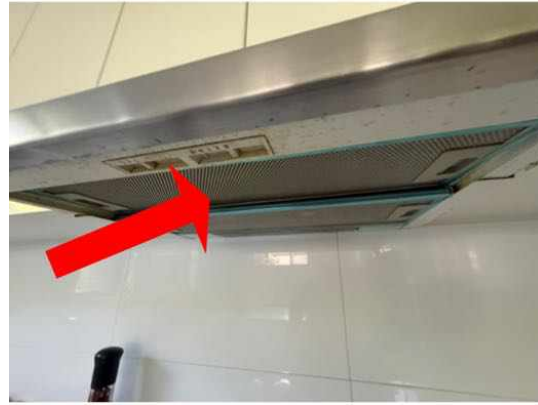
Finding 3.03

Building: Main Building
 Location: Kitchen
 Finding: Rangehood - Fan not working properly
 Information: While the range hood appears to be working at a satisfactory level, the fan to the structure was not working at the time of inspection.

Without a functional fan, a build-up of grease and evaporative moisture is likely to accelerate deterioration of the range hood and associated flue. This potential build up may also create a minor fire hazard, particularly if left uncleaned.

A licensed electrician should be appointed to replace the fan on the range hood to restore it to a fully operational state.

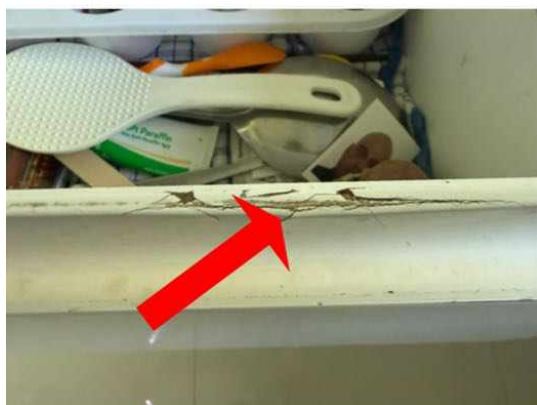
Building: Main Building
 Location: Kitchen
 Finding: Kitchen Cabinetry - Scratches, Surface Damage & Laminate Delamination
 Information: Scratches, scuff marks, chipped edges and visible delamination of the laminate surface were observed on several sections of the kitchen cabinetry. Laminate is lifting at the edges and joints, and multiple panels show surface wear and damage.

Delamination and surface damage can:

- Permit moisture ingress, leading to swelling and further failure of the substrate.
- Reduce the durability and service life of the cabinetry.
- Be considered below acceptable workmanship under NCC and AS installation requirements.

Engage a qualified cabinet maker/joiner to:

- Repair or replace damaged panels,
- Re-adhere or re-laminate lifted sections, and
- Seal exposed edges to prevent moisture penetration.

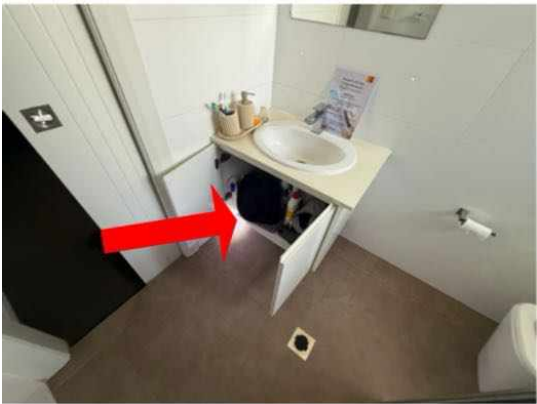
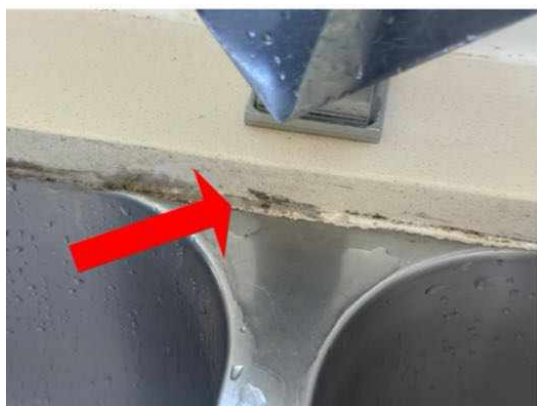
Finding 3.06

Building:	Main Building
Location:	Bathroom
Finding:	Sealant and grouting - Missing or damaged
Information:	It was noted on inspection that sealant or grout is degraded to the tiled shower alcove and or other areas of the bathroom.

Different materials and floor areas move at different rates, generally causing cracking to grout or sealant at this point. A flexible sealant is required to allow for expected expansion and contraction, while keeping the joint water tight and protective of all associated building materials.

There appears to be excessive mould to the sealant and grout which will likely require scraping out and replacement.

Flexible and mould resistant materials should be applied to affected areas to prevent any subsequent water damage that is likely to occur. Regular maintenance and replacement of damage or missing or damaged sealant and grout is highly recommended to the wet areas, as this is a regular wear and tear defect. Sealant and grouting in areas that come into regular contact with water should be maintained for the long term care of your property.

A sealant specialist or tiling contractor should be appointed to complete these works as soon as possible

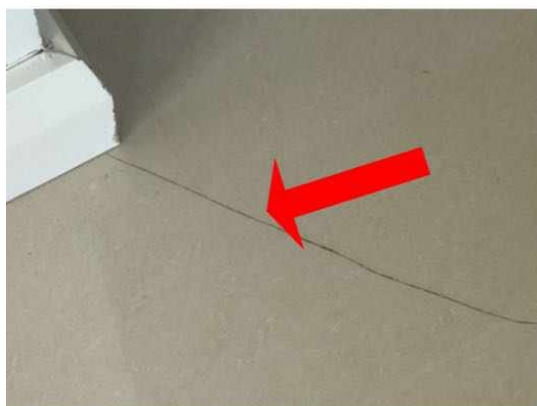
Finding 3.07

Building:	Main Building
Location:	Kitchen
Finding:	Cracked floor tiles
Information:	Cracking in the floor tiles was evident in this area at the time of inspection. It is suspected that this cracking has occurred as a result of minor settlement or shrinkage of the slab.

Cracked tiles throughout the household detract from the overall appearance of the affected areas however it is unlikely to create or lead to any secondary defects.

While not considered a matter of urgency, replacement of cracked floor tiles is recommended at the clients discretion. A tiling contractor may be appointed to perform these works. Where cracks become more numerous, contact a licensed building inspector for further investigation.

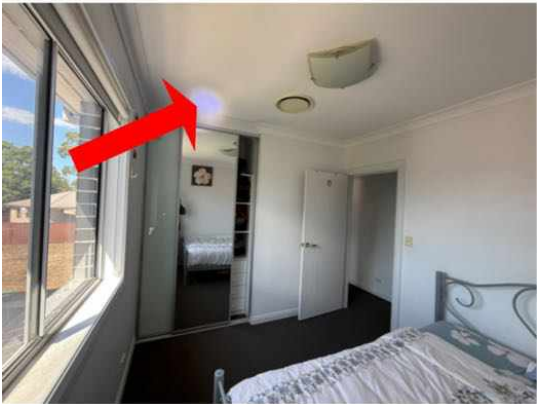
Nail/screw popping was observed to the ceiling lining. This is indicated by visible protrusions and minor cracking around the fixing points of the plasterboard. This condition is typically caused by inadequate fixing, movement of framing members, or poor installation workmanship.

Installation of plasterboard should comply with AS/NZS 2589:2017 – Gypsum Linings – Application and Finishing and NCC 2022 – Housing Provisions H2D2 (Construction in accordance with good building practice).

It is recommended that the builder rectify the affected areas by re-fixing the plasterboard where necessary and making good the ceiling finish.

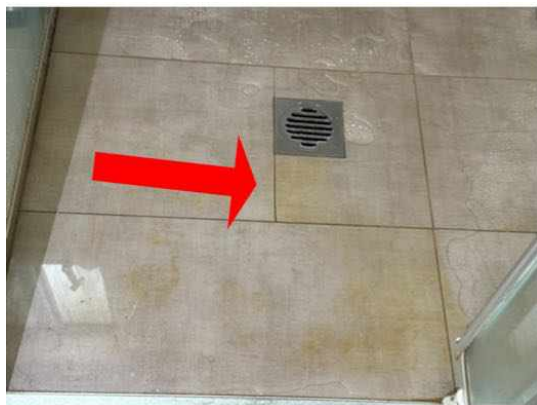
Finding 3.10

Building:	Main Building
Location:	Ensuite
Finding:	Shower base - Water pooling
Information:	Evidence of water pooling around the floor waste in the shower recess was noticed at the time of inspection. It is suspected that this excessive moisture is attributed to insufficient fall in the shower floor tiles.

This pooling is minor overall but is still considered unsatisfactory, as standard tiling practices would not permit this situation to occur. Pooling water around floor wastes can create a slip hazard in extreme cases and create conditions that are conducive to mould growth over time. Where left unmanaged, the degradation of sealant and grouting is also likely to occur, possibly necessitating further repair works.

Remedial works may involve some sections of tiling and flooring repair and replacement. A tiling contractor or bathroom specialist should be appointed to provide further advice on reparation options and to perform works as necessary.

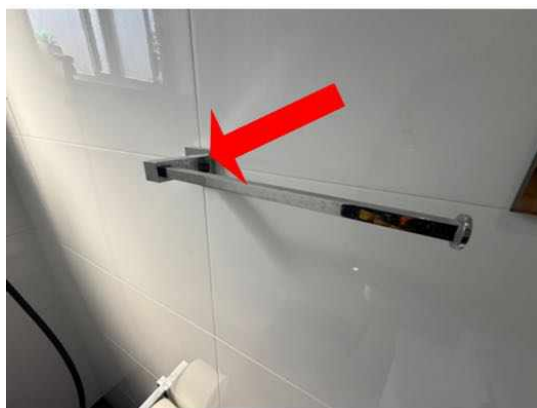
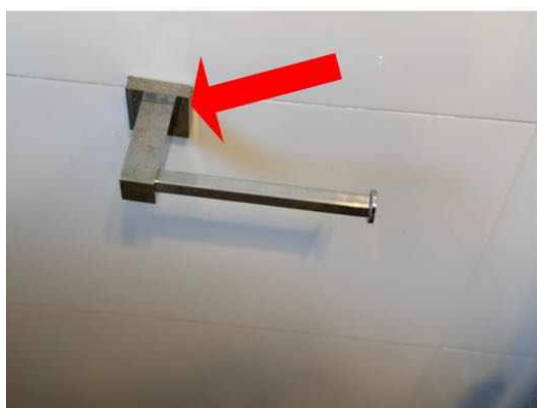
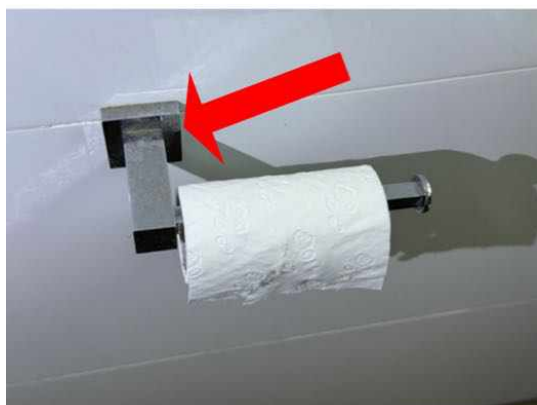
Finding 3.12

Building:	Main Building
Location:	Bathroom
Finding:	Bathroom holders - Loose
Information:	The bathroom holder was found to be loose at the time of inspection. While not a major operational defect, function can deteriorate if the problem is left unmanaged.

It is advised that the homeowner performs remedial works to re-attach the bathroom holder to its original fixing. A general handyperson may be required to perform these works.

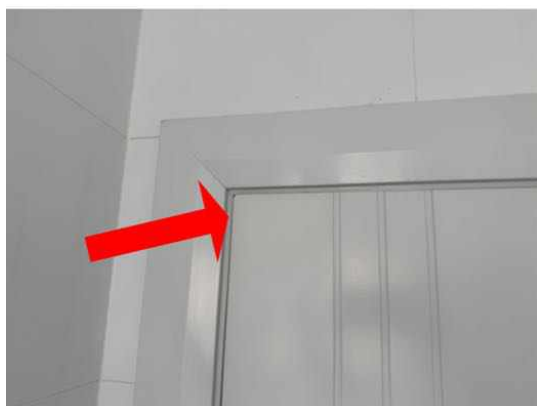
Building:	Main Building
Location:	All Internal Areas
Finding:	Door - Binding/jamming
Information:	Binding and/or jamming of this door is evident during standard operation. This defect inhibits the functionality of the affected door as well as creating potential for secondary defects to associated building elements, such as damage to the floor covering.

A door that binds to flooring or to the associated door frame may have several causes, ranging from minor defects, such as poor installation of the door or deteriorated hinges, through to major structural issues, such as damage to subfloor structures.

Where door binding/jamming appears to indicate major structural issues, a registered builder specialising in re-stumping should be appointed to provide an estimate on the cost of rectification.

For minor causes, a qualified carpenter or general handyperson should be appointed to perform minor rectification works at client discretion.

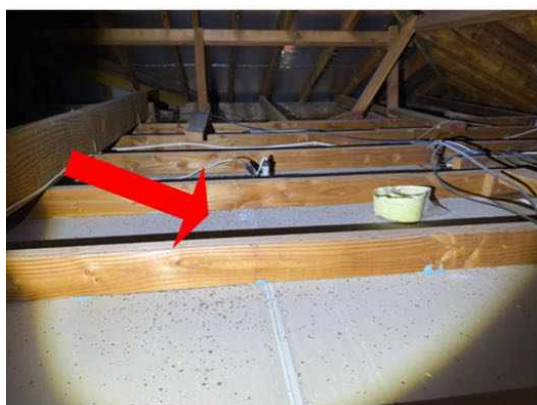
Finding 3.16

Building:	Main Building
Location:	Roof Void
Finding:	Insulation - Missing
Information:	Upon inspection of the roof void it was noted that insulation is not present.

Insufficient insulation will result in a comparatively higher cost to heat and cool a property as there is a lack of Insulation (or uneven coverage of insulation) which works as a barrier to heat transfer. This helps to keep out unwanted heat in summer and preserves warmth inside your home in winter. It can also help soundproof your home from unwanted airborne noise transfer.

Where insulation is absent, the area does not meet current Australian Standards. Installation of adequate insulation is required and should be conducted as soon as possible.

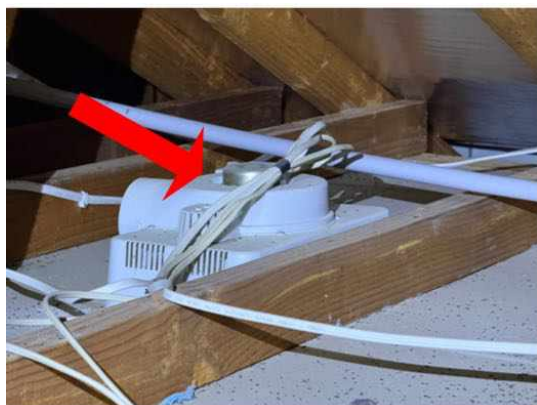
Finding 3.17

Building:	Main Building
Location:	Roof Void
Finding:	Extractor Fan - Vented into Roof Space
Information:	The bathroom extractor flue was found to lead directly into the roof space, rather than

venting to the exterior of the building. The positioning of this flue is likely to lead to a build-up of grease and grime in the surrounding area within the ceiling void, which can pose as a fire hazard in the roof void. The presence of insulation surrounding the flue adds to this fire safety risk. Without re-direction to the exterior of the building, the Rangehood is not considered fully operational and is deemed a minor safety hazard. It is therefore preferable that the flue be re-directed to vent into the external environment. A licensed plumber should be appointed as soon as possible to provide further consultation on the scope of these works and to provide quotations for any necessary works.

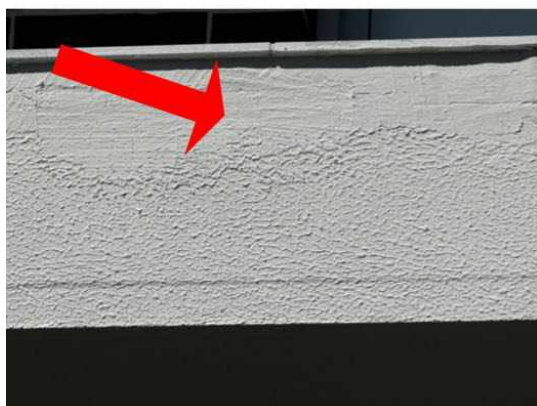
Building: Main Building
Location: Exterior walls
Finding: Wall cladding - cracking or other distortion
Information: Cracking or other distortion affecting the wall cladding was identified this is considered to be a defect under Standards and Tolerances.

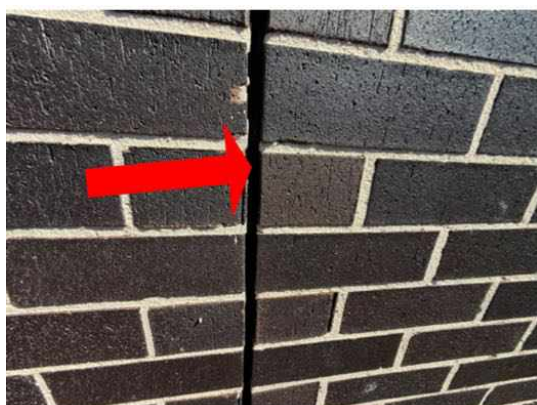
Finding 3.20

Building:	Main Building
Location:	Exterior walls
Finding:	Articulation joints - Inadequate
Information:	The articulation or control joints throughout the exterior brickwork were deemed as insufficient at the time of inspection. Mortar, a non-compressive material, is still evident in some of the joints, not allowing the joints to do their job and allow the brick walls to expand and contract as required during different weather conditions.

Articulation joints must be cleaned of all non-compressive material and then sealed with an appropriate flexible sealant. Failure to perform these necessary works is likely to lead to excessive moisture ingress into these joints, or cracking to the brick walls during extreme weather conditions, which may carry major implications for associated building elements if left unmanaged.

These preventative works are important in ensuring the structural integrity of the associated brickwork. Appointment of a qualified builder or bricklayer is advised to perform remedial works as necessary.

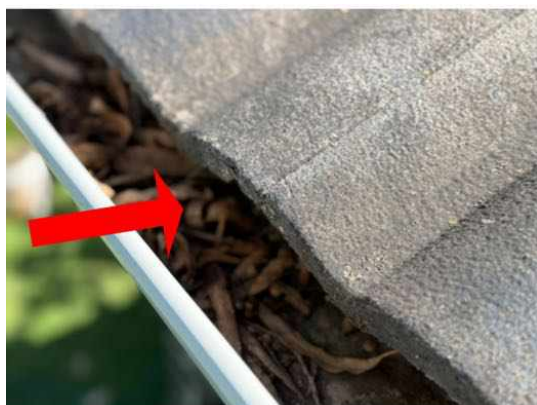
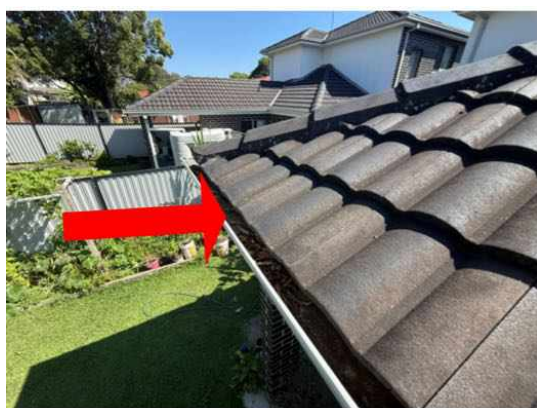
Finding 3.21

Blocked gutters are likely to lead to high levels of moisture in the affected areas. Such moisture will not only cause rust and decay of the associated building materials, but can also provide conditions that are conducive to termite and timber pest activity. Blockages in gutters should therefore be removed immediately to ensure dry conditions are maintained.

Consult a Licensed Plumber for further specific advice on remedial works that may be required. In the interim, it is highly advised that blocked gutters be removed by the homeowner or a general handyperson as a matter of urgency.

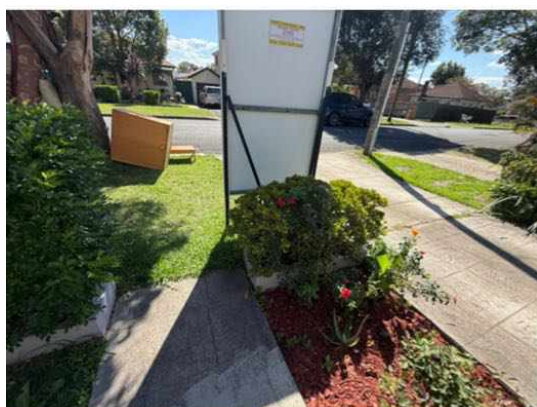
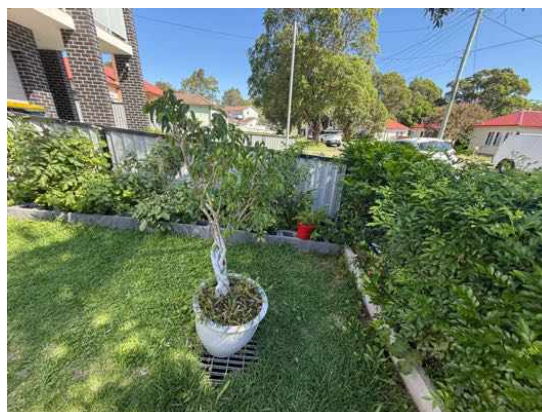
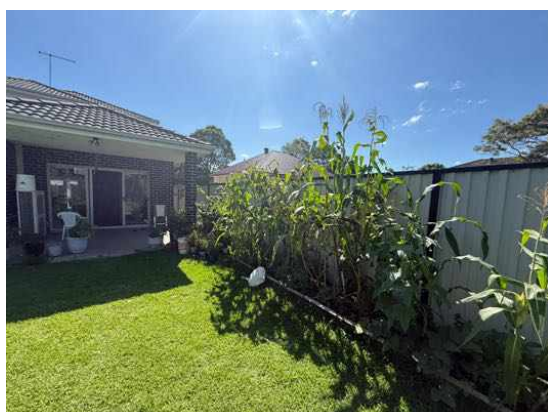
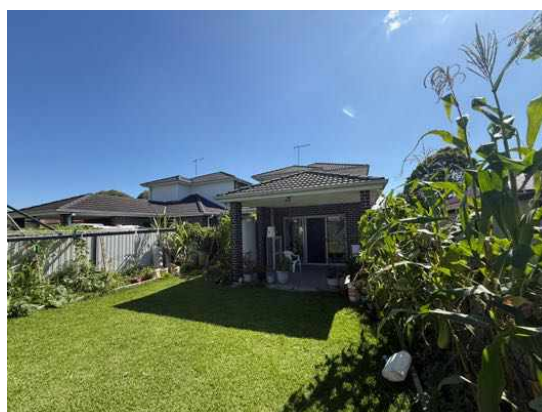
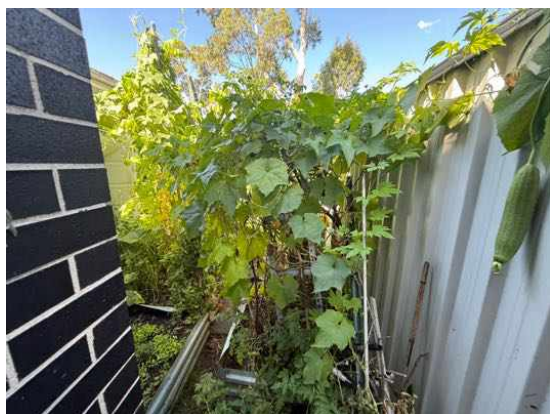
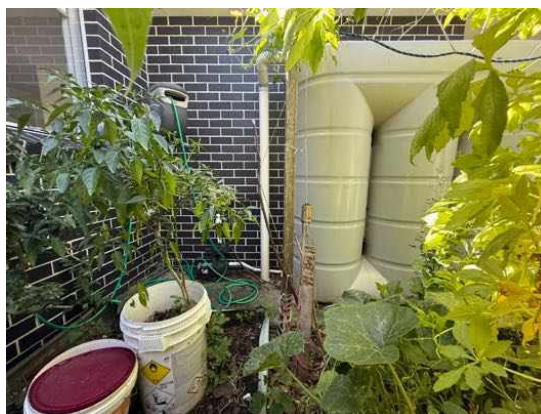
Finding 6.01

Building:	Main Building
Location:	All Areas
Finding:	Garden Beds - Conditions Conducive to Termites
Information:	Garden beds were found to be evident in the garden area. These garden beds can include untreated timber, and with a combination of moisture from watering hosing can make conditions conducive to termite activity and termite ingress.

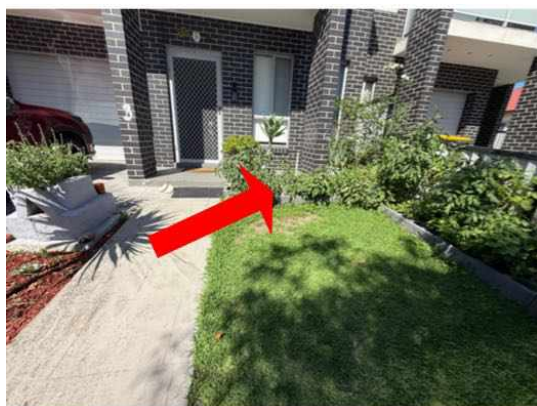
Finding 6.02

Building:	Main Building
Location:	All Areas
Finding:	Bridging of termite barrier/inspection zones
Information:	Bridging is the spanning of a termite barrier or inspection zone so that subterranean termites are provided with passage over or around that barrier.

Where bridging has occurred, full inspection is prevented and termites may enter a property in a concealed or undetectable manner.

It is recommended that minimum 75mm clearance below the bottom of weep or ventilation holes be maintained where possible, otherwise annual inspections should be conducted by a licensed pest control company. Vegetation should also be kept clear of walls to allow regular inspection of all areas.
