Building and Timber Pest Inspection Report

Inspection Date: Tue, 17 Mar 2026

Property Address: 65 Grasslad Grove Leopold, Vic

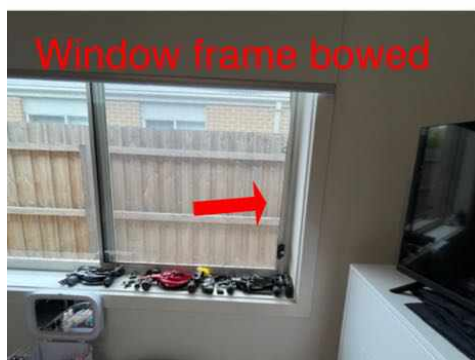
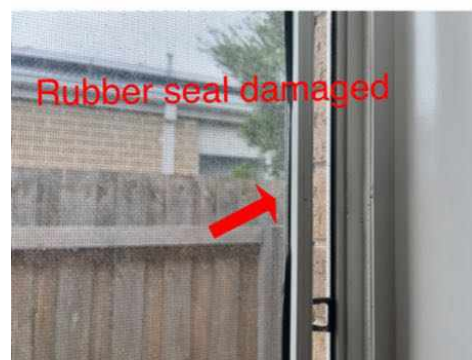
Finding 1.01

Location: Bedroom2

Finding: Window /glass frame - deteriorated

Information: The window is considered compromised.

The window frame has been damaged and the retaining rubber seals that secures the glass has pulled away exposing the glass the risk breakage.

The sliding window frame is clearly bowed on the RH side.this needs to be rectified.

Where window is damaged or deteriorated, the window may break

Also the window may no longer be weather-tight; rain penetration and subsequent water damage is therefore likely to become an ensue.

There is a sliding window in BR2 that needs to have the frame repaired. Please see the safety defect in the report for more information. This item should be addressed immediately to reduce the risk of failure that may result in personal injury.

It is recommended that all deteriorated window be replaced or an expert glazier be engaged to prevent any further damage and to restore the window to a fully functional level.

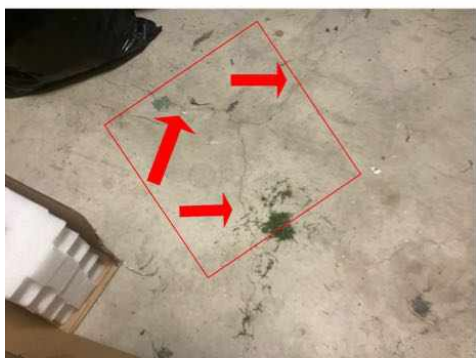
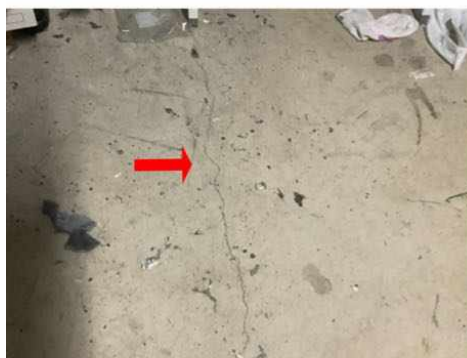
Finding 3.01

Location: Garage
 Finding: Crack in concrete slab - Category 1
 Information: Most of the garage floor was hidden from view due to stored personal items, furniture and boxes. This significantly limits the opportunity to detect any defect.

One area that was exposed was a small area of the concrete slab in the middle of the garage where cracking was observed in the concrete.

This is not uncommon and the type of cracking, is seen in many garage floors and seldom becomes a major defect.

A crack coded as Category 1 was identified in the slab. A Category 1 crack is described as a fine but noticeable crack, with the slab at an otherwise reasonable level.

To be considered Category 1, the approximate width of the crack is less than 1.0mm, or a less than 10mm change in offset when a 3m straight edge is placed over the defect.

Category 1 cracks should be monitored for a period of 12 months. At the end of the monitoring period, identified cracks that are rated greater than Category 2 are considered defects, and require rectification.

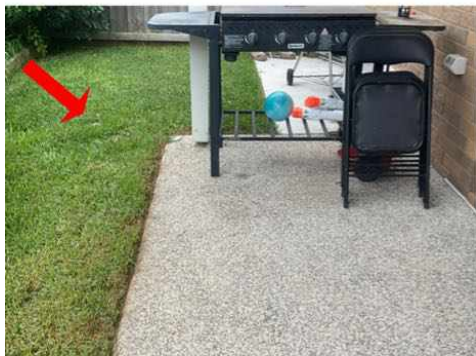
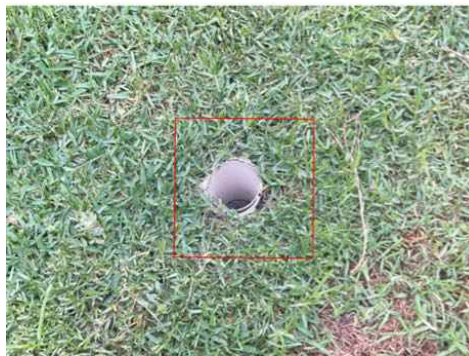
Finding 3.02

Building:
 Location: Yard - Back
 Finding: Drain cover not installed or damage
 Information: The PVC riser needs to be capped to prevent foreign material entering the drain.

Australian standard, A.S350 0.3 Stormwater Plumbing, states that foreign objects cannot be allowed to enter a stormwater drainage system.

Any blockage could result in costly repair, whilst a drain cover is an inexpensive item available from most plumbing suppliers.

If needed a licensed plumber could assist with installing the correct plumbing fitting.

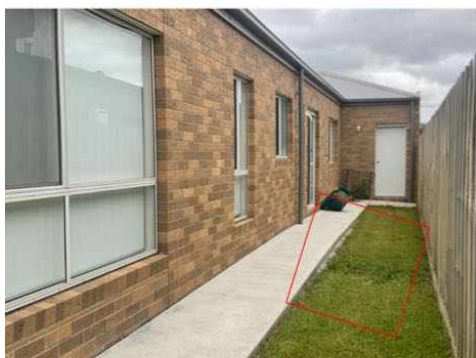
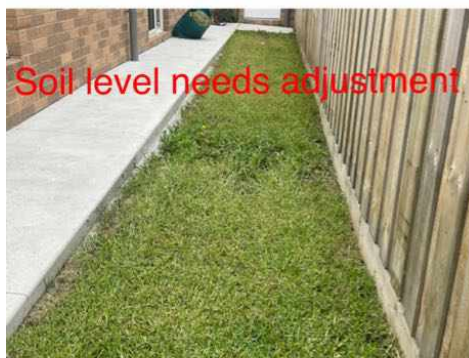
Finding 3.03

Location: Yard - Side

Finding: Site drainage - Inadequate /soil adjustment needed.

Information: The site drainage in this area was found to be inadequate at the time of inspection, creating potential for subsequent water pooling which can result in undermine associated building elements.

It is important that water does not lie against the base of walls; surrounding paths and ground levels should be sloped to drain water away from walls. Downpipes should not discharge stormwater onto lower walls or plinths. Stormwater should be carried away by large, regularly cleaned drains.

Ignoring soil settlement can result in secondary defects and avoidable additional costly repairs.

Topping up the side yard with soil will help maintain the property over time.

These works can be arrived out by a handyman or landscaper.

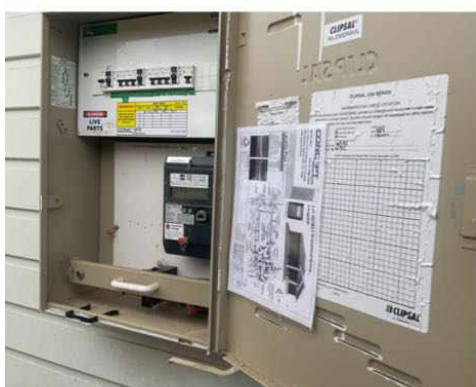
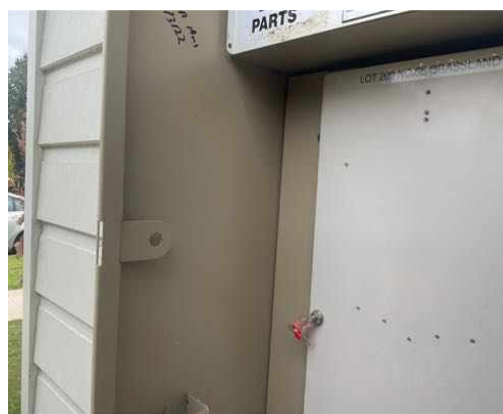
Finding 6.01

Location: Meter Box

Finding: Termite Management System - no evidence of a chemical installation

Information: The application of a post-construction chemical termite barrier is highly recommended for all properties, particularly if live termite activity has been found on the site previously. Such barriers are highly effective in preventing termite attack on any timber building elements throughout the property.

A durable notice should be placed in the switchboard unit to indicate current termite barriers. At the time of inspection, it appeared as though no termite management system has been installed, with no evidence to suggest preventative works taking place.

The client may consider gaining further advice from a pest controller as to the costs and procedures involved with this application. It is recommended that obtaining such advice be a short-term priority.

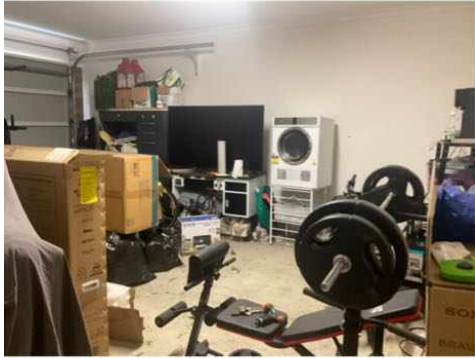
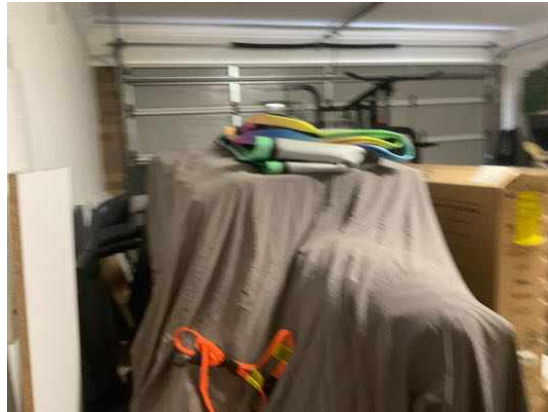
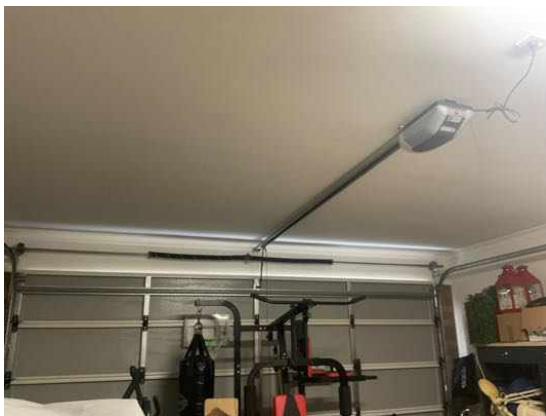
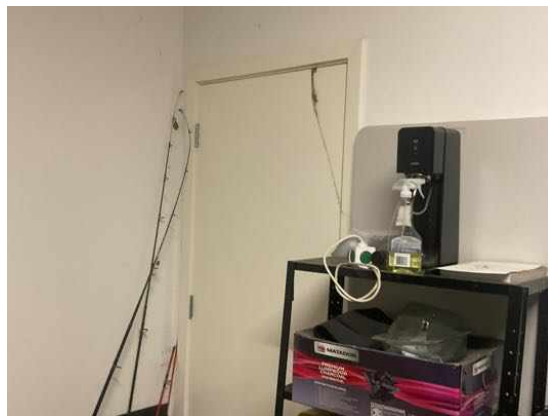
Finding 6.02

Location: Garage

Finding: Additional Photos - Obstructions and Limitations

Information: These photographs are an indication of the obstructions and limitations which impeded full inspection of the property at the time of inspection.

These obstructions can hide an array of defects and should be removed to allow full inspection to be carried out.

A re-inspection is recommended once the areas are made accessible.

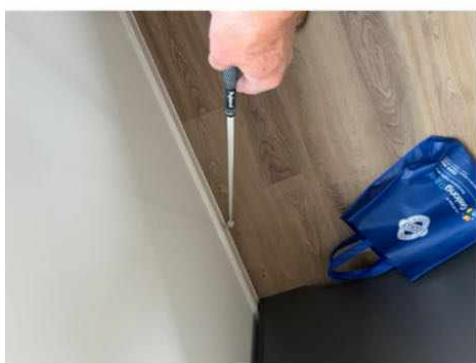
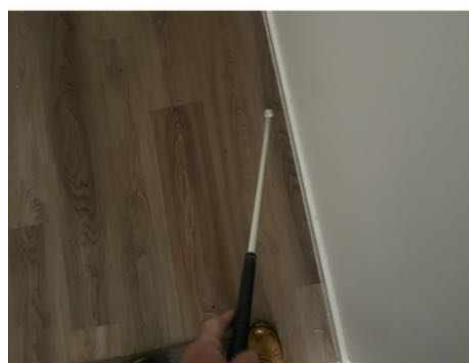
Location: All Areas

Finding: Termite Techniques

Information: All areas of the dwelling are checked with particular attention paid to wet areas which were closely assessed to check for excessive levels of moisture and temperature anomalies.

No evidence of termite activity was found inside the house at the time of the inspection.

Wall paneling, floating timber flooring, carpet and fixed cabinetry can obscure termite activity.

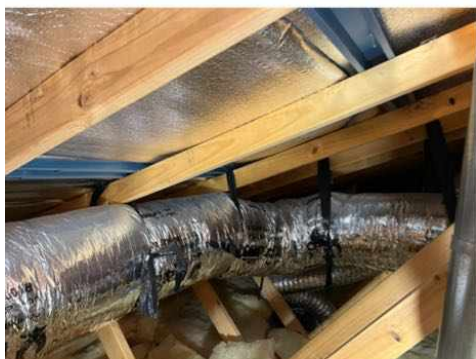
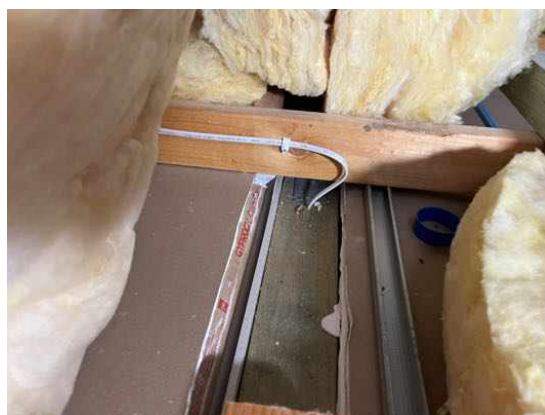
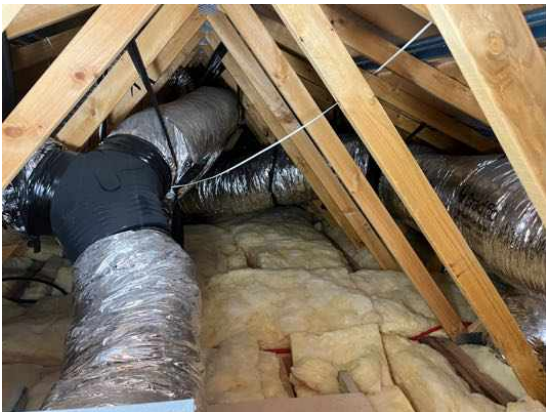
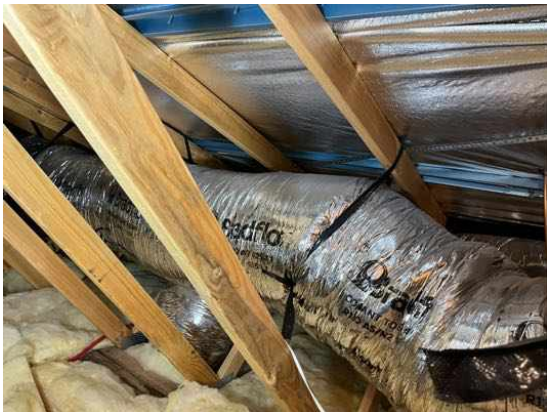
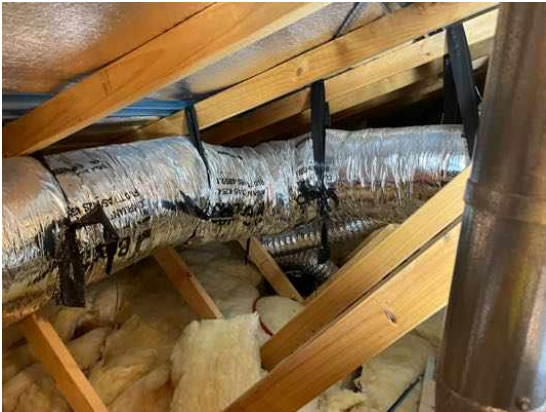
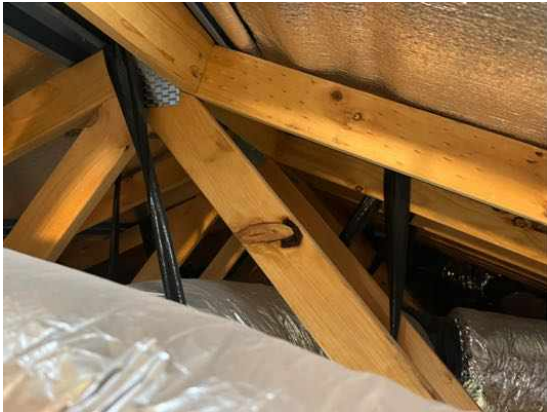
Building:
 Location: Roof Void
 Finding: Additional Photos - Obstructions and Limitations
 Information: These photographs are an indication of the obstructions and limitations which impeded full inspection of the property at the time of inspection.

Bulk insulation is covering almost 50% of the timber surfaces where termite activity is able to go on undetected.

These obstructions can hide an array of defects and where possible, should be removed to allow full inspection to be carried out.

A re-inspection is recommended once the areas are made accessible.

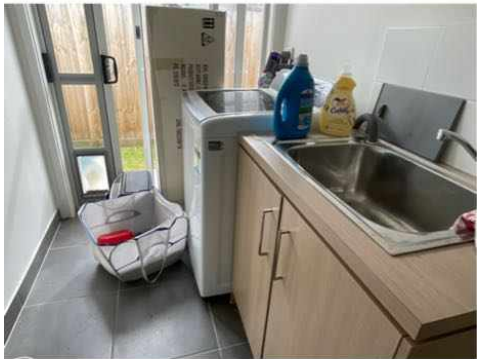
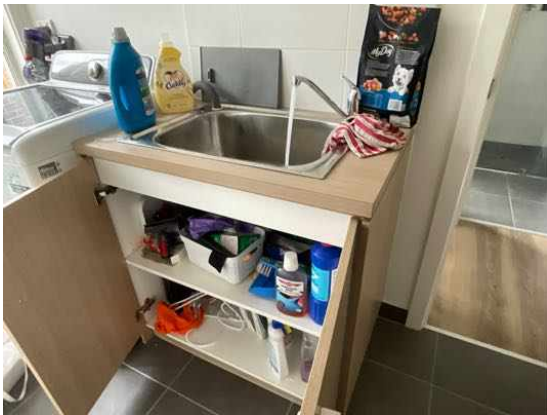
Location: Laundry

Finding: Additional Photos - Obstructions and Limitations

Information: These photographs are an indication of the obstructions and limitations which impeded full inspection of the property at the time of inspection. These obstructions can hide an array of defects and should be removed to allow full inspection to be carried out. A re-inspection is recommended once the areas are made accessible.

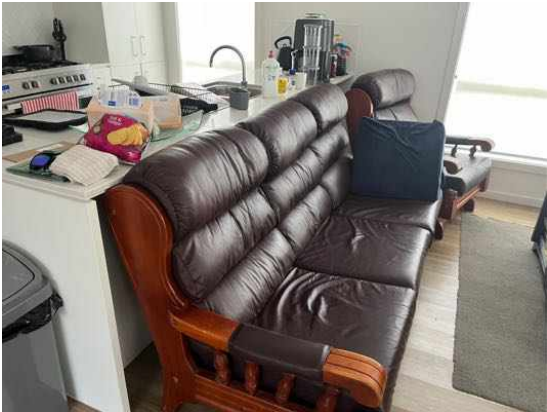
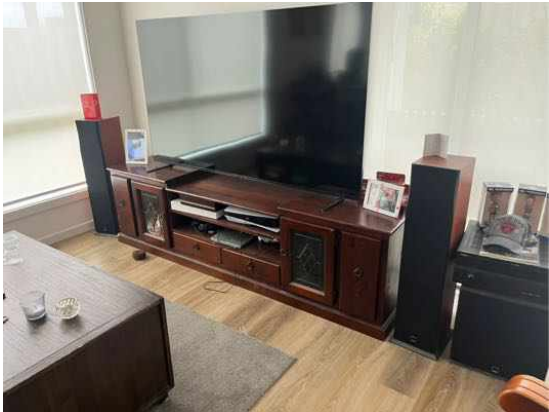
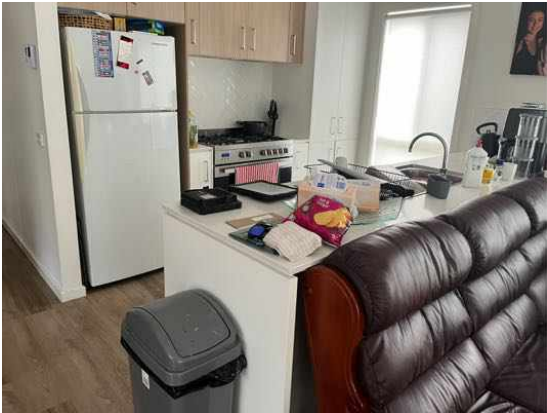
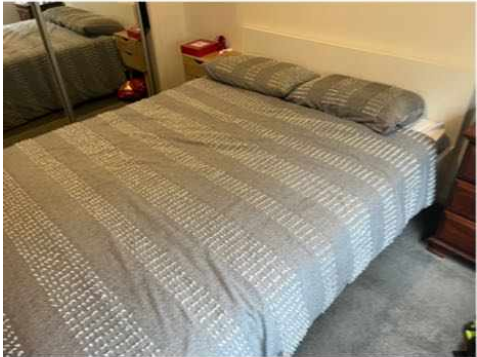
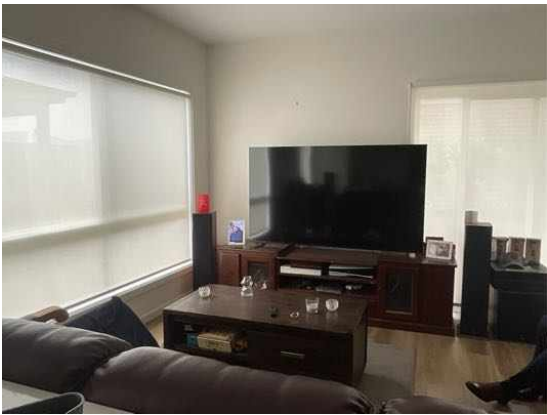
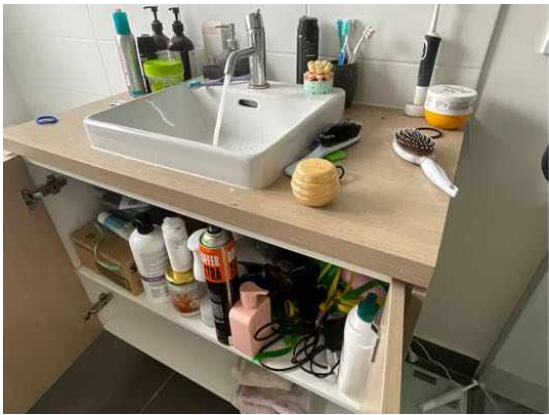
Building:
Location: All Areas
Finding: Additional Photos - Obstructions and Limitations
Information: These photographs are an indication of the obstructions and limitations which impeded full inspection of the property at the time of inspection. These obstructions can hide an array of defects and should be removed to allow full inspection to be carried out. A re-inspection is recommended once the areas are made accessible.

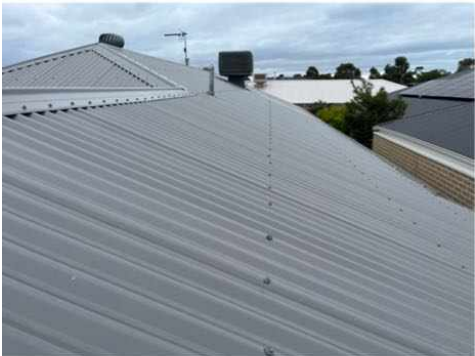
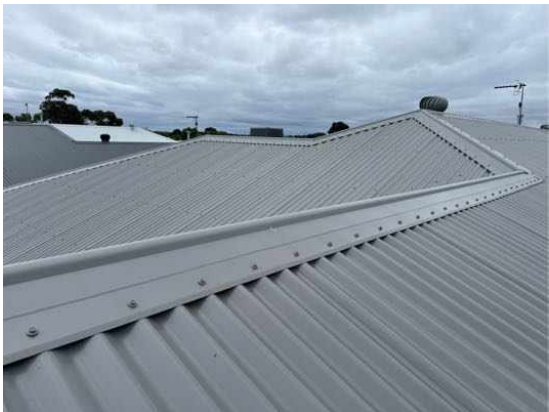
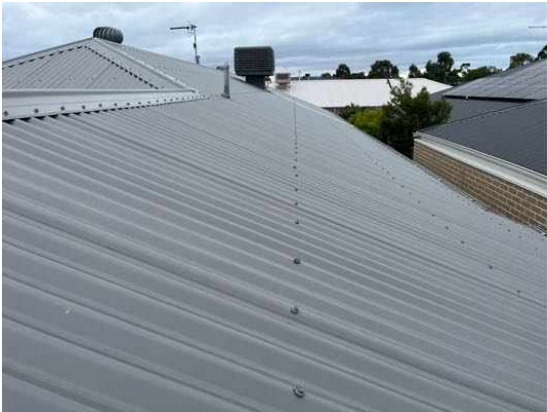
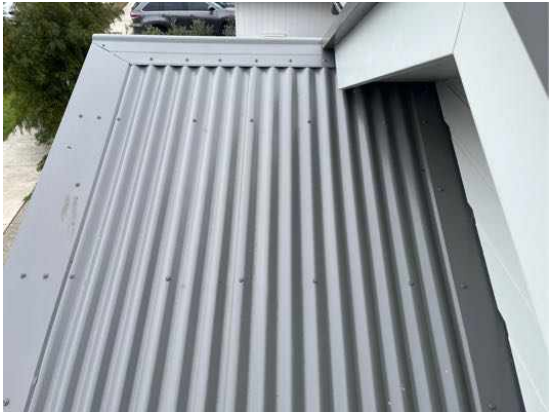
Building:
Location: Roof Exterior
Finding: Additional Photos
Information: Additional photos are provided for your general reference.

exterior roof was found to be in good condition.
