# Building and Timber Pest Inspection Report

Inspection Date: Mon, 2 Feb 2026

Property Address: 23 Bambil Cres, Dapto NSW 2530, Australia

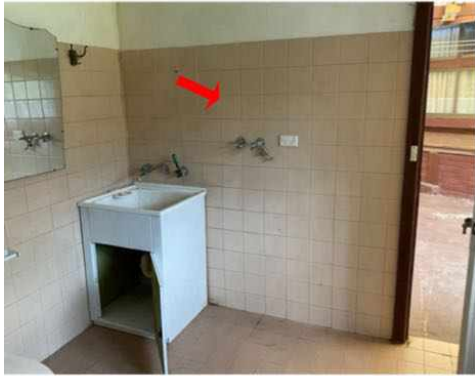
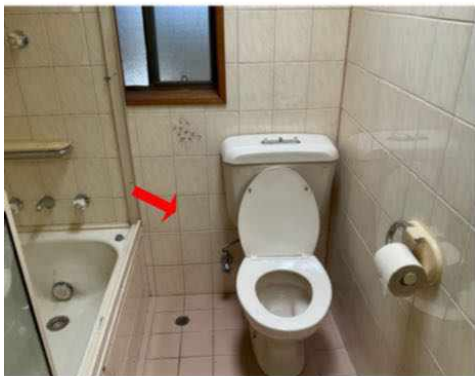
Building:	Building 3
Location:	Verandahs, Bathrooms
Finding:	Bowing in all walls
Information:	Bulging / bowing was noted to all walls in the rear building 3 - bathroom and the main house bathroom. This has led to many cracked tiles. It is suspected that this bulging is caused by lack of or failure in adhesion to framing, and water ingress.

Other defects in the rear building 3 area are as follows -

1. Leaking shower screen.
2. Cracked tiles
3. Substandard sealant.
4. Uneven tiling falling to the rear left leading to rotting the base of the portable cupboard.

Building works required to fix bulging building elements should be completed as the cause may be significant and may indicate a structural defect which would require extensive works in the long-term future, including works to floor structures, walls, and associated finishes.

Further invasive inspection is required to determine the actual cause. If the cause is structural it is advisable that an Engineer also inspects the building.

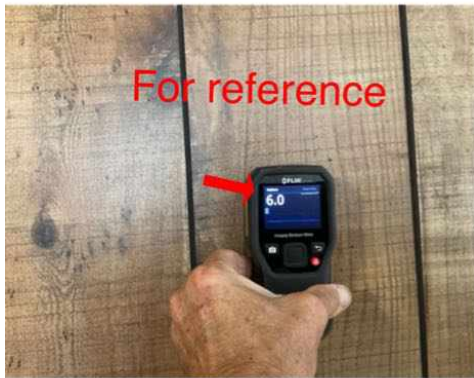
Building: Building 1  
 Location: Rear and front verandah ceilings  
 Finding: Evidence of excessive moisture was present at the time of inspection  
 Information: Excessive moisture found in the front and rear internal verandah rooms. This can attract termites and produce conditions that promote termite attack, fungal growth and wood decay. Excessive moisture is generally caused by deteriorated, inadequate or missing roof drainage, damaged external sealant, leaking plumbing pipes or fixtures and poor site drainage. It is highly recommended that all roofing sheets and fittings be maintained regularly in order to prevent excessive moisture being present in the internal property.

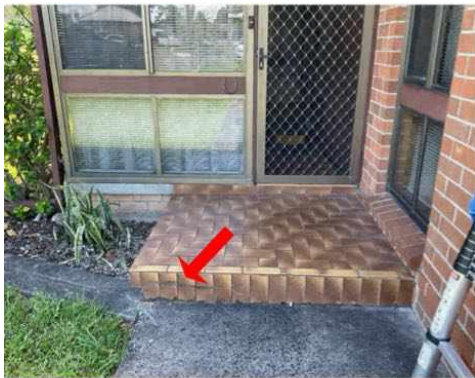
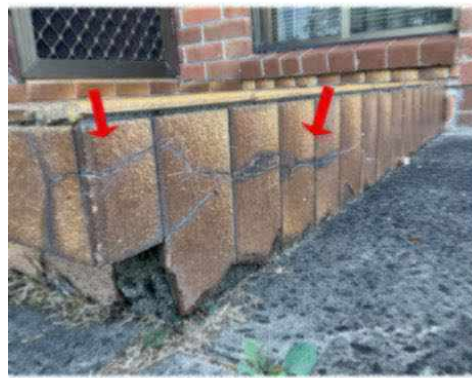
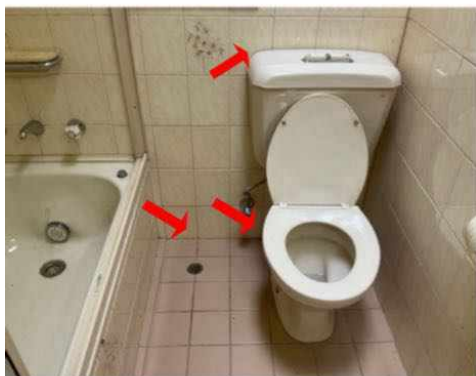
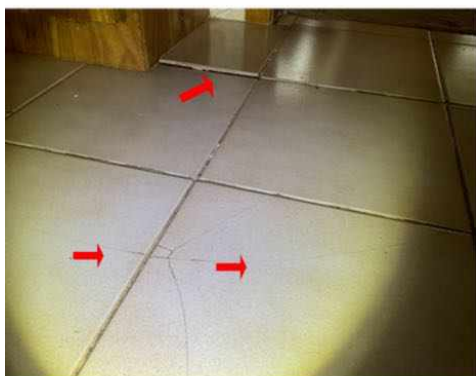
### Finding 3.03

Building:	Building 1
Location:	Verandahs, bathrooms, kitchen.
Finding:	Tiles cracked
Information:	Over 3 dozen cracked tiles were evident on the external porches, wet areas, kitchen etc at the time of inspection. It is suspected that this cracking has occurred as a result of both minor settlement and impact damage. Cracked tiles throughout the household detract from the overall appearance of the affected areas. In wet areas of kitchens and bathrooms, it can lead to water damage of adjoining walls and floors.

Replacement of any sharp cracked tiles is recommended to prevent injury. A tiling contractor may be appointed to perform these works.

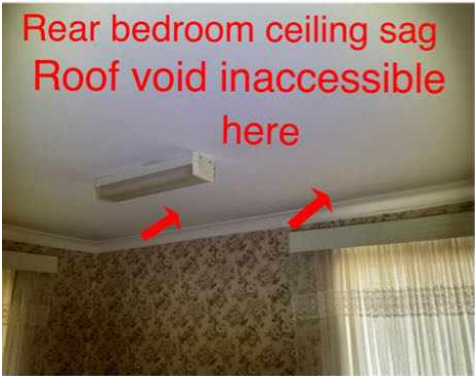
Building:	Building 1
Location:	Porch, lounge room, kitchen, rear bedroom
Finding:	Ceilings - Sagging
Information:	Sections of these ceilings were found to be sagging at the time of inspection. Sagging to the fixed ceiling structure generally indicates that the building materials have swollen, due to contact with water, or that fixings (e.g. nails or glue) have become loose and require reattachment.

Rear bedroom ceiling sag  
Roof void inaccessible  
here

Where minor sagging is evident, comparatively minor works, such as re-gluing of ceiling sheets, may be required. Such works may be performed by relevant tradespeople, such as plasterers and painters. Where excessive moisture has caused the roofing structure to swell and sag, the source of the water leak should primarily be identified prior to any remedial works being performed.

In some cases, sagging ceiling linings may also indicate that there are structural issues, causing surfaces to warp, twist or sag. Where sagging appears to be major, appointment of a structural engineer is advised to further inspect the property and identify the source and rectification works required.

The appropriate action should be taken by the client as soon as possible to ensure that any potential further damage is limited.

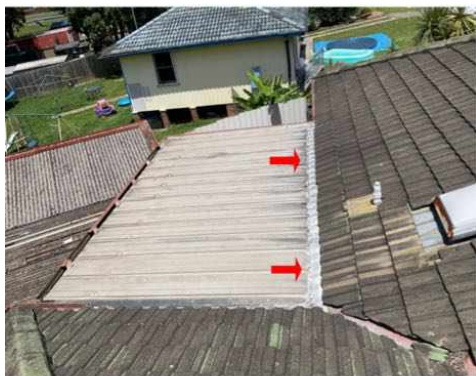
Finding 3.05

Building: Building 1  
Location: Roof Exterior  
Finding: Roofing areas - Weathered  
Information: Upon inspection of the exterior roofing, the majority of the roof areas were considered to be in a fair condition. While weathering of these pictured areas is consistent with the age of the property, maintenance works are required. The many areas of repaired sealant in the front and rear verandahs appear to be still leaking.

Re-sealing and replacing small areas of gaps, damage or rust the may be considered as an interim solution by the client to help preserve and extend the life span of these roofing areas. Where left unmanaged, deteriorating roofing materials are likely to lead to a number of secondary defects, including minor water leaks and weather exposure to internal roofing structures.

Remedial works are likely to increase the longevity of the exterior roofing structure.

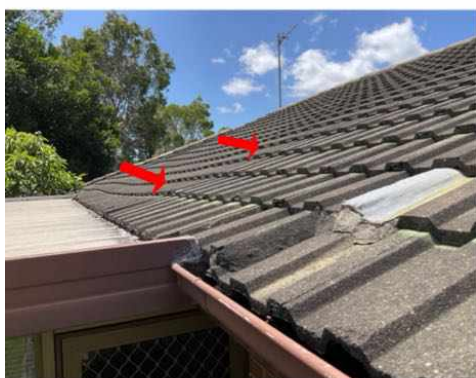
### Finding 3.06

Building:	Building 1
Location:	Pictured areas
Finding:	Roof structure - Connections (Sagging)
Information:	The roofing structure was found to be sagging slightly in certain sections at the time of inspection. Sagging roof structures are likely to create strain on associated building elements, creating potential for secondary damage.

Annual monitoring is recommended and if further sagging is found, remedial works are advised and should be performed by a registered builder or roofing contractor.

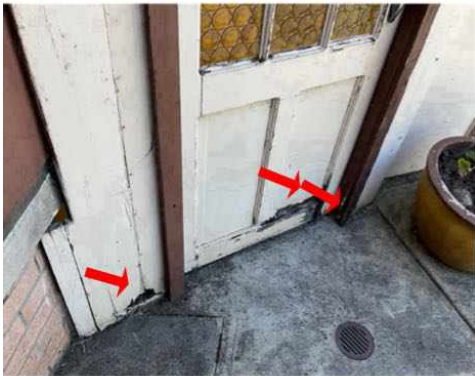
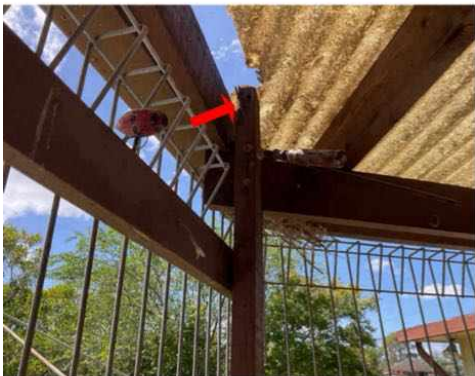
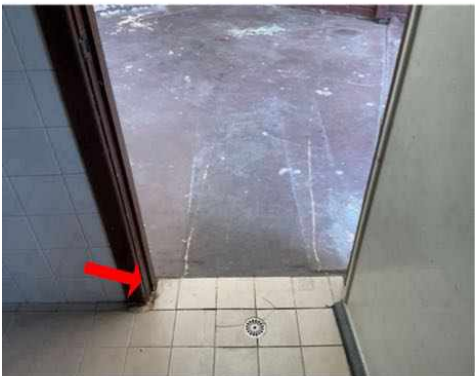
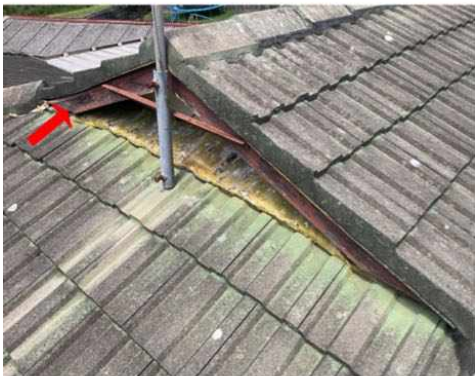
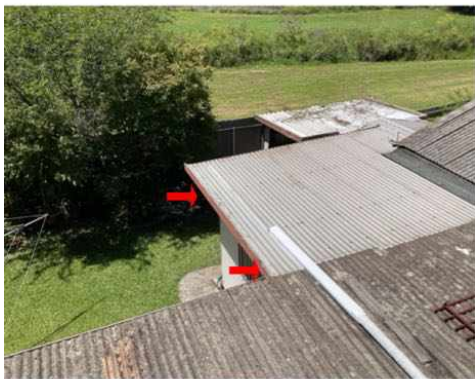
### Finding 3.07

Building:	Building 1
Location:	Garage and rear areas
Finding:	Wood rot to all buildings
Information:	The buildings shows evidence of wood rot. Wood rot, also known as Fungal Decay, occurs when timbers and other cellulose building materials are exposed to damp conditions on an ongoing basis. This could be the result of exposure to weathering over a prolonged period of time, or the attraction of excessive moisture from other abutting building materials.

Early intervention and regular maintenance, particularly of exterior timbers, will prolong the useful life of these building elements. Prior to any works being performed, the cause of the moisture that has created the visible wood rot should be identified and addressed in a suitable manner. Replacement of affected timbers may then be a necessary step in protecting surrounding building elements from such deterioration.

A qualified carpenter or registered builder may also be required to replace affected building materials.

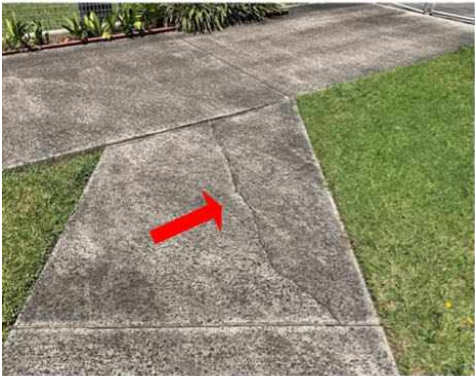
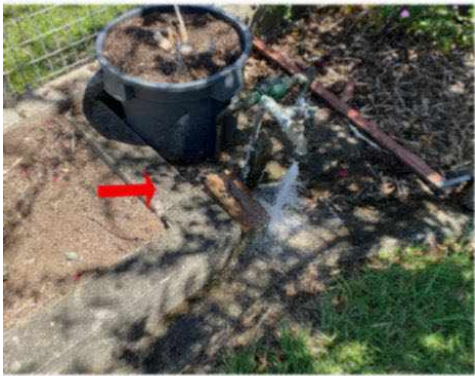
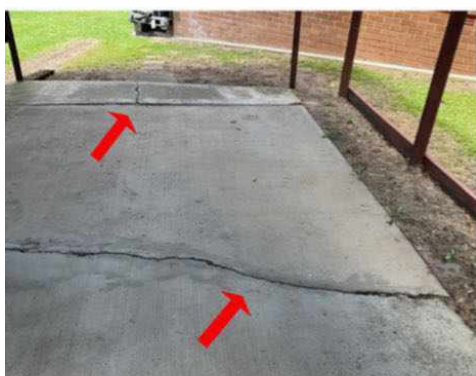
Building: Building 1  
Location: Yard - front & rear  
Finding: Crack in concrete areas - Category 3  
Information: Cracks coded as Category 3 was identified in the slab. A Category 3 crack is described as a wide crack with obvious curvature or change in level, affecting the slab.

The approximate width of the crack to be considered Category 3 is greater than 2.0mm, or a change in offset of 15-25mm when a 3m straight edge is placed over the defect.

Category 3 cracks to slabs exceed allowable Standards and Tolerances, and are considered defects requiring rectification.

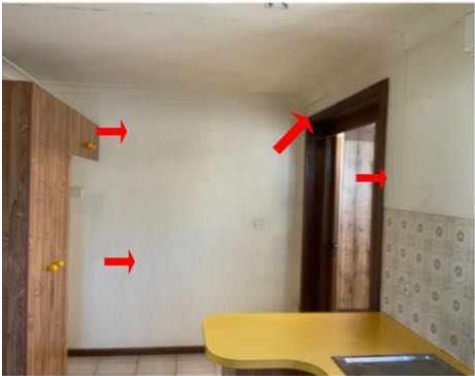
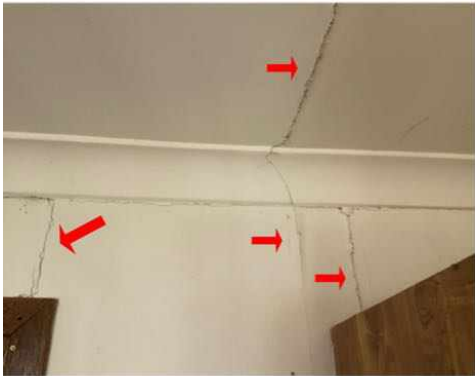
### Finding 3.10

Building:	Building 1
Location:	Many areas
Finding:	Cracking - Damage Category 2 - Noticeable (up to 5mm)
Information:	Numerous noticeable cracks are a common occurrence as a result of many primary defects. Such causes may include age, general wear and tear, expected building movement, general expansion/contraction of building materials in different weather conditions, and/or minor failings in the installation or application of building materials.

Noticeable cracks may result in minor sticking or jamming of associated doors and windows, which require easement. However, noticeable cracks are easily filled and repaired. A plasterer can be consulted to install an expansion joint at this point to allow for this movement during different weather conditions.

Monitoring of all cracking should be conducted frequently. Always contact a building inspector should cracks widen, lengthen, or become more numerous. Additionally, your building inspector should also be contacted if associated building elements such as doors and windows become more difficult to operate over time.

Relevant tradespeople, such as carpenters, painters and plasterers, should be appointed to perform remedial works, as deemed necessary.

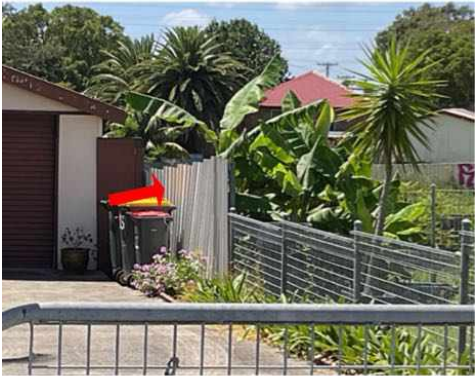
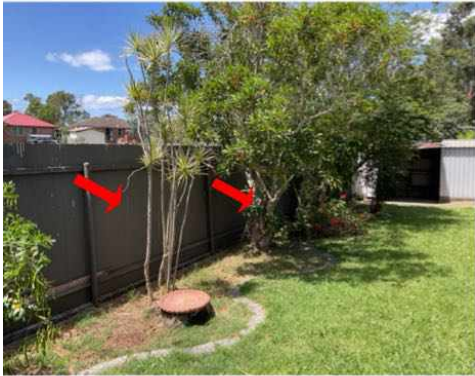
**Finding 3.11**

Building: Building 1  
 Location: Pictured fences  
 Finding: Fences damaged - leaning  
 Information: Evidence of damage to the pictured fences was identified at the time of the inspection. The likely cause of these fences leaning is not enough concrete used in the post footings. If left unmanaged these fences may deteriorate further. It is suggest a fencing contractor be engaged for rectification when convenient.

The cost of repairing fences is often shared between neighbours.

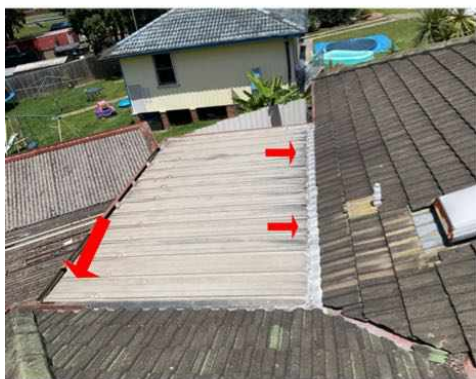
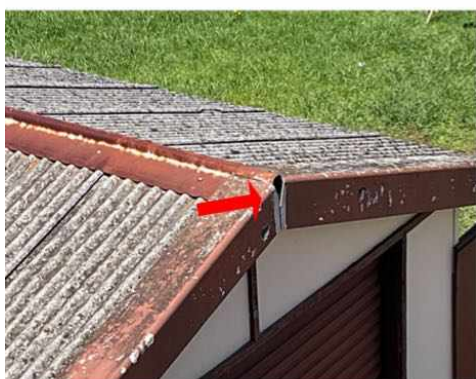
### Finding 3.12

Building:	Building 1
Location:	Pictured Areas
Finding:	Sealant (external) - Missing.
Information:	It was noted on inspection that areas of external sealant was missing to small areas of the external walls and rooves.

Flexible sealants should be applied to these affected areas to prevent any subsequent water damage that is likely to occur.

A sealant specialist or skilled handy person should be appointed to complete these works as soon as possible

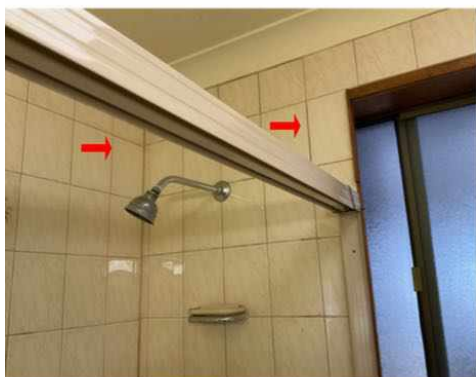
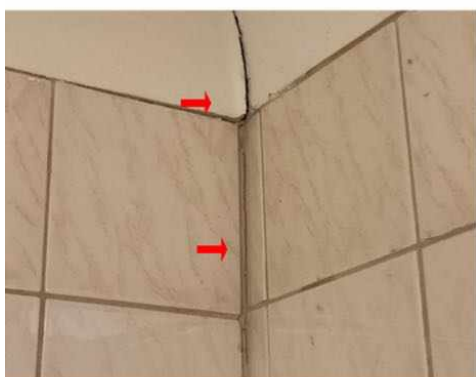
### Finding 3.13

Building:	Building 1
Location:	Kitchen and bathroom
Finding:	Sealant and grouting - Missing or damaged
Information:	It was noted on inspection that sealant or grout is degraded to these pictured wet

Different materials and floor areas move at different rates, generally causing cracking to grout or sealant at this point. A flexible sealant is required to allow for expected expansion and contraction, while keeping the joint water tight and protective of all associated building materials.

Flexible and mould resistant materials should be applied to affected areas to prevent any subsequent water damage that is likely to occur. Regular maintenance and replacement of damage or missing or damaged sealant and grout is highly recommended to the wet areas, as this is a regular wear and tear defect. Sealant and grouting in areas that come into regular contact with water should be maintained for the long term care of your property.

A sealant specialist or tiling contractor should be appointed to complete these works as soon as possible

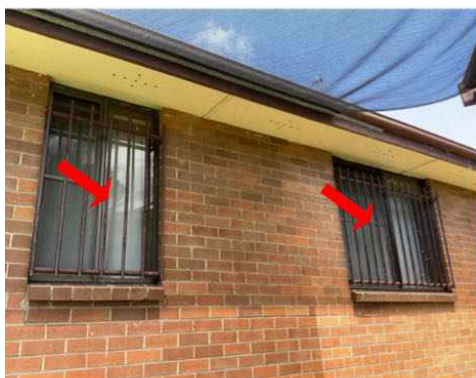
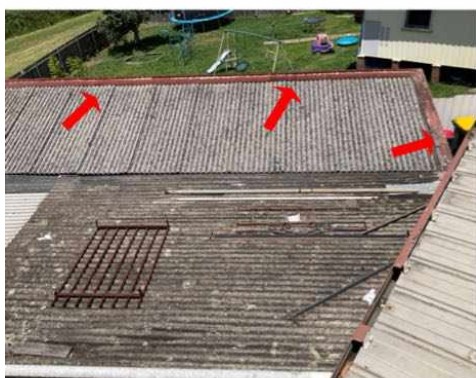
As surface rust provides no protection to the underlying iron, the deteriorating condition is likely to worsen if not addressed in the short-term future.

Rusting and corrosion should be managed by ideally removing or limiting the affected surface from exposure to moisture. A registered builder may be appointed to replace any building elements that have been severely affected by rust or water damage.

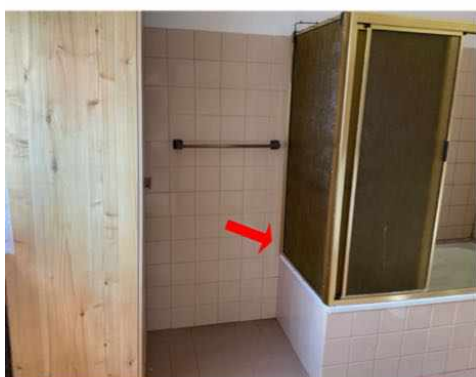
See also safety defect of the leaking main bathroom shower.

Appointment of a sealant expert is required to repair or replace this missing sealant. Such works should be performed as soon as possible to ensure that no further damage occurs.

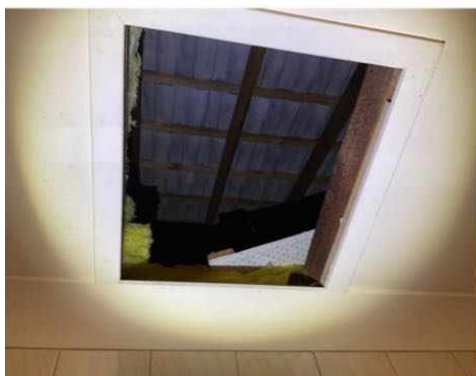
### Finding 3.22

Building:	Building 1
Location:	Roof Void
Finding:	Sarking - Missing

Although not a requirement at the time of construction, replacement of any missing building element is advisable (although this can be quite expensive to do after the time of construction). Where sarking is missing, regular inspections of the roof tiles for cracking and potential moisture penetration is required.

Sarking may be retrospectively fitted by a registered builder at the discretion of the client.

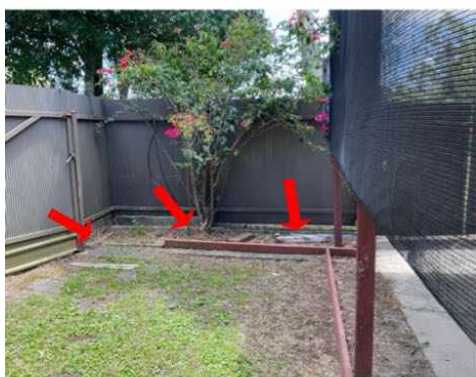
Removal of all waste timber that is in direct contact with ground is highly advised. This timber is promoting mould and wood rot and is very attractive to termites.

Frequent pest inspections are advised to readily identify any termite activity in these areas.

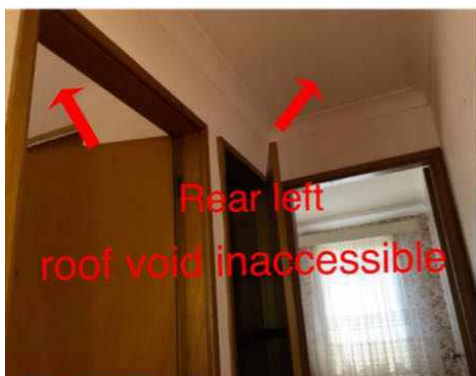
Building: Building 1  
 Location: All Roof cavity areas  
 Finding: Additional Photos - Obstructions and Limitations of the ROOF CAVITY  
 Information: These photographs are an indication of the obstructions and limitations which impeded full inspection of roof cavity areas at the time of inspection. These obstructions can hide an array of defects and should be removed to allow full inspection to be carried out if applicable. A re-inspection is recommended once the areas are made accessible.

The inspection was also limited to areas with an allowable crawl space of 600mm x 600mm, in particular towards the external walls where the roof line diminishes, these areas were not accessible.

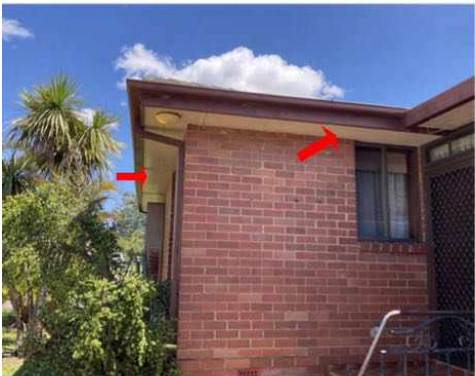
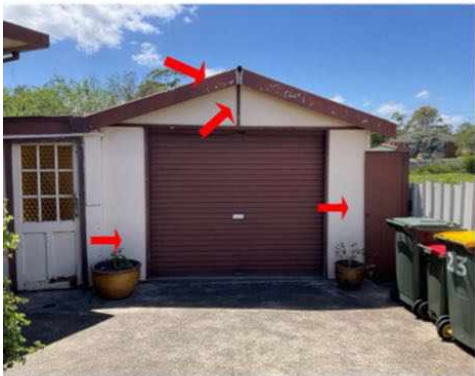
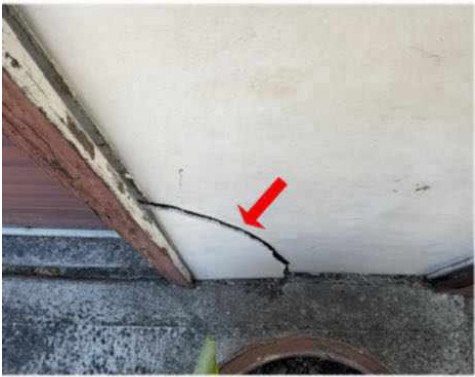
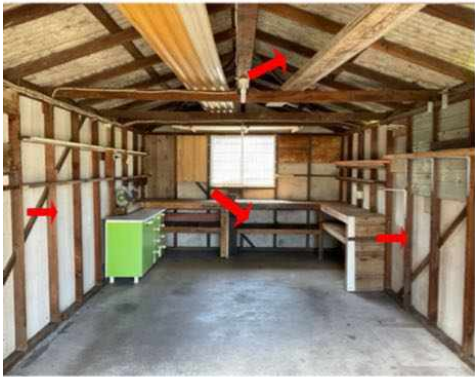
Building: Building 1  
 Location: Garage, shed, bathrooms, eaves.  
 Finding: Asbestos - ACM Identified on Site

In the interim, the client is advised to act with caution, especially when considering any damage to building materials, general wear and tear, renovations, extensions, demolition and general maintenance activities due to the suspected presence of Asbestos.

Contact this inspector for Asbestos Report and testing.
