Building and Timber Pest Inspection Report

Inspection Date: Wed, 28 Jan 2026

Property Address: 84 Venezia St, Prestons NSW 2170,
Australia

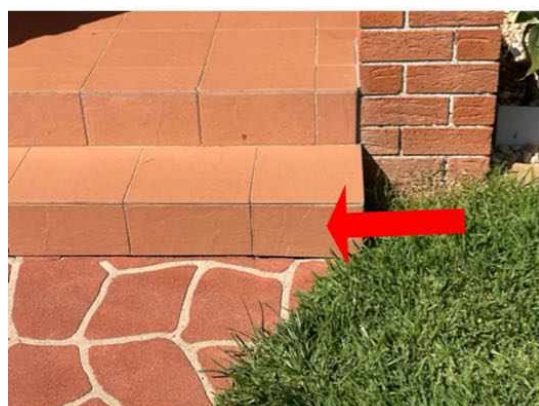
Building: Main Building
Location: Porch
Finding: Tiles - Cracked or damaged
Information: Cracking was evident to the tiling in this area at the time of inspection. While the cracking appears to be minor, this area is frequently exposed to water, allowing potential for water penetration into adjoining sections of walls or flooring.

If left unmanaged, water penetration to these areas may lead to subsequent water damage, which is likely necessitate repair work to affected building elements.

A tiling contractor should be appointed to ensure that no further water damage occurs. The re-application of silicone and grouting throughout remaining tile work is also advised, to further protect the area against water penetration.

Where water penetration has led to water damage, appointment of a relevant tradesperson may be required to repair damaged building elements.

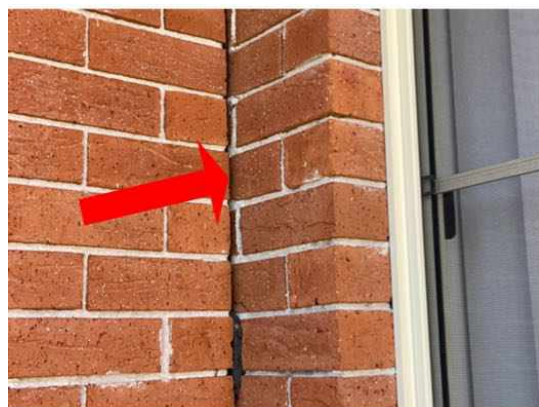
Finding 3.02

Location: Exterior walls
 Finding: Articulation joints - Inadequate
 Information: The articulation or control joints throughout the exterior brickwork were deemed as insufficient at the time of inspection. Mortar, a non-compressive material, is still evident in some of the joints, not allowing the joints to do their job and allow the brick walls to expand and contract as required during different weather conditions.

Articulation joints must be cleaned of all non-compressive material and then sealed with an appropriate flexible sealant. Failure to perform these necessary works is likely to lead to excessive moisture ingress into these joints, or cracking to the brick walls during extreme weather conditions, which may carry major implications for associated building elements if left unmanaged.

These preventative works are important in ensuring the structural integrity of the associated brickwork. Appointment of a qualified builder or bricklayer is advised to perform remedial works as necessary.

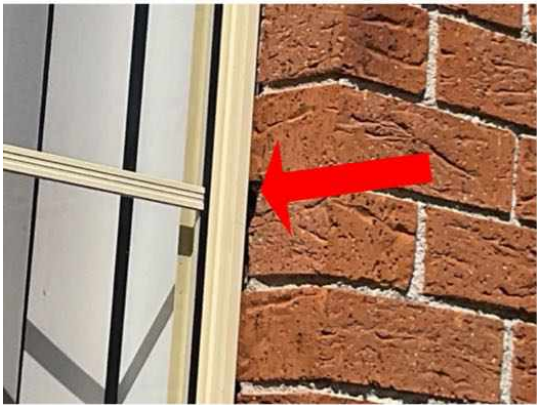
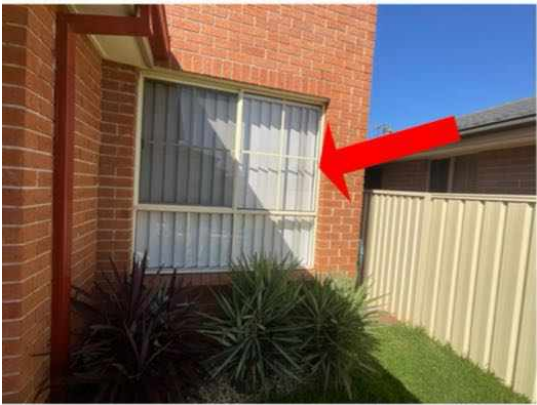
Finding 3.03

Building: Main Building
 Location: Exterior walls
 Finding: Window - Gap
 Information: A significant gap was identified between the brick and window frame in this area. Where large gaps to the head appear, it may be indicative of a variety of defects, ranging from uneven framework, sagging hinges or uneven flooring.

A gap to the head of the window may also indicate movement of the foundation of the property, which is a common occurrence and does not indicate structural damage.

A qualified tradesman should be appointed to perform remedial works to restore the window to a fully operational level.

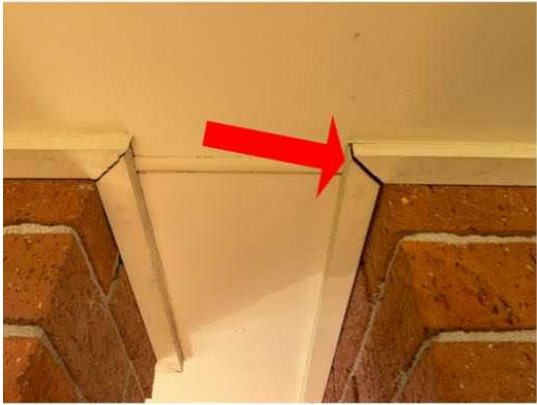
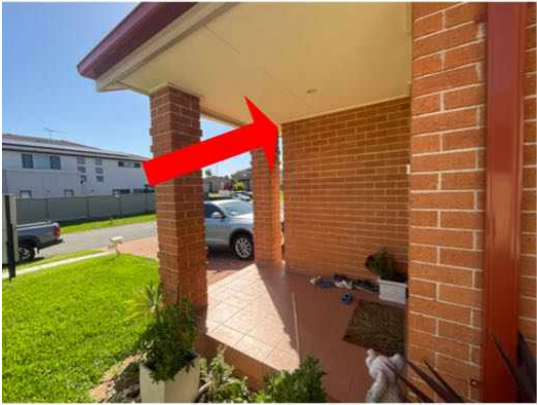
Finding 3.04

Finding: Beads - damage

Information: Where beading (also known as 'quad') are damaged from the eaves It was noted at the time of inspection that beading in this area has deteriorated. Beading is important in weatherproofing the surrounding building elements and preventing termite or pest ingress. Furthermore, beading works to protect the joins of building materials, which are more susceptible to deterioration and decay. Repair or replacement of the beading is advised to ensure the protection and longevity of any associated building elements. Such works may be performed by a general handyperson or qualified carpenter.

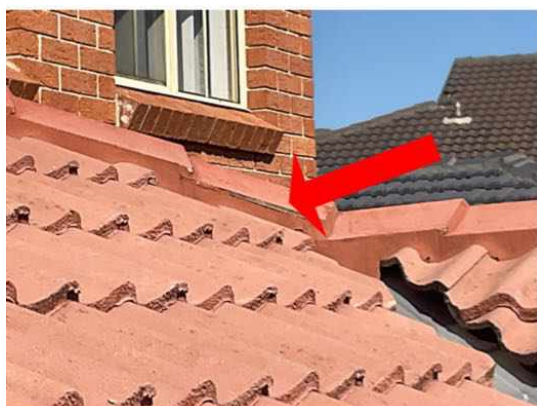
Building: Main Building
 Location: Roof Exterior
 Finding: Mortar - Deterioration
 Information: Mortar, or 'bedding', is the material which fills joints and intersections between tiles and other building elements on the exterior roof covering, such as gable ends, hip capping and valleys. Upon inspection of the exterior roof, it was noted that sections of the

mortar show varying levels of deterioration.

Mortar generally deteriorates as a result of frequent exposure to weather conditions over a prolonged period of time. Mortar that is deteriorating may allow water ingress into the roof void, putting associated building elements and roofing structures at risk of water damage. Deteriorated mortar also detracts from the functionality of roof tiles and other roofing elements, potentially decreasing weather tightness and roof drainage.

Mortar deterioration can be attended to by a handyperson where areas of deterioration are localised and easily accessible. Otherwise, consultation with a roofing contractor is advised where greater works are required.

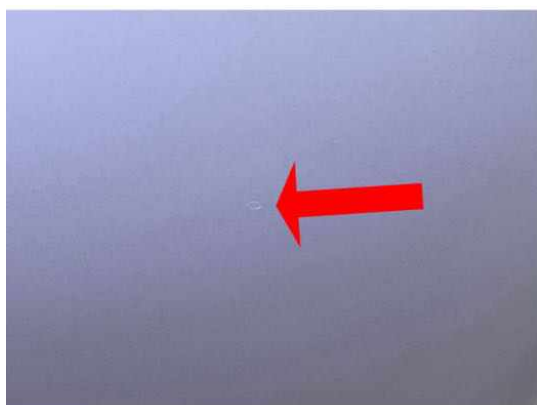
| Information: | Numerous popped nails were identified in the internal ceiling at the time of inspection. Nails and screws hold simply by the friction between them and the surface they are applied to. Over time, the nails and screws can back out, which is often a result of general ageing and deterioration of the building structure. |

If left unmanaged, the ceiling sheets may become loose and unstable, increasing the rate of deterioration of the internal ceiling and creating potential for the development of secondary defects.

Re-fastening of popped nails will help to maintain the stability of the internal ceiling and associated building elements. Such minor works will also help to improve the appearance of the affected area and secure the ceiling sheets, so as to prevent the onset of ceiling sagging. These works should be performed by a qualified carpenter or plasterer at client discretion.

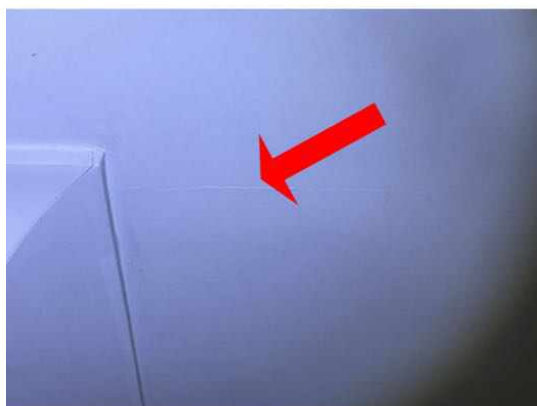
Finding 3.09

| Finding: | Cracking - Damage Category 1 - Fine (up to 1mm) |
| Information: | Although fine cracks are quite noticeable, they are often only considered to be an appearance defect, and usually do not indicate any structural damage. Generally, the cause of a fine crack is indicative of a separation between building materials and finishes (e.g. paint, plaster, etc.) along joins. |

Cracking of this nature can generally be repaired with minor sanding, filling and/or repainting. Such works should be performed by a qualified painter or a general handyman.

Monitoring of all cracking should be conducted frequently. Always contact a building inspector should cracks widen, lengthen, or become more numerous.

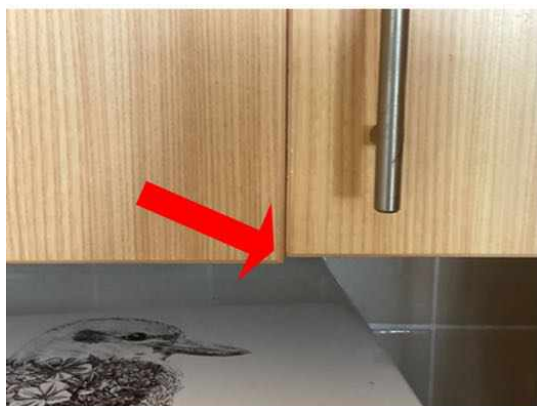
| Finding: | Cabinet doors - misaligned |
| Information: | It is observed that some of the cabinet doors are not aligned and / or have inconsistent gaps between the doors. |

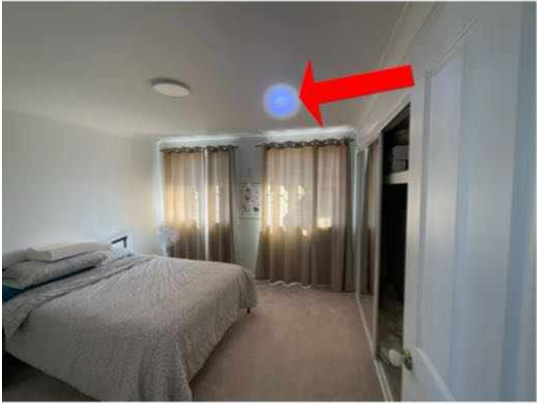
Finding 3.12

| Finding: | Paint finish - Substandard, Wear and Tear |
| Information: | The paint finish in this area was found to have been completed to a substandard level or wear and tear as the normal deterioration of a property from ordinary, everyday use. Exposure to the elements, time, as well as day to day living can cause fair wear and tear. |

If this applies, further areas of poor and incomplete finishes could develop over time. Furthermore, substandard, wear and tear paint finishes in areas exposed to moisture, e.g. external areas or wet areas, could lead to deterioration of underlying building materials.

Substandard, wear and tear paint finishes should be sanded back, filled, leveled and repainted, as applicable. Where inadequate paint protection has led to the deterioration of the associated building element, repair and/or replacement of this building element may be required.

A painting contractor should be appointed as soon as possible to perform necessary works to aid the appearance of the affected area and to ensure that the area is protected against further deterioration. Alternatively, the homeowner following manufacturer instructions may be able to provide this service.

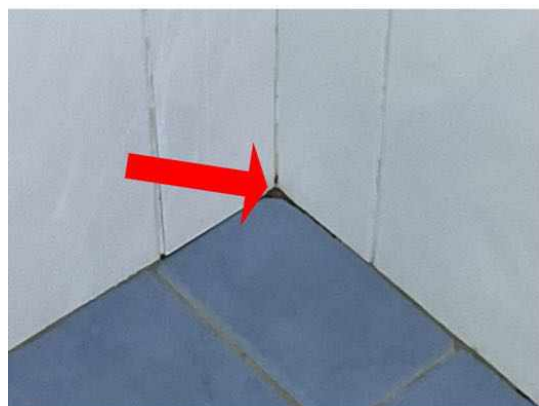
Finding 3.13

| Finding: | Sealant and grouting - Missing or damaged |
| Information: | It was noted on inspection that sealant or grout is degraded to the tiled shower alcove and or other areas of the bathroom. |

Different materials and floor areas move at different rates, generally causing cracking to grout or sealant at this point. A flexible sealant is required to allow for expected expansion and contraction, while keeping the joint water tight and protective of all associated building materials.

There appears to be excessive mould to the sealant and grout which will likely require scraping out and replacement.

Flexible and mould resistant materials should be applied to affected areas to prevent any subsequent water damage that is likely to occur. Regular maintenance and replacement of damage or missing or damaged sealant and grout is highly recommended to the wet areas, as this is a regular wear and tear defect. Sealant and grouting in areas that come into regular contact with water should be maintained for the long term care of your property.

A sealant specialist or tiling contractor should be appointed to complete these works as soon as possible

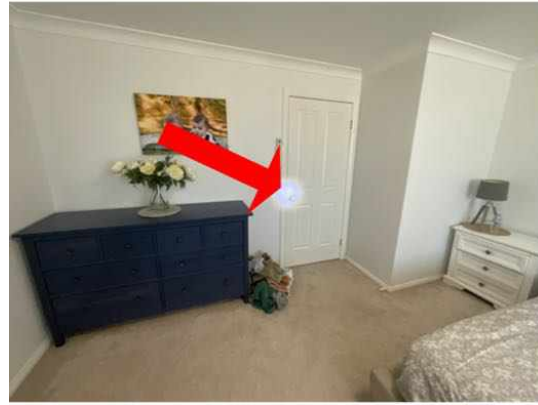
Building: Main Building
 Location: Bedroom - Master
 Finding: Door handle - Not latching
 Information: It was noted that the door in this area was not latching during operation at the time of inspection. Whilst detracting from the functionality of this building element, this minor defect may also be a security risk, and may therefore have serious implications if left unattended.

It is suspected that this defect has occurred due to minor issues with the associated hinges. Such damage is identified as general wear and tear, which is expected for building elements of this age.

A qualified carpenter or general handyperson may be appointed to perform rectification works as necessary, at client discretion. If left unattended, further functional impairment is likely to occur.

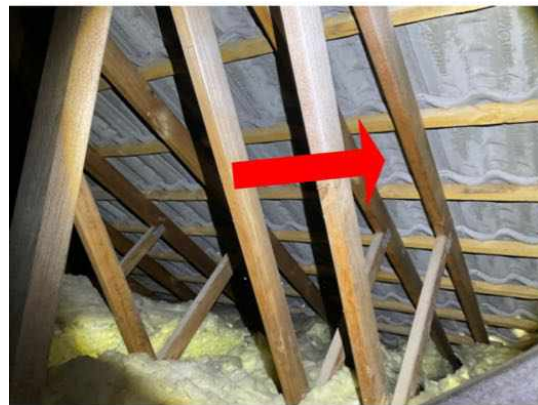
Finding 3.18

| Finding: | Sarking - Missing |
| Information: | Sarking is missing under the roof sheeting. Sarking acts as an insulator that helps with noise reduction and protects against water penetration. Sarking plays a key role in the operation and function of the overall roofing structure and its performance. |

Although not a requirement at the time of construction, replacement of any missing building element is advisable (although this can be quite expensive to do after the time of construction). Where sarking is missing, regular inspections of the roof tiles for cracking and potential moisture penetration is required.

Sarking may be retrospectively fitted by a registered builder at the discretion of the client.

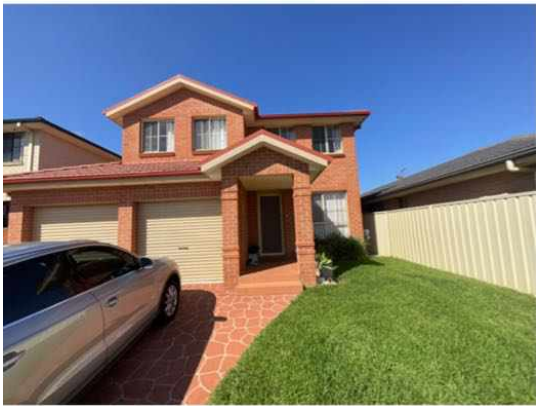
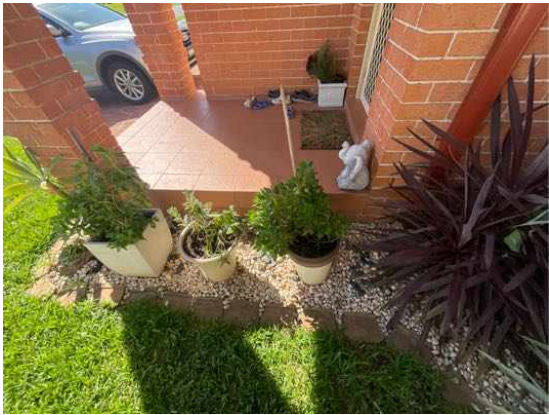
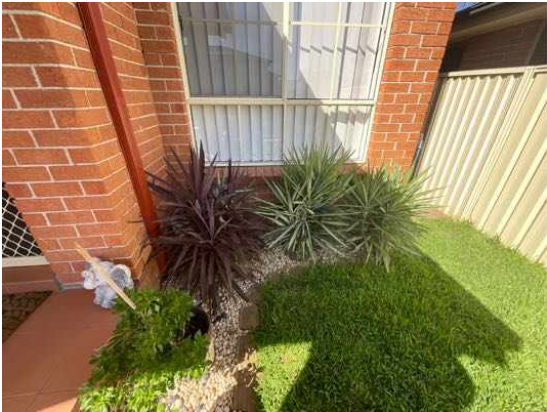
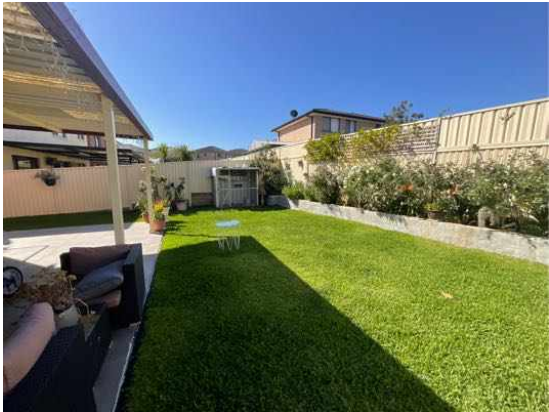
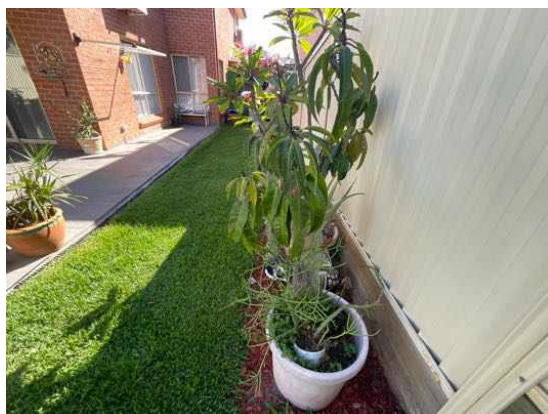
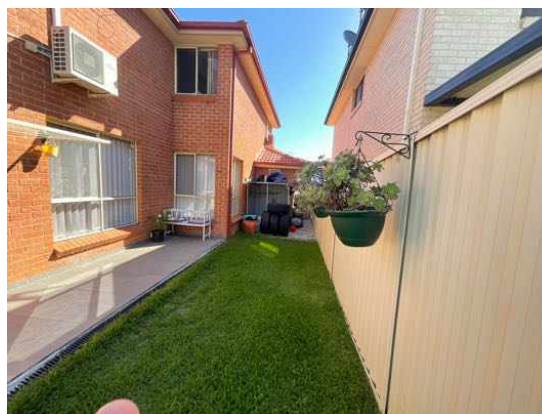
Finding 6.01

Building: Main Building
Location: All Areas
Finding: Garden Beds - Conditions Conducive to Termites
Information: Garden beds were found to be evident in the garden area. These garden beds can include untreated timber, and with a combination of moisture from watering hosing can make conditions conducive to termite activity and termite ingress.

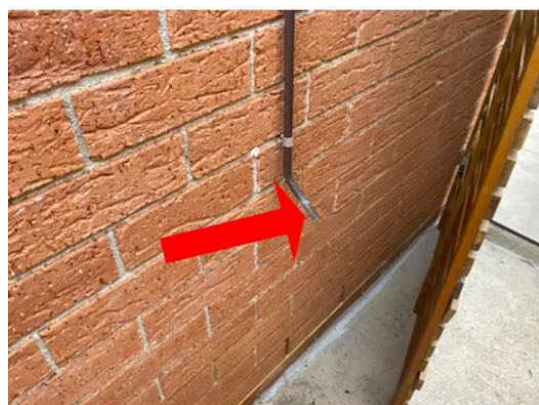
Finding 6.02

Building: Main Building
 Location: All Areas
 Finding: HWS Overflow - Not Connected
 Information: The Hot Water System (HWS) overflow was found to be disconnected from storm water drainage and is creating excessive moisture in the surrounding area.

These damp conditions can lead to secondary defects such as rot, rust or corrosion of associated building elements, the formation of fungal decay, or even the creation of potential slip hazards. When coupled with poor site drainage, pooling of water may also attract termite activity to this area.

It is highly recommended that a licensed plumber be appointed to connect the HWS overflow in order to prevent such an environment from being created. These minor works should be carried out as soon as possible.

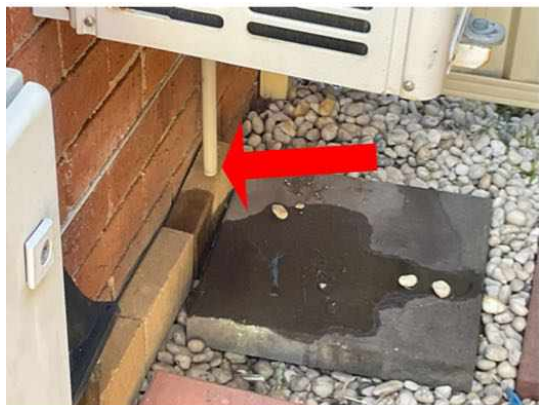
Finding 6.03

Building: Main Building
 Location: All Areas
 Finding: Air conditioner - Disconnected overflow
 Information: The Air Conditioner (A/C) overflow was found to be disconnected from storm water

drainage and is creating excessive moisture in the surrounding area.

Such leaking creates an environment which is conducive to an array of defects, including water damage to associated building elements and the attraction of termite or timber pest infestation.

It is highly recommended that a licensed plumber be appointed to connect the A/C overflow in order to prevent such an environment from being created. These minor works should be carried out as soon as possible.

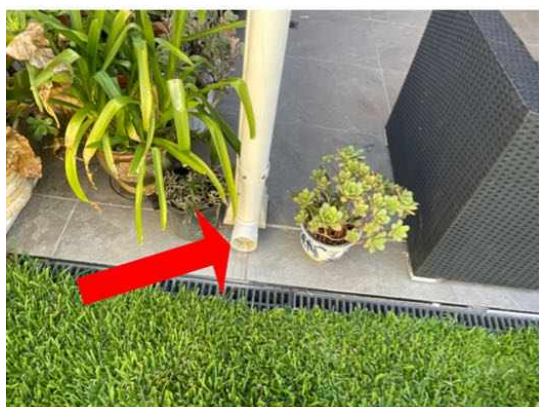
Finding 6.04

Building: Main Building
 Location: All Areas
 Finding: Overflow - Not plumbed for drainage
 Information: The overflow is not plumbed or connected to suitable drainage, which has resulted in the surrounding area becoming excessively damp. These damp conditions can lead to secondary defects such as rot, rust or corrosion of associated building elements, the formation of fungal decay, or even the creation of potential slip hazards. When coupled with poor site drainage, pooling of water may also attract termite activity to this area. It is highly recommended that a qualified plumber be appointed to install adequate drainage to the overflow. These works will ensure that the area remains dry and free of any secondary defects.

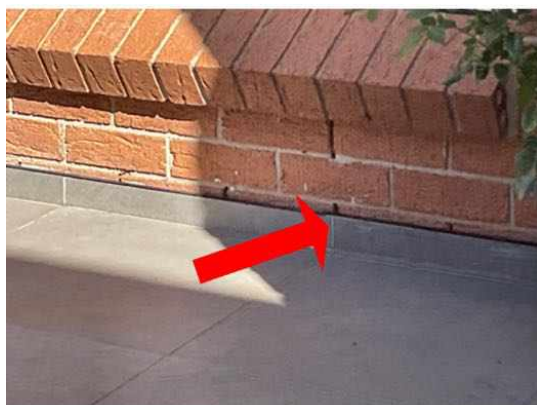
Finding 6.05

Weep holes in the exterior brickwork of the property are designed to allow condensation that may build up between the brickwork and subsequent timber framework to drain from within the wall hence preventing any deterioration of the timber building elements.

Additionally build-up of moisture is likely to occur if weep holes are covered further attracting termite activity to these areas.

It is highly recommended that weep holes are left exposed in all areas throughout the external property. Therefore if any termite activity leading into weep holes becomes easily detectable during frequent pest inspections.

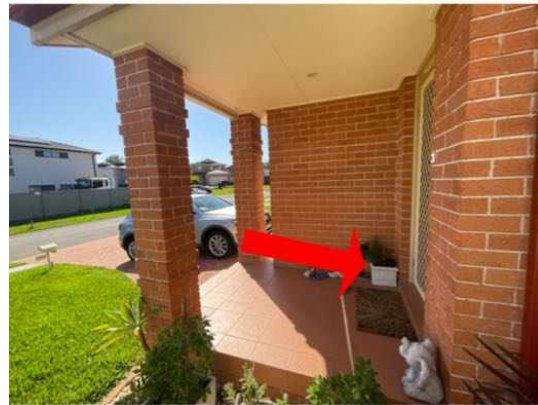
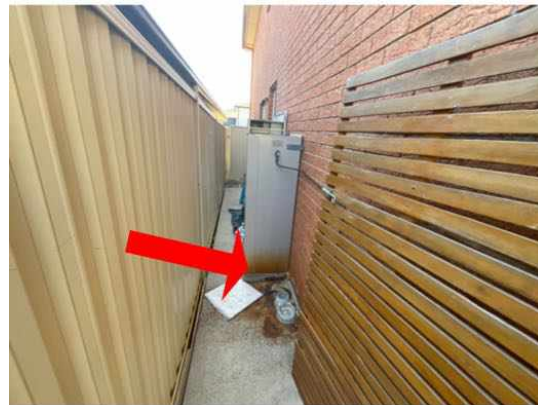
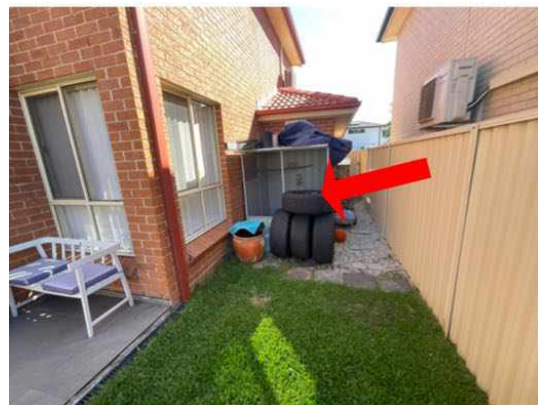
Finding 6.06

Where bridging has occurred, full inspection is prevented and termites may enter a property in a concealed or undetectable manner.

It is recommended that minimum 75mm clearance below the bottom of weep or ventilation holes be maintained where possible, otherwise annual inspections should be conducted by a licensed pest control company. Vegetation should also be kept clear of walls to allow regular inspection of all areas.
