Building and Timber Pest Inspection Report

Inspection Date: Fri, 23 Jan 2026

Property Address: 18/162 Kanahooka Rd, Kanahooka NSW
2530, Australia

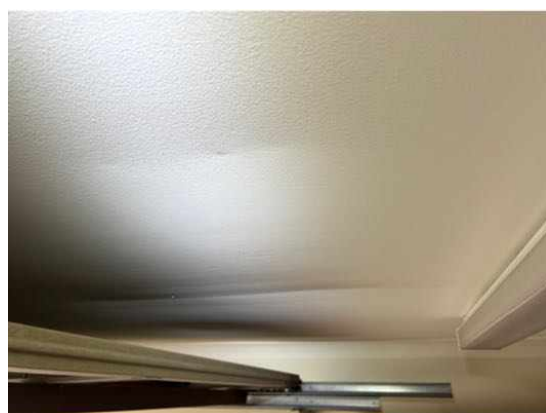
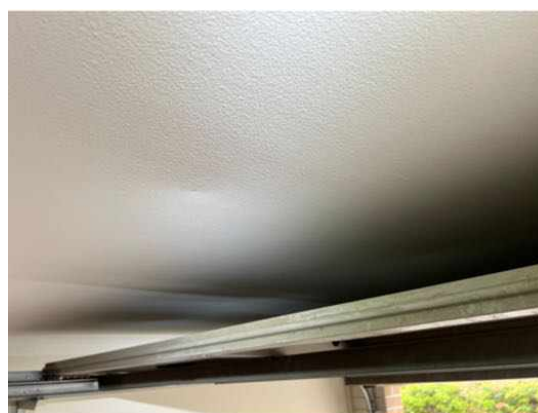
Building: Main Building
Location: Garage
Finding: Ceiling sagging - Garage
Information: Sections of the ceiling were found to be sagging at the time of inspection. Sagging to the fixed ceiling structure generally indicates that the building materials have swollen, due to contact with water, or that fixings (e.g. nails or glue) have become loose and require reattachment. This is a very common defect in carports due to their lack of insulation and or their susceptibility to moisture. Condensation builds up in the roof and rests on the plasterboard softening it somewhat which makes it more likely to sag and release from its fixing points.

Ceilings detached from joist throughout garage

While damage is minimal at this stage a licensed plasterboard contractor should be appointed to repair the ceiling. Insulating the area could be a considered by the client once repaired.

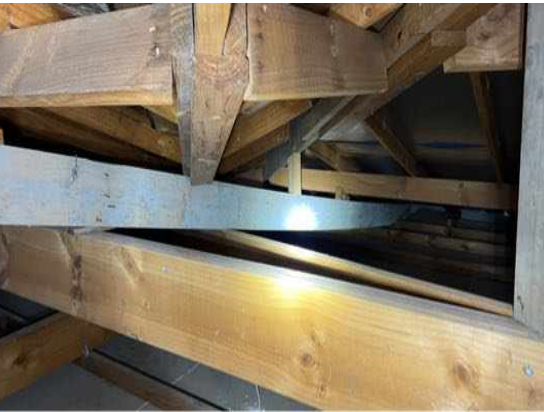
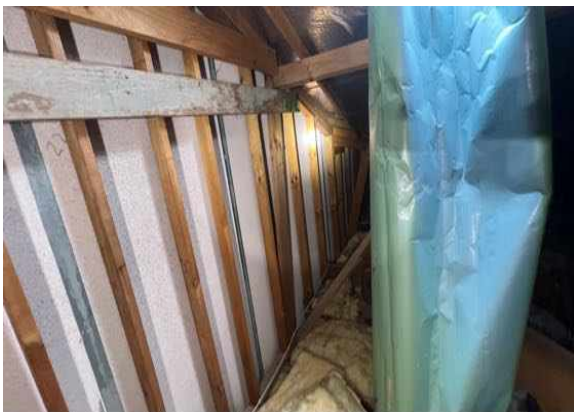
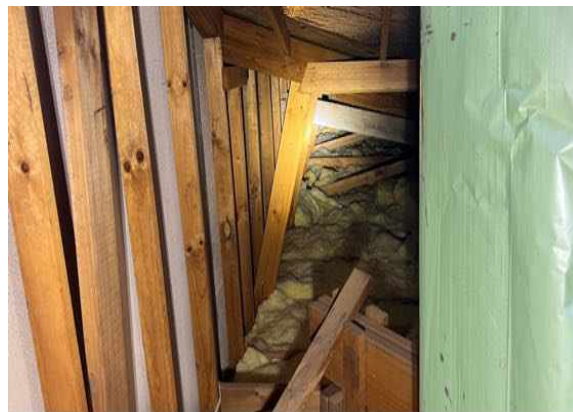
Building:	Main Building
Location:	Roof Void
Finding:	Roof structure - Altered Conventional Framing
Information:	Alterations to the original conventional roof framing were observed within the roof void. The configuration of purlins, struts, and associated members is irregular and not consistent with typical or accepted construction practices for conventional roof structures. Several members appear to rely on ad-hoc packing, non-uniform bearing points, and interrupted load paths, which raises concern regarding the adequacy of structural support and long-term performance of the roof system.

The extent and nature of these alterations indicate that the roof structure may not be performing as originally intended and may be subject to abnormal load transfer or localised overstressing of framing members. As this inspection was visual only and non-invasive, the full extent of the alterations and their structural implications could not be determined.

Further assessment by a registered builder or a structural engineer experienced in conventional roof construction is recommended as a matter of priority to determine compliance, structural adequacy, and whether remedial works are required to reinstate the roof structure to an acceptable standard.

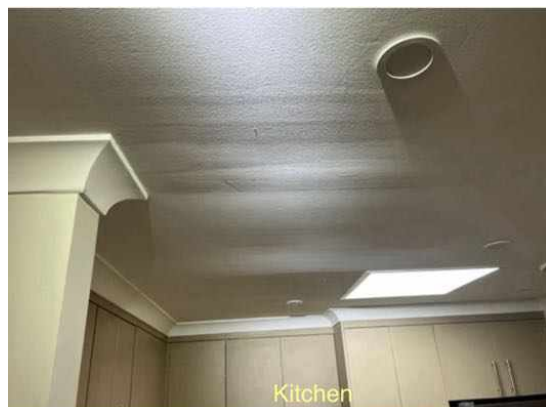
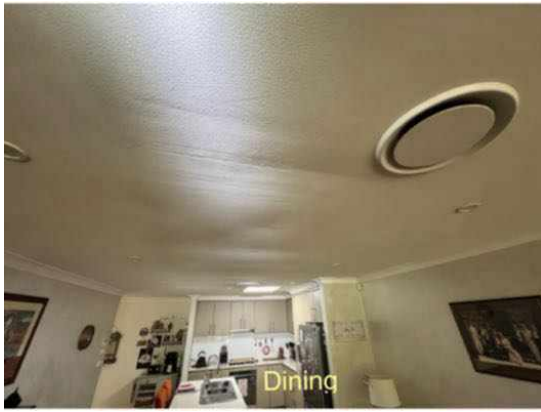
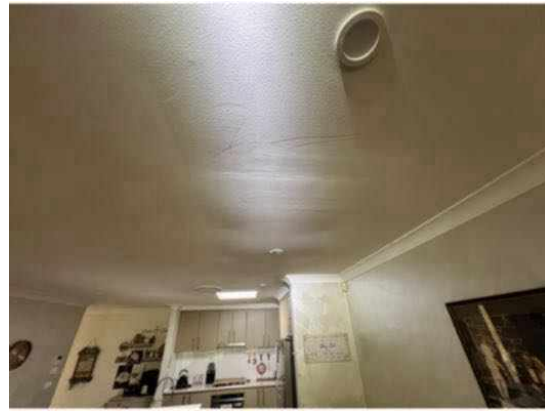
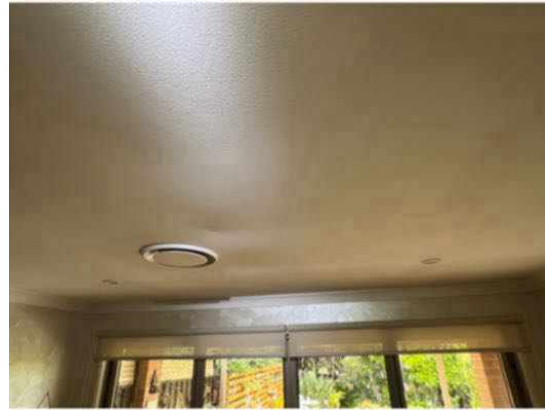
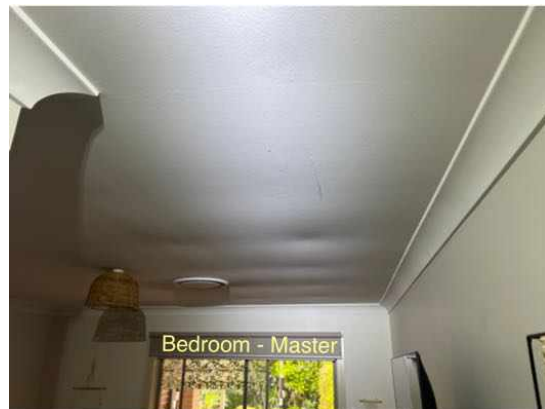
Finding 3.01

Building:	Main Building
Location:	Kitchen, Dining Room, Lounge Room, Bedroom 3, Bedroom - Master
Finding:	Ceiling Defects – Poor Finishing and Localised Sagging
Information:	Visual inspection revealed several ceiling defects, including localised sagging, nail popping, and inconsistent flushing of join lines. Minor sagging across ceiling surfaces suggests that back-blocking may have been omitted or poorly executed during installation. Additionally, evidence of substandard patching and finishing was noted in areas where previous defects have been addressed, but not to an acceptable visual standard.

Nail popping and poor join treatment, while generally not structural, can lead to further deterioration of ceiling linings if left unmanaged. These issues detract from the ceiling's appearance and may compromise the long-term durability of the plasterboard fixing.

Rectification by a qualified plasterer is recommended. Works should include securing loose fixings, re-flushing affected joints, and applying back-blocking where necessary to stabilise the ceiling structure and improve the visual condition.

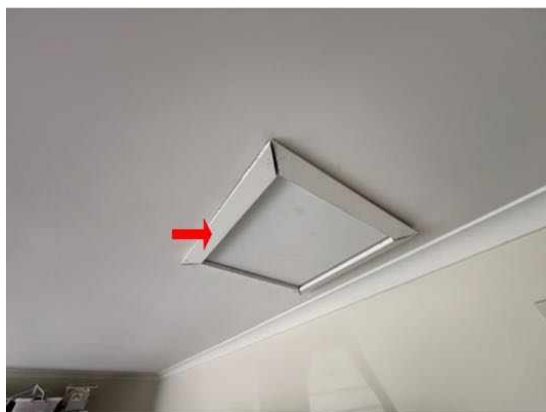
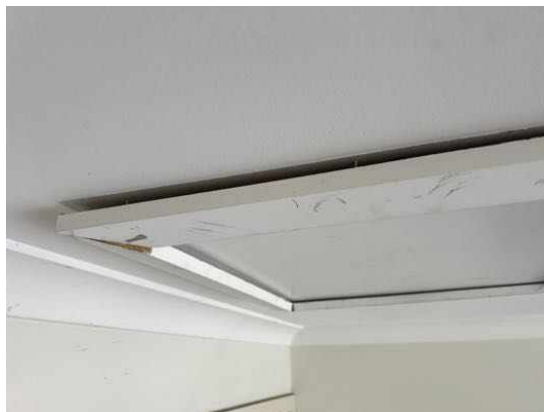
Finding 3.02

Building: Main Building
 Location: Garage
 Finding: Man hole surround - Damaged
 Information: Breakage occurs generally when the building materials have either aged and decayed, or as a result of damage (accidental or deliberate).

A carpenter or handyman should be appointed to repair or replace the affected building element prior to any subsequent damage being caused.

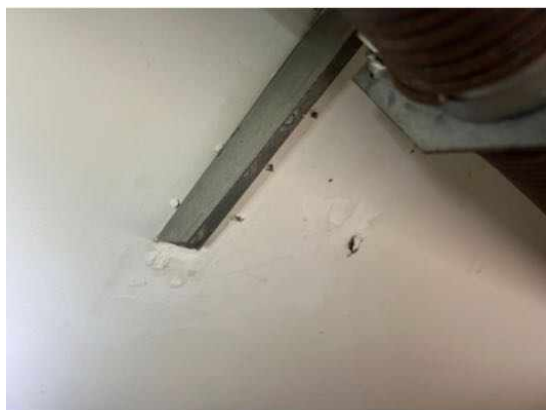
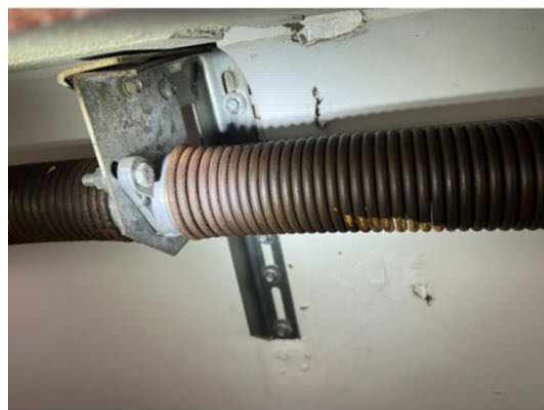
Finding 3.03

Building:	Main Building
Location:	Garage
Finding:	Plasterboard - Damaged
Information:	Breakage occurs generally when the building materials have either aged and decayed, or as a result of damage (accidental or deliberate).

A plasterer or general handy person should be appointed to repair or replace the affected building element prior to any subsequent damage being caused followed by a painter.

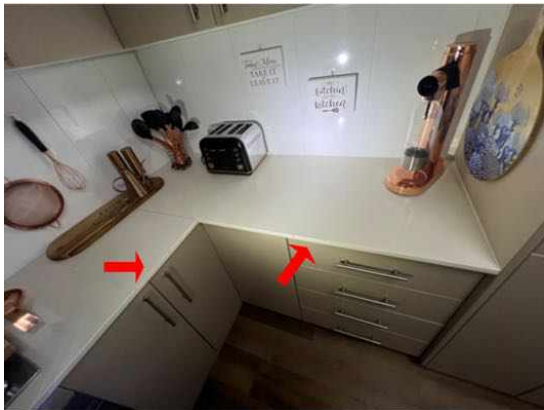
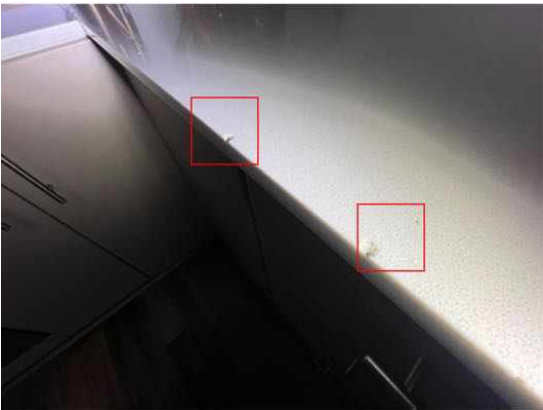
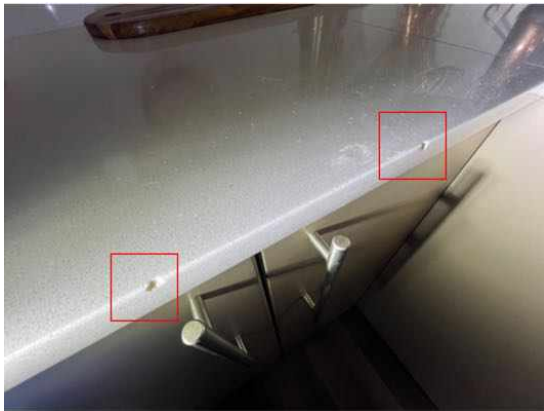
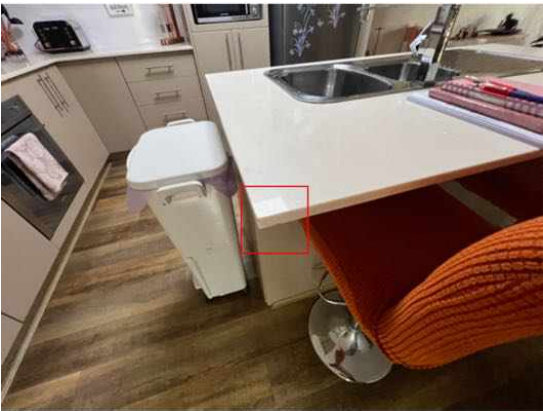
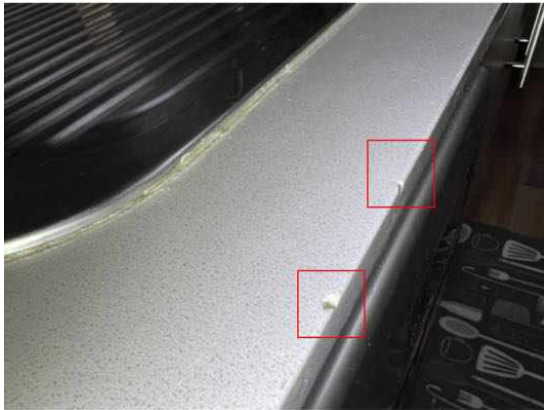
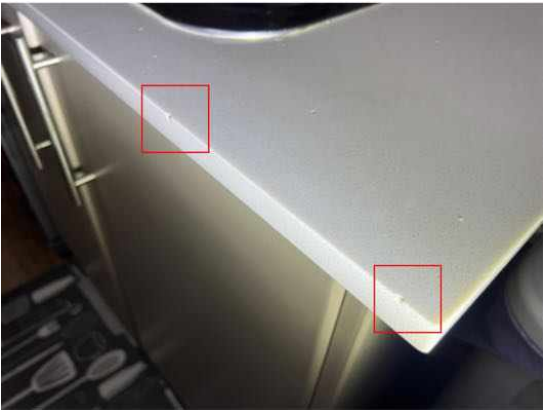
Finding 3.04

Location: Kitchen
Finding: Stone Benchtop – Chips to Surface
Information: Several visible chips were identified to the surface of the stone benchtop. This type of damage is typically the result of excessive impact, point loading, or internal stress within the material.

Chipping may compromise both the appearance and integrity of the benchtop and could worsen over time with ongoing use or exposure to temperature fluctuations.

Assessment by a qualified stone or cabinetry specialist is recommended to determine whether repair or replacement is necessary.

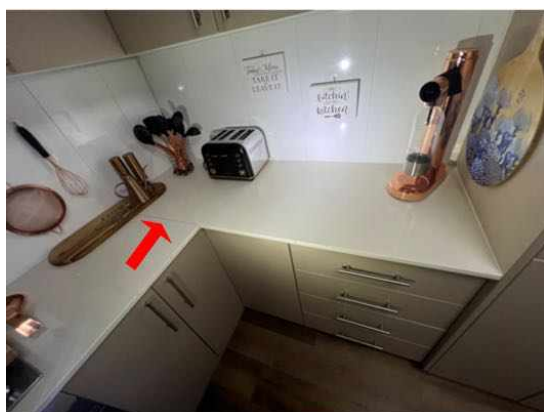
Finding 3.05

Building:	Main Building
Location:	Kitchen
Finding:	Stone Benchtop - join Separation/Deterioration
Information:	The stone benchtop joints were observed to have separated and deteriorated at the time of inspection. This is commonly caused by natural movement, thermal expansion and contraction, or substandard installation.

If left unmanaged, gaps in the benchtop joints may allow moisture ingress, leading to further deterioration, potential bacterial growth, and compromising the integrity and appearance of the surface.

It is recommended that a qualified stonemason or benchtop specialist be engaged to assess and repair the affected joints to restore functionality and durability.

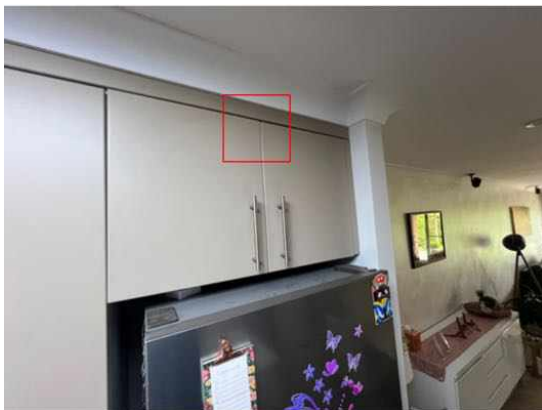
Finding 3.06

Building:	Main Building
Location:	Kitchen
Finding:	Joinery Doors - Binding
Information:	Binding of joinery doors is evident during standard operation. This defect inhibits the functionality of the affected door as well as creating potential for secondary defects to associated building elements, such as damage to the adjacent joinery.

A door that binds may have several causes, ranging from minor defects, such as poor installation of the door or deteriorated hinges.

Recommend a qualified carpenter or general handyperson should be appointed to perform minor rectification works at client discretion.

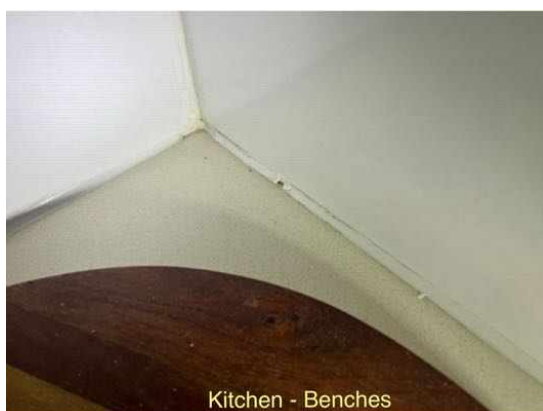
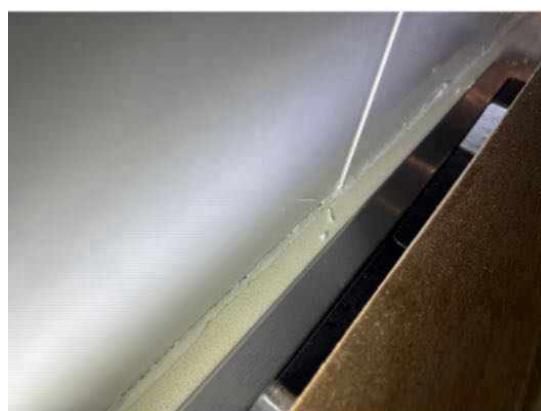
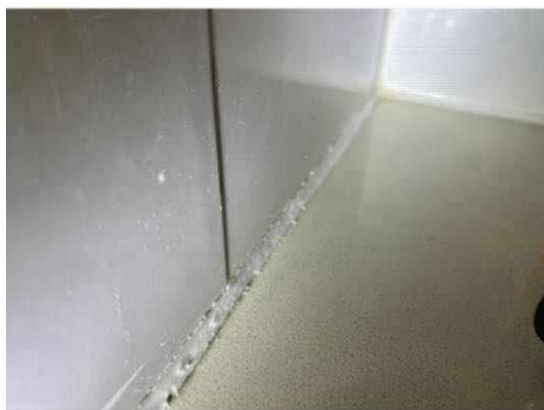
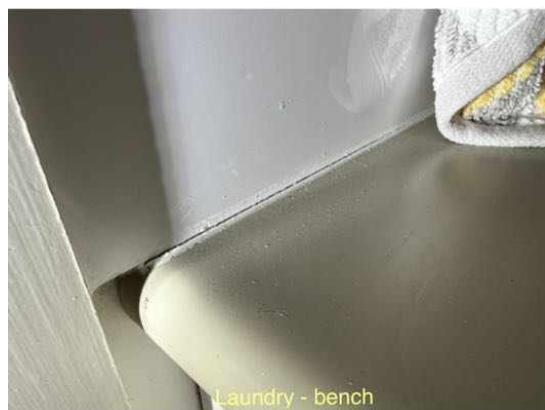
Finding 3.07

Building:	Main Building
Location:	Kitchen, Laundry
Finding:	Sealant - degraded
Information:	It was noted on inspection that sealant or grout is degraded to this area.

Different materials move at different rates, generally causing cracking to grout or sealant at this point. A flexible sealant is required to allow for expected expansion and contraction, while keeping the joint water tight and protective of all associated building materials.

Flexible and mould resistant materials should be applied to affected areas to prevent any subsequent water damage that is likely to occur. Regular maintenance and replacement of damage or missing or damaged sealant and grout is highly recommended to the wet areas, as this is a regular wear and tear defect. Sealant and grouting in areas that come into regular contact with water should be maintained for the long term care of your property.

A sealant specialist or tiling contractor should be appointed to complete these works as soon as possible

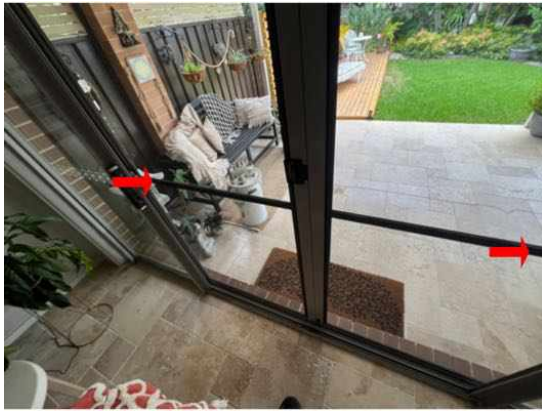
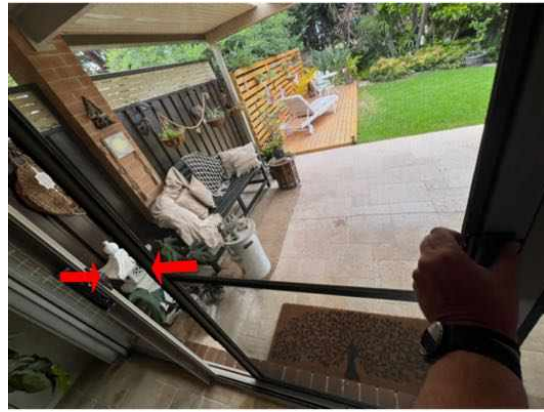
Finding 3.08

Building:	Main Building
Location:	Lounge Room
Finding:	Sliding Flyscreens - No Stop to Track
Information:	The sliding flyscreens were observed to travel beyond the centre of the opening in both directions due to the absence of a stop or angle to the track or stile. As a result, the screens do not align or stop correctly within the opening.

This condition restricts effective use of the flyscreens and detracts from their intended function. Uncontrolled travel may also contribute to increased wear to the tracks, frames, or screen panels over time.

It is recommended that a licensed carpenter or window installer assess the flyscreen track arrangement and install appropriate stops or restraints to allow correct alignment and operation.

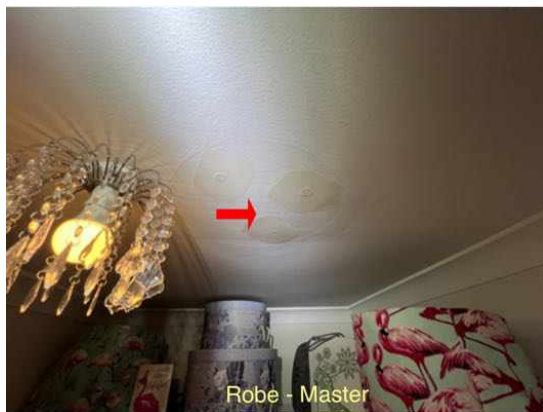
Works that have not been completed to a satisfactory level create potential for the development of building defects and may impede on the safety and integrity of the overall structure.

It is highly recommended that a licensed plasterboard contractor and or painter should be appointed to repair the ceiling. To ensure the safety of the area and the longevity of all associated building elements.

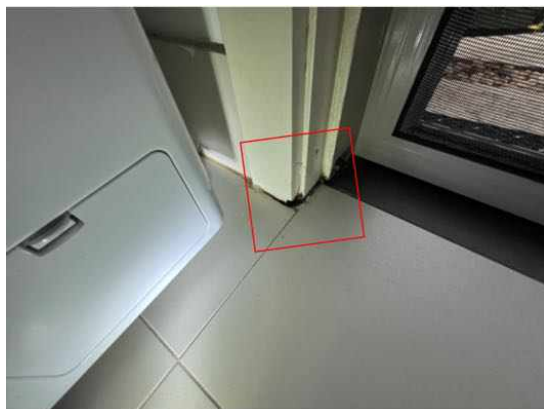
Finding 3.11

Finding: Door Jamb – Water Damage

Information: Water damage was observed to the base of the door jamb in this area. This type of defect is typically caused by moisture exposure from wet areas, inadequate sealing, or failed waterproofing at adjoining tiled surfaces.

If left unmanaged, water ingress may result in swelling, decay, or deterioration of the timber, potentially affecting the operation of the door and compromising surrounding finishes.

It is recommended that a qualified carpenter or builder assess the extent of damage and carry out repairs or replacement of the affected section as required. Improved

sealing or waterproofing should also be considered to minimise recurrence.

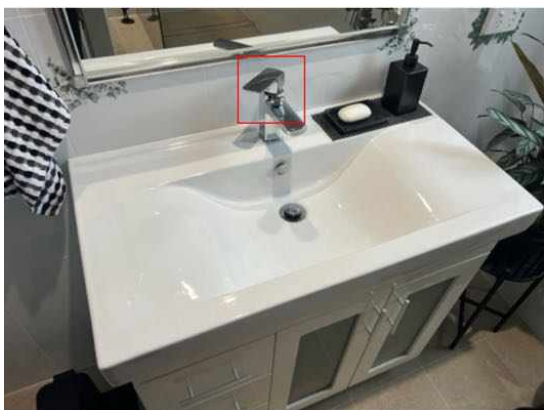
Finding 3.12

Building:	Main Building
Location:	Bathroom
Finding:	Tap - Water hammer
Information:	This tap shows evidence of water hammer being present. Water hammer, a pressure surge resulting when a fluid is forced to suddenly change direction, is a common defect in plumbing fittings, particularly those that are aged and not frequently maintained. Water hammer is generally caused by factors that create high water pressure in the affected plumbing fixture, usually evidenced by a faint banging noise during operation of the affected tap.

Although water hammer is generally considered to be a minor defect, subsequent damage such as erosion of tap hardware and/or water damage to associated building elements is likely to occur if left unmanaged.

A licensed plumber should be appointed as soon as possible to replace any affected tap hardware and perform any remedial works as necessary. Please be advised that the appointment of a cabinet maker or qualified carpenter may be necessary if water damage to associated building elements has occurred.

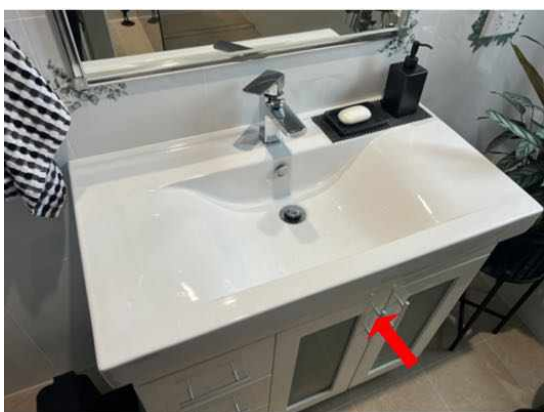
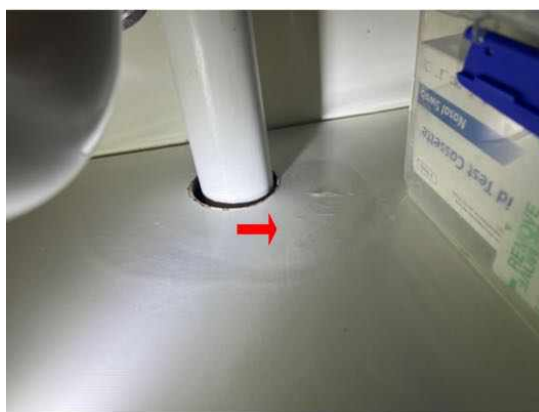
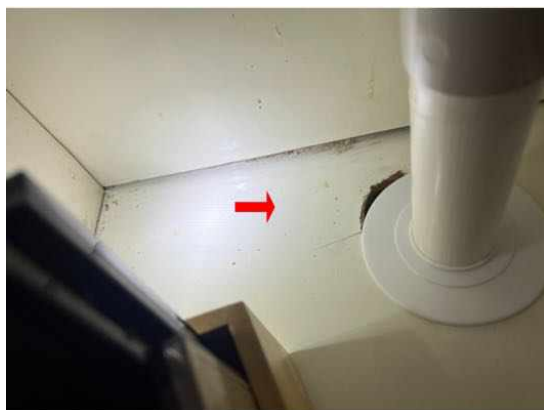
Finding 3.13

Building: Main Building
Location: Bathroom
Finding: Swelling of Material - exposed to moisture
Information: Swelling of building materials was observed, indicating prolonged exposure to moisture from leaks or direct water contact. This swelling typically occurs in materials like timber, MDF, or particleboard, which absorb moisture and expand, leading to deformation.

Swollen materials can compromise the structural integrity of the affected area, potentially leading to further damage, such as warping, cracking, or weakening of the surrounding framework. Continued exposure to moisture may result in mold growth, wood rot, or further deterioration if not addressed. Aesthetic issues may arise, reducing the overall quality and finish of the building elements.

Engage a licensed plumber to identify and rectify the source of the leak or moisture ingress. Replace or repair all affected building materials that have suffered swelling or deformation. This work should be carried out by a qualified carpenter. Monitor the repaired areas to ensure no further swelling occurs.

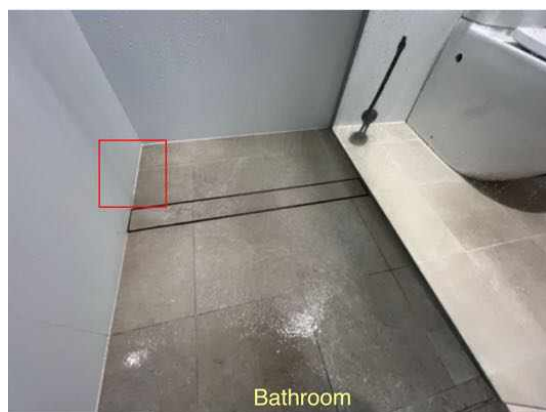
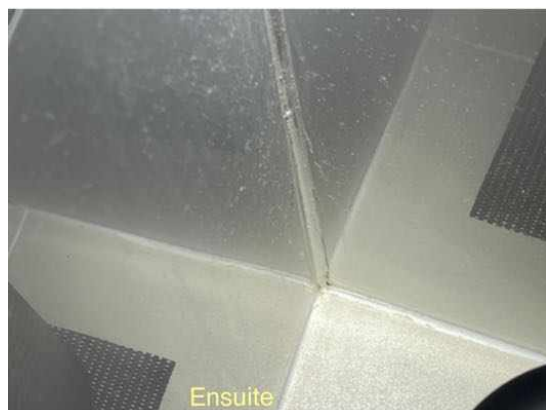
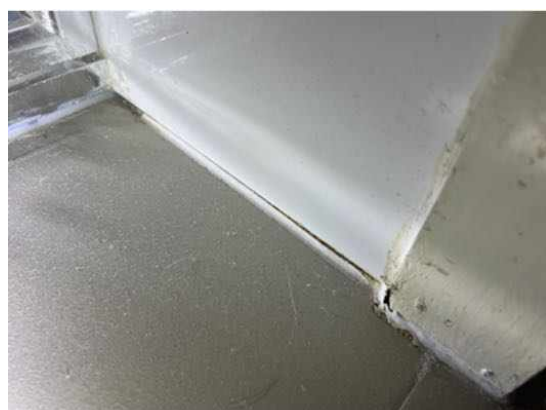
Finding 3.14

Building:	Main Building
Location:	Bathroom, Ensuite
Finding:	Sealant and grouting - Missing or damaged
Information:	It was noted on inspection that sealant or grout is degraded to the tiled shower alcove and or other areas of the bathroom.

Different materials and floor areas move at different rates, generally causing cracking to grout or sealant at this point. A flexible sealant is required to allow for expected expansion and contraction, while keeping the joint water tight and protective of all associated building materials.

There appears to be excessive mould to the sealant and grout which will likely require scraping out and replacement.

A sealant specialist or tiling contractor should be appointed to complete these works as soon as possible

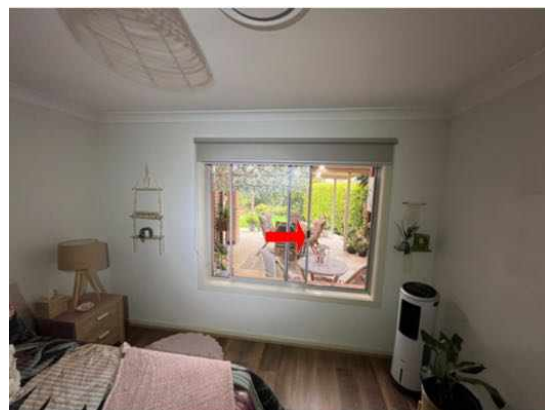
Finding 3.16

Building: Main Building
 Location: Bedroom 2, Bedroom - Master
 Finding: Window service recommended
 Information: Some windows throughout the property were found not to be fully operational. This may be due to the fact that they did not open, stiff to open, did not stay open or were binding at time of inspection. A window service is recommended.

A competent general handyman or carpenter may be engaged at the clients discretion.

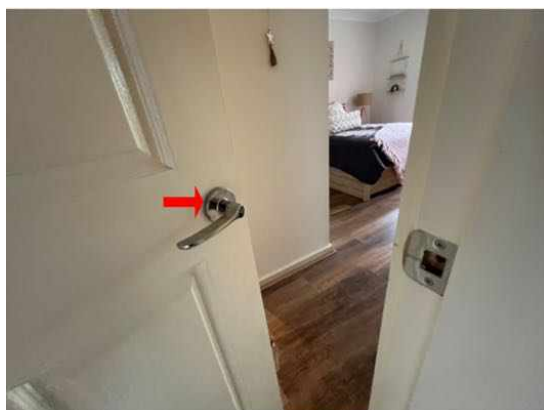
Finding 3.17

Building: Main Building
Location: Bedroom - Master
Finding: Door Handle - Loose (minor)
Information: The door handle in this area was identified as loose at the time of inspection. A loose door handle can impede the proper operation of the door and, if left unattended, may lead to further deterioration or damage to the associated door structure.

It is recommended that a qualified carpenter or general handyperson be appointed to secure or replace the handle to restore its functionality and ensure proper operation.

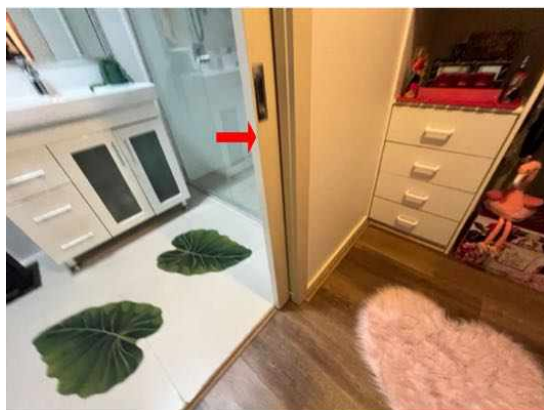
Finding 3.18

Building: Main Building
Location: Ensuite
Finding: Door – Jammed and Inoperable
Information: The door in this area was found to be jammed shut and could not be opened at the time of inspection. This may be due to misalignment, swelling from moisture, frame distortion, or obstruction within the door frame.

A licensed carpenter or general handyman should be appointed to assess the cause of the jamming and undertake any necessary adjustments or repairs to restore proper function.

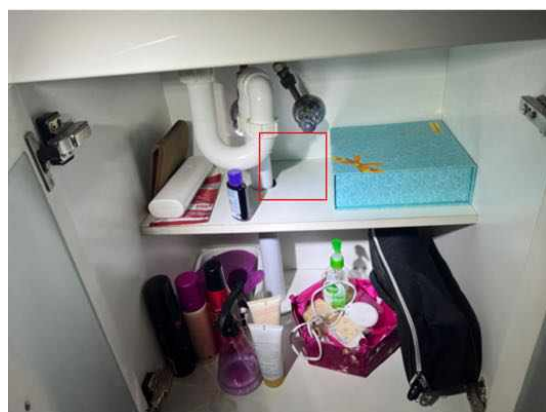
Finding 3.19

Building:	Main Building
Location:	Ensuite
Finding:	Water staining - sink cabinetry
Information:	A water staining was observed to the cabinetry beneath the sink at the time of inspection. Water staining in this area is generally indicative of a previous or active leak from plumbing fixtures, waste connections, or sealant deterioration around the sink junction.

If left unmanaged, persistent moisture can lead to material deterioration, mould growth, and potential damage to adjacent cabinetry or flooring. It is advised that a licensed plumber be engaged to inspect the area, determine if an active leak is present, and undertake any necessary rectification works.

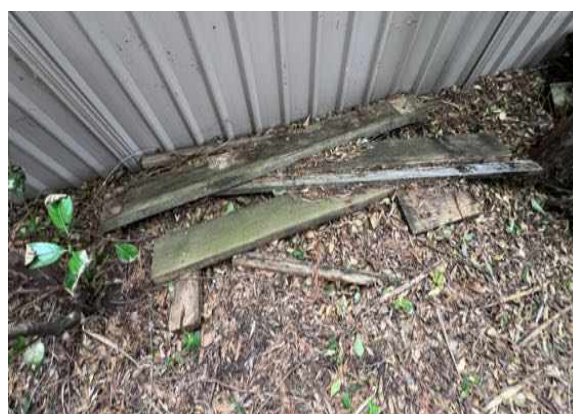
Finding 6.12

Building:	Yard
Location:	Yard - Back
Finding:	Stored timbers - subfloor space or external area
Information:	The storing of timbers in the subfloor space or around the external property increases the risk of termite activity being present. As they are likely to come into contact with weather conditions or excessive moisture wood rot is likely to develop on timbers that are not treated.

It is highly recommended that any stored timbers be immediately removed from areas in which they may attract any termite / timber pest attack. Minimisation of risk / prevention of termite attack is far more adequate than dealing with the presence of termite activity.

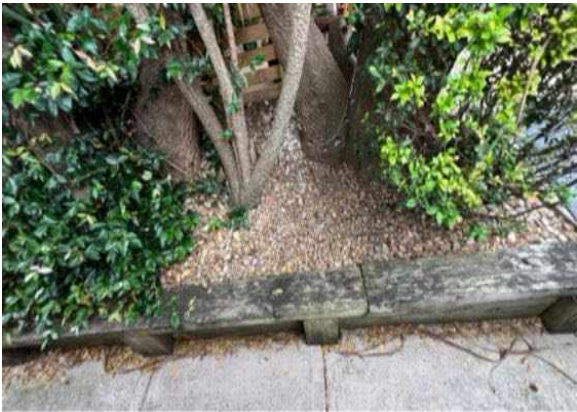
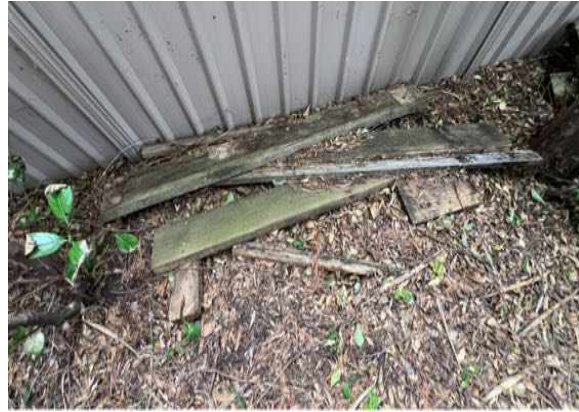
exposed to rain penetration.

In this case although the affected timber element is in a decaying state the extent of any visible damage appears to be localised to a specific area and is yet to spread to other parts of the building element or affect adjoining structures. The fungal decay is therefore likely to be of a relatively superficial nature with minimal impact on the structural integrity or tensile strength of the timber element.

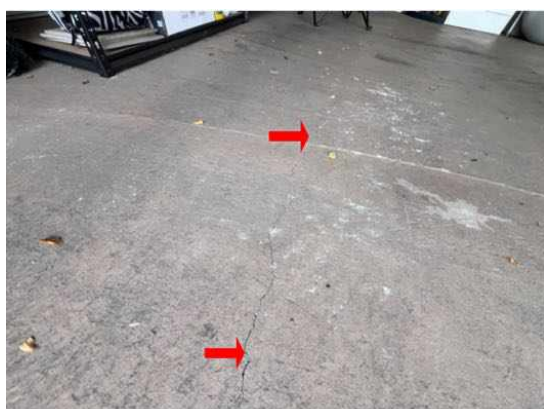
Building:	Main Building
Location:	Garage
Finding:	Cracking - Damage Category 0 - Hairline (less than 1mm)
Information:	Hairline cracks are very minor in nature and generally are only ever an appearance defect. While such cracking may be noticeable in some cases, it is quite common and does not indicate any structural damage.

Monitoring of all cracking should be conducted frequently. Always contact a building inspector should cracks widen, lengthen, or become more numerous.

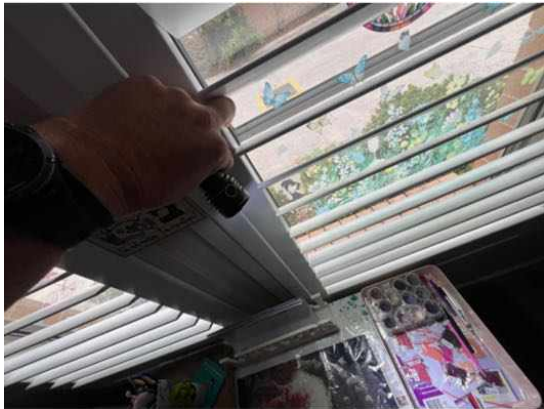
Building:	Main Building
Location:	Bedroom 3
Finding:	Windows - restricted access
Information:	Windows were noted as locked at the time of inspection, restricting the ability to assess their operation and condition. This may be due to key locking, stored items, furniture, or window treatments obstructing access, but is not limited to these reasons. Once access is available, it is recommended that all windows be reassessed for functionality, sealing, and general condition.
