Building and Timber Pest Inspection Report

Inspection Date: Thu, 26 Feb 2026

Property Address: 19 Archer St, Concord NSW 2137, Australia

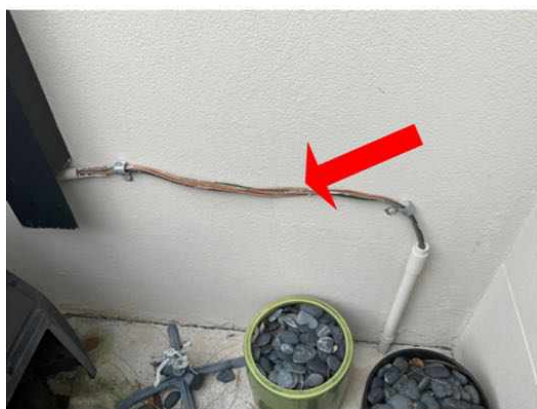
Finding 1.01

Building:	Main Building
Location:	All External Areas
Finding:	Electrical wires exposed
Information:	Exposed electrical wiring was identified. Exposed electrical wiring represents a potential safety hazard including for fire and personal contact. Contact a licensed electrician urgently for further inspection investigation and rectification.

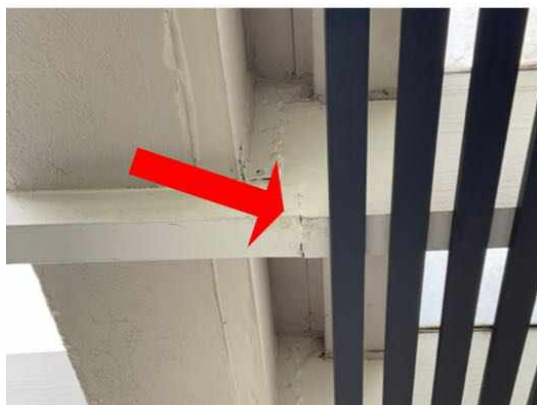
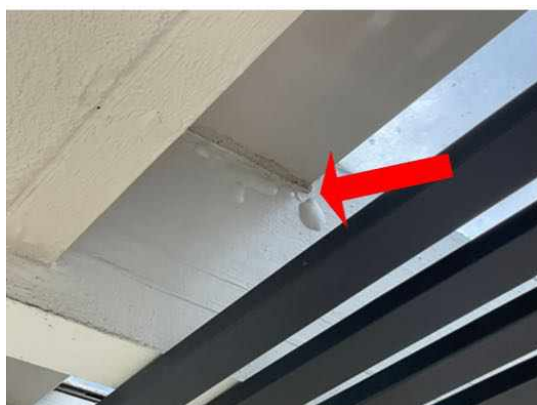
Finding 2.01

Building:	Main Building
Location:	Roof Exterior
Finding:	Exterior roof - Leaking
Information:	Active roof leaks were evident at the time of inspection. Roof leaks can have a number of causes, including damage to roof coverings, deterioration of roof fixtures and fittings, or loosely associated materials (fascias etc.).

Where water leaks are active, rain penetration is likely to cause water damage to associated structures and building elements in this area, which can have a range of implications. If left unmanaged, the development of major structural damage to the roofing and associated structures may occur.

A roof plumber should be appointed as soon as possible to primarily identify the cause of the leak, and to provide subsequent repair works as necessary. Depending on the extent of the damage, replacement of sections of the roof covering and/or roofing structures may be required, and may be performed by a registered builder or

qualified carpenter.

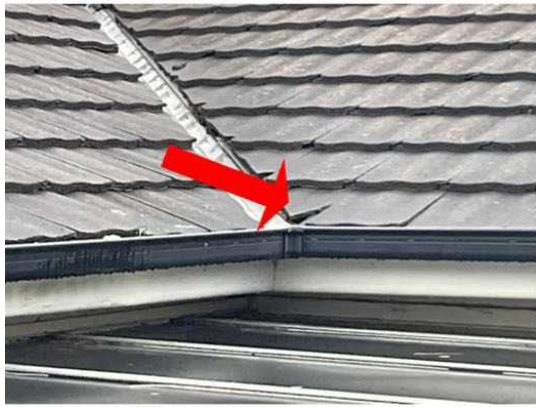
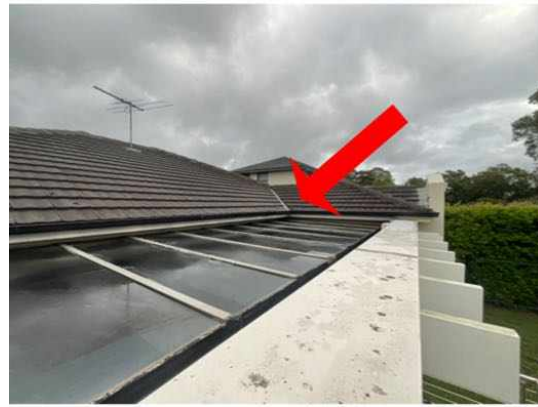
Finding 3.01

Building:	Main Building
Location:	Roof Exterior
Finding:	Roof tiles - Broken
Information:	Upon inspection of the exterior roof covering, broken roofing tiles were identified. Broken and friable roof tiles are generally the result of ageing and weathering of what is essentially a porous material.

If left to further deteriorate, broken and brittle roof tiles are likely to lead to water penetration via the roof into the ceiling space, causing secondary damage to ceiling linings, insulation and roof structures. Broken roof tiles are also likely to detract from the effectiveness of the roof drainage system, creating potential for secondary damage to the exterior roof covering and roof plumbing.

Replacement of broken tiles is required and should be performed by a roofing contractor as soon as possible.

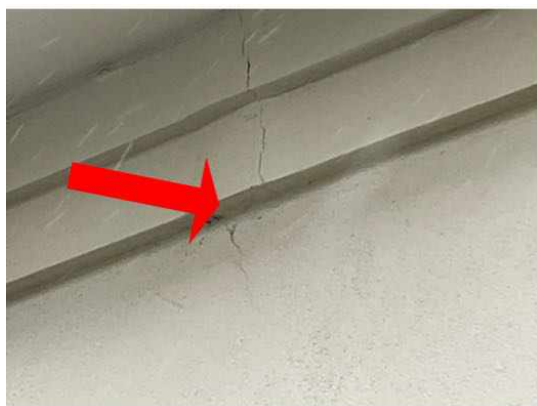
Building:	Main Building
Location:	Exterior walls
Finding:	Cracks to external render - Category 1

It has been observed that cracking to external rendered surfaces has occurred. The degree of damage falls within Category 1, described as fine cracks that do not need repair and which are less than 1.0mm in width limit.

Damage of this category is not considered a defect for rectification. Always contact your building inspector should cracks widen, lengthen, or become more numerous.

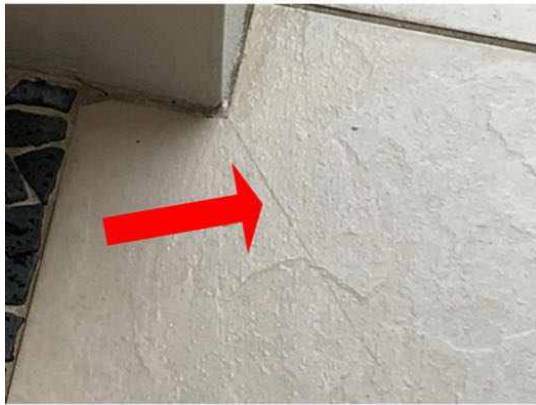
Finding 3.04

Building:	Main Building
Location:	Alfresco / Internal areas
Finding:	Floor tiles - Cracked
Information:	Cracking in the floor tiles was evident in this area at the time of inspection. It is suspected that this cracking has occurred as a result of the floor being uneven and lacking a solid or suitable foundation for the tiles to be laid on. Settlement in the floor foundations may also have caused movement and resulted in the cracking of tiles in this area.

Cracked tiles throughout the household detract from the overall appearance of the affected areas, as well as creating potential for water penetration to adjoining building elements. If left unmanaged, water damage may occur as a result of constant water penetration over a prolonged period of time.

While not considered a matter of urgency, replacement of cracked floor tiles is advised as a solution. A tiling contractor or general handyperson may be appointed to perform these works at client discretion. Where cracks become more numerous, consultation with a registered builder specialising in re-stumping may be required.

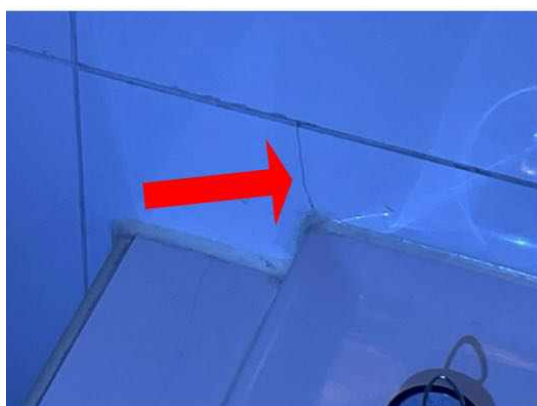
Finding: Tiles - Cracked or damaged

Information: Cracking was evident to the tiling in this area at the time of inspection. While the cracking appears to be minor, this area is frequently exposed to water, allowing potential for water penetration into adjoining sections of walls or flooring.

If left unmanaged, water penetration to these areas may lead to subsequent water damage, which is likely necessitate repair work to affected building elements.

A tiling contractor should be appointed to ensure that no further water damage occurs. The re-application of silicone and grouting throughout remaining tile work is also advised, to further protect the area against water penetration.

Where water penetration has led to water damage, appointment of a relevant tradesperson may be required to repair damaged building elements.

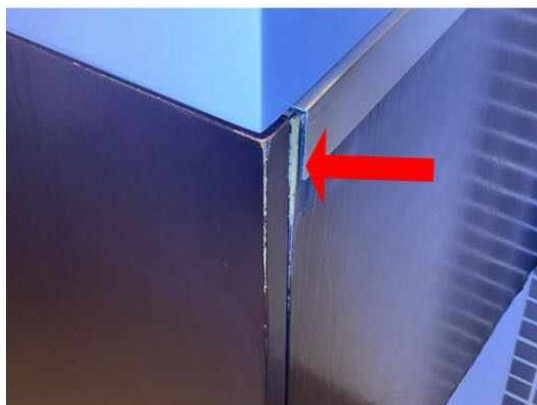
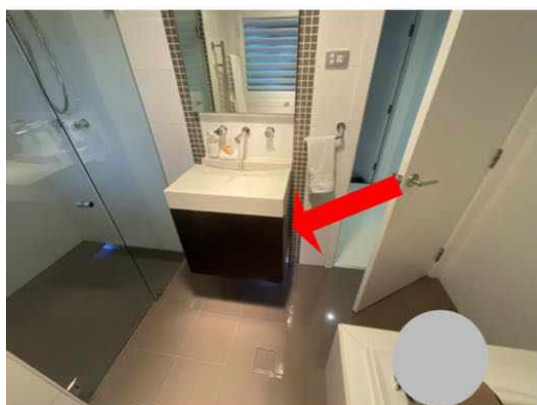
Finding 3.07

Building:	Main Building
Location:	Bathroom
Finding:	Delamination of timbers
Information:	Delamination is one means by which composite materials (e.g. layered timber composites) may fail over time. In laminated materials, repeated cyclic stresses may lead to the formation of mini-structures of separate layers, with significant loss of mechanical toughness. Water penetration or the presence of excessive moisture also generally contributes to delamination.

Where building materials have become delaminated, they lose their structural strength, and are likely to have a variety of appearance and serviceability defects as a result.

Delamination of timbers may be repaired where the area affected is minor and/or easily accessible, by gluing and screwing layers back together. However, this is an interim repair, and where delamination has occurred, the client should plan for the replacement of affected timbers sooner than would otherwise be expected.

All timber structures affected by delamination should be replaced as soon as possible to avoid any further damage. Repair and replacement estimates should be sought from a registered builder or qualified carpenter.

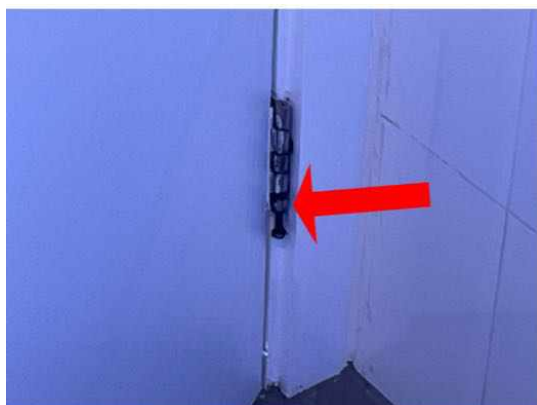
Finding 3.09

Building: Main Building
 Location: Bathroom >
 Finding: Door - Loose hinges
 Information: This door is not level and detract from the operational state of the door jamb. Upon further inspection, it was noted that the hinges to the door have deteriorated over time and, as a result, have come loose from their original fixing. To improve operation of the affected door, a general handyman may be appointed to replace the faulty hinges. Such works should be completed at discretion of the client.

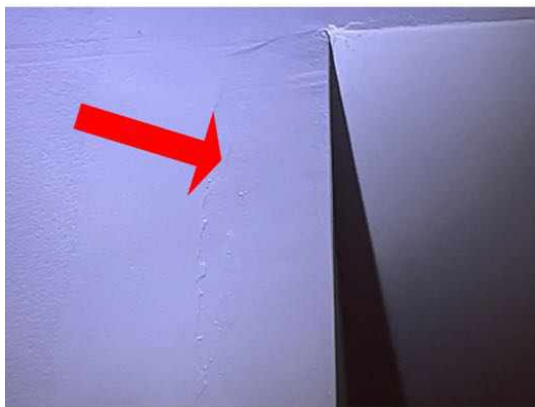
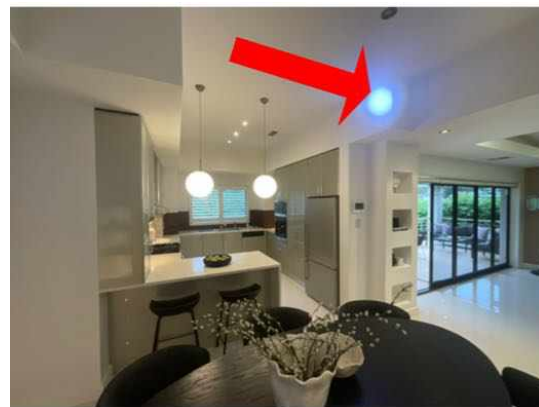
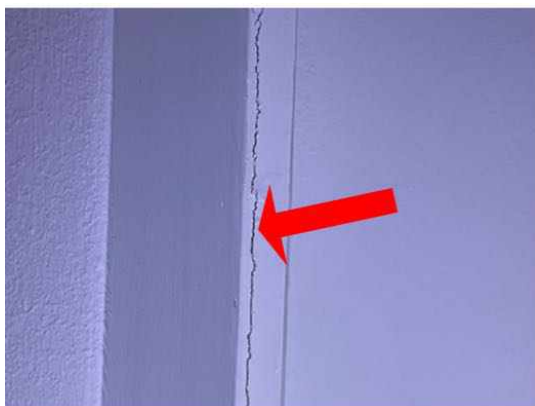
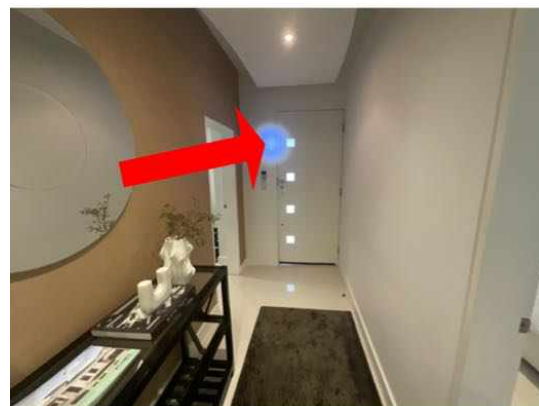
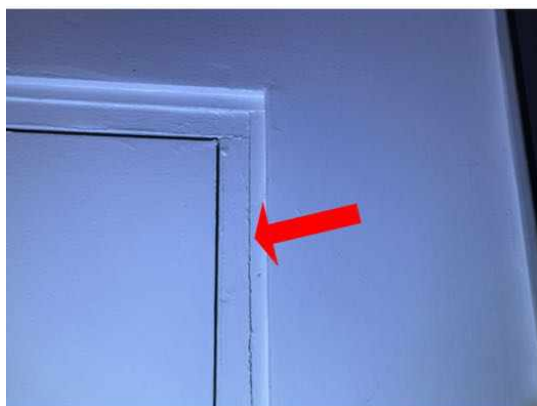
Building: Main Building
Location: Bedroom 1
Finding: Paint finish - Substandard, Wear and Tear
Information: The paint finish in this area was found to have been completed to a substandard level or wear and tear as the normal deterioration of a property from ordinary, everyday use. Exposure to the elements, time, as well as day to day living can cause fair wear and tear.

If this applies, further areas of poor and incomplete finishes could develop over time. Furthermore, substandard, wear and tear paint finishes in areas exposed to moisture, e.g. external areas or wet areas, could lead to deterioration of underlying building materials.

Substandard, wear and tear paint finishes should be sanded back, filled, leveled and repainted, as applicable. Where inadequate paint protection has led to the deterioration of the associated building element, repair and/or replacement of this building element may be required.

A painting contractor should be appointed as soon as possible to perform necessary works to aid the appearance of the affected area and to ensure that the area is protected against further deterioration. Alternatively, the homeowner following manufacturer instructions may be able to provide this service.

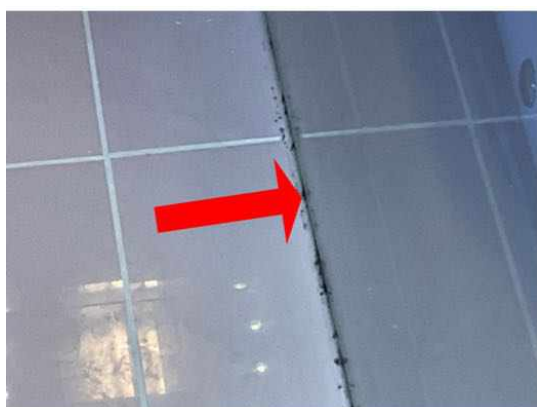
Finding 3.13

Building:	Main Building
Location:	Ensuite
Finding:	Mould Growth to Sealant – Bathroom Area
Information:	Mould is visible to the silicone sealant at the junction between the basin / tiles and the wall tiles. Mould growth indicates excess moisture and inadequate maintenance, which may lead to deterioration of the sealant and potential water ingress into adjoining surfaces. Recommend removal and replacement of the affected sealant with a suitable mould-resistant silicone and ensuring proper cleaning and ventilation to prevent recurrence.

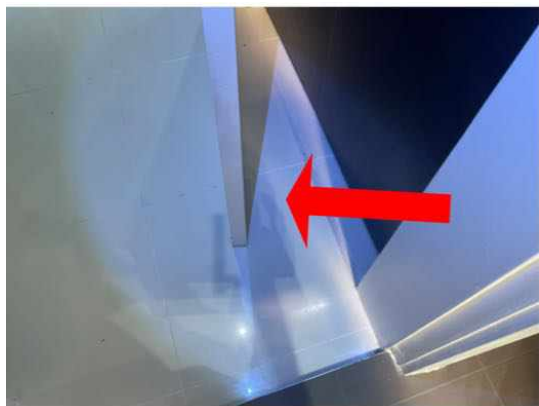
Finding 3.14

Building:	Main Building
Location:	Bedroom - Master
Finding:	Door stop - Missing
Information:	The door stop is missing or is inadequate to stop the door handle from damaging the wall. Although some building elements may seem irrelevant or unnecessary, all building elements play a key role in the operation and function of the overall structure and its performance.

Re-installation or replacement of the door stop is advised as soon as possible to

prevent any subsequent damage to the door or associated structures. A general handyman may be appointed to perform these works at client discretion.

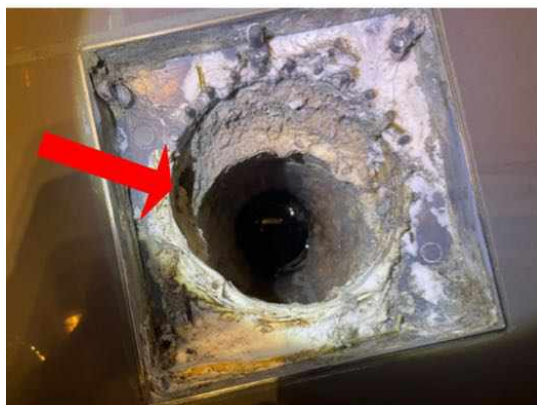
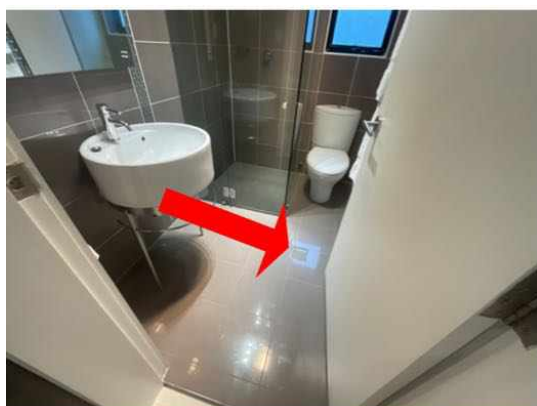
Building:	Main Building
Location:	Ensuite
Finding:	Bathroom Floor Waste Installation
Information:	The bathroom floor waste was observed to be poorly sealed with deteriorated sealant and debris accumulation around the waste collar. Gaps are visible between the floor tiles and waste fitting.

The installation appears incomplete and may not provide a watertight seal at the waterproof membrane termination point.

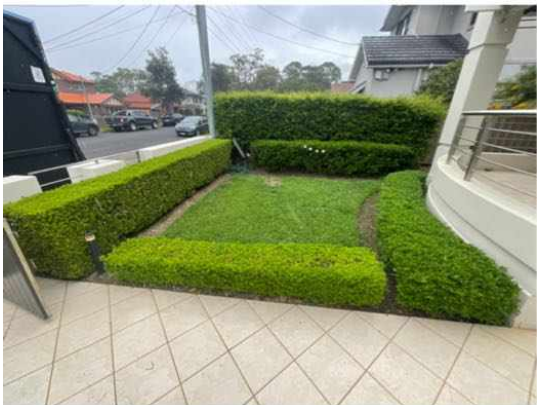
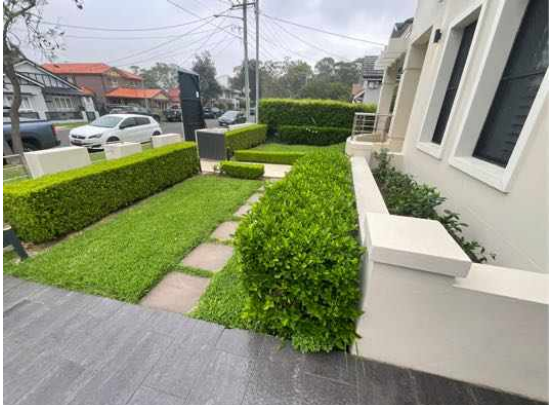
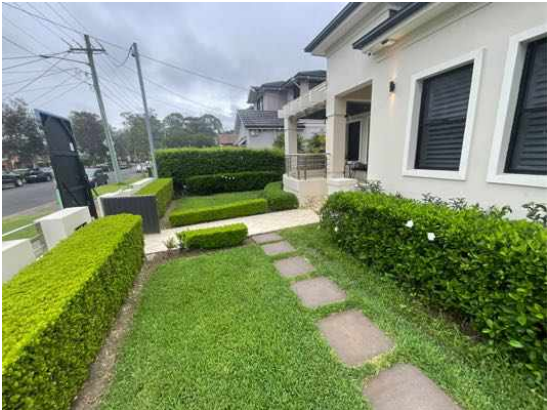
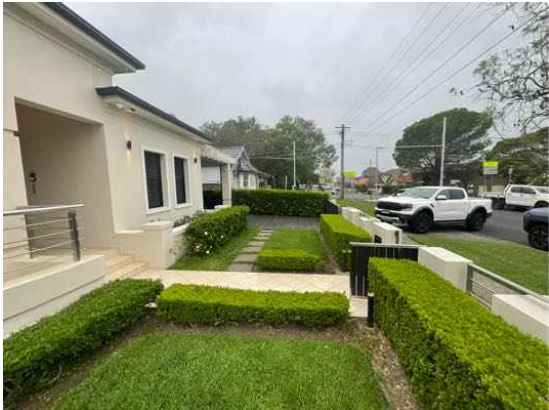
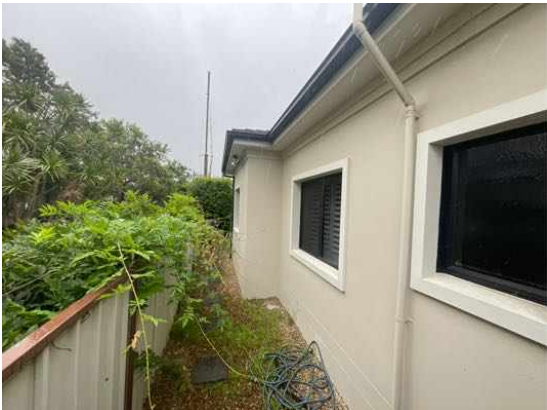
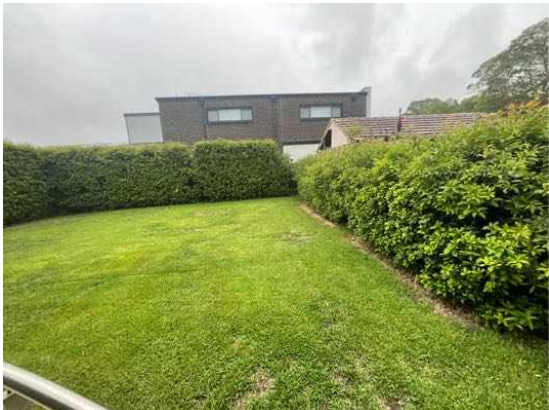
Finding 6.01

Building:	Main Building
Location:	All Areas
Finding:	Garden Beds - Conditions Conducive to Termites
Information:	Garden beds were found to be evident in the garden area. These garden beds can include untreated timber, and with a combination of moisture from watering hosing can make conditions conducive to termite activity and termite ingress.

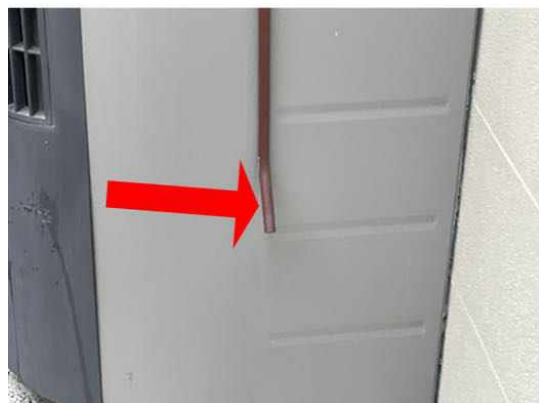
Finding 6.02

Building: Main Building
 Location: All Areas
 Finding: HWS Overflow - Not Connected
 Information: The Hot Water System (HWS) overflow was found to be disconnected from storm water drainage and is creating excessive moisture in the surrounding area.

These damp conditions can lead to secondary defects such as rot, rust or corrosion of associated building elements, the formation of fungal decay, or even the creation of potential slip hazards. When coupled with poor site drainage, pooling of water may also attract termite activity to this area.

It is highly recommended that a licensed plumber be appointed to connect the HWS overflow in order to prevent such an environment from being created. These minor works should be carried out as soon as possible.

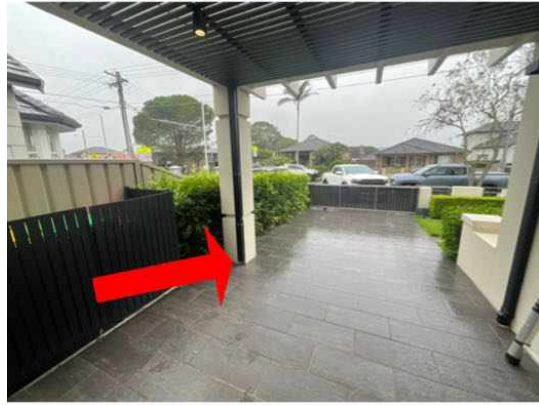
Finding 6.03

Building: Main Building
 Location: All Areas
 Finding: Overflow - Not plumbed for drainage
 Information: The overflow is not plumbed or connected to suitable drainage, which has resulted in the surrounding area becoming excessively damp. These damp conditions can lead to secondary defects such as rot, rust or corrosion of associated building elements, the formation of fungal decay, or even the creation of potential slip hazards. When coupled with poor site drainage, pooling of water may also attract termite activity to this area. It is highly recommended that a qualified plumber be appointed to install adequate drainage to the overflow. These works will ensure that the area remains dry and free of any secondary defects.

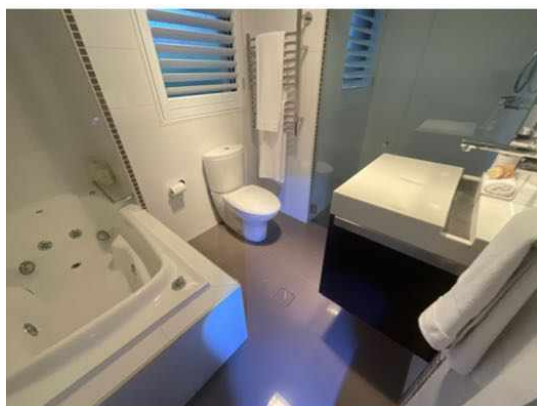
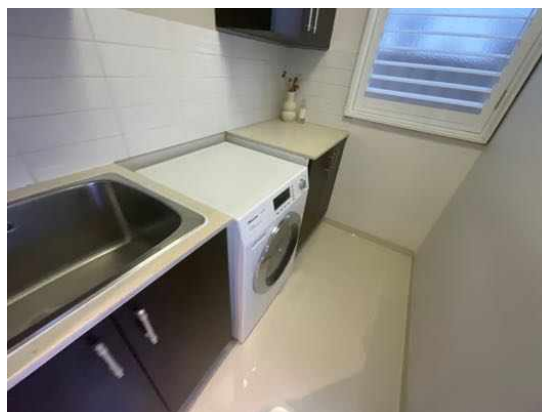
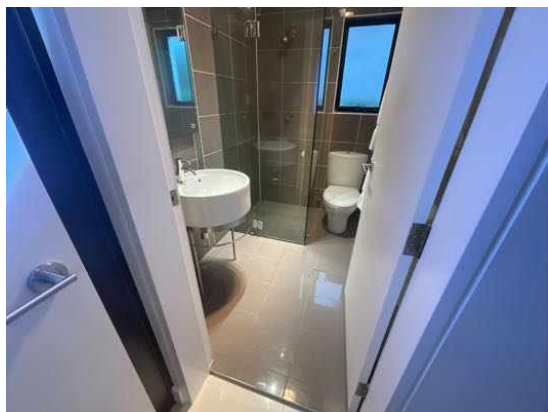
Building: Main Building
Location: All Areas
Finding: Water Proofing Membranes - Information Only
Information: Internal Water Proofing Membranes, are crucial in preventing water ingress into the property is important to know that the Membrane System used is to Australian Standards and has been installed correctly. Please refer to the original Building Documents or Maintenance Schedule for the relevant information including; - Membrane used and Manufacturers Specifications. - The Installer and Installation Certification. Especially with older property's where this information is unavailable, all wet areas should be monitored. Generally new waterproofing with a certificate may only have a guarantee of 8yrs. If any leaks, water staining, peeling or bubbling of the paint become evident to any adjacent walls or ceilings below a licensed builder or waterproofing specialist is recommended to investigate further.
