Building Inspection Report

Inspection Date: Fri, 20 Feb 2026

Property Address: 3/58 Crisp St, Hampton VIC 3188, Australia

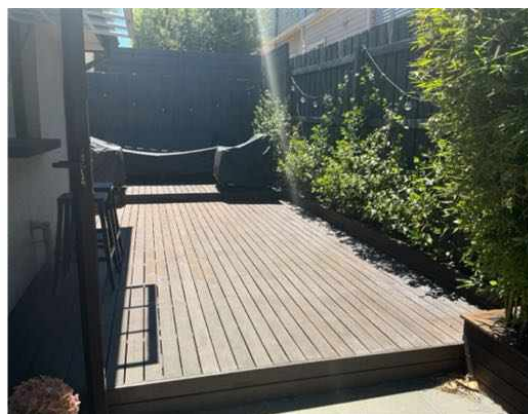
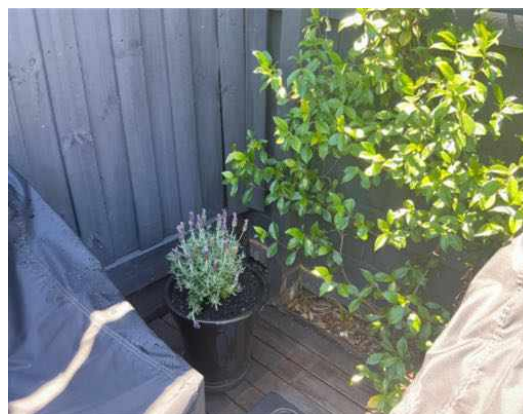
Defects 1.01

Building:	Main Building
Location:	Rear Elevation
Finding:	Timber deck to fence
Information:	A timber deck cannot encroach into the minimum 900mm setback required by the NCC, unless it is provided with some means of fire resistant construction. This ensures there is adequate fire separation between decks and the boundary to prevent the spread of fire to adjoining properties. This is particularly important due to the possibility of adjoining properties having decks that abut the common boundary fence, consequently enhancing the potential for spread of fire between both properties.

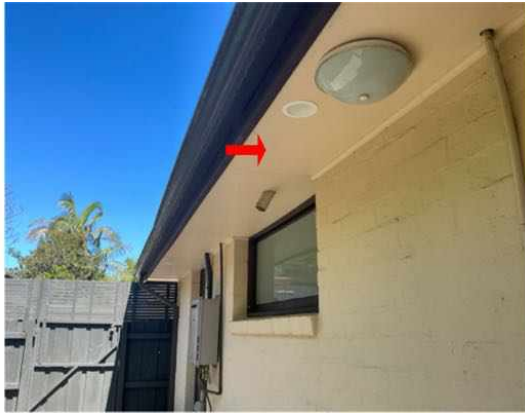
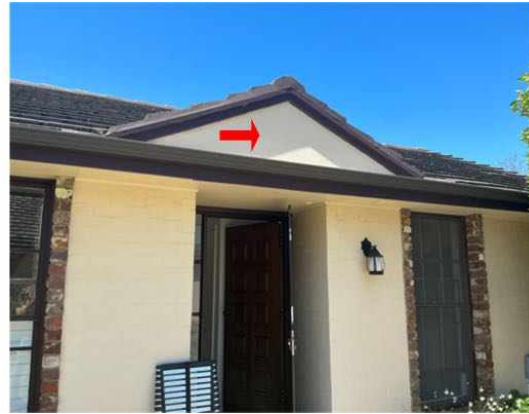
Defects 1.02

Building:	Main Building
Location:	Eaves and gable end
Finding:	Asbestos - Suspected ACM Identified on Site
Information:	Reporting on Asbestos is outside the Scope of this Report. This suspected defect is highlighted as a caution only. We suspect, based on our experience in the building industry, that there is a higher risk of the identified building element containing asbestos.

As Asbestos Reporting is outside the scope of this report, we advise that you consider a separate Asbestos Inspection and Condition Audit, which can include the taking of samples for definitive confirmation of the presence of Asbestos.

In the interim, the client is advised to act with caution, especially when considering any damage to building materials general wear and tear renovations extensions demolition and general maintenance activities due to the suspected presence of Asbestos.

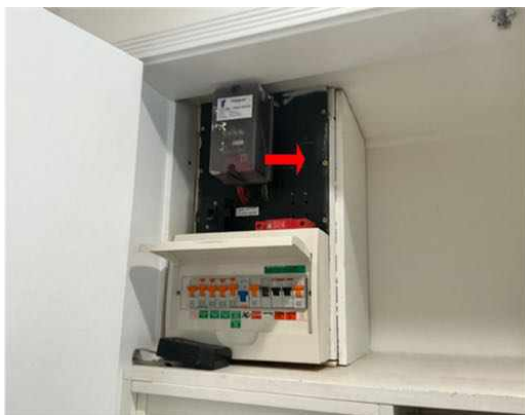
Defects 1.03

Building:	Main Building
Location:	Electrical Switchboard
Finding:	Asbestos suspected
Information:	Many areas of suspected asbestos containing material were found throughout the property as shown in photos. Reporting on Asbestos is outside the Scope of this Report. This suspected defect is highlighted as a caution only. We suspect, based on our experience in the building industry, that there is a higher risk of the identified building elements containing asbestos.

In the interim, the client is advised to act with caution, especially when considering any damage to building materials, general wear and tear, renovations, extensions, demolition and general maintenance activities due to the suspected presence of Asbestos.

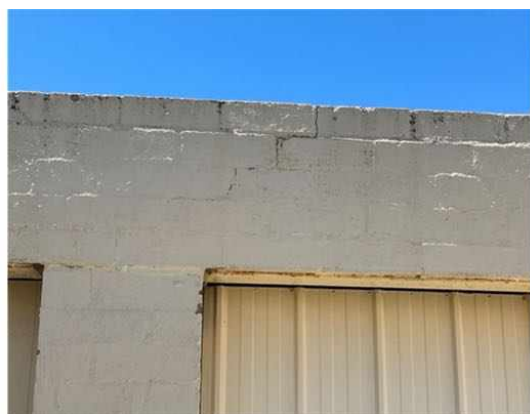
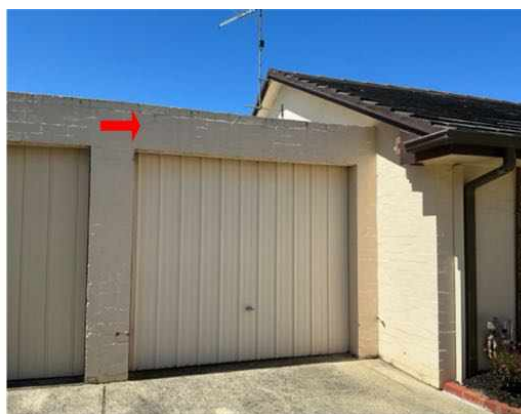
Defects 3.01

Building:	Main Building
Location:	Garage
Finding:	Brickwork - Step cracking
Information:	Step cracking was identified to the brickwork in this area at the time of inspection. Step cracking, which is similar to other forms of cracking, has a variety of possible causes. However, the most common is the subsidence of adjacent footings.

Step cracking is a relatively common defect, and is most likely to occur adjacent to windows, doors and other openings. Mortar failure in the gaps between affected bricks indicates the stresses and tensions affecting the wall.

Where step cracking is extensive or severe, the client is advised to consult a structural engineer. Minor step cracking can be used as a warning sign to address factors causing stress to the wall, which can include the effect of surrounding trees, water leaks, soil erosion, or even the presence of reactive soils in the surrounding area.

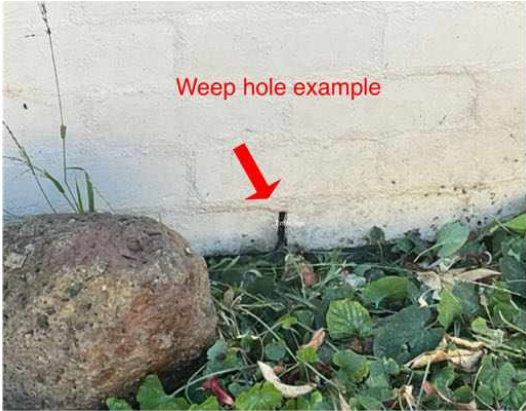
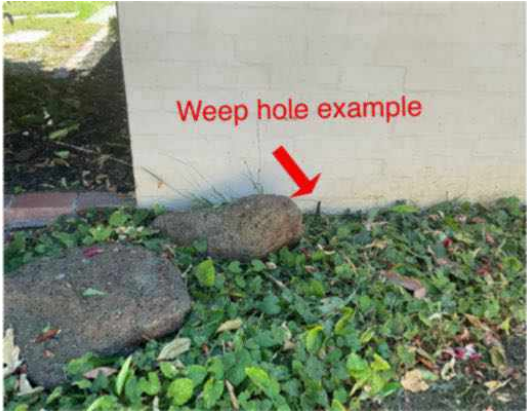
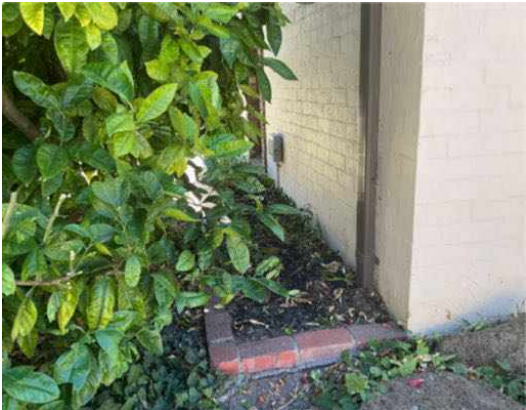
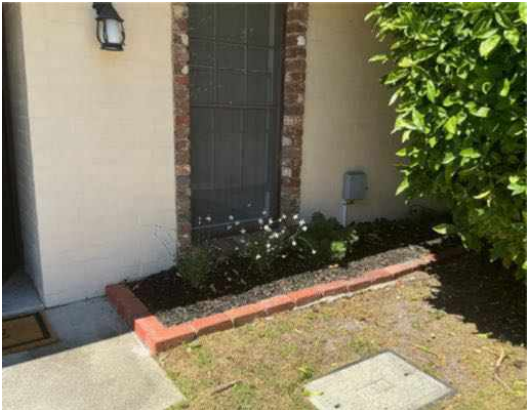
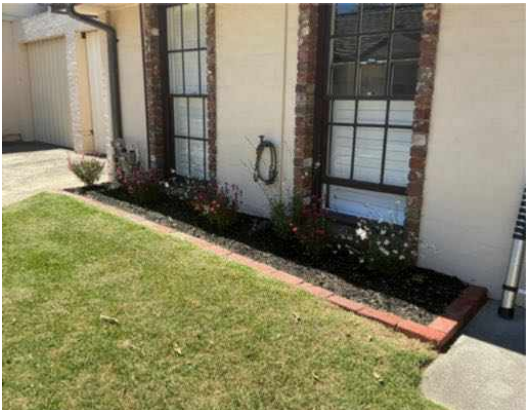
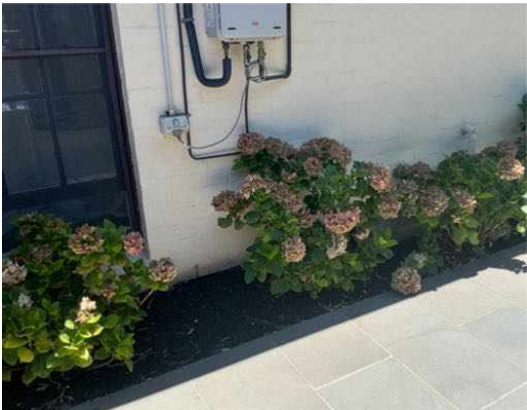
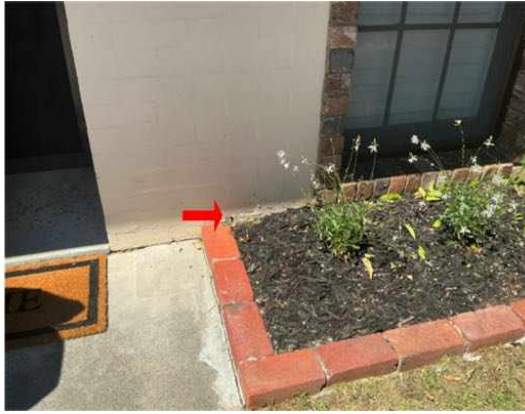
Defects 3.02

Building:	Main Building
Location:	All Areas
Finding:	Weep holes - Blocked
Information:	It was noted during the time of inspection that some of the weep holes to the brickwork were blocked. Weep holes are designed to allow water from leaks or seepages in brickwork to be directed to the external environment, prior to entering the wall cavity or associated building materials. Weep holes should therefore be kept clean and free of debris or blockages.

Blocked weep holes are likely to result in the presence of excessive moisture within the brickwork and associated structures, creating potential for water damage and moisture problems.

Depending on the nature of the blockage, the homeowner may be able to undertake

remedial works to remove blockages. Alternatively, appointment of a registered builder may be required to remove blockages. Preventative works are necessary in ensuring the structural integrity of the affected brickwork and should be performed as soon as possible.

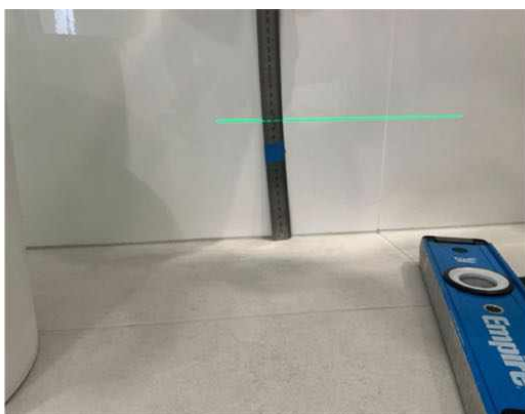
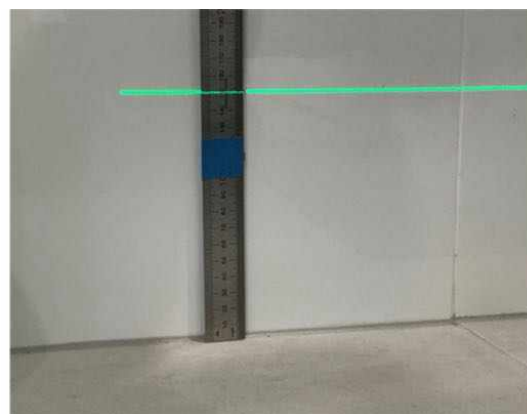
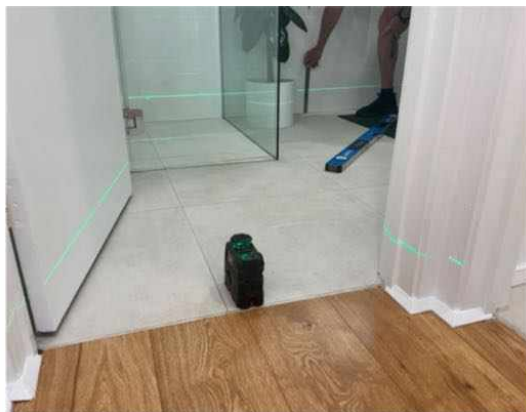
Defects 3.03

Information: The internal flooring in the bathroom is out of level and uneven. Uneven flooring may indicate minor defects such as expected movement of the foundations of the property or poor tiling of the bathroom area, but may also indicate subsidence or a crack to the slab.

It is advised that the flooring be closely monitored to identify any further movement. Where flooring remains relatively unchanged for an extended period of time (i.e. several months), it is likely that this defect has been caused by expected movement of the foundations of the property.

However, where flooring is uneven further, potentially invasive inspection of the slab in this area is required. In this case, works to repair are likely to be required, and would be carried out by a registered builder specialising in underpinning.

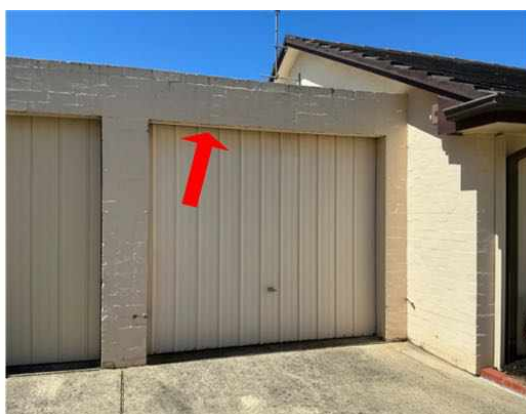
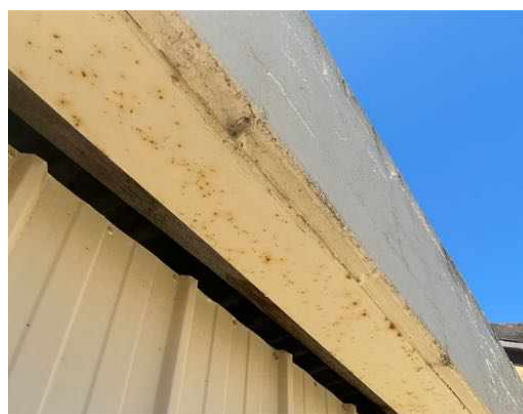
Defects 3.04

Building:	Main Building
Location:	Garage
Finding:	Lintels - Rusted or corroded
Information:	This building element shows evidence of rusting and corrosion, which is likely to have developed as a result of excessive exposure to moisture and or inadequate coatings.

As surface rust provides no protection to the underlying iron, the deteriorating condition is likely to worsen if not addressed in the short-term future.

Where possible, the use of galvanized (treated) metals or aluminium coated metals aid in rust prevention, as does regular general maintenance. Rust formation can be controlled with coatings, such as paint, that isolate the iron from the environment.

Rusting and corrosion should be managed by ideally removing or limiting the affected surface from exposure to moisture. A registered builder may be appointed to replace any building elements that have been severely affected by rust or water damage.

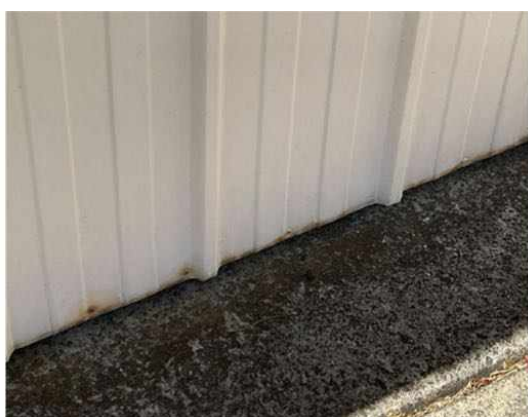
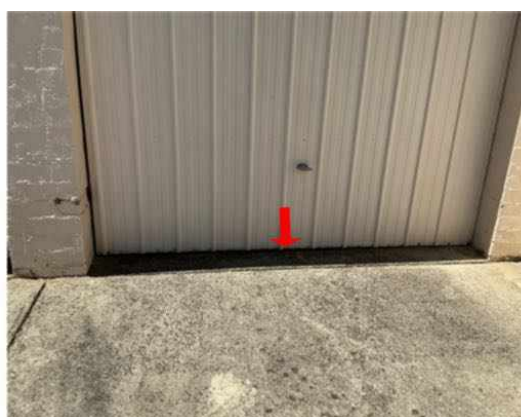
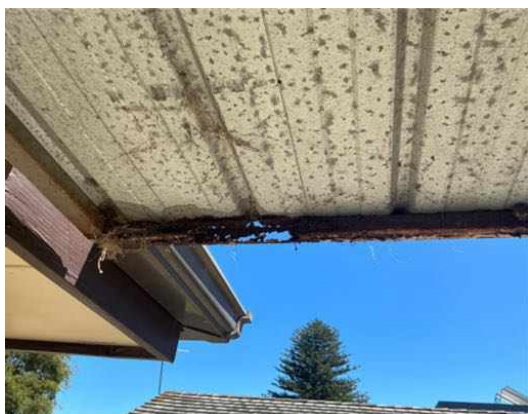
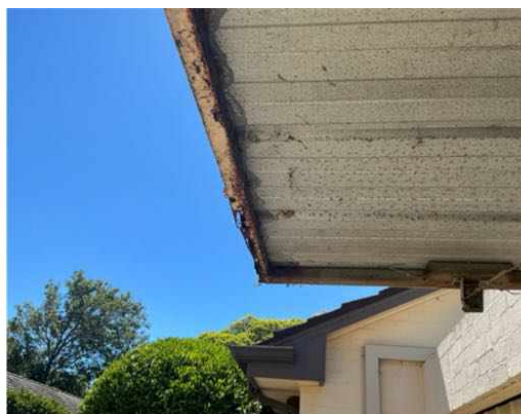
Defects 3.05

Building:	Main Building
Location:	Garage door
Finding:	Building element - Rusted or corroded

Information: This building element shows evidence of rusting and corrosion, which is likely to have developed as a result of excessive exposure to moisture and or inadequate coatings.

As surface rust provides no protection to the underlying iron, the deteriorating condition is likely to worsen if not addressed in the short-term future.

Where possible, the use of galvanized (treated) metals or aluminium coated metals aid in rust prevention, as does regular general maintenance. Rust formation can be controlled with coatings, such as paint, that isolate the iron from the environment.

Rusting and corrosion should be managed by ideally removing or limiting the affected surface from exposure to moisture. A registered builder may be appointed to replace any building elements that have been severely affected by rust or water damage.

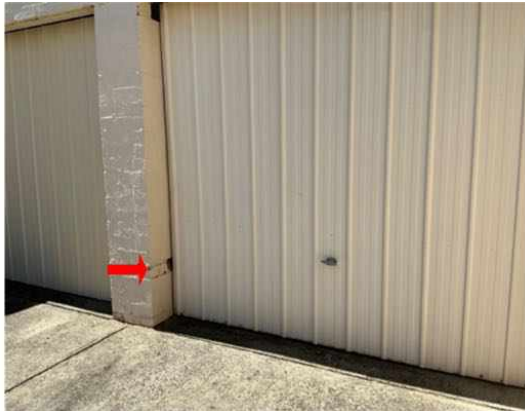
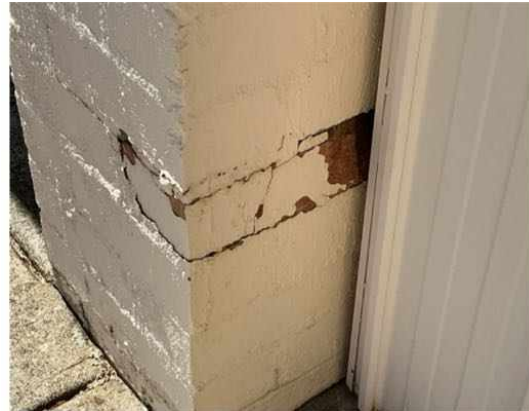
Defects 3.06

Building: Main Building
 Location: Garage
 Finding: Brickwork - damaged[Repair required]
 Information: Damage was identified to the brickwork in this area.

A qualified bricklayer should be contacted to estimate and perform repair and restoration works. Consultation with a structural engineer may be required where structural instability is found.

Always contact a building inspector should cracks or damage widen, lengthen, or become more numerous.

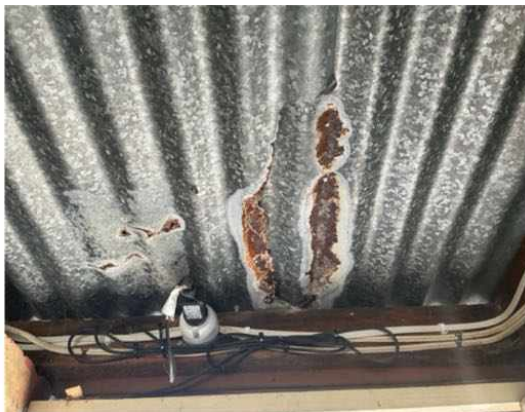
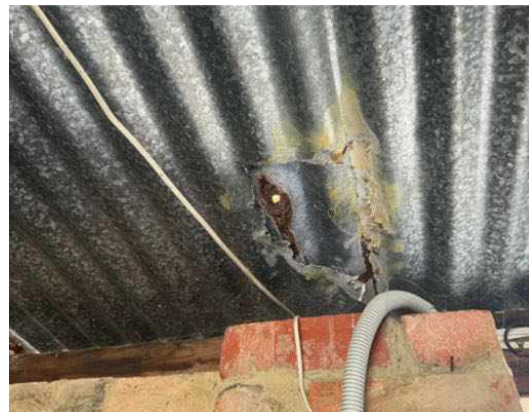
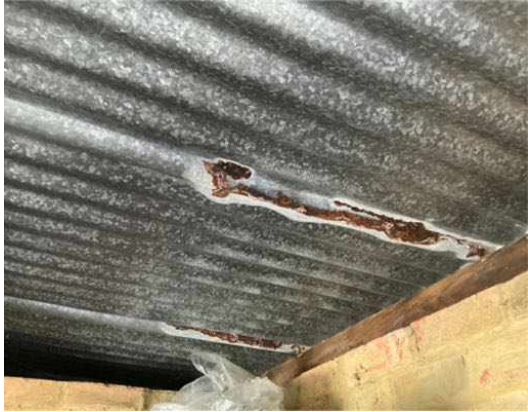
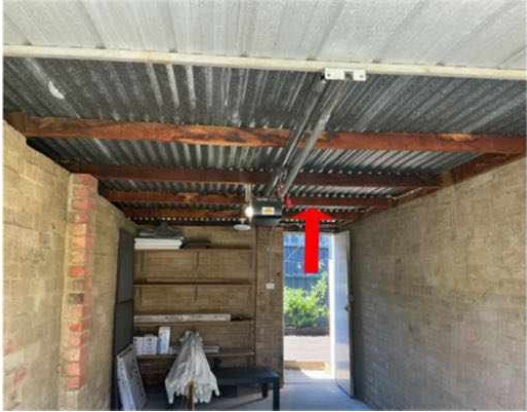
Defects 3.07

Building:	Garage
Location:	Garage
Finding:	Roof sheets - Rusted
Information:	Metal roofs generally comprise numerous individual sheets, which join and overlap. These intersections are particularly prone to lift at the edge and consequently rust at these points.

Upon inspection of the exterior roofing structure, evidence of rust to these sections was identified. If left unmanaged, these degrading joins can allow water ingress to the internal roofing structures, potentially leading to secondary damage of building elements. Accelerated deterioration of the roofing sheets and any associated building elements is also likely to occur.

A roofing contractor should be appointed immediately to assess the damage to the roofing sheets and to perform remedial works as necessary. Works may include replacement of severely affected roofing sheets or minor works such as the application of rust-retardant surface protectors.

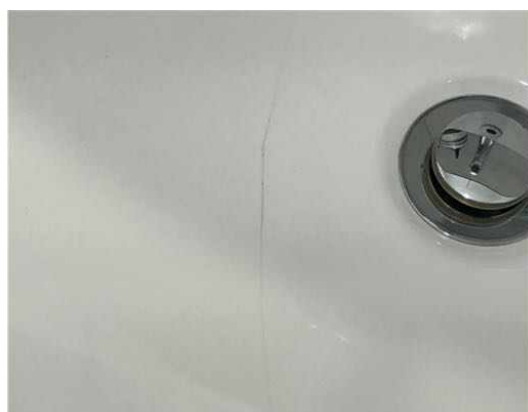
Defects 3.09

Building:	Main Building
Location:	Bathroom
Finding:	Basin - Cracked
Information:	Cracking was evident to the basin at the time of inspection, which is suspected to have been by minor impact damage. While the cracking appears to be minor, any further impact damage sustained by the basin may lead to additional cracking.

As the cracking provides potential ingress for water, secondary water damage may occur to associated cabinetry, walls or flooring, if the cracking is left unmanaged.

Consultation with a plumber regarding basin repair or replacement is required. Remedial works may be required to protect against any further damage.

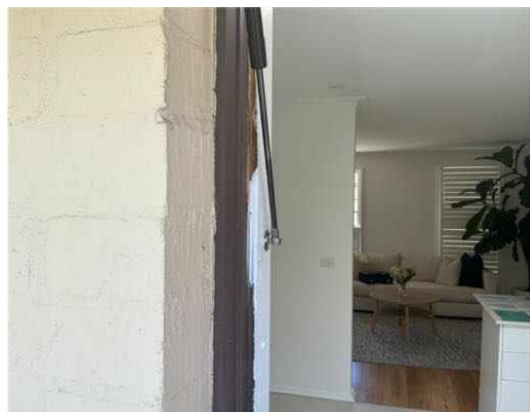
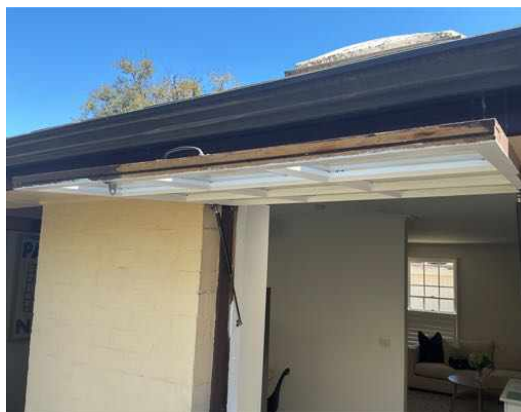
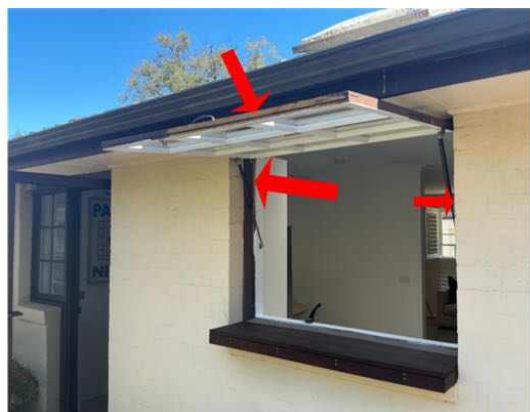
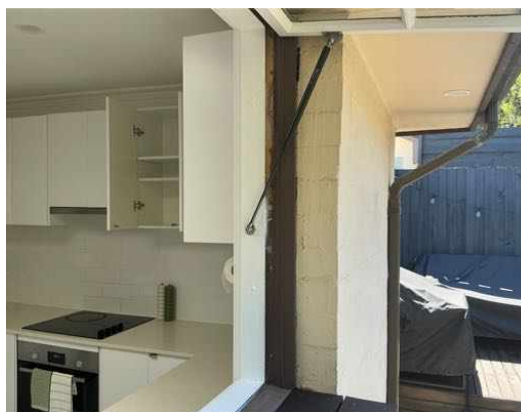
Defects 3.10

Building:	Main Building
Location:	Servery window
Finding:	Paint finish - Incomplete
Information:	The paint finish in this area was identified as being incomplete at the time of inspection.

Whilst incomplete or missing paint finish is generally an appearance defect, it can also lead to the development of secondary building defects over time. Incomplete areas of paint finish expose the area to moisture, potentially accelerating the deterioration of underlying building materials.

Incomplete paint finishes should be sanded back, filled, leveled and painted, as applicable. Where inadequate or missing paint protection has led to the deterioration of the associated building element, repair and/or replacement of this building element may be required.

A painting contractor should be appointed as soon as possible to perform necessary

works to aid the appearance of the affected area and to ensure the area is protected against further deterioration. Alternatively, the homeowner following manufacturer instructions may perform these works.

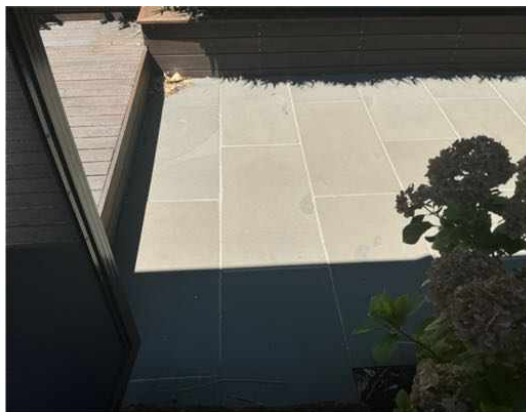
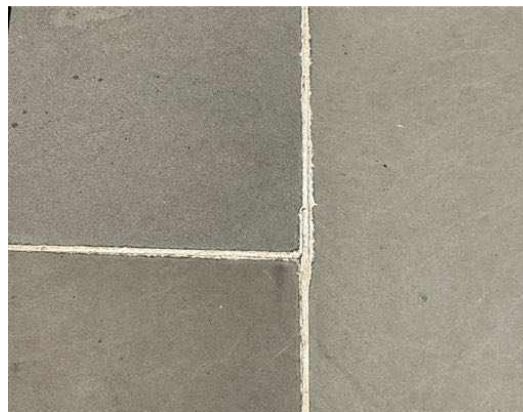
Defects 3.11

Building:	Main Building
Location:	Rear Paving
Finding:	Paving - Efflorescence
Information:	Efflorescence appears to be affecting the brickwork, concrete or tiles in this area. Efflorescence typically occurs when excess salts within the concrete or cement mortar is leached to the surface due to water transfer.

It is typically seen as white salt deposits on the surfaces of concrete pavement or mortar between bricks or tiles. While detracting from the overall appearance of the affected area, efflorescence is not likely to develop into secondary damage if left unmanaged.

Generally, soluble salt deposits can be removed by dry brushing with a stiff-bristled brush. Repeated dry brushing is an ideal treatment for eliminating this forming of efflorescence. A cleaning contractor or general handyperson may be appointed to perform these works at the discretion of the client.

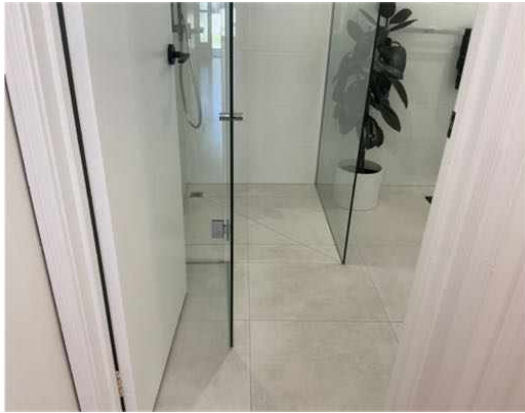
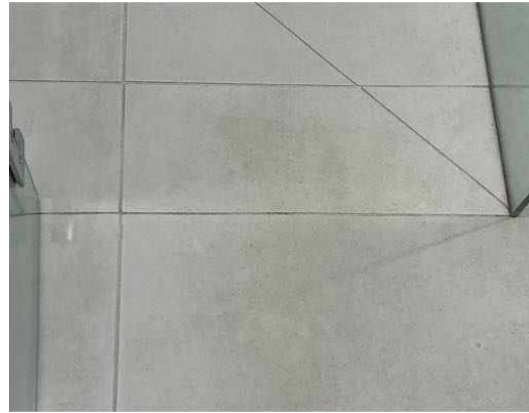
Building: Main Building
 Location: Bathroom
 Finding: Waterstop missing
 Information: A waterstop is a vertical extension of the waterproofing system forming a barrier to prevent the passage of moisture in the floor or vertically in a wall.

Waterstops are used as part of a waterproofing system to prevent water/moisture under the finished surface from escaping the wet area and causing damage to other materials and structural building elements.

A moisture meter was used and leaking from current shower recess to the adjoining

flooring of the bathroom area was not found at this time.

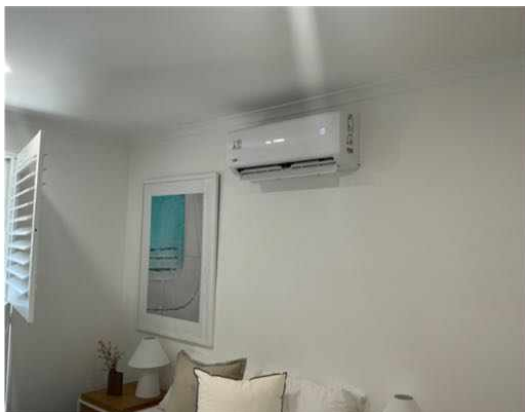
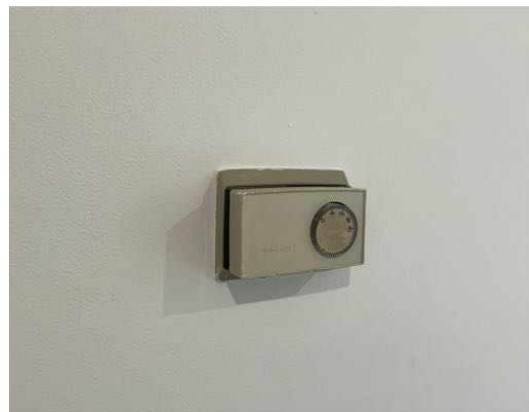
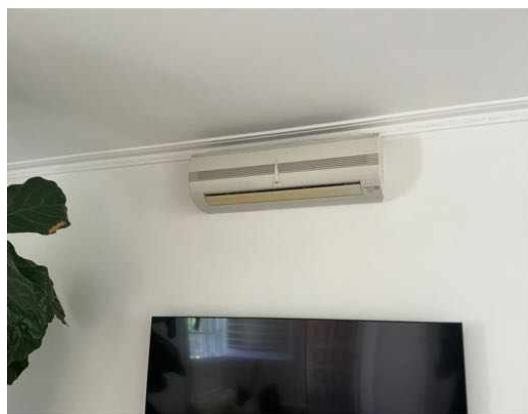
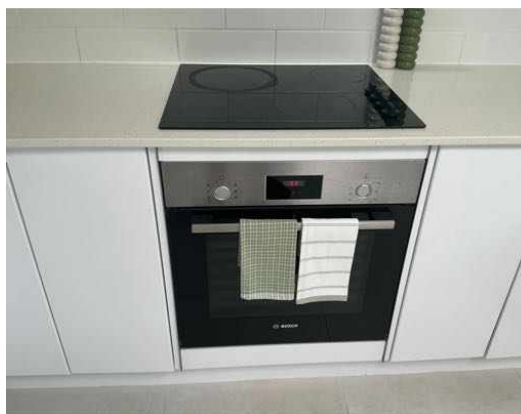
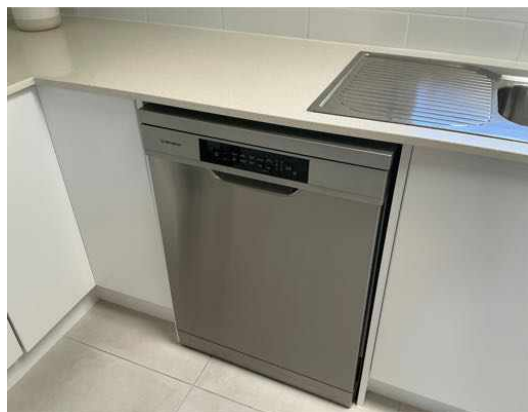
Finding: Warranty - Expired

Information: Where appliances are beyond their warranty period, the owner should be prepared to meet the cost of replacement or repair of the item at any time. The operation of the appliance can not be guaranteed and further inspection by an appropriately qualified tradesperson may be required.

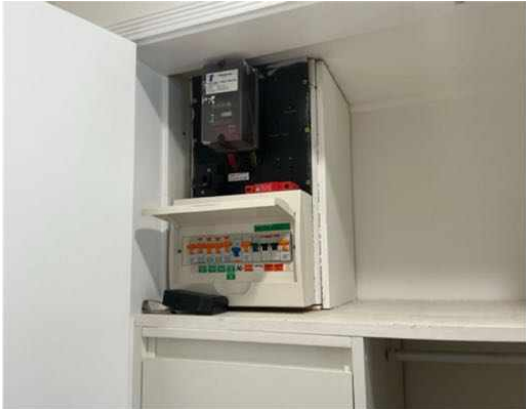
Building:	Main Building
Location:	Electrical Switchboard
Finding:	Termite Management System - no evidence of a chemical installation
Information:	The application of a post-construction chemical termite barrier is highly recommended for all properties, particularly if live termite activity has been found on the site previously. Such barriers are highly effective in preventing termite attack on any timber building elements throughout the property.

A durable notice should be placed in the switchboard unit to indicate current termite barriers. At the time of inspection, it appeared as though no termite management system has been installed, with no evidence to suggest preventative works taking place.

The client may consider gaining further advice from a pest controller as to the costs and procedures involved with this application. It is recommended that obtaining such advice be a short-term priority.
