Building Inspection Report

Inspection Date: Wed, 18 Feb 2026

Property Address: 39/27 Gawler Cres, Bracken Ridge QLD
4017, Australia

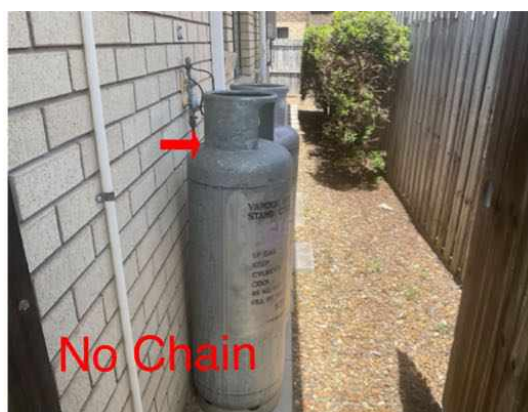
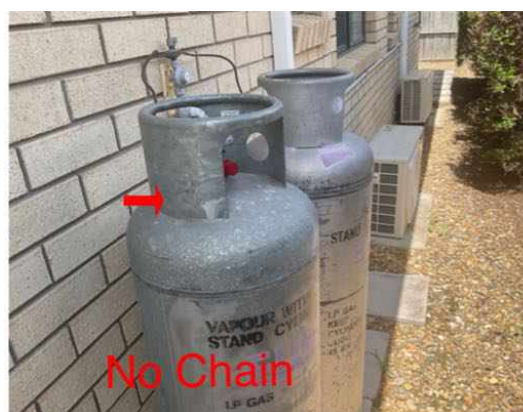
Defects 1.01

Building:	Main Building
Location:	Exterior walls - right side
Finding:	Gas Bottle - Non-compliant
Information:	In the opinion of the inspector, the gas bottle installation is non compliant. However, in relation to gas and related gas plumbing, you should always consult a licensed plumber/gas fitter for further advice.

Unfinished and substandard building works are likely to degrade more quickly and may create potential for secondary defects to associated building elements, as well as a potential safety hazard in the case of gas service management.

The findings are that there appears to be no compliance plate and the bottle is not securely fastened. Where installation is substandard and/or incomplete, the client should contact the responsible trade (gas plumber) to undertake rectification.

It has a safety hazard that needs immediate attention:
The gas bottles have no safety chain installed.

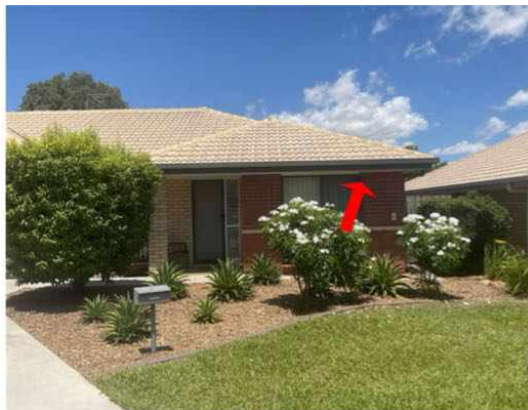
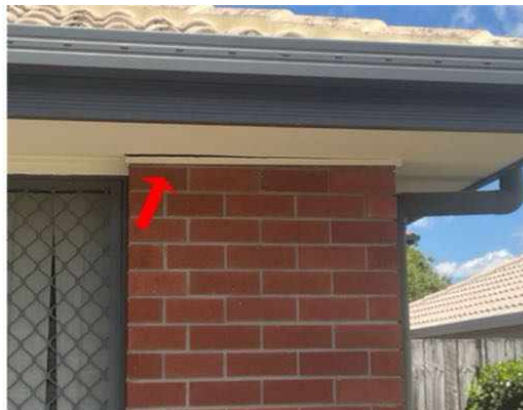
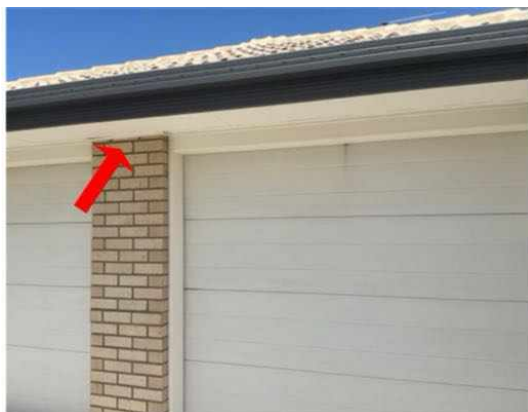
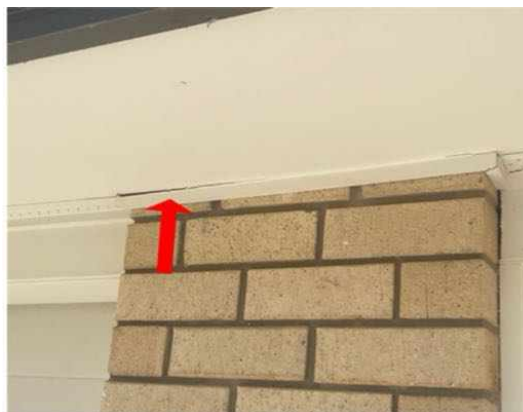
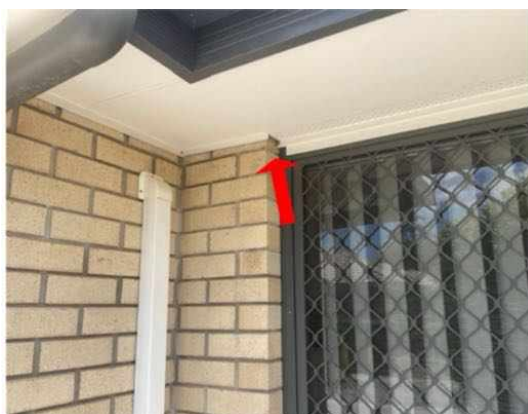
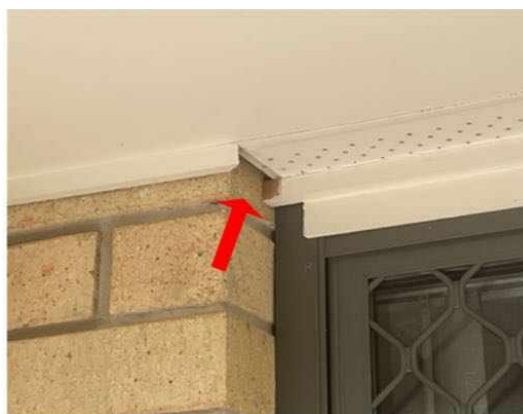
Defects 3.01

Building:	Main Building
Location:	Exterior walls - front
Finding:	Minor defect External
Information:	These photos are a selection of a few (but not all) of the minor defects throughout the

exterior of the property.

These are not structural and can be remedied at the owners convenience.

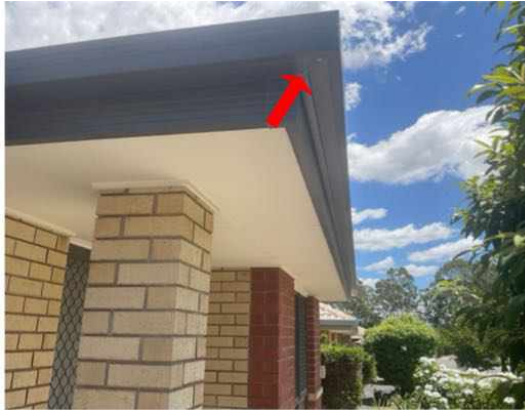
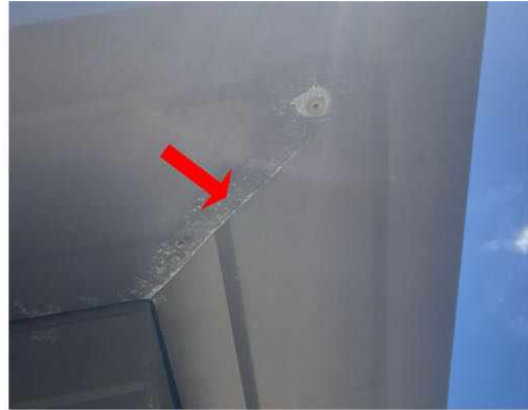
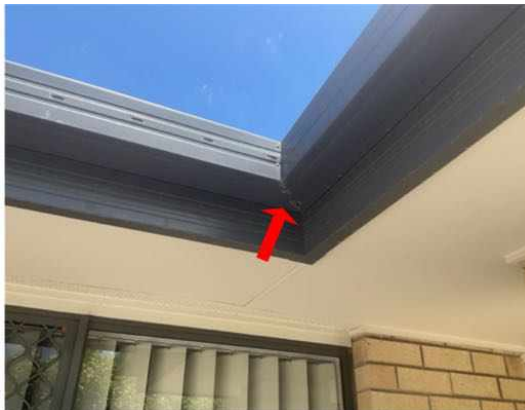
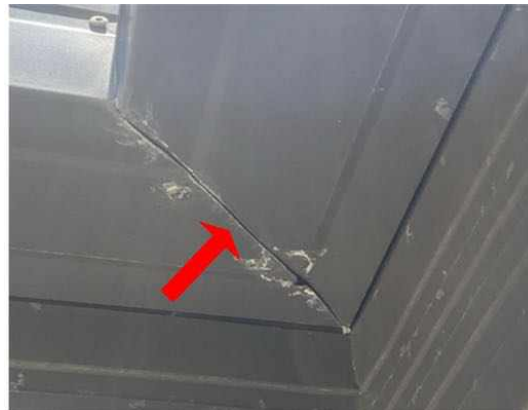
Defects 3.02

Building:	Main Building
Location:	All External Areas
Finding:	Gutters - leaking
Information:	It was noted that the roof plumbing and gutters were deteriorated and leaking at the time of the inspection.

Leaking roof plumbing can contribute to a range of further defects including dampness, mould and termite attraction to the property.

It is recommended that a licensed roof plumber be engaged to repair the guttering as a matter of urgency.

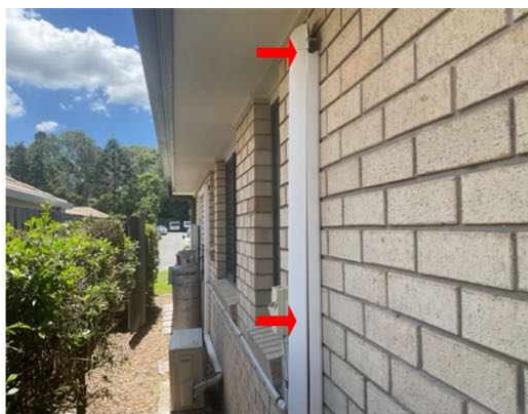
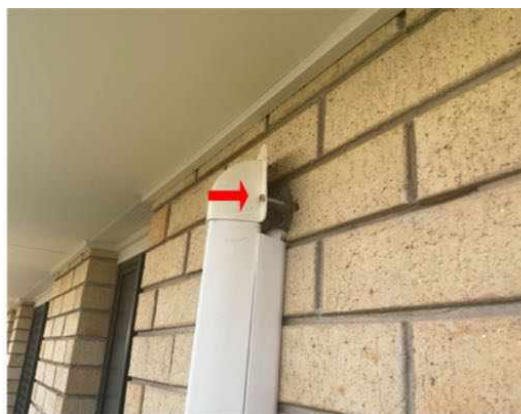
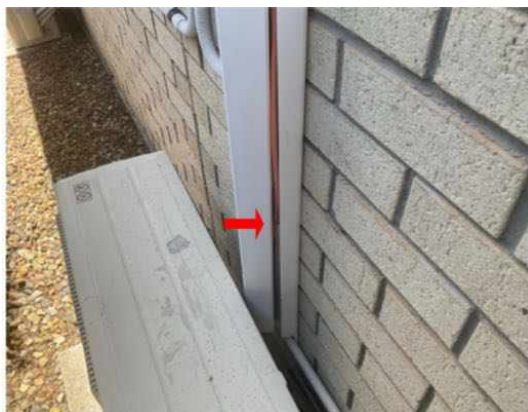
Defects 3.03

Building: Main Building
Location: Exterior walls - right side
Finding: Minor defect External
Information: These photos are a selection of a few (but not all) of the minor defects throughout the exterior of the property.

These are not structural and can be remedied at the owners convenience.

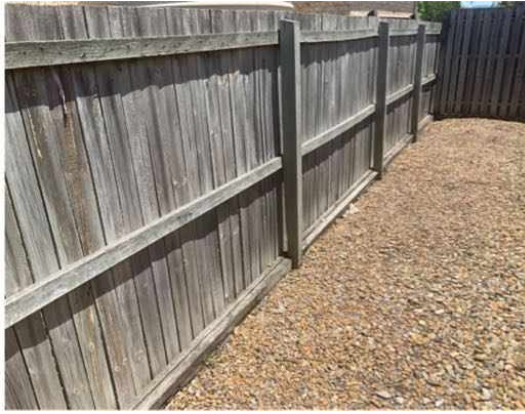
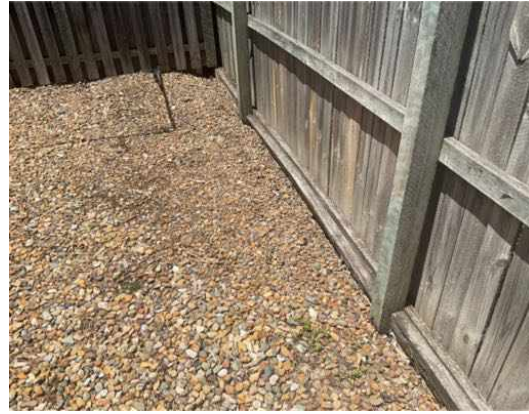
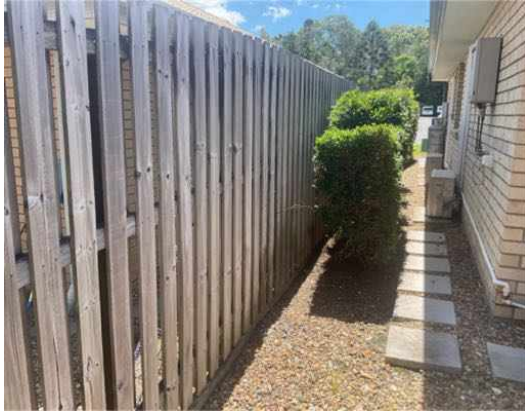
Defects 3.04

Building:	Main Building
Location:	All External Areas
Finding:	Fencing - Deteriorated
Information:	It was noted at the time of inspection that sections of the fencing throughout the property have deteriorated. Typically fencing deteriorates due to age and or wear, rot and or rust which is generally expected for a structure of this age, due to prolonged exposure to weather conditions. Sometimes inadequate installation or maintenance can be to blame.

If left unattended, it is likely that further damage will occur. It is suspected that repair of several elements of the fencing may be required however replacement may be a consideration of the client also.

A licensed fencing contractor should be appointed to provide further advice and perform rectification works as necessary.

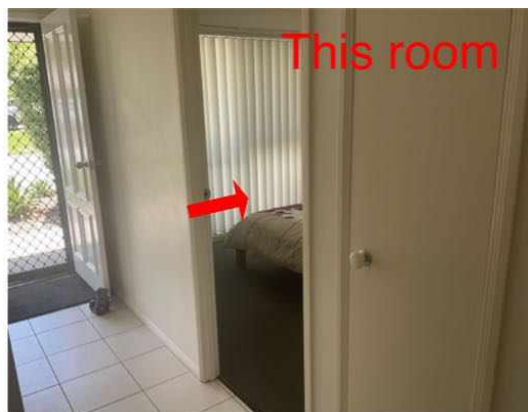
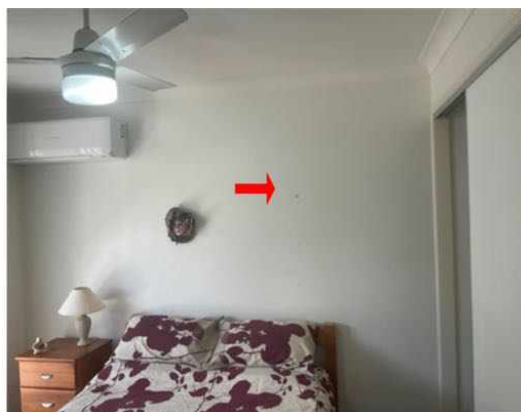
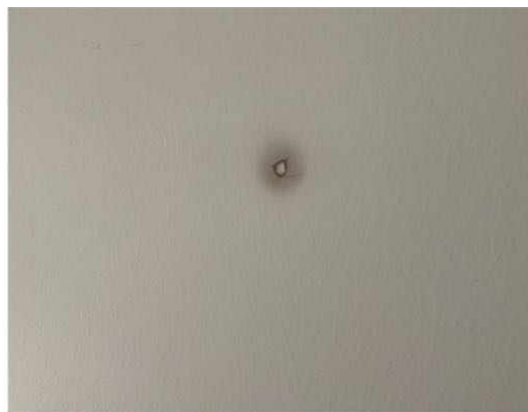
Defects 3.05

Building: Main Building
Location: Bedroom 2
Finding: Burn mark???
Information: There was what appeared to be a cigarette burn mark on the wall of this bedroom. The reason for this mark was not clear.

There was no other visible damage to the wall in this location.

A moisture meter was used in this area and showed no elevated levels of moisture.

A thermal camera was also used with no evidence of any temperature fluctuations in the area.

This area should be monitored and if any further deterioration is noted, a licensed builder should be engaged to assess the area.

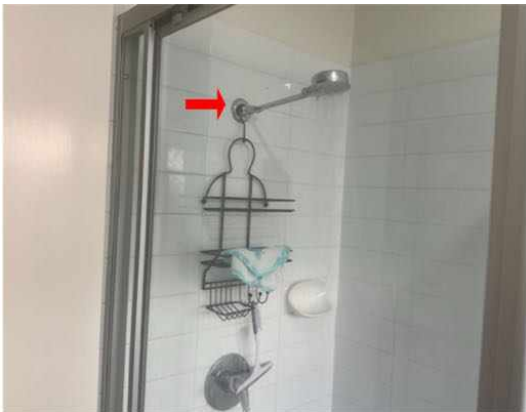
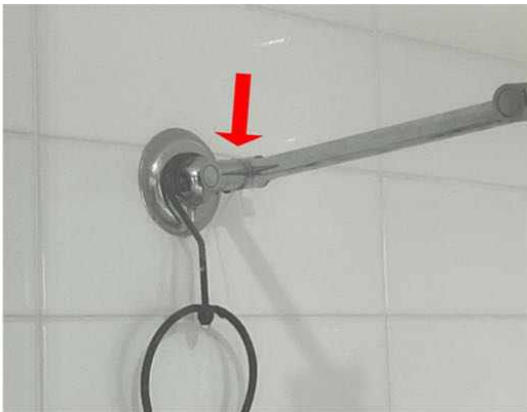
Defects 3.06

Building:	Main Building
Location:	Bathroom
Finding:	Shower rose leaks
Information:	It was noted that there was a leak from the joint in the shower rose in the bathroom.

While this does not let water into the wall area, as the leak is inside the shower area, it may be an indication that the shower fittings are ending their life span. If left unattended it is possible that further leaks may develop which could lead to moisture inside the wall cavity.

It is recommended that the a licensed plumber be engaged to assess and repair or replace the fitting as required.

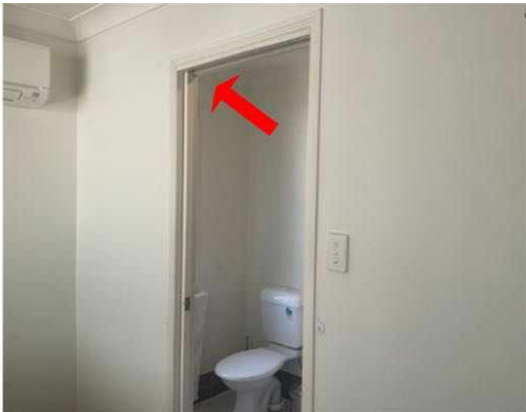
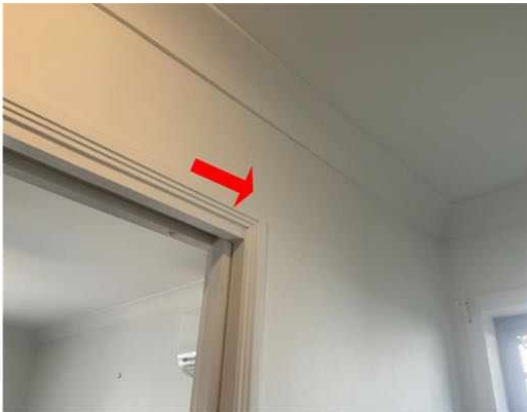
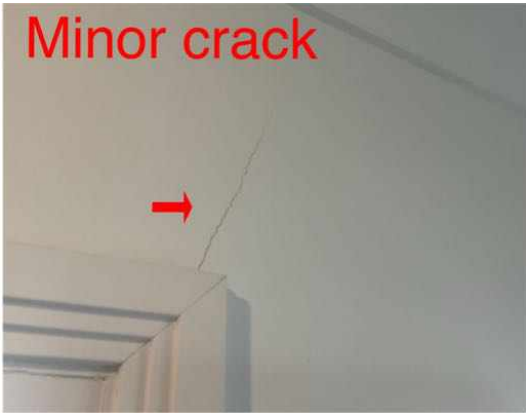
Defects 3.07

Building: Main Building
 Location: Ensuite - Master
 Finding: Minor defect internal
 Information: These photos show a selection of a few of the minor defects apparent throughout the interior of the property.

These are not structural and can be addressed by the owner at their convenience.

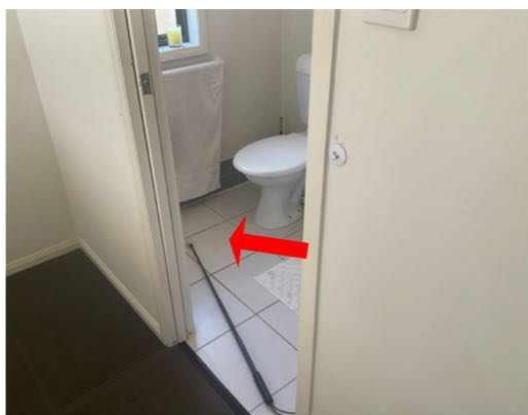
Defects 3.08

Building: Main Building
Location: Ensuite - Master
Finding: Tiles in the Ensuite- Drummy
Information: Drummy tiled areas were identified at the time of inspection. The term 'drummy' refers to tiles that have become detached from their fixing, despite otherwise being in relatively good condition. Such defects are generally caused by physical or moisture damage to the area. Drummy tiled areas may also be a direct result of poor workmanship during the construction process.

Tiled areas may swell and shrink with changes in air humidity if the area has sustained moisture damage. Any exposure to moisture is capable of causing tiled areas to become drummy and/or cracked over a prolonged period of time.

It is recommended that this area be monitored and if the tiles become dislodged, that a tiling contractor be engaged to assess the area and perform repairs/replacement as needed.

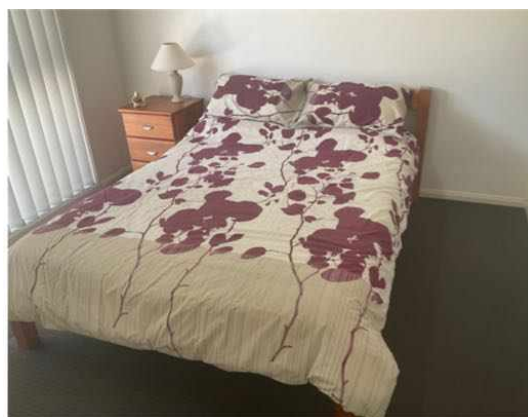
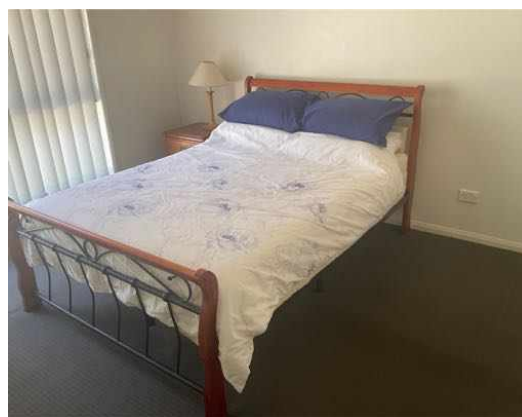
Building:	Main Building
Location:	All Internal Areas
Finding:	Additional Photos - Obstructions and Limitations
Information:	These photographs are an indication of the obstructions and limitations which impeded full inspection of the property at the time of inspection. These obstructions can hide an array of defects and should be removed to allow full inspection to be carried out. A re-inspection is recommended once the areas are made accessible.

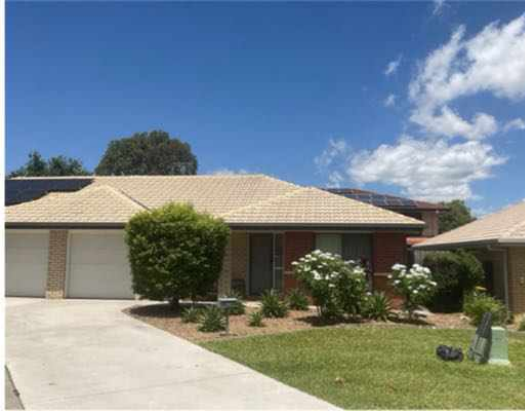
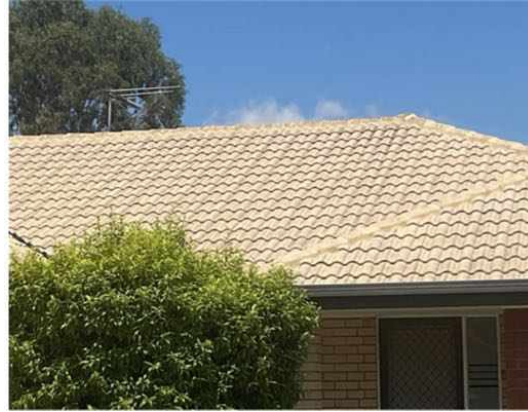
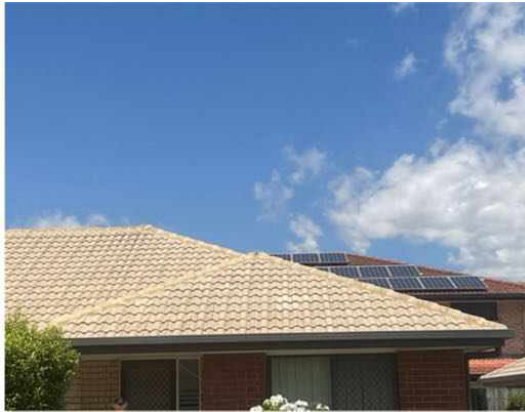
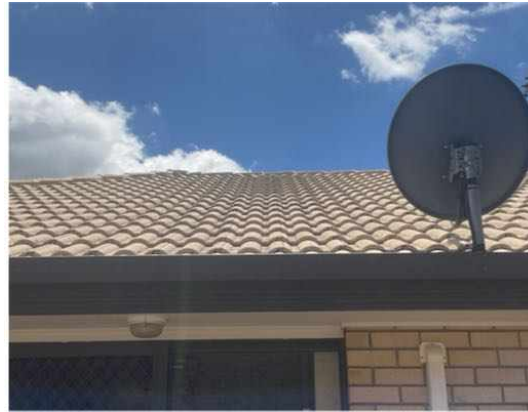
Building:	Main Building
Location:	Roof Exterior
Finding:	Roof tiles - Weathered
Information:	Upon inspection of the exterior roofing, the majority of roof tiles were considered to be in a fair condition. While weathering of the tiles is consistent with the age of the property, maintenance works are required.

Isolated areas of mortar have come loose in the valleys and minor cracking is also present. Re-pointing and re-sealing the may be considered as an interim solution by the client to help preserve and extend the life span of the tiles.

Where left unmanaged, deteriorating roof tiles are likely to lead to a number of secondary defects, including minor water leaks and weather exposure to internal roofing structures.

Consultation with a roofing contractor is highly advised to gain advice on cost of remedial works that may be required in the short to medium term. Remedial works are likely to increase the longevity of the exterior roofing structure.

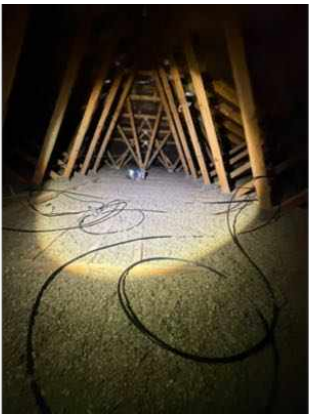
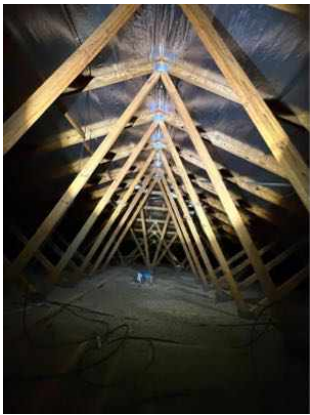
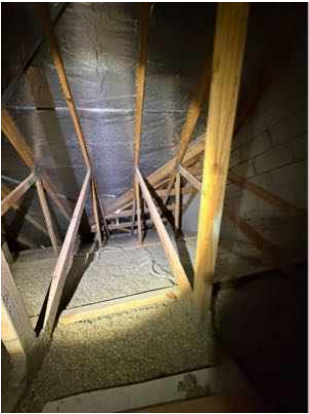
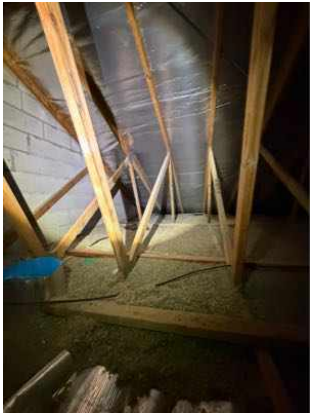
Building: Main Building
Location: Roof Void
Finding: Roof void access limitations
Information: Limited access to the roof void was present due to the presence of loose filled insulation making access hazardous, for this reason access to the roof void was minimal.

The roof space was insulated.

The visible area of the roof trusses and structure looked in good condition.
