# Building and Timber Pest Inspection Report

Inspection Date: Fri, 27 Mar 2026

Property Address: 13 Monti Place, North Richmond NSW 2754

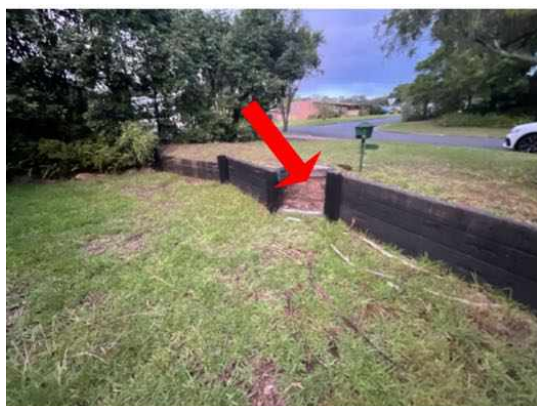
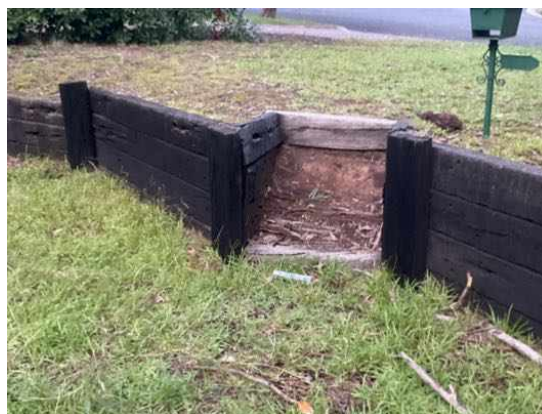
Building:	Yard
Location:	Yard - Front
Finding:	Safety Hazard - Landscaping stairs missing
Information:	Observation:

At the time of inspection, the stairs previously providing access from the front yard landscaping to the dwelling were found to be missing and not replaced. A change in level was present in this location, creating an abrupt drop toward the dwelling. Evidence of deterioration to the original stair structure was also noted, including timber decay consistent with fungal rot and missing or failed treads.

The absence of a compliant stair structure presents a safety hazard, with an increased risk of trip or fall when accessing the property. The observed deterioration indicates the previous installation had reached the end of its serviceable life, likely due to prolonged exposure to moisture and environmental conditions. While not structurally critical to the dwelling, the condition detracts from safe and practical access.

It is recommended that a suitably qualified contractor install new compliant stairs to reinstate safe access. Any replacement should incorporate durable, weather-resistant materials and appropriate construction methods to reduce the likelihood of premature deterioration. Ongoing maintenance should be carried out to preserve serviceability.

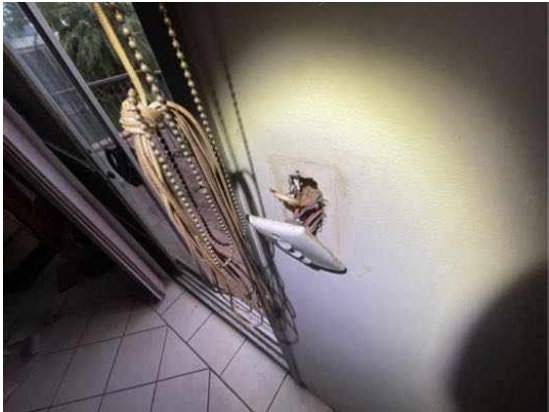
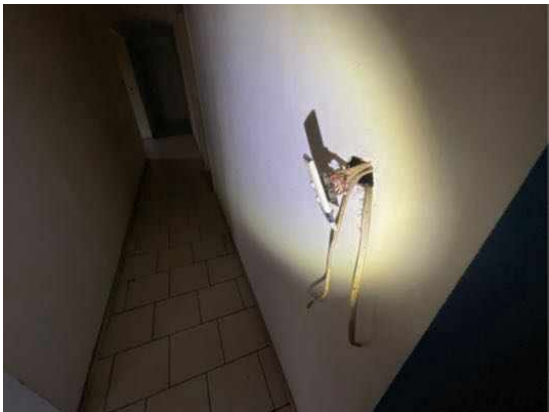
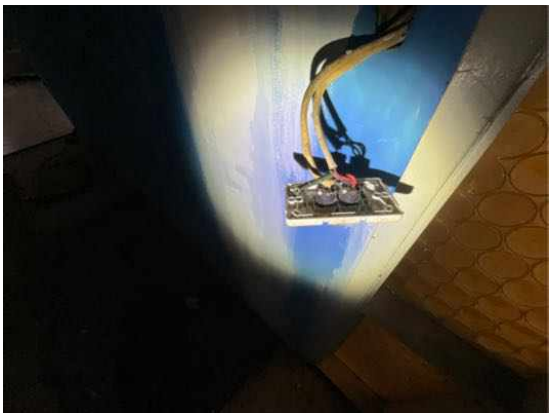
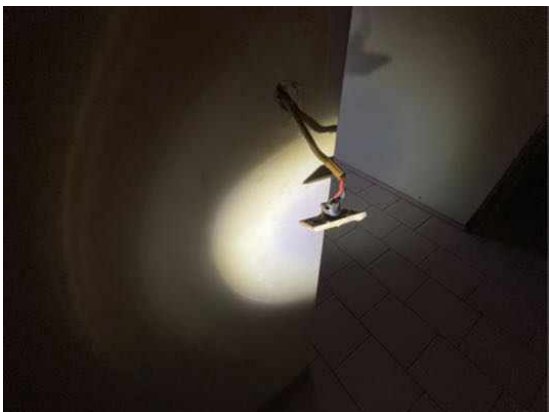
### Finding 1.03

Building:	Main Building
Location:	All Internal Areas
Finding:	Safety Hazard – Electrical Fittings
Information:	Observation:

At the time of inspection, a number of light switches and power outlets throughout the dwelling were observed to be loose, displaced, or removed, with sections of exposed wiring visible. The property was noted to be in poor overall condition and unoccupied at the time of inspection. Based on the presentation, it is suspected that the fittings have been intentionally removed, possibly for testing or inspection purposes, rather than as a result of general wear and tear.

Regardless of the cause, exposed wiring and incomplete electrical fittings present a significant safety hazard. There is an increased risk of electric shock, short circuiting, and potential fire hazards if the system is energised. The condition also indicates that the electrical installation may be incomplete or not in a safe, serviceable state for occupation.

It is strongly recommended that a licensed electrician be engaged to assess the electrical system in its entirety prior to occupation. All switches and power outlets should be reinstated, properly secured, and tested to ensure safe operation and compliance with current electrical safety standards. The electrical installation should not be relied upon until such assessment and certification have been completed.

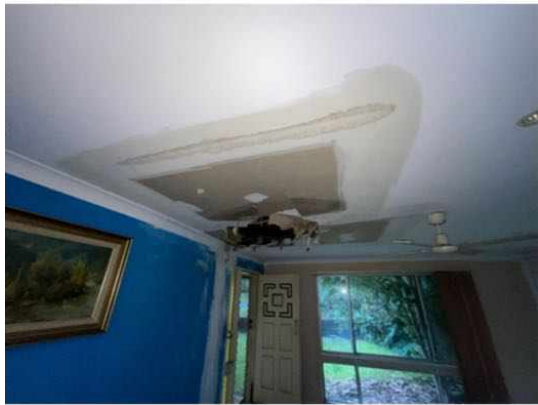
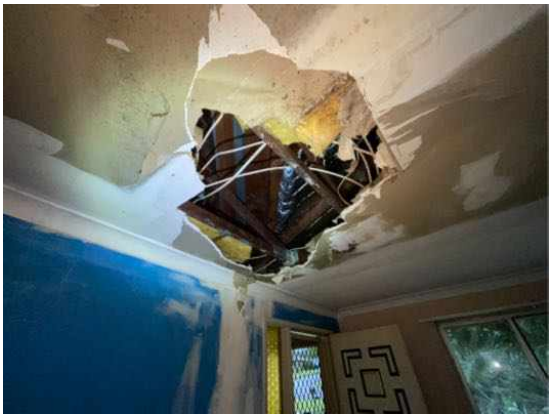
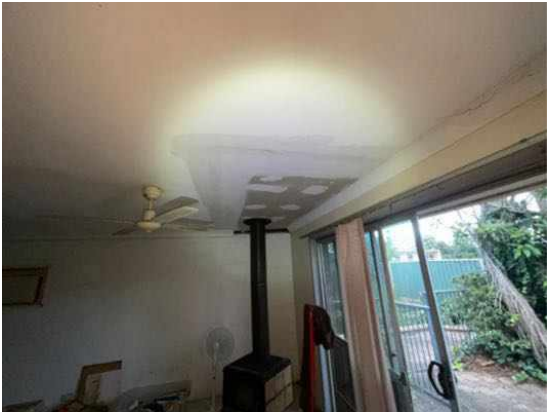
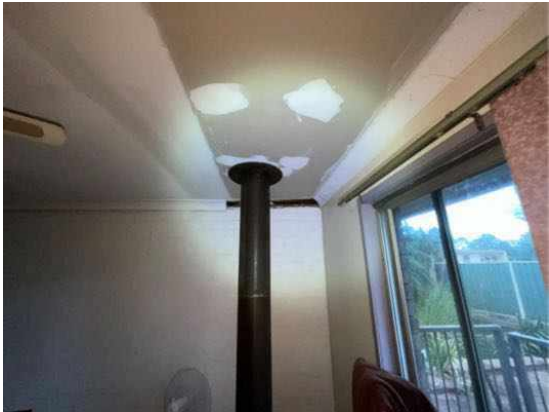
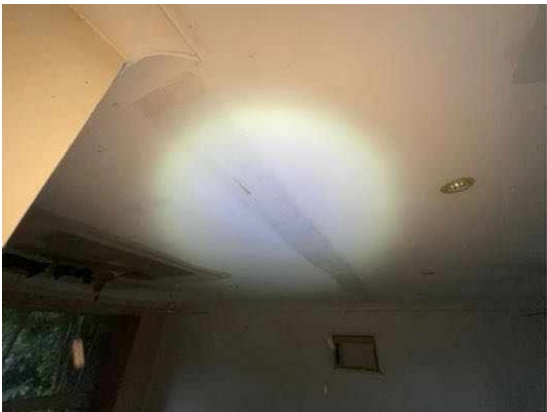
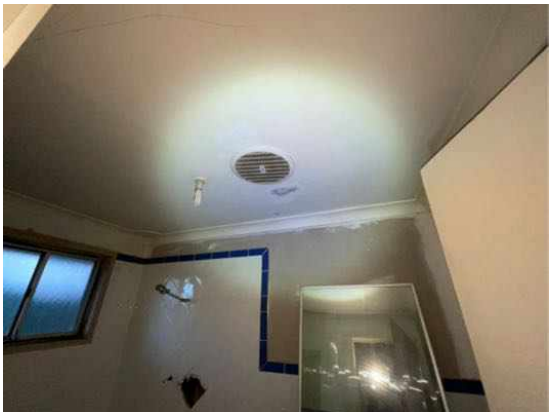
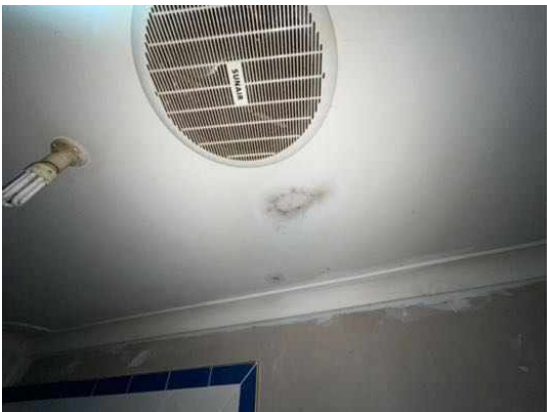
Building: Main Building  
Location: Living Room & Bathroom  
Finding: Ceiling - Water damaged  
Information: Major Defect – Ceiling Water Damage / Roof Drainage (Valley)

At the time of inspection, water damage was evident to sections of the internal ceiling

lining, including staining, deterioration, and localized deformation. The pattern and location of the damage are consistent with moisture ingress from above. External inspection of the corresponding roof area identified that the roof valley servicing this section was heavily obstructed with leaf matter and debris. The blockage is considered a likely contributing factor to water overflow and subsequent ingress into the ceiling space.

Blocked roof valleys can impede the effective discharge of rainwater, resulting in ponding and overflow beneath roof coverings. This significantly increases the likelihood of water penetration into the roof structure and ceiling cavity. Prolonged moisture exposure may lead to deterioration of ceiling linings, insulation, and structural timbers, and can promote conditions conducive to mould growth and timber decay. The observed damage is considered a major defect requiring prompt attention to prevent further internal damage and potential structural implications.

Immediate action is recommended. The roof valley should be cleared of all debris without delay to restore proper drainage. A suitably qualified roofing contractor should be engaged to inspect the valley and surrounding roof components, and to carry out any necessary repairs to prevent further water ingress.

A licensed building contractor should also be appointed to assess and rectify the internal damage. Works may include removal and replacement of affected ceiling linings, or localised patching where appropriate, once the source of the leak has been rectified and the area has fully dried. Following structural repairs, reinstatement by relevant trades (e.g. plastering and painting) should be undertaken to restore the affected areas.

Ongoing maintenance of roof drainage systems, including regular clearing of valleys and gutters, is recommended to minimise recurrence.

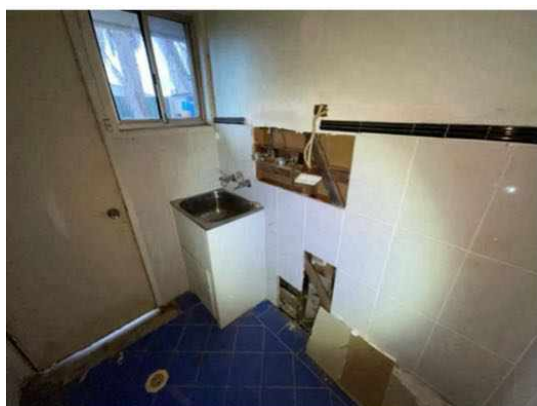
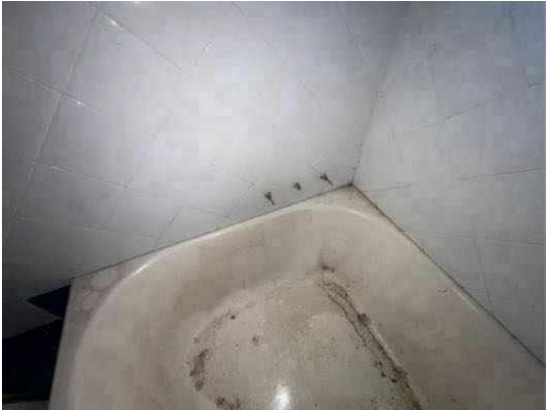
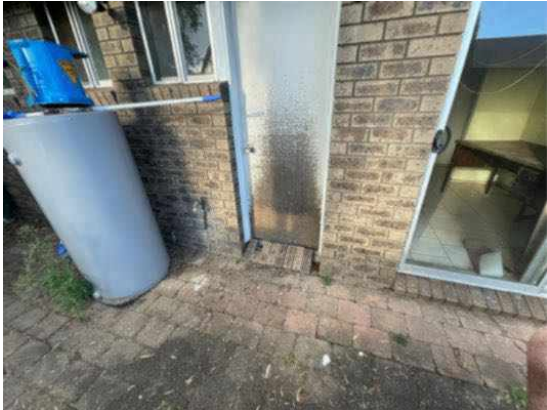
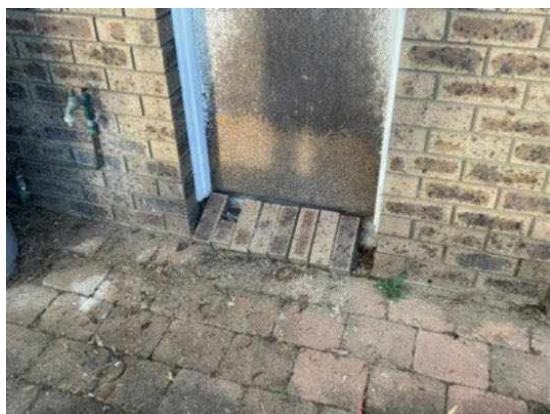
Finding 2.02

Building: Main Building  
Location: Laundry & Bathroom  
Finding: Major Defect – Bathroom and Laundry (Incomplete Works / Non-Functional Wet Areas)

At the time of inspection, the property was vacant and both the bathroom and laundry areas were observed to be in a poor and incomplete condition. There was clear evidence of attempted repair works that have not been finalised.

Multiple sections of tiled wall linings in both areas had been cut out or removed around plumbing penetrations, including at tap and pipe locations. These openings remain unfinished, with exposed wall cavities visible. In the bathroom, essential fittings including tapware, spout, and shower components to the spa bath and shower were missing. The vanity unit was not secured to the wall and was not connected to plumbing services, rendering it non-functional. A wall mirror was also noted to be loose and inadequately fixed.

In the laundry, water damage was visible to the wall framing bottom plate through one of the lower wall openings, indicating previous or ongoing moisture exposure. The external laundry door exhibited signs of water damage and deterioration. In addition, threshold bricks at the doorway were found to be loose and unstable.

The condition of the bathroom and laundry represents a significant defect, with both areas currently unsuitable for use. The incomplete state of repairs exposes internal building elements to potential ongoing moisture ingress and deterioration. Visible water damage to structural components such as the wall bottom plate raises concern for further concealed damage, including possible timber decay or degradation within wall cavities.

Missing fixtures and disconnected plumbing services indicate that the installations are incomplete and may not comply with current plumbing or building standards. Loose fixtures and unstable threshold elements also present safety hazards, including trip risks and potential injury.

A comprehensive assessment and rectification of both the bathroom and laundry areas is recommended. Engagement of a suitably qualified building contractor or

- Investigation and repair of any plumbing leaks or defects
- Replacement or reinstatement of wall linings and waterproofing systems in accordance with current standards
- Installation and connection of all required fixtures and fittings (including tapware, sanitary fixtures, and cabinetry)
- Repair or replacement of water-damaged structural elements, including framing as required
- Repair or replacement of the laundry external door
- Stabilisation and reinstatement of threshold bricks to eliminate trip hazards

Given the condition observed, a full renovation of these wet areas may be the most practical and cost-effective approach to ensure compliance, functionality, and durability.

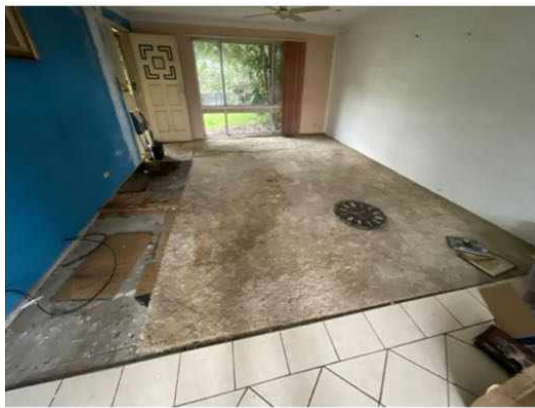
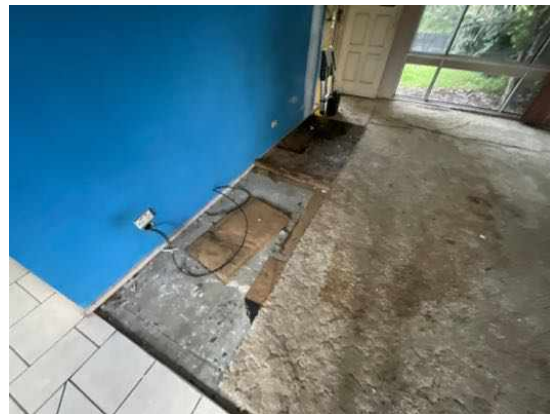
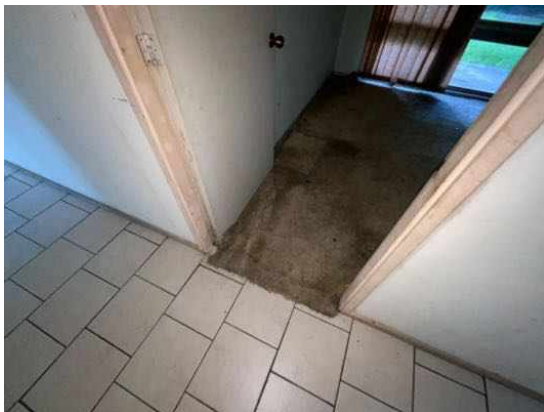
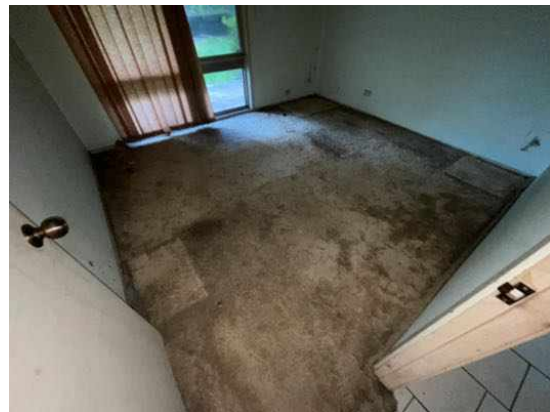
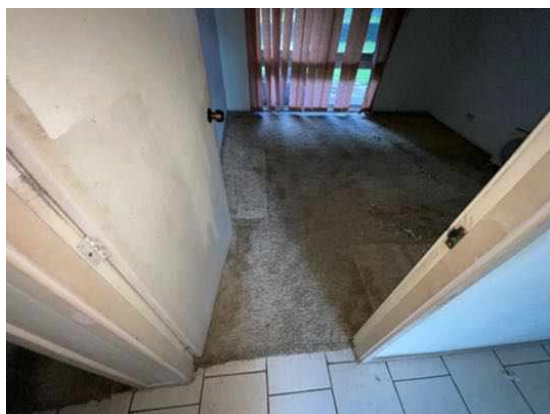
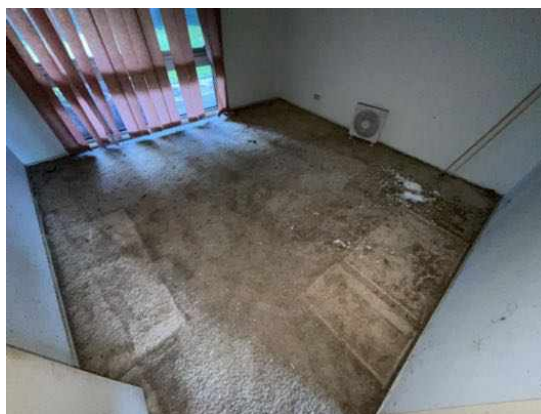
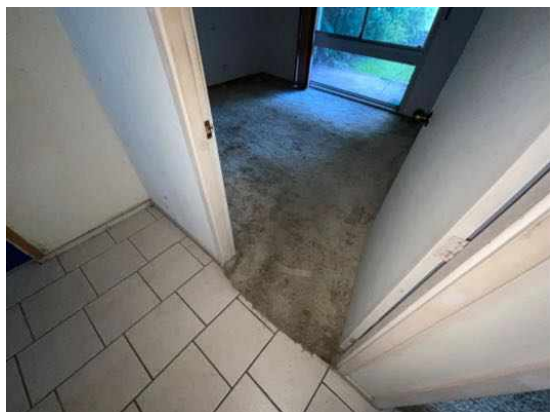
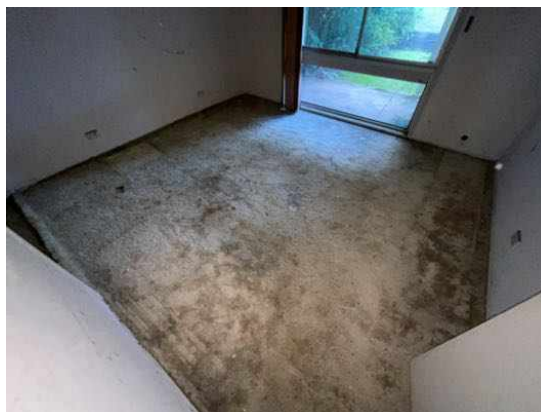
### Finding 2.03

Building: Main Building  
 Location: All Areas  
 Finding: Major Defect – Internal Floor Coverings (Carpet Condition & Mould Contamination)  
 Information:

At the time of inspection, the carpeted floor coverings throughout the property were found to be in poor and unsatisfactory condition. The carpets were observed to be loose in sections, heavily stained, and affected by mould growth. The extent and distribution of the mould contamination suggest prolonged exposure to moisture and/or elevated humidity levels within the dwelling.

Mould contamination within carpet and associated porous materials presents a potential health hazard, particularly for occupants with respiratory sensitivities, allergies, or compromised immune systems. The condition also indicates underlying environmental issues, such as previous or ongoing moisture ingress, inadequate ventilation, or unresolved water damage.

Carpets affected by mould cannot typically be effectively remediated due to the penetration of spores into the fibres and underlay. In addition, mould growth may extend beyond visible areas and impact adjacent materials, including skirting boards, wall linings, and subfloor or slab surfaces. If not addressed, the condition may lead to further deterioration of internal finishes and ongoing indoor air quality concerns.

Replacement of all affected carpet and underlay is recommended as a matter of urgency. Removal should be undertaken with appropriate precautions to minimise the spread of mould spores.

moisture damage. Any affected materials should be cleaned, treated, or replaced as necessary by suitably qualified trades.

It is also recommended that the underlying source of moisture contributing to the mould growth be identified and rectified prior to installation of new floor coverings. This may involve further investigation by a licensed builder or relevant specialist to prevent recurrence.

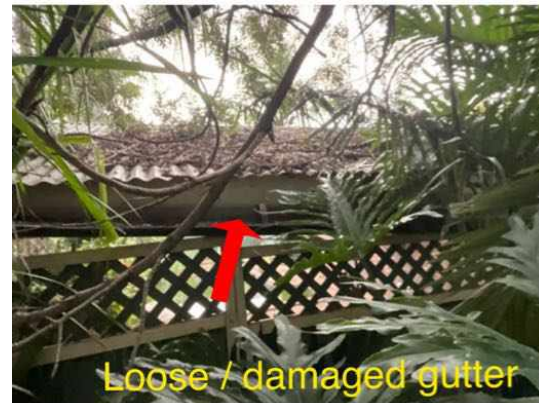
The absence of guttering and proper stormwater drainage in this area presents both functional and compliance issues. Prompt installation by a qualified roofing plumber is strongly recommended to mitigate moisture-related risks and ensure compliance with building standards.

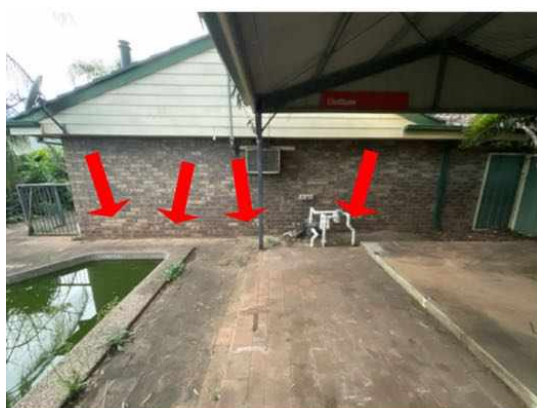
### Finding 3.06

Building:	Main Building
Location:	Exterior walls - left side
Finding:	Minor Defect - Deterioration to Lower Brickwork (Fretting Brickwork).
Information:	Observation:

- Improve site drainage to reduce moisture exposure at the base of the walls. A licensed drainage plumber should be appointed to assess and implement appropriate site water management solutions.
- Monitor affected areas for worsening conditions, particularly during periods of heavy rain.
- Where fretting is advanced, damaged bricks and mortar should be replaced by a licensed bricklayer experienced in masonry repairs and salt-damage mitigation.

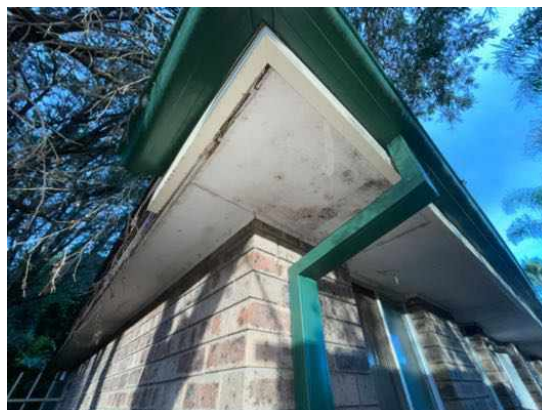
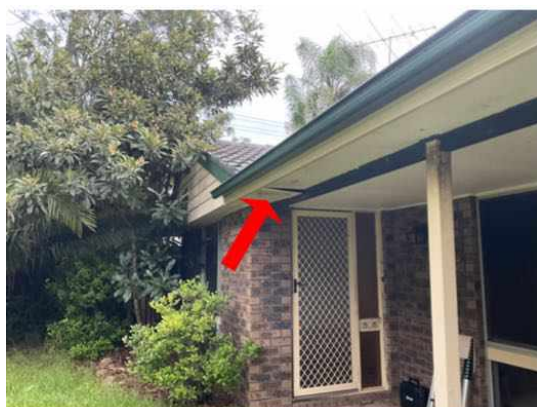
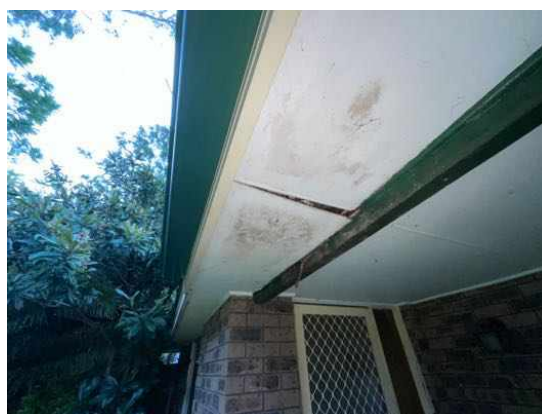
### Finding 3.08

Building: Main Building  
Location: Eaves - Front & Rear/right  
Finding: Eaves - Mould present.  
Information: Observation:

The source of moisture should be identified and rectified as necessary to prevent further mould development and potential damage. This may involve inspection of the roof covering, flashings, or guttering in the affected area.

Cleaning and/or repainting the eaves to restore appearance is at the client's discretion. A licensed painting contractor may be appointed to carry out such cosmetic works once the underlying cause has been addressed.

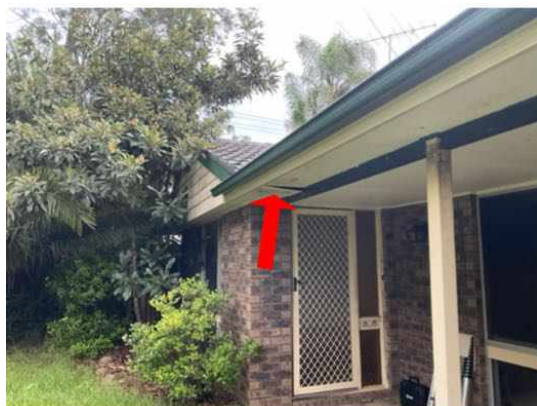
### Finding 3.09

Building: Main Building  
 Location: Eaves - Front  
 Finding: Sagging Eaves – Maintenance Required  
 Information: Observation:

- Minor rectification works are recommended. A qualified carpenter or general handyman should be appointed to reinstate and secure the eaves to ensure proper function and alignment.
- Early maintenance will help prevent more costly repairs from developing over time.

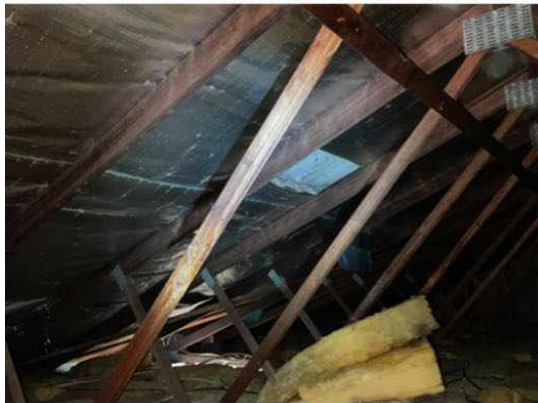
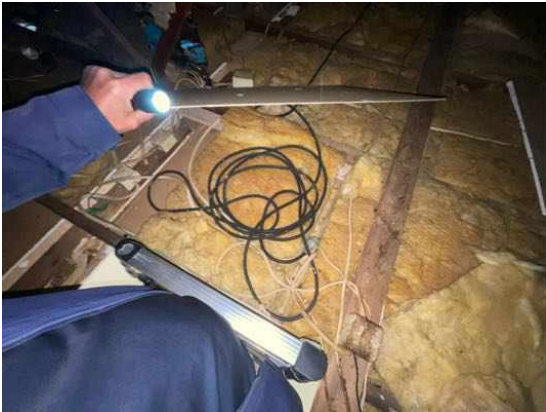
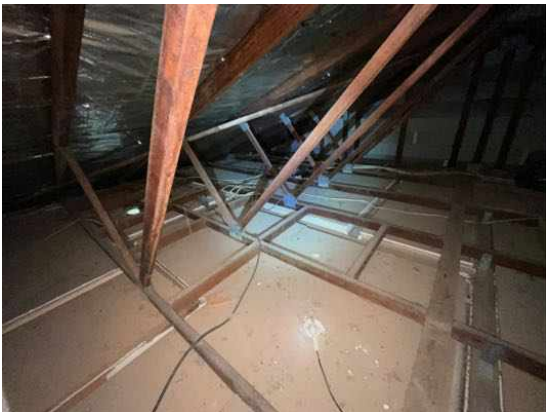
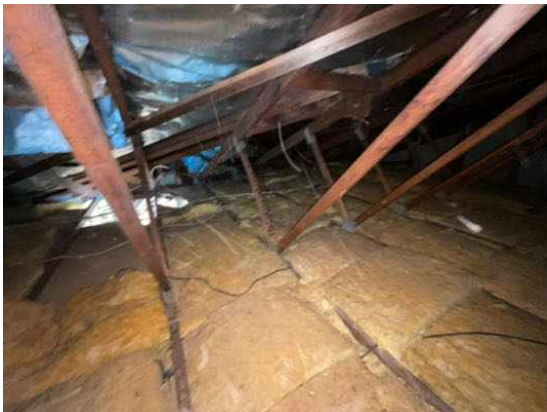
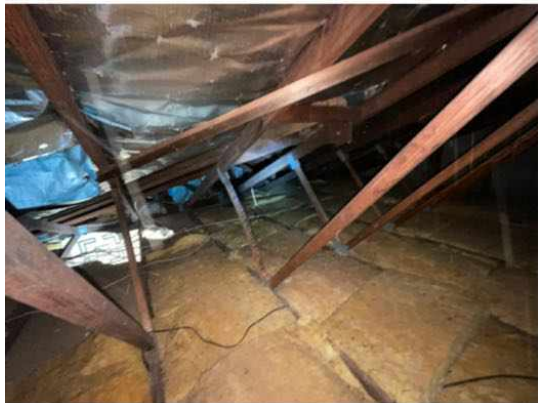
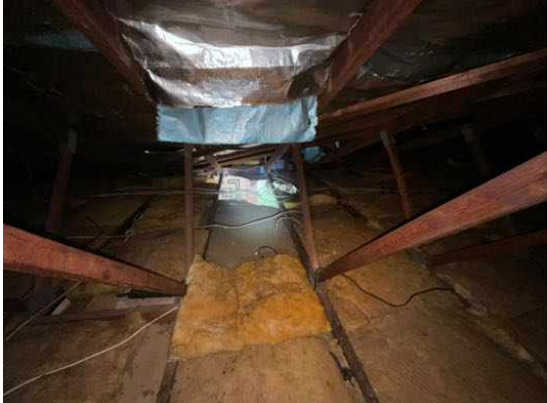
### Finding 3.10

Building: Main Building  
 Location: Roof Void  
 Finding: Roof Void Inspection Summary  
 Information: Access & Limitations

The roof void inspection identified evidence of active or recent water ingress resulting in damage to internal linings, insulation, and roof components. Access limitations restricted a full assessment; however, the extent of visible damage indicates the need for prompt investigation and repair. Early rectification is recommended to prevent further deterioration and potential secondary issues such as mould growth and structural damage.

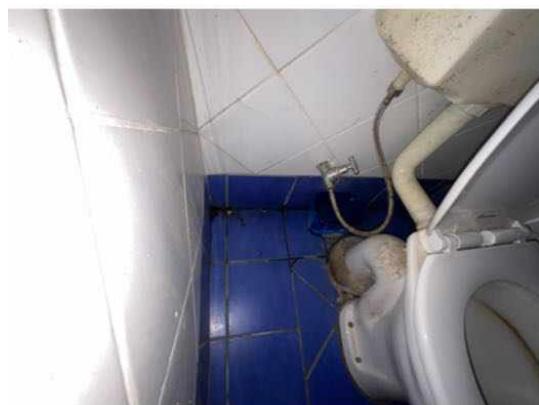
Finding 3.11

Building: Main Building  
Location: Toilet (WC)  
Finding: Toilet - Leaking.  
Information: Observation

It is recommended that a licensed plumber be engaged to inspect and repair the toilet as soon as practicable to prevent further deterioration and secondary moisture-related damage.

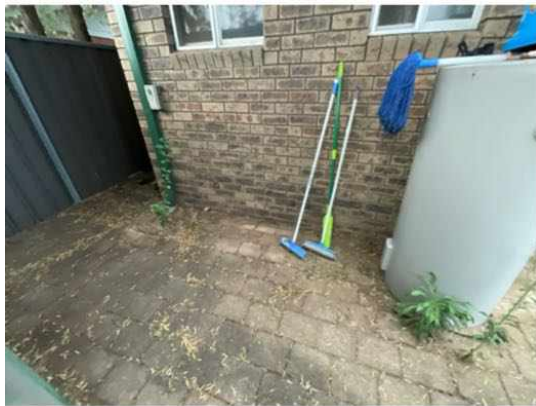
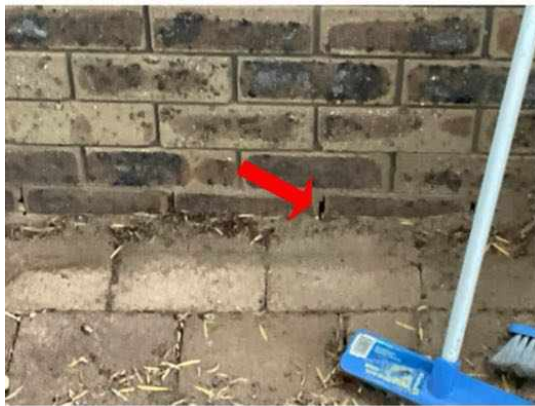
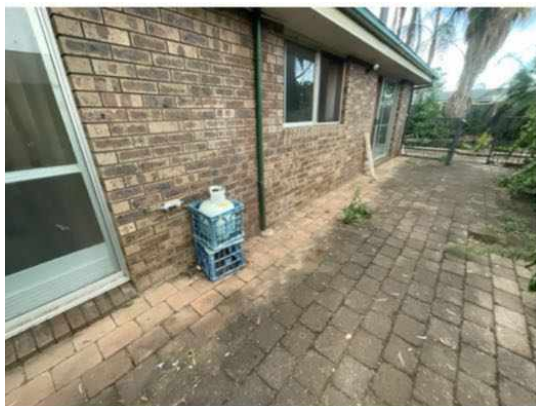
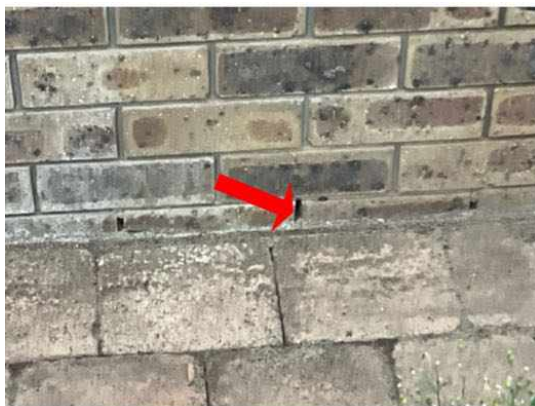
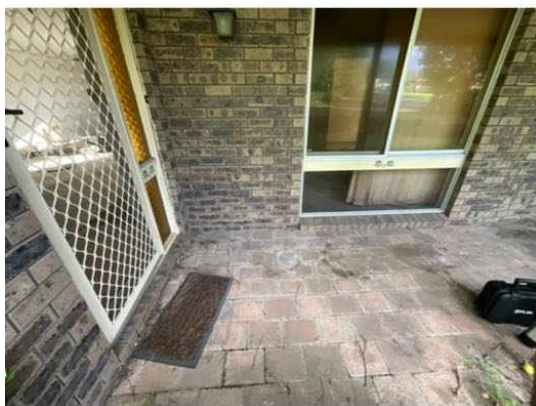
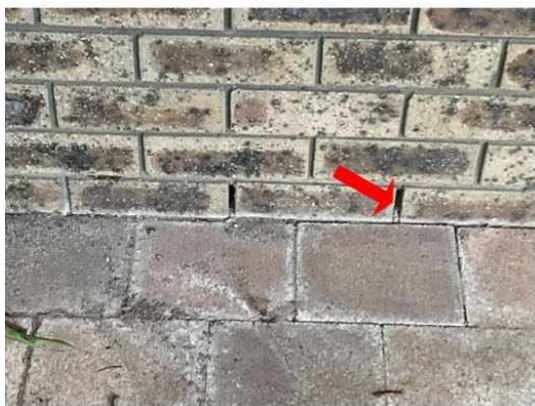
### Finding 6.03

Building:	Main Building
Location:	Exterior walls - front & rear
Finding:	Bridging of Termite Barriers – Concealed Weep Holes..
Information:	Observation:

- All weep holes should remain exposed and unobstructed across the entire property to allow for effective drainage and visual termite inspections.
- It is strongly advised that any material or structure covering weep holes be removed promptly, and a re-inspection carried out to ensure termite entry is not occurring undetected.
- Where removal of obstructions is not feasible, it is recommended that the area be inspected regularly, ideally every 3 to 6 months, to monitor for signs of termite activity or moisture-related damage.
