# Building and Timber Pest Inspection Report

Inspection Date: Tue, 24 Feb 2026

Property Address: 4/4 Kelsby St, Reservoir VIC 3073, Australia

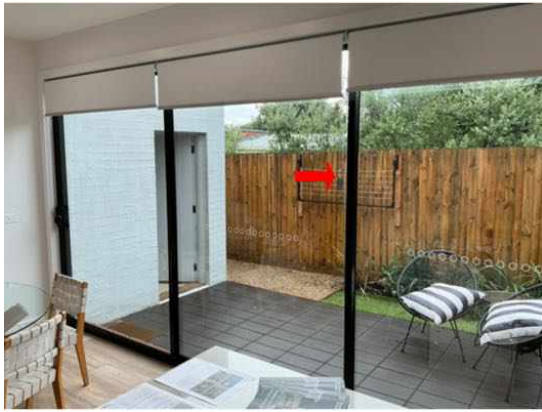
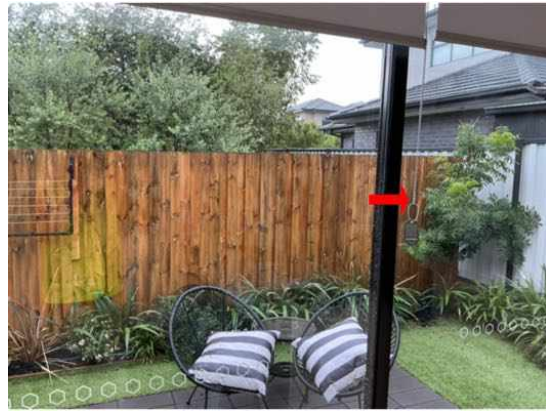
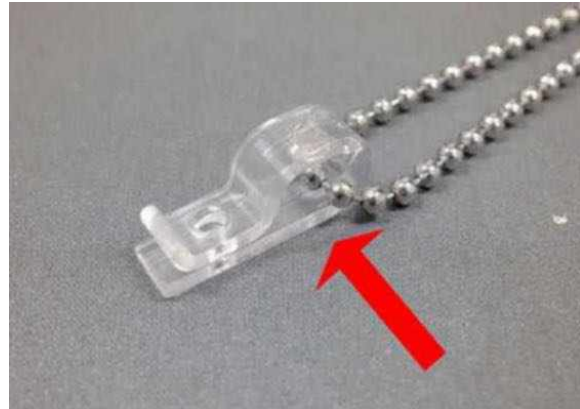
Building:	Main Building
Location:	Dining Room
Finding:	Curtain & Blind - Safety Cord
Information:	Looped curtain and blind cords pose a significant strangulation hazard for children as they can place the loop over their head and/or get tangled in the loose cords.

Secure any loose or looped cords with cleats or tension devices – these can be purchased from your local curtain and blind retailer or hardware store. Do not put furniture such as cots, beds, highchairs, playpens, couches, chairs, tables or bookshelves near a window where children can reach the blind or curtain cord.

It is recommended that this defect be resolved immediately to avoid harm to occupants.

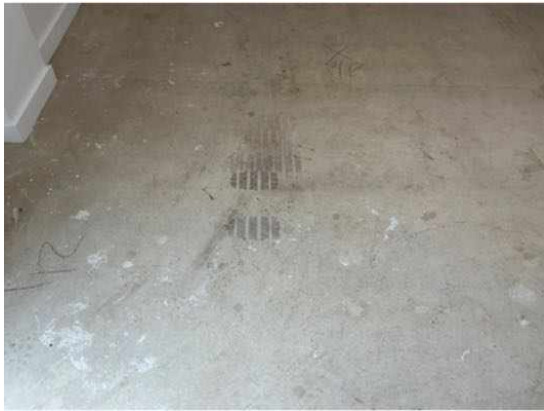
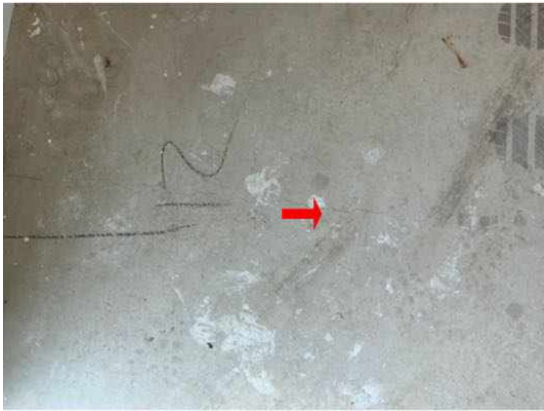
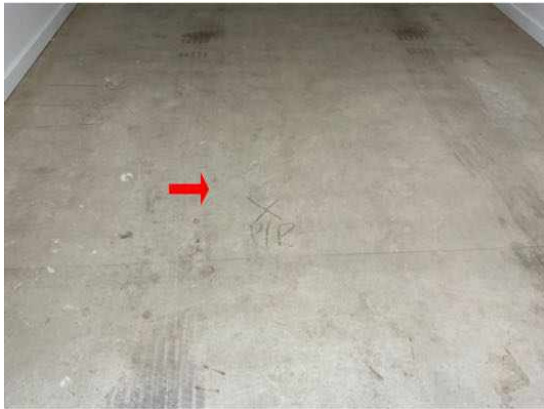
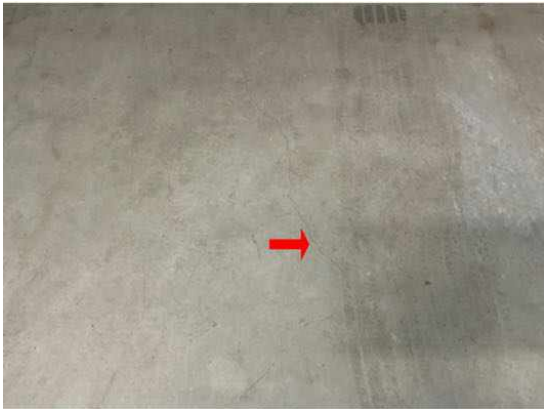
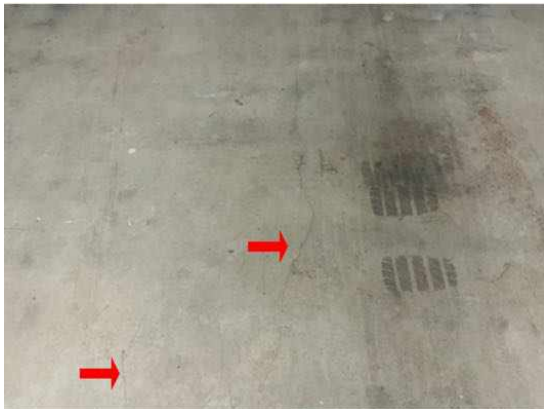
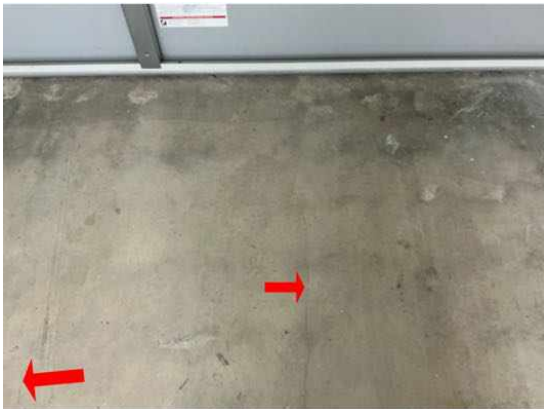
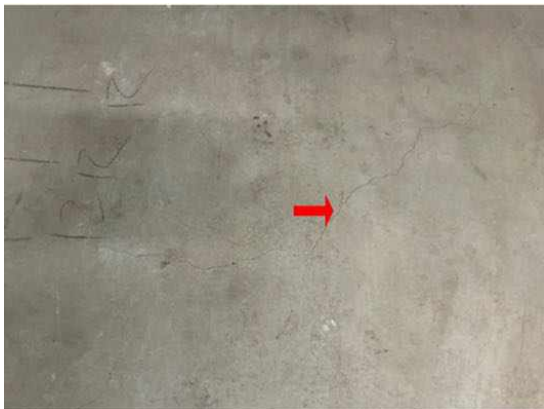
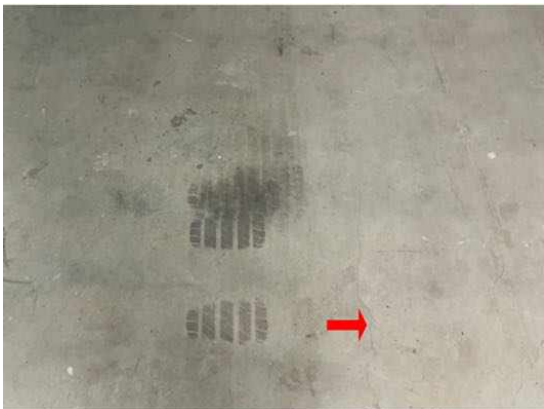
Building: Main Building  
 Location: Garage  
 Finding: Crack in concrete slab - Category 1  
 Information: A crack coded as Category 1 was identified in the slab. A Category 1 crack is described as a fine but noticeable crack, with the slab at an otherwise reasonable level.

To be considered Category 1, the approximate width of the crack is less than 1.0mm, or a less than 10mm change in offset when a 3m straight edge is placed over the defect.

Category 1 cracks should be monitored for a period of 12 months. At the end of the monitoring period, identified cracks that are rated greater than Category 2 are considered defects, and require rectification.

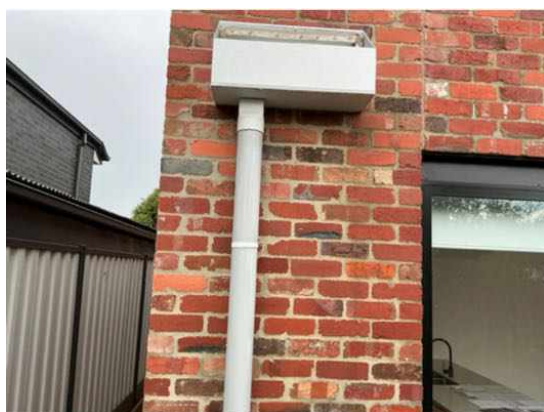
Finding 3.02

Building:	Main Building
Location:	Kitchen External wall
Finding:	Brickwork- Step cracking
Information:	Step cracking was identified to the brickwork in this area at the time of inspection. Step cracking, which is similar to other forms of cracking, has a variety of possible causes. However, the most common is the subsidence of adjacent footings.

Step cracking is a relatively common defect, and is most likely to occur adjacent to windows, doors and other openings. Mortar failure in the gaps between affected bricks indicates the stresses and tensions affecting the wall.

Where step cracking is extensive or severe, the client is advised to consult a Structural Engineer. Minor step cracking can be used as a warning sign to address factors causing stress to the wall, which can include the effect of surrounding trees, water leaks, soil erosion, or even the presence of reactive soils in the surrounding area.

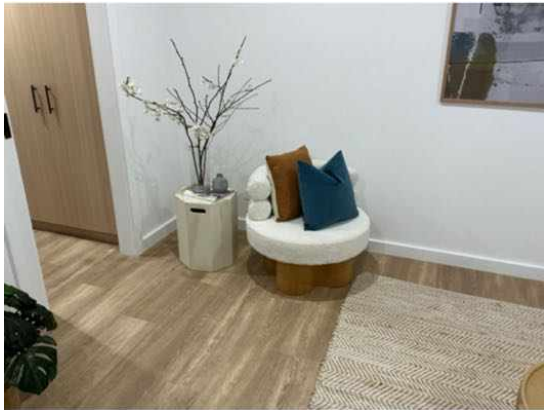
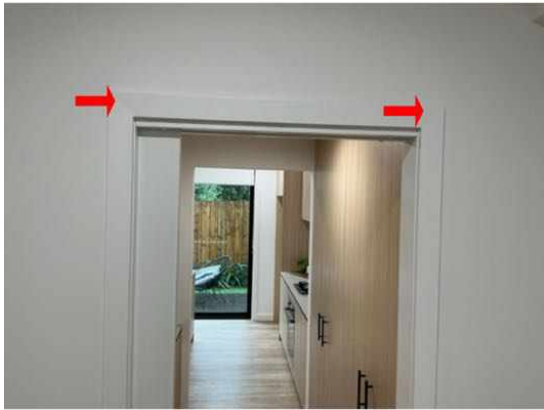
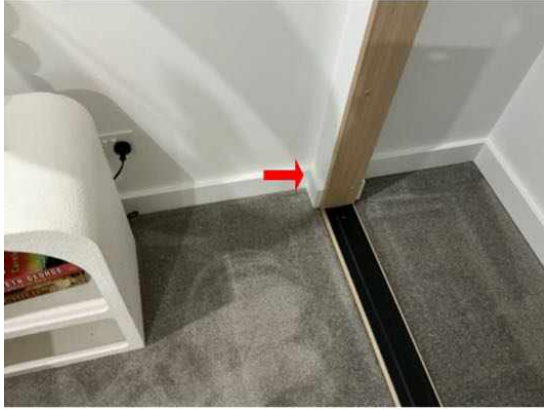
### Finding 3.03

Building:	Main Building
Location:	All Areas
Finding:	Cracking - Damage Category 1 - Fine (up to 1mm)
Information:	Although fine cracks are quite noticeable, they are often only considered to be an appearance defect, and usually do not indicate any structural damage. Generally, the cause of a fine crack is indicative of a separation between building materials and finishes (e.g. paint, plaster, etc.) along joins.

In this instance client have indicate that these cracks become visible after roof leaks. However the leaks have been repaired, and hence no change in terms of sizes.

Cracking of this nature can generally be repaired with minor sanding, filling and/or repainting. Such works should be performed by a qualified Painter or a general Handyman.

Monitoring of all cracking should be conducted frequently. Always contact a Building

Inspector should cracks widen, lengthen, or become more numerous.

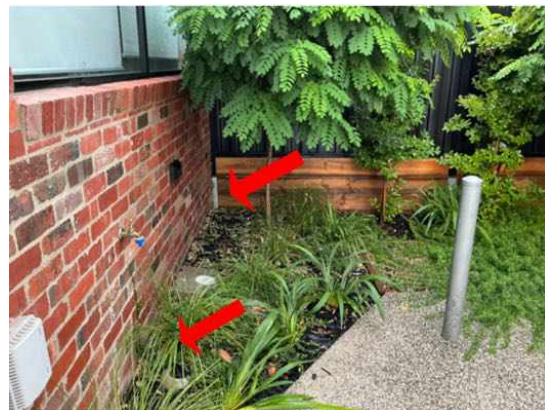
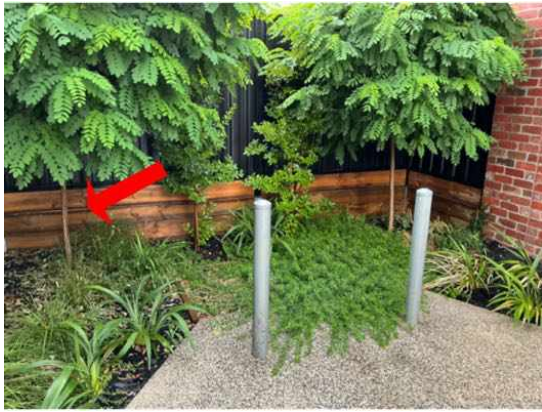
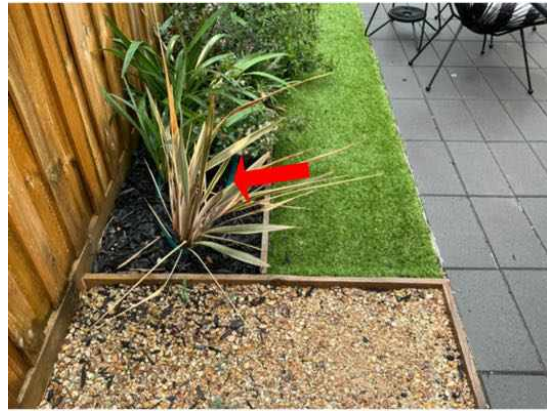
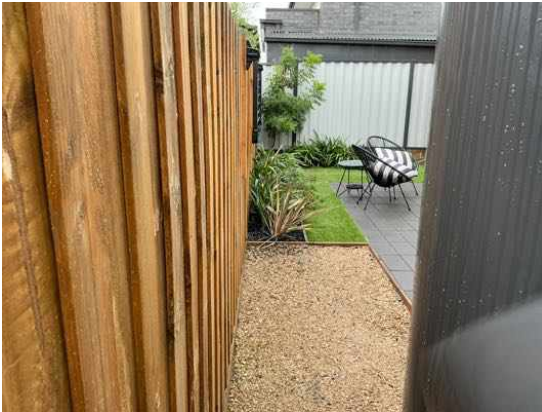
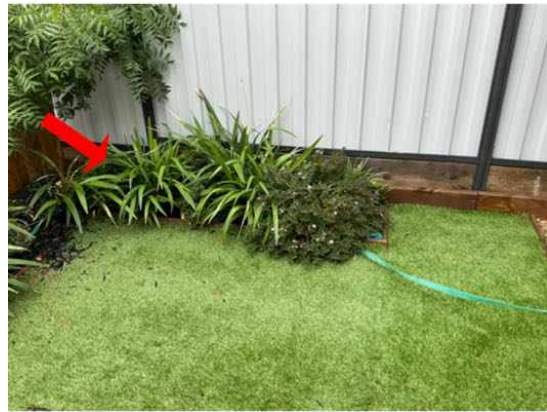
Building: Out Building  
 Location: Yard  
 Finding: Garden Beds - Conditions Conducive to Termite Attack  
 Information: Garden beds were found to be evident in close proximity to the building. Garden beds immediately adjacent to the perimeter of the building block the visual inspection of these areas, providing a concealed termite entry point.

Garden beds can include untreated timber and a combination of moisture from watering, which produce conditions conducive to termite activity and ingress.

Further advice from a Timber Pest Technician is required to ensure appropriate Termite Management systems are implemented.

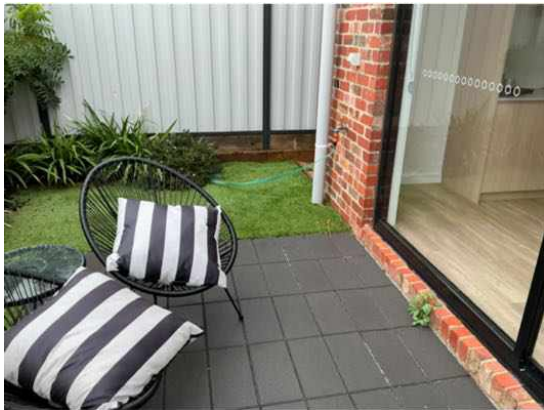
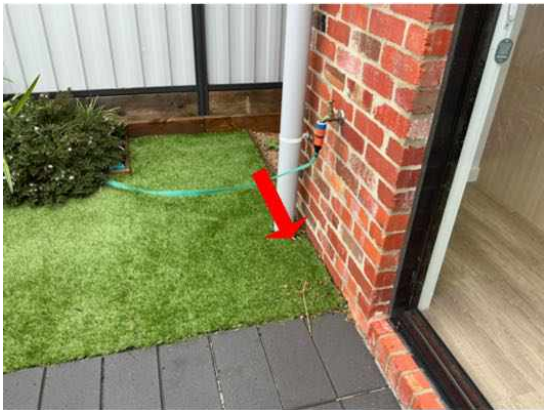
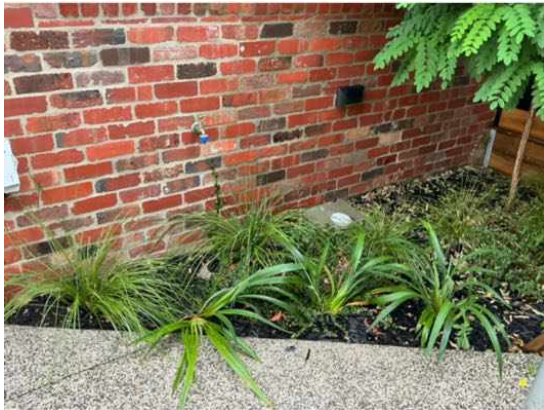
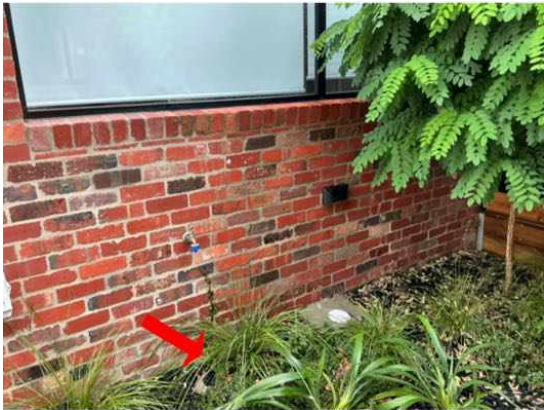
Building: Main Building  
 Location: Yard /Side  
 Finding: Tap- No Drain  
 Information: Upon inspection, it was discovered that the tap located at the rear of the building lacks a drain or basin beneath it. This omission would result in excessive water accumulating on the foundation of the building, creating an ideal environment for termite infestation.

Therefore, it is strongly recommended that a licensed plumber be engaged promptly to rectify this issue.

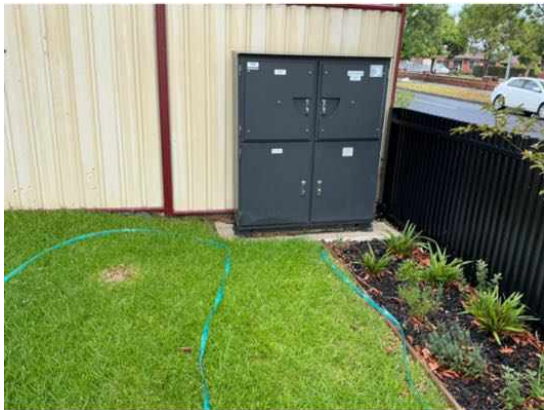
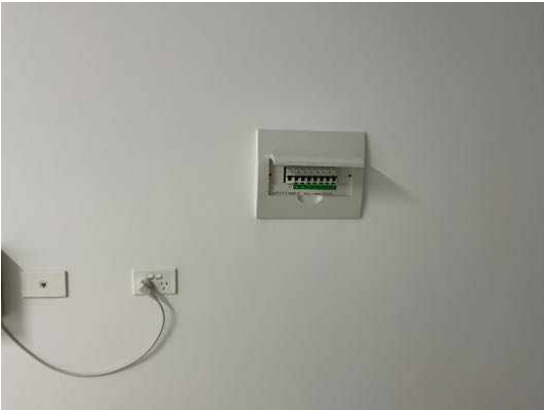
**Finding 6.04**

Building: Main Building  
Location: Electrical switchboard  
Finding: Termite Management System - no evidence of installation  
Information: The application of a post-construction chemical termite barrier is highly recommended for all properties, particularly if live termite activity has been found on the site previously. Such barriers are highly effective in preventing termite attack on any timber building elements throughout the property.

A durable notice should be placed in the switchboard unit to indicate current termite barriers. At the time of inspection, it appeared as though no termite management system has been installed, with no evidence to suggest preventative works taking place.

The client may consider gaining further advice from a pest controller as to the costs and procedures involved with this application. It is recommended that obtaining such advice be a short-term priority.

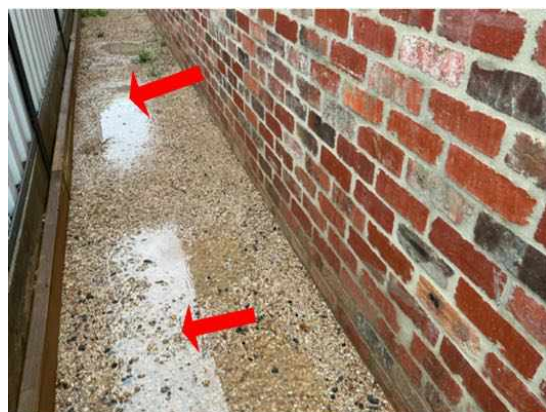
Building:	Out Building
Location:	The Site
Finding:	Inadequate Site Drainage
Information:	At the time of inspection, the site drainage at the back yard was found to be inadequate, posing a potential risk of subsequent water damage to associated building elements.

It is crucial that water does not accumulate against the base of walls. Surrounding paths and ground levels should be sloped to redirect water away from the walls. Downpipes should not discharge stormwater onto lower walls or plinths. Instead, stormwater should be conveyed away by large, regularly maintained drains. Ground levels may need to be lowered to expose a buried damp proof course (DPC).

In instances where site drainage is inadequate, the installation of an Agricultural Drain may be necessary. A qualified plumber should be engaged to conduct a thorough inspection of the property and undertake any necessary remedial works. Neglecting water management can lead to water damage and subsequent defects.

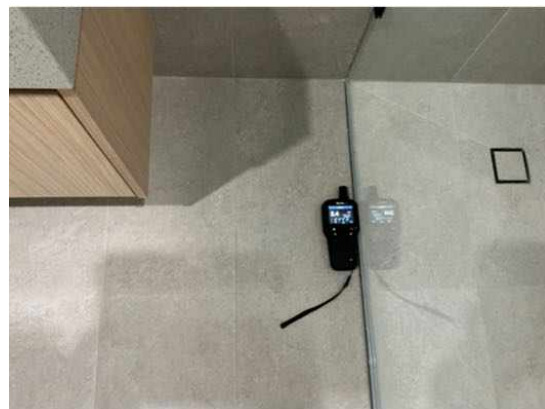
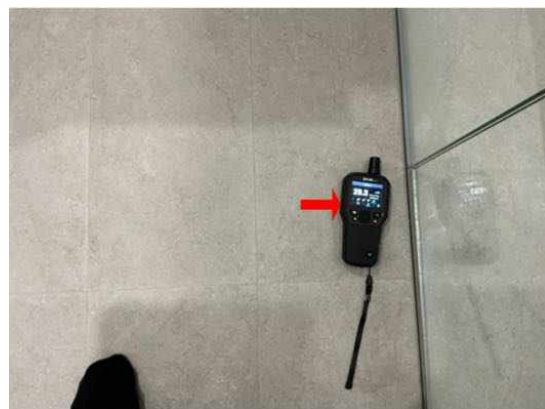
Building:	Main Building
Location:	Bathroom/main
Finding:	Evidence of excessive moisture was present at the time of inspection
Information:	A moisture meter was positioned at distance from the shower area to obtain a reference reading at the commencement of the measurements of the outside shower area. However, when I set the moisture meter to zero against the tiles next to the door, I observed elevated moisture readings.

Excessive moisture can facilitate the formation and development of mould and fungal growth, as well as the decay of associated building materials, compromising their structural integrity. This issue is frequently caused by deteriorated, inadequate, or non-existent waterproofing in the shower area. The shower in question was constructed prior to mandatory regulations requiring waterproofing of all wet areas.

Therefore, it is strongly recommended that all plumbing and drainage fixtures, fittings, tiles (grout and sealant), and other associated components be maintained regularly to prevent excessive moisture from accumulating within the internal property.

The shower was constructed prior to mandatory waterproofing to all wet areas. Therefore, we highly recommended that the shower be regouted with epoxy grout to prevent water penetration.

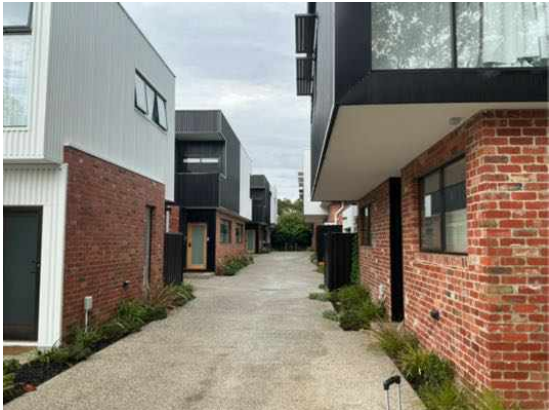
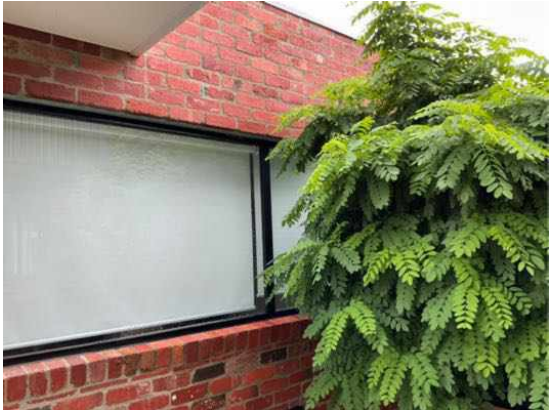
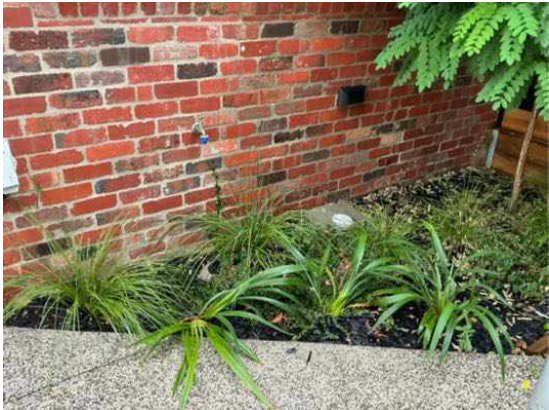
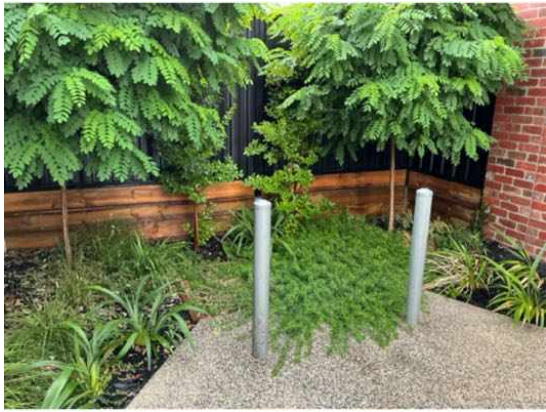
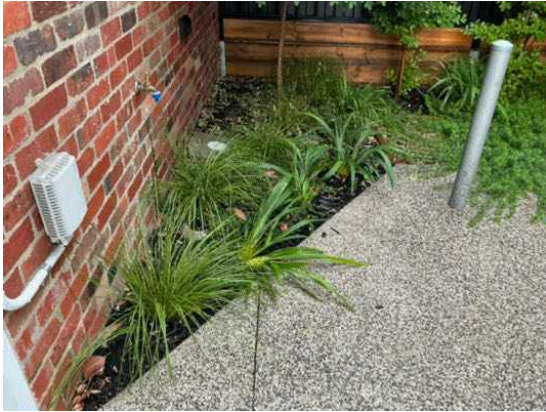
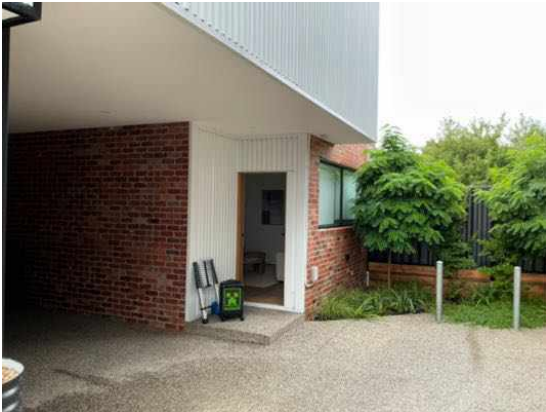
Building:	Main Building
Location:	All Areas
Finding:	Additional Photos - Obstructions and Limitations
Information:	These photographs are an indication of the obstructions and limitations which

impeded full inspection of the property at the time of inspection. These obstructions can hide an array of defects and should be removed to allow full inspection to be carried out. A re-inspection is recommended once the areas are made accessible.

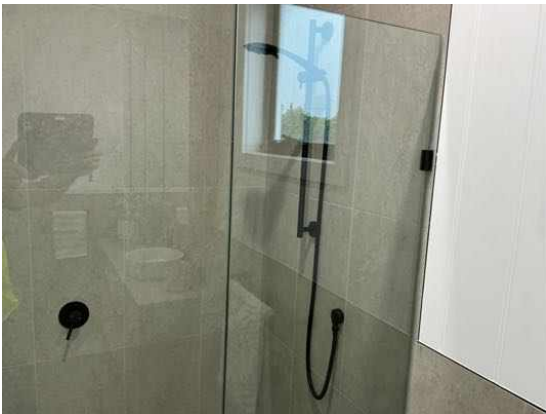
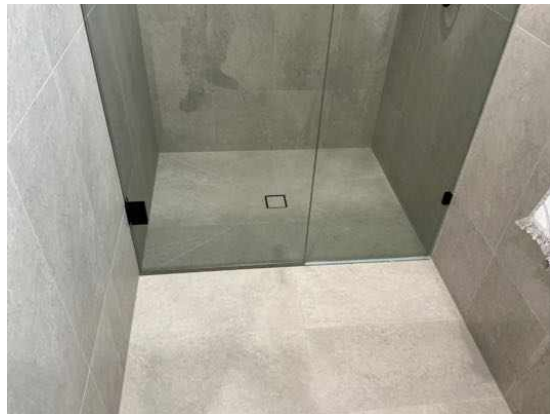
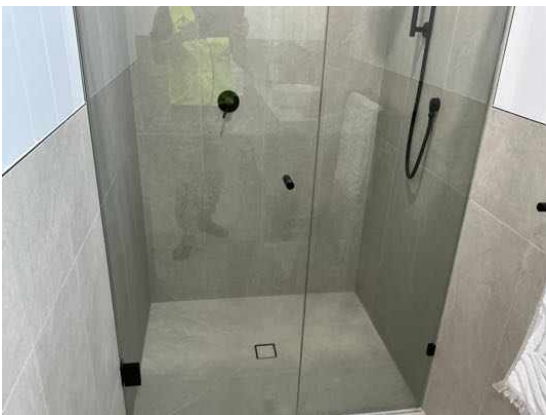
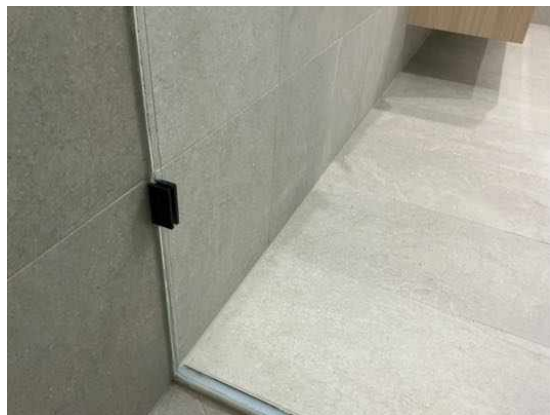
Finding: Additional Photos - Obstructions and Limitations

Information: These photographs are an indication of the obstructions and limitations which impeded full inspection of the property at the time of inspection. These obstructions can hide an array of defects and should be removed to allow full inspection to be carried out. A re-inspection is recommended once the areas are made accessible.
