# Building and Timber Pest Inspection Report

Inspection Date: Mon, 23 Mar 2026

Property Address: 5/2 Patricia St, Mays Hill NSW 2145,  
Australia

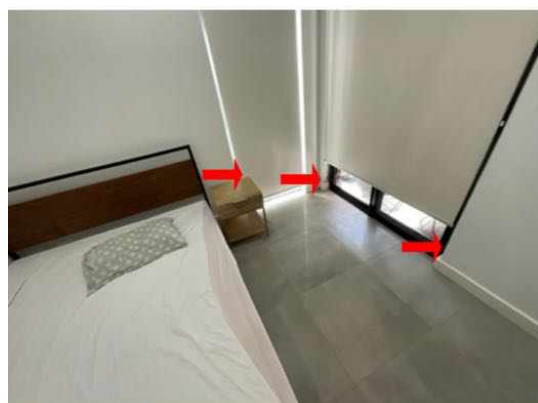
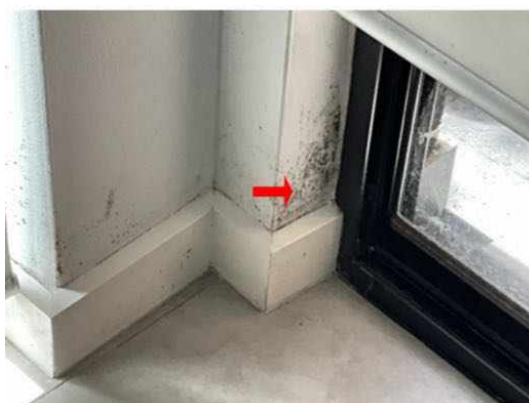
Building:	Main Building
Location:	Both bedrooms
Finding:	Mould - Present
Information:	Evidence of mould growth was noted, which is believed to have grown due to lack of ventilation to the area. Where evidence of mould growth was noted, there may be environmental, biological or health issues associated with the report. A specialist inspection by a suitably qualified environmental health inspector is warranted, where mould is extensive or where any queries regarding air quality spores or other related issues apply.

Generally, the client is advised to ensure that the general environment is free of moisture and humidity to aid in the prevention of mould formation and development. Any mould found during the inspection should be cleaned immediately by a cleaning contractor or the homeowner as applicable.

A safety hazard is due to mould. A mould remediation contractor is required to treat this mould urgently.

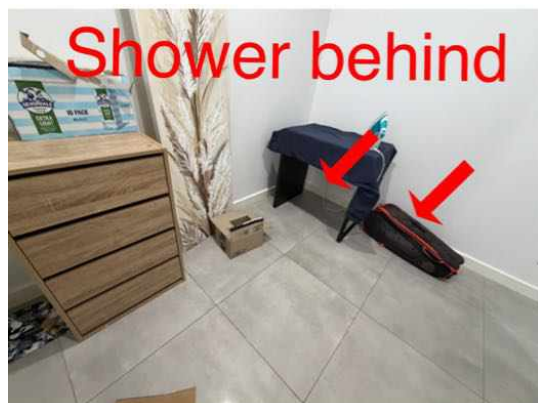
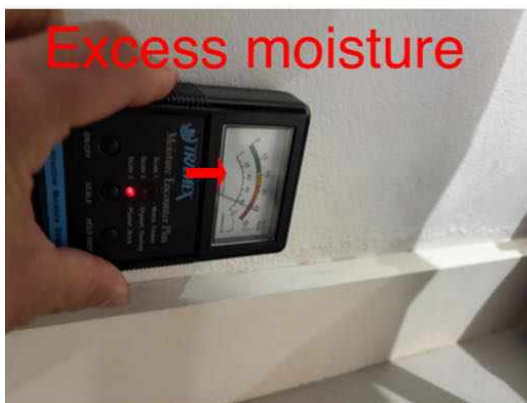
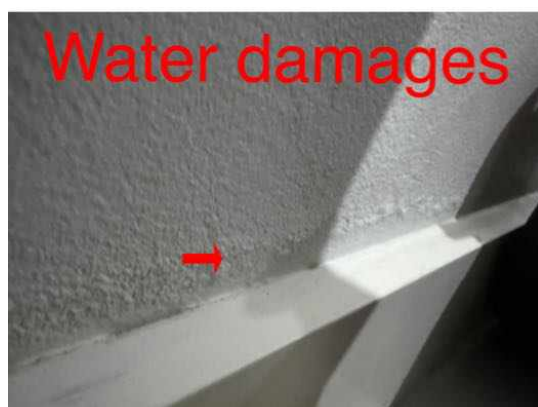
#### Finding 2.01

Building:	Main Building
Location:	Ensuite
Finding:	Waterproofing damage - Suspected
Information:	Excessive moisture was detected in these areas at the time of inspection. Internal water leaks can be detrimental to surrounding building elements. The potential cause in this area is damage to the waterproofing membrane inside the shower recess.

Attracting termites, corrosion, mould, decay and water damage are potential outcomes where a minor water leak is left unattended. More serious defects may also result, such as electrical hazards, or water damage to structural building elements.

In extreme cases, structural damage may develop due to a prolonged water leak. It is highly advised that this issue be addressed immediately by a bathroom specialist as a matter of relative urgency.

Excessive moisture was identified to the rear of the ensuite with evidence of water damage. It is suspected the shower waterproofing membrane to have damaged. A bathroom specialist must be appointed immediately for further assessment and carrying out any required rectifications.

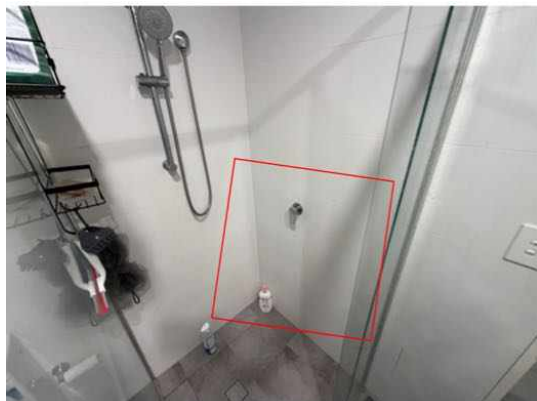
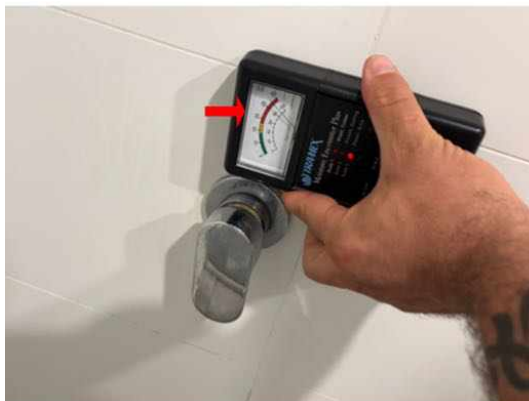
### Finding 2.02

Building:	Main Building
Location:	Bathroom
Finding:	Water leak - Suspected
Information:	A water leak is suspected in this area as excessive moisture was detected at the time of inspection. Another potential cause maybe moisture ingress behind the tiles from around the wall fittings and penetrations.

Internal water leaks can be detrimental to surrounding building elements; their potential causes include damage to plumbing fittings and fixtures, through to water damage and deterioration of associated building elements.

In extreme cases, structural damage may develop due to a prolonged water leak. It is highly advised that internal water leaks be addressed by a licensed plumber as a matter of relative urgency.

Excessive moisture was identified to the walls in the bathroom shower. There maybe a water leak OR otherwise moisture maybe penetrating around the fittings. A licensed plumber must be appointed urgently for further assessment and repairs.

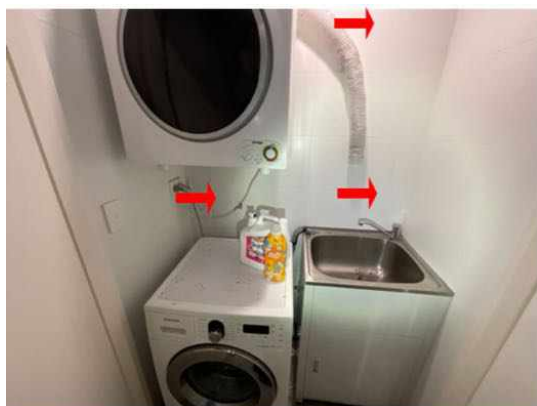
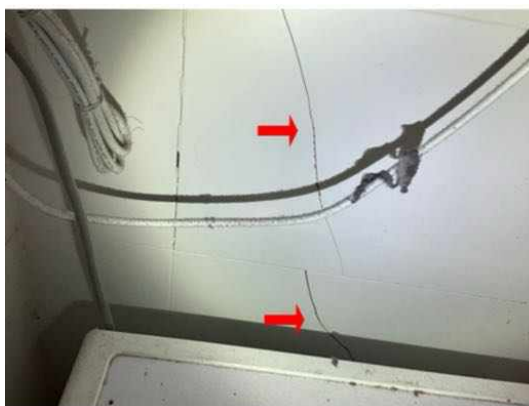
### Finding 3.01

Building:	Main Building
Location:	Laundry
Finding:	Wet area tiles - Cracked or damaged
Information:	Cracking was evident to the tiling in this area at the time of inspection. While the cracking appears to be minor, this area is frequently exposed to water, allowing potential for water penetration into adjoining sections of walls or flooring.

If left unmanaged, water penetration to these areas may lead to subsequent water damage, which is likely necessitate repair work to affected building elements.

A bathroom specialist should be appointed to determine the integrity of the bathroom waterproofing membrane. If the membrane was found to be intact then relatively minor works to replace the cracked tiles should be carried out to ensure no further damage occurs. The re-application of silicone and grouting throughout remaining tile work is also advised, to further protect the area against water penetration.

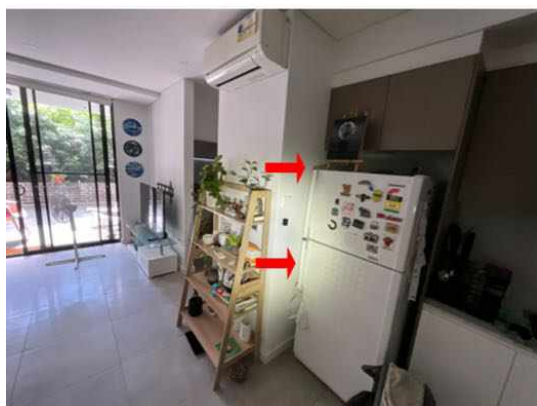
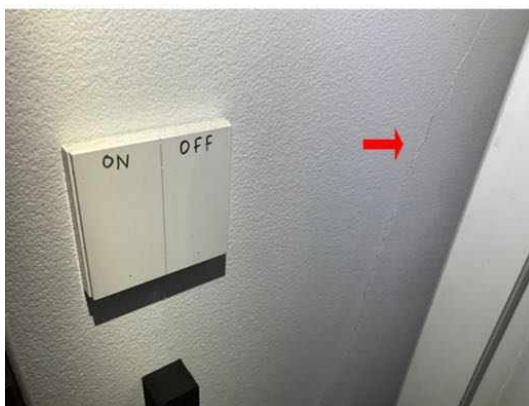
### Finding 3.02

Finding: Cracks to internal render - Category 1

Information: It has been observed that cracking to internal rendered surfaces has occurred. The degree of damage falls within Category 1, described as fine cracks that do not need repair and which are less than 1.0mm in width limit.

Damage of this category is not considered a defect for rectification. Always contact your building inspector should cracks widen, lengthen, or become more numerous.

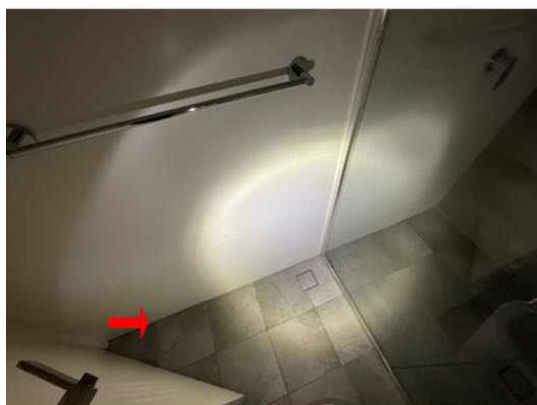
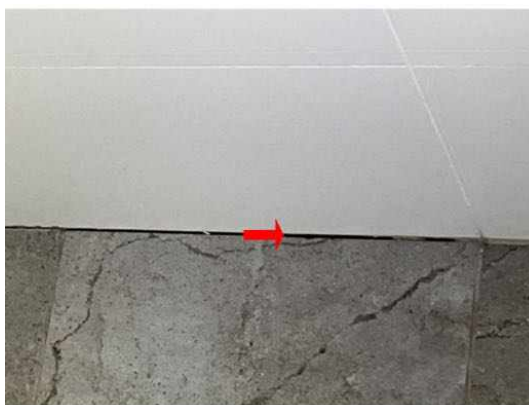
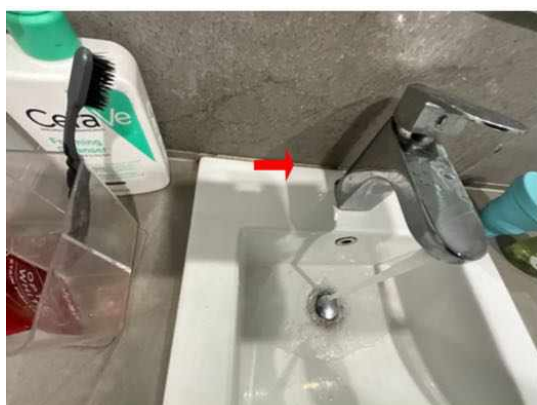
### Finding 3.03

Finding: Sealant and grouting - Missing or damaged

It was noted on inspection that sealant or grout is degraded to this area.

Different materials and floor areas move at different rates, generally causing cracking to grout or sealant at this point. A flexible sealant is required to allow for expected expansion and contraction, while keeping the joint water tight and protective of all associated building materials.

Flexible and mould resistant materials should be applied to affected areas to prevent any subsequent water damage that is likely to occur. Regular maintenance and replacement of damage or missing or damaged sealant and grout is highly recommended to the wet areas, as this is a regular wear and tear defect. Sealant and grouting in areas that come into regular contact with water should be maintained for the long term care of your property.

A sealant specialist should be appointed to complete these works as soon as possible.

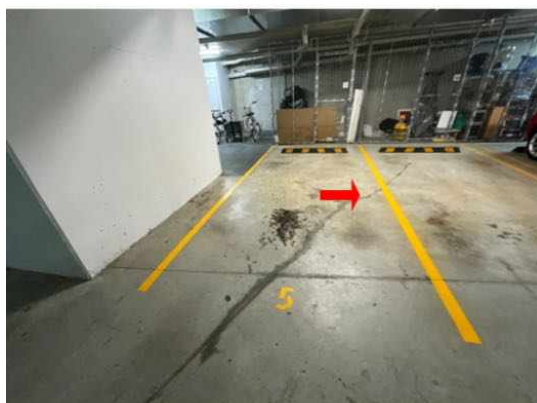
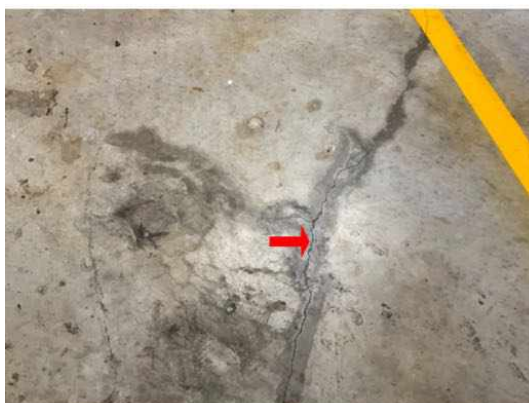
### Finding 3.04

Building: Main Building  
 Location: Basement  
 Finding: Crack in concrete slab - Category 1  
 Information: A crack coded as Category 1 was identified in the slab. A Category 1 crack is described as a fine but noticeable crack, with the slab at an otherwise reasonable level.

To be considered Category 1, the approximate width of the crack is less than 1.0mm, or a less than 10mm change in offset when a 3m straight edge is placed over the defect.

Category 1 cracks should be monitored for a period of 12 months. At the end of the monitoring period, identified cracks that are rated greater than Category 2 are considered defects, and require rectification.

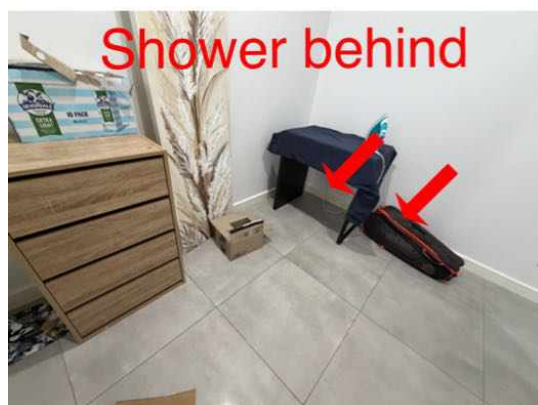
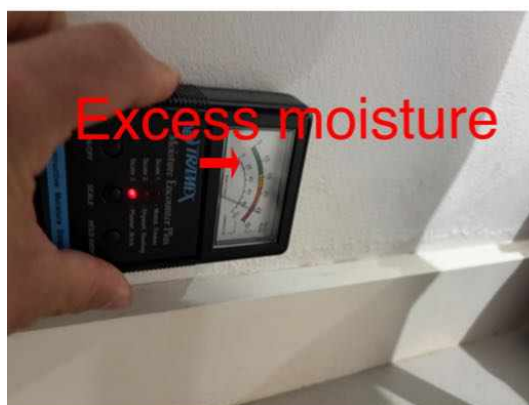
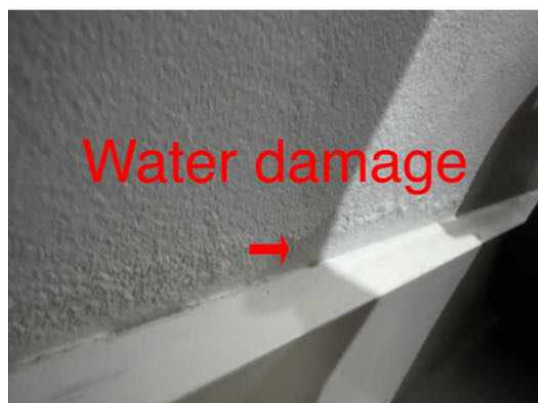
Building:	Main Building
Location:	Ensuite
Finding:	Waterproofing damage - Suspected
Information:	Excessive moisture was detected in these areas at the time of inspection. Internal water leaks can be detrimental to surrounding building elements. The potential cause in this area is damage to the waterproofing membrane inside the shower recess.

Attracting termites, corrosion, mould, decay and water damage are potential outcomes where a minor water leak is left unattended. More serious defects may also result, such as electrical hazards, or water damage to structural building elements.

In extreme cases, structural damage may develop due to a prolonged water leak. It is highly advised that this issue be addressed immediately by a bathroom specialist as a matter of relative urgency.

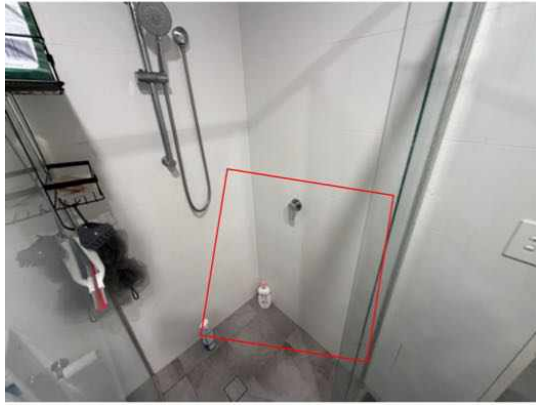
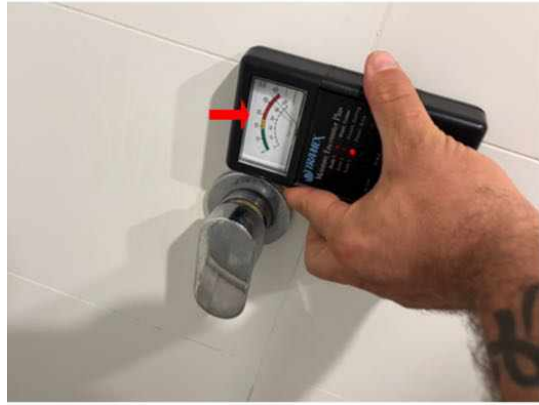
### Finding 6.02

Building:	Main Building
Location:	Bathroom
Finding:	Water leak - Suspected
Information:	A water leak is suspected in this area as excessive moisture was detected at the time of inspection. Another potential cause maybe moisture ingress behind the tiles from around the wall fittings and penetrations.

Internal water leaks can be detrimental to surrounding building elements; their potential causes include damage to plumbing fittings and fixtures, through to water damage and deterioration of associated building elements.

In extreme cases, structural damage may develop due to a prolonged water leak. It is highly advised that internal water leaks be addressed by a licensed plumber as a matter of relative urgency.

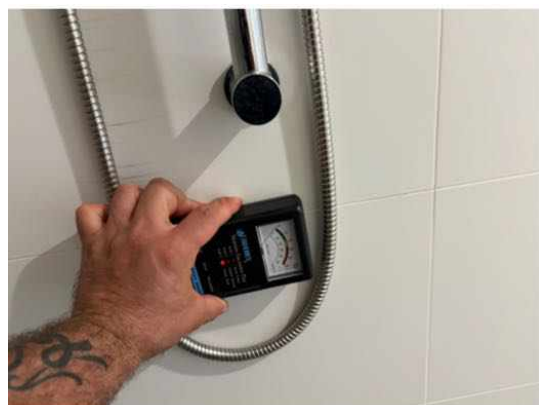
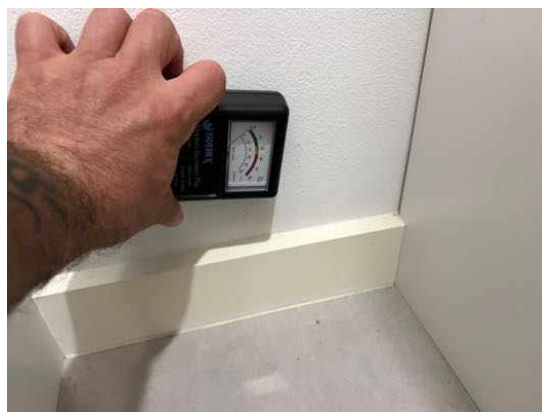
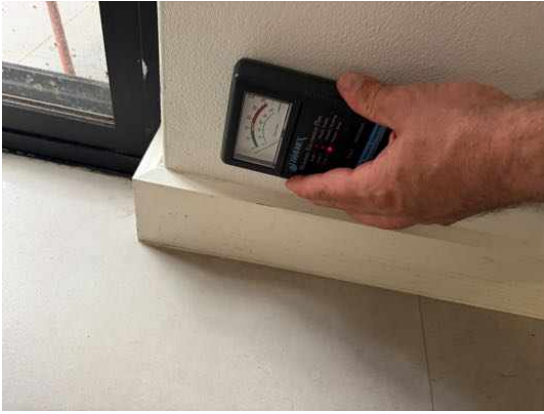
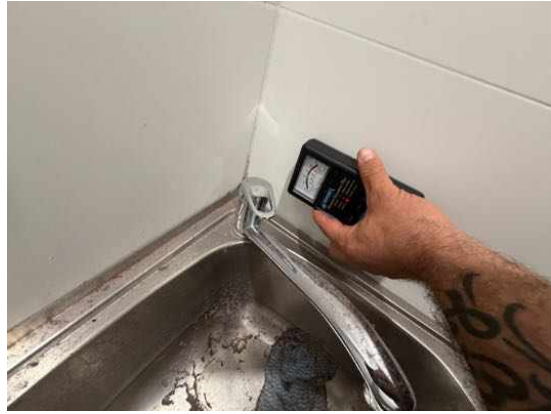
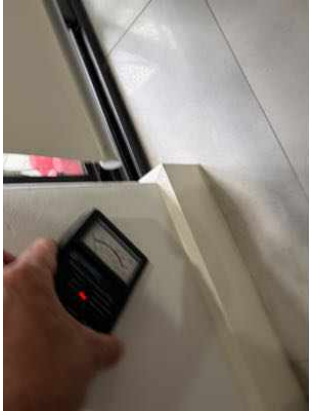
Building: Main Building  
 Location: All Areas  
 Finding: Moisture metre  
 Information: During the inspection the property was checked for moisture using a moisture metre.

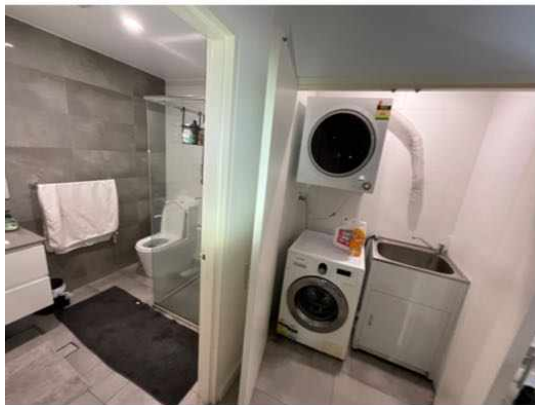
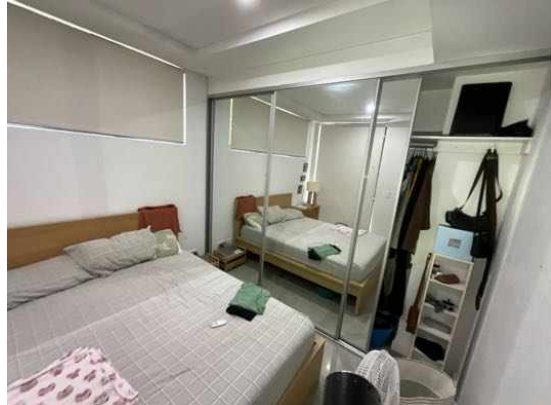
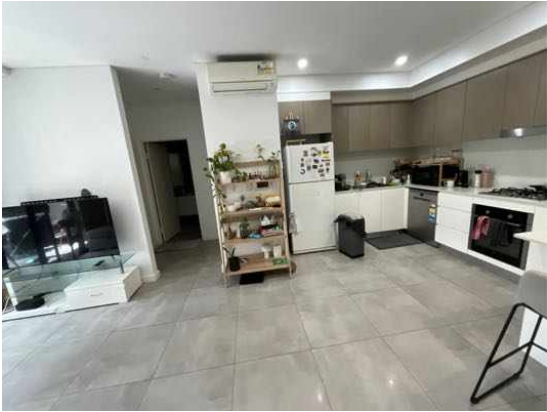
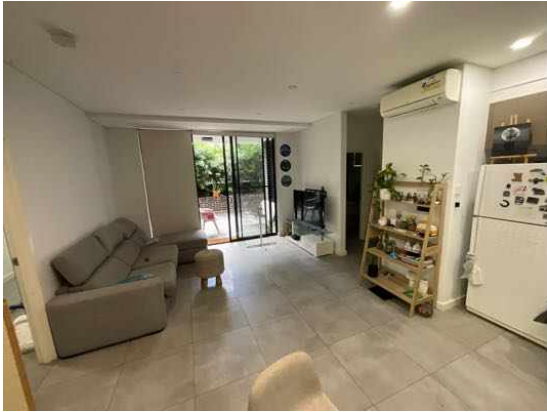
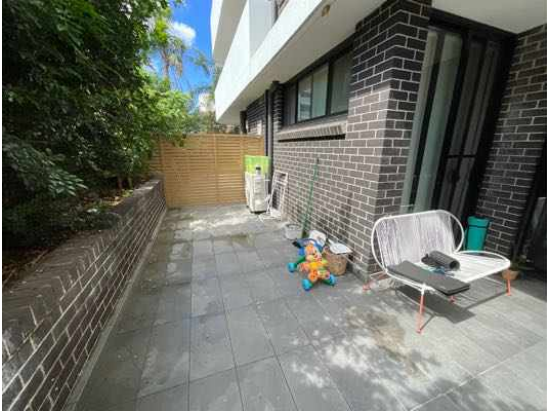
These photographs are an indication of the obstructions and limitations which impeded full inspection of the property at the time of inspection. These obstructions can hide an array of defects and should be removed to allow full inspection to be carried out. A re-inspection is recommended once the areas are made accessible.
