Building and Timber Pest Inspection Report

Inspection Date: Mon, 23 Feb 2026

Property Address: 7 Lexington Ave, Wadalba NSW 2259,
Australia

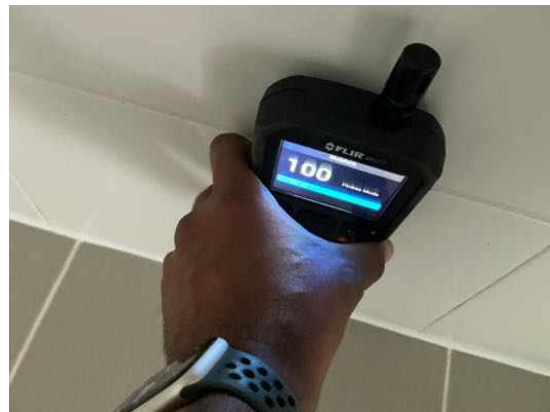
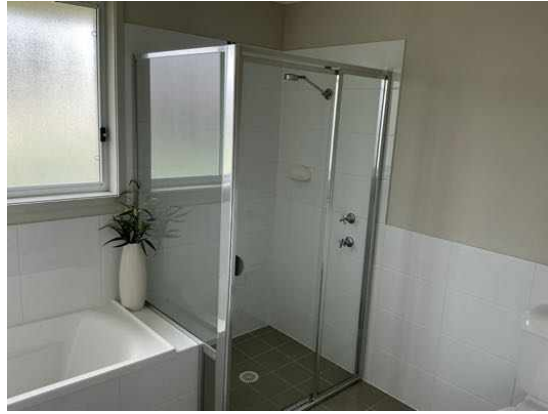
Building:	Main Building
Location:	Both Bathrooms
Finding:	Excessive Moisture - Shower Damp
Information:	At the time of inspection, excessive moisture was noted within the shower area, which is a common issue in wet areas due to the continual exposure to water. This condition is typically caused by moisture seeping through grout lines and settling behind tiles, resulting in localised high-moisture zones. Provided there is no evidence of water staining or elevated moisture readings on the opposite side of the wall, this is considered a minor defect.

However, persistently damp conditions may act as conducive conditions for termite activity, as termites are strongly attracted to moisture-rich environments. It is recommended that the client ensures regular use of the exhaust fan and maintains adequate ventilation after shower use to promote drying and reduce long-term moisture build-up, thereby also reducing the risk of attracting termites.

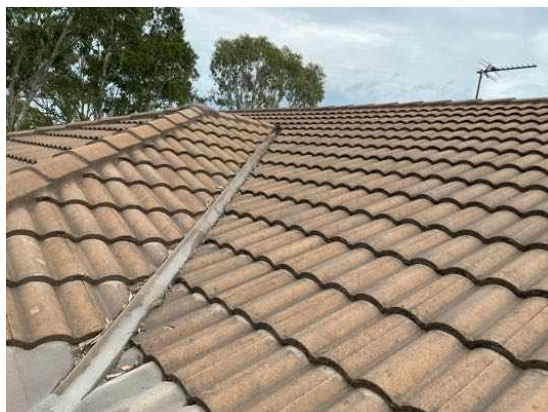
Finding 3.10

Information: It was noted at the time of inspection, the roof shows signs of weathering, with visible wear on the tiles and accumulated debris, such as leaves and branches. The tiles appear aged, which could lead to reduced durability if left unaddressed. Regular maintenance is advised to preserve the roof's integrity and prevent further deterioration.

Although no further action is required at the moment, the client is advised to get recommendation from Roofer for resurfacing in future.

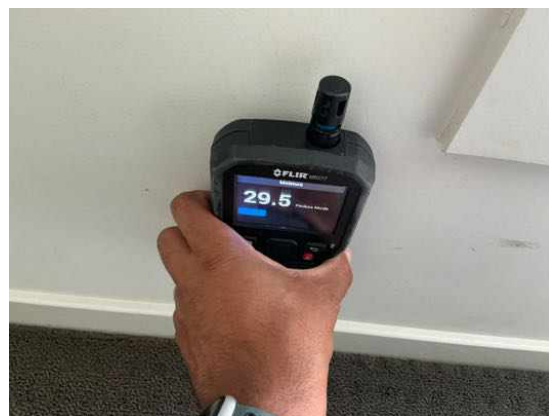
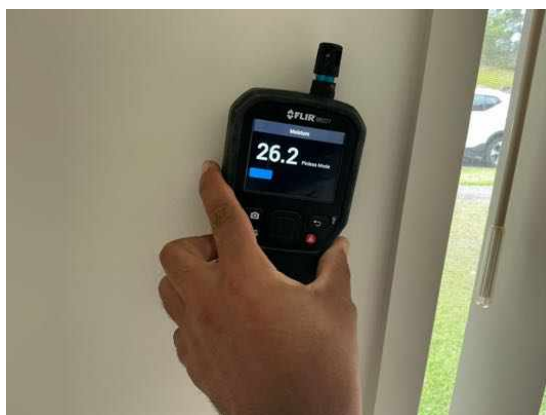
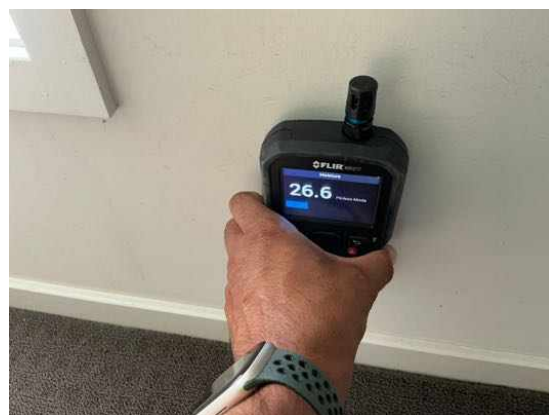
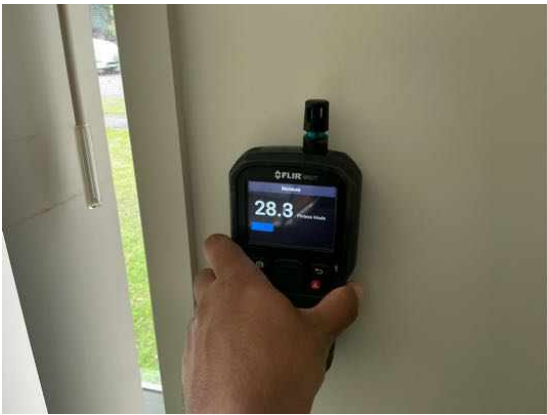
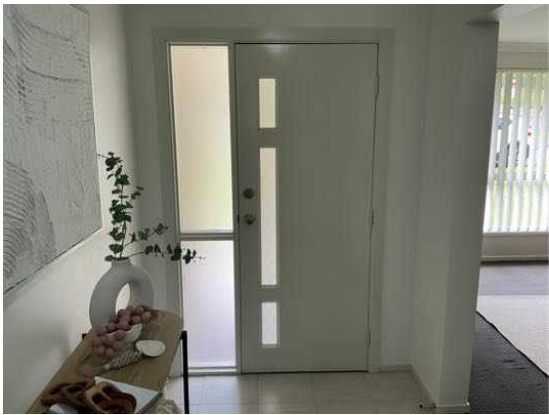
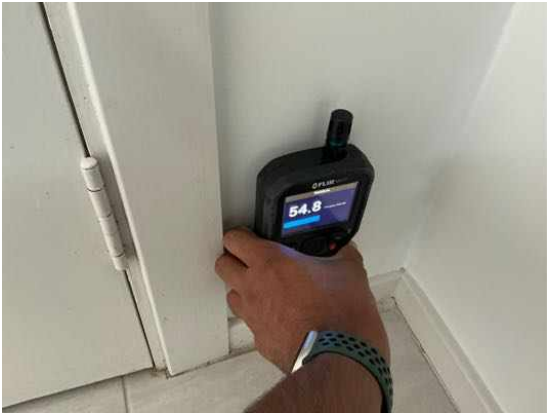
Building: Main Building
Location: All Areas
Finding: Additional Photos - Moisture Meter Readings
Information: Additional moisture meter reading photos have been provided for the property to offer further clarity on areas tested during the inspection. These photos are intended to give a visual reference for the specific locations where moisture levels were measured. These readings were taken at the time of the inspection to assess any potential moisture-related issues within the property. Any defects related to moisture that were identified during the inspection have been separately mentioned in the defect statements within the report.

It is important for the client to understand that moisture levels can fluctuate over time due to various factors, including changes in weather, humidity, and environmental conditions. While the readings reflect the property's moisture levels during the inspection, they may not represent future conditions, and increased moisture could lead to issues such as dampness, mould growth, or deterioration of building materials if left unmonitored.

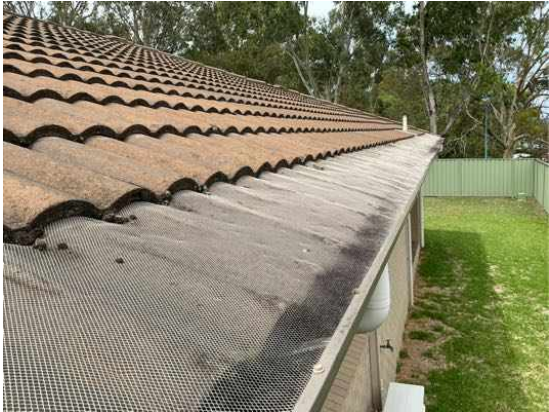
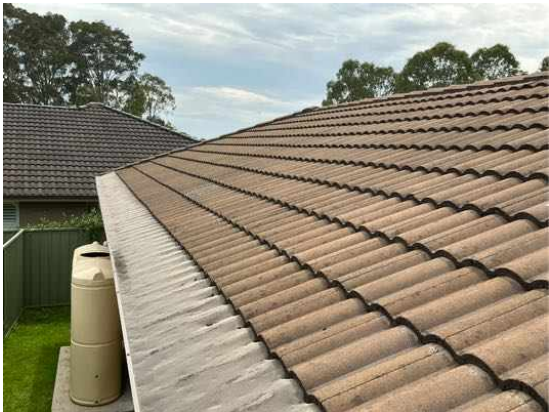
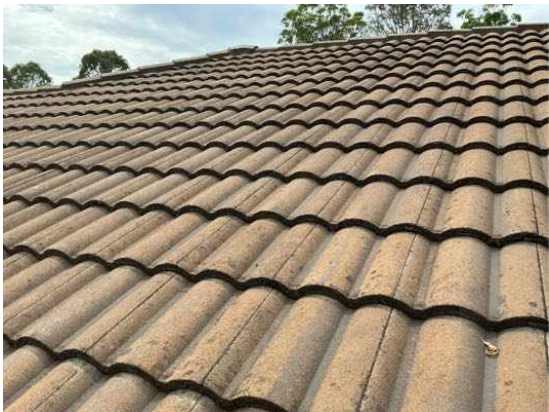
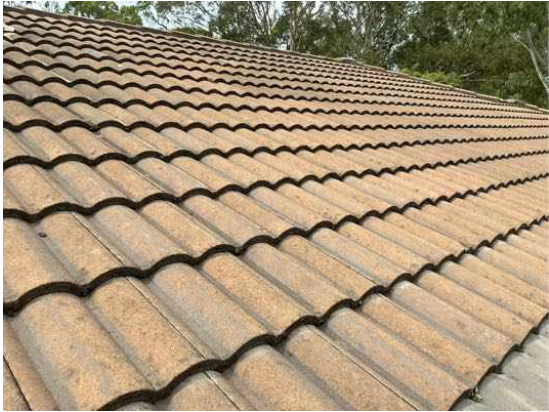
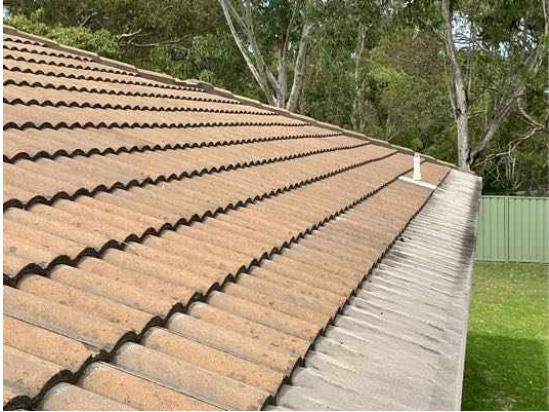
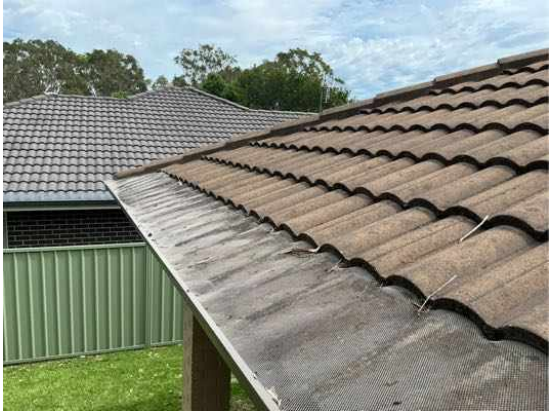
Building: Main Building
Location: Roof Exterior
Finding: Additional Roof Photos

Information: As part of the information provided, please note that the attached roof photos represent the condition of the roof at the time of inspection. These photos are for visual reference only and do not constitute a detailed roofing assessment. Any defects or issues identified with the roof are mentioned separately in the defect statements. It is strongly recommended that the client engage a qualified roofer to conduct a thorough inspection of the roof, ensuring that any potential issues, such as leaks, structural integrity, or wear and tear, are properly identified and addressed.

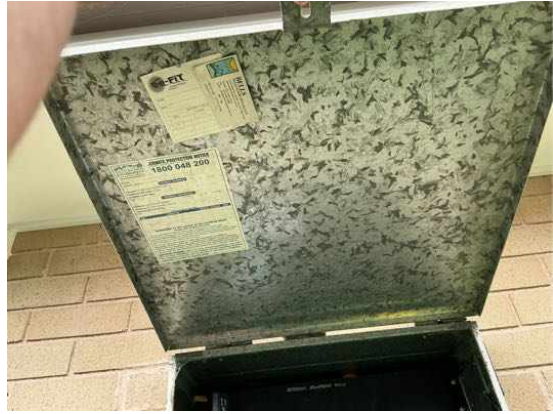
Building: Main Building
 Location: Meter Box
 Finding: Termite Management Recommendation – No Evidence of Chemical Installation
 Information: At the time of inspection, there was no visible evidence of a chemical termite management system installed around the property. Chemical barriers are a key component of termite protection and are particularly important in preventing concealed termite entry into timber elements of the structure.
