Building and Timber Pest Inspection Report

Inspection Date: Tue, 31 Mar 2026

Property Address: 213 The River Rd, Revesby NSW 2212,
Australia

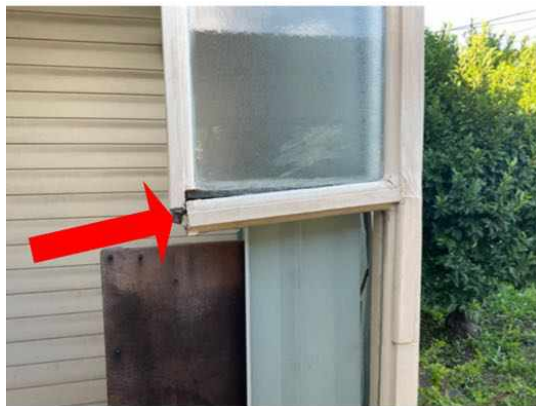
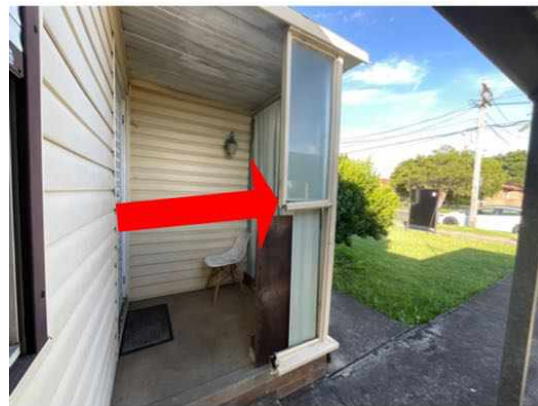
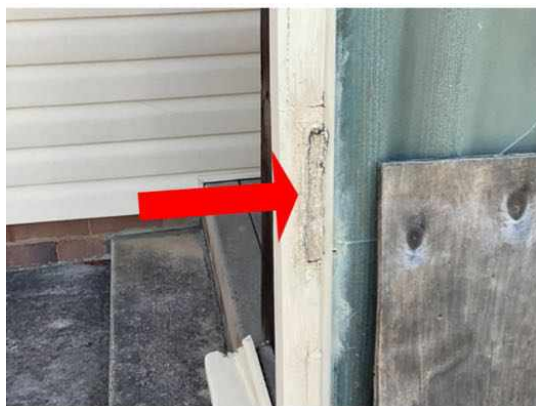
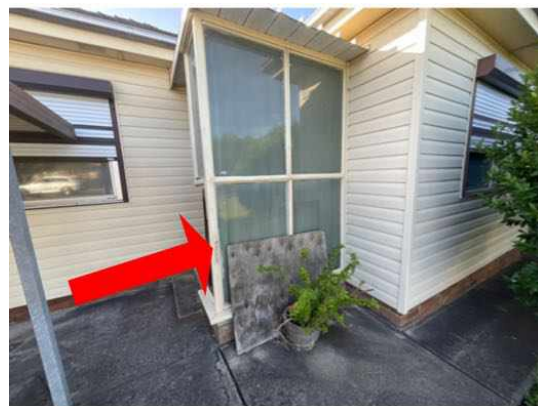
Building: Main Building
 Location: All External Areas
 Finding: External Timber - Weather damaged
 Information: Damaged external timbers were found during the inspection. External timber structures are also constantly exposed to weather elements and can deteriorate in an accelerated manner, ongoing assessments are required.

It is highly recommended that a Structural engineer further assess the external timber to inform the client of its load capacity. Regular maintenance inspections by competent practitioners is needed.

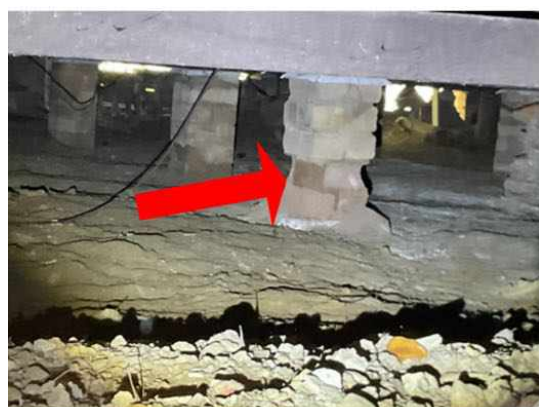
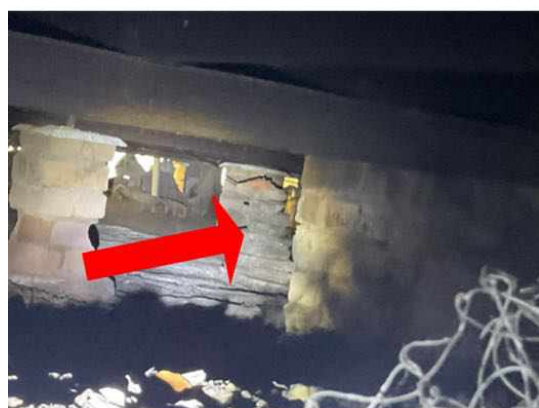
Finding 2.01

Location: Subfloor
 Finding: Brick Pier (Subfloor) - Deteriorated
 Information: The subfloor brick piers have significantly deteriorated, with visible cracking, displacement and loss of material integrity. The pier appears to have reduced load-bearing capacity and may no longer adequately support the structure above.

This condition is considered structural and major, as failure of the pier may lead to uneven settlement, floor sagging and potential structural instability.

Recommendation:

A structural engineer should be engaged to assess the extent of damage and design appropriate rectification, which may include replacement or underpinning of the pier. Urgent repair is recommended.

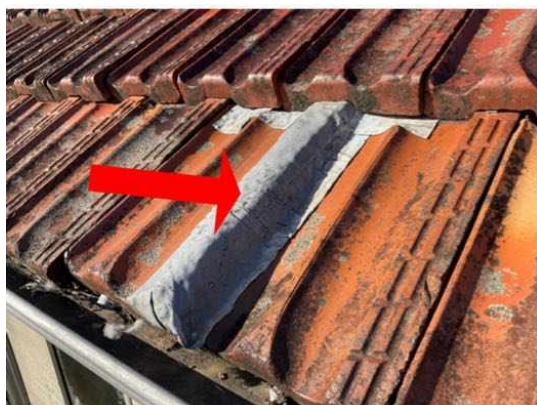
Finding 2.02

Building: Main Building
 Location: Roof Exterior
 Finding: Exterior roof - Leaking
 Information: Active roof leaks were evident at the time of inspection. Roof leaks can have a number of causes, including damage to roof coverings, deterioration of roof fixtures and fittings, or loosely associated materials (fascias etc.).

Where water leaks are active, rain penetration is likely to cause water damage to associated structures and building elements in this area, which can have a range of implications. If left unmanaged, the development of major structural damage to the roofing and associated structures may occur.

A roof plumber should be appointed as soon as possible to primarily identify the cause of the leak, and to provide subsequent repair works as necessary. Depending on the extent of the damage, replacement of sections of the roof covering and/or roofing structures may be required, and may be performed by a registered builder or qualified carpenter.

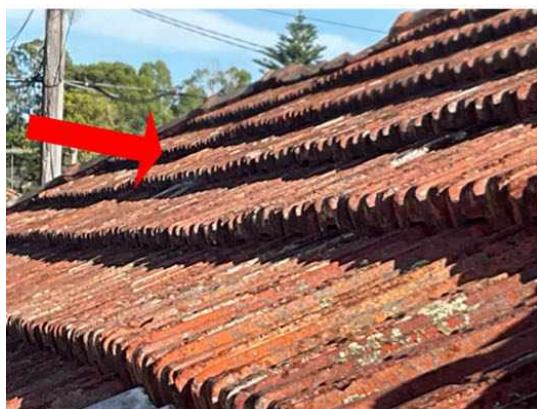
Building:	Main Building
Location:	Roof Exterior
Finding:	Roof structure - Connections (Sagging)
Information:	The roofing structure was found to be sagging in certain sections at the time of inspection. Upon closer inspection within the ceiling void and the roof exterior, it is suspected that the sagging is a direct result of inadequate connections, which appear to have deteriorated over a prolonged period of time.

Sagging roof structures are likely to create strain on associated building elements, creating potential for secondary damage. The roof is also unlikely to have sufficient support, which will lead to further sagging if left unmanaged.

It is critical to ensure that the fastenings holding important roof elements together remain structurally sound (i.e. not corroded) and tightly fastened. Any failure in fastenings can lead to movement of roof members, which is likely to result in an uneven or sagged appearance of the roof exterior. Improper nailing at the point where the ceiling joist connects to the bottom of the rafter may also cause sagging.

Remedial works are highly advised and should be performed by a registered builder or roofing contractor as soon as possible.

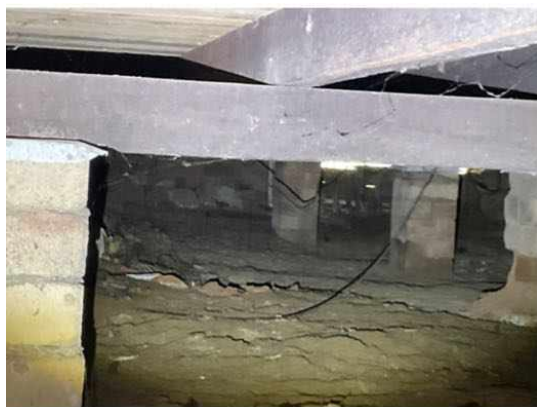
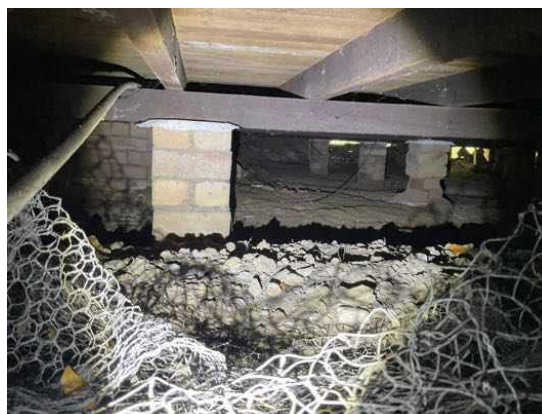
Building:	Main Building
Location:	Subfloor
Finding:	Subfloor - Lack of ventilation
Information:	It was noted at the time of inspection that the subfloor area lacks adequate ventilation. Ventilation can be restricted by a variety of minor defects, including obstructions in the subfloor space, a lack of vents or a low clearance.

A well ventilated subfloor aids in maintaining dry conditions, preventing secondary damage such as wood rot and pest activity, as well as preventing the development of mould and mildew (which can lead to respiratory safety hazards for occupants).

The initial step in improving ventilation is to ensure that the subfloor area is free of any debris or stored items. Where ventilation is still inadequate, it is advised to ensure that all vents are clear of blockages, and additional vents may be installed.

The client may also consider mechanical ventilation (powered fans) to improve subfloor airflow. Remedial works should be conducted as a matter of urgency to protect against the development of potentially harmful subfloor conditions.

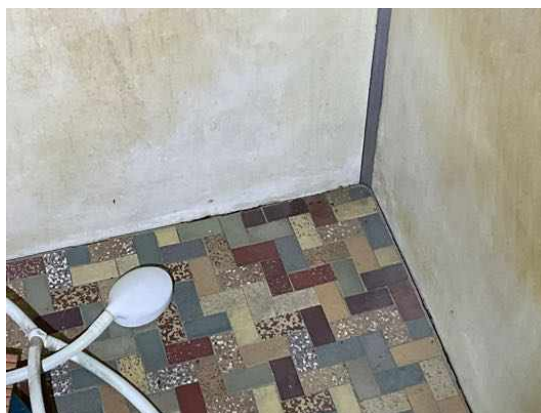
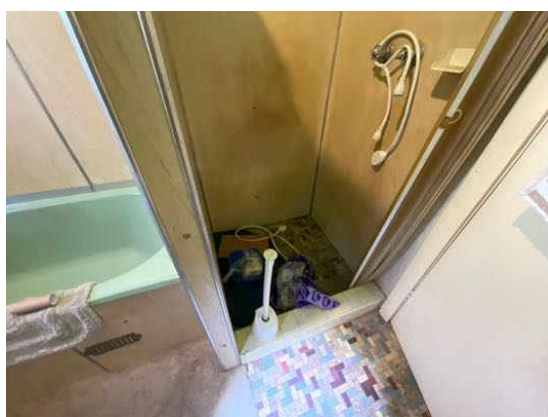
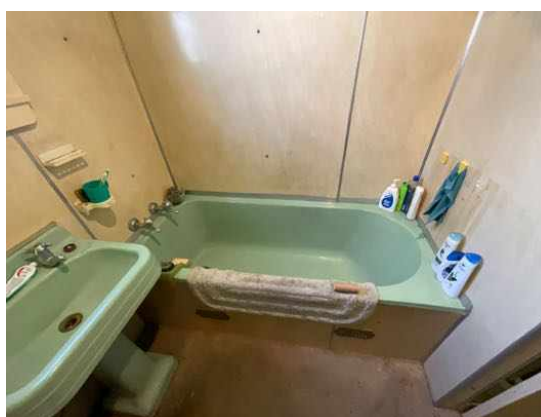
Finding 3.06

Building:	Main Building
Location:	Bathroom
Finding:	Bathroom - Below Current Standards
Information:	The bathroom is dated and constructed to an older standard. The floor and wall finishes, including junctions at wall/floor and shower area, do not appear to incorporate compliant waterproofing systems in accordance with current standards. Evidence of wear, staining and deterioration is present.

The shower area has inadequate water containment and may allow water ingress to surrounding areas and subfloor over time.

moisture ingress and deterioration.

Upgrade and renovation of the bathroom is recommended, including installation of compliant waterproofing system to AS 3740 by a licensed contractor.

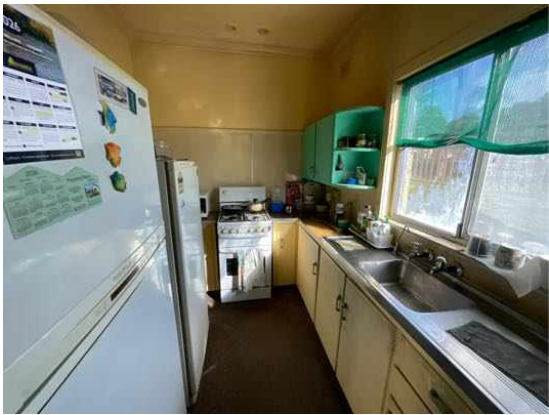
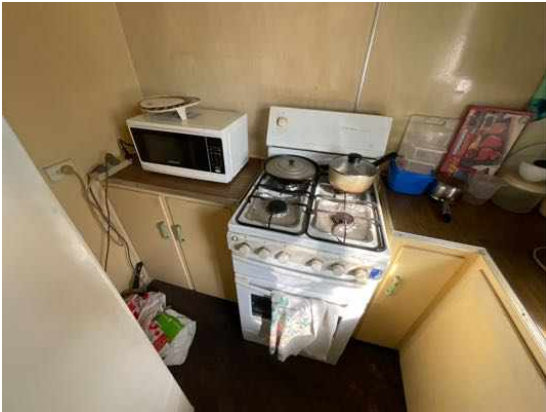
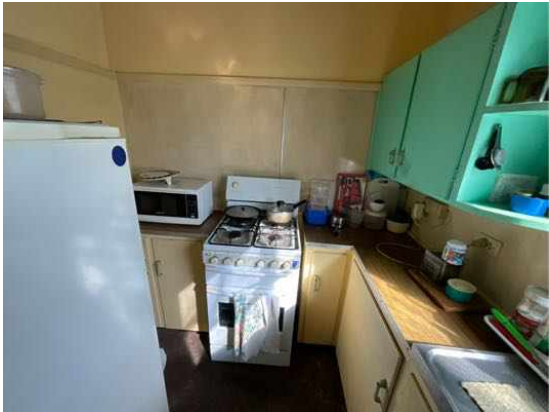
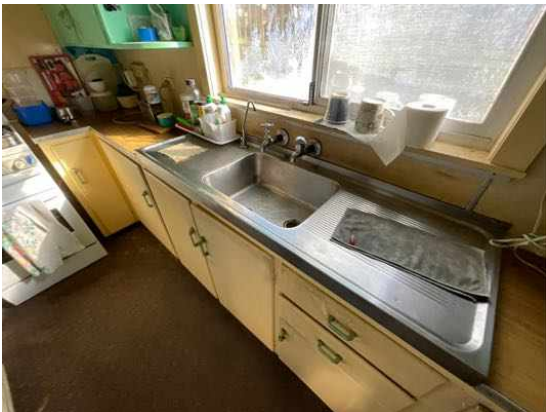
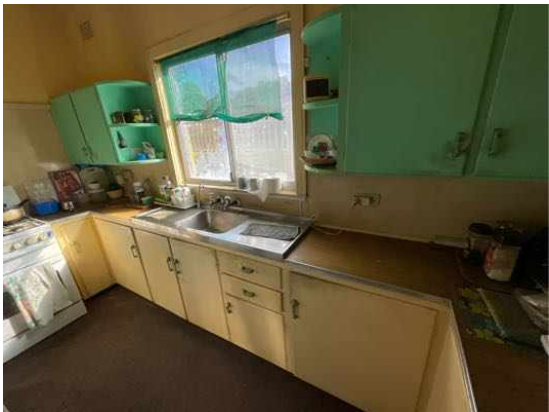
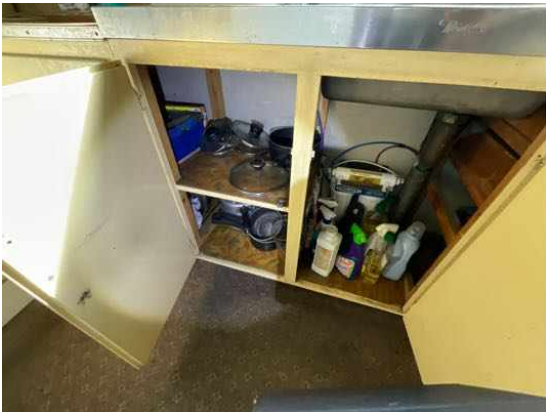
Building:	Main Building
Location:	Kitchen
Finding:	Kitchen - Outdated and Below Current Standards
Information:	The kitchen is dated and constructed to an older standard. Cabinetry, benchtops and wall linings show signs of wear, deterioration and ageing. The sink area and surrounding joinery show evidence of moisture exposure and potential long-term water ingress.

The electrical outlets and general layout appear outdated and may not comply with current safety and functional requirements. No visible waterproofing or moisture-resistant detailing is evident to wet areas around the sink.

While functional, the kitchen is obsolete and below current standards, with increased risk of moisture damage and serviceability issues.

Upgrade and renovation of the kitchen is recommended, including replacement of cabinetry, benchtop, and verification/upgrade of plumbing and electrical installations by licensed trades.

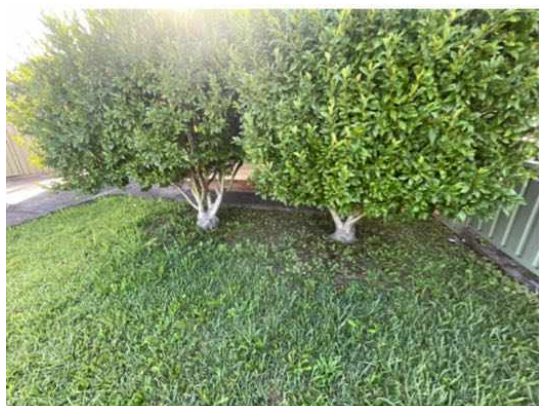
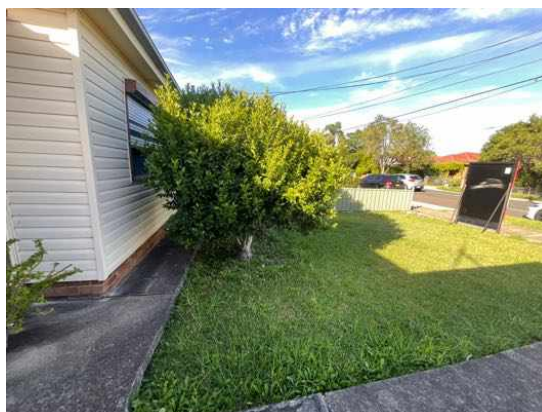
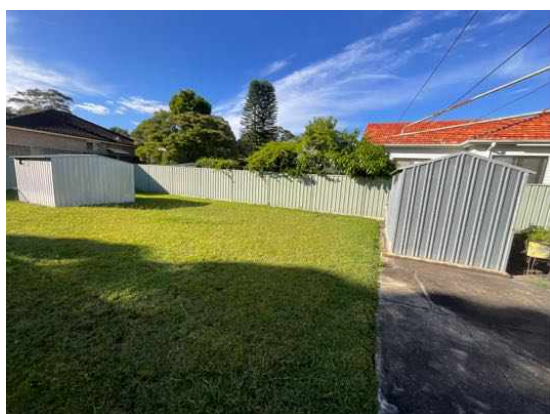
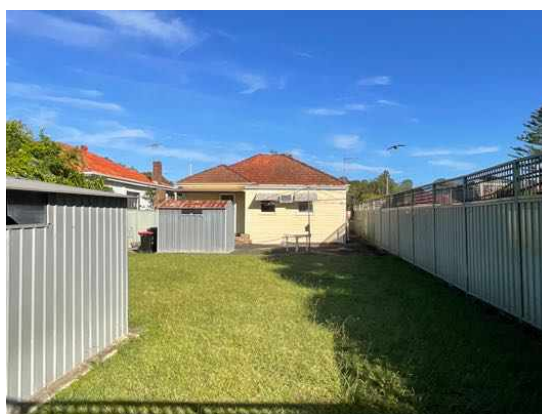
Finding 6.01

Building: Main Building
Location: All Areas
Finding: Garden Beds - Conditions Conducive to Termites
Information: Garden beds were found to be evident in the garden area. These garden beds can include untreated timber, and with a combination of moisture from watering hosing can make conditions conducive to termite activity and termite ingress.

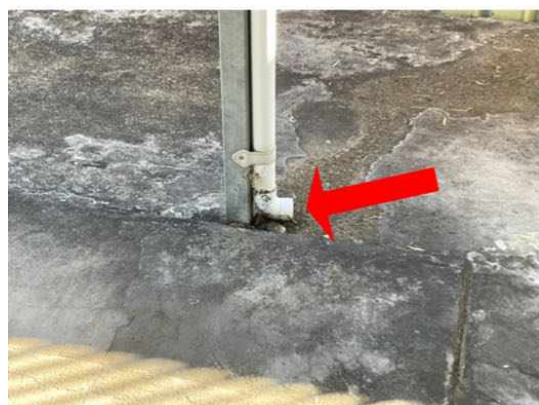
Building: Main Building
 Location: All External Areas
 Finding: Overflow (Downpipe) - Not plumbed for drainage
 Information: The overflow is not plumbed or connected to suitable drainage, which has resulted in the surrounding area becoming excessively damp. These damp conditions can lead to secondary defects such as rot, rust or corrosion of associated building elements, the formation of fungal decay, or even the creation of potential slip hazards. When coupled with poor site drainage, pooling of water may also attract termite activity to this area. It is highly recommended that a qualified plumber be appointed to install adequate drainage to the overflow. These works will ensure that the area remains dry and free of any secondary defects.

not connecting downpipes to the stormwater system can lead to various problems, including structural damage, safety hazards, and regulatory issues. It's essential to address this issue promptly by ensuring that downpipes are properly connected and directing water away from the building to mitigate these risks.

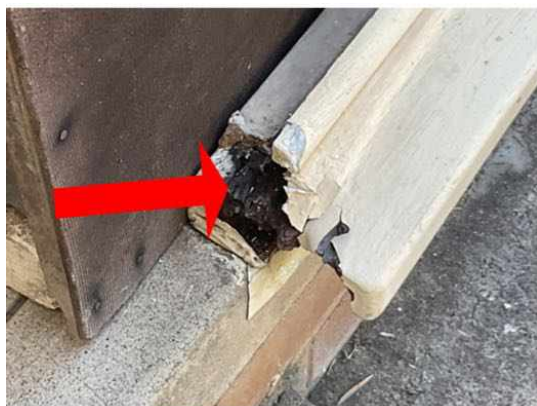
Finding 7.01

Building:	Main Building
Location:	All Areas
Finding:	Wood rot
Information:	This building element shows evidence of wood rot. Wood rot, also known as Fungal Decay, occurs when timbers and other cellulose building materials are exposed to damp conditions on an ongoing basis. This could be the result of exposure to weathering over a prolonged period of time, or the attraction of excessive moisture from other abutting building materials. Contributing factors also include poor air ventilation in the area.

Wood rot is often associated with general damp problems and is evidenced by a 'musty' smell or mould and mildew occurring on surfaces. If left unmanaged, damp conditions can lead to further health problems and the decay of timbers will continue.

Early intervention and regular maintenance, particularly of exterior timbers, will prolong the useful life of these building elements. Prior to any works being performed, the cause of the moisture that has created the visible wood rot should be identified and addressed in a suitable manner. Replacement of affected timbers may then be a necessary step in protecting surrounding building elements from such deterioration.

A qualified plumber may be appointed to assess the cause of excessive moisture and to provide advice on any remedial works as required. A qualified carpenter or registered builder may also be required to replace affected building materials.

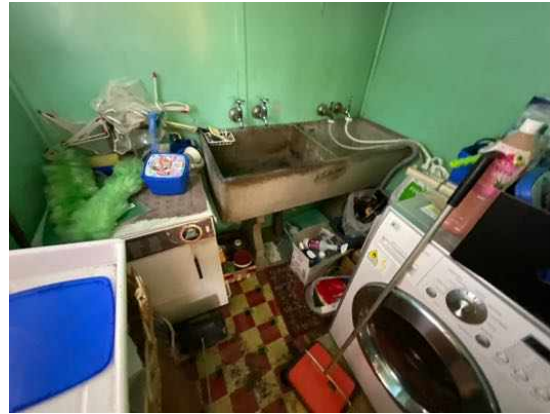
Building:	Main Building
Location:	All Areas
Finding:	Water Proofing Membranes - Information Only
Information:	Internal Water Proofing Membranes, are crucial in preventing water ingress into the property is important to know that the Membrane System used is to Australian Standards and has been installed correctly. Please refer to the original Building Documents or Maintenance Schedule for the relevant information including; - Membrane used and Manufacturers Specifications. - The Installer and Installation Certification. Especially with older property's where this information is unavailable, all wet areas should be monitored. Generally new waterproofing with a certificate may only have a guarantee of 8yrs. If any leaks, water staining, peeling or bubbling of the paint become evident to any adjacent walls or ceilings below a licensed builder or

waterproofing specialist is recommended to investigate further.

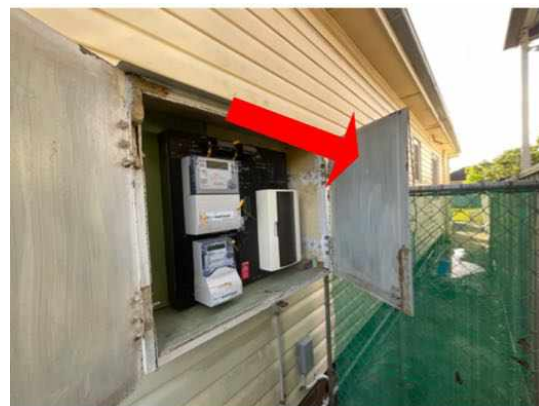
Building: Main Building
 Location: All Areas
 Finding: Termite Management System - no evidence of a chemical installation
 Information: The application of a post-construction chemical termite barrier is highly recommended for all properties, particularly if live termite activity has been found on the site previously. Such barriers are highly effective in preventing termite attack on any timber building elements throughout the property.

A durable notice should be placed in the switchboard unit to indicate current termite barriers. At the time of inspection, it appeared as though no termite management system has been installed, with no evidence to suggest preventative works taking place.

The client may consider gaining further advice from a pest controller as to the costs and procedures involved with this application. It is recommended that obtaining such advice be a short-term priority.
