Building and Timber Pest Inspection Report

Inspection Date: Wed, 21 Jan 2026

Property Address: 90 Harold St, Blacktown NSW 2148,
Australia

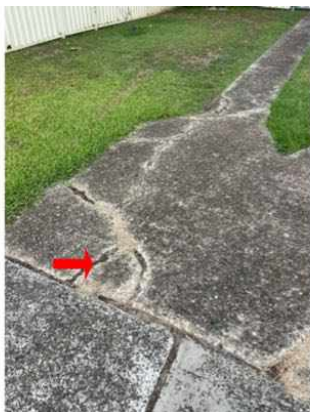
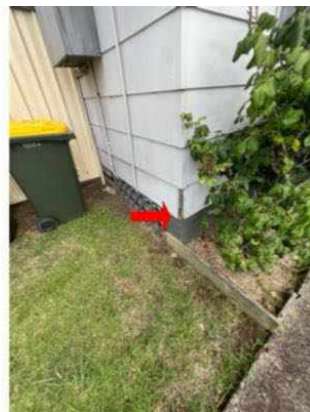
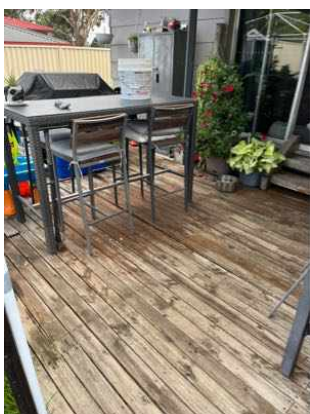
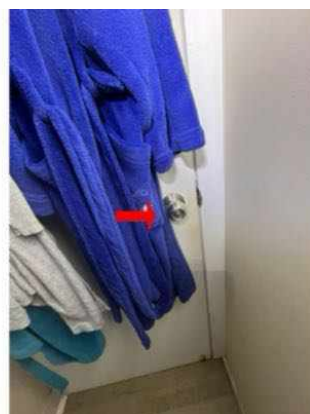
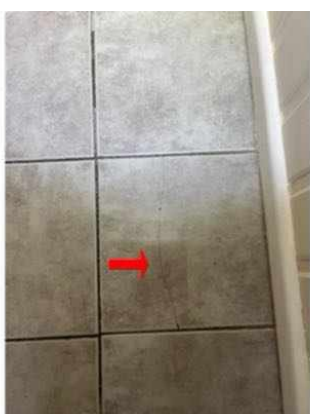
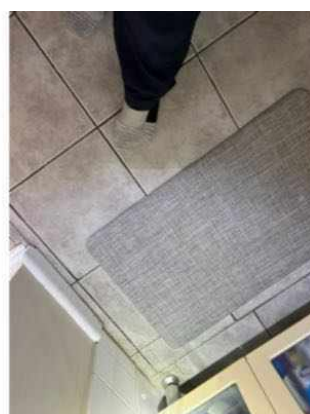
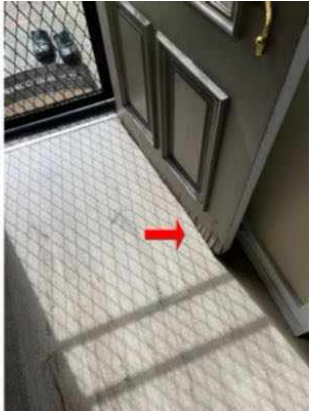
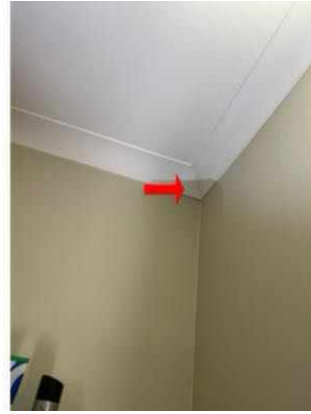
Finding 3.01

Finding: Deterioration caused by Fair and Wear and Tear

Information: During the inspection, several building elements were noted to display deterioration consistent with fair wear and tear for a property of this age and construction type. Timber decking boards exhibit weathering, surface discolouration and general ageing, which is common where external trafficable surfaces remain exposed to the elements. Localised paint breakdown and surface cracking was also observed to external concrete steps, again typical of long-term exposure and the natural breakdown of older coatings. External concrete pathways show cracking and movement between sections; such settlement-related cracking is generally expected over time and does not necessarily indicate significant structural concern unless excessive displacement or trip hazards are present.

Internally, isolated cracking to ceramic floor tiles and minor separation to grout joints were observed, consistent with age-related movement and normal substrate behaviour. Some doors display swelling, surface wear or minor moisture-affected deterioration at the lower edges, which is common where older joinery is subject to fluctuating internal humidity or weather exposure. Internal plasterboard linings show light cracking or surface imperfections that are typical in established dwellings and generally fall within acceptable tolerances for normal building settlement.

Around the exterior envelope, aged cladding panels show minor impact damage, surface wear and small gaps at junctions, which appear consistent with prolonged exposure rather than defective installation. Landscaping and boundary interfaces show minor soil erosion and wear, also considered normal for properties where ground levels and drainage fluctuate over time.

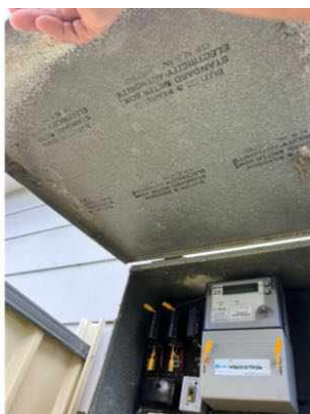
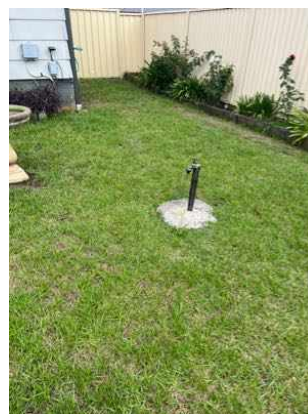
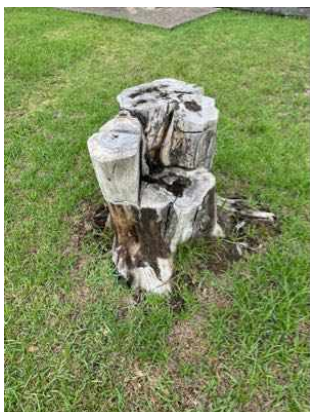
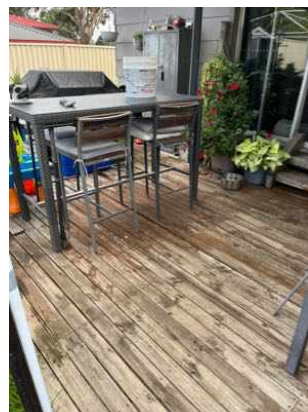
Building: Main Building
 Location: All Areas
 Finding: Conditions Conducive to Termite
 Information: During the inspection, several conditions commonly found in residential properties were noted that may, over time, contribute to an environment conducive to termite activity if left unaddressed. These are typical in many homes and do not indicate active termite presence but highlight areas where general maintenance or preventative measures would be beneficial.

* Absence of a Termite Management System: No visible evidence of a current termite management system was observed at the time of inspection. This is not unusual, particularly in established homes. As a precaution, installation of a termite management system may be considered in accordance with AS 3660 for added protection.

* General Moisture-Related Items (e.g., HWS and Air Conditioner Overflow): Minor overflow drainage from hot water systems and air conditioning units was noted. These are common features in residential dwellings and can be easily managed by ensuring proper discharge to appropriate drainage points.

* Taps and External Drains: Occasional unconnected or unprotected taps were noted. Ensuring that external taps are adequately drained is a simple maintenance task that helps manage moisture near the building perimeter.

* Vegetation and Garden Features: The presence of tree stumps or garden beds near the structure is typical in many residential landscapes. While they may attract termites if left unmanaged, they can be easily maintained or relocated to reduce potential risk.

General Recommendation: □ The conditions identified are typical of residential dwellings and can be readily managed through routine maintenance. No evidence of active termite activity was found at the time of inspection. To ensure continued protection of the property, it is recommended to maintain good site drainage, remove timber debris, and consider installing a termite management system as a precautionary measure. Regular inspections in accordance with Australian Standards are also advisable.

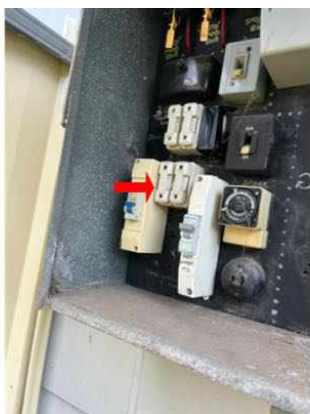
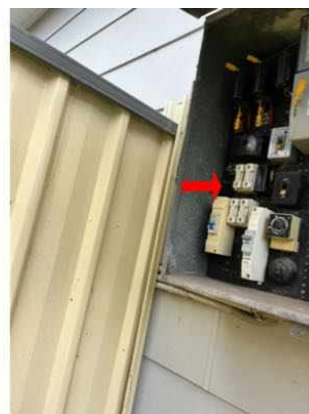
Building: Main Building
 Location: Meter Box
 Finding: Electrical switchboard - Old ceramic fuses
 Information: The electrical switchboard while appearing to have adequate safety switches installed has old ceramic fuses in place.

While this on its own on is not considered a defect it is noted for the clients consideration that a switchboard upgrade may be required in the short to mid term to improve the functionality of the electrical system. A licensed electrician could be appointed to provide quotation for the works at the client's discretion which may in turn expose other required works to bring the system up to a compliant state.

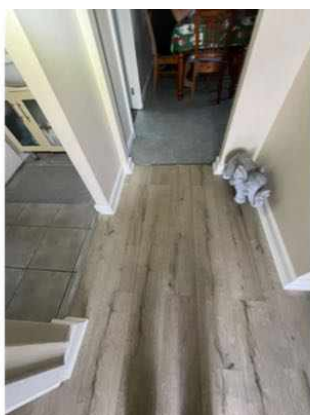
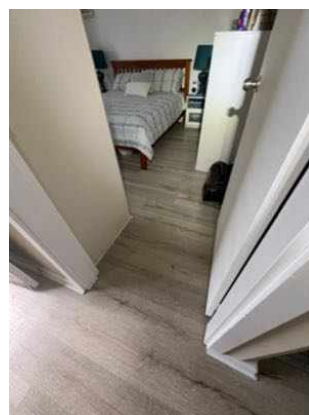
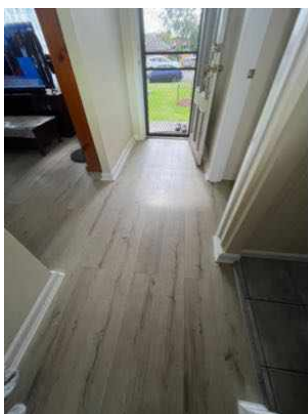
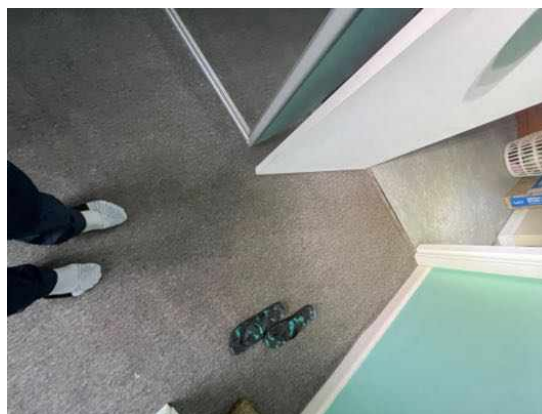
Finding: Uneven Flooring

Information: The internal flooring within this area exhibits minor unevenness along with some isolated squeaking under foot traffic. These characteristics are commonly observed in dwellings of this type and age and are generally associated with normal, long-term settlement and seasonal movement of the building rather than any defect of a structural nature. Such conditions are typical in older homes and, in isolation, do not indicate an immediate or significant structural concern.

It is recommended that the area be monitored over time to confirm ongoing stability. Where the flooring levels and squeaking remain consistent over a period of several months, this would reasonably indicate that the movement is historic and has stabilised. Should any noticeable increase in unevenness or noise be observed in the future, a more detailed assessment of the subfloor structure may be considered as a precautionary measure only. Any minor adjustments, if ever required, can be readily addressed by a suitably qualified professional experienced in re-stumping or subfloor maintenance.

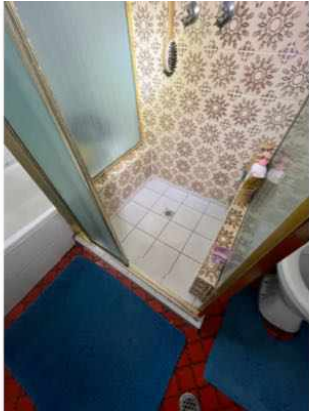
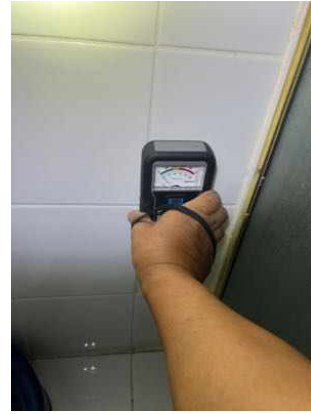
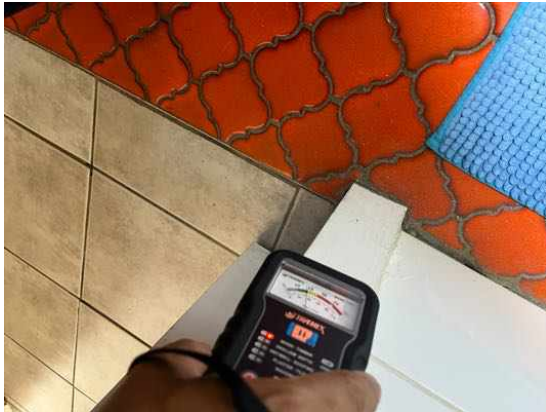
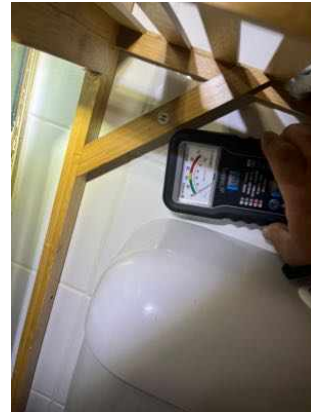
Building:	Main Building
Location:	Bathroom
Finding:	Minimum Moisture Readings Detected
Information:	After assessing the shower recess, the moisture content of the walls within and surrounding the wet area was examined. The readings showed no significant variation between the walls behind the shower and other internal walls, and there were no visible signs of recent moisture-related damage on the surrounding accessible wall surfaces. Based on these findings, the waterproofing system appears to be performing adequately at the time of inspection, with no current evidence of active leakage.

However, it must be acknowledged that if the shower has not been used recently, moisture meter readings may not provide an accurate indication of the waterproofing condition. A lack of elevated readings under these circumstances does not conclusively confirm that the shower is free from leaks.

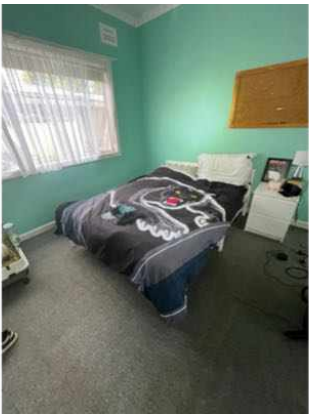
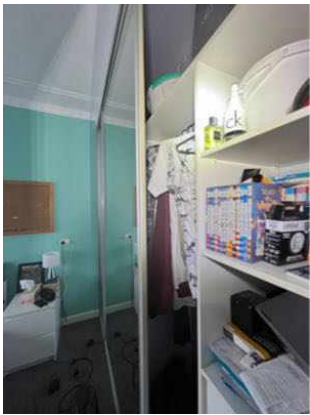
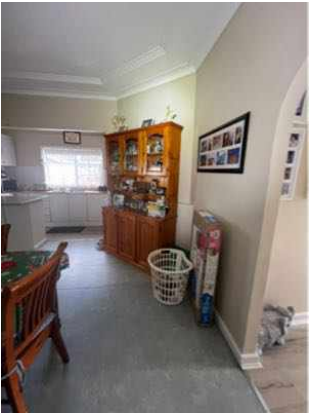
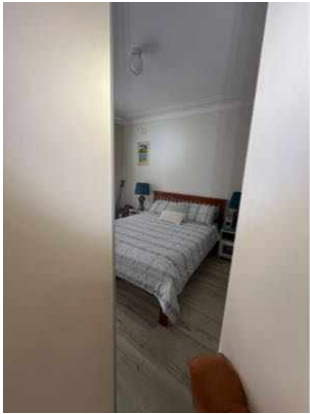
Building:	Main Building
Location:	All Areas
Finding:	Note Regarding Mould and Staining
Information:	It should be noted that the presence of furniture or stored items within the dwelling may restrict airflow and ventilation, particularly behind such items, creating conditions conducive to condensation and subsequent mould or staining.

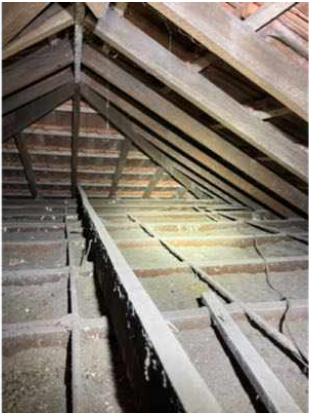
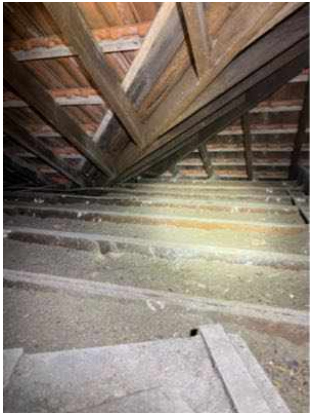
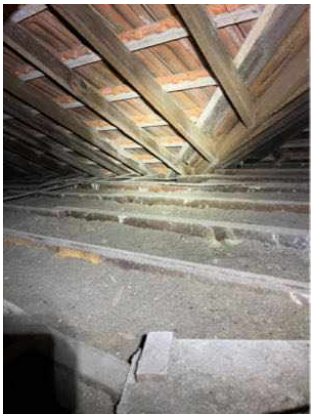
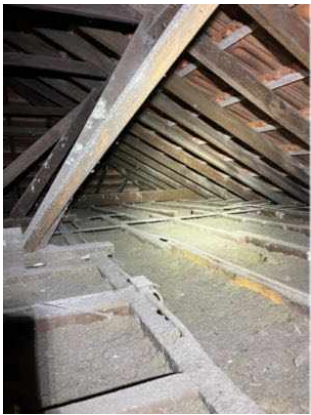
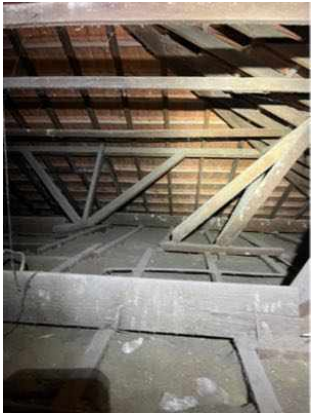
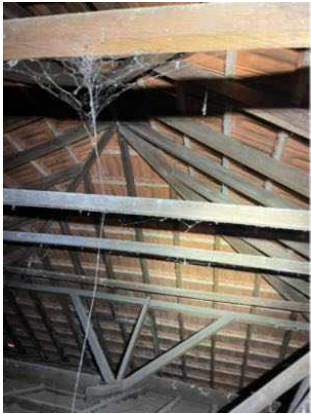
Building: Main Building
Location: Roof Void
Finding:
Information:

- During the inspection of the roof void, the timber framing was found to be in generally sound and stable condition, with rafters, joists and bracing members presenting as straight, well-supported and free from any indicators of structural concern.

The timbers show only normal ageing and surface dust consistent with a dwelling of this period, and importantly, no evidence of active timber pest activity, moisture damage, or deterioration that would impact structural performance was noted.

The roof tiles appeared well-seated from below, and although the roof void does not contain sarking—which is common for homes of this vintage—there were no signs of water ingress or defects associated with this type of construction.

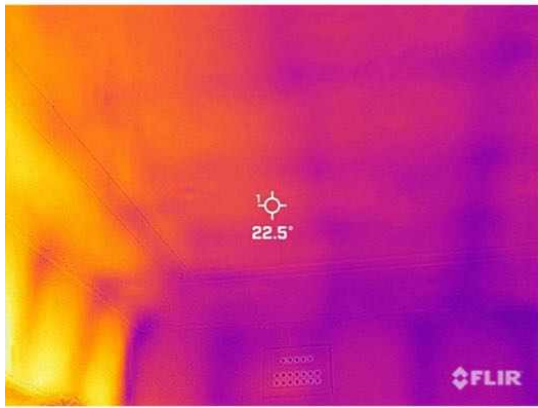
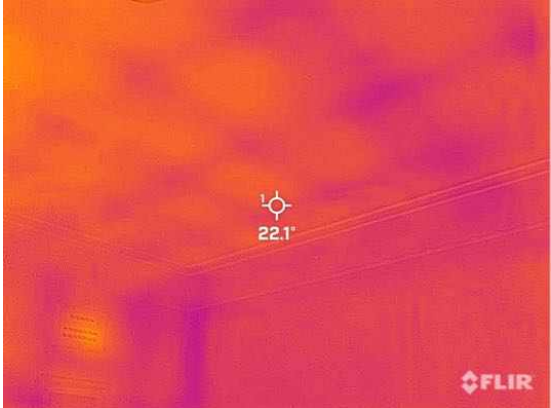
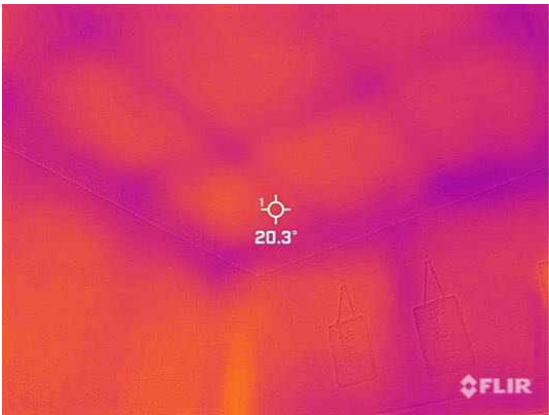
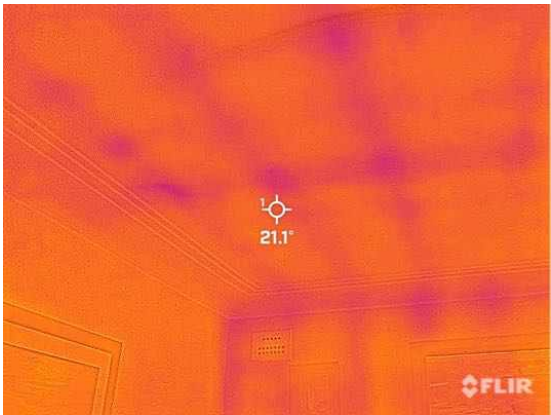
Building: Main Building
Location: All Areas
Finding: Additional Photos
Information: Thermal imaging camera was used to detect any active water leaks or/ and termite activities in the property. No water leaks or termite activities were found from inspection by thermal imaging camera. Additional photos are attached for general reference.
