Building Inspection Report

Inspection Date: Sun, 4 Jan 2026

Property Address: 62 Victoria Rd, Loch VIC 3945, Australia

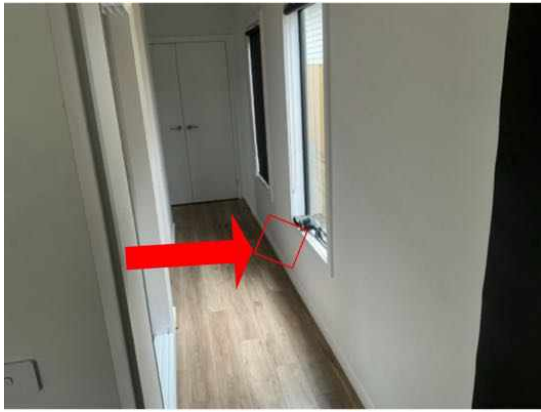
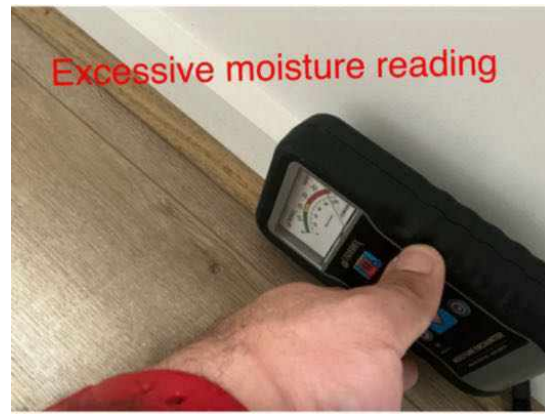
Defects 2.01

Building: Main Building
Location: Hallway
Finding: Major Defect – Suspected Water Ingress Affecting Hallway Wall and Finishes Adjacent to Window

At the time of inspection, excessive moisture readings were detected to the skirting boards beneath the hallway window. In addition, visible deterioration was observed to the internal plasterboard above the same window, including paint peeling, cracking along the plaster joint, and surface damage. Non-invasive moisture testing and thermal imaging identified abnormal moisture presence in this area. The combined findings are consistent with moisture ingress occurring at or around the window opening, allowing water to enter the wall cavity and affect both lower and upper internal finishes.

As this dwelling has been recently completed and handed over by the builder, the presence of moisture-related damage within internal wall linings is of significant concern. If left unrectified, ongoing water ingress may continue to penetrate the wall cavity, potentially resulting in deterioration of concealed timber framing, swelling or decay of skirting boards, degradation of plasterboard linings, and an increased risk of mould growth. Continued exposure to moisture may also lead to more extensive damage and increased rectification costs over time.

It is strongly recommended that a registered builder and/or licensed plumber be engaged immediately to undertake an invasive investigation to determine the exact source and pathway of water ingress, including removal of internal linings where necessary. Any defects identified to the window installation, flashing, sealing, or integration with the external cladding system must be rectified without delay. Prompt action is essential to prevent further moisture penetration and consequential damage, particularly given the recent completion of the dwelling.

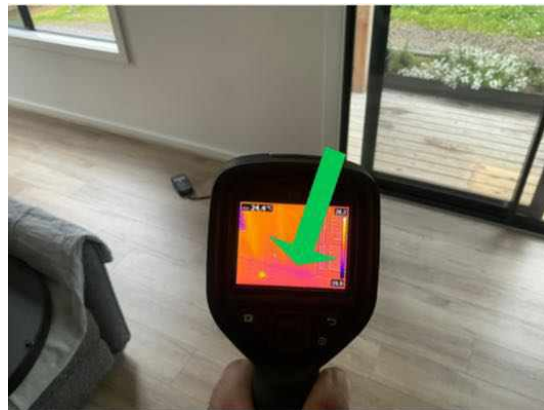
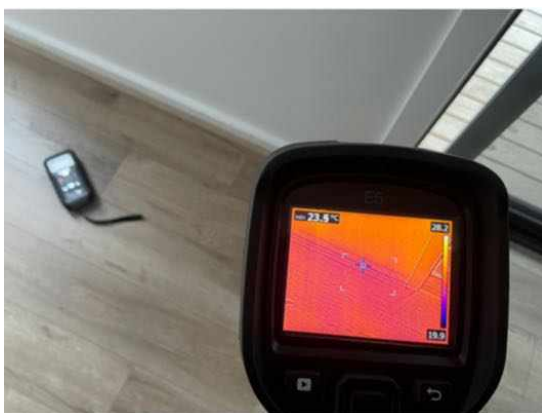
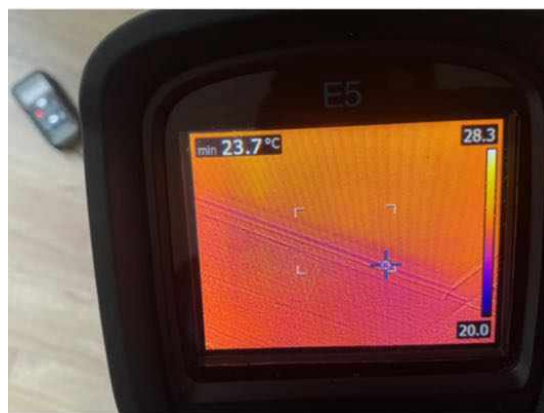
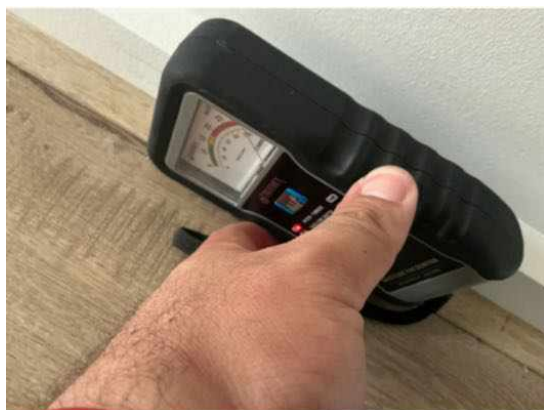
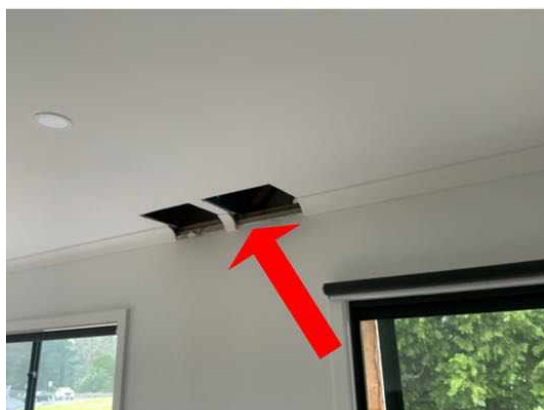
Defects 2.02

Building: Main Building
 Location: Entry
 Finding: Major Defect – Unrectified Ceiling Damage and Suspected Ongoing Moisture Ingress Adjacent to Entrance Sliding Door

Information: At the time of inspection, evidence of a previous water leak was observed at the entrance area adjacent to the sliding door. Sections of the internal ceiling plasterboard in this location had been cut to allow access to the roof space for repair works. However, at the time of inspection, these ceiling areas had not been reinstated, with exposed and unfinished plaster edges remaining visible. In addition, thermal imaging of the wall adjacent to the affected ceiling area identified abnormal moisture

concentration. Further non-invasive moisture testing to the skirting boards in this area recorded excessive moisture readings, indicating retained moisture within the wall cavity.

As this dwelling has been recently completed and handed over by the builder, the presence of unrectified ceiling damage and ongoing moisture within internal wall elements is of significant concern. If this condition remains unresolved, trapped moisture within the wall cavity may lead to deterioration of timber framing, damage to internal linings, and an increased risk of mould growth. The incomplete reinstatement of ceiling linings also represents poor finish and workmanship and may allow further moisture ingress if the original source has not been fully addressed.

It is strongly recommended that a registered builder and/or licensed plumber be engaged immediately to undertake an invasive investigation to determine the exact source and pathway of the moisture ingress, including inspection within the wall cavity and roof space as required. Any identified defects must be rectified without delay. Following confirmation that the moisture source has been rectified, all affected ceiling and wall linings are to be properly reinstated, including filling, sanding, and repainting to a smooth, consistent finish. Prompt rectification is essential given the recent completion of the dwelling and to prevent further moisture-related damage.

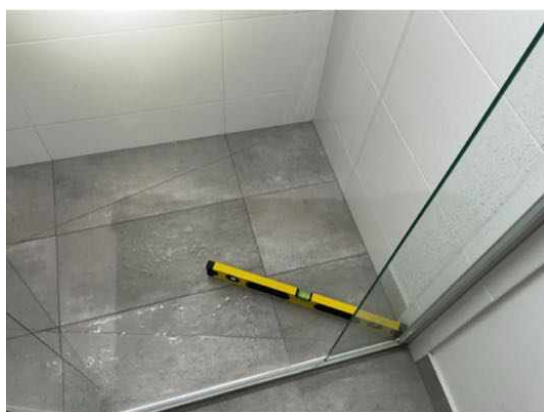
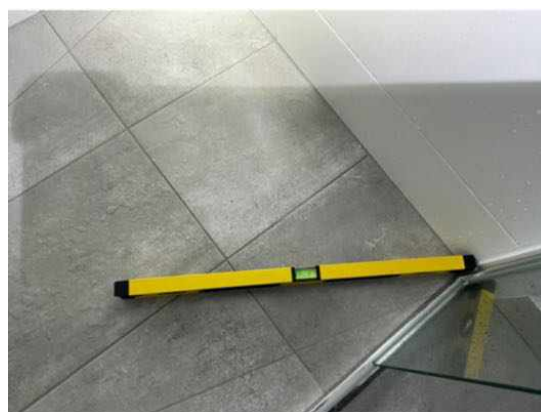
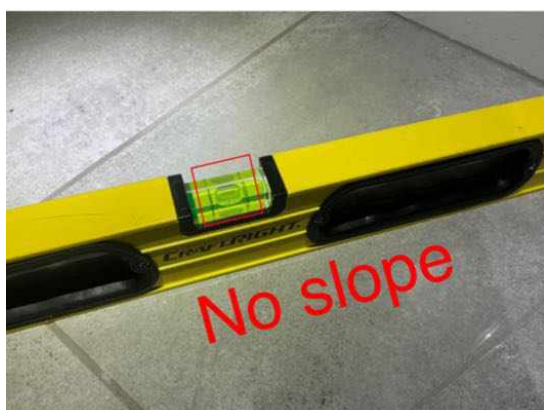
Defects 2.03

Building:	Main Building
Location:	Bathroom
Finding:	Major Defect – Non-Compliant Shower Floor Falls and Inadequate Drainage Performance
Information:

At the time of inspection, the shower floor was assessed using a 600 mm spirit level placed at multiple locations within the shower area. Several sections of the shower floor were found to have insufficient falls toward the floor waste, with some areas recording no measurable fall (flat). In accordance with AS 3740, shower floors are required to be graded to the waste with a minimum fall of 1:60, which equates to approximately 10 mm fall over every 600 mm. This minimum required fall was not achieved in the areas inspected.

To assess functional performance, the shower was operated continuously for approximately 20 minutes. During this period, water was observed to pool and remain scattered across multiple areas of the shower floor, rather than draining efficiently to the floor waste. The ponding visible in the shower area following operation confirms that the shower floor grading is ineffective and non-compliant.

Inadequate shower floor falls increase the risk of persistent water ponding, accelerated deterioration of grout and waterproofing systems, and potential moisture penetration to adjoining wall and floor junctions. This condition does not comply with

the minimum requirements of AS 3740 and is considered a significant defect in a recently completed dwelling.

It is strongly recommended that a registered builder and/or qualified tiler be engaged to carry out rectification works. Rectification is likely to require removal of floor tiles, inspection of the substrate and waterproofing membrane, regrading of the shower base to achieve compliant falls (minimum 10 mm fall over 600 mm toward the waste), and reinstatement of finishes. Rectification should be undertaken without delay.

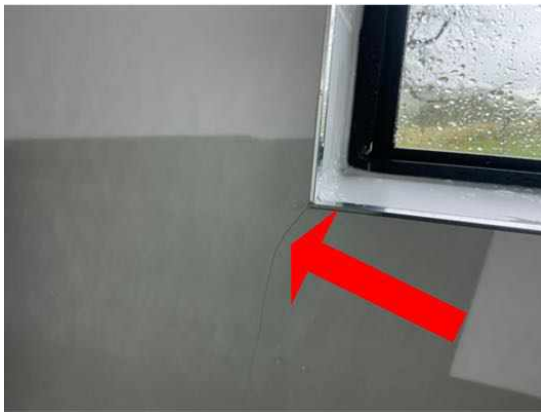
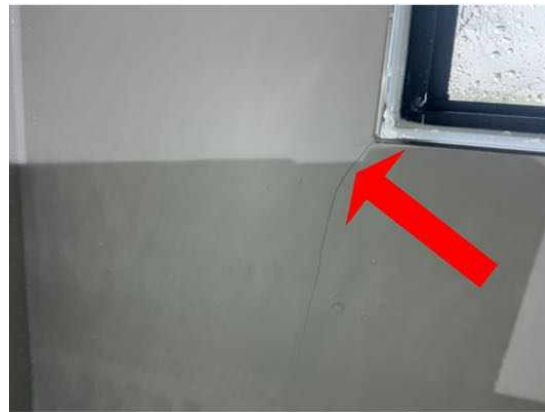
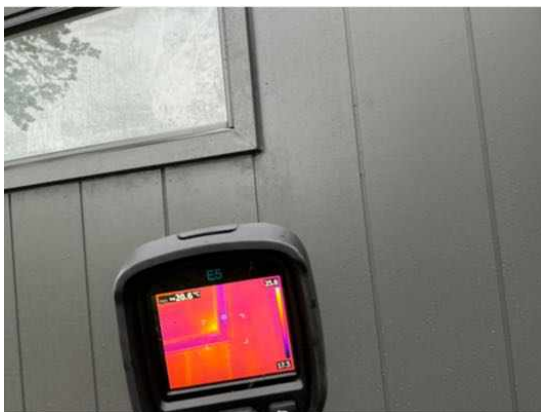
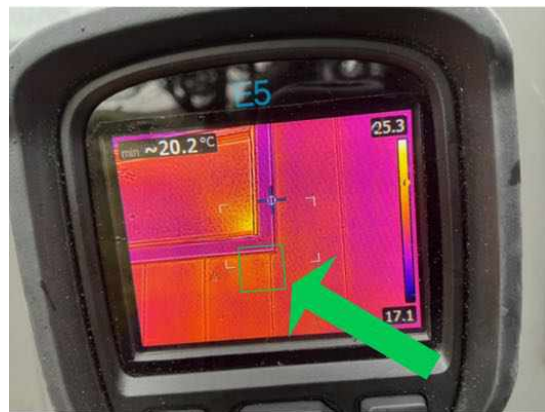
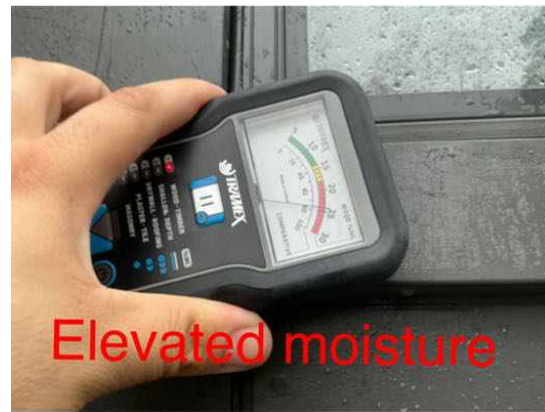
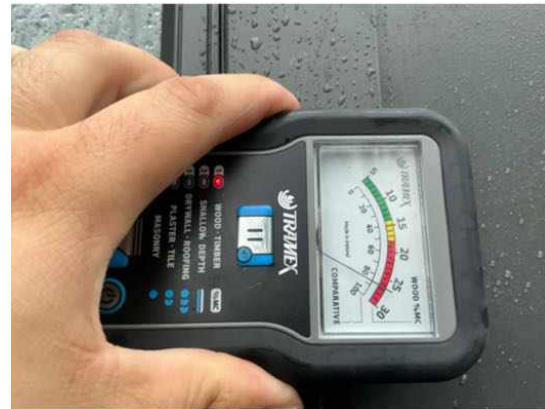
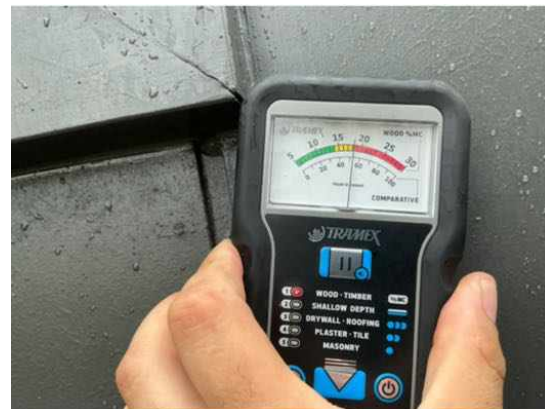
Defects 2.04

Building: Main Building
 Location: Bathroom
 Finding: Major Defect – Cracked Shower Tile and Suspected Water Ingress Through Wall Assembly

Information: At the time of inspection, a cracked floor tile was observed within the shower area. Given the dwelling is newly constructed, the presence of a cracked tile in a wet area is abnormal and of concern. A targeted water test was conducted by directing water toward the cracked tile for approximately 15 minutes. Subsequent inspection to the opposite side of the affected wall, including moisture testing to the external wall/cladding directly behind the crack location, identified elevated to excessive moisture readings in multiple areas.

The findings indicate that water may be penetrating past the tiled surface and waterproofing system at the location of the cracked tile, allowing moisture to enter the wall cavity. If left unaddressed, this condition may result in deterioration of the waterproofing membrane, damage to concealed wall framing, and an increased risk of mould growth and long-term moisture-related damage. This is a significant concern in a newly completed dwelling and suggests a failure in either the tile installation, substrate preparation, or waterproofing system.

It is strongly recommended that a licensed plumber and/or registered builder be engaged immediately to undertake an invasive investigation. This should include removal of the cracked tile, inspection of the underlying waterproofing membrane, and assessment of the wall cavity to confirm whether moisture is present or trapped behind the lining. Any defective waterproofing or tiling works must be rectified in full before reinstating finishes. Prompt action is required to prevent further moisture ingress and consequential damage.

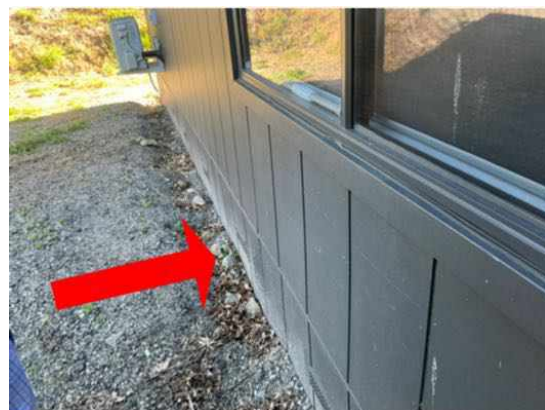
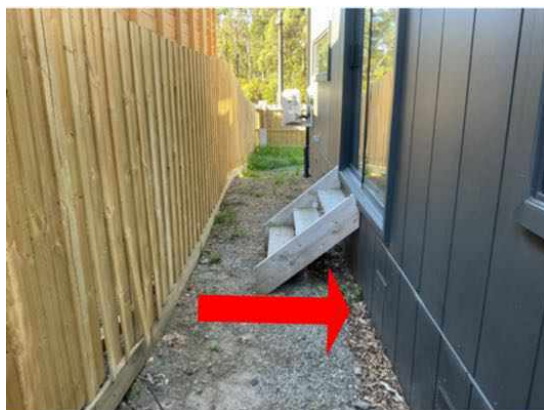
Defects 2.05

Building:	Main Building
Location:	All External Areas
Finding:	Inadequate Surface Drainage Resulting in Water Ponding and Subfloor Moisture Risk
Information:

At the time of inspection, the site was observed to have inadequate surface drainage around the dwelling, with ground levels sloping toward the building in multiple locations. Water is likely to pool against the external cladding and enter the subfloor area during rainfall events. This condition was particularly evident at the southern and eastern elevations, with the southern (rear) elevation being of heightened concern due to the significant natural slope behind the dwelling, which is likely to direct substantial volumes of surface water toward the building.

The current ground conditions indicate that, during periods of rainfall, water is likely to accumulate adjacent to the building perimeter and migrate into the subfloor area. Evidence of prior ground disturbance, including excavation or trenching works around the southern and eastern elevations, was noted; however, no visible evidence of subsoil (agi) drainage pipes or an effective perimeter drainage system was identified at the time of inspection.

If left unaddressed, ongoing water ingress into the subfloor may lead to persistent damp conditions, deterioration of building materials, increased moisture levels within the structure, and the creation of conditions conducive to termite activity. Prolonged exposure to subfloor moisture can also result in long-term durability and health concerns.

It is strongly recommended that the builder and/or a qualified drainage contractor be engaged as a matter of urgency to design and install an appropriate site drainage solution. This should include regrading of surface levels to direct water away from the building and the installation of a perimeter subsoil drainage system (agi drains) where required, connected to a lawful point of discharge. These measures are necessary to protect the dwelling from moisture ingress, particularly during heavy rainfall events.

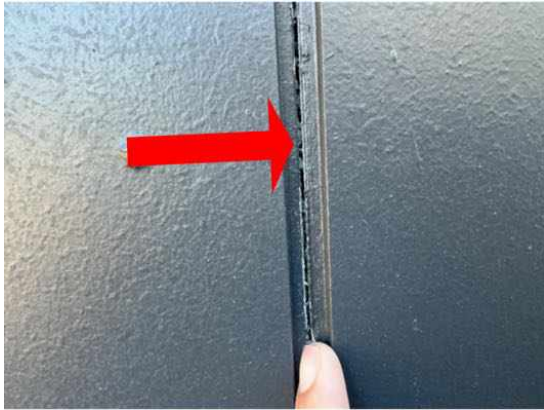
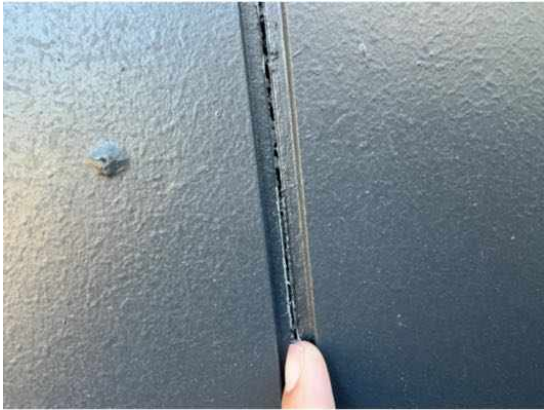
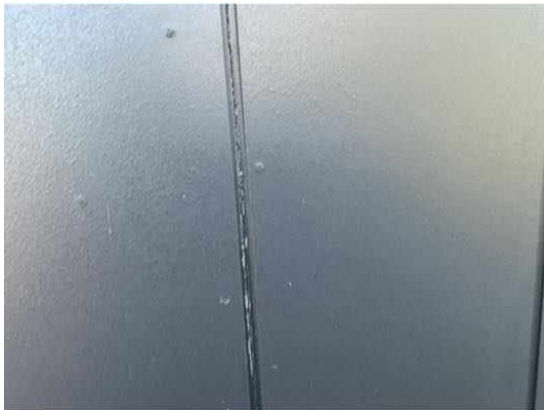
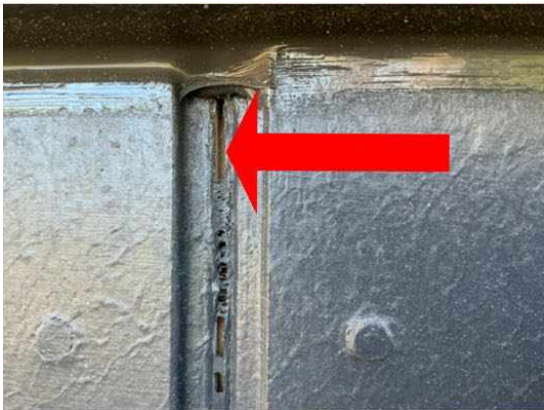
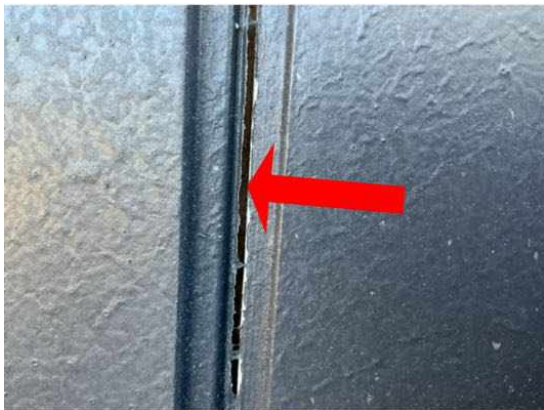
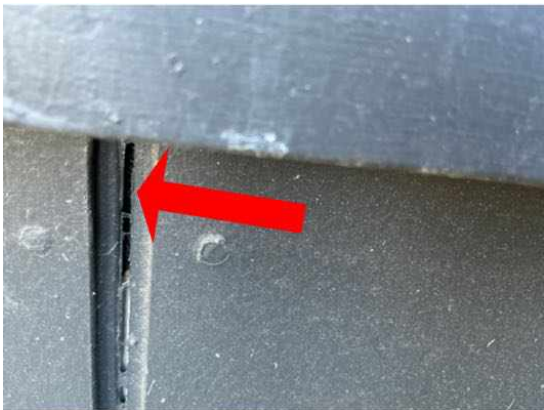
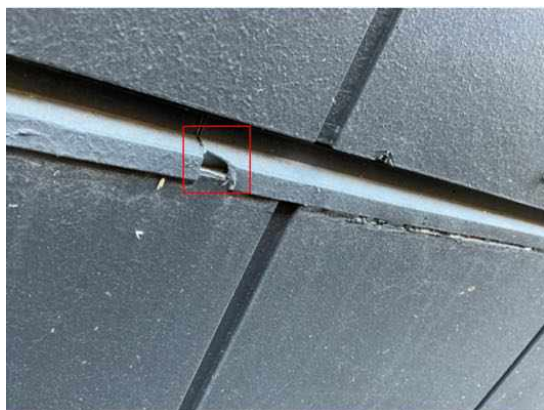
Defects 2.06

Building:	Main Building
Location:	All External Areas
Finding:	External Weathertex Cladding Joints Separated / Open Gaps Between Sheets
Information:

At the time of inspection, the external Weathertex cladding was observed to have open gaps and separation at sheet joints, with sections of the joint line appearing unsealed and inconsistent. In multiple locations, the joint opening appears large enough to expose the backing/interface behind the cladding, indicating the joint has not been finished or has separated since installation.

Open or poorly sealed cladding joints can compromise the weatherproofing performance of the external wall system. If left unrectified, wind-driven rain and moisture may enter behind the cladding, potentially wetting the wall wrap, battens/cavity components and framing, leading to moisture damage, deterioration of materials, and an increased risk of mould growth. This is of particular concern on a newly completed dwelling and is not consistent with acceptable workmanship for an external building envelope.

It is strongly recommended that the builder and/or qualified cladding installer be engaged to investigate and rectify the cladding joint detailing without delay. Rectification should include confirming the correct jointing method has been used for this Weathertex system (e.g., appropriate jointer/trim/backing strip and sealing method), reinstating the joints in accordance with the manufacturer's installation requirements, and confirming the wall wrap and cavity behind the affected joints have not been compromised by moisture. Any defective sheets, trims, or sealants should be replaced and the joint finish made good to achieve a consistent, weather-resistant outcome.

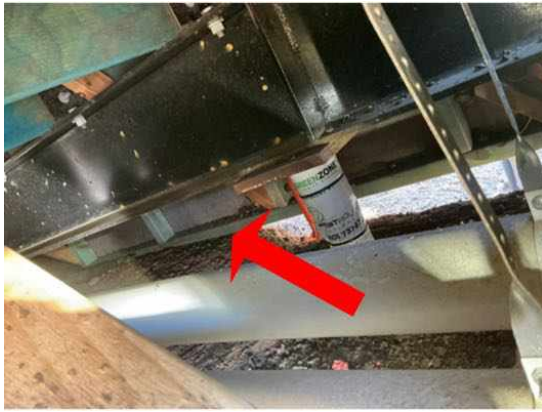
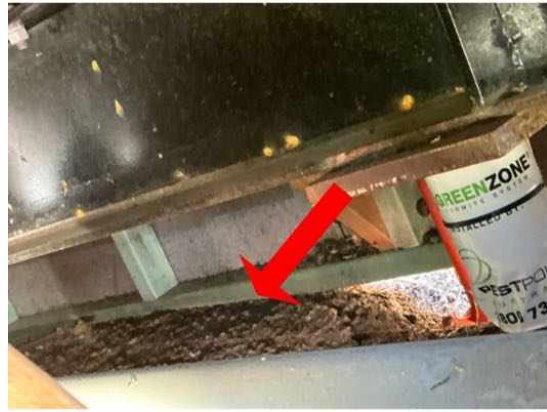
Defects 2.07

Building:	Main Building
Location:	All External Areas
Finding:	Timber framing in direct contact with soil
Information:

Sections of the subfloor timber framing were observed to be in direct contact with, or bearing on, the natural ground/soil. The timber is visibly seated against moist soil with no physical separation, capillary break, or durable barrier provided between the timber and the ground. This condition indicates that the timber is exposed to persistent ground moisture and wicking from the soil.

Timber in direct contact with soil is subject to continuous moisture exposure through capillary action, which significantly increases the risk of fungal decay, loss of structural integrity, and long-term deterioration of the timber section. Prolonged moisture exposure can lead to softening, rot, and reduction in load-bearing capacity. In addition, soil contact creates concealed conditions that accelerate biological attack and makes early detection of deterioration difficult.

The timber framing should not be in direct contact with soil. A registered builder should be engaged to remove soil contact, reinstate an appropriate separation between timber and ground, and repair or replace any affected timber. Works may include re-supporting the framing on compliant supports, improving ground levels and drainage, and replacing any timber that shows signs of moisture damage or deterioration to prevent ongoing structural and durability issues.

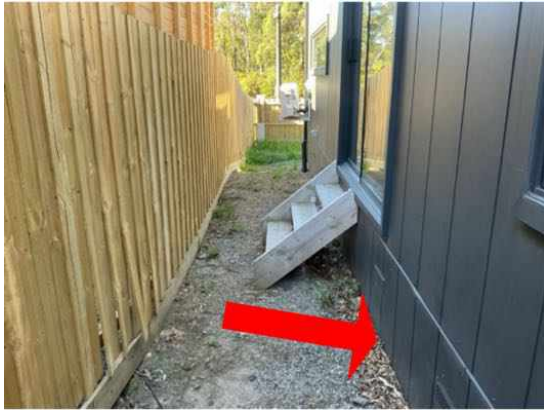
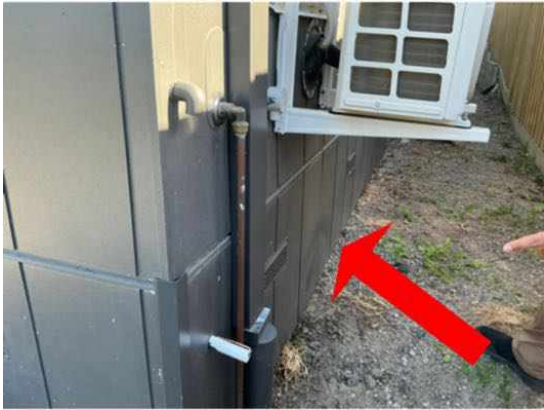
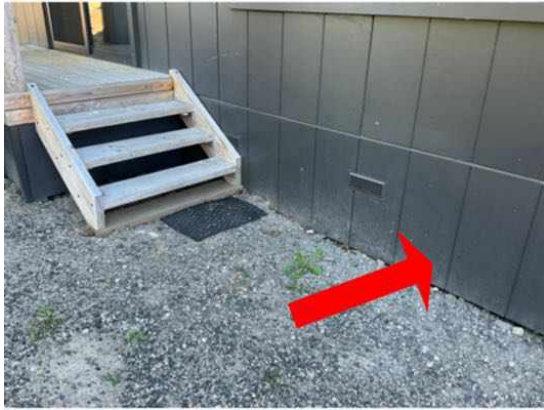
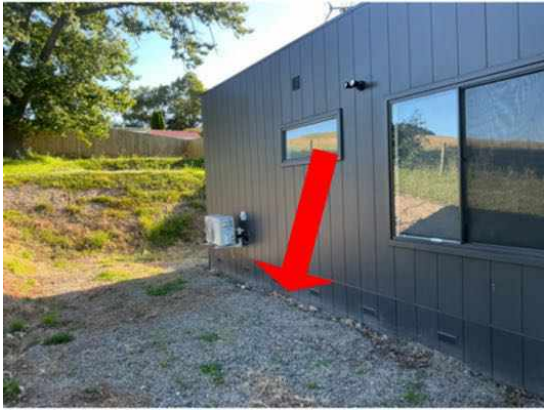
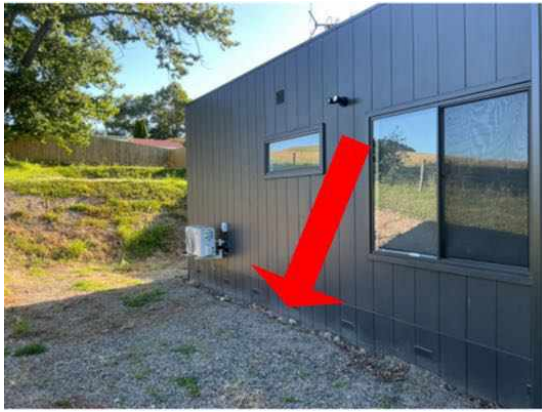
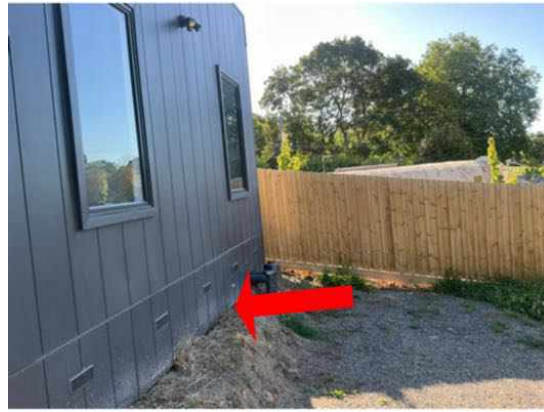
Defects 2.08

Building: Main Building
 Location: All External Areas
 Finding: Major Defect – External Weathertex Cladding Installed with Inadequate Ground Clearance

Information: At the time of inspection, the external Weathertex wall cladding was observed to be installed with insufficient clearance to the surrounding unprotected ground in multiple locations around the entire perimeter of the dwelling. In many areas, the cladding terminates at or very near ground level, with soil, gravel, leaf debris, and natural ground buildup in close proximity or direct contact with the bottom edge of the cladding.

This installation does not comply with the Weathertex installation manual, which requires a minimum clearance of 225 mm between the bottom edge of the cladding and unprotected ground (such as soil, garden beds, or natural ground). Inadequate ground clearance significantly increases the risk of moisture ingress through capillary action and splash-back, leading to persistently damp conditions at the base of the wall system. If left unrectified, this may result in deterioration of cladding materials, moisture penetration into the wall cavity, internal moisture damage, and the creation of conditions conducive to termite activity, particularly given the reduced ability to visually inspect the subfloor perimeter.

It is strongly recommended that the builder be engaged to urgently rectify this condition by regrading and lowering ground levels around the entire dwelling perimeter to reinstate a minimum 225 mm clearance to unprotected ground, in strict accordance with the Weathertex installation requirements. Where site conditions result in water collecting or flowing toward the building, appropriate surface and/or subsoil drainage measures should also be installed to ensure water is directed away from the structure and does not accumulate against the cladding or subfloor area.

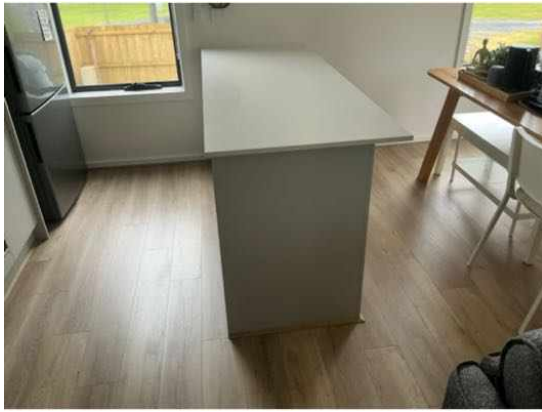
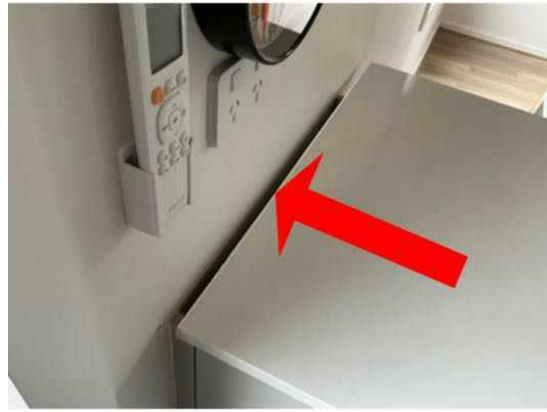
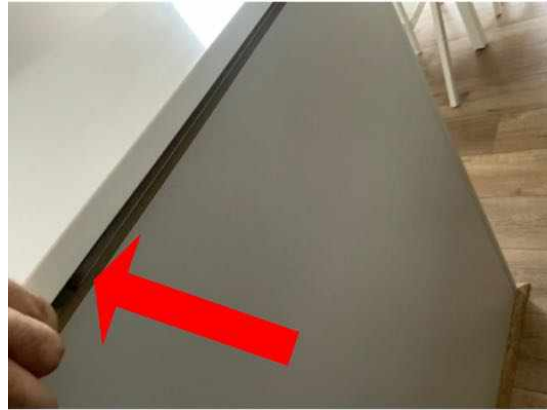
Defects 3.01

At the time of inspection, the kitchen benchtop was found to be inadequately secured to the underlying cabinetry. The benchtop was loose and moved when light pressure was applied, indicating that it has not been fixed correctly to the joinery.

If left unrectified, continued movement may result in damage to the benchtop or cabinetry and reflects poor workmanship for a recently completed dwelling.

It is recommended that a qualified cabinetmaker or kitchen installation specialist be engaged to properly secure the benchtop to the joinery in accordance with standard installation practices.

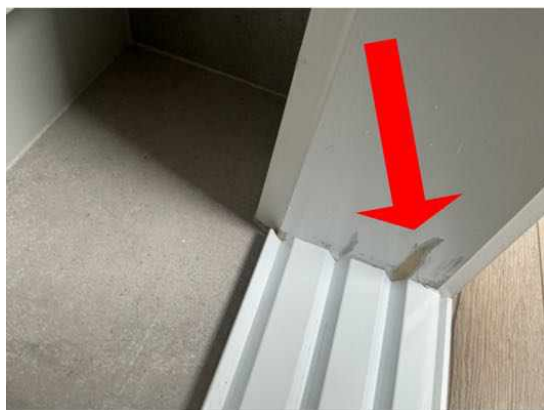
Defects 3.02

Building: Main Building
 Location: Laundry
 Finding: Damaged Paint Finish to Timber Sliding Door Frame (Laundry)
 Information:

At the time of inspection, damage to the paint finish was observed to the lower section of the timber frame to the sliding door in the laundry. The paint appears to have been removed or damaged, likely due to impact.

If left unrectified, the damaged finish may detract from the appearance of the door frame and reduce the durability of the painted surface.

It is recommended that the affected area be lightly sanded, prepared, and repainted to achieve a consistent and satisfactory finish.

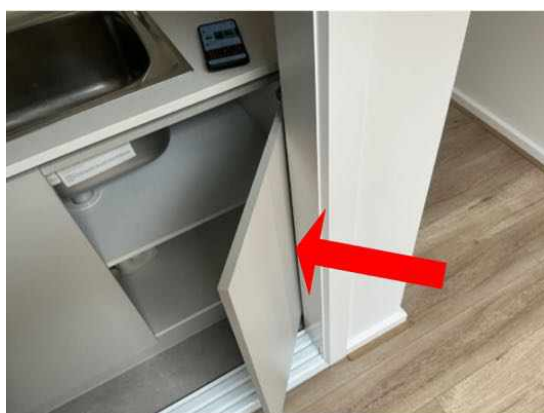
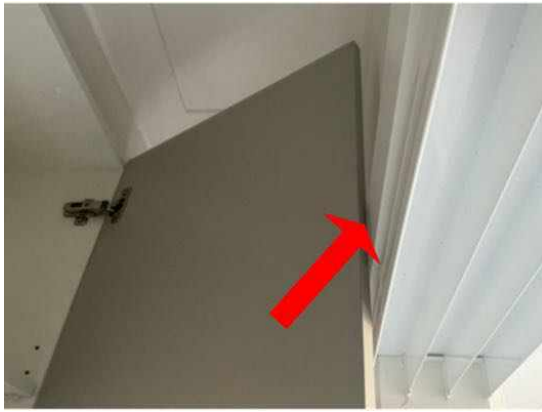
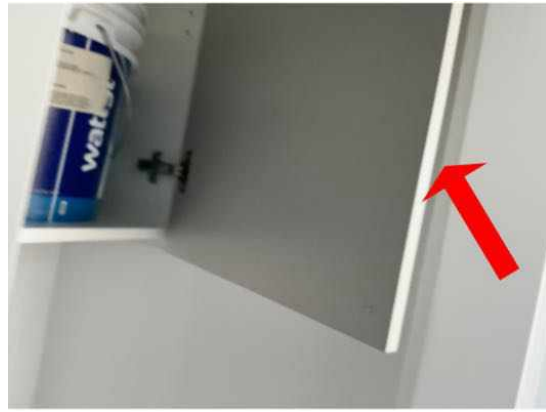
Defects 3.03

Building: Main Building
 Location: Laundry
 Finding: Laundry Cabinetry Doors Obstructed by Sliding Door and Frame
 Information:

At the time of inspection, the laundry cabinetry doors were found to be unable to open fully due to obstruction from the adjacent sliding door tracks and sliding door frame. This condition prevents proper access to the cabinetry and significantly restricts the functionality of the laundry space. It was noted that some internal cabinetry doors have been removed by the occupant to allow access, which is not an acceptable outcome for a completed dwelling.

The current configuration represents a poor design outcome given the limited size of the laundry, as the hinged cabinetry doors require clearance that is not available within the space.

It is recommended that the builder and/or cabinetmaker review the laundry cabinetry design and modify it to a more suitable solution, such as installing sliding or alternative low-clearance cabinetry doors, to allow practical and unobstructed use of the laundry without interference.

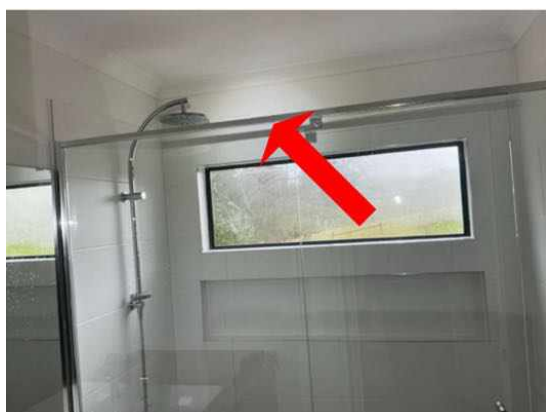
Defects 3.04

Information: At the time of inspection, the shower screen frame was observed to be flimsy and lacked adequate rigidity. Movement was evident when light pressure was applied, indicating that the frame has not been sufficiently secured or braced.

If left unrectified, continued movement may result in premature wear, loosening of fixings, or misalignment of the shower screen components.

It is recommended that a glazier or bathroom installation specialist review and adjust

the shower screen installation to ensure it is properly fixed and adequately rigid.

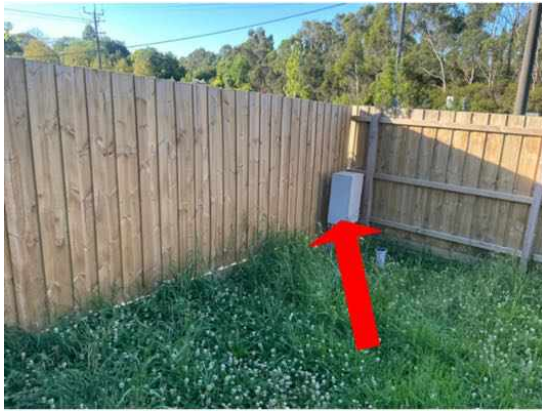
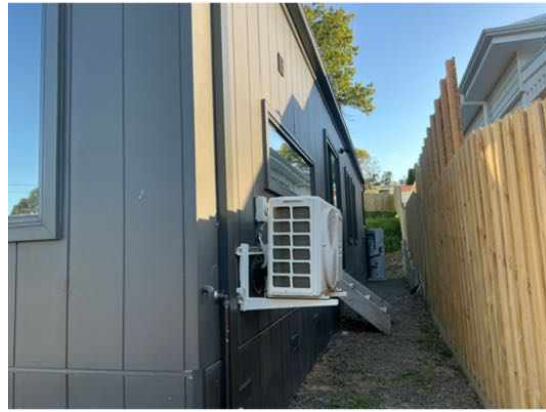
Defects 3.05

Building: Main Building
 Location: Western elevation
 Finding: Electrical switchboard installed contrary to approved stamped plans
 Information:

The approved stamped construction plans indicate that the main electrical switchboard was designed to be installed on the western elevation wall adjacent to the external air-conditioning unit. However, at the time of inspection, the main electrical switchboard was found to be installed in the front yard near the boundary fence. This location is not shown, detailed, or noted anywhere within the approved stamped plans provided for this dwelling.

Installation of the electrical switchboard in a location that differs from the approved stamped plans represents a departure from the approved design and raises concerns regarding regulatory compliance, design coordination, and owner consent. No evidence was available at the time of inspection to confirm that this change was formally approved, documented, or amended through revised plans, permits, or written owner authorisation. Unapproved changes of this nature can affect compliance, safety considerations, access requirements, and future maintenance or alterations.

The builder should be requested to provide written clarification and documentary evidence confirming whether this change was approved by the relevant authority and whether amended plans or permits were issued. If no approval exists, the installation should be reviewed by a licensed electrician and the relevant building surveyor to determine compliance requirements and whether rectification or formal approval is required to align the works with the approved documentation.

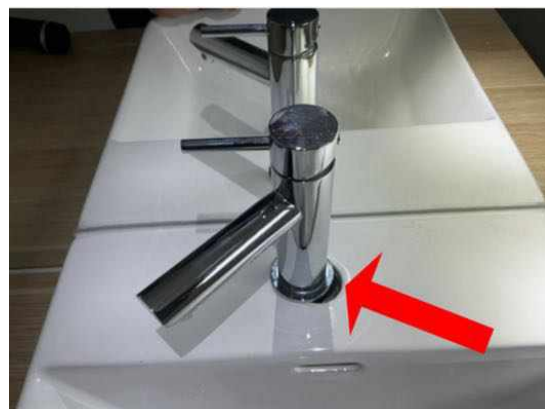
Defects 3.08

Building: Main Building
 Location: Bathroom
 Finding: Tap - Loose
 Information: The tap in the bathroom has not been installed correctly and is consequently loose. This tap being loose creates potential for water leaks and subsequent water damage to the surrounding area.

Where taps or spouts are loose, a qualified plumber should be appointed to re-fix the plumbing fitting.

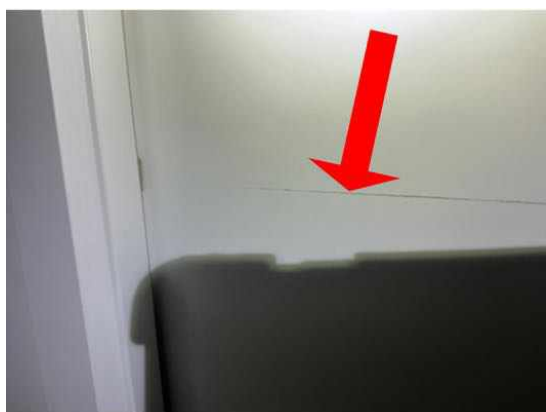
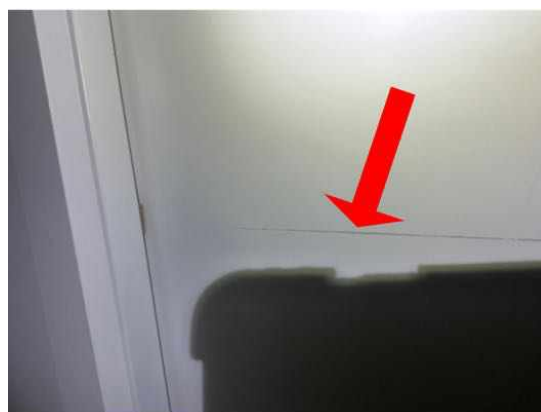
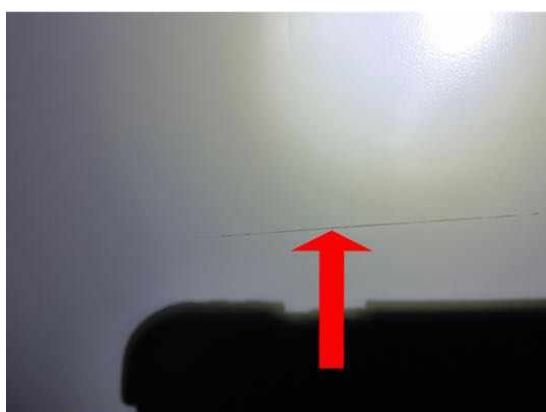
Defects 3.09

Building: Main Building
 Location: Toilet (WC)
 Finding: Sliding Door to WC Requires Realignment

Information: At the time of inspection, the sliding door to the WC was found to be misaligned and did not operate smoothly. The door showed signs of internal scratching, likely caused by contact with fixings or components within the wall cavity.

If left unrectified, continued operation in this condition may result in further damage to the door and affect its functionality.

It is recommended that a qualified carpenter or handyman realign the sliding door and adjust internal components as required to ensure smooth operation and prevent further damage.

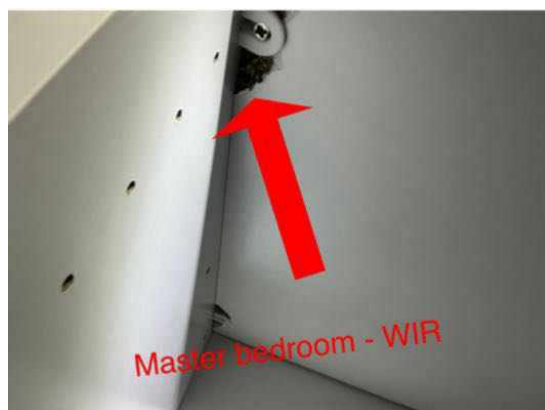
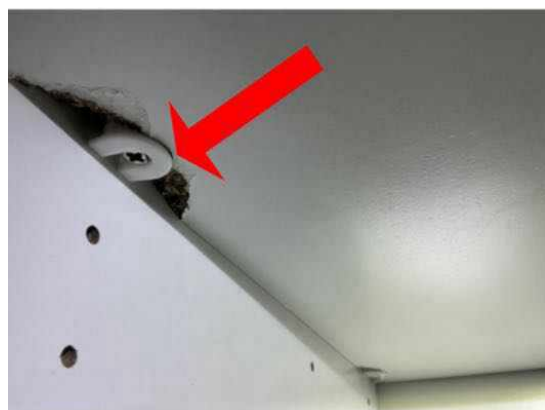
Defects 3.11

Building:	Main Building
Location:	All Internal Areas
Finding:	Substandard Workmanship to Joinery, Fixtures, and Finishes
Information:	The photographs provided show multiple instances of poor workmanship and incomplete finishes throughout the dwelling. These include cabinet modifications where screw and nail fixings have been left exposed without cover caps, damaged or inadequately installed flyscreens, bathroom door frames exhibiting an unsatisfactory finish requiring sanding and repainting, and poorly finished reworked cabinetry within the master bedroom walk-in robe. In addition, the silicone sealant applied around the kitchen window was found to be excessive and non-uniform, resulting in an untidy and visually unacceptable finish.

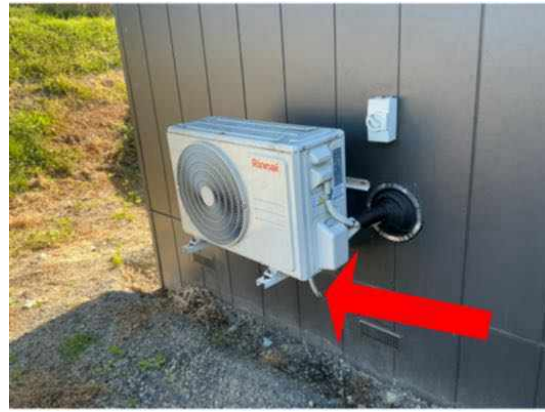
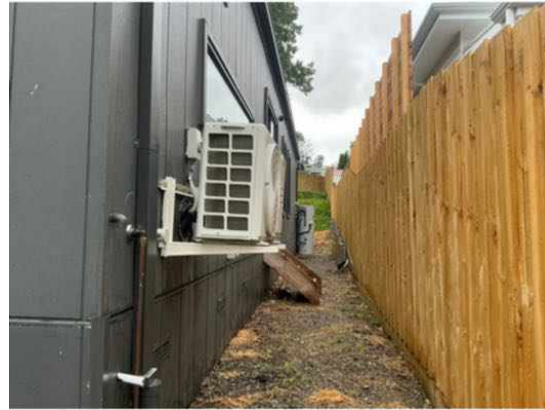
Defects 3.12

Building:	Main Building
Location:	All External Areas
Finding:	Air Conditioning Condensate Overflow Not Connected
Information:

It is recommended that a licensed plumber or qualified HVAC installer connect the condensate overflow to an approved drainage system, such as the stormwater system, in accordance with NCC plumbing requirements.

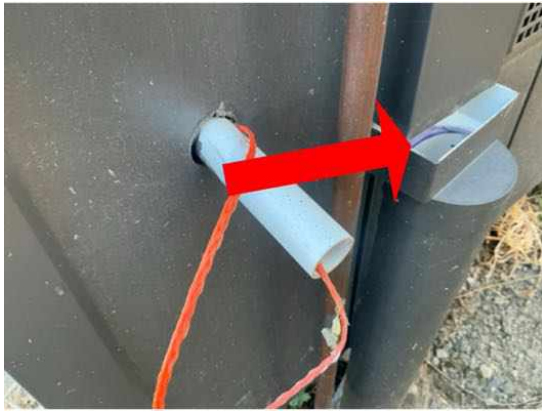
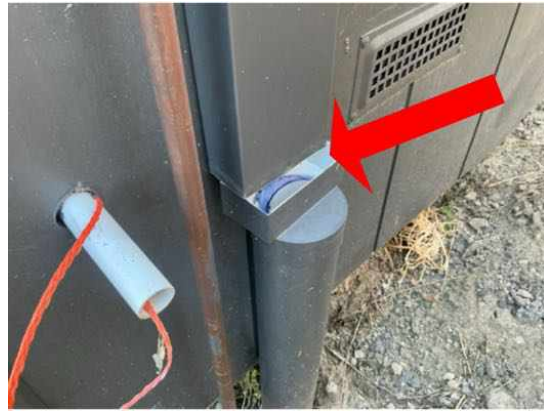
Defects 3.13

Building: Main Building
 Location: Western elevation
 Finding: Disconnected Downpipe at Western Elevation
 Information:

It is recommended that the builder or licensed plumber reconnect the downpipe to the stormwater system and make good the surrounding ground levels as required to ensure effective drainage.

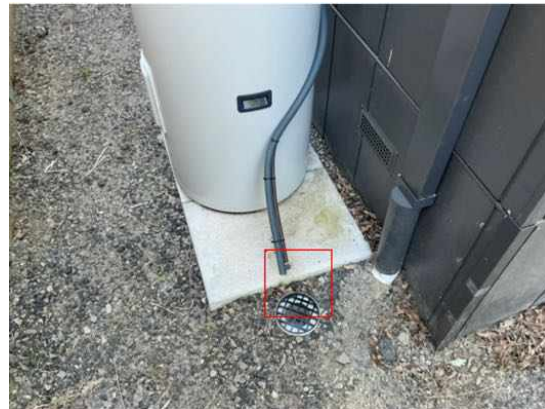
Defects 3.16

Building:	Main Building
Location:	Western elevation
Finding:	HWS Overflow - Not Connected
Information:	The Hot Water System (HWS) overflow was found to be disconnected from storm water drainage and is creating excessive moisture in the surrounding area.

It is highly recommended that a licensed plumber be appointed to connect the HWS overflow in order to prevent such an environment from being created. These minor works should be carried out as soon as possible.

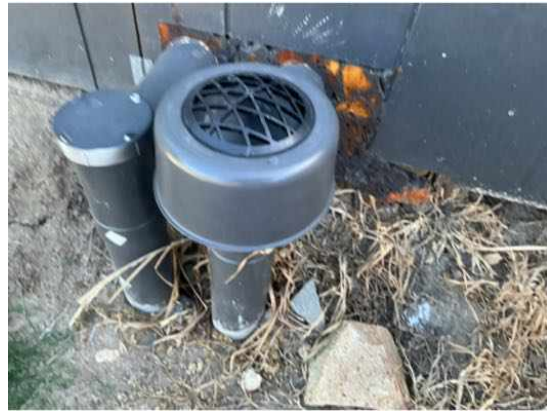
Defects 3.19

Building: Main Building
 Location: Northern elevation
 Finding: Northern Elevation: Use of Expanding Foam at Subfloor Penetrations
 Information:

It is recommended that the foam filler be removed and the penetrations be rectified by a suitably qualified contractor using appropriate flashing, sleeves, and sealants in accordance with good building practice and the cladding manufacturer's installation requirements, to ensure a durable and weather-tight outcome.

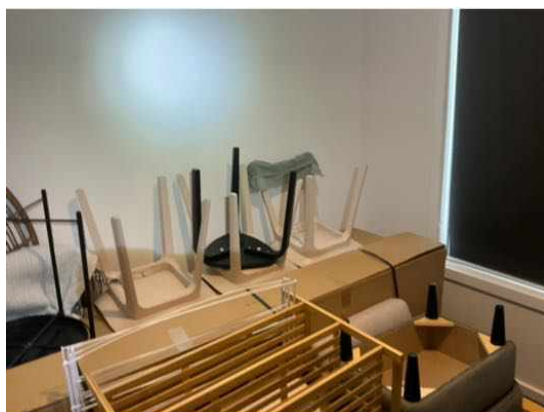
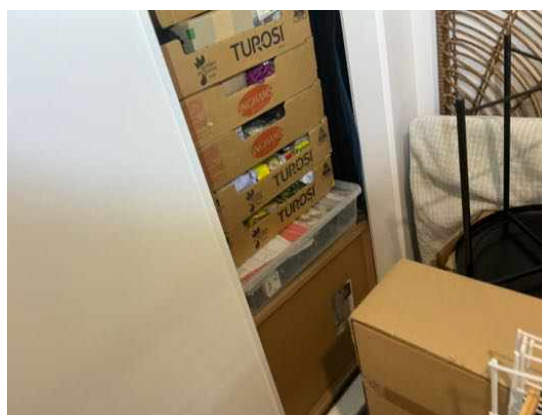
Building:	Main Building
Location:	All Internal Areas
Finding:	Obstructions and Limitations - Interior
Information:	These photographs are an indication of the obstructions and limitations which impeded the inspection of the internal areas of the property at the time of inspection. These obstructions can hide an array of defects and should be removed to allow full inspection to be carried out. A re-inspection is recommended once the areas are made accessible.

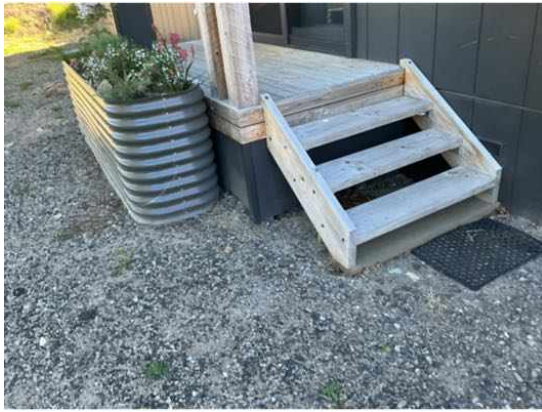
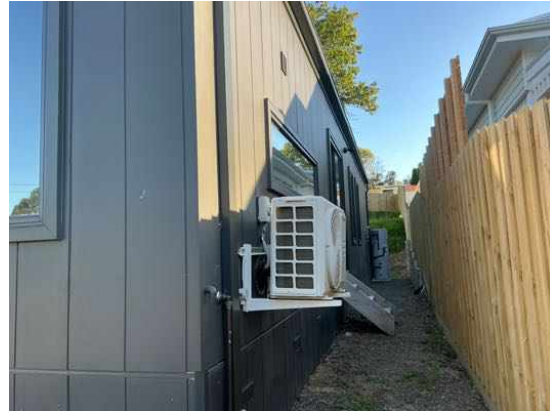
Building:	Main Building
Location:	All External Areas
Finding:	Obstructions and Limitations - Exterior
Information:	These photographs are an indication of the obstructions and limitations which impeded the inspection of the external areas of the property at the time of inspection. These obstructions can hide an array of defects and should be removed to allow full inspection to be carried out. A re-inspection is recommended once the areas are made accessible.

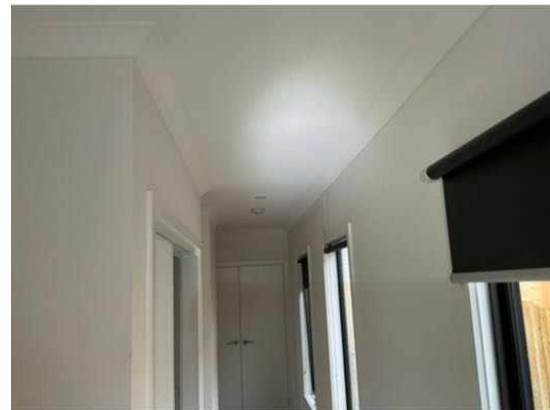
Building:	Main Building
Location:	Roof Void
Finding:	Obstructions and Limitations - Roof Cavity No access Hole
Information:	The roof cavity was inaccessible at the time of the inspection due to no access hole which impeded the inspection of the roof cavity of the main building at the time of inspection. These obstructions can hide an array of defects and should be removed to allow full inspection to be carried out. A re-inspection is recommended once the areas are made accessible.
