# Building and Timber Pest Inspection Report

Inspection Date: Thu, 26 Mar 2026

Property Address: 6 River St, Springfield NSW 2250, Australia

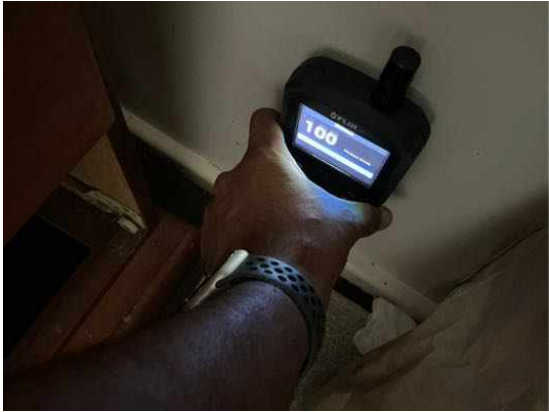
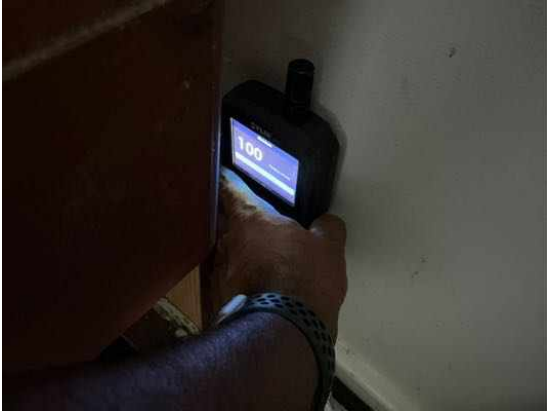
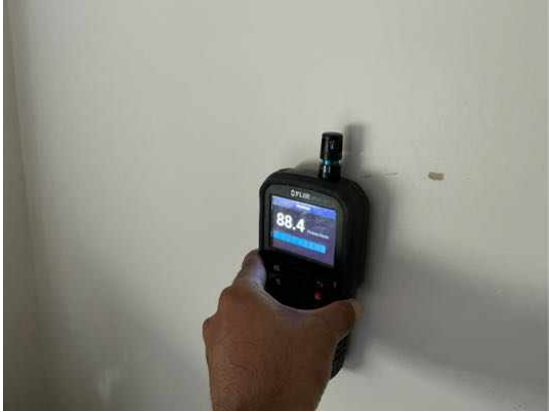
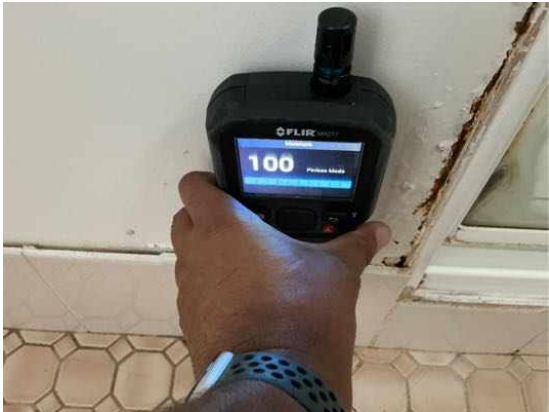
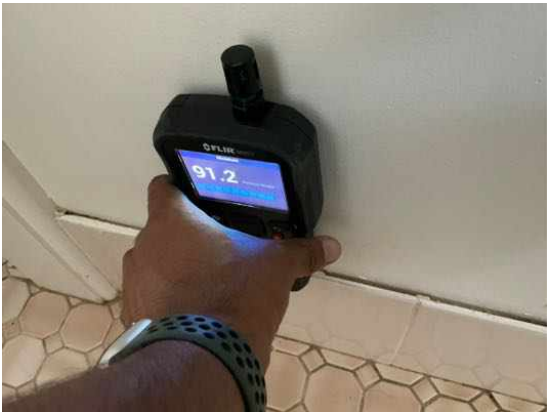
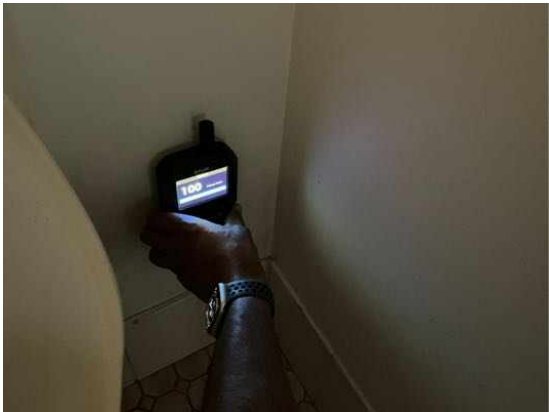
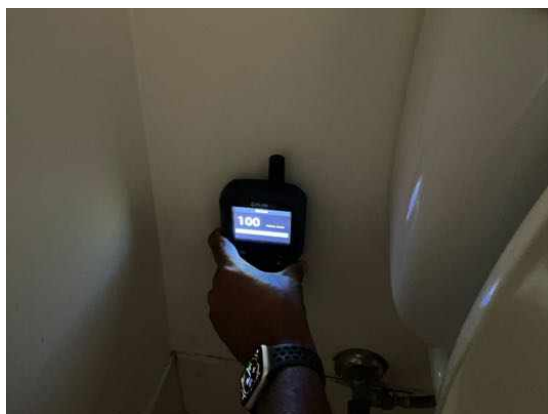
Building:	Main Building
Location:	Bathroom
Finding:	Excessive Moisture on Walls (Adjacent Bathroom) - Major Defect
Information:	A major defect was identified during the inspection, with evidence of moisture penetration noted on the walls adjoining the bathroom and shower area. These walls are shared with the bedrooms on either side of the bathroom. The presence of moisture raises serious concerns about the integrity of the waterproofing system, which is a critical component in preventing water ingress into adjoining structures.

The moisture penetration is likely due to a failure or inadequacy in the waterproofing membrane beneath the tiled surfaces in the bathroom and shower area. Waterproofing systems are designed to act as a barrier, and any breach can result in water escaping into adjacent walls. This could also be exacerbated by inadequate sealing around fixtures, joints, or tiles, which are common entry points for water. Additionally, the defect may be attributed to substandard installation practices or the natural wear and tear of waterproofing materials over time, both of which can compromise the membrane's effectiveness.

If left unaddressed, this issue could lead to significant consequences. Persistent moisture can weaken the structural integrity of the walls, resulting in costly repairs or replacement. Damp conditions also create an ideal environment for mould growth, which poses health risks and further compromises the interior condition of the property. Moreover, unresolved waterproofing issues can adversely impact the property's value and marketability.

The client is advised to use services of a professional waterproofing specialist as soon as possible.

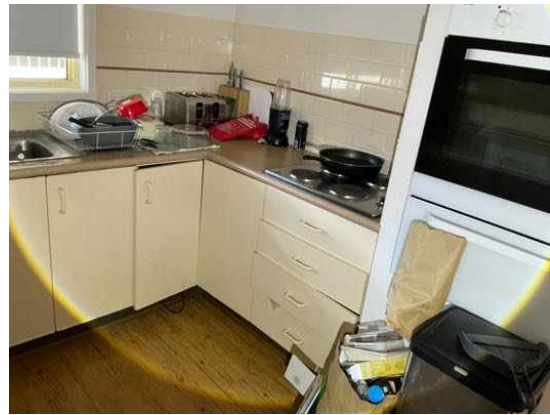
Building:	Main Building
Location:	Kitchen
Finding:	Kitchen Exhaust Fan - Missing
Information:	It was noted at the time of inspection, the kitchen is missing an exhaust fan, which is essential for proper ventilation.

Without adequate extraction, cooking fumes, steam, and grease particles can accumulate, leading to poor indoor air quality, excess moisture, and potential mould growth over time. Additionally, inadequate ventilation can cause lingering odours and contribute to the deterioration of cabinetry and wall finishes. To mitigate these risks and ensure compliance with ventilation standards, we recommend engaging a licensed electrician to install an appropriate exhaust fan that effectively removes airborne contaminants and improves overall air circulation.

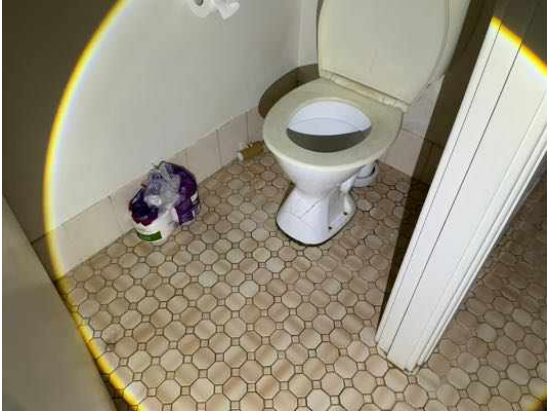
### Finding 3.09

Building:	Main Building
Location:	All Areas
Finding:	Tiles Coming off & Deteriorating Sealant/Grout
Information:	At the time of inspection, sections of tile were noted to be coming loose, with missing or deteriorated grout and sealant in the affected area. This condition may allow water to penetrate beneath the tiles, leading to potential moisture damage, mould growth, or further tile displacement. Rectification by a qualified tiler is recommended to resecure the loose tiles and reapply grout and waterproof sealant to restore the integrity of the surface.

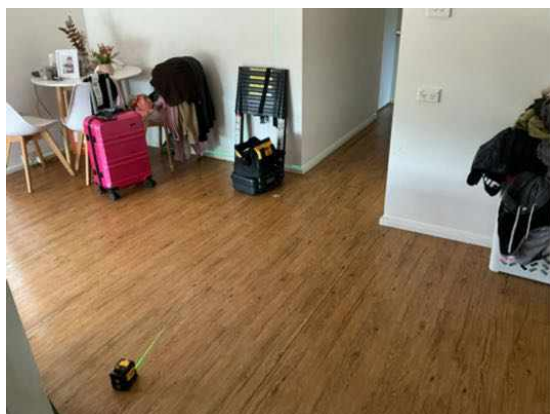
not pose an immediate structural risk, it can affect the overall durability and appearance of the flooring. Further actions are recommended such as leveling the subfloor, adjusting the flooring material, or reinforcing the underlying structure.

The client is advised to engage services of a flooring specialist at their own discretion.

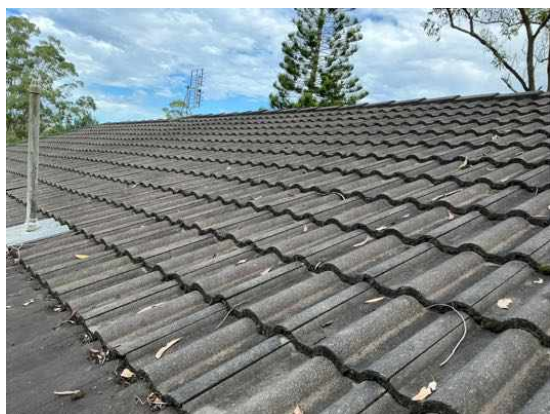
Finding:	Roof Tiles - Weathered
Information:	<p>It was noted at the time of inspection, the roof shows clear signs of weathering, with visible wear on the tiles and accumulated debris, such as leaves and branches. The tiles appear aged, which could lead to reduced durability if left unaddressed. There is also potential for moss, lichen or algae growth, which could exacerbate the degradation of the tiles and result in water ingress. It is recommended that the roof undergo a thorough cleaning and inspection to assess for any underlying damage. Regular maintenance is advised to preserve the roof's integrity and prevent further deterioration.</p> <p>The client is advised to engage services of a qualified roofer to undergo complete assessment of the roof.</p>

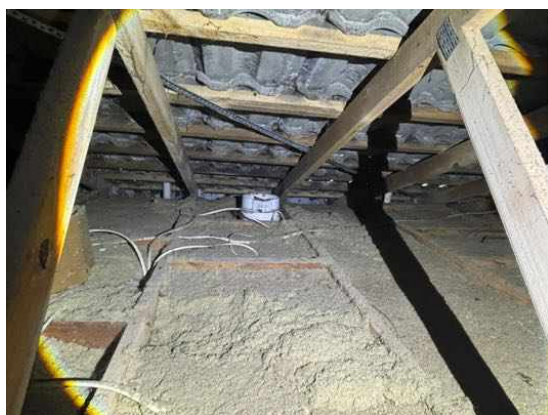
This configuration is a defect as it allows moist air to accumulate within the roof cavity, increasing the risk of condensation, mould growth, and deterioration of insulation or timber framing. Proper ventilation is essential to maintain a healthy indoor environment and protect the structural integrity of the building. It is recommended that the vent be appropriately re-routed to discharge externally in compliance with relevant building standards.

A licensed mechanical ventilation contractor/electrician should be appointed as soon as possible to provide further consultation on the scope of these works and to provide quotations for any necessary works.

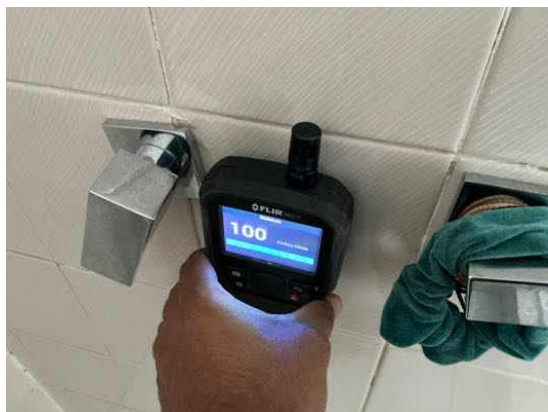
### Finding 3.23

Building:	Main Building
Location:	Bathroom
Finding:	Excessive Moisture - Shower Damp
Information:	At the time of inspection, excessive moisture was noted within the shower area, which is a common issue in wet areas due to the continual exposure to water. This condition is typically caused by moisture seeping through grout lines and settling behind tiles, resulting in localised high-moisture zones. Provided there is no evidence of water staining or elevated moisture readings on the opposite side of the wall, this is considered a minor defect.

However, persistently damp conditions may act as conducive conditions for termite activity, as termites are strongly attracted to moisture-rich environments. It is recommended that the client ensures regular use of the exhaust fan and maintains adequate ventilation after shower use to promote drying and reduce long-term moisture build-up, thereby also reducing the risk of attracting termites.

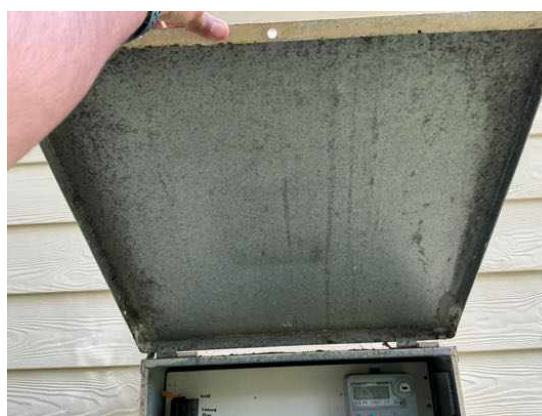
During the inspection, there was no indication that a termite management system had been installed, nor was there any evidence to suggest that preventative measures had previously been undertaken. The client is encouraged to seek further advice from a licensed pest controller regarding the costs and procedures involved in the application of a termite barrier. Prioritizing this step in the short term is strongly advised to ensure long-term protection.

Additionally, the client may want to consult with the vendor to determine whether regular Timber Pest inspections, as per AS4349.3 or AS 3660.2, have been conducted in the past. This will provide further insights into any past termite management practices and help inform the appropriate course of action.

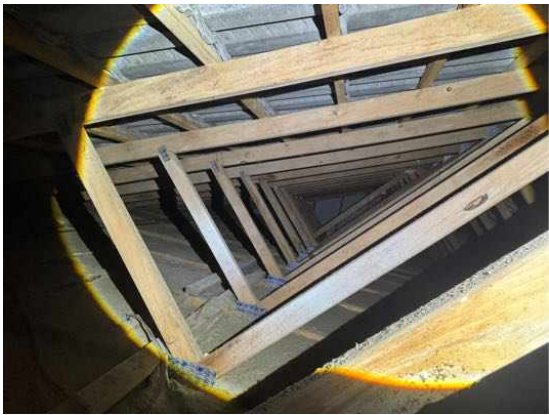
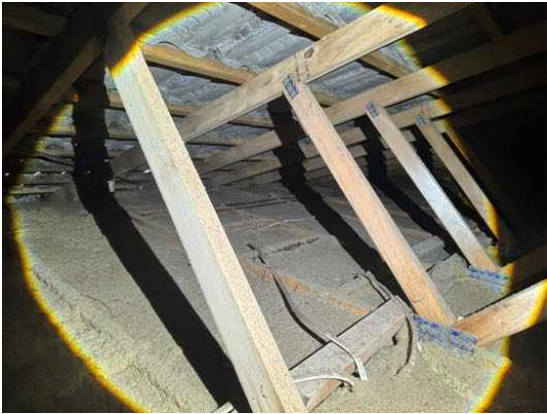
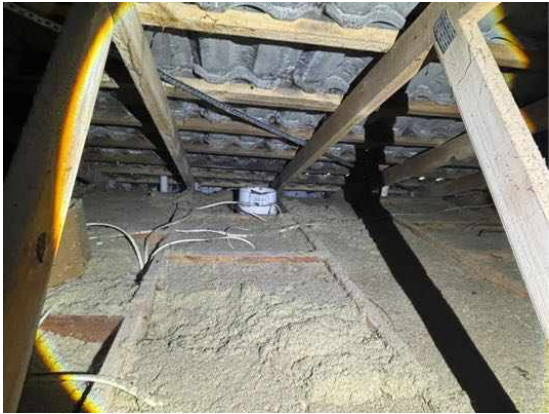
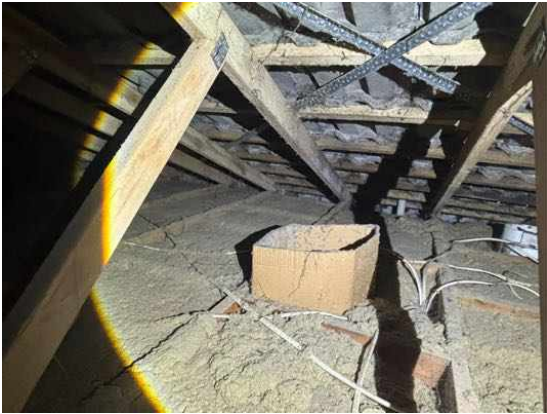
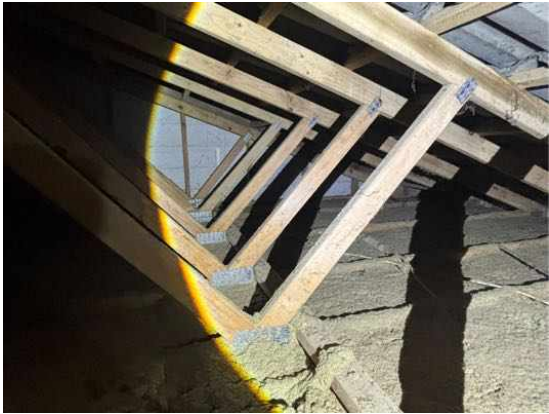
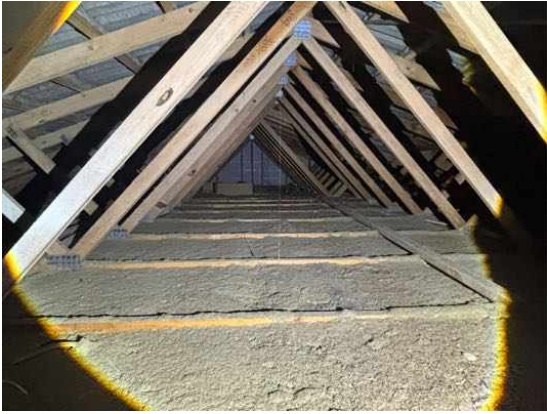
Building: Main Building  
 Location: Roof Void  
 Finding: Obstructions, Limitations, and General Roof Space Condition  
 Information: The photographs provided document both the general condition and the obstructions and limitations that were present in the roof cavity of the main building at the time of inspection. These obstructions—such as insulation materials, stored items, structural elements, or electrical wiring—restricted safe and adequate access to key areas within the roof space. As a result, a comprehensive inspection of all components could not be completed.

Obstructions of this nature may conceal a variety of potential defects, including damaged framing, compromised insulation, evidence of moisture ingress, pest activity, or electrical hazards. While no major issues were observed in the visible areas, the presence of these limitations means that some defects may remain undetected.

It is recommended that these barriers be removed or repositioned to facilitate full and safe access to the roof space. Once clear, a follow-up inspection should be conducted to allow for a thorough assessment of all concealed areas. This will help ensure that the condition of the roof cavity is accurately evaluated and any hidden issues are appropriately identified and addressed.

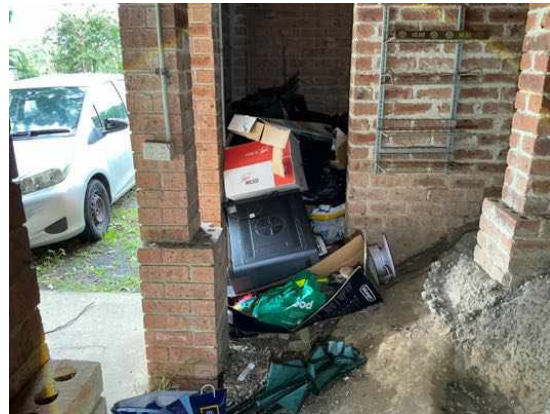
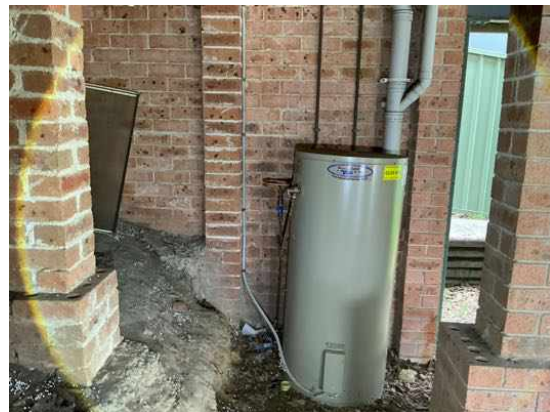
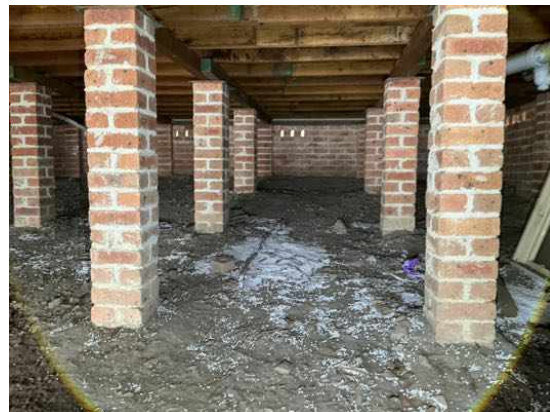
Building: Main Building  
 Location: Subfloor  
 Finding: Obstructions, Limitations, and General Subfloor Condition  
 Information: The attached photographs illustrate the obstructions and access limitations that restricted a full inspection of the subfloor area of the main property at the time of assessment. Items such as stored materials, construction debris, low-hanging services, and insulation impeded movement and visibility within key sections of the subfloor. In addition, the limited crawl height further restricted safe access to inspect critical structural components.

While no major concerns were identified in the accessible areas, a full and unobstructed inspection is necessary to properly assess the overall condition of the subfloor. It is recommended that obstructions be removed and access improved where possible. Once adequate clearance is provided, a re-inspection should be arranged to ensure that any concealed defects can be identified and addressed accordingly. This will assist in providing a more comprehensive understanding of the

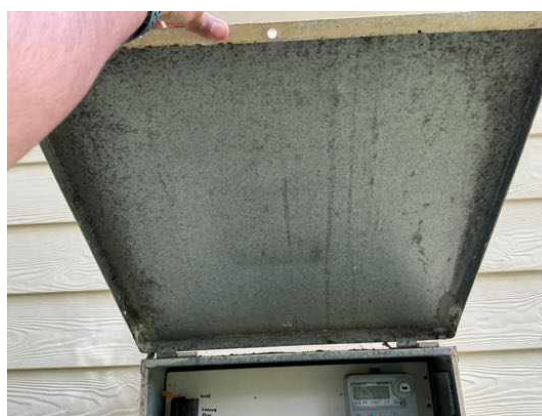
Building: Main Building  
 Location: Meter Box  
 Finding: Termite Management Recommendation – No Evidence of Chemical Installation  
 Information: At the time of inspection, there was no visible evidence of a chemical termite management system installed around the property. Chemical barriers are a key component of termite protection and are particularly important in preventing concealed termite entry into timber elements of the structure.

In accordance with standard requirements, a durable notice should be located within the electrical switchboard to detail any termite protection systems applied, including chemical treatments. No such notice was observed during the inspection.

It is recommended that the client engage a licensed pest controller to assess the suitability of installing a chemical barrier, and to provide advice on associated costs and procedures. This should be considered a short-term priority, particularly if the property has any history of termite activity or is located in a high-risk area.
