# Building and Timber Pest Inspection Report

Inspection Date: Wed, 4 Mar 2026

Property Address: 20 Ravenswood Rise, Bella Vista NSW 2153, Australia

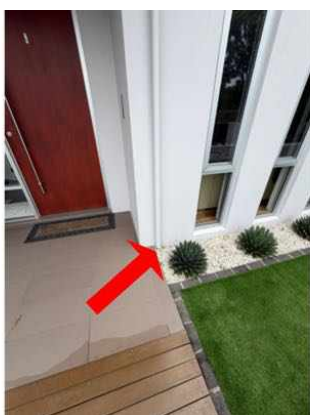
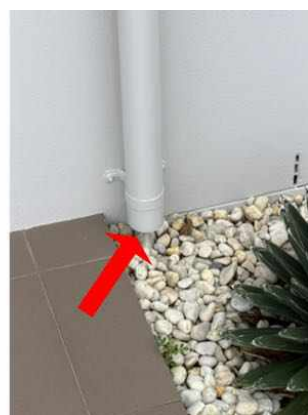
### Finding 6.02

Building:	Main Building
Location:	Downpipes
Finding:	Downpipe(s)-not connected
Information:	The roof plumbing is not adequately connected to stormwater drainage on the site. This disconnection negatively impacts the functional capacity of the roof plumbing.

Where roof plumbing doesn't drain adequately, the area at the base perimeter can become excessively damp, potentially creating an environment that is susceptible to rust and corrosion of surrounding building elements, as well as attracting termites and other pests.

It is highly recommended that a plumber be appointed to further inspect the area and to connect all downpipes adequately as soon as possible.
