Building Inspection Report

Inspection Date: Thu, 26 Feb 2026

Property Address: 9 Franklin Court, Sheidow Park SA 5158,
Australia

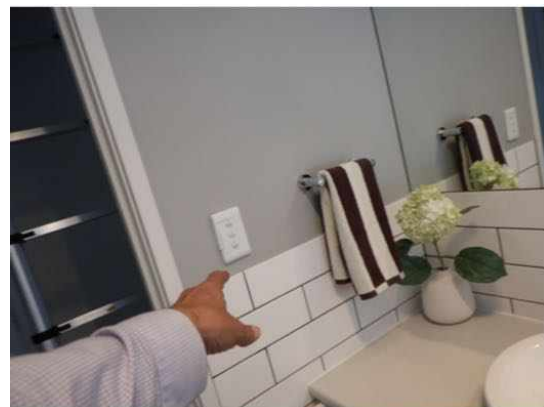
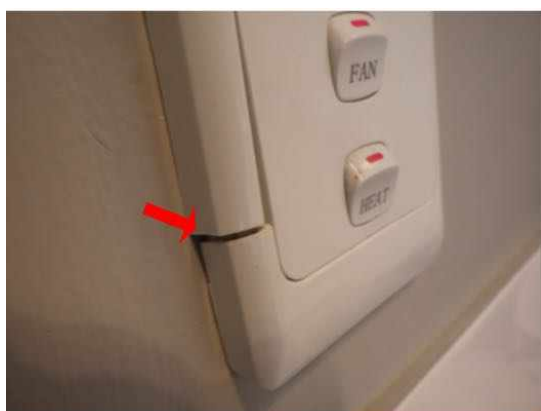
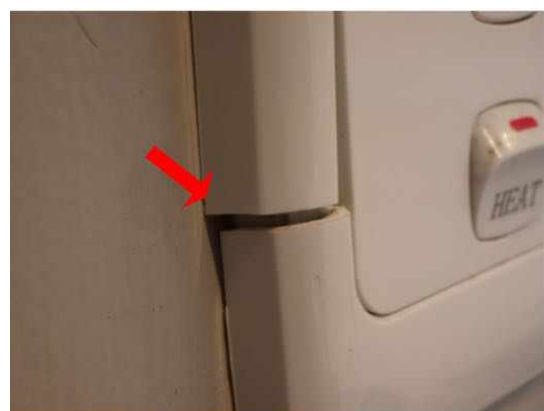
Defects 1.01

Building: Building 1
Location: Bathroom 2
Finding: Electrical fitting - Broken
Information: The electrical fitting in this bathroom-2 area was found to be broken at the time of inspection. Breakage occurs generally when the building materials have aged and decayed, but may also be indicative of impact damage to the building element (accidental or deliberate).

Left unmanaged, the fitting is unlikely to cause further damage to surrounding building elements. However, the broken fitting does expose electrical works, and may create a safety hazard if there is potential contact with persons in the area.

Repair and/or replacement of the broken fitting is advised. A Licensed electrician should be appointed to repair/replace the fitting immediately.

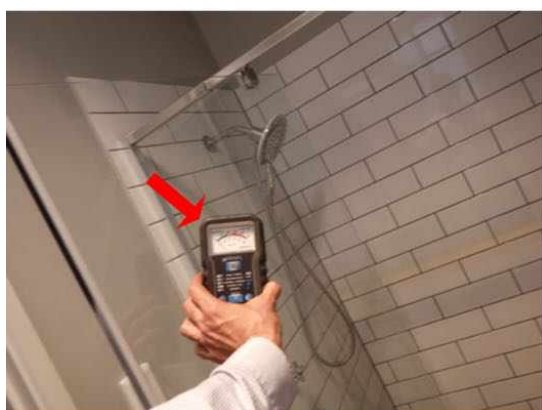
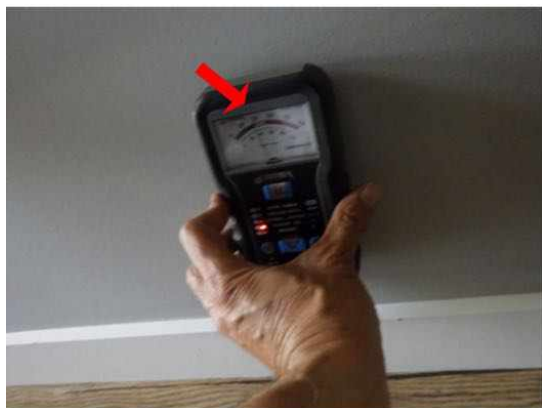
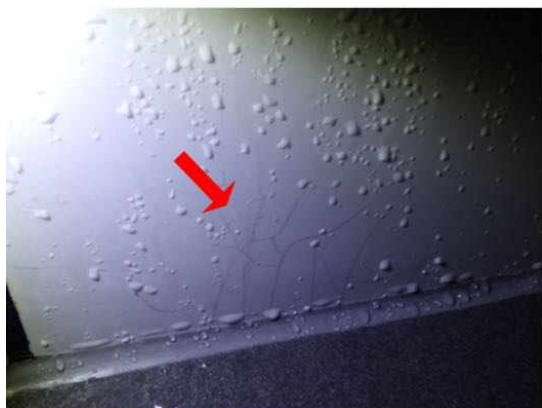
Defects 2.01

| Finding: | Shower Alcove - Damp & Moisture transferring to other side of the walls |
| Information: | Damp is evident to the lower 400mm approximately of wall to the shower alcove. This defect is quite common, and is suspected to have been caused by moisture permeating through the grouting in this area, which shows evidence of deterioration. Leaking pipes within the adjoining wall is also a possible cause. |

Apart from that at the time of inspection it was also noticed that moisture is transferring to other side of the walls.

Unmanaged damp in the shower recess is likely to facilitate the formation and development of mould and fungi growth, decaying associated building materials and compromising their structural integrity. Exposure to these contaminants is associated with a wide range of respiratory and other health-related problems.

Consultation with a qualified plumber or bathroom specialist is advised immediately to identify the cause of damp and to perform remedial works as required. Where excessive mould growth is present, further inspection by a specialist environmental health inspector should also be considered.

Always ensure that sealant and grout is in good condition to prevent any moisture issues occurring in the future.

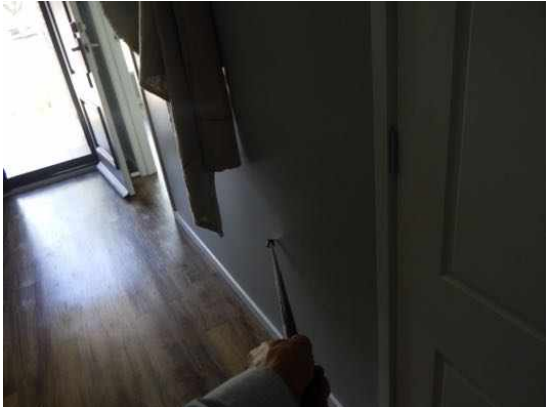
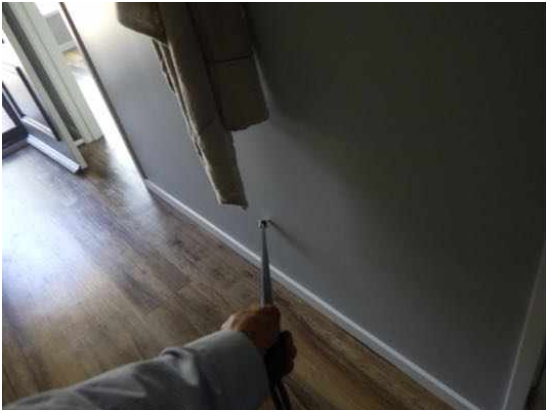
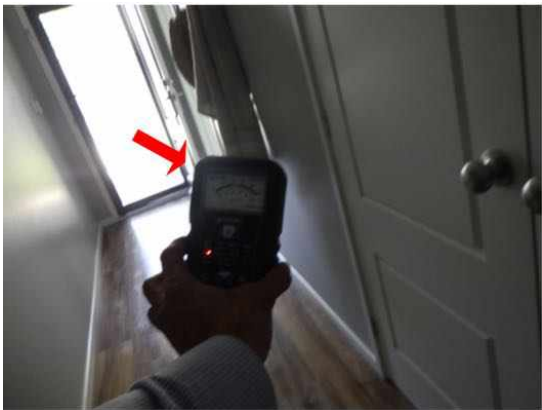
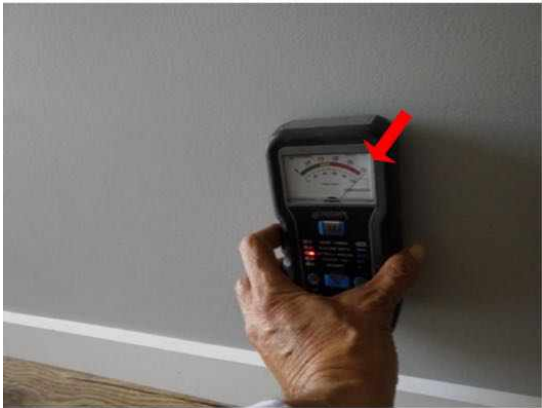
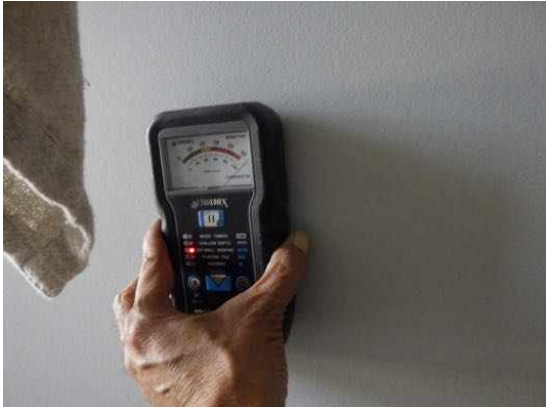
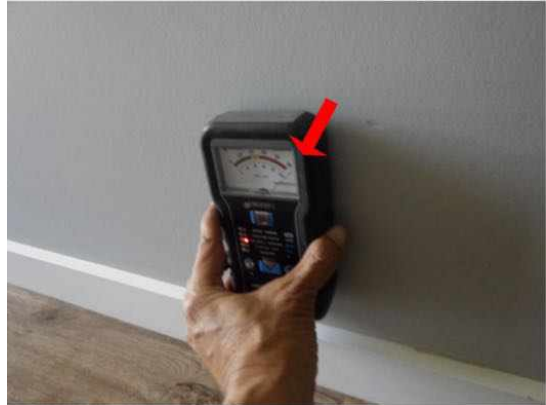
Defects 2.02

| Finding: | Internal walls - Damp adjacent to bathroom wall |
| Information: | At the time of inspection it was noticed that high moisture readings were noticed in this internal walls adjacent to bathroom - ensuite . |

Unmanaged damp facilitates the formation and development of mould, fungi growth and wood rot, decaying associated building materials and compromising their structural integrity. Damage to finishes is also likely to occur, including lifting, bubbling, peeling and staining of paint, plaster and wallpaper.

The first step in addressing damp is to diagnose the cause. The identified cause

should be addressed first prior to repairing the appearance and other defects which have resulted from the rising damp. If the original cause is not resolved, further cases of damp are likely to ensue, resulting in secondary defects.

Consultation with a qualified plumber is advised immediately to identify the cause of damp and perform remedial works as required. Where excessive mould growth is present, further inspection by a specialist environmental health inspector should also be considered.

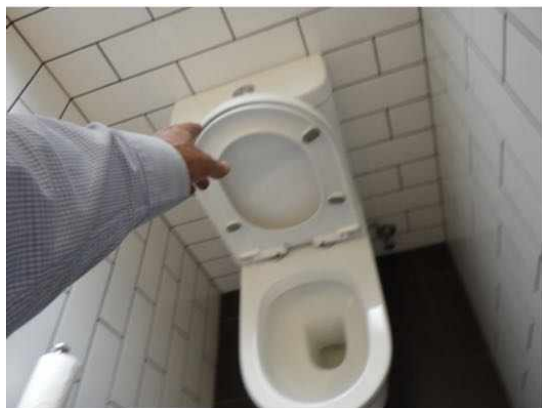
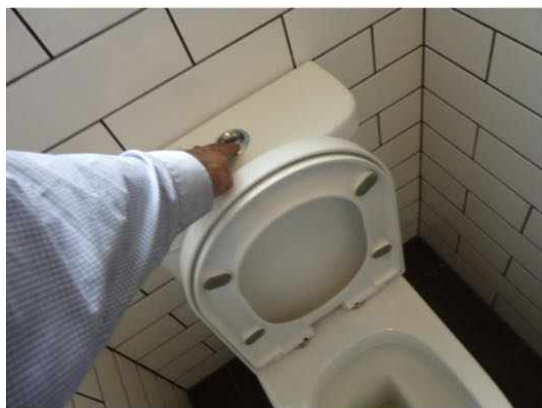
Defects 2.03

| Information: | At the time of inspection, it was observed that the water supply was not connected to the toilet assembly, rendering the fixture non-operational. |

Non-operational fixtures and services should be addressed to ensure the building is capable of full and intended use. Where building elements are not functioning as designed, there is potential for secondary defects or damage to occur due to prolonged non-operation.

It is recommended that the water supply be connected and the toilet assembly inspected, repaired, or replaced as required. Repair and/or replacement of the faulty building element is recommended. It is highly recommended that the relevant tradesperson be engaged to as soon as perform any necessary works.

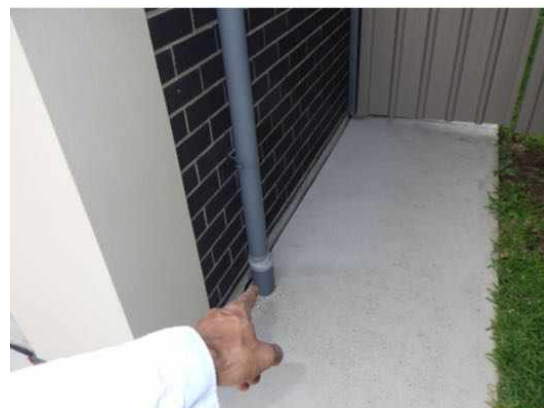
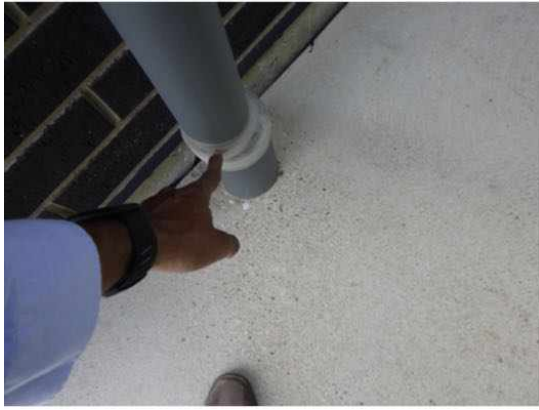
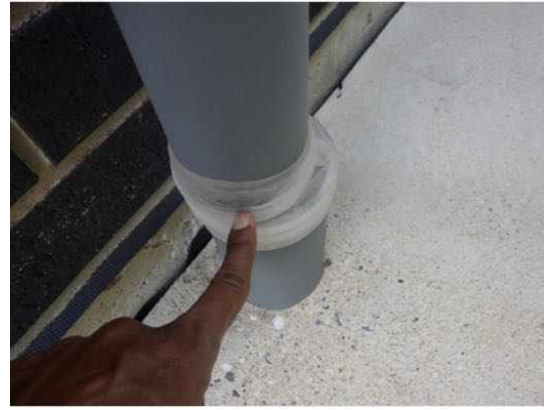
Defects 3.02

| Finding: | Downpipes - Damaged & Evidences of repairs |
| Information: | At the time of inspection it was noticed that downpipe is damaged and evidence of repairs to the downpipe at lower base in this external wall front area. |

Breakage occurs generally when the building materials have either aged and decayed, or as a result of damage (accidental or deliberate).

Repair and/or replacement of broken elements is advised to ensure that additional secondary defects do not arise as a consequence. Such works are necessary, as all building elements play a key role in the operation and function of the overall structure and its performance.

A relevant tradesperson should be appointed to repair or replace the affected building element prior to any subsequent damage being caused.

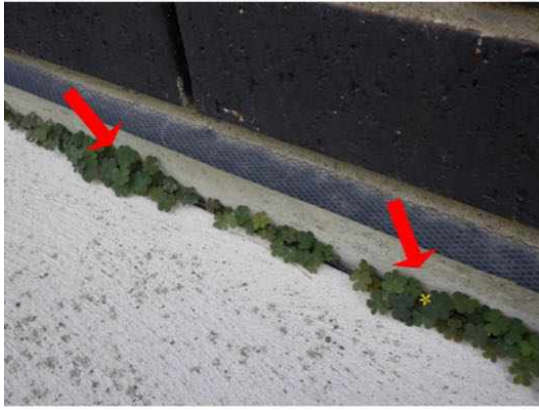
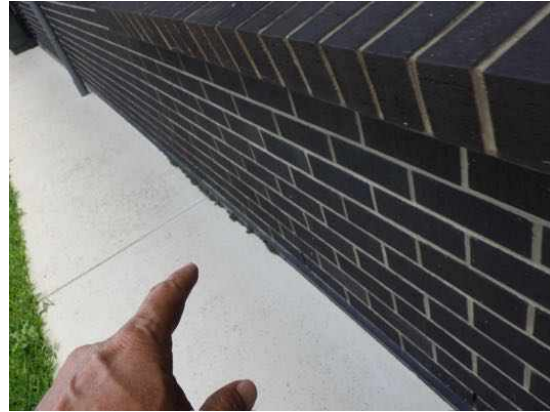
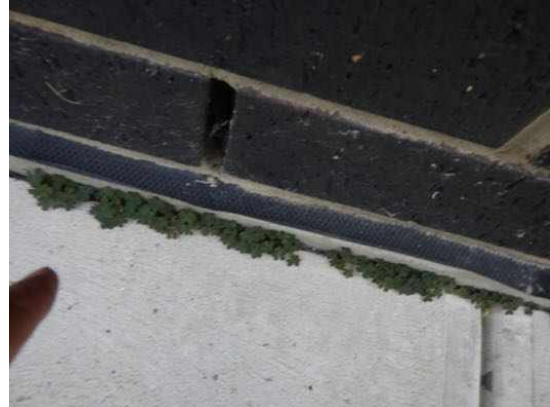
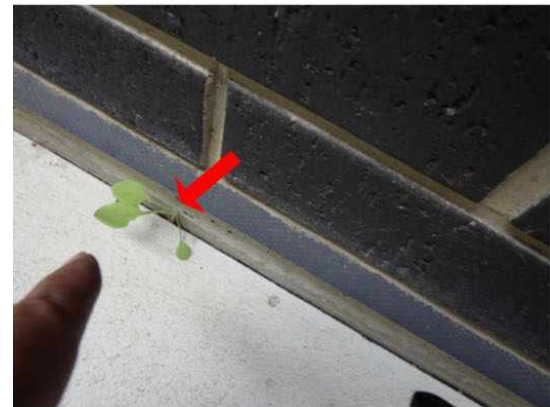
Defects 3.03

| Information: | Where vegetation obstructs inspection of building elements, also known as bridging as it provides a bridging point for the access of termites, full inspection can not be achieved. Consequently moisture or dampness may be present and the areas becomes conducive to termite activity. Plants against or very close to buildings provide cover, shade and can provide an environment that is attractive to termite infestation. |

The removal of any such materials that may be conducive to termite activity should be carried out as soon as possible and arrange re inspection to minimize the risk of termite attack.

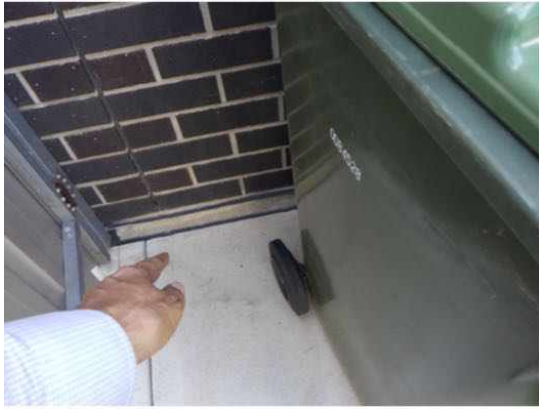
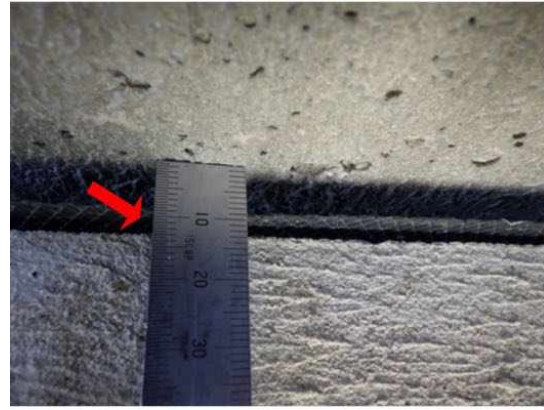
Defects 3.04

| Information: | Gap in external concrete paving were identified at the time of inspection. Gaps in slab are significant and are likely to lead to the development of secondary defects if left unmanaged, such as the creation of a trip hazards and water entry point. |

including roof and ground flows, contained and continually maintained. High moisture also creates an environment that is conducive to termite attack.

A licensed Plumber should be appointed immediately to ensure that the storm water pipework is in tact and adequate, and all gaps to concrete, driveways and paths should be sealed by a licensed builder or a general handy person to keep moisture from entering.

A licensed concreter may be required to place pavements that area beyond repairs.

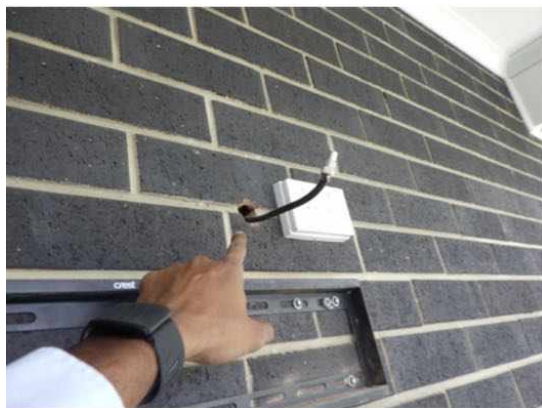
Defects 3.05

Gaps and holes around pipework makes the area susceptible to insect and vermin ingress, as well as allowing water penetration to the cavity wall. As such, associated building elements are likely to deteriorate at an accelerated rate, and major implications are expected if holes around the pipework are left unmanaged.

All excessive holes, gaps or cracks should be adequately filled by a suitable sealant or trimmings as soon as possible to prevent any further damage. Such works may be conducted by a general handyperson or licensed plumber.

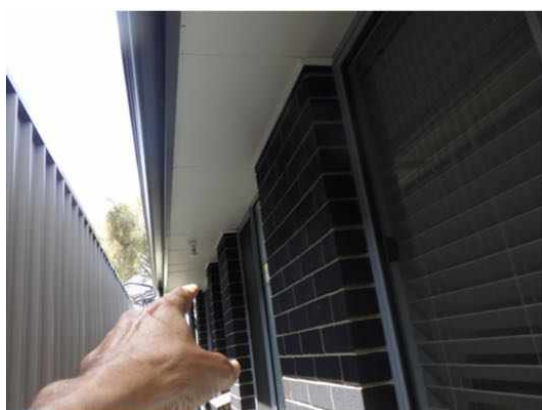
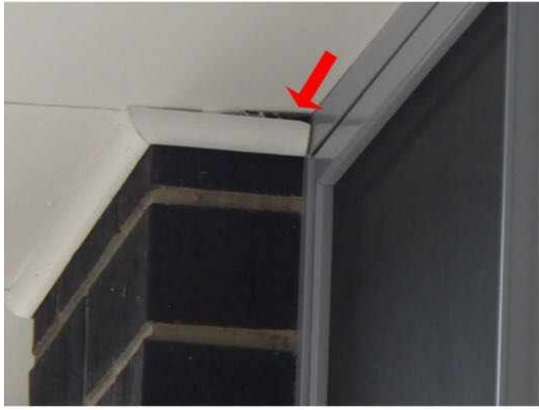
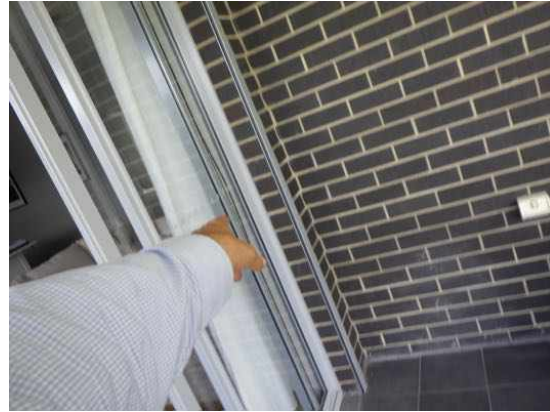
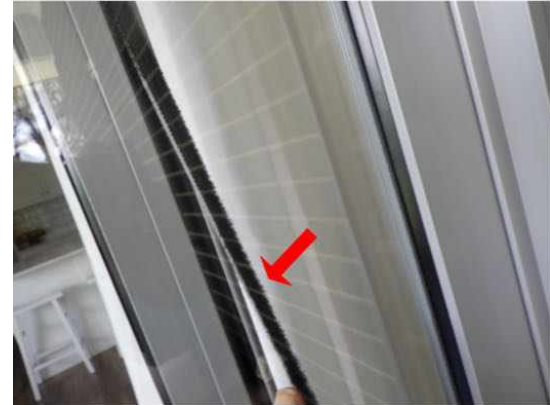
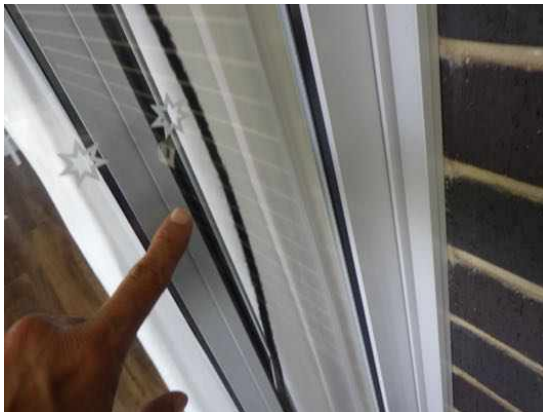
Defects 3.06

| Finding: | Building element - Damaged/ Loose from its original fixing |
| Information: | At the time of inspection it was noticed that few sections of building element were damaged around the property . |

Breakage occurs generally when the building materials have either aged and decayed, or as a result of damage (accidental or deliberate).

Repair and/or replacement of broken elements is advised to ensure that additional secondary defects do not arise as a consequence. Such works are necessary, as all building elements play a key role in the operation and function of the overall structure and its performance.

A relevant tradesperson should be appointed to repair or replace the affected building element prior to any subsequent damage being caused.

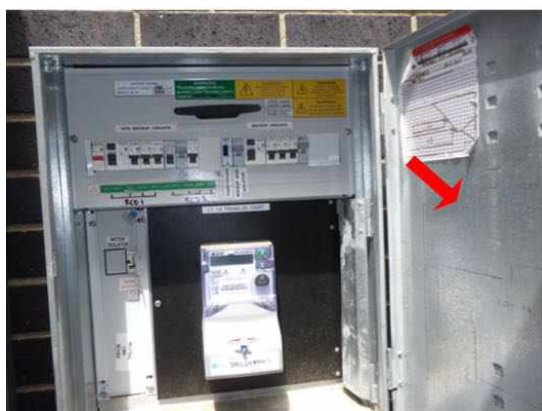
Building: Building 1
 Location: All External Areas >
 Finding: Termite Management System - No evidence of a chemical installation
 Information: The application of a post-construction chemical termite barrier is highly recommended for all properties, particularly if live termite activity has been found on the site previously. Such barriers are highly effective in preventing termite attack on any timber building elements throughout the property.

A durable notice should be placed in the switchboard unit to indicate current termite barriers. At the time of inspection, it appeared as though no termite management system has been installed, with no evidence to suggest preventative works taking place.

The client may consider gaining further advice from a pest controller as to the costs and procedures involved with this application. It is recommended that obtaining such advice be a short-term priority.

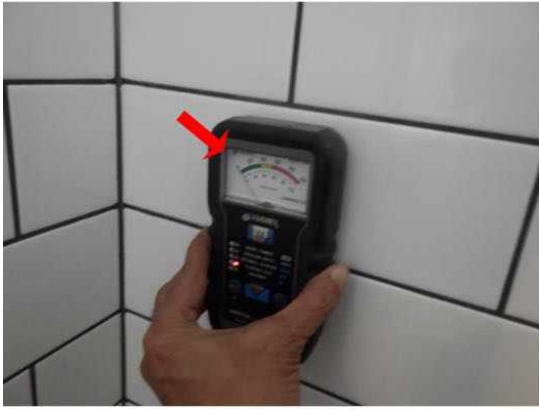
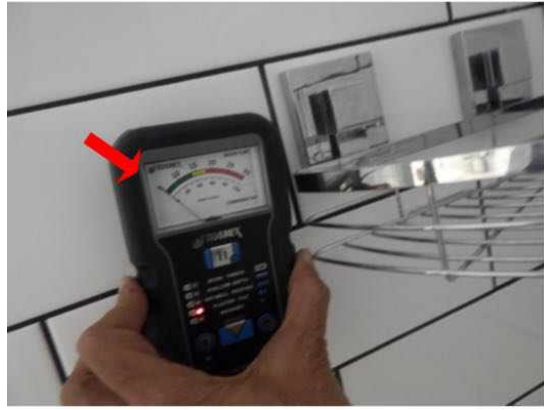
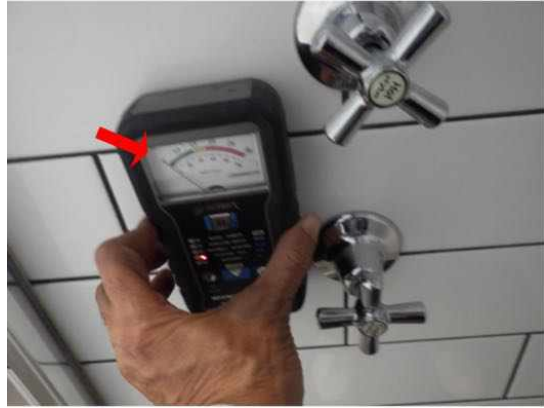
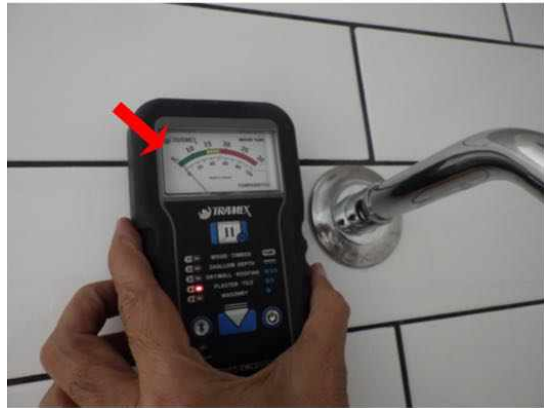
Building: Building 1
 Location: Bathroom 2
 Finding: Shower Alcove - No Damp
 Information: At the time of inspection it was noticed that damp is not evident to the shower alcove.
