# Building and Timber Pest Inspection Report

Inspection Date: Thu, 12 Mar 2026

Property Address: 18 Bellavita Ave, Clyde VIC 3978, Australia

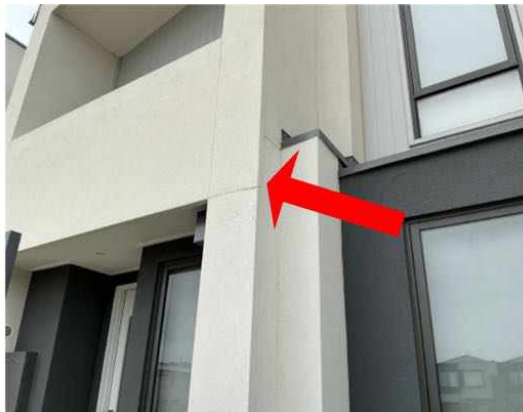
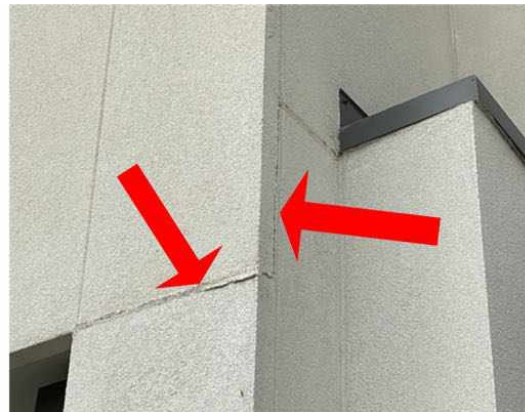
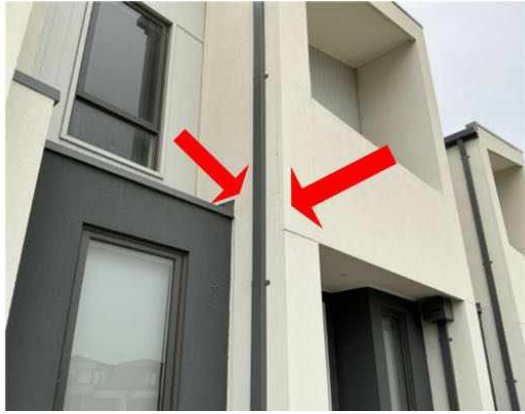
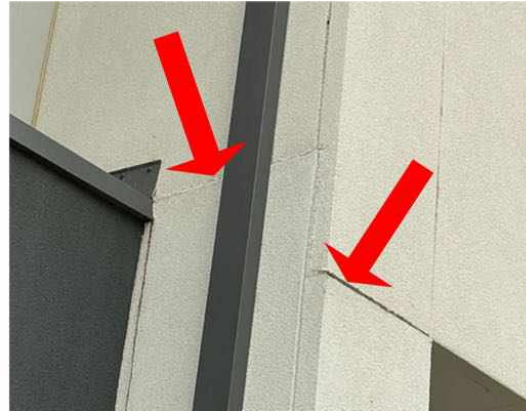
Building: Main Building  
Location: Exterior walls - front  
Finding: Render Cracks and deterioration  
Information: It has been observed that cracking and deterioration to the external rendered surfaces has occurred to these parts of the building.

Noticeable cracks are a common occurrence in external render and are a likely result of age expected building movement, general expansion, and/or contraction of building materials in different weather conditions. Noticeable cracks in render may develop if left unattended. Recommend engaging a renderer to repair to make more aesthetic and to reduce the risk of further deterioration at the owners discretion.

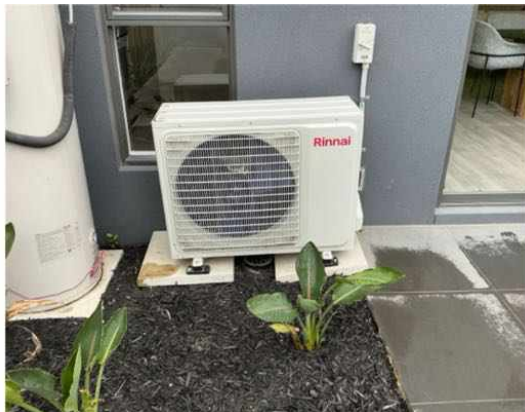
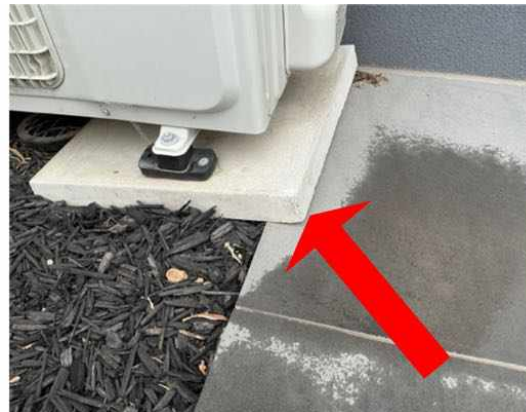
### Finding 3.02

Building:	Main Building
Location:	Yard - Back
Finding:	Air conditioning unit leaning
Information:	The air conditioning unit is leaning, which is suspected to be caused by poor installation of the air-conditioning support. Recommend engaging an air-conditioning specialist to rectify to reduce the risk of further deterioration as soon as possible.

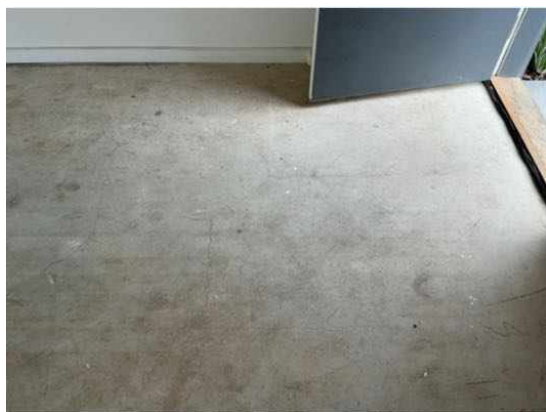
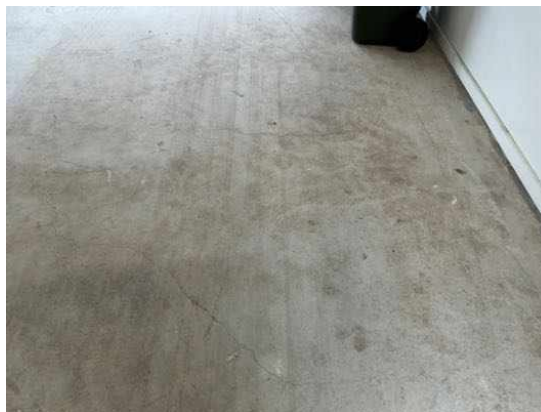
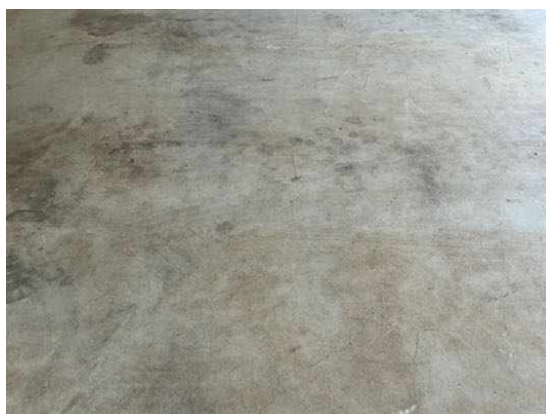
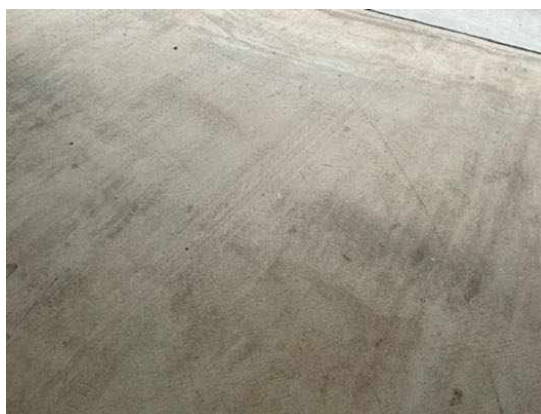
### Finding 3.03

Building:	Main Building
Location:	Garage
Finding:	Garage Cracking - Concrete Paving Damage Category 1 - Fine (less than 2mm)
Information:	Fine cracks were identified in the garage concrete paving. Although fine cracks are quite noticeable, they are often only considered to be an appearance defect, and usually do not indicate any structural damage. To be considered a Category 1 or fine crack, the crack is found to be less than 2mm in width.

Generally the cause of a hairline crack in existing concrete paving such as driveways and pathways is indicative of the expansion and contraction of the concrete. Such causes are generally due to environmental factors, such as moisture levels, weather conditions, root systems of nearby trees or the soil types on which they are laid.

Fine cracks may also be due to poor original installation of the concrete. Factors such as poor compaction of the sub surface and/or inadequate reinforcing of the slab may create cracking and other secondary defects.

Monitoring of all cracking should be conducted frequently. Always contact a building inspector should cracks widen, lengthen, or become more numerous.

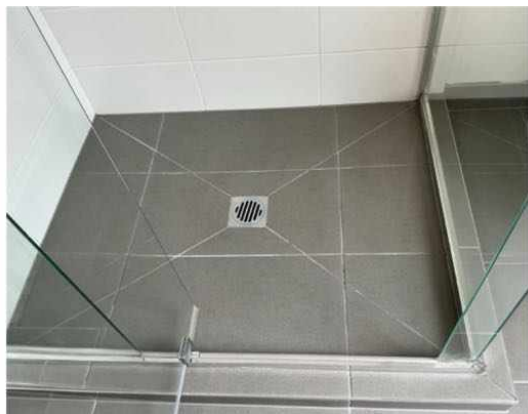
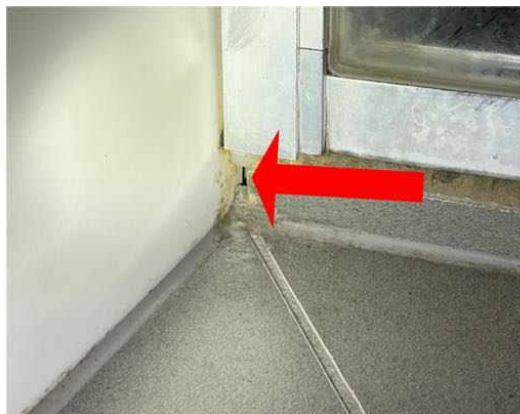
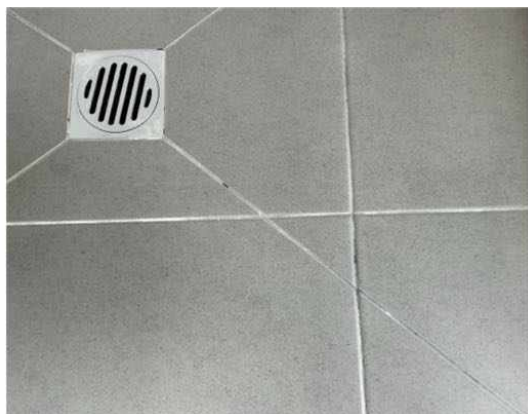
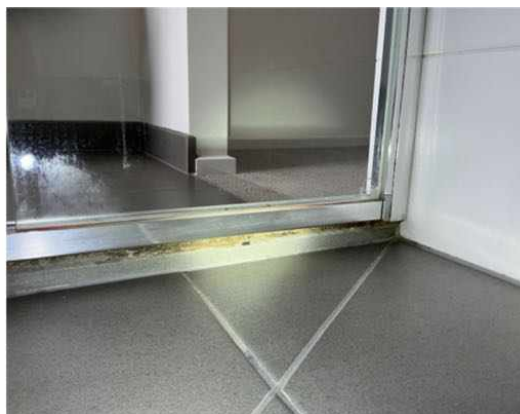
### Finding 3.04

Building:	Main Building
Location:	Ensuite - Master
Finding:	Bathroom Sealant and grouting - Missing or damaged
Information:	It was noted on inspection that sealant or grout is degraded to the tiled shower alcove and or other areas of the bathroom.

Different materials and floor areas move at different rates, generally causing cracking to grout or sealant at this point. A flexible sealant is required to allow for expected expansion and contraction, while keeping the joint water tight and protective of all associated building materials.

Flexible and mould resistant materials should be applied to affected areas to prevent any subsequent water damage that is likely to occur. Regular maintenance and replacement of damage or missing or damaged sealant and grout is highly

recommended to the wet areas, as this is a regular wear and tear defect. Sealant and grouting in areas that come into regular contact with water should be maintained for the long term care of your property.

A sealant specialist or tiling contractor should be appointed to complete these works as soon as possible

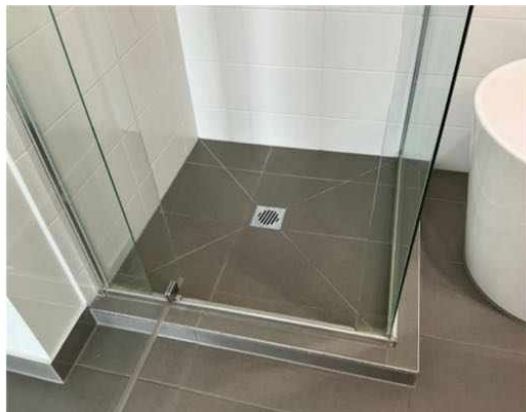
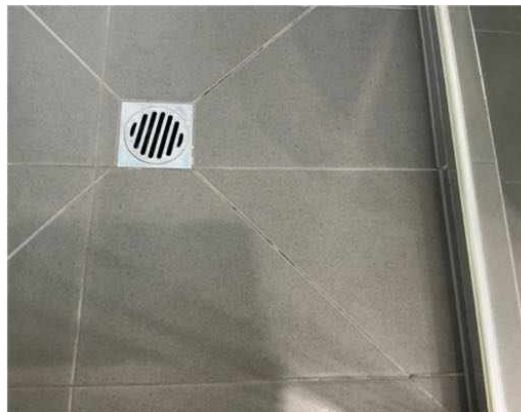
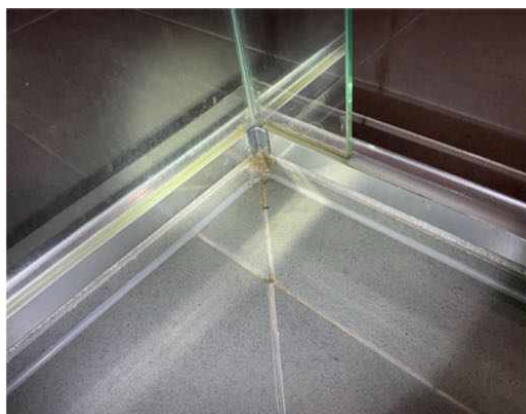
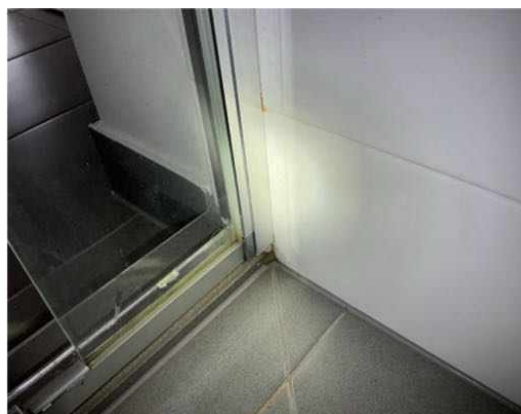
### Finding 3.05

Building:	Main Building
Location:	Bathroom
Finding:	Bathroom Sealant and grouting - Missing or damaged
Information:	It was noted on inspection that sealant or grout is degraded to the tiled shower alcove and or other areas of the bathroom.

Different materials and floor areas move at different rates, generally causing cracking to grout or sealant at this point. A flexible sealant is required to allow for expected expansion and contraction, while keeping the joint water tight and protective of all associated building materials.

Flexible and mould resistant materials should be applied to affected areas to prevent any subsequent water damage that is likely to occur. Regular maintenance and replacement of damage or missing or damaged sealant and grout is highly recommended to the wet areas, as this is a regular wear and tear defect. Sealant and

grouting in areas that come into regular contact with water should be maintained for the long term care of your property.

A sealant specialist or tiling contractor should be appointed to complete these works as soon as possible

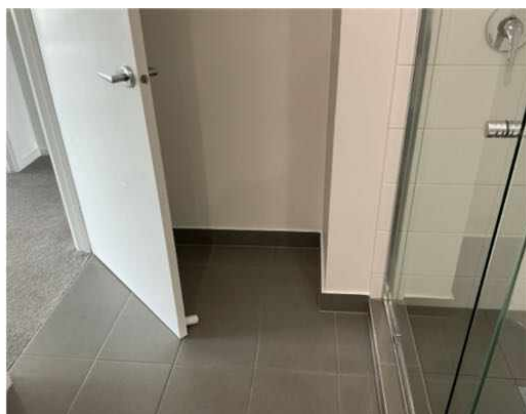
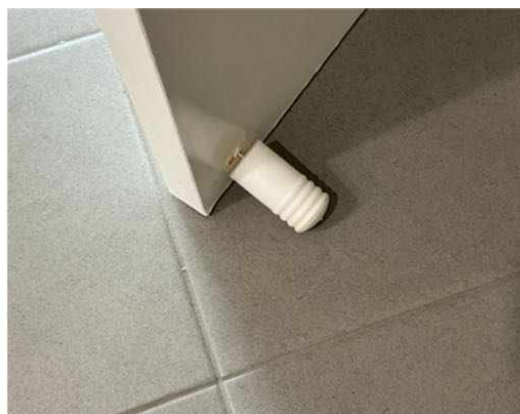
### Finding 3.06

Building:	Main Building
Location:	Bathroom
Finding:	Door stop - requires tightening
Information:	The bathroom door stop is loose and needs tightening. Although some building elements may seem irrelevant or unnecessary, all building elements play a key role in the operation and function of the overall structure and its performance.

Re-installation or replacement of the door stop is advised as soon as possible to prevent any subsequent damage to the door or associated structures. A general handyman may be appointed to perform these works at client discretion.

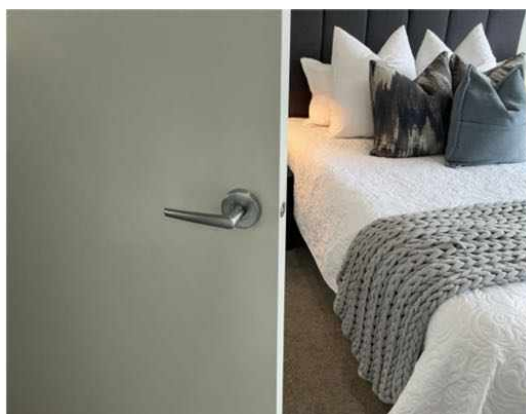
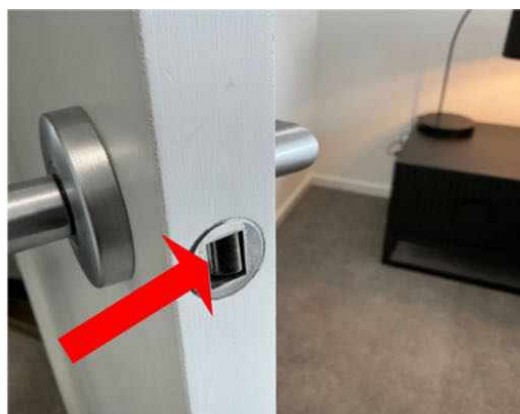
### Finding 3.07

Building:	Main Building
Location:	Bedroom - Master
Finding:	Door latch requires repair/replacement
Information:	The master bedroom door latch is not retracting and requires repair/replacement to make it operate properly. This can happen overtime with deterioration or lack of maintenance. Recommend engaging a carpenter to repair/replace at the owners discretion.

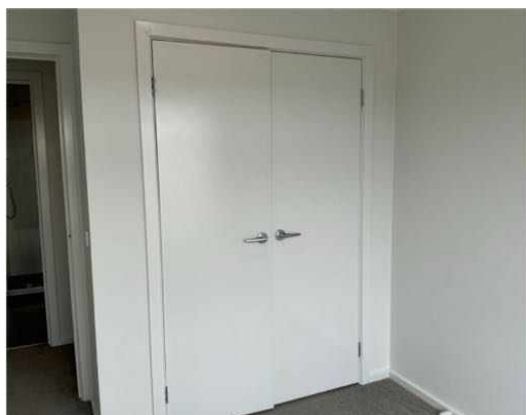
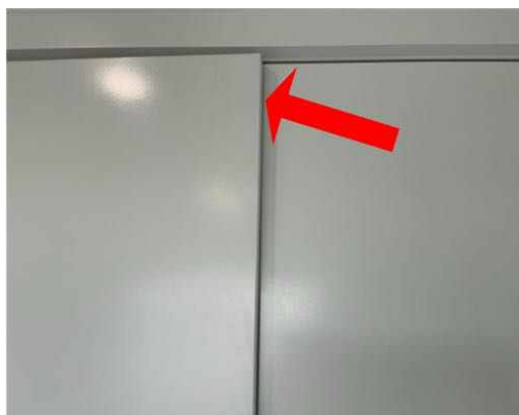
### Finding 3.08

Building:	Main Building
Location:	Bedroom 4
Finding:	Door - Binding/jamming cupboard bedroom
Information:	Binding and/or jamming of the bedroom cupboard doors is evident during standard operation. This defect inhibits the functionality of the affected door as well as creating potential for secondary defects to associated building elements.

A door that binds to the associated door frame may have several causes, ranging from minor defects, such as poor installation of the door or deteriorated hinges.

For minor causes, a qualified carpenter or general handyperson should be appointed

to perform minor rectification works at client discretion.

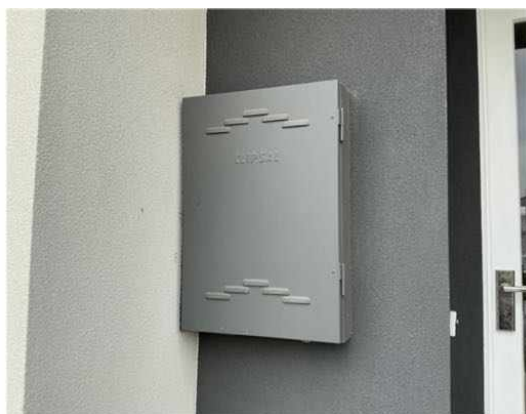
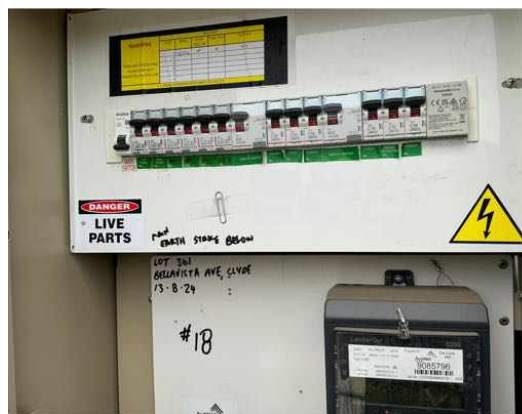
Building:	Main Building
Location:	All External Areas
Finding:	No Termite Management System - no evidence of a chemical installation
Information:	The application of a post-construction chemical termite barrier is highly recommended for all properties, particularly if live termite activity has been found on the site previously. Such barriers are highly effective in preventing termite attack on any timber building elements throughout the property.

A durable notice should be placed in the switchboard unit to indicate current termite barriers. At the time of inspection, it appeared as though no termite management system has been installed, with no evidence to suggest preventative works taking place.

The client may consider gaining further advice from a pest controller as to the costs and procedures involved with this application. It is recommended that obtaining such advice be a short-term priority.

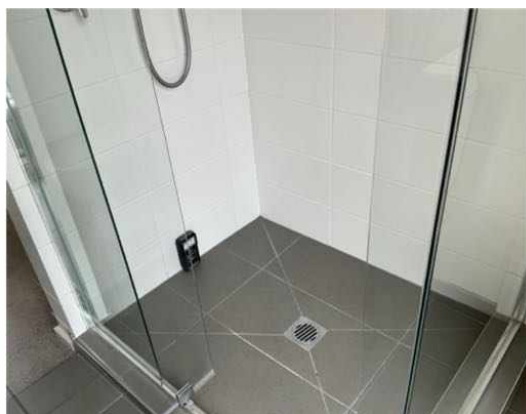
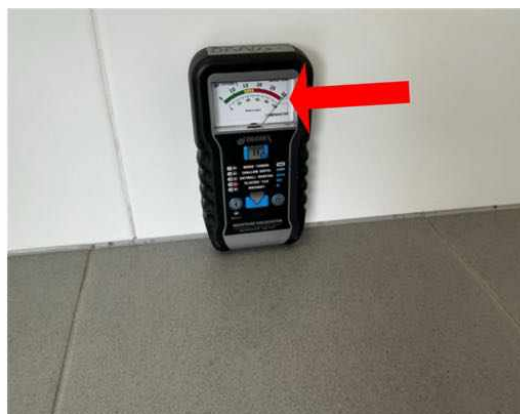
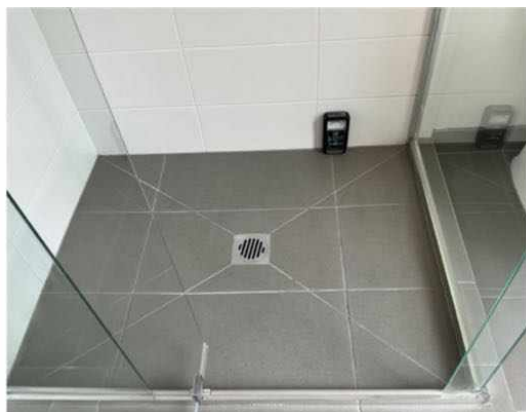
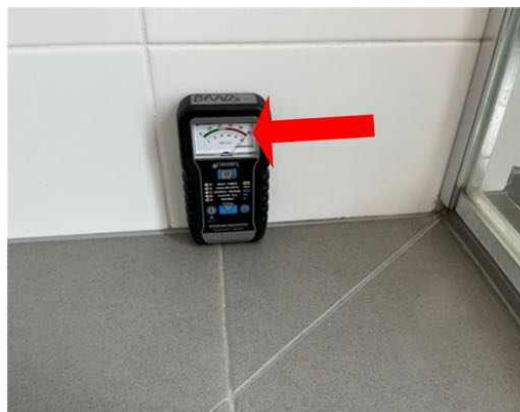
## Finding 6.02

Building: Main Building  
 Location: Ensuite - Master  
 Finding: Shower - Damp  
 Information: Damp is evident to parts of the bathroom shower alcove found using using a moisture meter. This defect is quite common, and is suspected to have been caused by moisture permeating through the grouting in this area, which shows evidence of deterioration creating moist conditions. Leaking pipes within the adjoining wall is also a possible cause. Excessive moisture can attract termites.

Damp (or structural damp) refers to the presence of unwanted moisture in the structure of a building, either as the result of intrusion from outside, or condensation from within the structure. In the shower area, internal water leaks or other sources of excessive moisture are generally the cause of damp.

Unmanaged damp in the shower recess is likely to facilitate the formation and development of mould and fungi growth, decaying associated building materials and compromising their structural integrity. It is important to address damp conditions, as the World Health Organisation notes that excess moisture leads - on almost all indoor materials - to growth of microbes such as moulds, fungi and bacteria, which subsequently emit spores and other matter into the indoor air. Exposure to these contaminants is associated with a wide range of respiratory and other health-related problems.

Consultation with a qualified plumber or bathroom specialist is advised immediately to identify the cause of damp and to perform remedial works as required. Where excessive mould growth is present, further inspection by a specialist environmental health inspector should also be considered.

Always ensure that sealant and grout is in good condition to prevent any moisture issues occurring in the future.

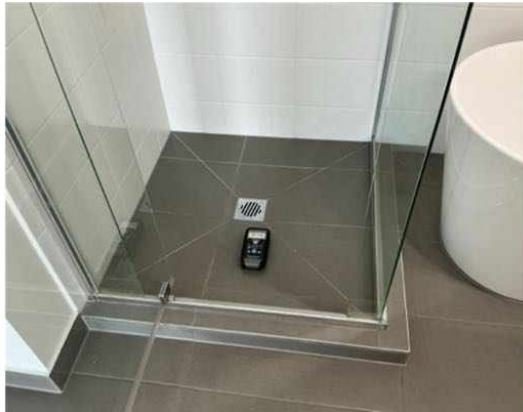
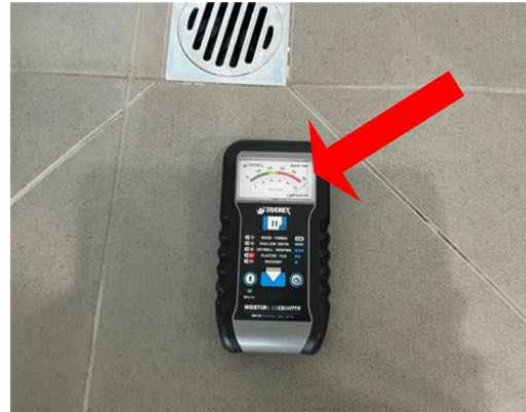
### Finding 6.03

Building:	Main Building
Location:	Bathroom
Finding:	Shower - Damp
Information:	Damp is evident to parts of the bathroom shower alcove found using using a moisture meter. This defect is quite common, and is suspected to have been caused by moisture permeating through the grouting in this area, which shows evidence of deterioration creating moist conditions. Leaking pipes within the adjoining wall is also a possible cause. Excessive moisture can attract termites.

Damp (or structural damp) refers to the presence of unwanted moisture in the structure of a building, either as the result of intrusion from outside, or condensation from within the structure. In the shower area, internal water leaks or other sources of excessive moisture are generally the cause of damp.

Unmanaged damp in the shower recess is likely to facilitate the formation and development of mould and fungi growth, decaying associated building materials and compromising their structural integrity. It is important to address damp conditions, as the World Health Organisation notes that excess moisture leads - on almost all indoor materials - to growth of microbes such as moulds, fungi and bacteria, which subsequently emit spores and other matter into the indoor air. Exposure to these contaminants is associated with a wide range of respiratory and other health-related problems.

Consultation with a qualified plumber or bathroom specialist is advised immediately to identify the cause of damp and to perform remedial works as required. Where excessive mould growth is present, further inspection by a specialist environmental health inspector should also be considered.

Always ensure that sealant and grout is in good condition to prevent any moisture issues occurring in the future.

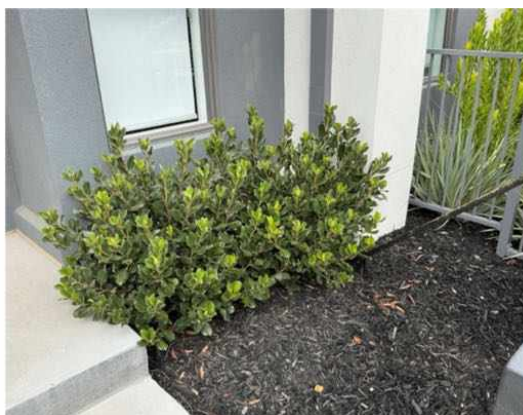
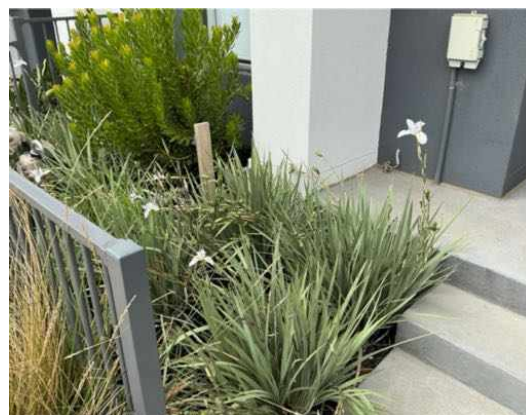
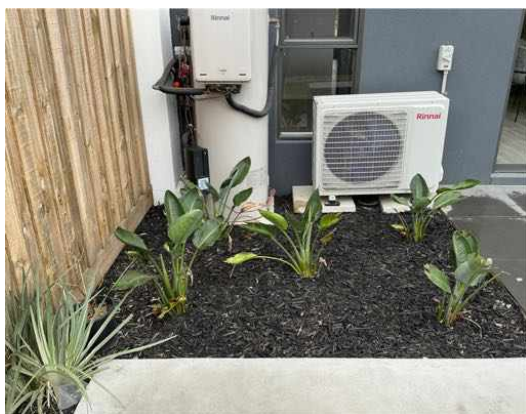
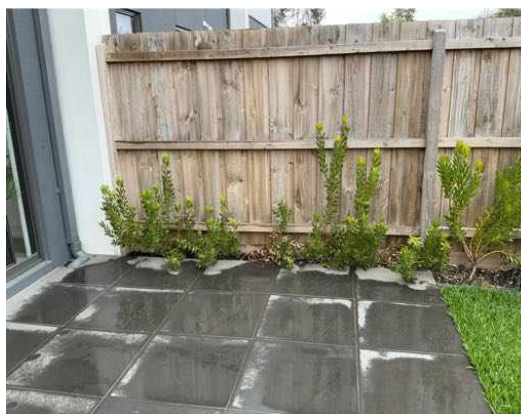
#### Finding 6.04

Building:	Main Building
Location:	Yards
Finding:	Garden Beds Conditions Conducive to Termites
Information:	Garden beds were found to be evident in close proximity to the building. Garden beds immediately adjacent to the perimeter of the building block the visual inspection of these areas, providing a concealed termite entry point.

These garden beds can include untreated timber, and with a combination of moisture from watering hosing can make conditions conducive to termite activity and termite ingress.

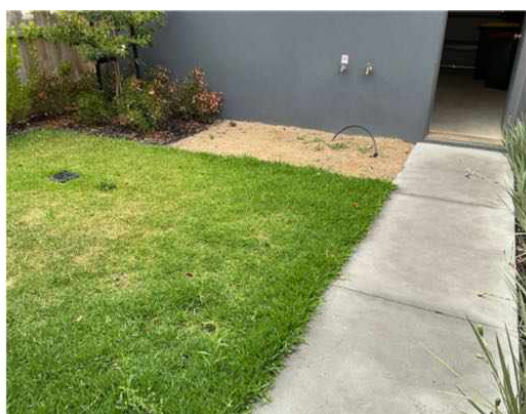
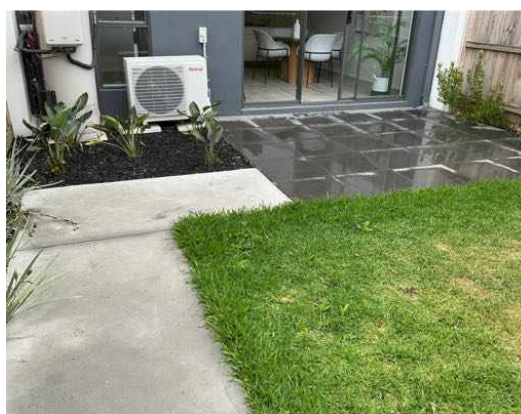
### Finding 6.05

Building:	Main Building
Location:	Yard - Back
Finding:	Site drainage - poor/inadequate
Information:	The site drainage to parts of the rear yard was found to be inadequate at the time of inspection, creating potential for subsequent water damage to associated building elements. Excessive moisture will attract termites.

It is important that water does not lie against the base of walls; surrounding paths and ground levels should be sloped to drain water away from walls. Downpipes should not discharge stormwater onto lower walls or plinths. Stormwater should be carried away by large, regularly cleaned drains. Ground levels may need to be lowered to expose a buried DPC.

Where site drainage is inadequate, installation of an Agricultural (Aggie) Drain may be required. A qualified plumber should be appointed to further inspect the property and perform any remedial works as necessary. Water damage and secondary defects are likely to occur if left unmanaged.

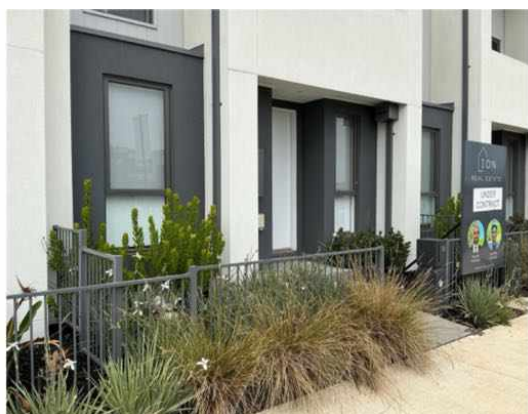
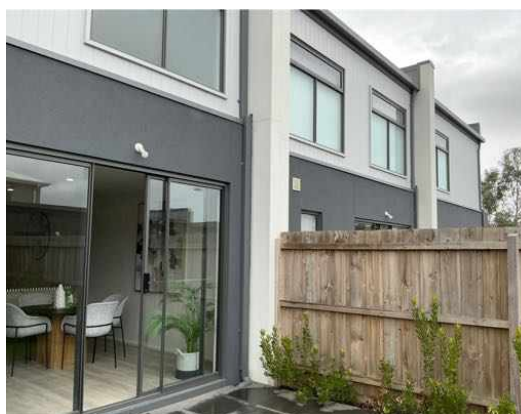
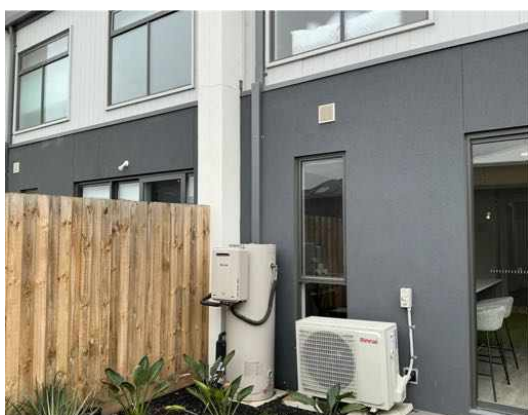
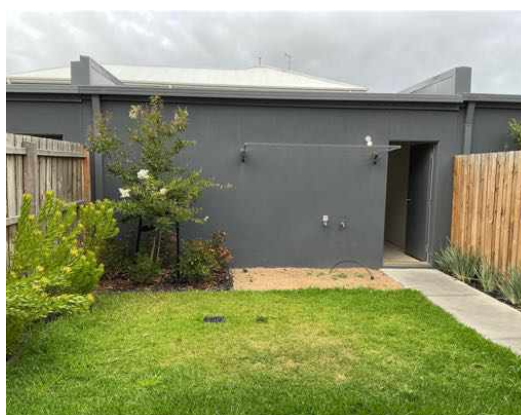
### Finding 6.06

Building:	Main Building
Location:	Various parts of the building

Where any part of an attachment to a building is not isolated and is not provided with a clear gap of not less than 25mm from building, bridging occurs. Attachments to buildings such as hot water services, downpipes, verandahs, decks, steps, fences, service conduits and the like provide the opportunity for concealed entry.

Building attachments of this nature need to be frequently inspected for termite activity by a qualified inspector.

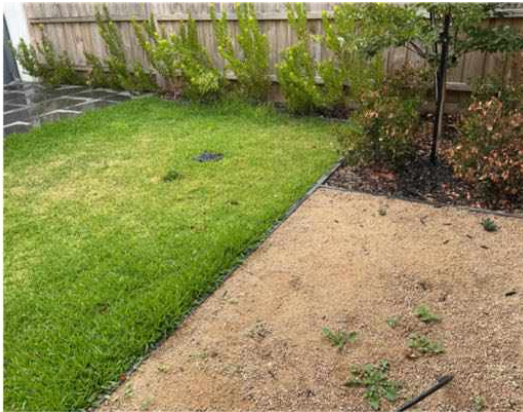
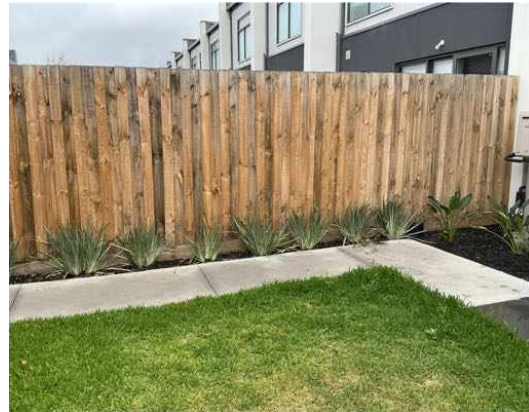
### Finding 6.07

Building: Main Building  
 Location: Various parts of the building  
 Finding: In ground contact  
 Information: Any timbers in direct ground contact provide opportunity for concealed termite entry and are likely to be subject to premature rot and decay as the soil retains moisture or damp conditions against the timbers.

Remove untreated timber that is in direct contact with external grounds. Consider replacement with more durable materials i.e. treated timber or non timber elements.

Frequent pest inspections are advised to readily identify any termite activity in these areas.

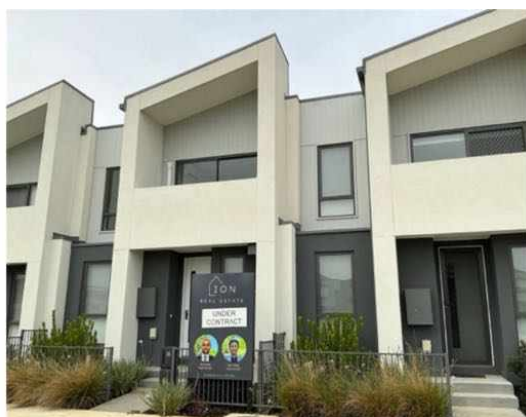
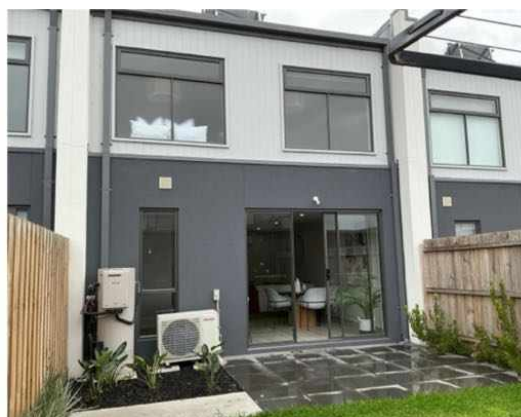
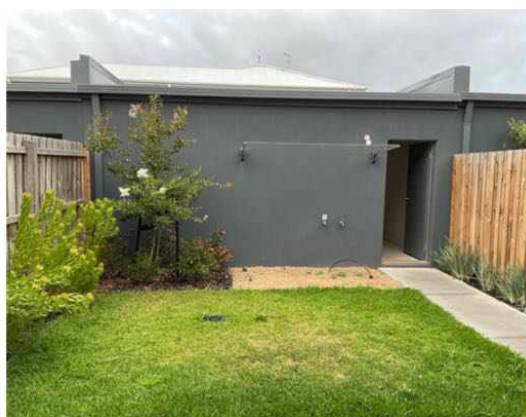
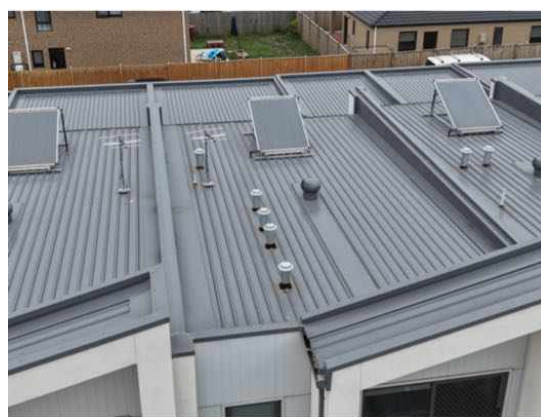
Building: Main Building  
 Location: All External Areas  
 Finding: Additional Photos - Obstructions and Limitations  
 Information: These photographs are an indication of the obstructions and limitations which impeded full inspection of the property at the time of inspection. These obstructions can hide an array of defects and should be removed to allow full inspection to be carried out. A re-inspection is recommended once the areas are made accessible.

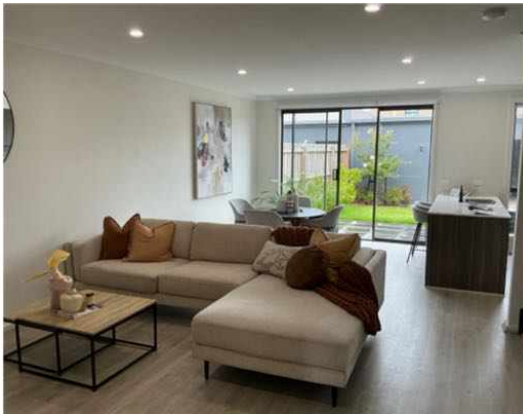
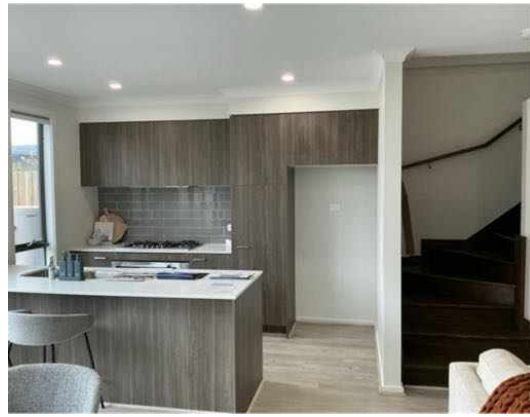
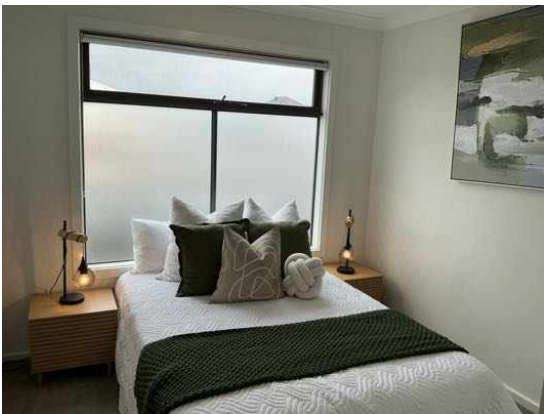
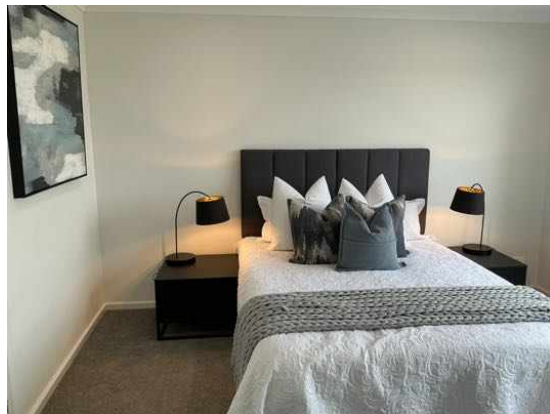
Building: Main Building  
 Location: All Internal Areas  
 Finding: Additional Photos - Obstructions and Limitations  
 Information: These photographs are an indication of the obstructions and limitations which impeded full inspection of the property at the time of inspection. These obstructions can hide an array of defects and should be removed to allow full inspection to be

carried out. A re-inspection is recommended once the areas are made accessible.

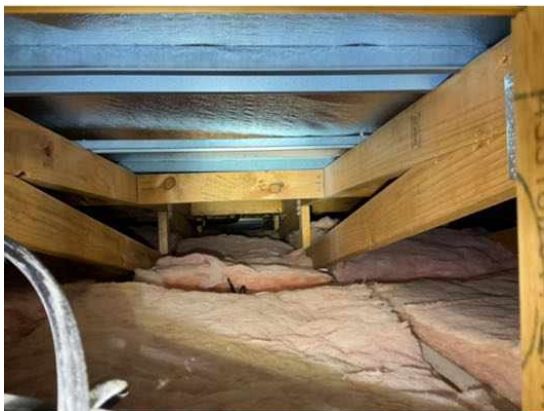
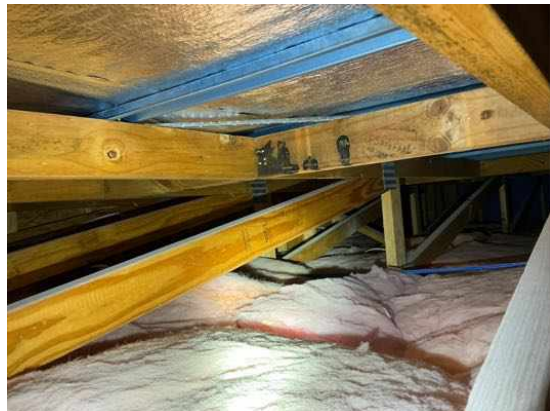
Building: Main Building  
Location: Roof Void  
Finding: Obstructions and Limitations -roof cavity  
Information: These photographs are an indication of the obstructions and limitations which impeded full inspection of the roof cavity at the time of inspection. These obstructions can hide an array of defects and should be removed to allow full inspection to be carried out. A re-inspection is recommended once the areas are made accessible.

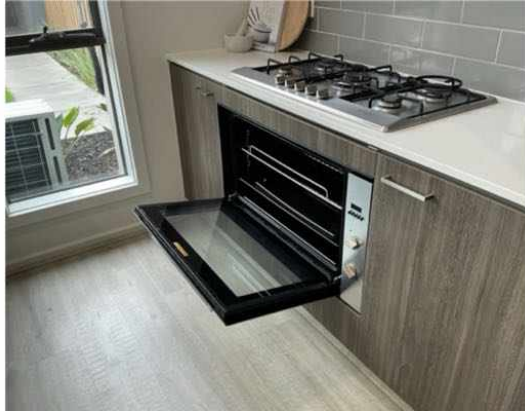
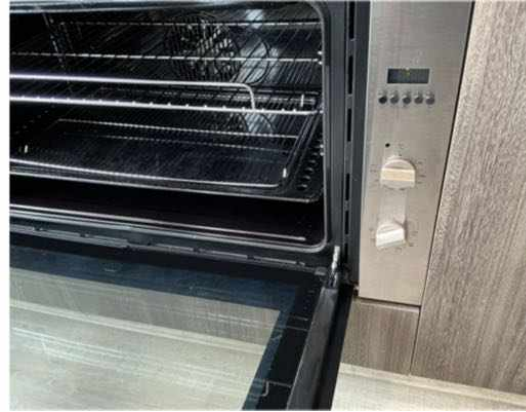
Finding: Oven not working

Information: On inspection, I tried to turn the oven on and could not get it to work. Recommend an appliance repair/maintenance man to inspect and provide appropriate advice and recommendations to make operational.
