# Building and Timber Pest Inspection Report VR

Inspection Date: Wed, 25 Feb 2026

Property Address: 138 Salisbury Rd, Camperdown NSW 2050,  
Australia

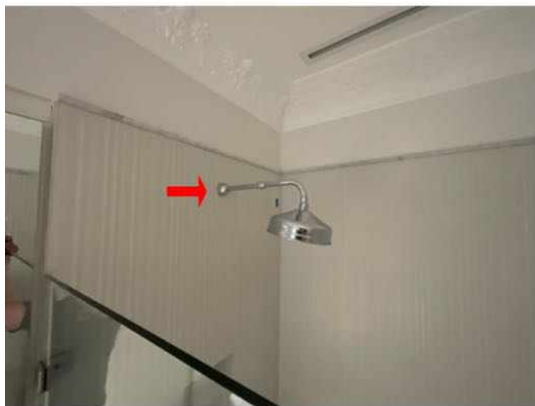
#### Finding 3.01

Building: Main Building  
 Location: Bathroom  
 Finding: Fitting or fixture - Loose (Shower Head)  
 Information: The fitting in this area is loose and requires adjustment to tighten.

If left unmanaged, the fitting may further deteriorate, causing potential for the development of other minor secondary defects.

A relevant tradesperson should be appointed to perform these rectification works at discretion of the client.

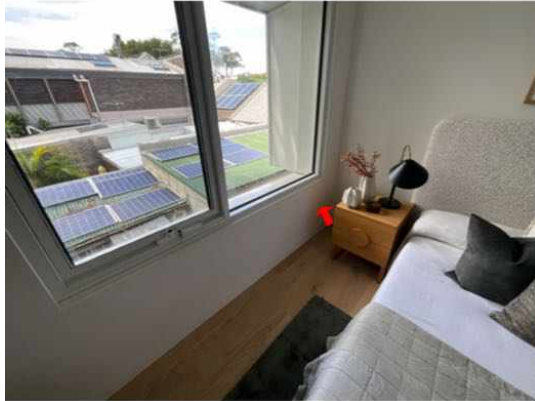
#### Finding 3.02

Building: Main Building  
 Location: Bedroom 2  
 Finding: Damp - Rain penetration  
 Information: Rain penetration (also known as penetrating damp) is a common form of dampness that can occur through walls, roofs or openings (e.g. windows).

Common causes include faulty or missing flashing and lack of sealant.

The cause of the water leak should be addressed to prevent further damage. It is recommended that the water leak be resolved prior to any repairs of the damaged area, which may require localised replacement of building materials and refinishing.

I recommend appointing a builder to see what necessary works are required.
