Building and Timber Pest Inspection Report

Inspection Date: Sat, 14 Feb 2026

Property Address: 3 Sinclair Dr, Numurkah VIC 3636, Australia

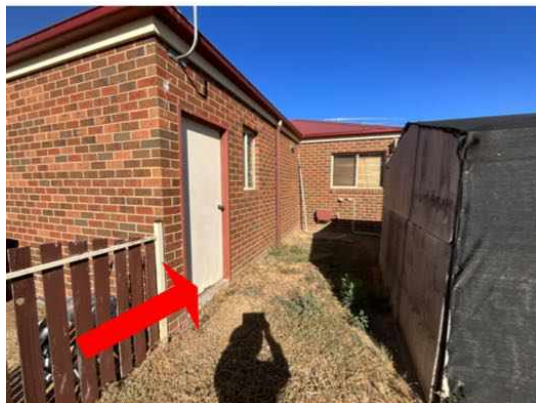
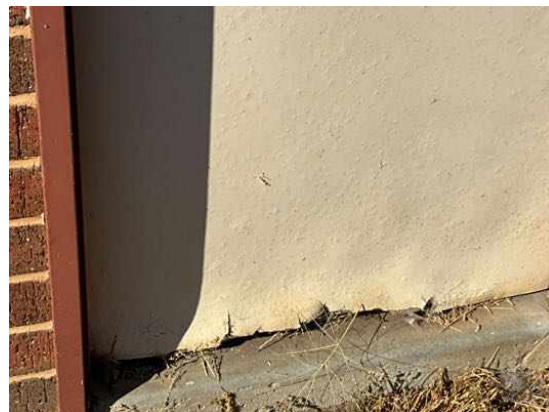
Finding 3.01

Building: Building 1
 Location: Garage
 Finding: Timber - exposed to weather
 Information: External timbers that are frequently exposed to harsh weather conditions require adequate protection in order to maintain their condition. Where timbers have not been painted or treated adequately, general deterioration is likely to occur at an accelerated rate.

If left unattended, replacement of these timbers is likely to be necessary in the short-term future. Adequate treatment of these timbers is required as soon as possible by a painting contractor or general handyman.

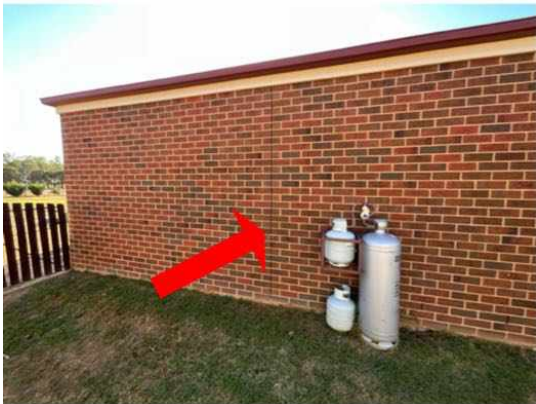
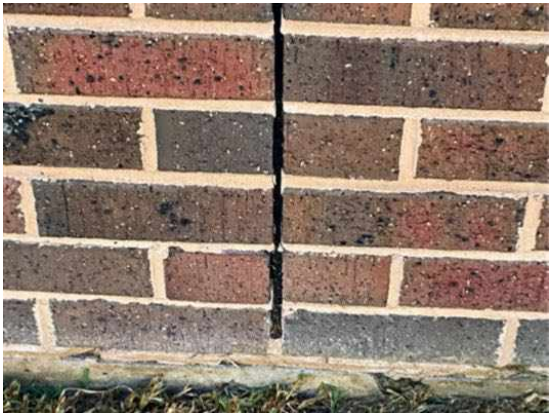
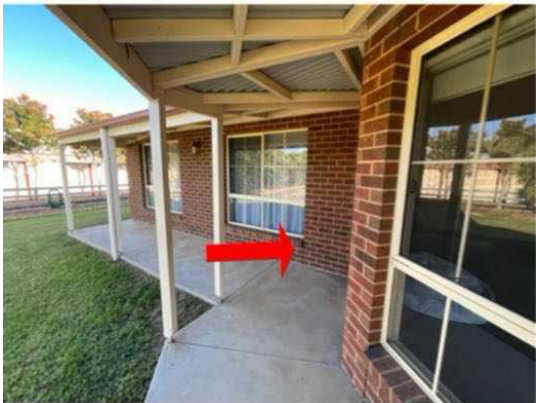
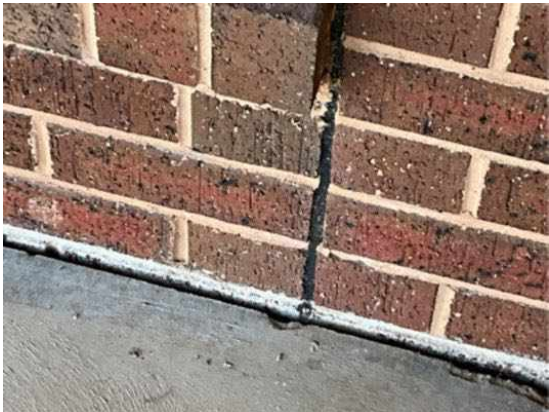
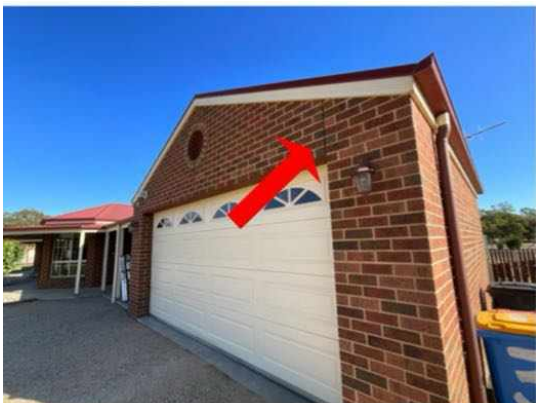
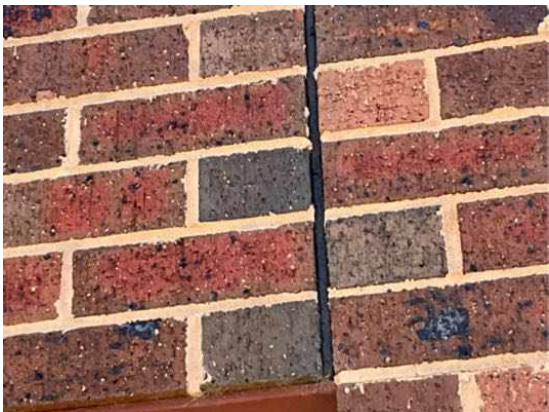
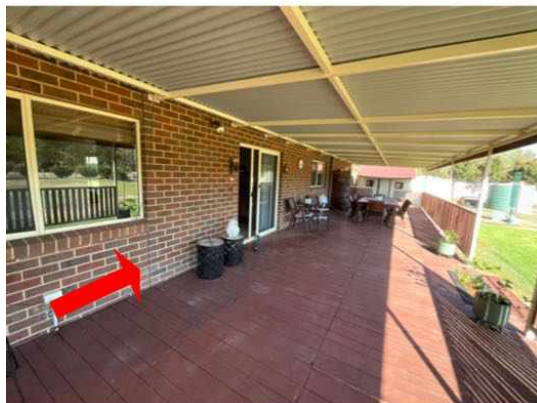
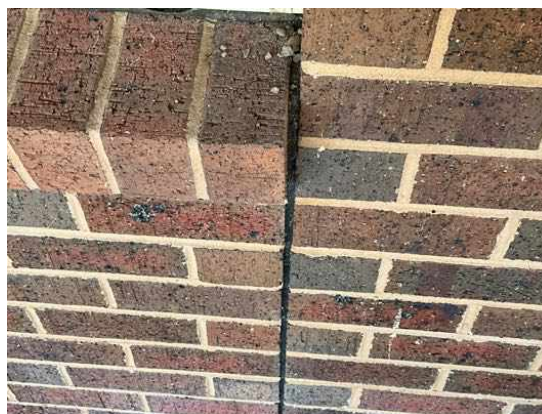
Finding 3.02

Building: Building 1
 Location: Expansion joints
 Finding: Inadequate sealant/caulking
 Information: This area has a lack of effective Sealant or Grout. This may be allowing the ingress of water to the structure.

The presence of water encourages Termite attack, Mould and Fungal Decay.

A Caulker or General Handy person must be contacted soon to effect repairs and prevent possible deterioration.

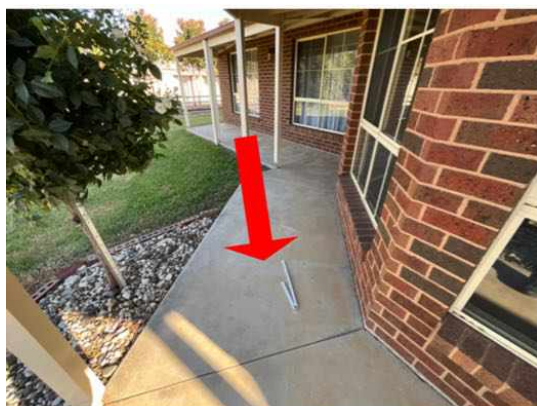
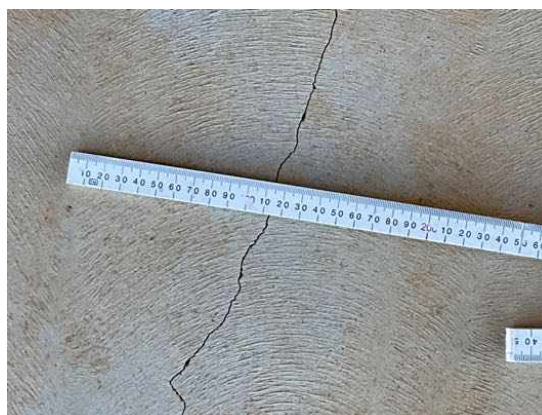
Finding 3.03

Building:	Building 1
Location:	Verandah
Finding:	Cracking - External Concrete Paving Damage Category 1 - Fine (less than 2mm)
Information:	Fine cracks were identified in external concrete paving. Although fine cracks are quite noticeable, they are often only considered to be an appearance defect, and usually do not indicate any structural damage. To be considered a Category 1 or fine crack, the crack is found to be less than 2mm in width.

Generally the cause of a hairline crack in existing concrete paving such as driveways and pathways is indicative of the expansion and contraction of the concrete. Such causes are generally due to environmental factors, such as moisture levels, weather conditions, root systems of nearby trees or the soil types on which they are laid.

Fine cracks may also be due to poor original installation of the concrete. Factors such as poor compaction of the sub surface and/or inadequate reinforcing of the slab may create cracking and other secondary defects.

Monitoring of all cracking should be conducted frequently. Always contact a building inspector should cracks widen, lengthen, or become more numerous.

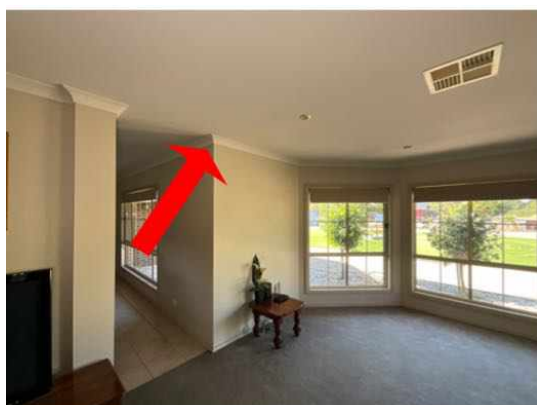
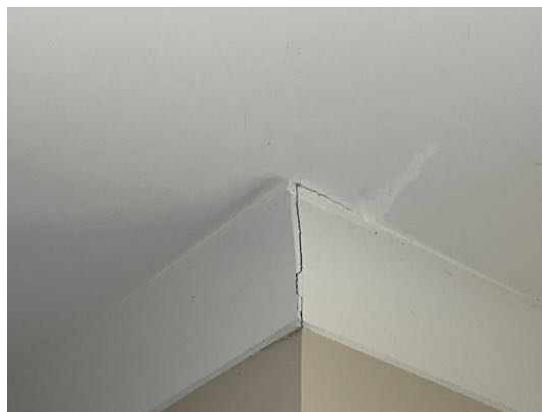
Finding 3.04

Building: Building 1
 Location: Living Room
 Finding: Cracking - Damage Category 1 - Fine (up to 1mm)
 Information: Although fine cracks are quite noticeable, they are often only considered to be an appearance defect, and usually do not indicate any structural damage. Generally, the cause of a fine crack is indicative of a separation between building materials and finishes (e.g. paint, plaster, etc.) along joins.

Cracking of this nature can generally be repaired with minor sanding, filling and/or repainting. Such works should be performed by a qualified painter or a general handyman.

Monitoring of all cracking should be conducted frequently. Always contact a building inspector should cracks widen, lengthen, or become more numerous.

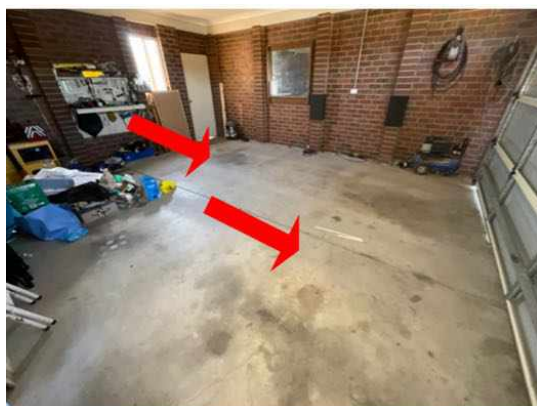
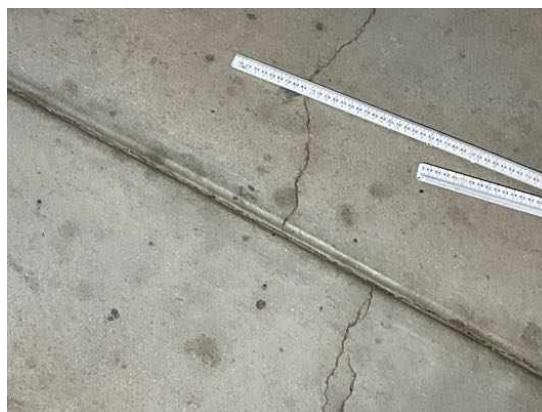
Finding 3.05

Building: Building 1
 Location: Garage
 Finding: Crack in concrete slab - Category 1
 Information: A crack coded as Category 1 was identified in the slab. A Category 1 crack is described as a fine but noticeable crack, with the slab at an otherwise reasonable level.

To be considered Category 1, the approximate width of the crack is less than 1.0mm, or a less than 10mm change in offset when a 3m straight edge is placed over the defect.

Category 1 cracks should be monitored for a period of 12 months. At the end of the monitoring period, identified cracks that are rated greater than Category 2 are considered defects, and require rectification.

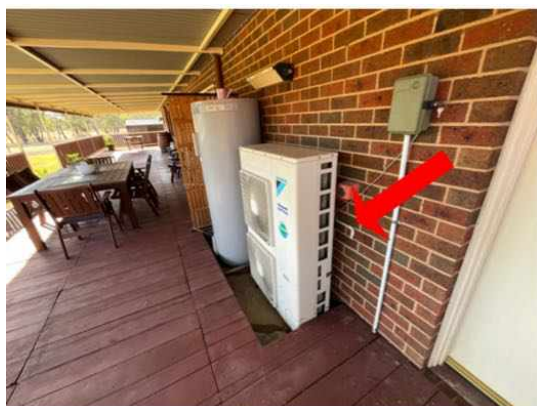
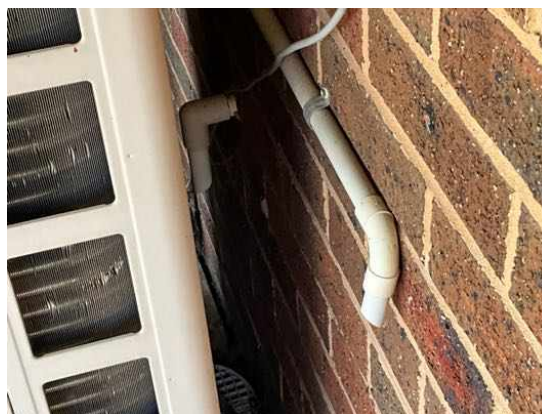
Finding 6.01

Building:	Building 1
Location:	Verandah
Finding:	Air conditioner - Disconnected overflow
Information:	The Air Conditioner (A/C) overflow was found to be disconnected from storm water drainage and is creating excessive moisture in the surrounding area.

Such leaking creates an environment which is conducive to an array of defects, including water damage to associated building elements and the attraction of termite or timber pest infestation.

It is highly recommended that a licensed plumber be appointed to connect the A/C overflow in order to prevent such an environment from being created. These minor works should be carried out as soon as possible.

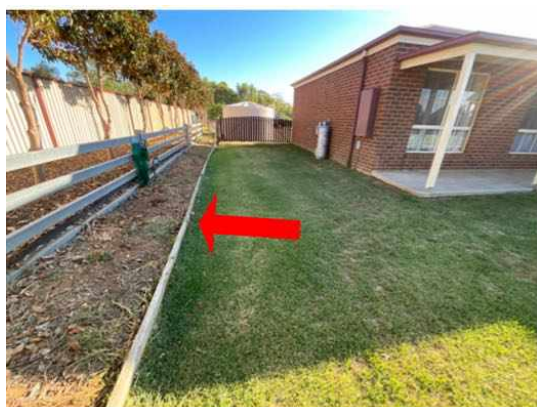
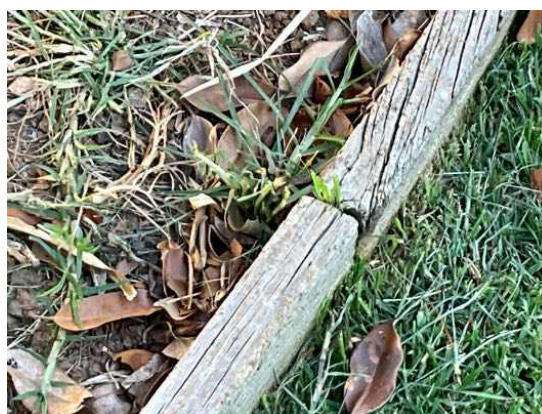
Finding 6.02

Building:	Building 1
Location:	Yard - Front
Finding:	Untreated or non-durable timbers in a hazardous environment
Information:	To reduce the risk of timber pest attack it is essential that timber used in a hazardous environment (e.g. in direct contact with the ground or frequently exposed to damp conditions) is of sufficient durability and/or is adequately preservative treated.

Untreated timbers in direct contact with the ground are likely to develop severe wood rot and/or fungal decay if left unattended creating attraction for subterranean termites to infest the timbers from surrounding areas.

If untreated or non-durable timbers are found to be in a hazardous environment it is highly advised that replacement of these building elements be performed as soon as possible to aid the protection of the property against termite / timber pest attack.

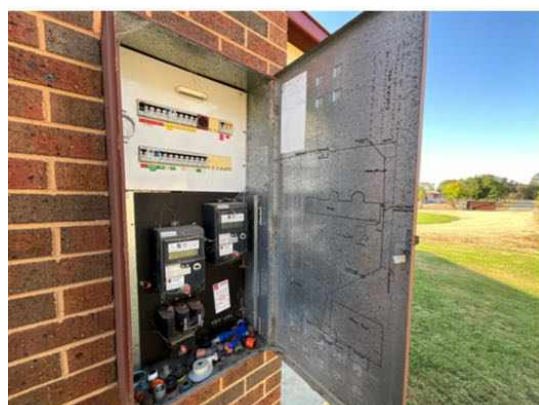
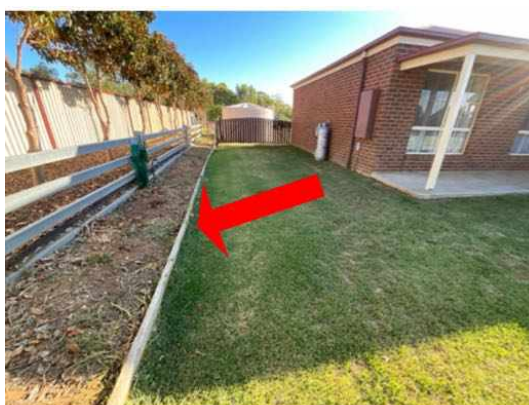
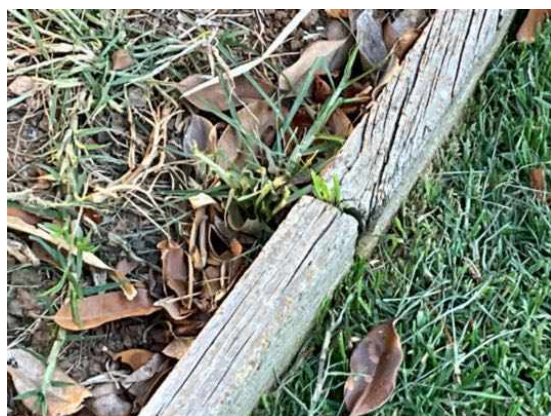
Finding 6.03

Building:	Building 1
Location:	All External Areas
Finding:	Termite Management System - no evidence of a chemical installation
Information:	The application of a post-construction chemical termite barrier is highly recommended

for all properties, particularly if live termite activity has been found on the site previously. Such barriers are highly effective in preventing termite attack on any timber building elements throughout the property.

A durable notice should be placed in the switchboard unit to indicate current termite barriers. At the time of inspection, it appeared as though no termite management system has been installed, with no evidence to suggest preventative works taking place.

The client may consider gaining further advice from a pest controller as to the costs and procedures involved with this application. It is recommended that obtaining such advice be a short-term priority.

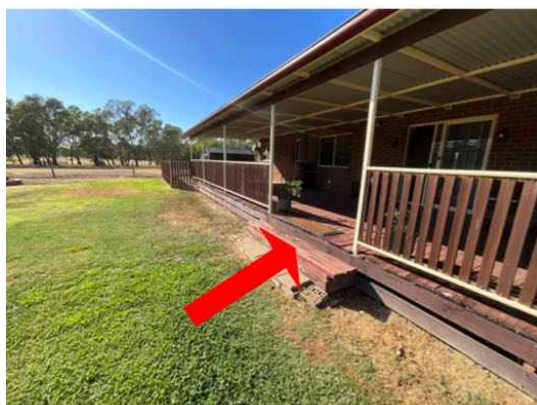
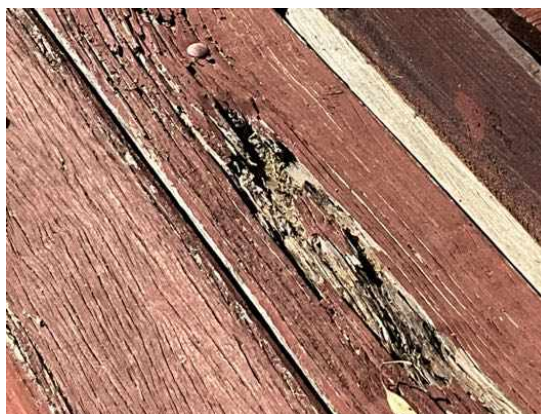
Finding 7.01

Building:	Building 1
Location:	Verandah
Finding:	Fungal decay - present (localised)
Information:	Fungal decay also known as wood decay or wood rot generally refers to the deterioration of timber elements when in contact with excessive levels of moisture for a

prolonged period of time.

The development of fungal decay is accelerated by temperatures in the range of 5degreeC to 40degreeC as well as the presence of oxygen. Generally fungal decay develops on timber elements that are in use in an external environment which are exposed to rain penetration.

In this case although the affected timber element is in a decaying state the extent of any visible damage appears to be localised to a specific area and is yet to spread to other parts of the building element or affect adjoining structures. The fungal decay is therefore likely to be of a relatively superficial nature with minimal impact on the structural integrity or tensile strength of the timber element.

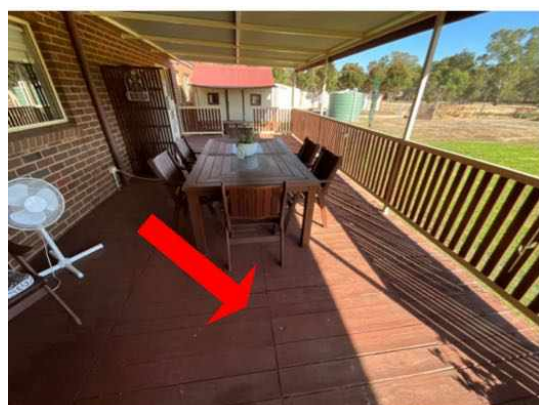
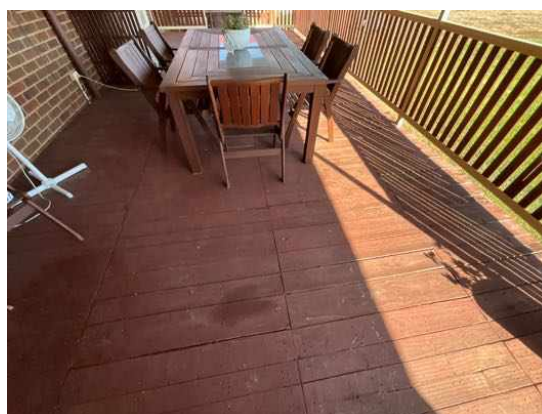
Building: Building 1
 Location: Verandah > Rear
 Finding: Handyman/substandard works
 Information: The works to this area appear to be incomplete or have been completed to a substandard level.

Works that have not been completed to a satisfactory level create potential for the development of building defects and may impede on the safety and integrity of the overall structure.

It is highly recommended that the relevant trades be appointed to complete these works and ensure the safety of the area and the longevity of all associated building elements.

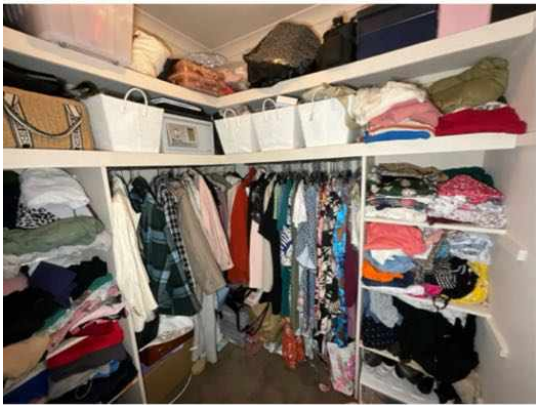
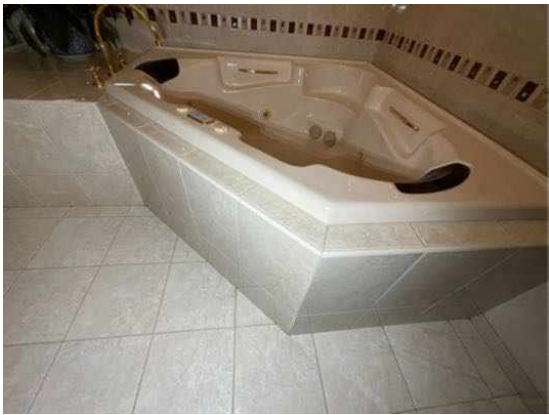
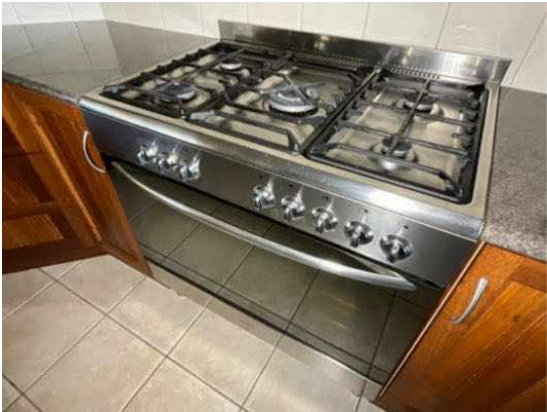
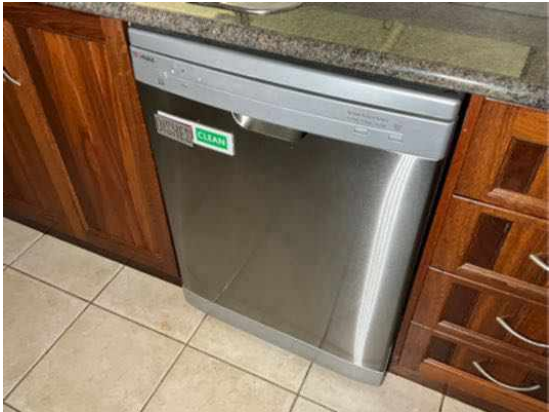
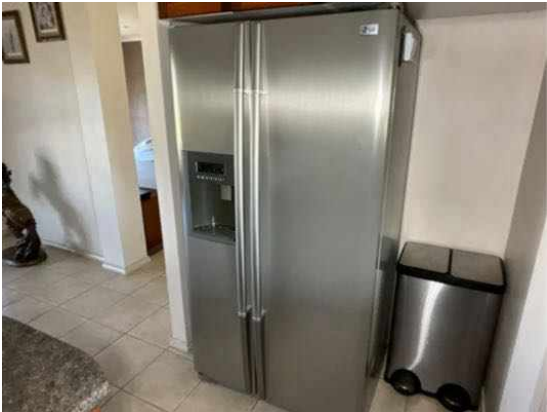
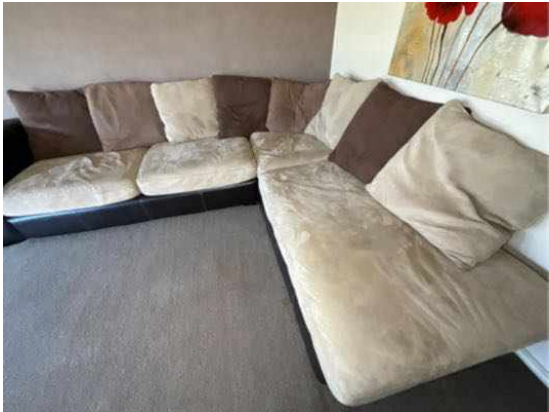
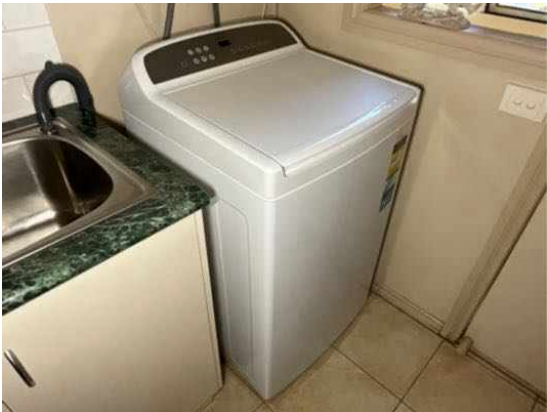
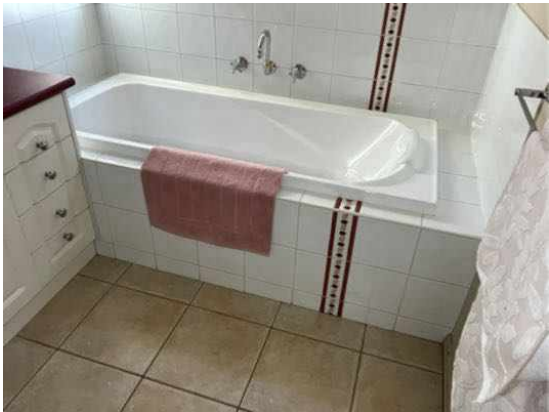
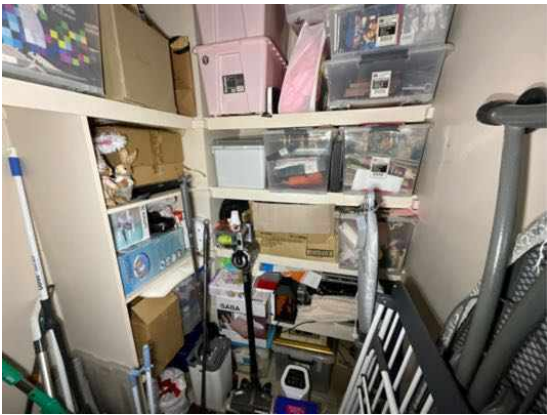
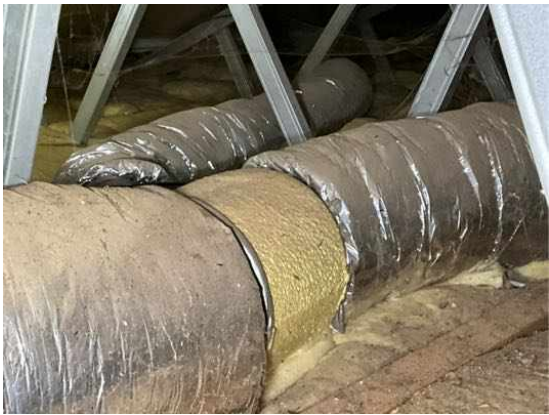
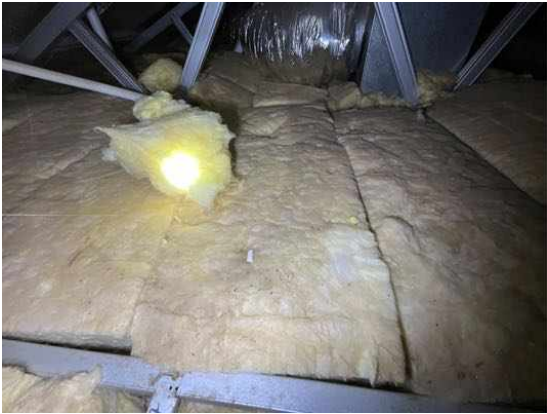
Building: Building 1
 Location: All Areas
 Finding: Additional Photos - Obstructions and Limitations
 Information: These photographs are an indication of the obstructions and limitations which impeded full inspection of the property at the time of inspection. These obstructions can hide an array of defects and should be removed to allow full inspection to be carried out. A re-inspection is recommended once the areas are made accessible.
