Building and Timber Pest Inspection Report

Inspection Date: Wed, 4 Mar 2026

Property Address: 15 Kurmond St, Jamisontown NSW 2750,
Australia

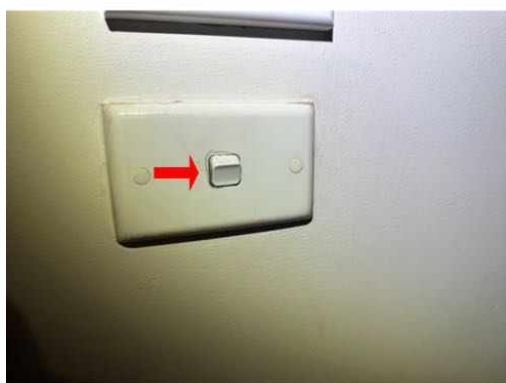
Building:	Main Building
Location:	All Areas > All Areas
Finding:	Electrical fittings: Deteriorated damage.
Information:	The electrical fitting in this area was found to be showing signs of deterioration at the time of inspection.

Left unmanaged, the fitting is unlikely to cause further damage to surrounding building elements. However, the broken fitting may create a safety hazard if there is potential contact with persons in the area.

Repair and/or replacement of the broken fitting is advised. A Licensed electrician should be appointed to repair/replace the fitting immediately.

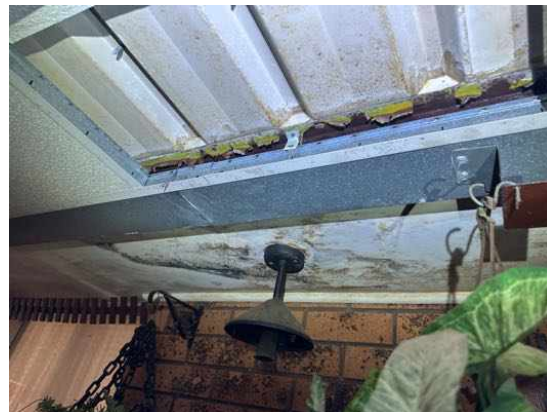
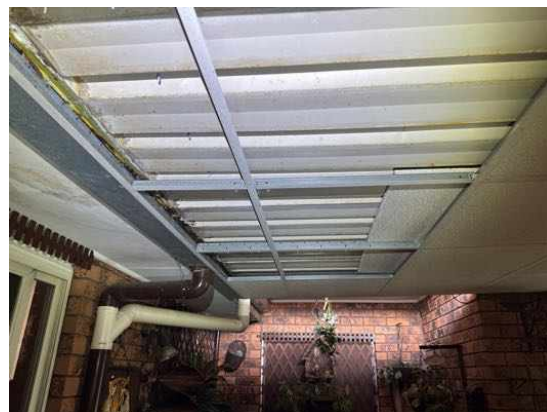
Finding 2.01

Building:	Main Building
Location:	Alfresco > Rear
Finding:	Water staining
Information:	Water staining was evident in this area at the time of inspection. Water staining indicates that surfaces have been exposed to excessive moisture over time. The minerals and other elements in the water lead to staining, which may graduate to corrosion and deterioration if left unmanaged.

While mostly an appearance defect, water staining can be indicative of more serious defects, which may be currently concealed by other building elements.

Where water staining is active, a licensed plumber must be consulted to identify the cause of the staining and to provide advice on any reparation works that may be required. Replacement of any broken or damaged structures is advised.

Conversely, where water staining is old and inactive, affected building materials may be repaired or replaced at client discretion. A qualified carpenter or registered builder may be appointed to perform these works.

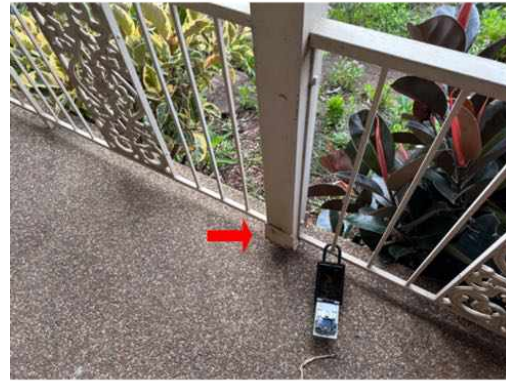
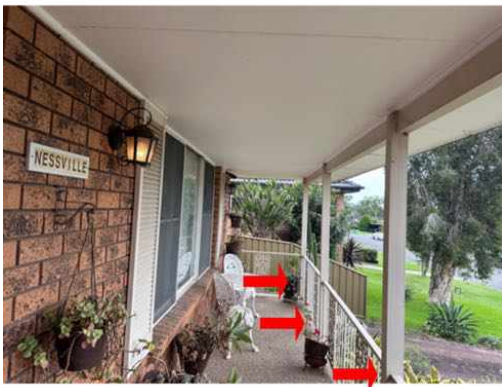
Finding 2.02

Building: Main Building
Location: Front Elevation > Front Right
Finding: Building element - Rusted or corroded
Information: This building element shows evidence of rusting and corrosion, which is likely to have developed as a result of excessive exposure to moisture and or inadequate coatings.

As surface rust provides no protection to the underlying iron, the deteriorating condition is likely to worsen if not addressed in the short-term future.

Where possible, the use of galvanized (treated) metals or aluminium coated metals aid in rust prevention, as does regular general maintenance. Rust formation can be controlled with coatings, such as paint, that isolate the iron from the environment.

Rusting and corrosion should be managed by ideally removing or limiting the affected surface from exposure to moisture. A registered builder may be appointed to replace any building elements that have been severely affected by rust or water damage.

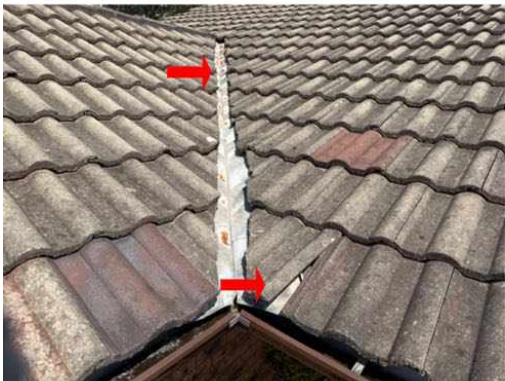
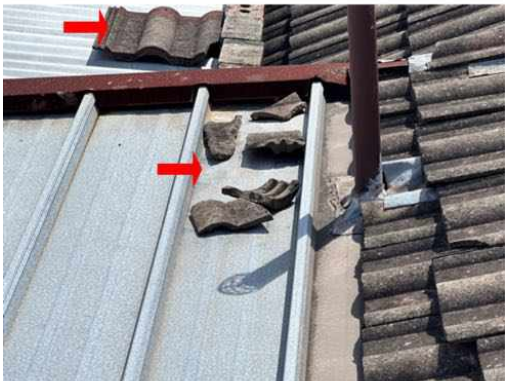
Building: Main Building
Location: Roof Exterior > All Areas
Finding: Roof tiles - Weathered
Information: Upon inspection of the exterior roofing, the majority of roof tiles were considered to be in a fair condition. While weathering of the tiles is consistent with the age of the property, maintenance works are required.

Isolated areas of mortar have come loose in the valleys and minor cracking is also present. Re-pointing and re-sealing the may be considered as an interim solution by the client to help preserve and extend the life span of the tiles.

Where left unmanaged, deteriorating roof tiles are likely to lead to a number of secondary defects, including minor water leaks and weather exposure to internal roofing structures.

Consultation with a roofing contractor is highly advised to gain advice on cost of remedial works that may be required in the short to medium term. Remedial works are likely to increase the longevity of the exterior roofing structure.

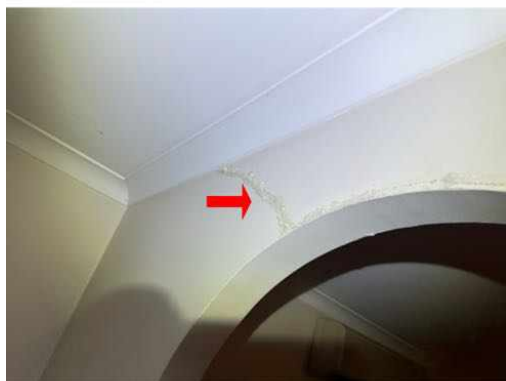
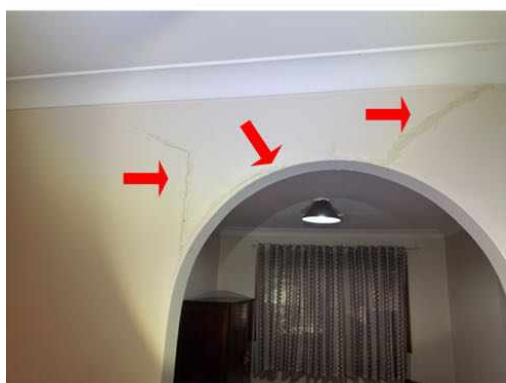
Finding 3.03

Building: Main Building
 Location: Dining Room > Rear Right
 Finding: Cracking - Damage Category 2 - Noticeable (up to 5mm)
 Information: Noticeable cracks are a common occurrence as a result of many primary defects. Such causes may include age, general wear and tear, expected building movement, general expansion/contraction of building materials in different weather conditions, and/or minor failings in the installation or application of building materials.

Noticeable cracks may result in minor sticking or jamming of associated doors and windows, which require easement. However, noticeable cracks are easily filled and repaired. A plasterer can be consulted to install an expansion joint at this point to allow

Monitoring of all cracking should be conducted frequently. Always contact a building inspector should cracks widen, lengthen, or become more numerous. Additionally, your building inspector should also be contacted if associated building elements such as doors and windows become more difficult to operate over time.

Relevant tradespeople, such as carpenters, painters and plasterers, should be appointed to perform remedial works, as deemed necessary.

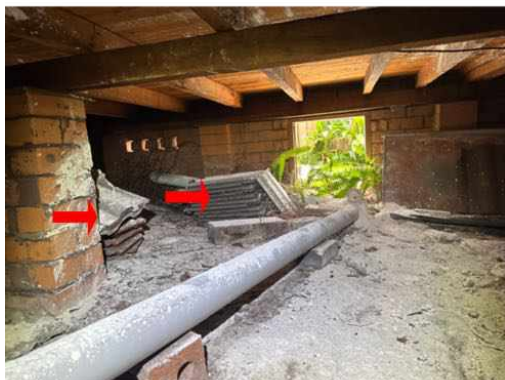
Finding 3.04

Building:	Main Building
Location:	Subfloor > All Areas
Finding:	Subfloor - Debris
Information:	An array of debris was found in the subfloor area at the time of inspection. Debris in this area restricts subfloor ventilation and creates potential for concealed pest entry. Stored timbers and other materials may also make the area susceptible to termite activity and wood rot.

A clear and empty subfloor will be better ventilated and easier to maintain in a dry condition. The removal of any timber debris is vital in minimising the risk of termite or wood borer activity.

Debris in the subfloor should be removed as soon as possible. Depending on the location and amount of debris and stored items, the homeowner may elect to undertake this task. Alternatively there are a large number of rubbish removal subcontractors that could undertake these works.

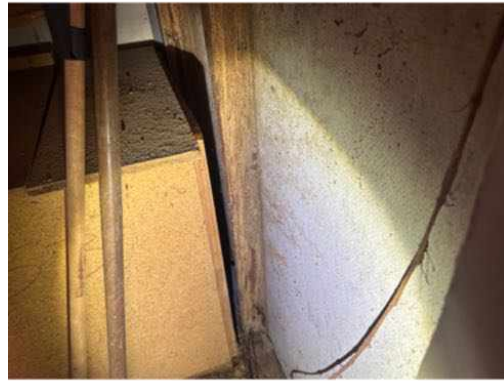
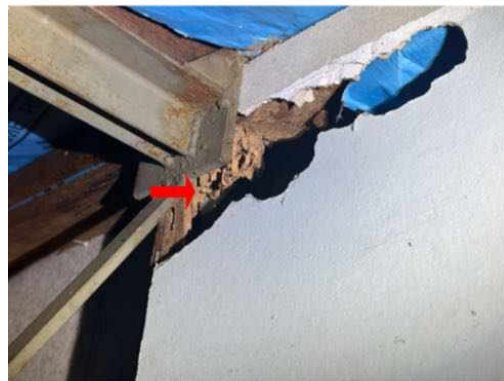
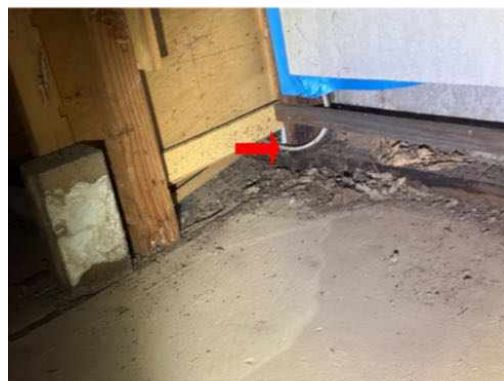
Building:	Garage
Location:	Garage > Rear Right
Finding:	Evidence of termite damage - structural
Information:	Despite no live termite or timber pest activity being identified, previous termite damage was found in this area. This damage is considered to be major and structural in nature. Such damage creates a potential safety hazard, and is likely to worsen and cause further damage to adjoining building materials.

If left unattended, this damage creates an unsafe environment and is likely to lead to the need for major structural works.

A building contractor should be appointed immediately to advise on options to prevent further damage and repair all affected building materials. Until such time, caution should be taken by all people coming into contact with these building elements and this area.

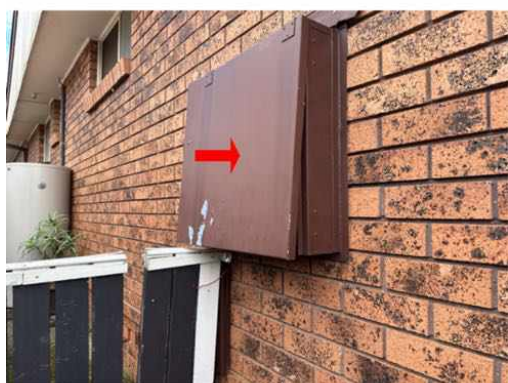
Finding 6.01

Building:	Main Building
Location:	Electrical circuit box > Front Left
Finding:	Termite Management System - no evidence of a chemical installation
Information:	The application of a post-construction chemical termite barrier is highly recommended for all properties, particularly if live termite activity has been found on the site previously. Such barriers are highly effective in preventing termite attack on any timber building elements throughout the property.

A durable notice should be placed in the switchboard unit to indicate current termite barriers. At the time of inspection, it appeared as though no termite management system has been installed, with no evidence to suggest preventative works taking place.

The client may consider gaining further advice from a pest controller as to the costs and procedures involved with this application. It is recommended that obtaining such advice be a short-term priority.

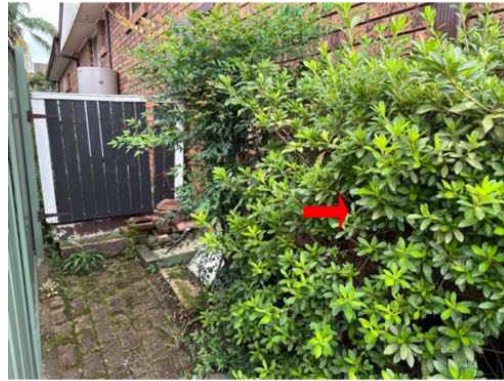
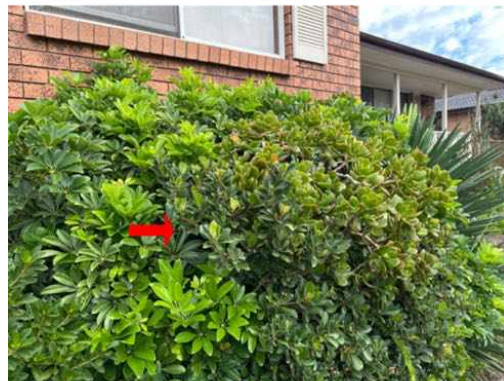
Finding 6.02

Building:	Main Building
Location:	All Areas > All Areas
Finding:	Bridging - Vegetation
Information:	Where vegetation obstructs inspection of building elements, also known as bridging as it provides a bridging point for the access of termites, full inspection can not be achieved. Consequently moisture or dampness may be present and the areas becomes conducive to termite activity. Plants against or very close to buildings provide cover, shade and can provide an environment that is attractive to termite infestation.

The removal and replanting of species that do not provide "cover" or cutting back of existing vegetation will assist greatly in preventing Bridging from occurring.

The removal of any such materials that may be conducive to termite activity should be carried out as soon as possible and arrange re inspection to minimize the risk of termite attack.

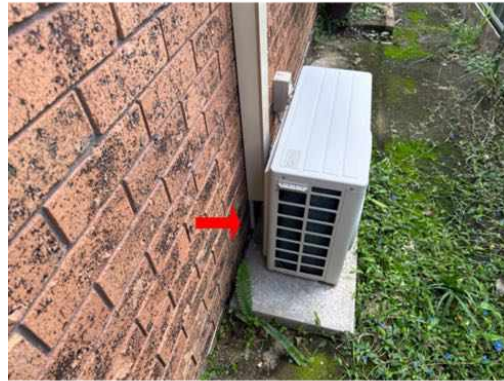
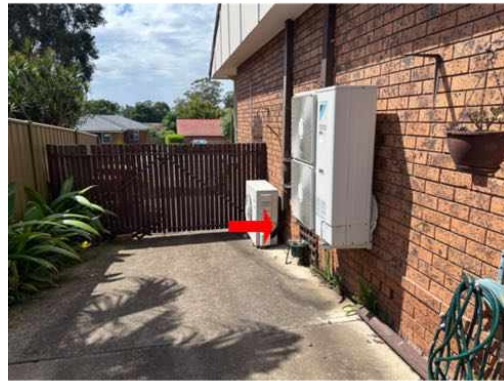
Finding 6.03

Building:	Main Building
Location:	All Areas > All Areas
Finding:	Air conditioner - Disconnected overflow
Information:	The Air Conditioner (A/C) overflow was found to be disconnected from storm water drainage and is creating excessive moisture in the surrounding area.

Such leaking creates an environment which is conducive to an array of defects, including water damage to associated building elements and the attraction of termite or timber pest infestation.

It is highly recommended that a licensed plumber be appointed to connect the A/C

overflow in order to prevent such an environment from being created. These minor works should be carried out as soon as possible.

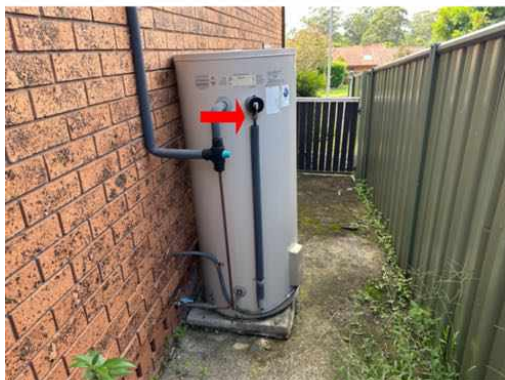
Finding 6.04

Building:	Main Building
Location:	Exterior walls - left side > Centre Left
Finding:	HWS Overflow - Not Connected
Information:	The Hot Water System (HWS) overflow was found to be disconnected from storm water drainage and is creating excessive moisture in the surrounding area.

These damp conditions can lead to secondary defects such as rot, rust or corrosion of associated building elements, the formation of fungal decay, or even the creation of potential slip hazards. When coupled with poor site drainage, pooling of water may also attract termite activity to this area.

It is highly recommended that a licensed plumber be appointed to connect the HWS overflow in order to prevent such an environment from being created. These minor works should be carried out as soon as possible.

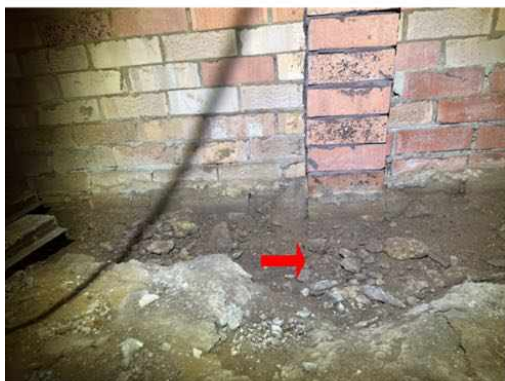
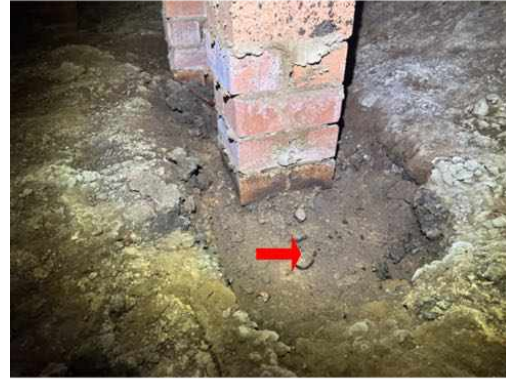
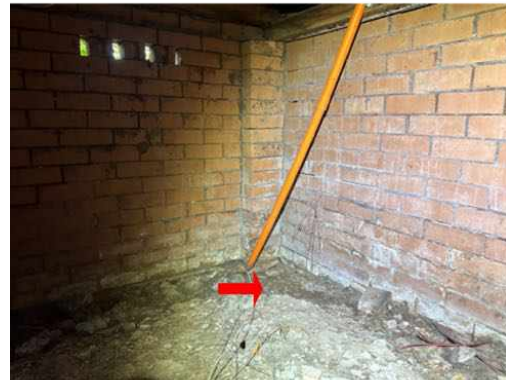
Finding 6.05

Building: Main Building
 Location: Subfloor > All Areas
 Finding: Subfloor: Damp.
 Information:

At the time of inspection there appeared to be sections of the subfloor area with excessive moisture which can lead to secondary defect of other building materials. A well drained sub floor can aid in preventing secondary damage such as wood rot and pest activity, as well as preventing the development of mould and mildew (which can lead to respiratory safety hazards for occupants). This should be investigated as soon as possible by a plumber for leaking pipes or to improve site drainage.

Ventilation can be restricted by a variety of minor defects, including obstructions in the subfloor space, a lack of vents or a low clearance.

The initial step in improving ventilation is to ensure that the subfloor area is free of any debris or stored items. Where ventilation is still inadequate, it is advised to ensure that all vents are clear of blockages, and additional vents may be installed.

The client may also consider mechanical ventilation (powered fans) to improve subfloor airflow. Remedial works should be conducted as a matter of urgency to protect against the development of potentially harmful subfloor conditions.

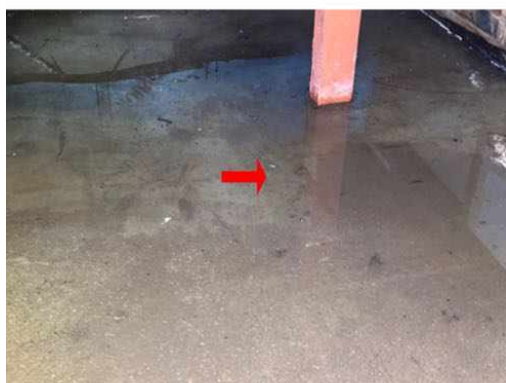
Finding 6.06

Building:	Garage
Location:	Garage > Rear Right
Finding:	Damp
Information:	Damp (or structural damp) refers to the presence of unwanted moisture in the structure of a building, either as the result of intrusion from outside, or condensation from within the structure. Generally, structural damp is caused by rain penetration, rising damp, and leaks from plumbing pipes.

Unmanaged damp facilitates the formation and development of mould, fungi growth and wood rot, decaying associated building materials and compromising their

structural integrity. Damage to finishes is also likely to occur, including lifting, bubbling, peeling and staining of paint, plaster and wallpaper.

The first step in addressing damp is to diagnose the cause. The identified cause should be addressed first prior to repairing the appearance and other defects which have resulted from the rising damp. If the original cause is not resolved, further cases of damp are likely to ensue, resulting in secondary defects.

Consultation with a qualified plumber is advised immediately to identify the cause of damp and perform remedial works as required. Where excessive mould growth is present, further inspection by a specialist environmental health inspector should also be considered.

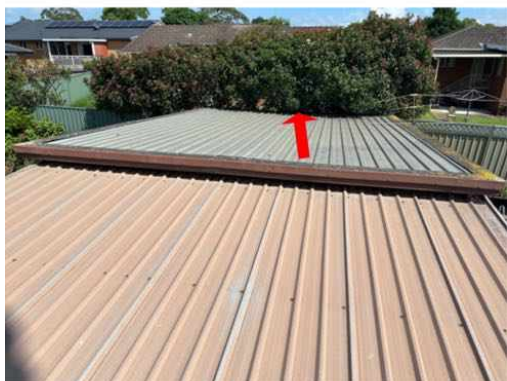
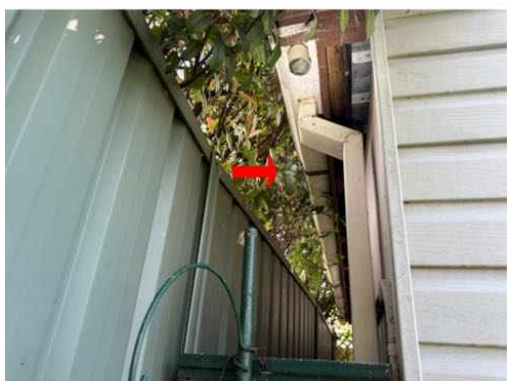
Finding 6.07

Building:	Garage
Location:	Garage > Rear Right
Finding:	Bridging - Vegetation
Information:	Where vegetation obstructs inspection of building elements, also known as bridging as it provides a bridging point for the access of termites, full inspection can not be achieved. Consequently moisture or dampness may be present and the areas becomes conducive to termite activity. Plants against or very close to buildings provide cover, shade and can provide an environment that is attractive to termite infestation.

The removal and replanting of species that do not provide "cover" or cutting back of existing vegetation will assist greatly in preventing Bridging from occurring.

The removal of any such materials that may be conducive to termite activity should be carried out as soon as possible and arrange re inspection to minimize the risk of termite attack.

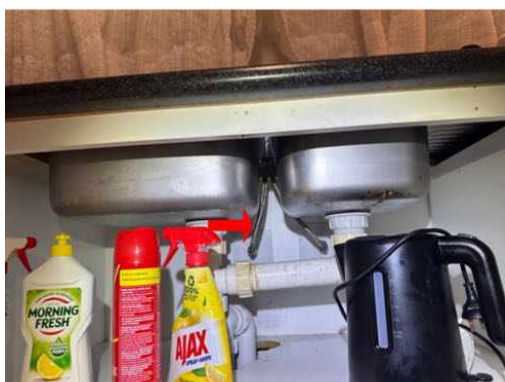
Building:	Main Building
Location:	All Areas > All Areas
Finding:	Pipe: Flexible Braided pipes.
Information:	Braided Stainless Steel Flexi connector hose are popular in modern home fit outs because they can be bent into shape. They started to be installed in the early two thousands and their use is now extremely widespread in contemporary construction and renovations.

It is recommended that the Flexi pipes to be replaced at the owners discretion to avoid an “escape water incident” which may lead to water damage to other building elements in the home.

This work can be undertaken by a licensed plumber, general handy person at the owners discretion.
