Building and Timber Pest Inspection Report

Inspection Date: Thu, 22 Jan 2026

Property Address: 21 Evergreen Pl, Forest Lake QLD 4078,
Australia

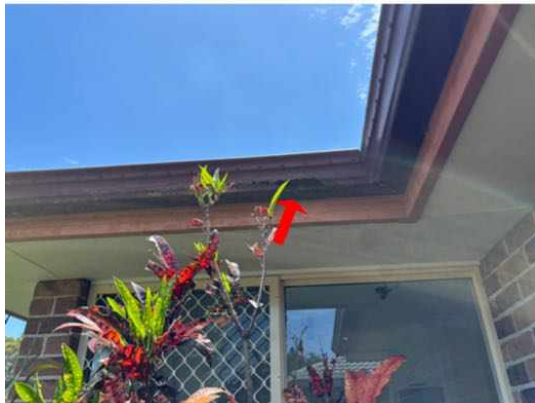
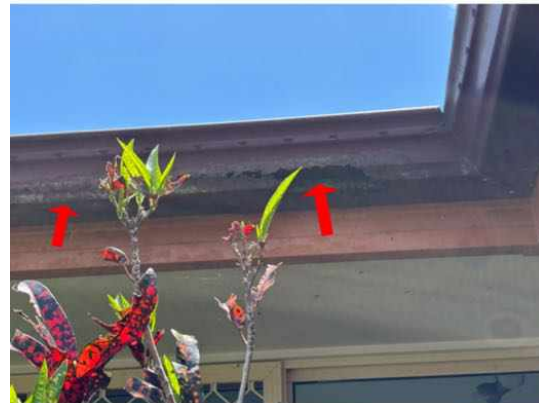
Finding 3.01

Building: Main Building
 Location: All External Areas
 Finding: Gutters - rusting
 Information: At the time of the inspection, it was noted that the gutters were rusting and as such leaking. Gutters need to be in good working order to drain the roof properly.

If gutters are leaking, moisture may get to areas of the building that are meant to be kept dry. Damage to building elements may result of moisture ingress.

A licensed roof plumber should be appointed to inspect the gutters and advise on necessary rectification works. This should be done as a matter of urgency.

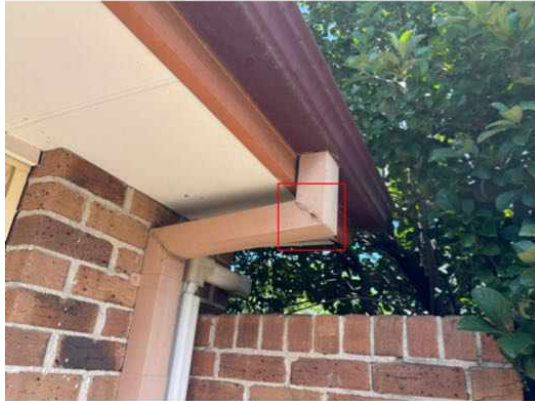
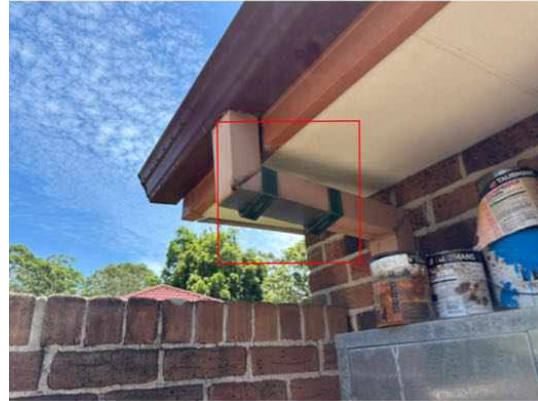
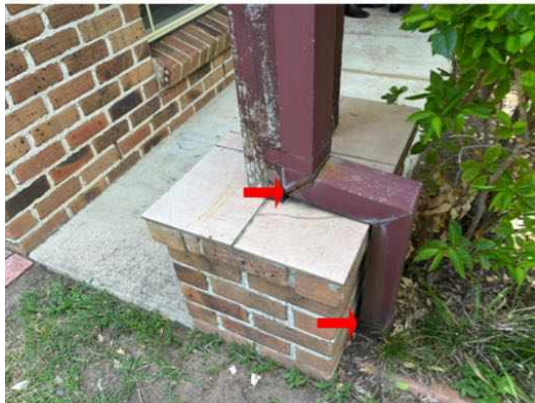
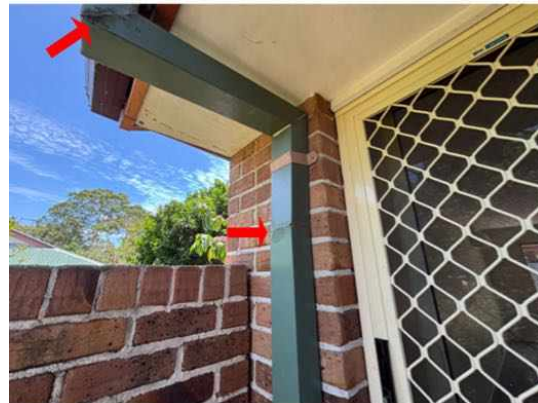
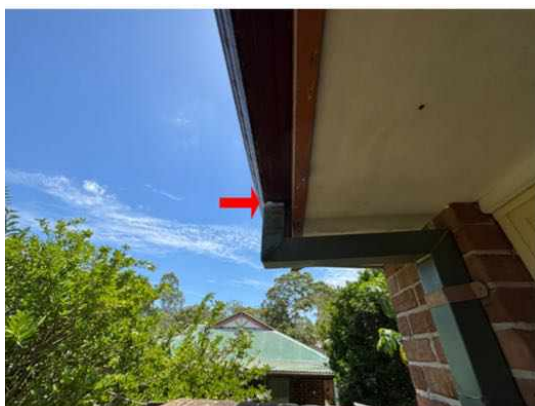
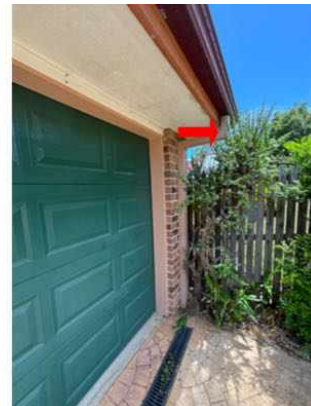
Finding 3.02

Building: Main Building
 Location: All External Areas
 Finding: Down pipes - leaking
 Information: At the time of the inspection, it was noted that the metal down pipes to the dwelling, showed signs of leaking. This may be due to the age of the materials. Moisture will be draining next to the foundation of the dwelling rather than to the storm water system.

A moist environment next to the foundations of the dwelling can create a conducive environment for termite activity and may damage the associated building materials.

A licensed plumber should be engaged to replace any affected down pipes. This should be done as a short term priority.

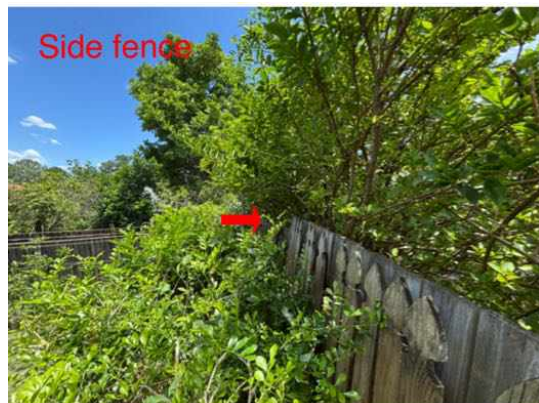
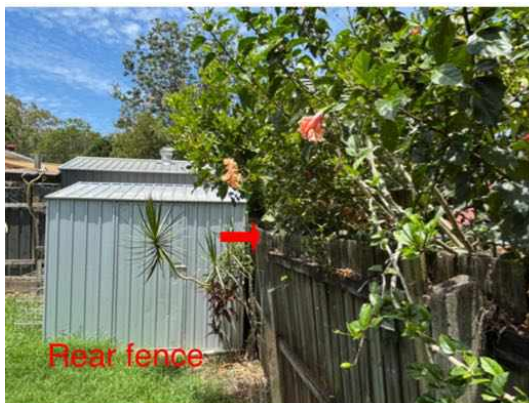
Finding 3.03

Building:	Main Building
Location:	All External Areas
Finding:	Boundary fences - deteriorating
Information:	At the time of the inspection, it was noted that the side and rear timber boundary

fences were deteriorating. The rear fence is leaning into the yard due to wood rot to the timber fence posts. The side fence is leaning over due to the boundary retaining leaning over. The fences are currently upright however there is movement when pressure is applied to them.

A fencing contractor should be engaged to assess the fences and provide a solution to rectify this issue. This can be done at the clients discretion.

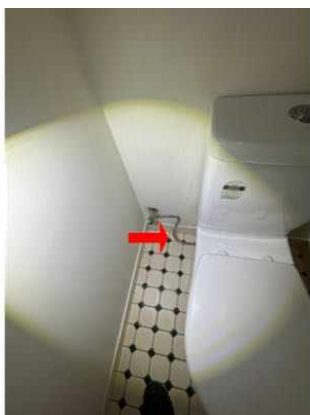
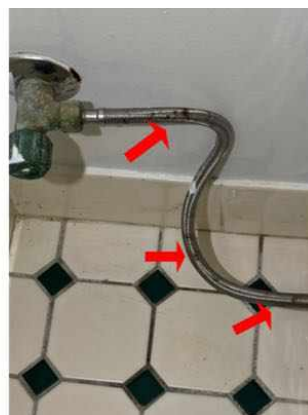
Finding 3.04

Building:	Main Building
Location:	Toilet
Finding:	Toilet - flexible hose has signs of rust
Information:	At the time of the inspection, it was noted that a flexible hose to the toilet had signs of rusting. This may be due to the age of the hose. Flexible hoses typically have a 5 - 10 year lifespan. It is recommended that they be changed if they have signs of bulging, fraying, kinking or rust.

A licensed plumber should be engaged to replace the flexible hose to the toilet. This should be done as a matter of urgency.

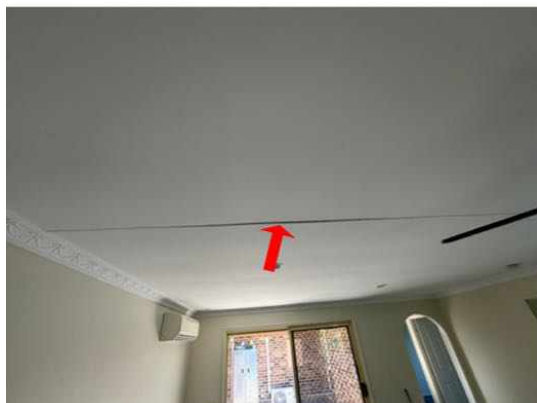
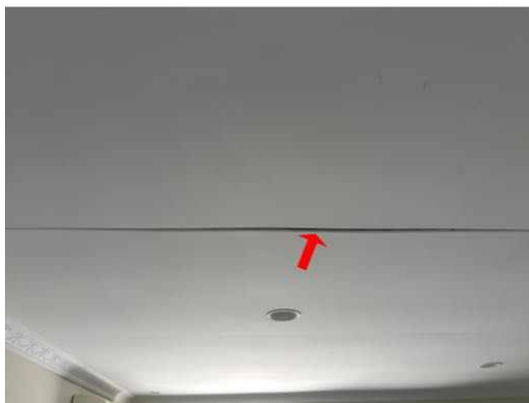
Finding 3.05

Building: Main Building
 Location: Toilet
 Finding: Lounge - ceiling lining loose
 Information: At the time of the inspection, it was noted that a section of the ceiling lining in the lounge was loose. This section needs to be re-attached to the timber framing to prevent further deterioration.

A building maintenance professional should be engaged to carry the necessary repairs to this section of the ceiling lining. This should be done as a short term priority.

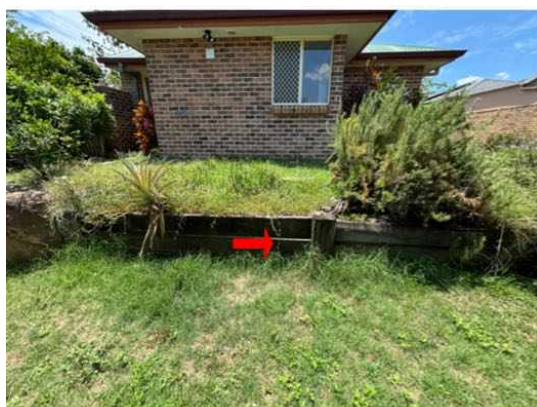
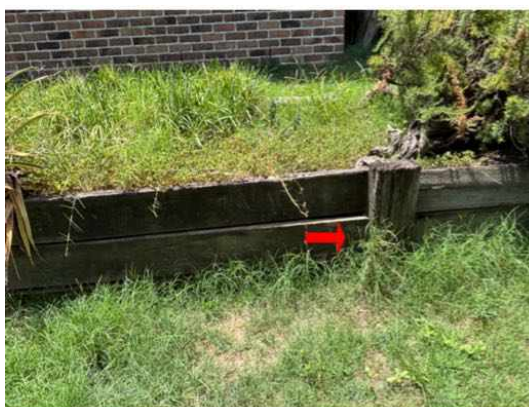
Finding 3.06

Building: Main Building
 Location: Back yard
 Finding: Back yard - low retaining wall deterioration
 Information: At the time of the inspection, it was noted that the low timber retaining wall has some deterioration to it. This may be due to the age of the materials and general weathering.

A retaining wall specialist or landscaper could be engaged to replace this low retaining wall. This can be done at the clients discretion.

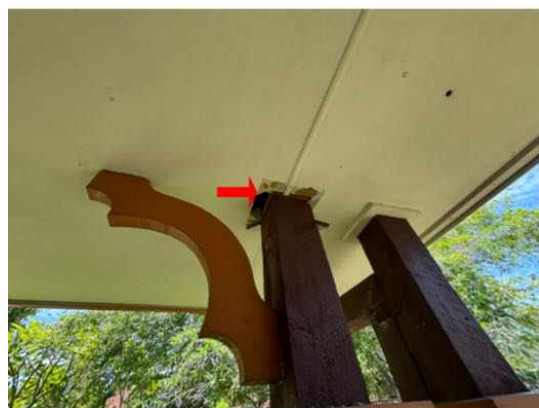
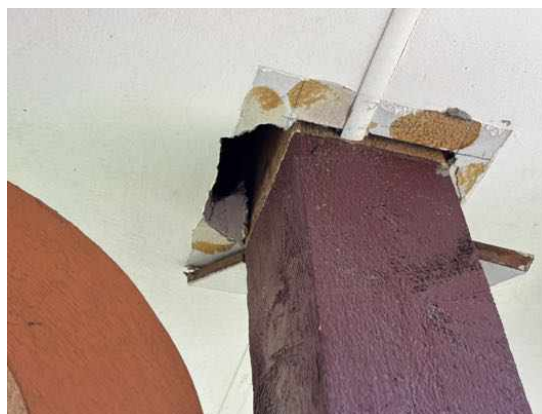
Finding 3.07

Building:	Main Building
Location:	Front elevation
Finding:	Front posts - mouldings missing
Information:	At the time of the inspection, it was noted that timber mouldings around a timber post at the front of the dwelling were missing.

A building maintenance professional could be engaged to replace these timber mouldings. This can be done at the clients discretion.

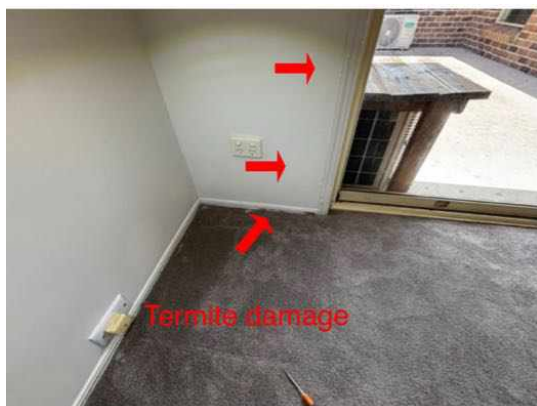
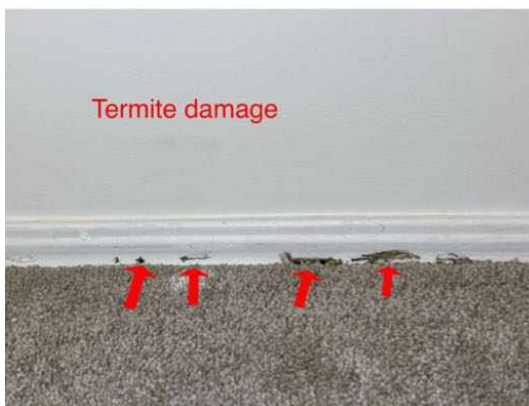
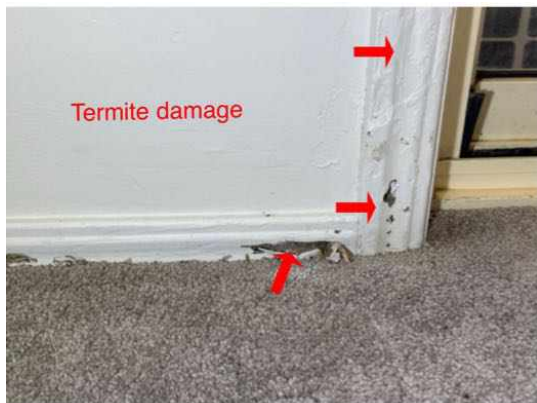
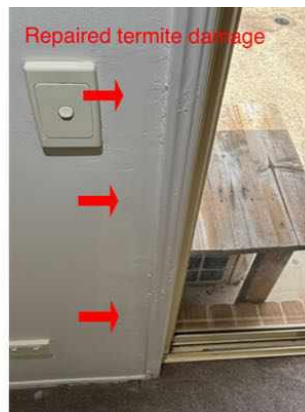
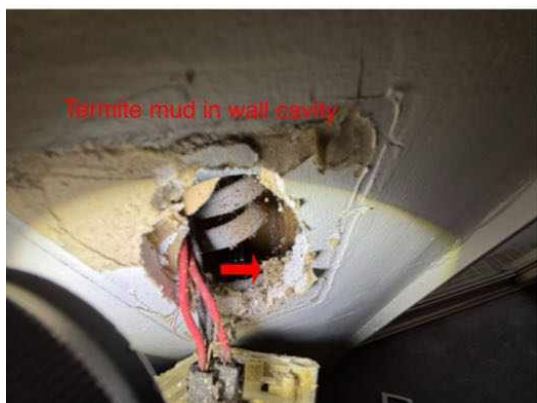
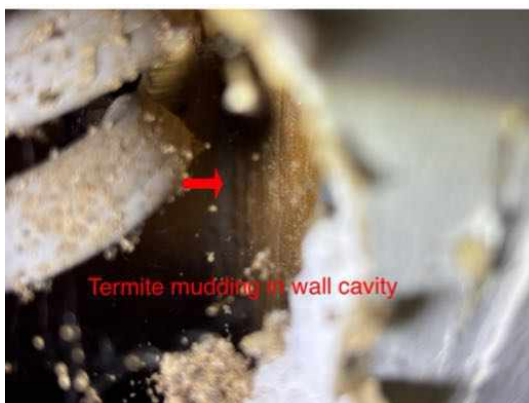
Finding 5.01

Building:	Main Building
Location:	Lounge
Finding:	Evidence of termite damage
Information:	At the time of the inspection, it was noted that there was termite damage to building materials in the lounge. Damage to a section of the wall lining has been poorly executed.

Termite damage was found to building materials in the lounge.

It is advised that the area be visually inspected frequently to ensure that the condition of affected building materials does not worsen.

A building contractor may be appointed to provide a further invasive inspection if further damage is evident.

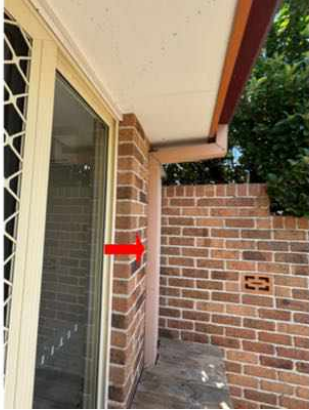
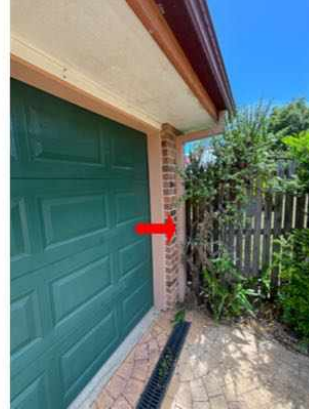
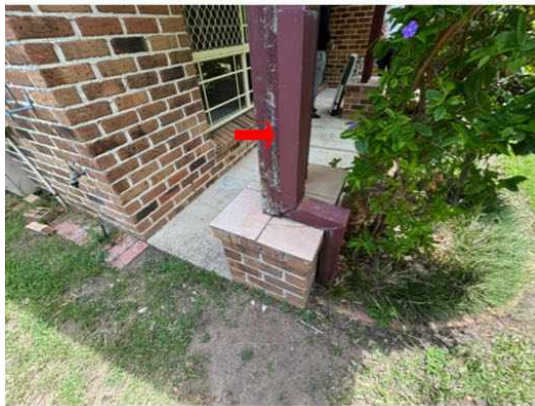
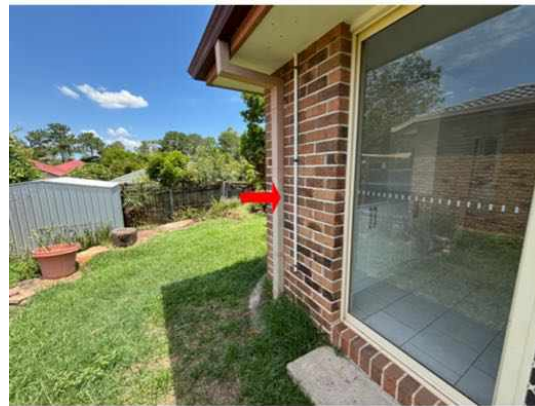
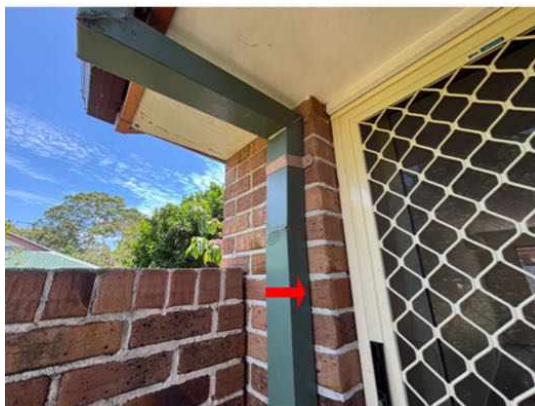
Finding 6.01

Building:	Main Building
Location:	All External Areas
Finding:	Down pipes mounted close to the building
Information:	At the time of the inspection, it was noted that the down pipes for the storm water system were mounted close to the building and as a result there is no visible inspection zone behind them to check for potential termite activity. The down pipes should be replaced with a type that allows for visual inspection behind them.

Annual termite inspections must be carried out, this becomes more important when conducive conditions are present. Extra attention should be paid to these areas.

A plumber should be engaged to replace the down pipes. This should be done as a matter of urgency.

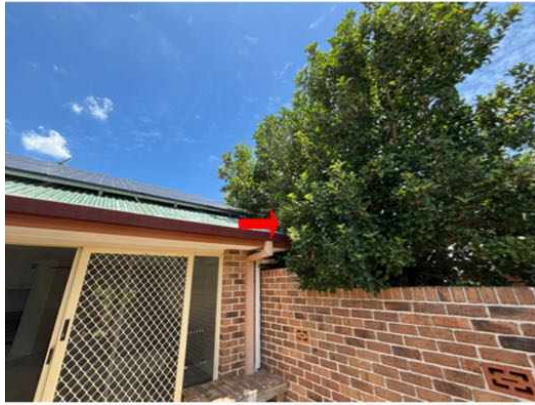
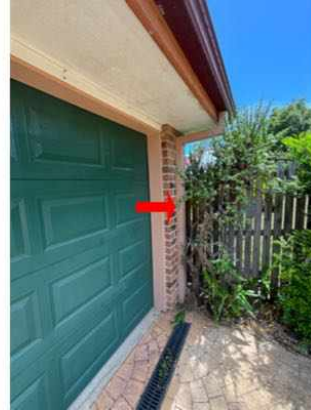
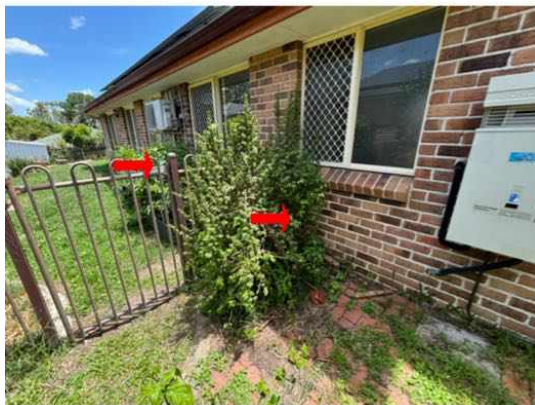
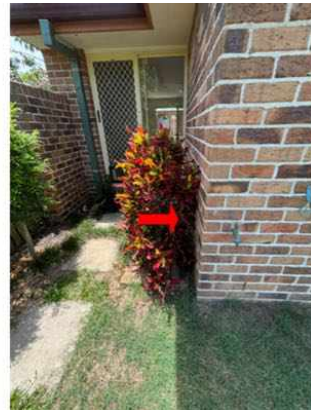
Finding 6.02

Building: Main Building
 Location: All External Areas
 Finding: Vegetation touching the building
 Information: At the time of the inspection, it was noted that there was vegetation touching the

building in several locations. This creates a potential access point for termites to enter the building undetected. This is a conducive condition for termite activity.

The client is to ensure that the vegetation is trimmed back to prevent undetected termite entry to the building and to provide a clear inspection area between the vegetation and the dwelling. This should be done as a matter of urgency.

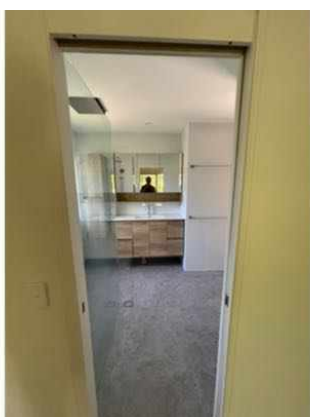
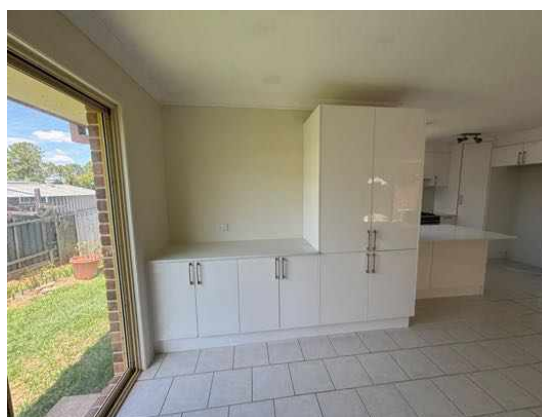
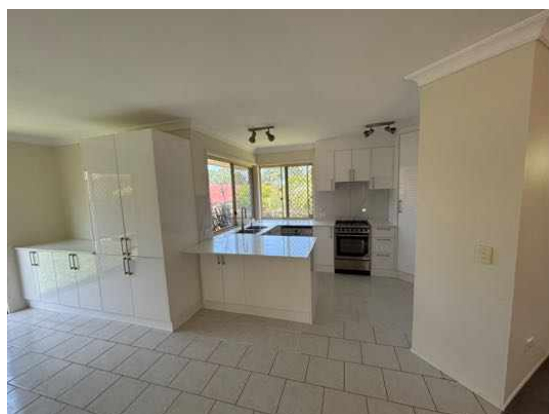
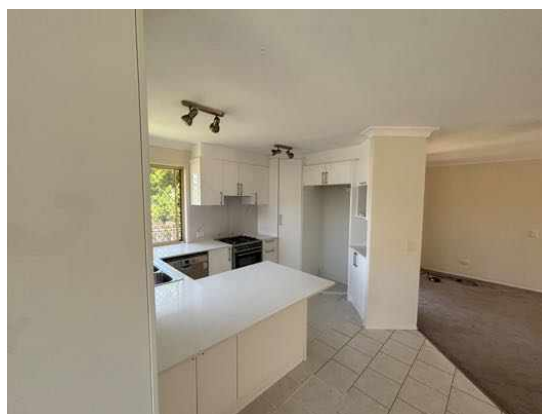
Building: Main Building
 Location: All Internal Areas
 Finding: Obstructions and Limitations - Internal areas
 Information: These photographs are an indication of the obstructions and limitations which impeded full inspection of the property of the internal areas at the time of inspection. These obstructions can hide an array of defects and should be removed to allow full inspection to be carried out. A re-inspection is recommended once the areas are made accessible.

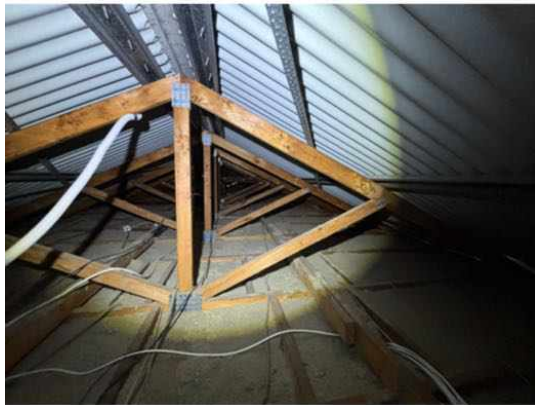
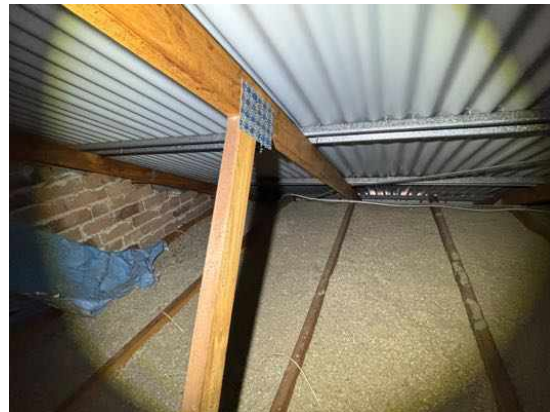
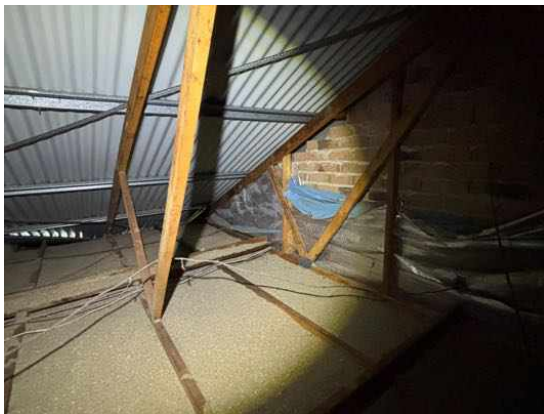
Building: Main Building
 Location: Roof Void
 Finding: Obstructions and Limitations - Roof cavity
 Information: These photographs are an indication of the obstructions and limitations which impeded full inspection of the property of the roof cavity

at the time of inspection. These obstructions can hide an array of defects and should be removed to allow full inspection to be carried out. A re-inspection is recommended once the areas are made accessible.

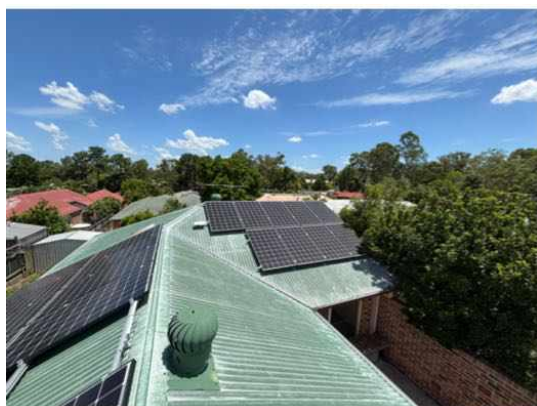
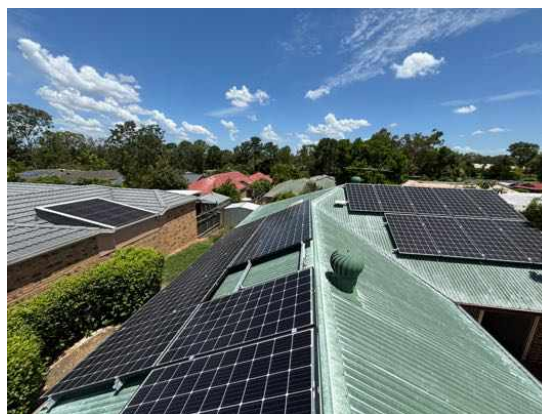
Building: Main Building
 Location: Roof Exterior
 Finding: Obstructions and Limitations - Roof exterior
 Information: These photographs are an indication of the obstructions and limitations which impeded full inspection of the property of the roof exterior

at the time of inspection. These obstructions can hide an array of defects and should be removed to allow full inspection to be carried out. A re-inspection is recommended once the areas are made accessible.

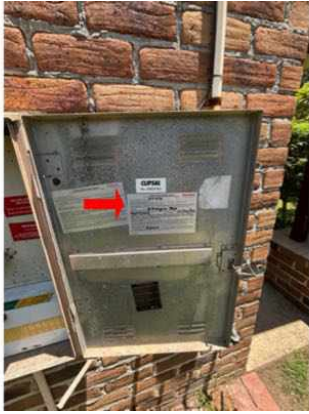
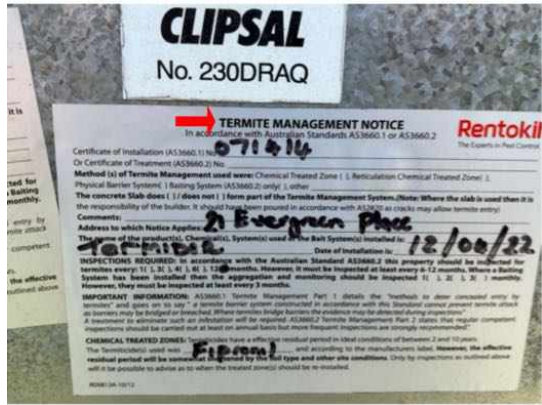
Building:	Main Building
Location:	All External Areas
Finding:	Evidence of a current chemical termite management system was identified.
Information:	At the time of the inspection, evidence of a current chemical termite management system was found by way of a durable notice in the electricity meter box.

A chemical soil treatment was carried out on the 12/04/2022 via injection and trenching. This has a life expectancy of 5 years in ideal conditions. It cannot be determined how the right hand side of the dwelling has been treated due to it being right on the boundary. No record was found onsite of annual termite inspections having carried out.

The client should contact the company that installed the system to see if there are any transferable warranties associated with this system. The client should have annual termite inspections carried out as per AS 3660.2 to help protect the dwelling and as per the durable notice.
