Building and Timber Pest Inspection Report

Inspection Date: Wed, 18 Feb 2026

Property Address: 74 Osborne St, Williamstown VIC 3016,
Australia

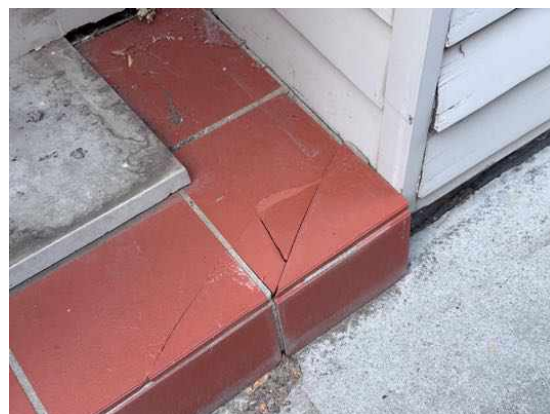
Building: Main Building
Location: Exterior walls - left side
Finding: Cracked Tiles at Side Laundry Entry
Information: Cracking was observed to multiple ceramic tiles at the side laundry entry threshold area. The cracking appears to extend diagonally across the tile surfaces and is likely associated with minor movement, impact loading, or inadequate substrate support beneath the tiled base.

While the defect is currently cosmetic in nature, cracked tiles may progressively deteriorate over time, allowing moisture ingress beneath the tile surface and potentially leading to loosening or further damage to adjacent tiles.

It is recommended that the affected tiles be replaced and the substrate condition checked to ensure adequate support and bonding prior to re-tiling to prevent recurrence.

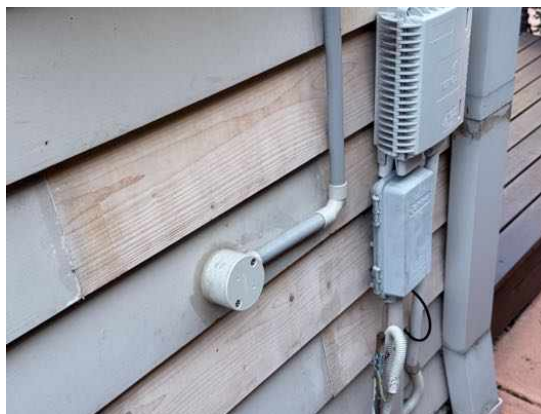
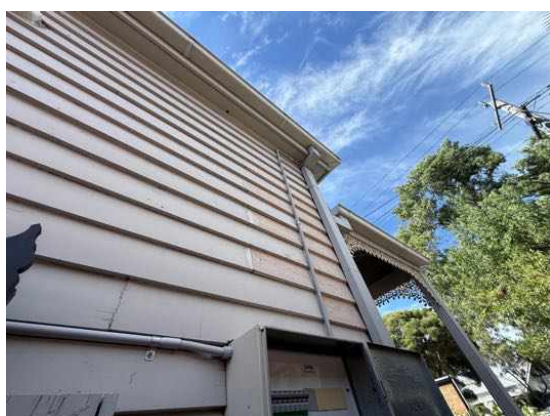
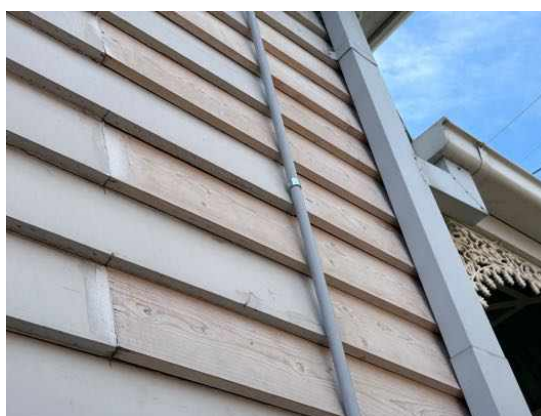
Finding 3.02

Building: Main Building
Location: Exterior walls - left side

Whilst incomplete or missing paint finish is generally an appearance defect, it can also lead to the development of secondary building defects over time. Incomplete areas of paint finish expose the area to moisture, potentially accelerating the deterioration of underlying building materials.

Incomplete paint finishes should be sanded back, filled, leveled and painted, as applicable. Where inadequate or missing paint protection has led to the deterioration of the associated building element, repair and/or replacement of this building element may be required.

A painting contractor should be appointed as soon as possible to perform necessary works to aid the appearance of the affected area and to ensure the area is protected against further deterioration. Alternatively, the homeowner following manufacturer instructions may perform these works.

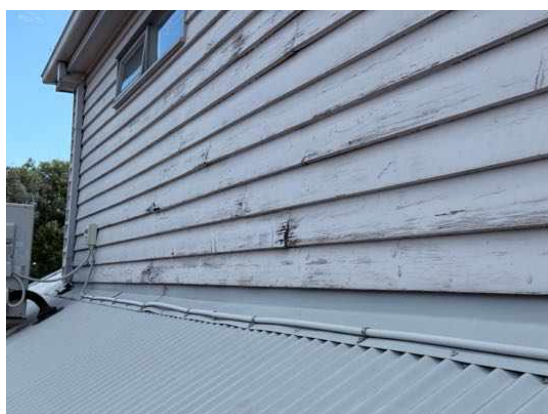
Finding 3.03

Building: Main Building
 Location: Some External Areas

Finding: Timber exposed to weather
Information: External timbers that are frequently exposed to harsh weather conditions require adequate protection in order to maintain their condition. Where timbers have not been painted or treated adequately, general deterioration is likely to occur at an accelerated rate.

If left unattended, replacement of these timbers is likely to be necessary in the short-term future. Adequate treatment of these timbers is required as soon as possible by a painting contractor or general handyman.

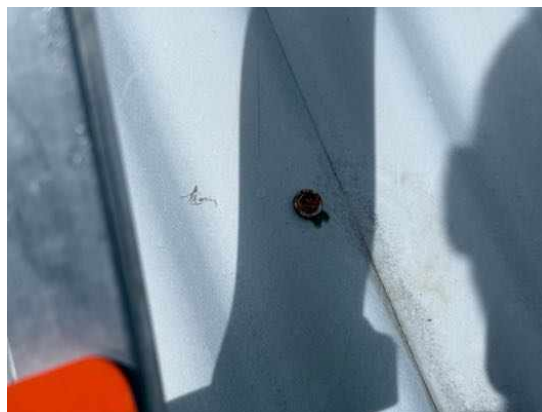
Finding 3.04

Building: Main Building
Location: Roof Exterior
Finding: Rusted Roofing Screws
Information: A number of roofing screws were noted to have surface rust at various locations across the roof. At present, the issue appears localised and has not resulted in visible leaks or damage to the roof sheeting. However, rusted screws may deteriorate further over time, potentially reducing their clamping strength and affecting the roof's water-tightness.

It is recommended that the affected screws be replaced during routine maintenance with suitable corrosion-resistant roofing screws and washers to maintain durability and prevent future water ingress.

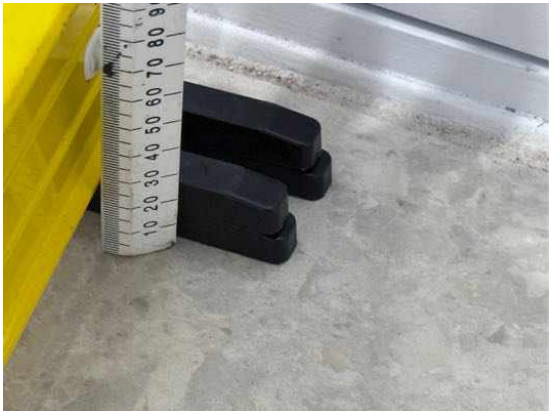
Finding 3.05

Building:	Main Building
Location:	Some Internal Areas
Finding:	Subsidence- minor to moderate
Information:	It is suspected that the subfloor structure might have been affected by movement of the foundations, often referred to as sinking or subsidence.

General subsidence is usually initiated by changes in soil moisture content. The most critical factor is identifying the specific causes, and identifying if this is a recurring or ongoing problem, or one that has been resolved by previous works in the past.

Maximum deviation of 20 mm in 2m distance was noted.

Subsidence can have complex and varying causes, which will influence the required remedial works. If secondary defects like door binding, cracks around the cornices, or gaps between walls & flooring are evident. It will be advised to begin by consulting a structural engineer to determine the required scope of works. This generally includes some form of underpinning, as well as addressing the underlying cause.

A Registered Builder specialising in re-stumping would then generally carry out works as advised by an Engineer.

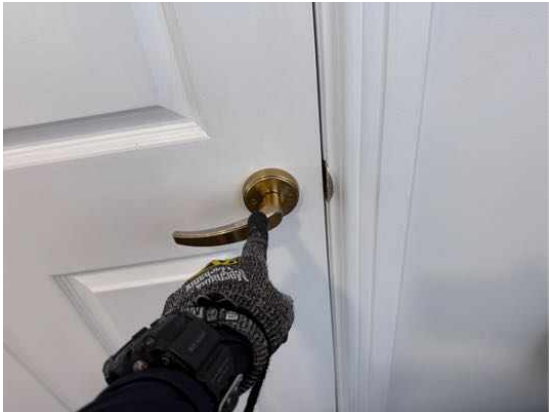
Finding 3.06

Building: Main Building
Location: Bedroom 1
Finding: Door not latching
Information: The door knob/ latch was found to be non operational at the time of inspection.

Consultation with a locksmith or general handyman is required to gain further advice.

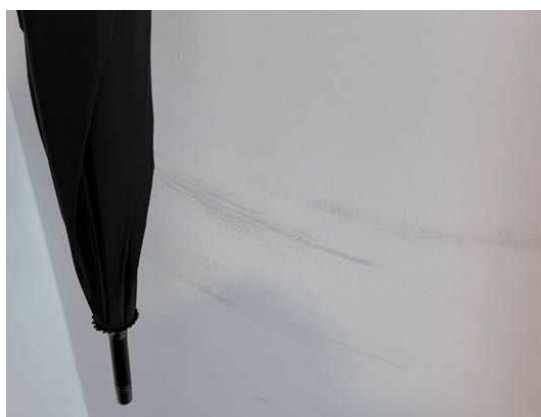
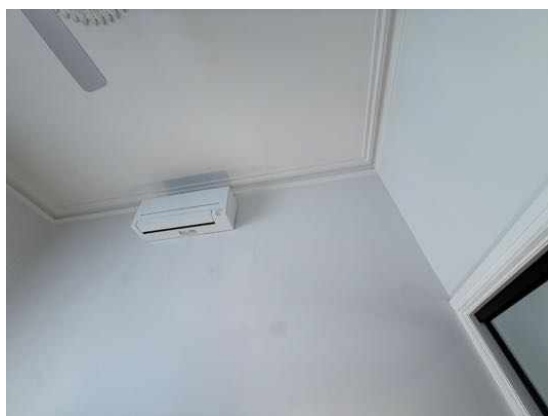
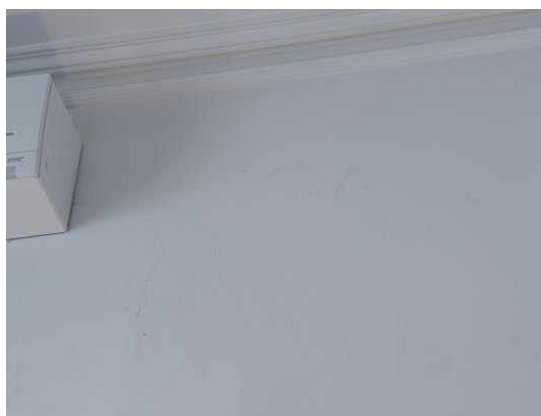
Finding 3.07

Building: Main Building

Location: Some Internal Areas
 Finding: Surface - Marked
 Information: Although detracting from the overall appearance, marked or stained surfaces do not indicate any operational or structural damage. This degree of surface damage is consistent with general wear and tear and is expected of a property of this age and condition.

Marked surfaces may be left as is at client discretion, as no repairs or replacement are necessarily required for this appearance defect. However, the client may wish to seek quotations for the cost to refurbish or replace the identified building element.

A painting or cleaning contractor may be appointed to rectify marked surfaces at the discretion of the client.

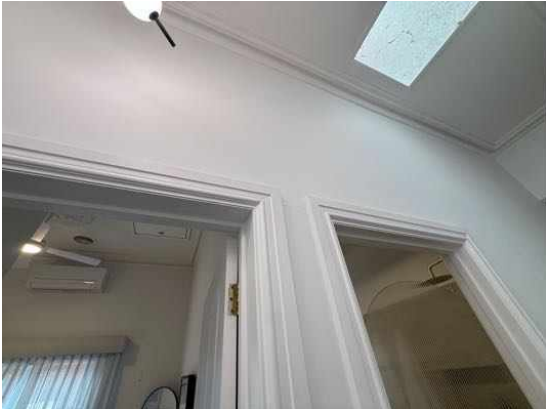
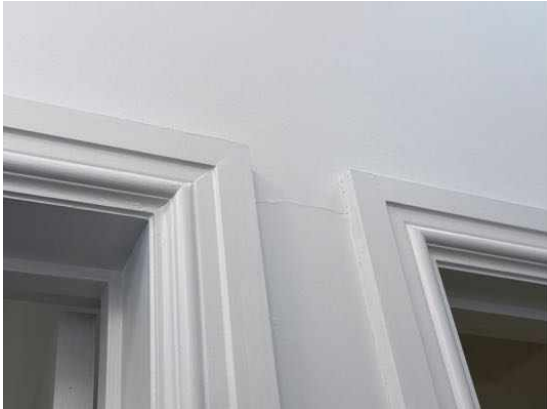
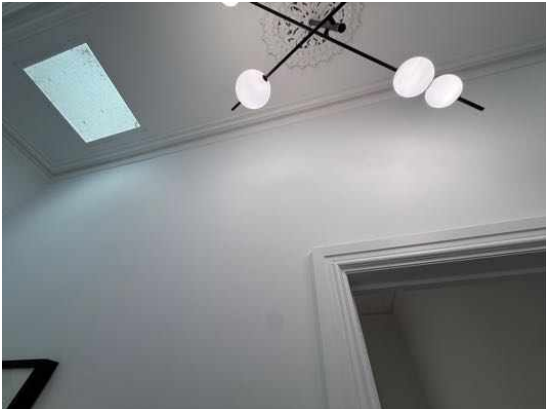
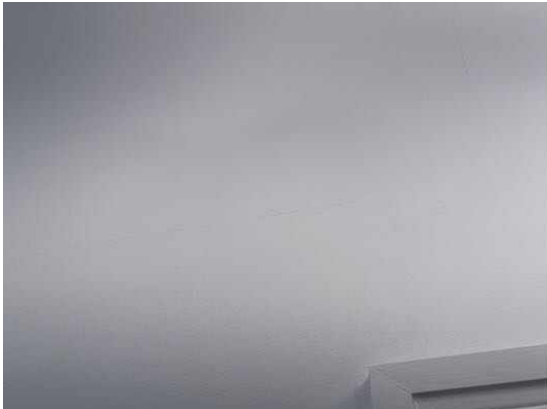
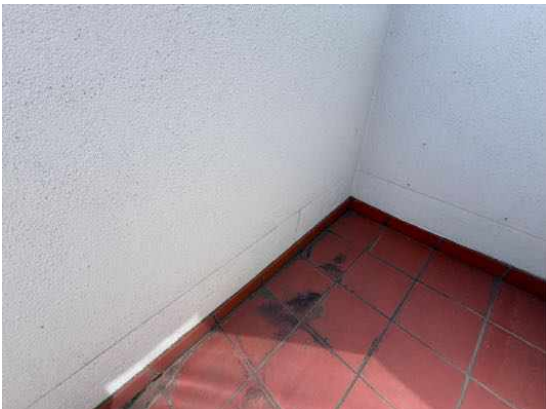
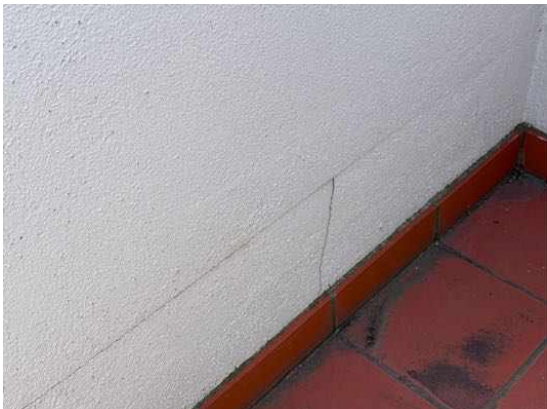
Finding 3.08

Building: Main Building
 Location: Some Internal Areas
 Finding: Cracking - Damage Category 1 - Fine (up to 1mm)
 Information: Although fine cracks are quite noticeable, they are often only considered to be an appearance defect, and usually do not indicate any structural damage. Generally, the cause of a fine crack is indicative of a separation between building materials and finishes (e.g. paint, plaster, etc.) along joins.

Cracking of this nature can generally be repaired with minor sanding, filling and/or repainting. Such works should be performed by a qualified painter or a general handyman.

Monitoring of all cracking should be conducted frequently. Always contact a building inspector should cracks widen, lengthen, or become more numerous.

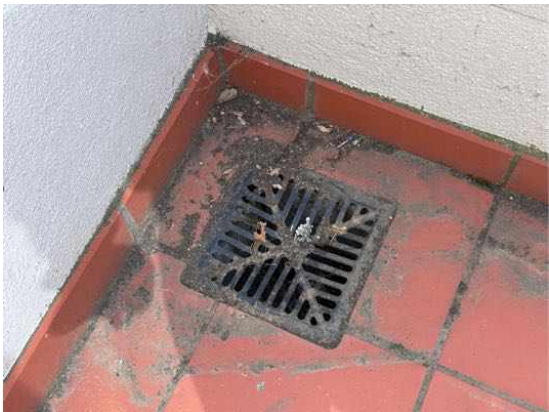
Finding 3.09

Building:	Main Building
Location:	Balcony
Finding:	Balcony Drain Requires Cleaning
Information:	The balcony floor waste drain was observed to contain accumulated debris, dirt, and organic matter at the time of inspection. The build-up is partially obstructing the drain grate and may restrict the effective discharge of stormwater during rainfall events. If not maintained, this condition can lead to ponding of water against the balcony surface and adjoining walls, increasing the risk of moisture ingress and premature deterioration of finishes.

It is recommended that the drain grate be removed and the waste cleared to ensure free-flowing drainage. Ongoing periodic maintenance is advised to prevent recurrence.

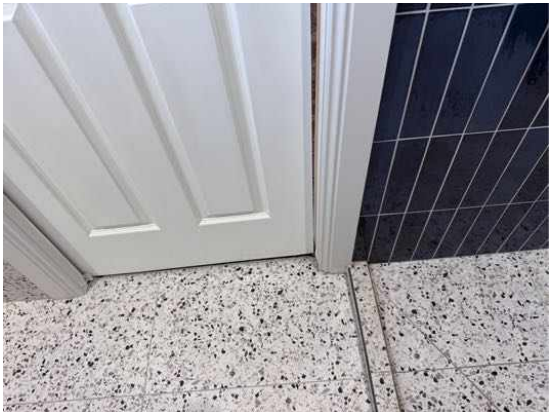
Finding 3.10

Building: Main Building
Location: Ensuite
Finding: Door Misaligned on closing.
Information: The bathroom sliding door was observed to be misaligned when in the closed position. The door does not sit flush within the frame and exhibits uneven clearances along the jamb, indicating possible misalignment of the track, rollers, or door stops. This condition may result in improper latching, reduced privacy, and premature wear to the sliding mechanism over time.

Adjustment of the door alignment, including inspection of the track, rollers, and guides, is recommended to ensure smooth operation and proper closure. This is considered a minor maintenance issue at the time of inspection.

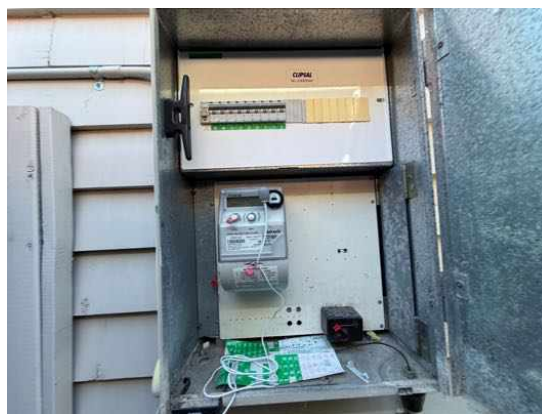
Building:	Main Building
Location:	Meter Box
Finding:	Termite Management System - no evidence of a chemical installation
Information:	The application of a post-construction chemical termite barrier is highly recommended for all properties, particularly if live termite activity has been found on the site previously. Such barriers are highly effective in preventing termite attack on any timber building elements throughout the property.

A durable notice should be placed in the switchboard unit to indicate current termite barriers. At the time of inspection, it appeared as though no termite management system has been installed, with no evidence to suggest preventative works taking place.

The client may consider gaining further advice from a pest controller as to the costs and procedures involved with this application. It is recommended that obtaining such advice be a short-term priority.

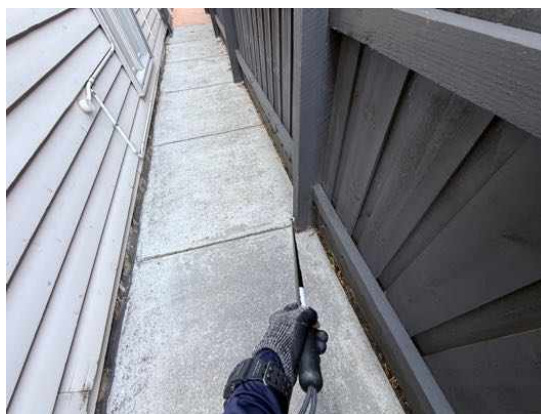
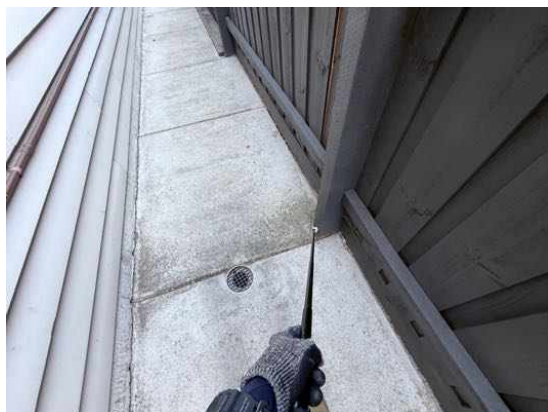
Building:	Main Building
Location:	All External Areas
Finding:	In ground contact
Information:	Any timbers in direct ground contact provide opportunity for concealed termite entry and are likely to be subject to premature rot and decay as the soil retains moisture or damp conditions against the timbers.

Remove untreated timber that is in direct contact with external grounds. Consider replacement with more durable materials i.e. treated timber or non timber elements. Frequent pest inspections are advised to readily identify any termite activity in these areas.

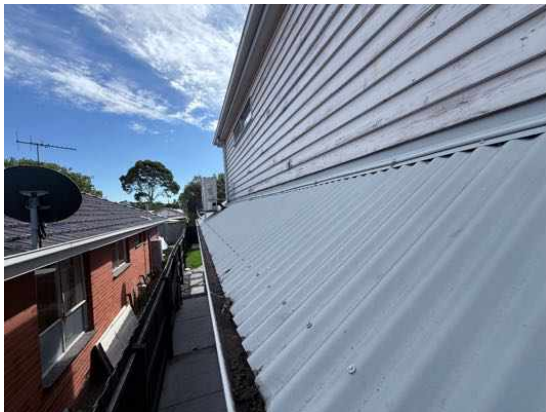
Finding 6.04

Building:	Main Building
Location:	Roof Exterior
Finding:	Gutters - Needs maintenance
Information:	Roof plumbing structures, such as guttering and downpipes, should be free of all debris to prevent blockages. Accumulation of debris in gutters and downpipes will lead to pooling and accumulated water overflows, which is likely to subsequently flood eaves and exterior walls.

Blocked or partially blocked gutters can lead to high levels of moisture in the affected areas (eg: entry porch). Such moisture will not only cause rust and decay of the associated building materials, but can also provide conditions that are conducive to termite and timber pest activity. Blocked part of the gutters should therefore be cleaned immediately to ensure dry conditions are maintained.

It is advised that gutters should be maintained regularly by the homeowner & a general handyperson should be appointed as a matter of urgency to clean the gutters.

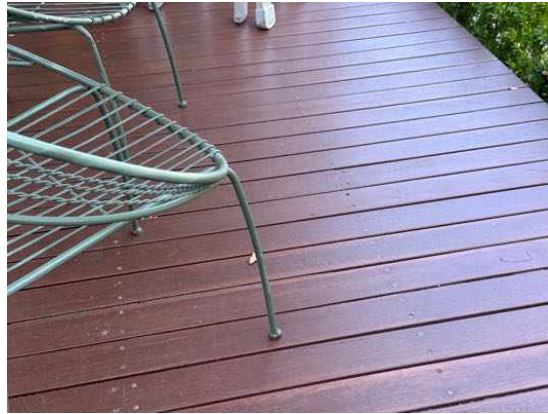
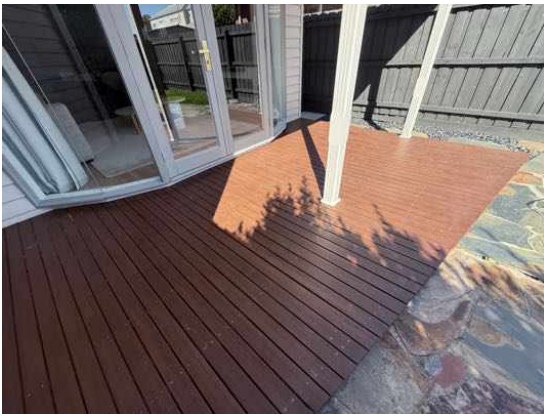
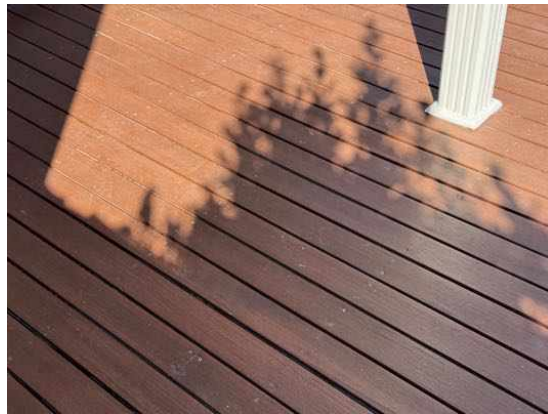
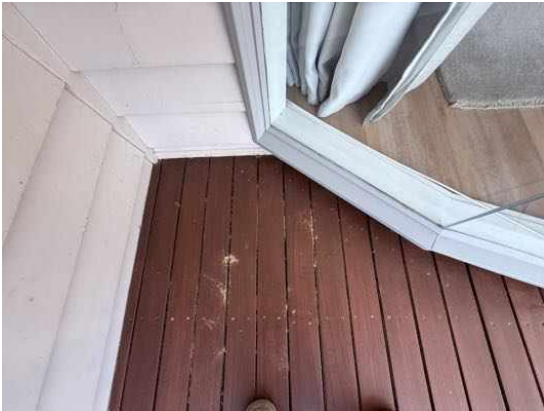
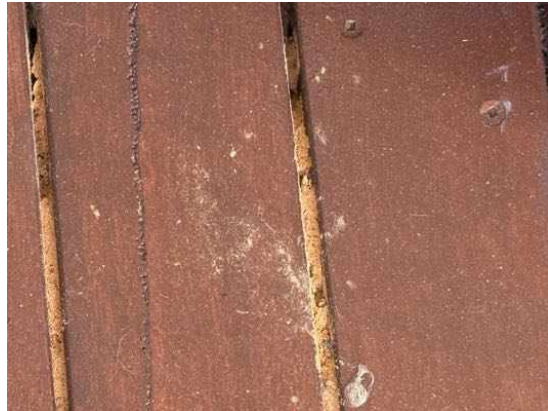
Finding 6.05

Building:	Main Building
Location:	All External Areas
Finding:	Timber deck- High conducive condition.
Information:	We are unable to inspect under the timber deck if its in close proximity to the ground.

Where we are unable to inspect timber structures, decks and subfloor areas the risk of undetected termite activity is rated as extremely High.

We strongly recommend the purchaser prioritise a termite treatment by a Licensed Pest Controller to protect and maintain the asset as it is a timber structure.

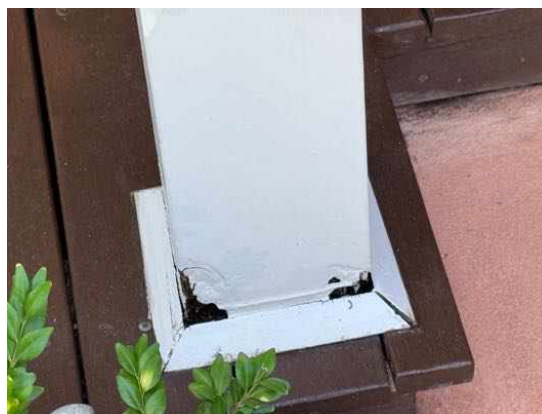
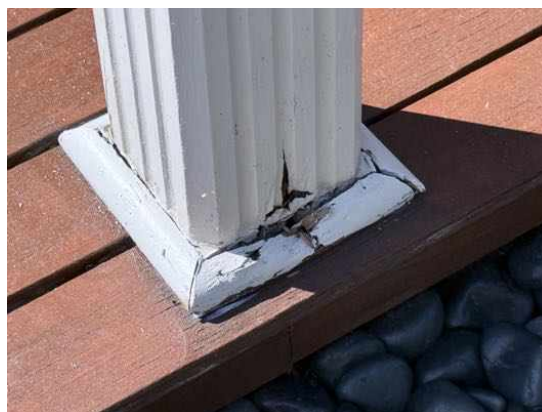
Finding 7.01

Building:	Main Building
Location:	All External Areas
Finding:	Timber Post Base Deterioration (Entry & Alfresco Areas)
Information:	Timber posts at the front entry and alfresco areas were observed to have localised wood rot and paint deterioration at their base sections. The decay appears concentrated around the lower plinth/trim where the posts interface with the decking, likely due to prolonged moisture exposure and inadequate sealing at ground/deck

level. Timber fibres in these sections show softness and minor material loss; however, no significant structural displacement or instability was noted at the time of inspection yet.

While the current condition does not indicate imminent structural failure, continued moisture ingress may accelerate decay and compromise the load-bearing capacity of the posts over time.

A qualified carpenter should assess the affected sections. Localised repair or replacement of the deteriorated base trim/post sections is recommended, including removal of decayed timber, installation of treated material, and proper sealing/painting to prevent further moisture penetration. Ongoing monitoring is advised to ensure deterioration does not progress.

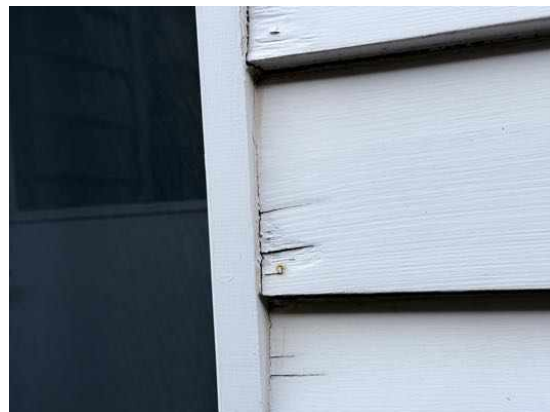
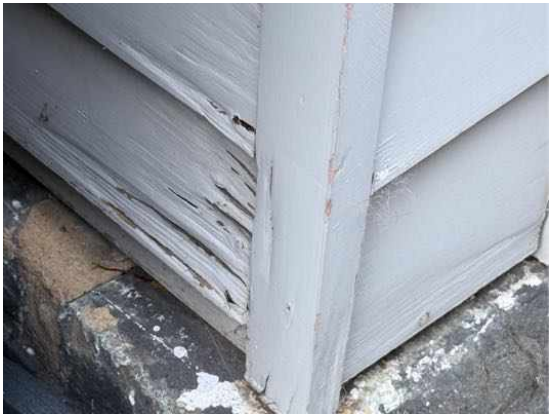
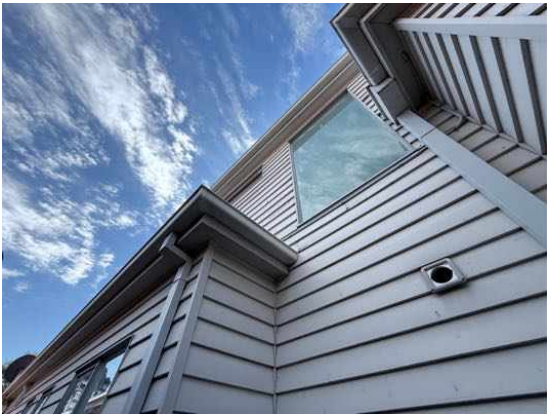
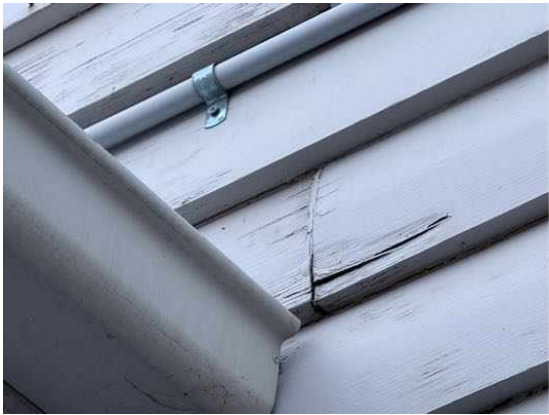
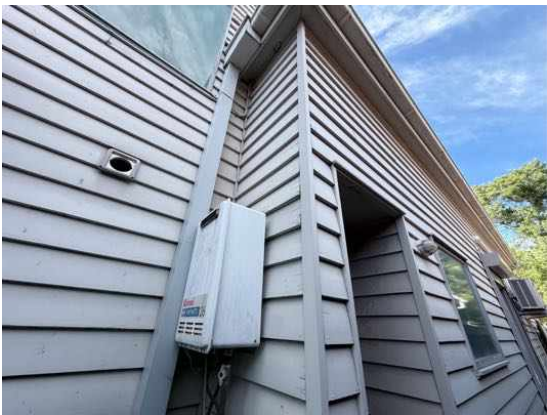
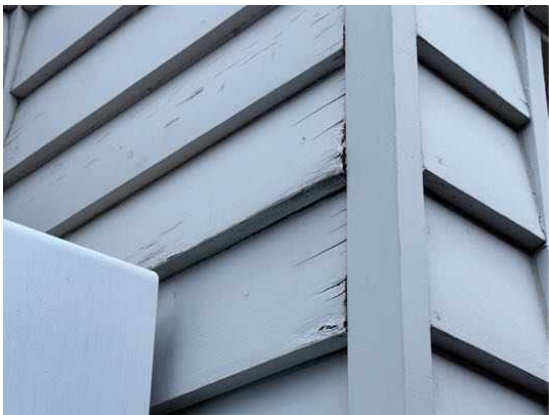
Finding 7.02

Building:	Main Building
Location:	All External Areas
Finding:	Weatherboards - Rotting
Information:	The external weatherboards show signs of fungal decay (wood rot) in several sections. This wood rot is suspected to have developed over a prolonged period of time due to frequent weather exposure, which is expected in a property of this age and condition

Weatherboards are sealed and protected by paint and other sealants. When these sealants deteriorate over time, they allow water penetration to the weatherboards, causing wood rot. If left unmanaged, the wood rot is likely to develop further, possibly necessitating major repair or replacement works in the long-term future.

To maintain the condition of the external wall cladding, any severely affected weatherboards should be substituted as soon as possible with pre-treated replacements. Where weatherboards have rotted due to excessive moisture other than rain penetration, the cause of the moisture should be identified immediately by a licensed plumber. A qualified carpenter should be appointed to repair and replace rotting weatherboards.
