# Building Inspection Report

Inspection Date: Fri, 30 Jan 2026

Property Address: 16 Dodson Rd, Officer VIC 3809, Australia

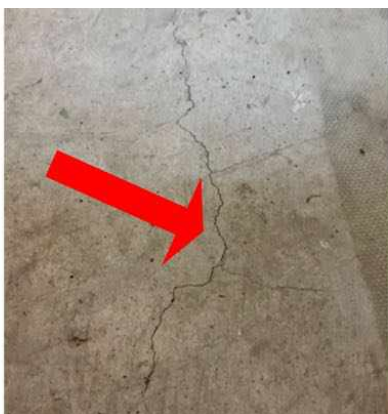
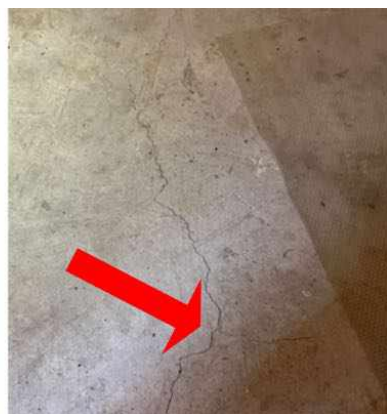
#### Defects 3.01

Building: Main Building  
Location: Garage  
Finding: Noticeable cracks in concrete slab of the the garage floor  
Information: During the inspection, multiple noticeable cracks were identified in the concrete slab of the garage floor. These cracks vary in size and location, which may indicate underlying movement or stress within the slab. While they do not currently appear to significantly impact the structural integrity, their presence suggests potential early-stage deterioration.

It is recommended that the cracks be monitored closely over the next 12 months. If any of the cracks widen or worsen during this period, it is critical to engage a structural engineer immediately to assess the situation and recommend appropriate rectification measures to prevent further damage and ensure the long-term stability of the structure.

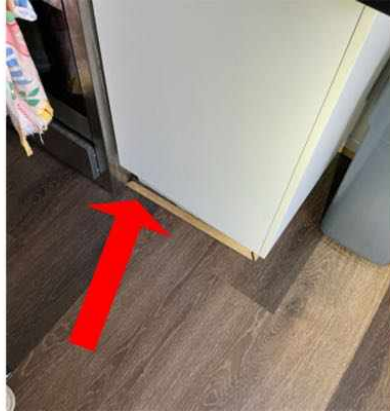
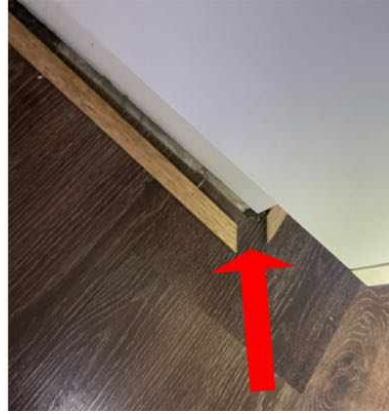
#### Defects 3.02

Building: Main Building  
Location: Kitchen  
Finding: Floor trim - Detached

**Information:** The floor trim in the kitchen has detached, indicating improper installation, wear and tear, or possible movement in the flooring. This defect may affect the overall finish of the flooring. Rectification should involve securely refixing or replacing the trim using appropriate fixing methods to ensure durability and compliance with Australian Standards for flooring installation. A handyman can be allocated to completed this task at client's discretion.

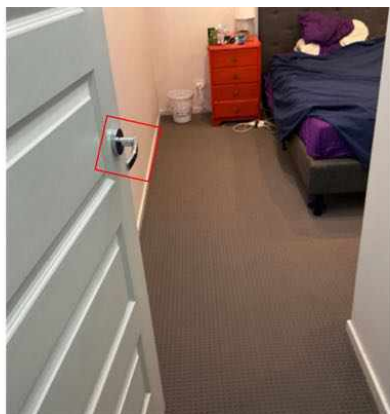
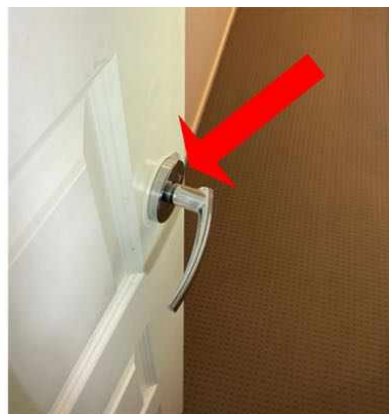
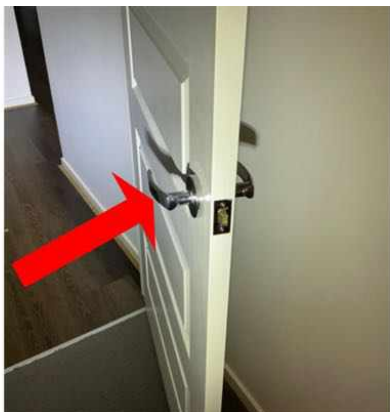
### Defects 3.03

**Building:** Main Building  
**Location:** Bedroom - Master  
**Finding:** Door handle - Loose  
**Information:** The door handle in the master bedroom is loose and requires adjustment to tighten.

If left unmanaged, the fitting may further deteriorate, causing potential for the development of other minor secondary defects.

A handyperson should be appointed to perform these rectification works at discretion of the client.

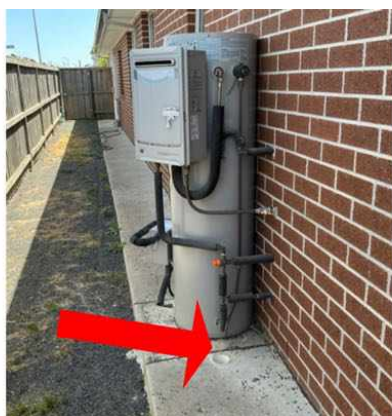
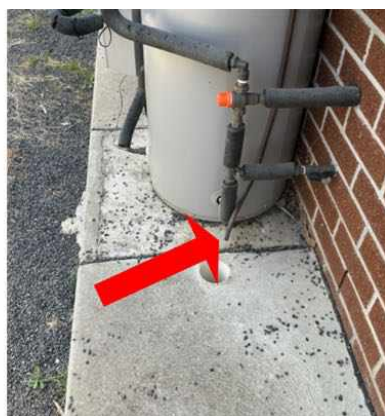
### Defects 3.04

Building:	Main Building
Location:	Yard - Side
Finding:	HWS not plumbed to drainage
Information:	Upon visual inspection, we found that the hot water system is not plumbed for proper drainage. This issue may create conditions conducive to water accumulation around the building, potentially leading to moisture-related problems such as wood rot or fungal decay. The stagnant water could also attract termites, creating an environment where they may thrive and cause damage to timber components of the property.

We recommend that a licensed plumber be engaged to ensure that the hot water system is properly connected to a drainage system to prevent any moisture buildup around the area. This will help avoid any future risks of structural damage, pest infestations, or deterioration of the building's materials. Immediate attention is advised to mitigate any potential issues and protect the property from long-term damage.

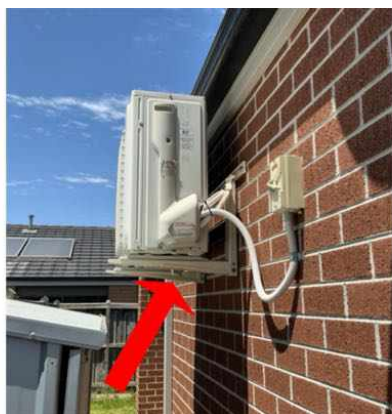
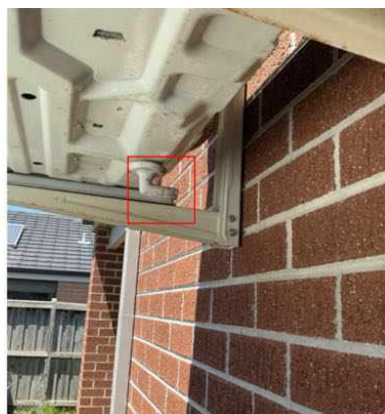
### Defects 3.05

Building:	Main Building
Location:	Yard - Side
Finding:	AC Overflow - Not plumbed to suitable drainage
Information:	Upon inspection, it was found that the AC overflow is not plumbed or connected to

suitable drainage. This could lead to the surrounding area becoming excessively damp, which in turn may cause secondary defects such as rot, rust, corrosion of associated building elements, and the formation of fungal decay. In addition, prolonged damp conditions could create potential slip hazards. Poor site drainage may exacerbate the issue, potentially attracting termite activity to the area.

We recommend that a licensed plumber be appointed to properly plumb the AC overflow and connect it to suitable drainage. This will help ensure that the area remains dry and free from secondary defects.

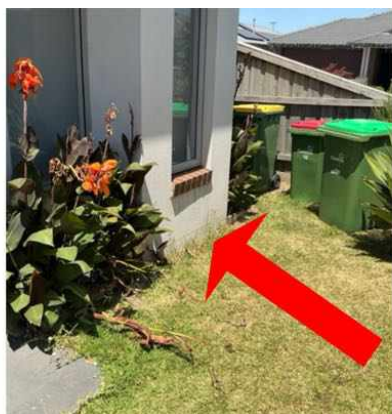
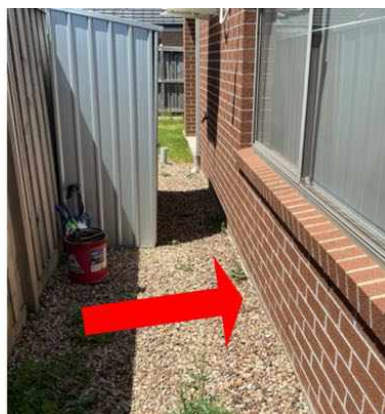
### Defects 3.06

Building:	Main Building
Location:	All External Areas
Finding:	Site drainage - Inadequate
Information:	The site drainage in sections of the front yard and the side yard was found to be inadequate at the time of inspection, creating potential for subsequent water damage to associated building elements.

It is important that water does not lie against the base of walls; surrounding paths and ground levels should be sloped to drain water away from walls. Downpipes should not discharge stormwater onto lower walls or plinths. Stormwater should be carried away by large, regularly cleaned drains. Ground levels may need to be lowered to expose a buried DPC.

Where site drainage is inadequate, installation of an Agricultural (Aggie) Drain may be required. A qualified plumber should be appointed to further inspect the property and perform any remedial works as necessary. Water damage and secondary defects are likely to occur if left unmanaged.

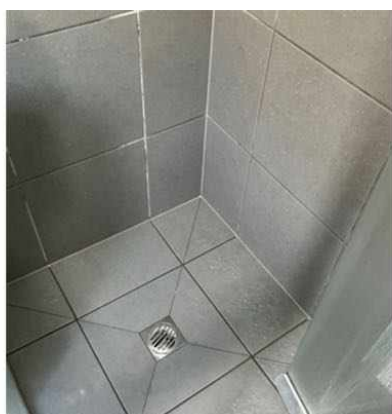
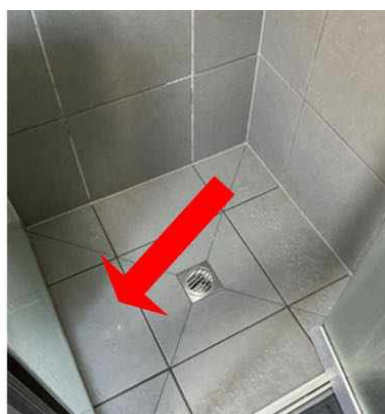
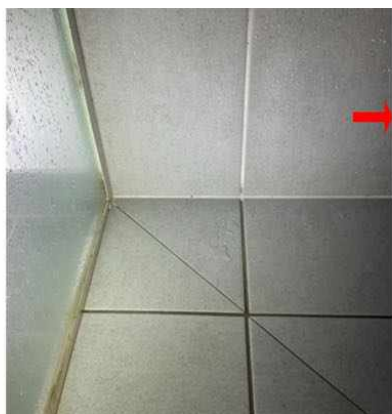
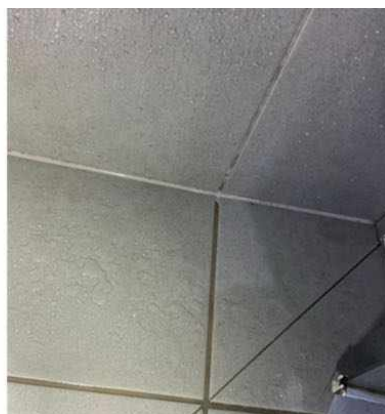
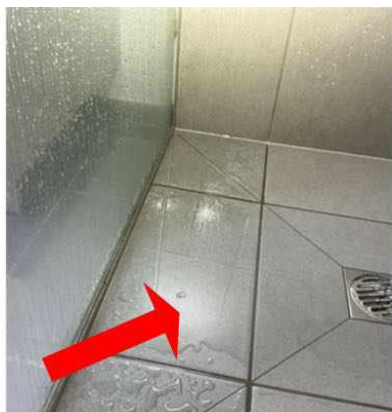
### Defects 3.07

Building:	Main Building
Location:	Both showers
Finding:	Slow Drainage Observed to Shower Bases – Both Bathrooms
Information:	At the time of inspection, both showers were found to be in generally good and serviceable condition, with no visible defects noted to the shower enclosures or finishes. However, after operating the showers for approximately 10–15 minutes, it was observed that water took longer than normal to drain from the shower bases. This may indicate that the floor falls within the shower areas are not sufficiently steep to promote rapid drainage.

While no immediate defects were identified, it is recommended that the occupants ensure shower floors are dried after use and that grout and sealant are regularly inspected and maintained. Re-grouting and re-sealing should be carried out whenever deterioration is observed to reduce the risk of moisture ingress and long-term water-related damage.

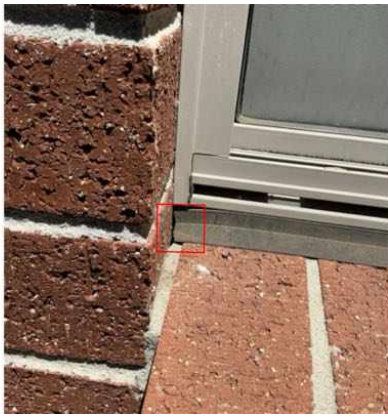
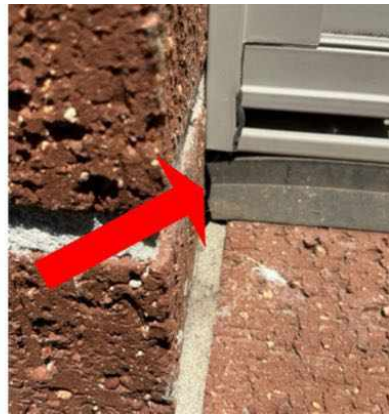
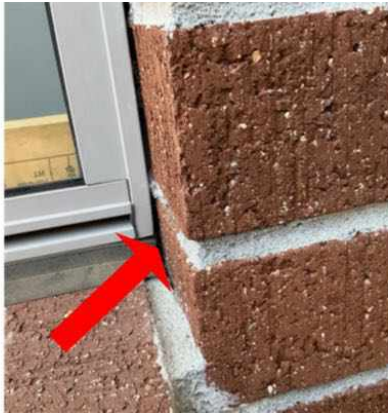
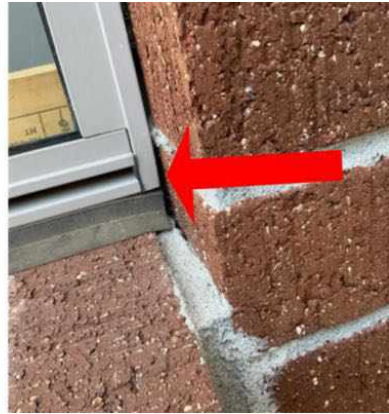
### Defects 3.08

Building:	Main Building
Location:	All External Areas
Finding:	Gaps Around External Window Frames
Information:	Multiple gaps were identified between the external window frames and the adjoining brickwork across several elevations. These gaps appear to be the result of either poor or inconsistent sealant application during installation, or deterioration of the original sealant over time.

Unsealed or poorly sealed gaps can allow moisture ingress, wind-driven rain, draughts, and provide potential entry points for pests. Ongoing exposure to moisture may also contribute to internal dampness and premature deterioration of surrounding building elements.

A qualified handyman or registered builder should apply a consistent, waterproof, flexible exterior-grade sealant around all affected windows to ensure adequate weatherproofing and protection against moisture and pest entry.

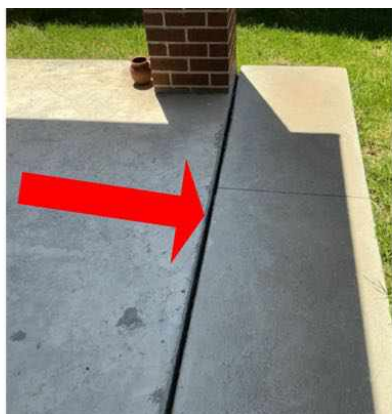
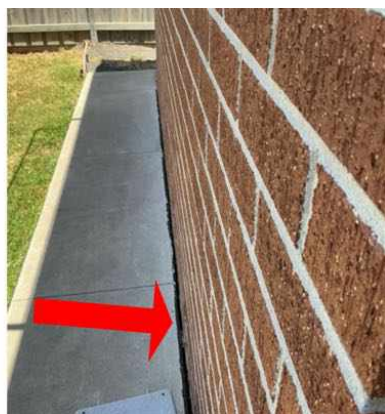
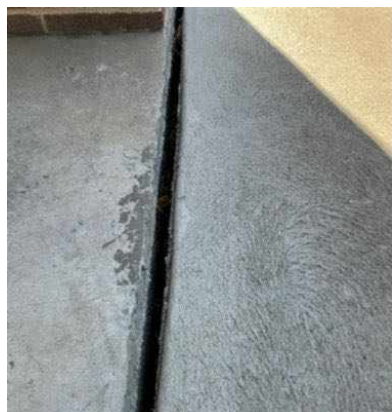
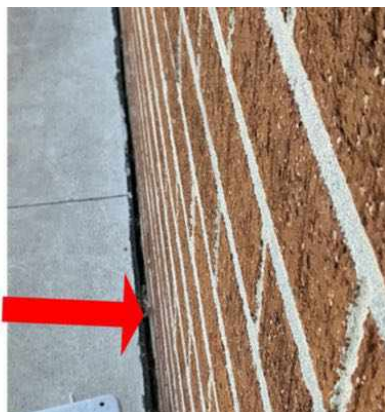
### Defects 3.09

Building: Main Building  
 Location: Yard - Back  
 Finding: Gaps Between Paving, Brickwork, and Pergola Slab – Backyard  
 Information:

At the time of inspection, gaps were observed between the external paving and the adjacent brickwork in the backyard. In addition, a gap was also noted between the completed external paving and the adjoining concrete slab of the pergola area. These gaps may allow water to penetrate into the underlying soil and against the building structure, increasing the risk of moisture ingress and ground saturation.

It is recommended that a qualified caulking or sealing specialist be engaged to fill and seal these gaps using an appropriate flexible, weather-resistant sealant to prevent water ingress and potential moisture-related issues in these areas.

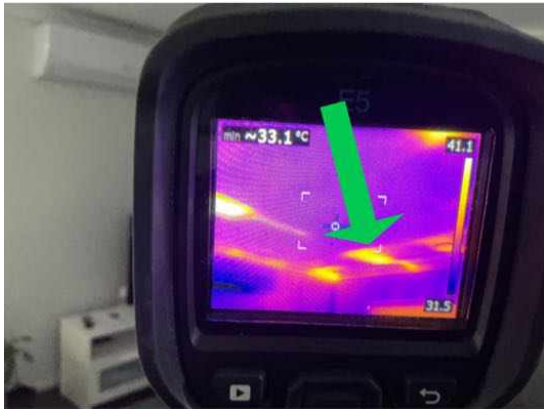
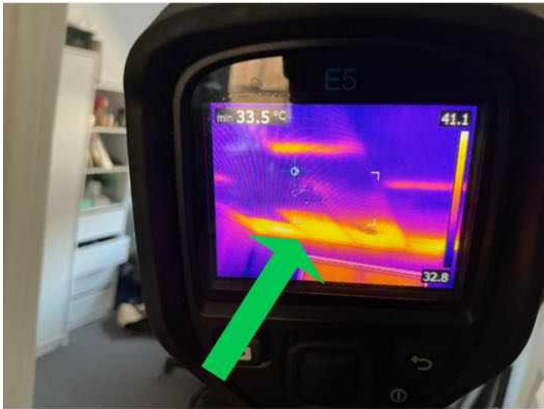
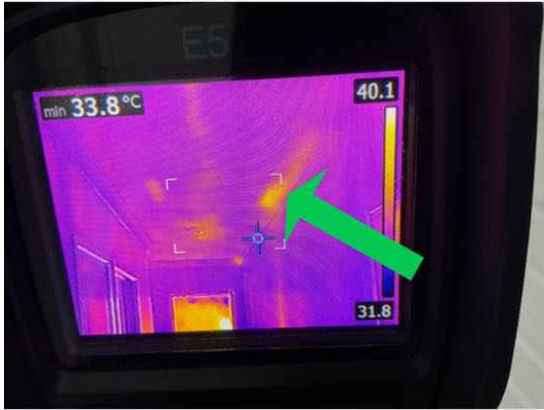
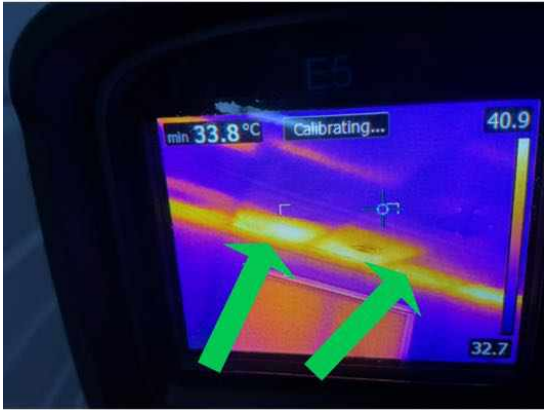
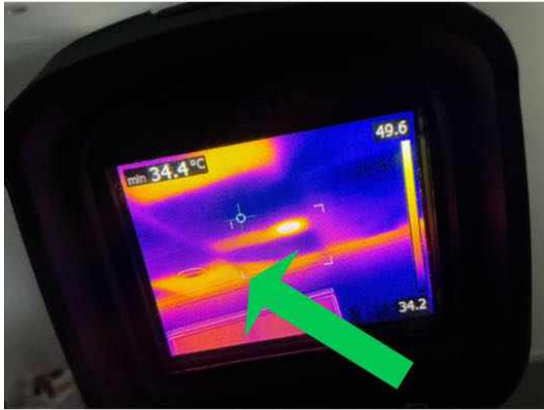
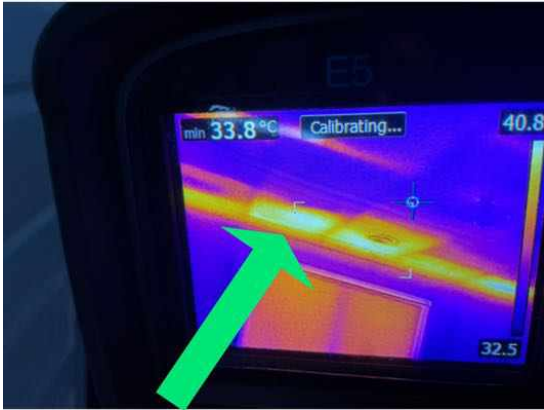
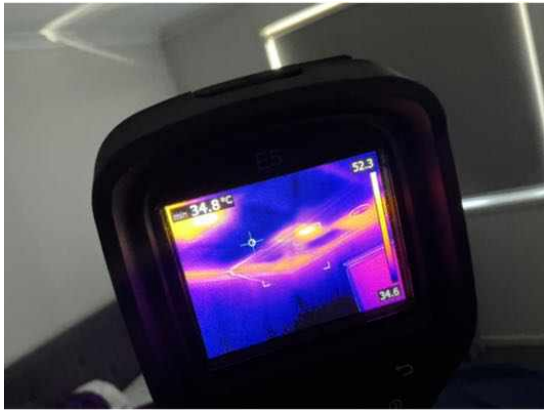
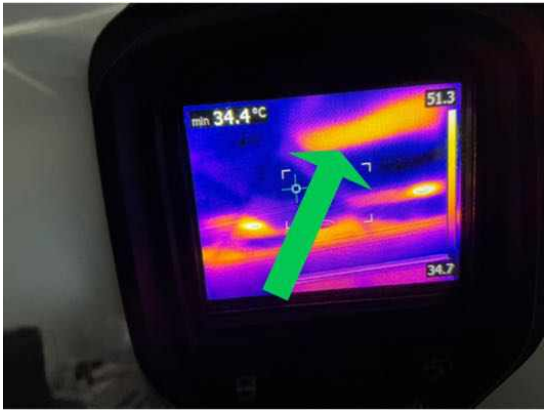
### Defects 3.10

Building:	Main Building
Location:	All Internal Areas
Finding:	Inconsistent Thermal Performance to Ceiling Areas – Suspected Insulation Deficiencies
Information:	Thermal imaging conducted to internal ceiling areas at the time of inspection identified inconsistent heat patterns, which are indicative of variations in thermal performance across the roof space. These patterns are commonly associated with areas of missing, displaced, or insufficient insulation above the ceiling linings.

Inadequate or uneven insulation coverage can reduce the energy efficiency of the dwelling, contribute to heat loss in cooler periods and heat gain in warmer conditions, and may result in reduced occupant comfort and increased heating and cooling costs. Due to the non-invasive nature of the inspection, the exact extent and condition of insulation could not be confirmed visually in all affected areas.

It is recommended that a qualified insulation contractor inspect the roof space, assess insulation coverage and condition, and top up or reinstate insulation where required to achieve consistent thermal performance throughout the property.

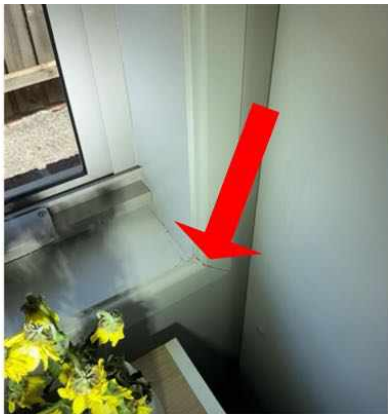
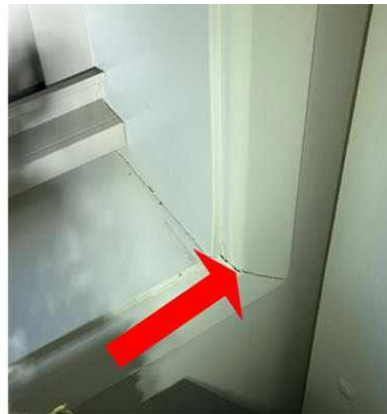
Defects 3.11

Building: Main Building  
Location: All Internal Areas  
Finding: Minor Settlement Cracks to Internal Window and Door Frames  
Information:

At the time of inspection, multiple settlement and movement-related cracks were observed around internal window frame joints, architraves, and door frame junctions. These cracks are consistent with normal building movement and seasonal settlement and are common in residential construction. No structural concerns were identified in relation to these cracks at the time of inspection.

No action is required from a structural perspective. However, for appearance purposes only, the client may choose to fill, sand, and repaint the affected areas at their discretion. The example shown below is representative of similar cracks observed throughout the dwelling.

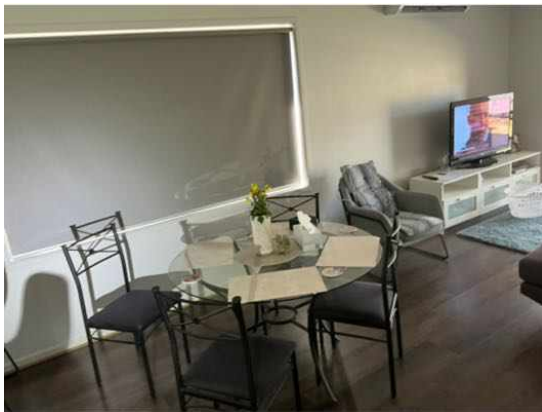
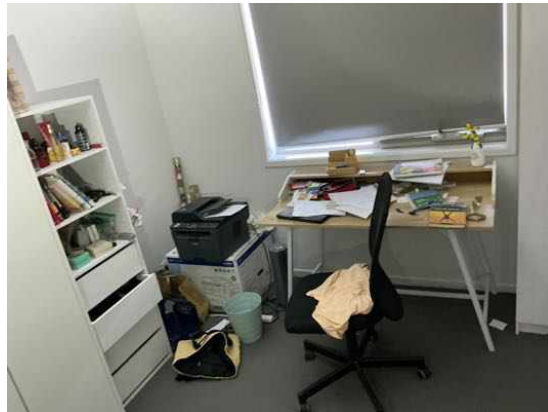
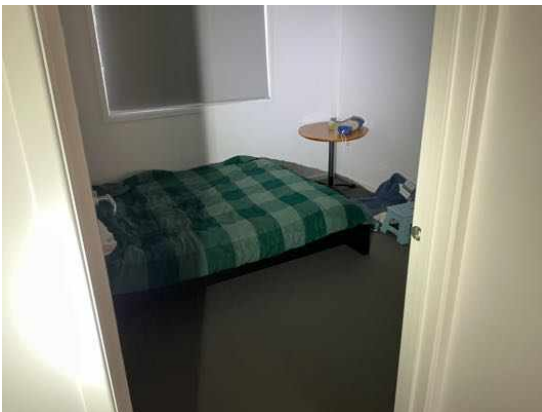
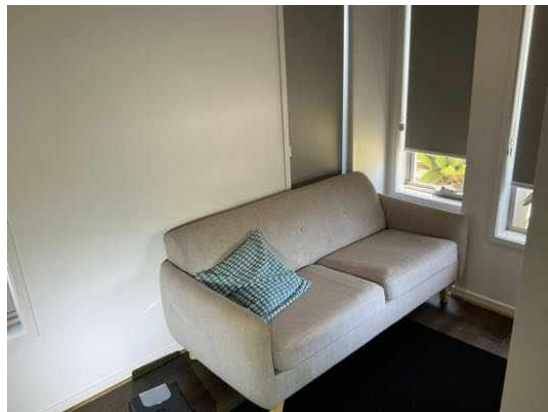
Building: Main Building  
 Location: All Areas  
 Finding: Obstructions and Limitations - Interior  
 Information: These photographs are an indication of the obstructions and limitations which impeded the inspection of the internal areas of the property at the time of inspection. These obstructions can hide an array of defects and should be removed to allow full inspection to be carried out. A re-inspection is recommended once the areas are made accessible.

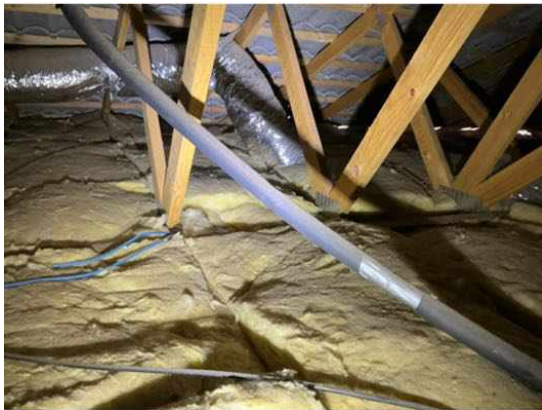
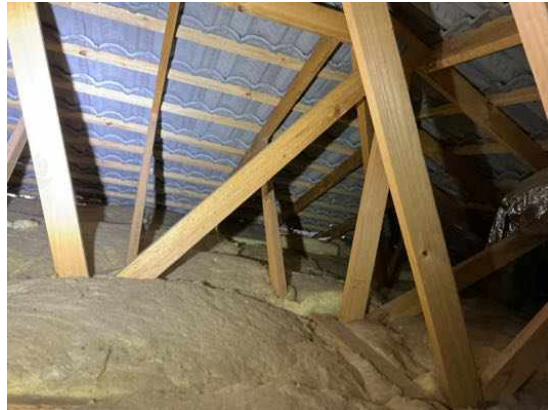
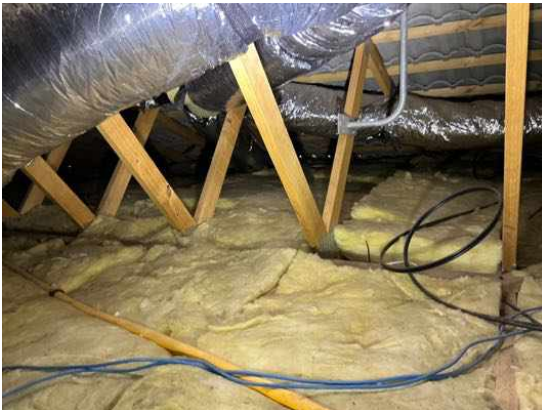
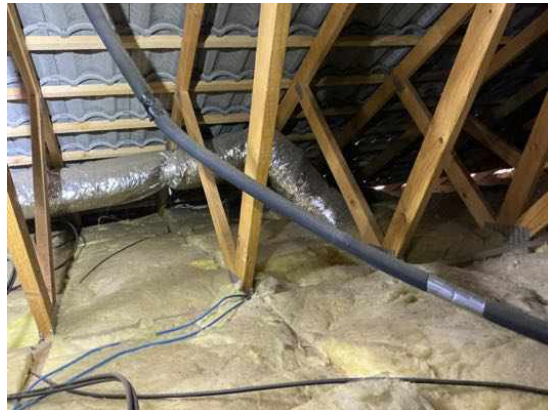
Building: Main Building  
 Location: Roof Void  
 Finding: Obstructions and Limitations - roof cavity  
 Information: These photographs are an indication of the obstructions and limitations which impeded the inspection of the roof cavity area of the property at the time of inspection.

These obstructions can hide an array of defects and should be removed to allow full inspection to be carried out. A re-inspection is recommended once the areas are made accessible.

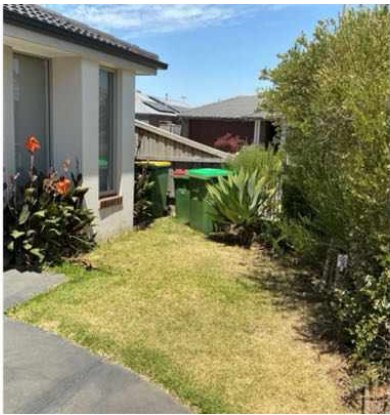
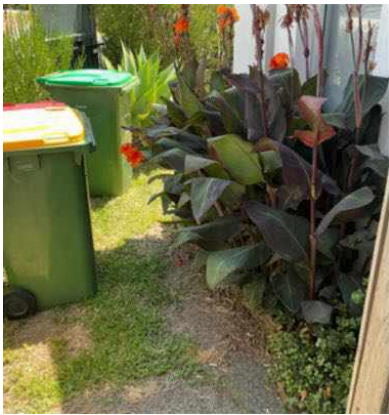
Building:	Main Building
Location:	All External Areas
Finding:	Obstructions and Limitations - Exterior
Information:	These photographs are an indication of the obstructions and limitations which impeded the inspection of the external areas of the property at the time of inspection. These obstructions can hide an array of defects and should be removed to allow full inspection to be carried out. A re-inspection is recommended once the areas are made accessible.
