## Building Inspection Report

Inspection Date: Tue, 7 Apr 2026

Property Address: 2/99 Reddall Parade, Lake Illawarra NSW  
2528, Australia

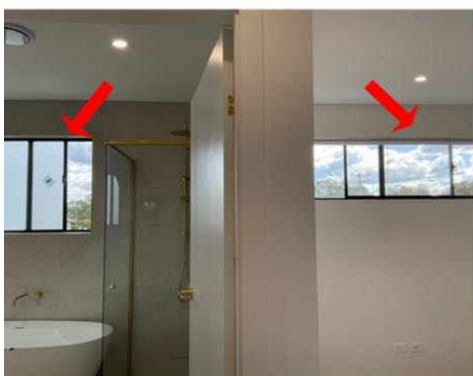
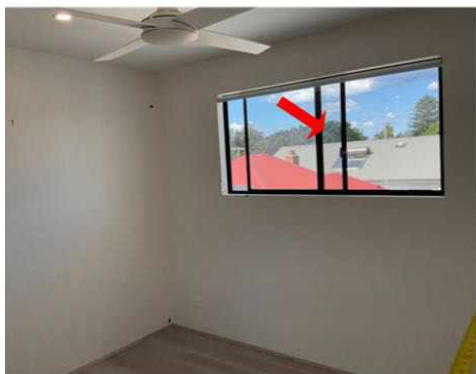
#### Defects 1.01

Building:	Building 1
Location:	Most upper windows
Finding:	Window opening restrictors missing.
Information:	The Building Code of Australia rules require all openable windows (where the internal floor is more than 2m above the ground outside) in residential rooms to be fitted with a suitable screen or restrictor. Windows located 1.7m above the floor level do not require protection.

Window restrictors are required to these pictured windows where people who are vulnerable to the risk of falling have access to windows. This means all windows above ground level which do not have another fall prevention safety measure in place, such as a balcony or balustrade should have a restrictor.

These need to be added urgently for the safety of all persons.

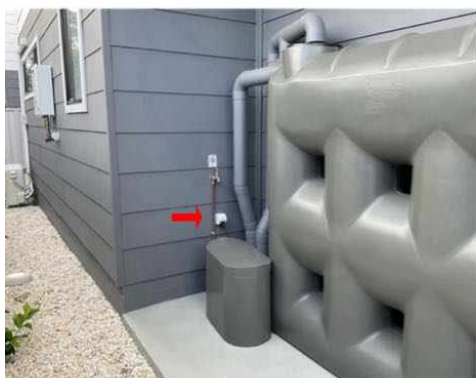
## Defects 1.02

Information: There was insufficient separation found between the rear wall electrical wiring and the plumbing at the time of the inspection. The tap pipe is under 18mm from the electrical outlet. Locating a tap over the electrical outlet also presents an increased safety risk to nearby persons.

As 3000-2018 Electrical Installations - Wiring rules states "Wiring systems shall maintain a separation of not less than 25 mm from any above-ground gas or water piping."

Where a building elements installation fails to achieve the required minimum standard at the time of the inspection, the builder needs to complete the works to the required standard prior to purchase.

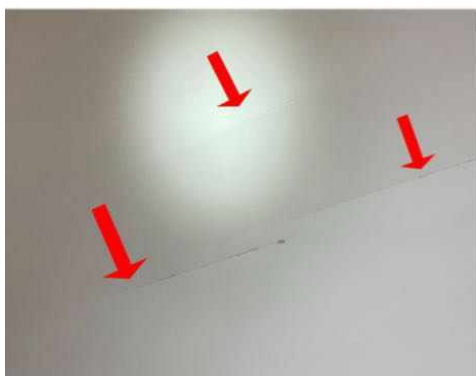
### Defects 2.01

Location: Stairs - Internal east wall >  
 Finding: Bow in upper wall  
 Information: Bulging was noted to the stairs upper wall surface. The upper wall is out of plumb . The wall plaster has cracked horizontally in the middle. Vertically, this wall is bowing 38mm over 2m in the middle.

Building works required to fix this bulging wall should be completed immediately and before purchase as the cause may be significant and may indicate a structural defect which would require extensive works in the long-term future.

Further invasive inspection is required to determine the actual cause. It is advised to consult a Structural Engineer to determine the cause and advise on rectification works required.

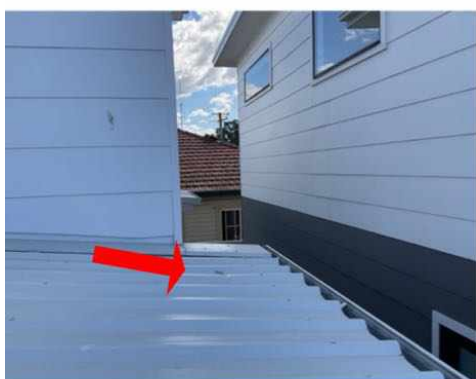
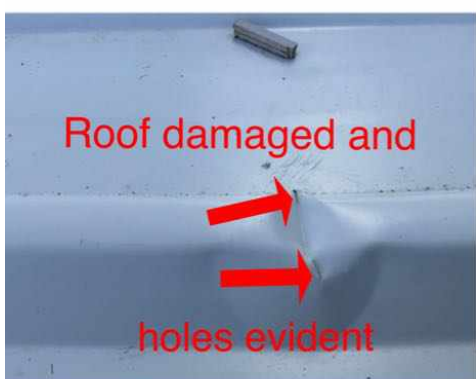
## Defects 2.02

Building: Building 1  
 Location: Roof Exterior  
 Finding: Roof sheet damaged  
 Information: Upon inspection of the exterior roof covering, it was noted that one roof sheet in the front right has impact damage. It is suspected that something very heavy has been dropped on these sheets and has caused holes in two roof sheet ridges.

Damaged roof sheeting detracts from the weather tightness of the roof covering and will be subject to premature rust and water ingress.

This applies here where these holes will allow rainwater to damage internal building areas.

These need to be brought to the attention of the builder for urgent rectification.

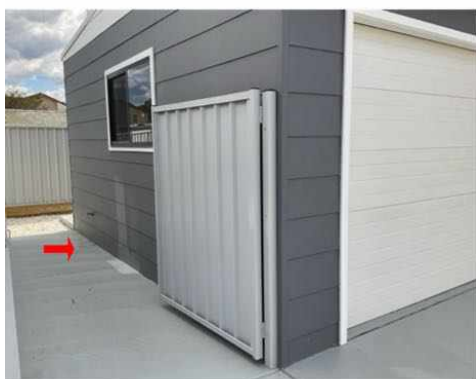
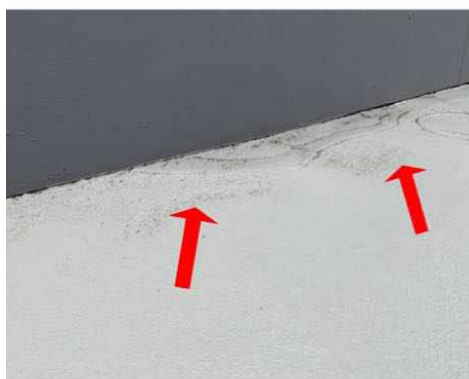
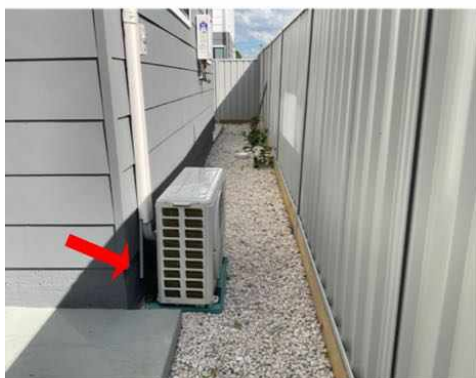
### Defects 3.02

Building: Building 1  
 Location: South wall  
 Finding: Water pooling - Surface Water Drainage - NCC 2022 Housing Provisions Part 3.3.3  
 Information: Water has been observed pooling on external concrete/paved surfaces adjacent to the dwelling, with falls directing water towards the building instead of away from it.

Where water is pooling against the house, water damage to the external wall cladding is imminent. The rear wall air conditioner runoff also runs onto the rear house wall.

Such water pooling and Ac runoff also increases the risk of termite activity and the development of fungal decay in these areas.

These need to be brought to the attention of the builder.

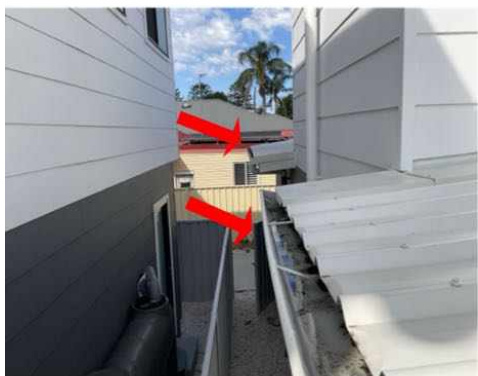
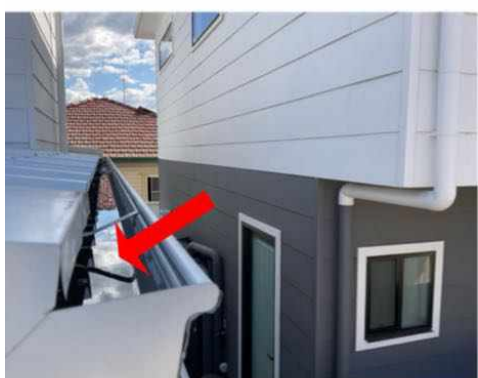
### Defects 3.03

Building:	Building 1
Location:	North gutters
Finding:	Gutters - Insufficient fall and water pooling
Information:	It was identified that there is insufficient fall or angle in the two north gutters which is leading to pooling of water in these gutters and will result in secondary related building defects such as rust and fascia damage. Such defects are likely to include material deterioration, leaks and/or corrosion of associated building materials.

Over time, if this defect is not addressed, further building defects will develop.

These need to be brought to the attention of the builder.

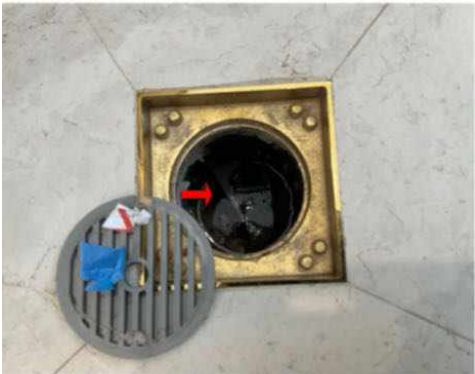
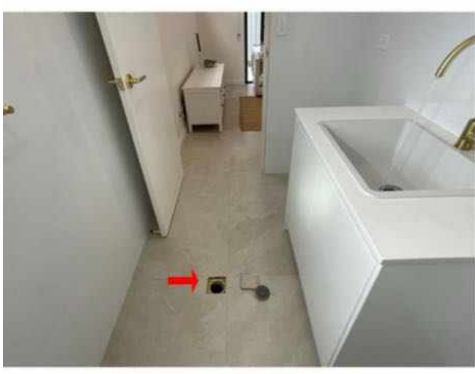
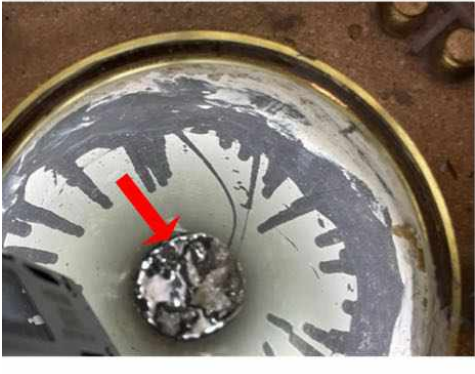
### Defects 3.04

Building:	Building 1
Location:	Roof areas, driveway, bathroom & laundry drains
Finding:	Building waste in drains and on roofs
Information:	Builders waste was found on rooves and in driveway and bathroom floor wastes at the time of the inspection. Builders waste left in any drains or roof areas has the potential to interrupt the normal function of these drains or gutters and may lead to blockages and flooding of surrounding areas. Some waste left on the front right roof is rusting the roof sheets.

These areas need to be brought to the attention of the builder.

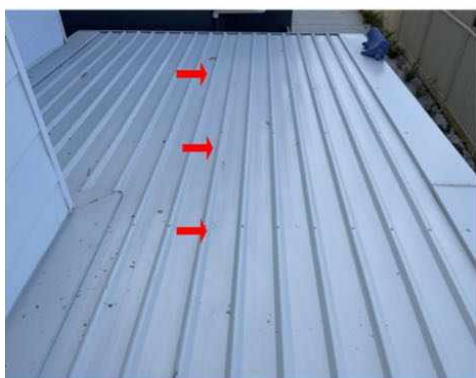
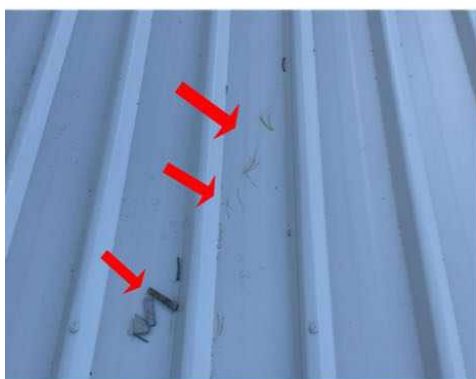
Defects 3.05

Building:	Building 1
Location:	Roof Exterior
Finding:	Swarfing stains
Information:	This pictured areas shows evidence of rusting and corrosion, which is a result of swarfing.

Fresh swarf stains are characterised by small red-brown coloured areas with a central dark spot (the remains of the steel particles). The surface will feel like sandpaper, and the particle may be lifted with a fingernail. An old swarf stain will appear as a localised red- brown stain, the steel particle having corroded away, and the surface will be smoother. Prevention of swarf staining is the responsibility of the installer.

This needs to be brought to the attention of the builder and cleaned immediately.

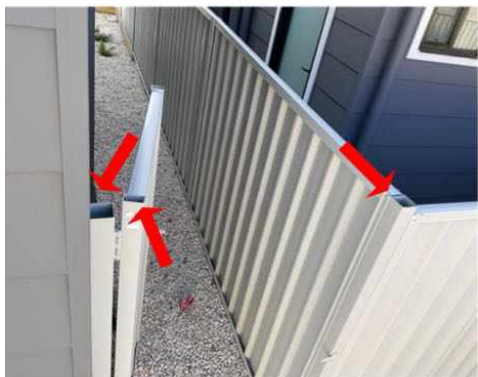
### Defects 3.06

Location: Pictured front areas  
 Finding: Fence and gate capping missing  
 Information: Fence and gate caps were missing at the time of inspection. Where these caps are missing, these areas will fill with rainwater and prematurely rust.

These need to be brought to the attention of the builder.

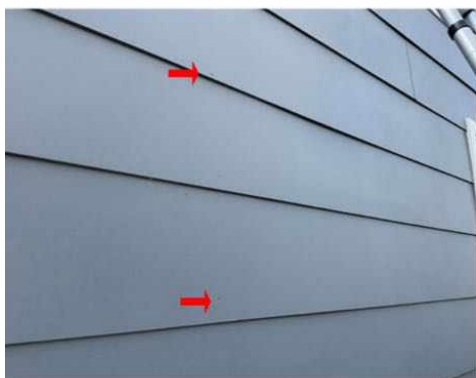
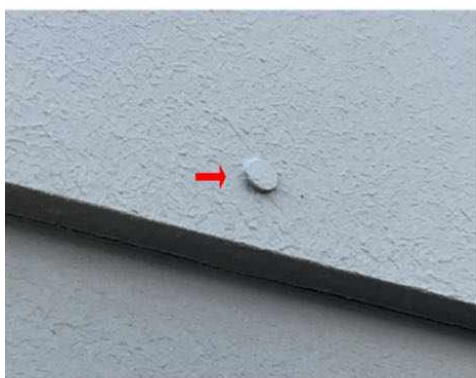
### Defects 3.07

Building: Building 1  
 Location: Pictured areas  
 Finding: Nails protruding from cladding and nail holes not sealed.  
 Information: The external wall cladding fixings have been installed without sealing to nail/screw penetrations. This is non-compliant with NCC requirements for weatherproof external walls and manufacturer installation instructions. Unsealed fixings pose a risk of water ingress and deterioration of wall elements. Rectification is required to seal all exposed fasteners with a suitable external-grade sealant or as per the cladding manufacturer's specifications.

Nails that are not driven flush break the cladding's weather-resistant surface. Water can track down the nail shank and enter the wall cavity. This increases risk of moisture ingress, rot, mould, and corrosion. All protruding nails need to be driven in and sealed.

These areas need to be brought to the attention of the builder.

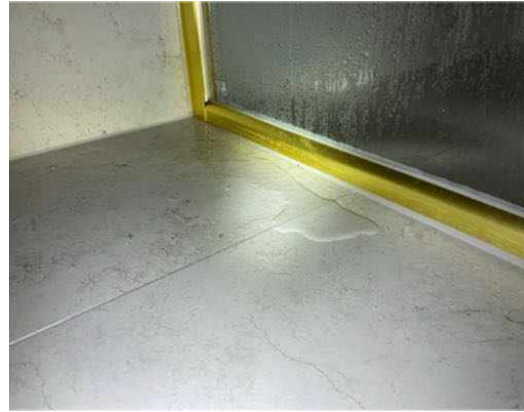
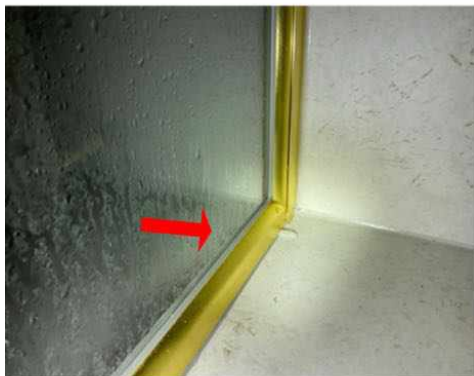
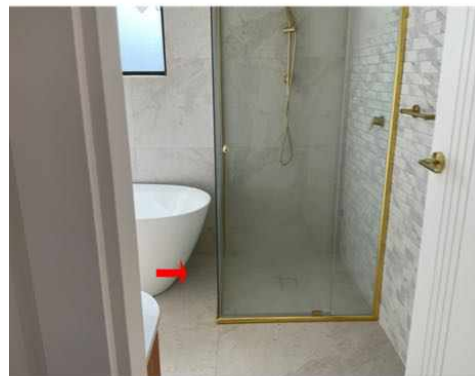
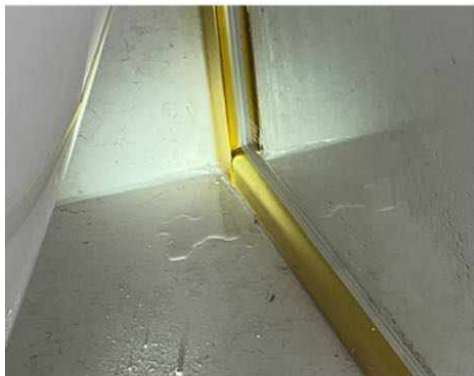
### Defects 3.08

Building:	Building 1
Location:	Bathrooms
Finding:	Shower screens - Leaking
Information:	Three leaks were evident to the two shower screens at the time of inspection. It is suspected that the leaking has occurred as a result missing sealant. Leaking from the showers , where left unattended, is likely to lead to water damage to adjoining flooring and walls. Such damage can lead to water damage and necessitate extensive remedial works being required. Active water leaks may also create an environment that is susceptible to the formation and development of mould.

This should be brought to the attention of the builder.

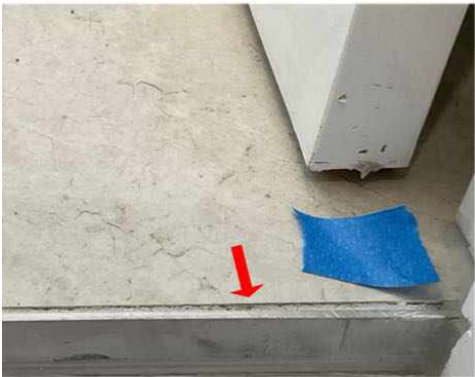
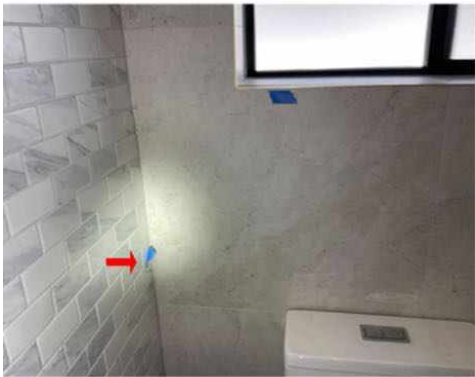
**Defects 3.10**

Building: Building 1  
Location: Bathrooms  
Finding: Sealant and grouting - Missing  
Information: It was noted on inspection that sealant or grout is missing to the pictured bathroom areas. A flexible sealant is required to allow for expected expansion and contraction, while keeping the joint water tight and protective of all associated building materials.

These areas need to be brought to the attention of the builder.

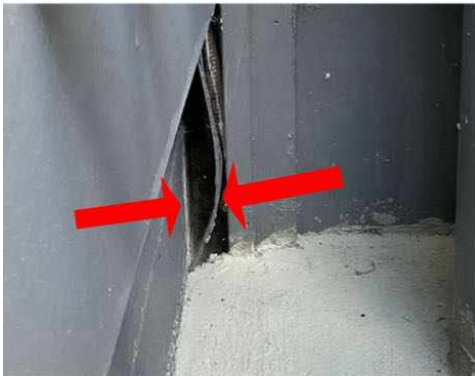
Defects 3.11

Building: Building 1  
Location: Many areas  
Finding: Sealant in External areas - The NSW Standards and Tolerances 2017 - 12.7  
Information: It was noted on inspection that sealant or flashing is missing to some external wall areas. Pictures 4 to 6 show missing flashing/ cladding which is required to stop water ingress to internal areas.

Flexible or waterproof sealants to junctions are defective if they are not installed when required by the BCA and AS 3958.1.

All holes, gaps or cracks should be adequately filled by a suitable sealant or flashings as soon as possible to prevent any water damage that may occur.

These areas need to be brought to the attention of the builder.

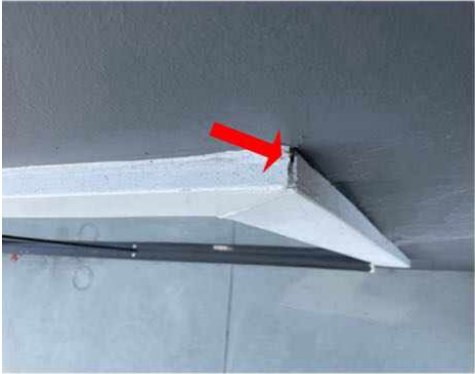
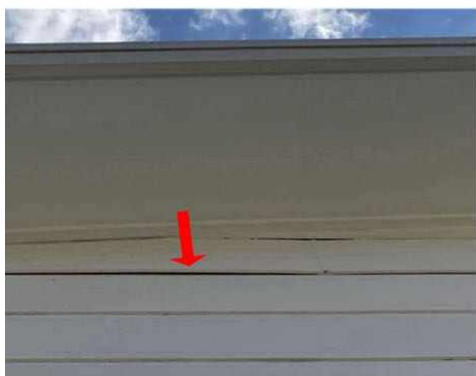
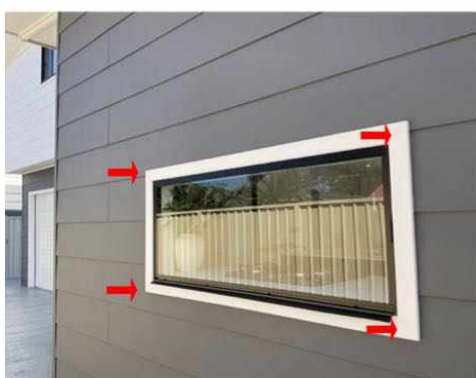
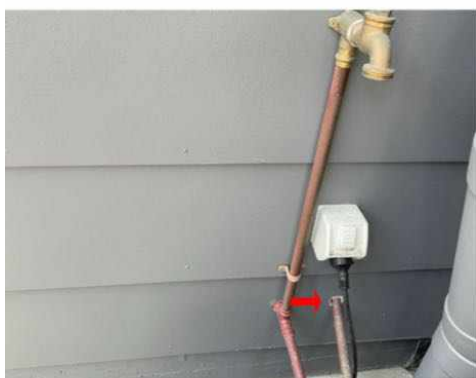
Defects 3.12

Building: Building 1  
Location: Pictured external areas  
Finding: Sealant in External areas - The NSW Standards and Tolerances 2017 - 12.7 (continued)  
Information:

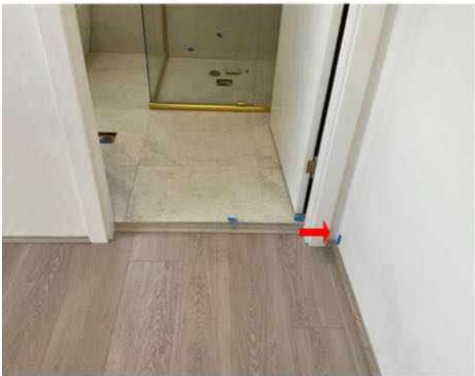
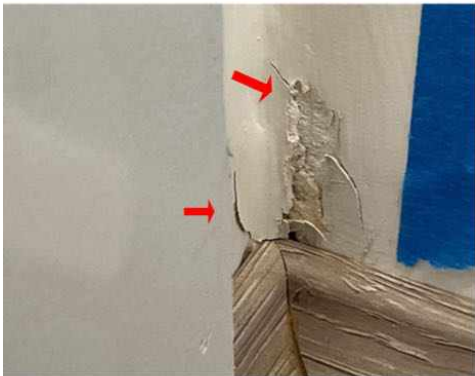
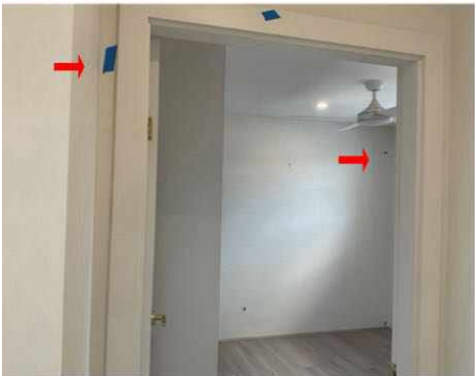
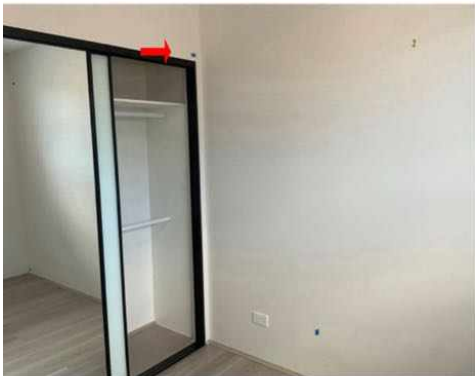
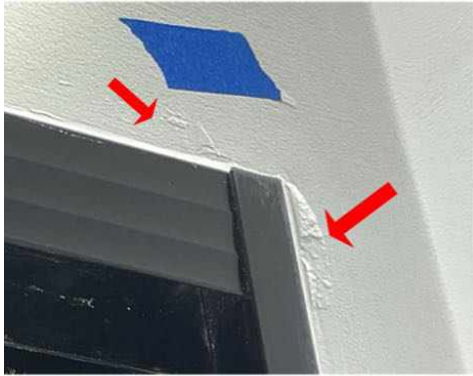
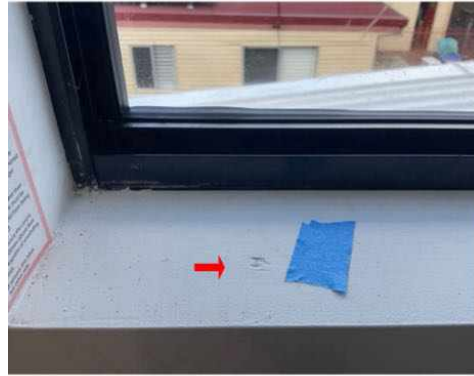
**Defects 3.14**

Building:	Building 1
Location:	External and Internal areas
Finding:	Paintwork defective - NSW Guide to standards and tolerances part 13.2
Information:	Several areas of substandard paint finishes were identified on the building at the time of the inspection. Paintwork is defective if the application has blemishes such as paint runs, paint sags, wrinkling, dust, bare or starved painted areas, colour variations, surface cracks, irregular and coarse brush marks, sanding marks, blistering, non-uniformity of gloss level and other irregularities in the surface that are visible from a normal viewing position. Paintwork is defective if the application results in excessive over-painting of fittings, trims, skirtings, architraves, glazing and other finished edges.

Building: Building 1  
Location: Many upstairs areas  
Finding: Paintwork defective - NSW Guide to standards and tolerances part 13.2 (continued)  
Information: These areas need to be brought to the attention of the builder.

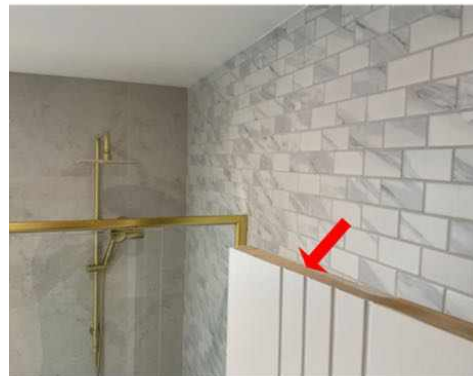
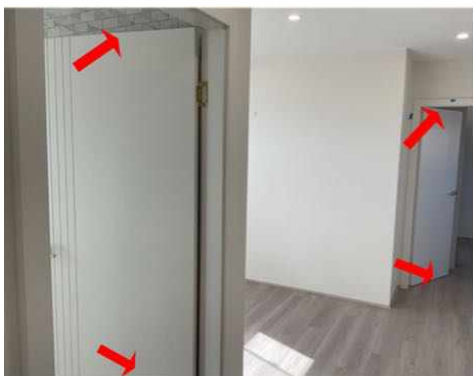
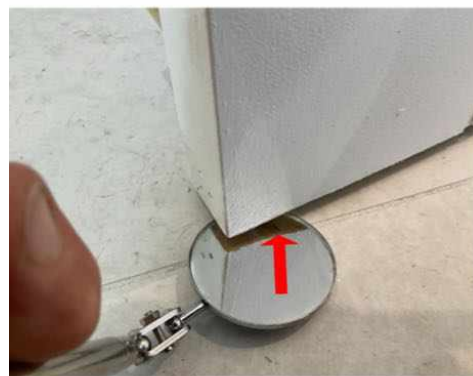
### Defects 3.15

Building:	Building 1
Location:	Many doors
Finding:	Paint finish on doors - Incomplete and minor damage evident
Information:	The paint finish to many doors was identified as being incomplete at the time of inspection.

NSW Guide to Standards and Tolerances 9.6 states that "door leaves are defective if they do not have all sides, top and bottom edges sealed/painted

Whilst incomplete or missing paint finish is generally an appearance defect, it can also lead to the development of secondary building defects over time. Incomplete areas of paint finish expose the area to moisture, potentially accelerating the deterioration of underlying building materials.

Incomplete paint finishes should be sanded back, filled, leveled and painted, as applicable. Where inadequate or missing paint protection has led to the deterioration of any doors, replacement of the damaged doors will be required.

These areas need to be brought to the attention of the builder.

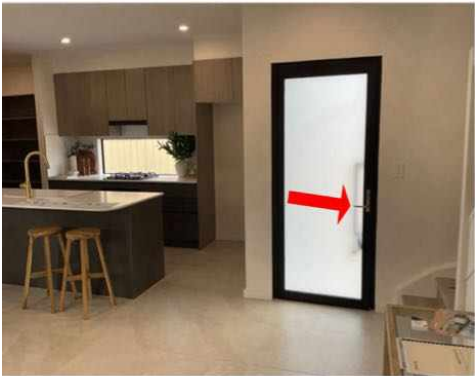
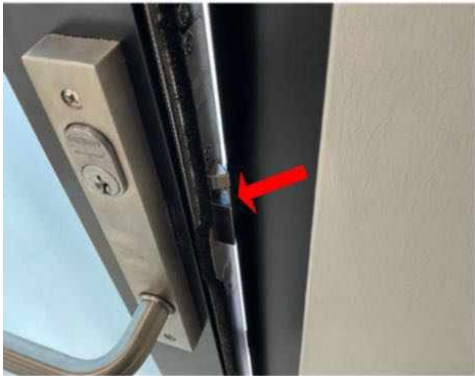
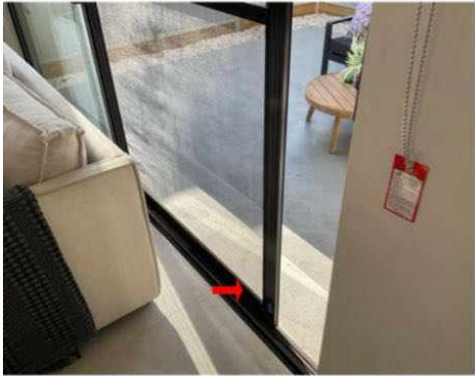
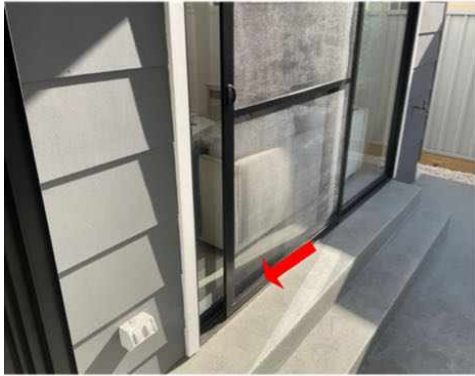
**Defects 3.16**

Building: Building 1  
Location: Entry, rear garage, loungeroom screen door  
Finding: Doors - Binding/jamming  
Information: Binding and/or jamming of these three doors was evident during standard operation. This defect inhibits the functionality of the affected doors as well as creating potential for secondary defects to associated building elements, such as damage to the floor covering.

These areas need to be brought to the attention of the builder.

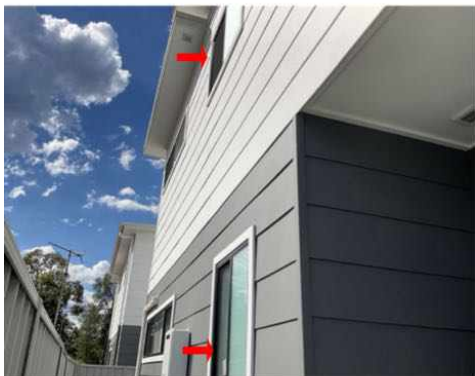
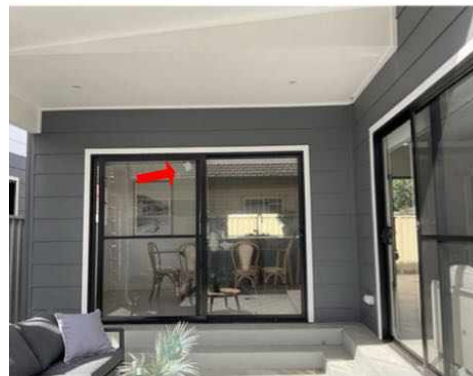
### Defects 3.17

Building:	Building 1
Location:	Windows
Finding:	Cleaning of building elements - NSW Standards and Tolerance 2017 - 3.11
Information:	It was observed that the pictured windows are not cleaned and ready for use. Many stickers are still applied to windows. Some of these areas are inaccessible to remove.

These window areas need to be cleaned and ready for use.

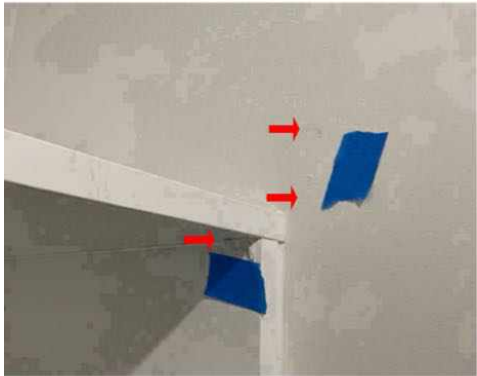
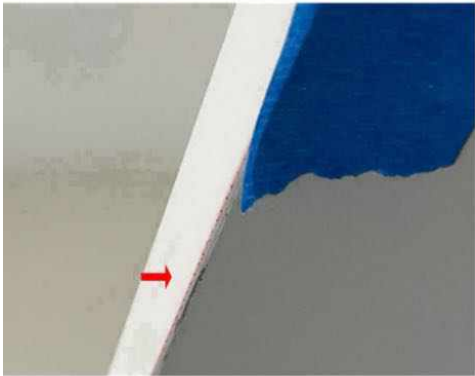
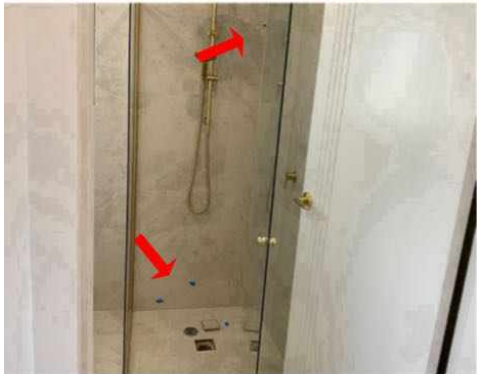
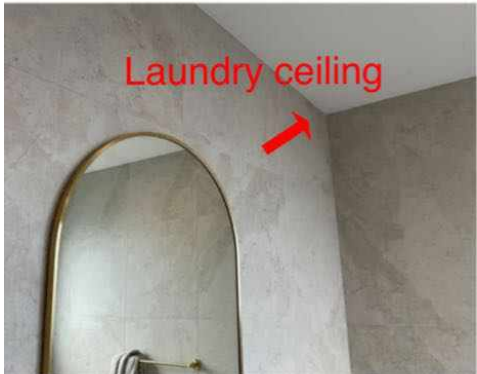
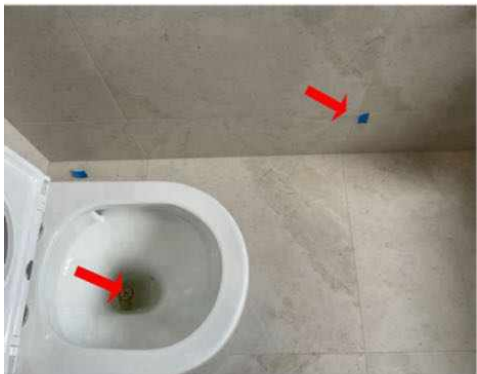
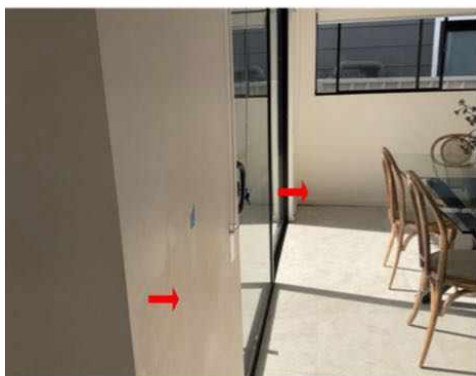
### Defects 3.18

Building:	Building 1
Location:	Many Internal Areas
Finding:	Cleaning of building elements - NSW Standards and Tolerance 2017 - 3.11
Information:	It was observed that the pictured building elements are not cleaned and ready for use.

“Stains, mortar smears and damage caused by cleaning are defective if they are visible from a normal viewing position.”

These areas need to be cleaned and ready for use.
