## Building and Timber Pest Inspection Report

Inspection Date: Fri, 20 Feb 2026

Property Address: 2/123 Cooper St, Waterloo NSW 2017,  
Australia

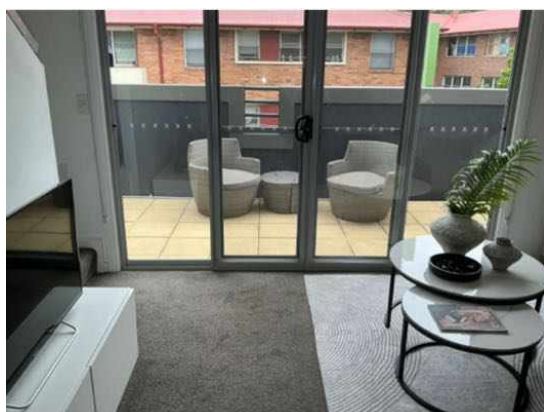
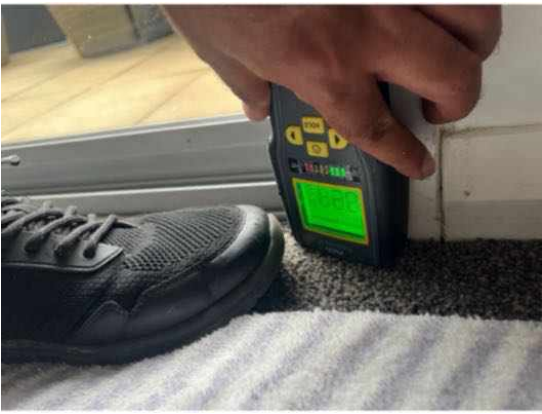
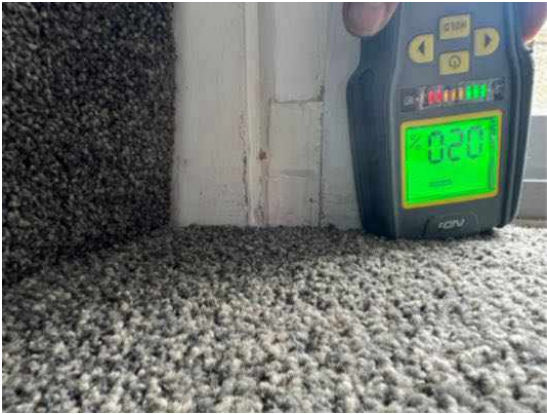
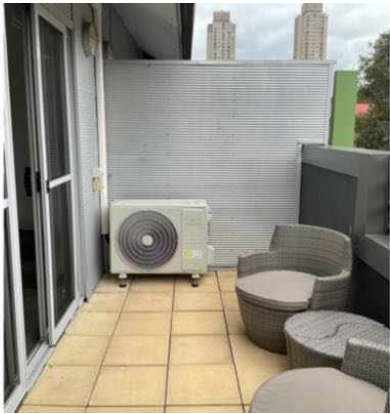
Building: Main Building  
Location: Lounge Room  
Finding: Elevated Moisture at Balcony and skirting  
Information: Minor deterioration and elevated moisture levels were detected to the balcony tiling and adjoining sliding door skirting, indicating a possible moisture pathway from the external balcony or cladding into the internal wall structure. The pattern of readings suggests potential water ingress through the balcony membrane, tiling system, or door threshold detailing. This condition may contribute to concealed deterioration of building materials, timber decay or mould growth if left unresolved. Further investigation and appropriate rectification by a licensed waterproofing contractor and builder are recommended.

Depending on the strata plan, this area may form part of the common property, in which case remedial responsibility may rest with the owners corporation (strata). Purchasers should seek clarification from the strata manager and legal adviser prior to purchase.

Failure to investigate and rectify this defect could cause further damage to the area and associated costs.

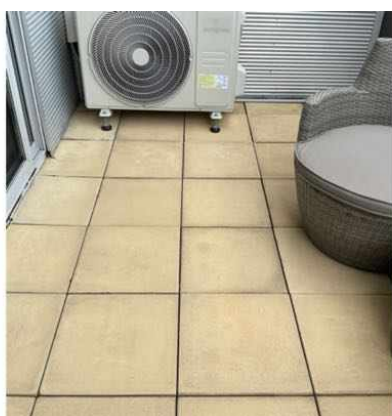
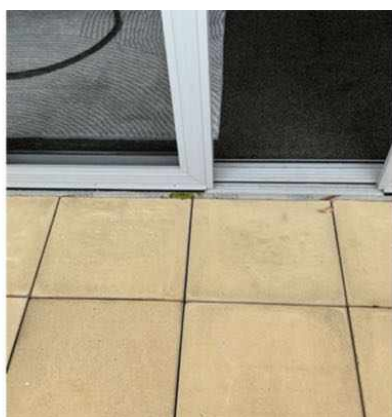
Finding 3.02

Building: Main Building  
 Location: Lounge Room  
 Finding: Pedestal Paver System - Balcony  
 Information: Vegetation growth was observed within the perimeter drainage cavity of the balcony pedestal paver system, indicating accumulation of debris and ongoing moisture retention in an area intended to remain clear for drainage and ventilation. Organic build-up in this zone can obstruct water flow, promote prolonged damp conditions against adjacent wall surfaces, and increase the risk of waterproof membrane deterioration or moisture ingress over time. Cleaning of debris and removal of vegetation is recommended to reinstate proper drainage performance, and the condition of the underlying waterproofing should be monitored in accordance with AS 4654.2 where applicable

Minor movement of individual pavers can be characteristic of this system, however, any excessive rocking or instability should be assessed and adjusted to ensure even support and minimise trip hazards. Ongoing maintenance of pedestal alignment and drainage beneath the pavers is recommended.

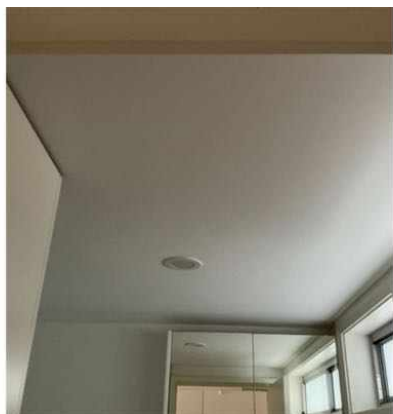
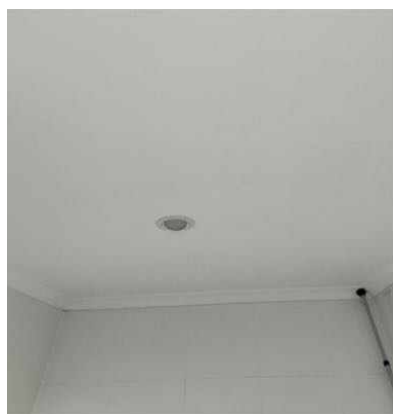
### Finding 3.03

Building: Main Building  
 Location: Laundry/Ensuite  
 Finding: Building element - Missing - No ventilation

Replacement of any missing building element should be conducted as soon as possible to ensure that no damage or functional issues occur to associated building materials.

The appropriate tradesperson should be appointed as soon as possible to replace the missing building element.

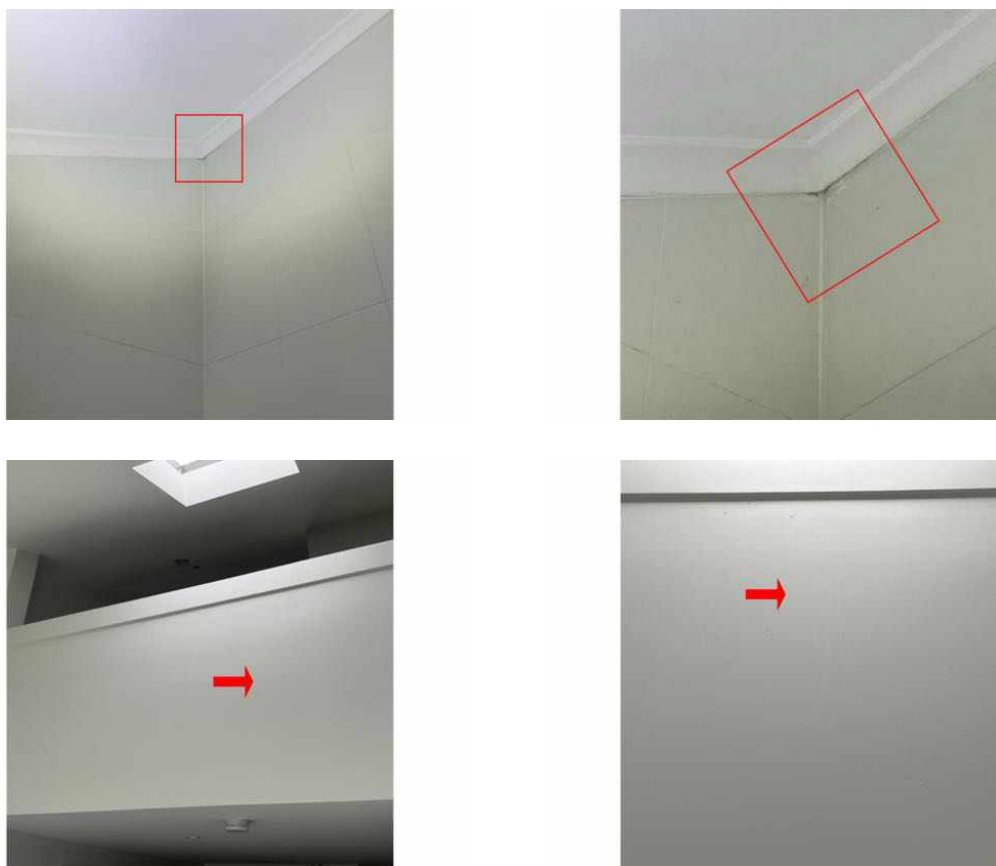
### Finding 3.05

Building: Main Building  
 Location: Bathroom, Lounge  
 Finding: Water Staining - Humidity or Ventilation  
 Information: The ceiling surface shows signs consistent with humidity-related staining, often found in bathroom or wet areas with insufficient ventilation. While there is no visible sagging or major water damage, the pattern suggests prolonged moisture exposure, possibly due to steam accumulation or minor condensation issues. According to AS 4349.1–2007 (Appendix C), this would be classified as a minor defect unless further deterioration or active leaks are found. Recommend improving mechanical or natural ventilation, cleaning the surface with mould treatment, and monitoring for recurrence.

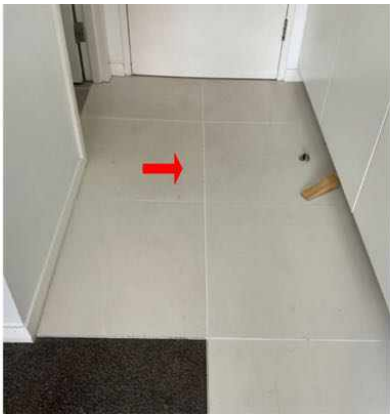
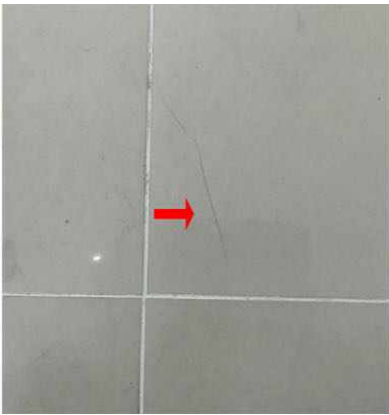
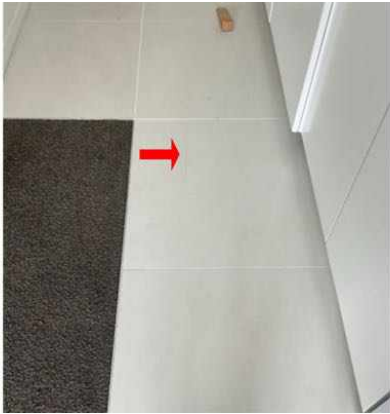
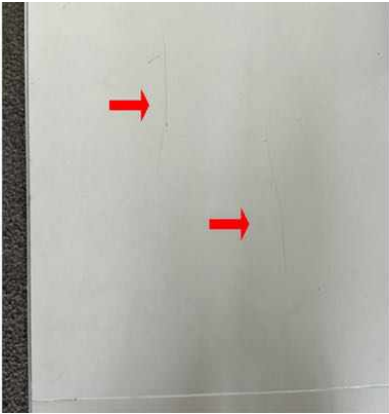
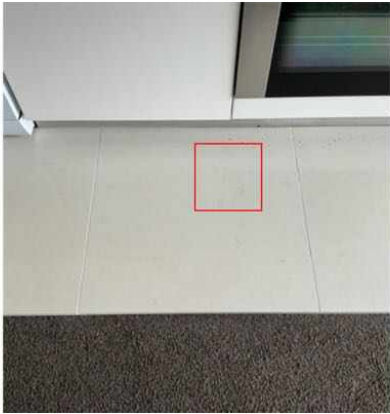
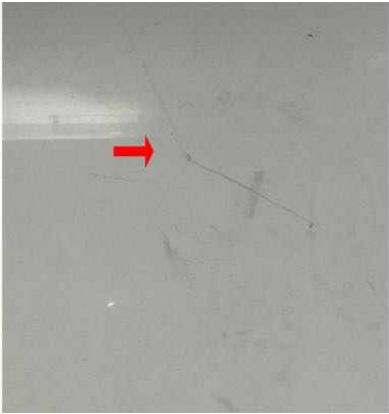
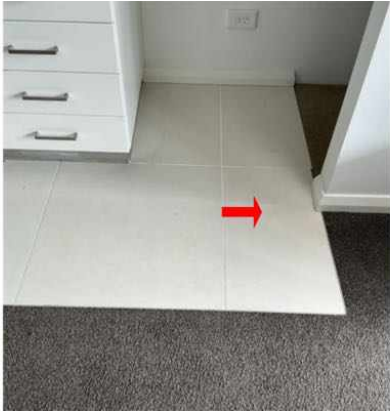
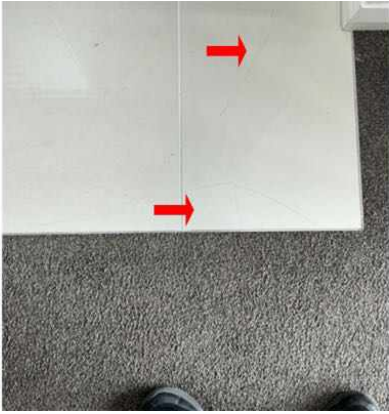
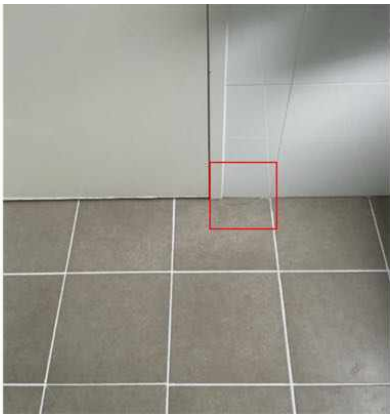
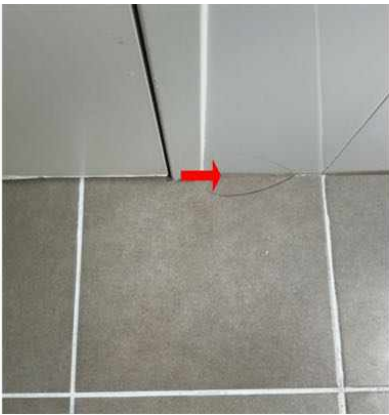
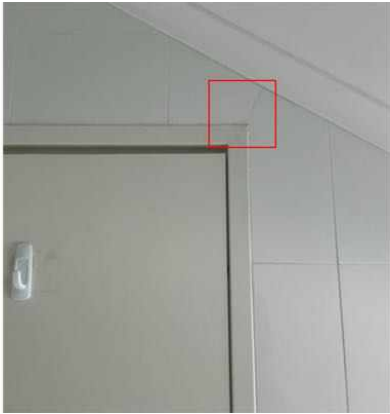
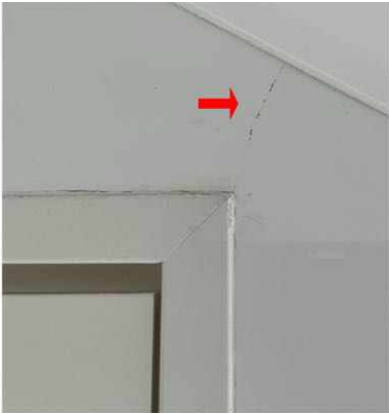
Building:	Main Building
Location:	All Internal Areas - Kitchen , Bathroom
Finding:	Tiles - Cracked or damaged to some areas
Information:	Cracking was evident to the tiling in this area at the time of inspection. While the cracking appears to be minor, this area is frequently exposed to water, allowing potential for water penetration into adjoining sections of walls or flooring.

If left unmanaged, water penetration to these areas may lead to subsequent water damage, which is likely necessitate repair work to affected building elements.

A tiling contractor should be appointed to ensure that no further water damage occurs. The re-application of silicone and grouting throughout remaining tile work is also advised, to further protect the area against water penetration.

Where water penetration has led to water damage, appointment of a relevant tradesperson may be required to repair damaged building elements.

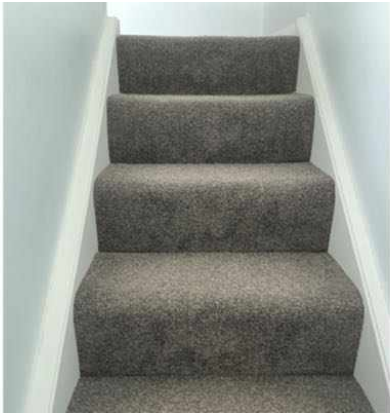
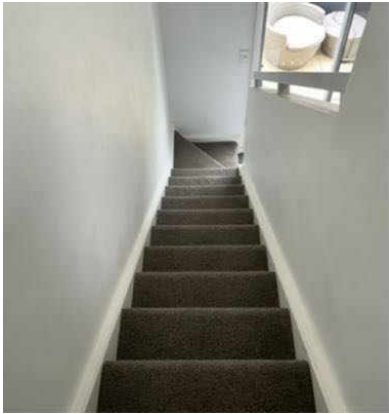
**Finding 3.06**

Building: Main Building  
Location: All Internal Areas  
Finding: Staircase – Creaking and Bouncy  
Information: The stair treads produce creaking noises and a slight bouncy sensation when under load. The cause could not be confirmed during the visual inspection but may relate to normal material flex, loose fixings, or subframe movement. No visible structural damage was evident. Monitoring is recommended, and further assessment by a licensed builder or carpenter may be considered if movement increases or noise persists.

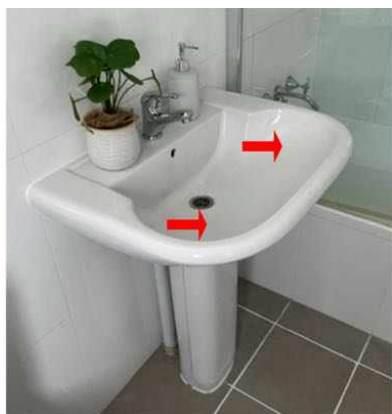
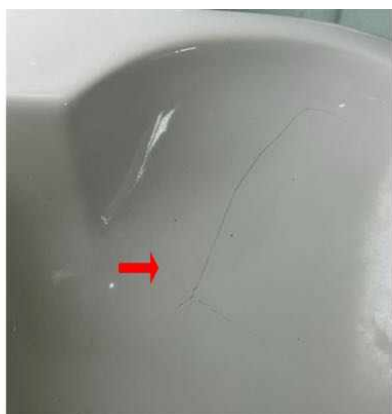
### Finding 3.07

Building:	Main Building
Location:	Bathroom
Finding:	Building element - Damaged - Sink cracked
Information:	Breakage occurs generally when the building materials have either aged and decayed, or as a result of damage (accidental or deliberate).

Repair and/or replacement of broken elements is advised to ensure that additional secondary defects do not arise as a consequence. Such works are necessary, as all building elements play a key role in the operation and function of the overall structure and its performance.

A relevant tradesperson should be appointed to repair or replace the affected building element prior to any subsequent damage being caused.

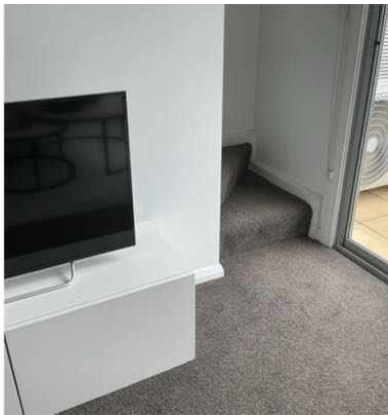
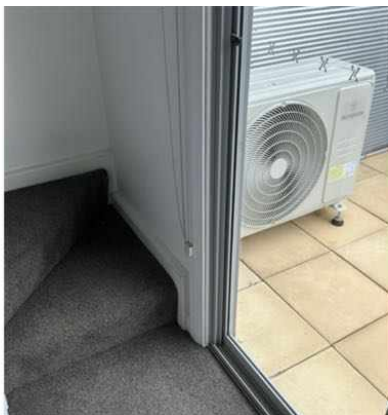
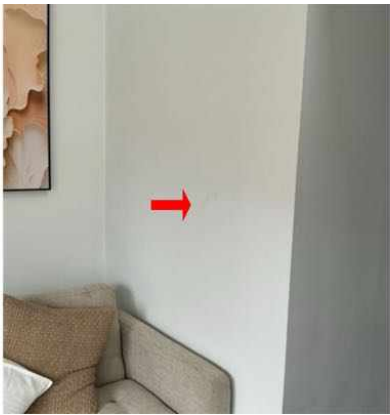
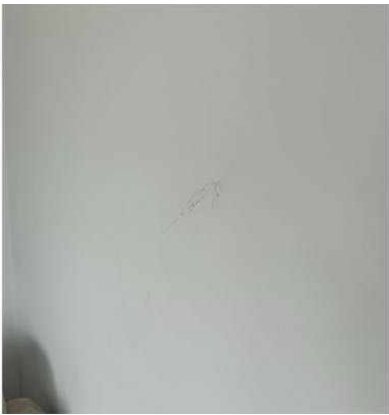
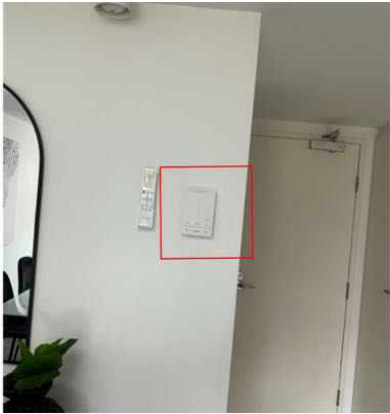
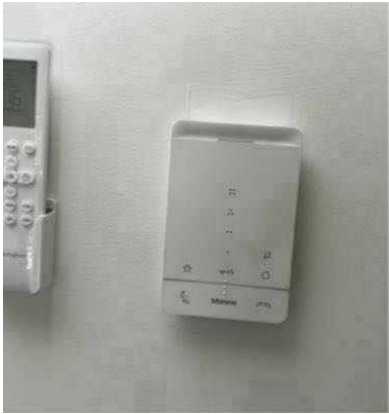
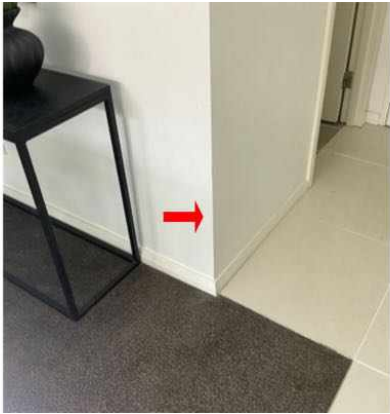
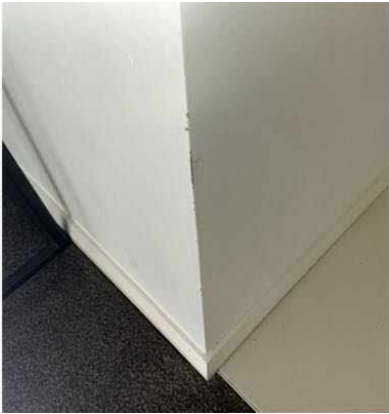
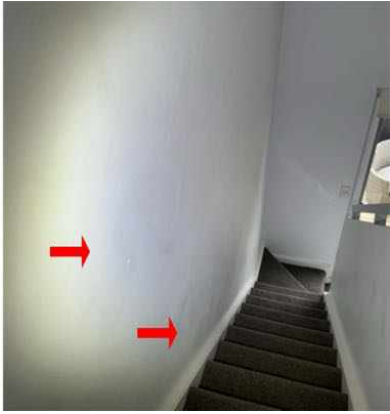
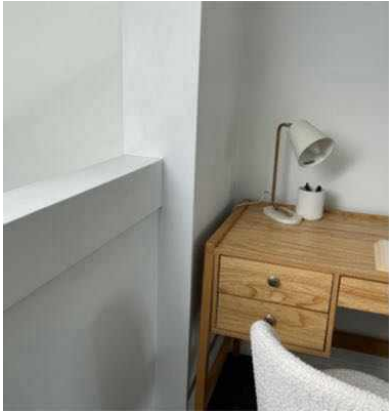
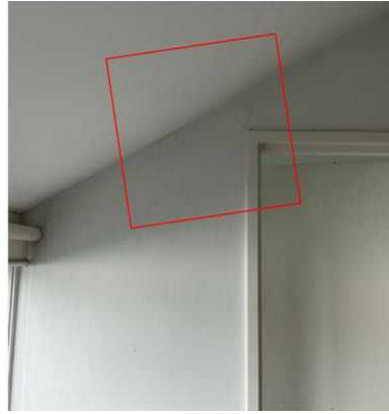
### Finding 3.08

Building:	Main Building
Location:	All Internal Areas
Finding:	Paint finish and hairline cracking
Information:	The paint finish in this area was identified as being incomplete at the time of inspection including some hairline minor cracking.

Whilst incomplete or missing paint finish is generally an appearance defect, it can also lead to the development of secondary building defects over time. Incomplete areas of paint finish expose the area to moisture, potentially accelerating the deterioration of underlying building materials.

Incomplete paint finishes should be sanded back, filled, leveled and painted, as applicable. Where inadequate or missing paint protection has led to the deterioration of the associated building element, repair and/or replacement of this building element may be required.

A painting contractor should be appointed as soon as possible to perform necessary works to aid the appearance of the affected area and to ensure the area is protected against further deterioration. Alternatively, the homeowner following manufacturer instructions may perform these works.

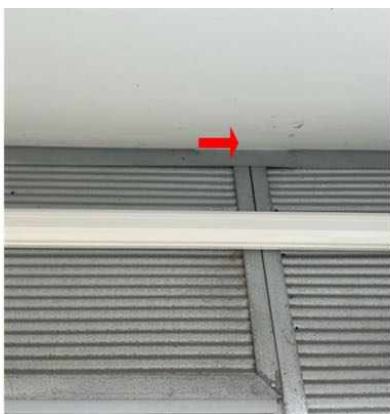
### Finding 3.09

Building:	Main Building
Location:	All Internal Areas
Finding:	Sealant and grouting - Missing or degraded to some areas
Information:	It was noted on inspection that sealant or grout is degraded. There is also evidence of poor workmanship and excessive use of sealant. Silicone should never be used as a first line of defence against waterproofing. Further inspection by a licensed waterproofing contractor is highly recommend

Different materials and floor areas move at different rates, generally causing cracking to grout or sealant at this point. A flexible sealant is required to allow for expected expansion and contraction, while keeping the joint water tight and protective of all

There appears to be excessive mould to the sealant and grout which will likely require scraping out and replacement.

Flexible and mould resistant materials should be applied to affected areas to prevent any subsequent water damage that is likely to occur. Regular maintenance and replacement of damage or missing or damaged sealant and grout is highly recommended to the wet areas, as this is a regular wear and tear defect. Sealant and grouting in areas that come into regular contact with water should be maintained for the long term care of your property.

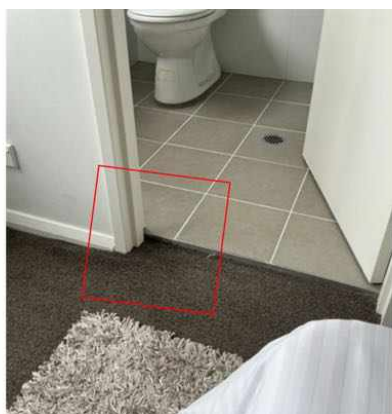
### Finding 3.10

Building:	Main Building
Location:	Bedroom
Finding:	Building element - Damaged - Carpet lifting to some areas
Information:	Breakage occurs generally when the building materials have either aged and decayed, or as a result of damage (accidental or deliberate).

Repair and/or replacement of broken elements is advised to ensure that additional secondary defects do not arise as a consequence. Such works are necessary, as all building elements play a key role in the operation and function of the overall structure and its performance.

A relevant tradesperson should be appointed to repair or replace the affected building element prior to any subsequent damage being caused.

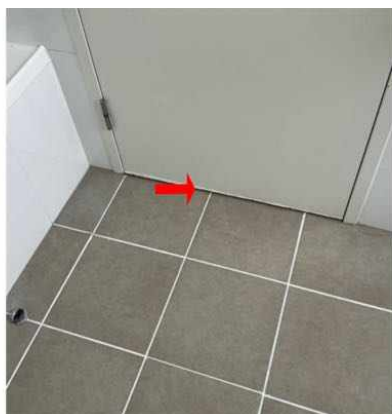
### Finding 3.11

Building:	Main Building
Location:	Bathroom
Finding:	Delamination of timbers
Information:	Delamination is one means by which composite materials (e.g. layered timber composites) may fail over time. In laminated materials, repeated cyclic stresses may

lead to the formation of mini-structures of separate layers, with significant loss of mechanical toughness. Water penetration or the presence of excessive moisture also generally contributes to delamination.

Where building materials have become delaminated, they lose their structural strength, and are likely to have a variety of appearance and serviceability defects as a result.

Delamination of timbers may be repaired where the area affected is minor and/or easily accessible, by gluing and screwing layers back together. However, this is an interim repair, and where delamination has occurred, the client should plan for the replacement of affected timbers sooner than would otherwise be expected.

All timber structures affected by delamination should be replaced as soon as possible to avoid any further damage. Repair and replacement estimates should be sought from a registered builder or qualified carpenter.

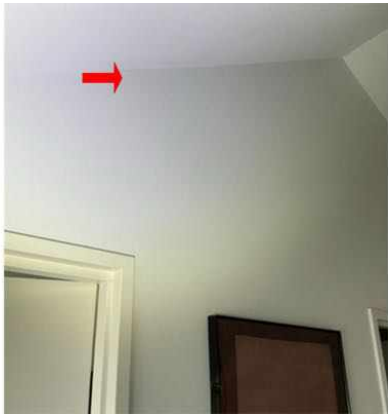
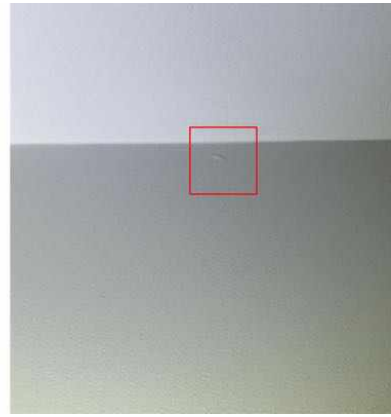
### Finding 3.12

Building:	Main Building
Location:	Bedroom
Finding:	Wall nails - Popping
Information:	popped nails were identified in the wall sheets at the time of inspection. Nails and screws are held by the friction between them and the surface that they are applied to. Over time, the nails and screws can back out, which is often a result of general ageing and deterioration of the building structure.

If left unmanaged, the wall sheets may become loose and unstable, increasing the rate of deterioration of the wall sheeting and creating potential for the development of secondary defects.

Re-fastening of popped nails will help to maintain the stability of the internal walls and associated building elements. Such minor works will also help to improve the appearance of the affected area and secure the wall sheets. These works should be performed by a qualified carpenter or plasterer at client discretion.

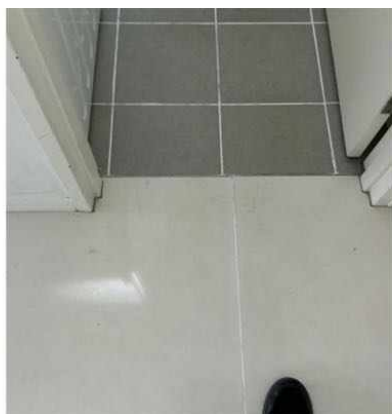
Building: Main Building  
Location: Laundry toilet  
Finding: Bathroom & external floor threshold  
Information: The bathroom floor is at the same level as the adjoining timber flooring. This configuration is typical in modern apartments and is permitted where compliant waterproofing and floor falls are provided. No evidence of moisture damage was observed at the time of inspection; however, waterproofing performance cannot be confirmed without invasive inspection.

Care should be taken to avoid excessive water migration beyond the bathroom during use.
