# Building and Timber Pest Inspection Report

Inspection Date: Mon, 16 Mar 2026

Property Address: 46 O'Farrell St, Yarraville VIC 3013,  
Australia

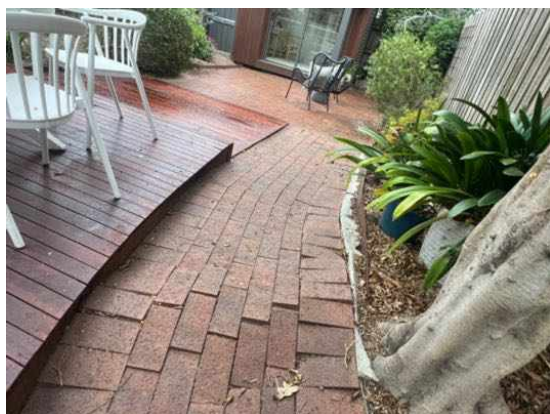
Building: Yard  
Location: Yard - Back > Rear Right  
Finding: Paving - Uneven  
Information: Sections of the external paved area are uneven, creating a potential trip hazard. It appears as though the area has been subject to rough installation, or that paving sections have lifted due to movements in the foundation of the property.

Where paving creates a trip hazard, personal injury may ensue if due caution is not taken by all persons within this area.

Re-paving of the area is required as soon as possible to remedy this situation. Further consultation with a specialist concreter is advised.

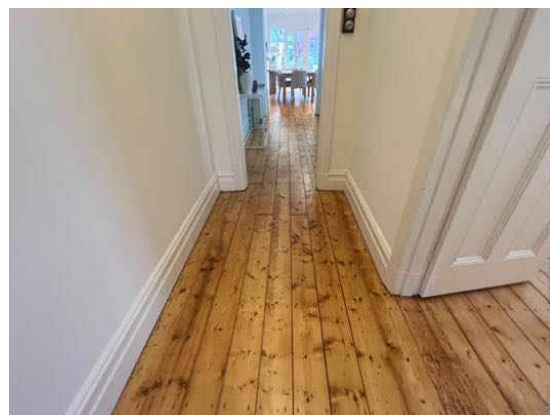
It is advised that the flooring be closely monitored to identify any further movement. Where flooring remains relatively unchanged for an extended period of time (i.e. several months), it is likely that this defect has been caused by expected movement of the foundations of the property.

However, where flooring is uneven further, potentially invasive inspection of the subfloor structures and stumps in this area is required. In this case, works to repair are likely to be required, and would be carried out by a registered builder specialising in re-stumping.
