# Building and Timber Pest Inspection Report

Inspection Date: Wed, 11 Mar 2026

Property Address: 140 Kalang Rd, Bellingen NSW 2454,  
Australia

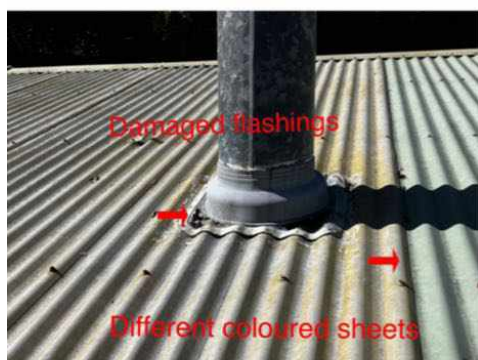
Building: Main Building  
Location: Roof Exterior  
Finding: Roof exterior and guttering  
Information: At the time of this inspection, the roof sheeting, roof flashings and roof penetration flashings appeared to be in weathered and poor condition with some deterioration evident.

The guttering was generally full of leaf litter and water and has minor rusting in the bottom of the gutters in areas. It is recommended that the guttering be cleaned out as soon as possible.

There were numerous rusted roofing screws, these should be replaced by a roofer.

It was observed that the hot water solar panels and the electrical solar panels had extensive mould and fungus evident, it is recommended that these items and the roofing be pressure cleaned.

It is recommended that a roofer thoroughly inspect the roof sheets, roof flashings and guttering as soon as possible and provide required maintenance.

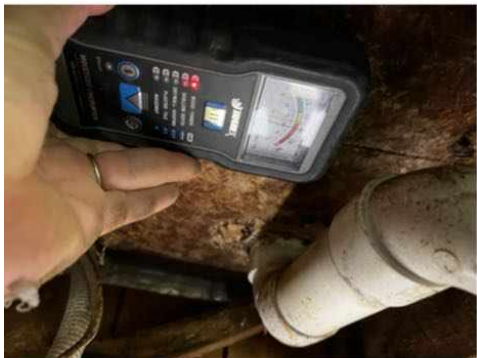
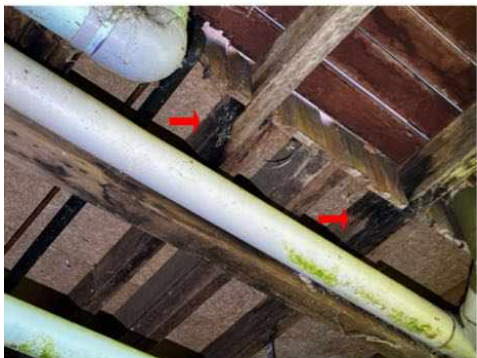
## Finding 2.02

Building:	Main Building
Location:	Subfloor
Finding:	Subfloor space - defects
Information:	At the time of this inspection it was observed that there were numerous defects in the subfloor area,

1 - The subfloor has a combination of masonry piers to the front wall and timber posts buried in the ground. It was observed that the masonry piers has metal ant caps fitted. The timber posts had no termite protection. It is recommended that a timber pest expert provide terminate protection to all timber posts as soon as possible.

2 - It was also noted that there was wet soil and areas where water runs under the floor, a plumber should be engaged to provide additional drainage to the front of the house to eliminate this issue.

3 - It was observed that some sections of the excessive vegetation was in contact with the timber floor structure elements, it is recommended that this vegetation be removed as soon as possible.

4 - It was further observed that some water was running down the rear wall timber cladding and under the floor structure creating water damage and mould. It is recommended that a carpenter repair any damage to the wall cladding and seal this junction.

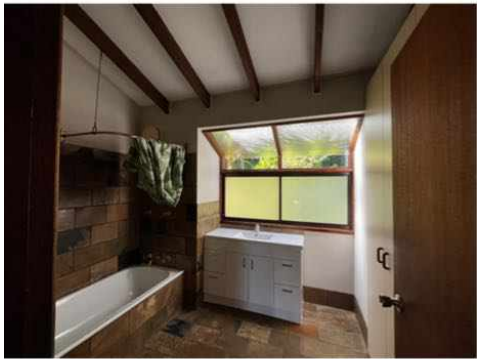
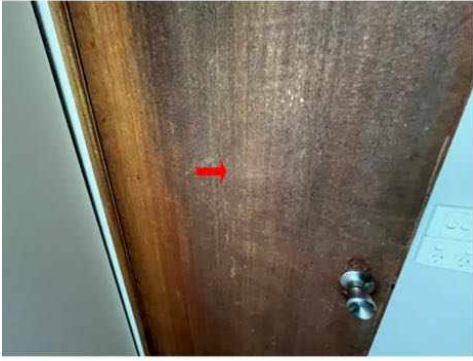
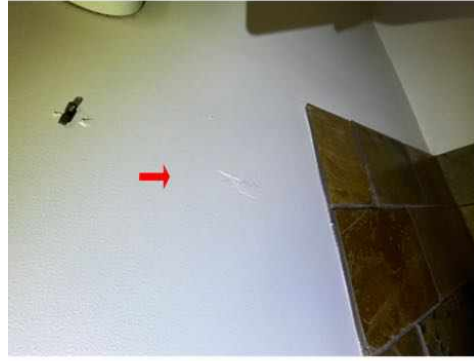
**Finding 2.03**

Building: Main Building  
Location: Powder room  
Finding: Powder room - defects  
Information: At the time of this inspection it was observed that there were a number of defects in the powder room area,

It appears that the water is leaking from the powder room and causing damage to the floor of the powder room, as detailed in this report under “excessive moisture”.

It is recommended that the powder room be renovated as soon as possible.

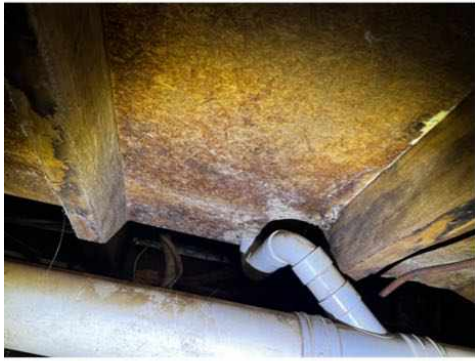
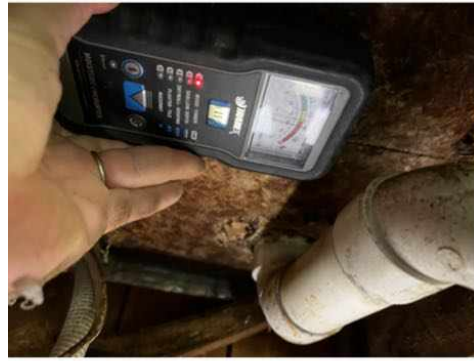
### Finding 2.04

Building: Main Building  
 Location: Powder room  
 Finding: Moisture - powder room excessive moisture evident  
 Information: At the time of this inspection a moisture meter was used to take reading of moisture outside the shower cubicle on both tiled walls.

An excessive moisture reading was evident in the wall tiles around the shower and bath.

The moisture readings in the tiles ranged from 22 to 28 on the moisture metre out of a

Water damage was evident under the bathroom floor and it appears that water is leaking from the shower area.

It is assumed that the waterproofing membrane has failed in the shower/ bathroom area.

It is recommended that a builder and plumber investigate this issue further to determine the cause of the excessive moisture content in the wall tiles and damage to the flooring and suggest remedial works to fix the underlying issue.

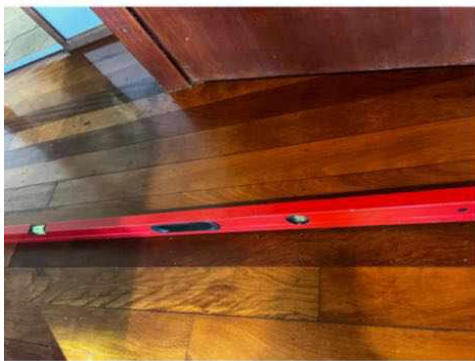
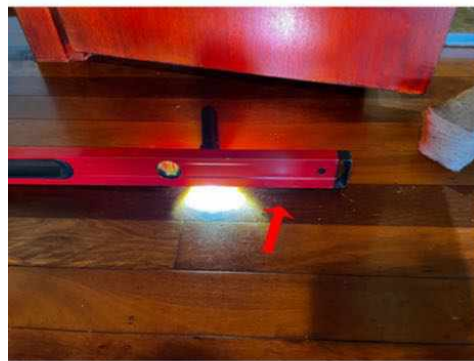
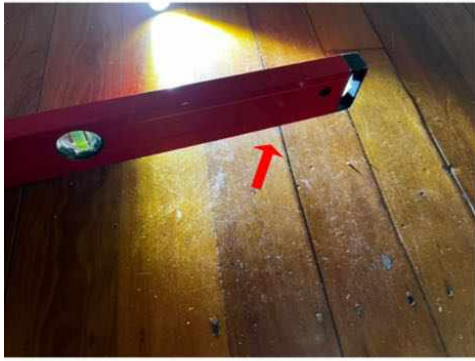
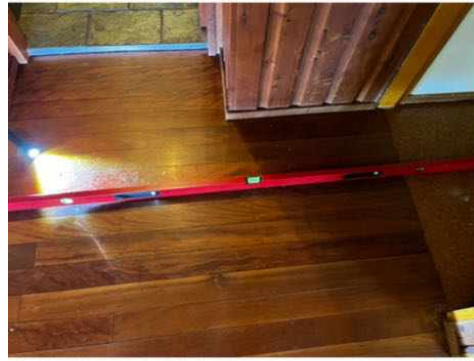
### Finding 2.05

Information: At the time of this inspection it was observed that the timber floors were generally level throughout the house.

It is assumed that this is as a result of minor movement in the subfloor piers and floor.

It is recommended that a builder thoroughly inspect the subfloor area to determine any remedial works required to level the floors, at your discretion.

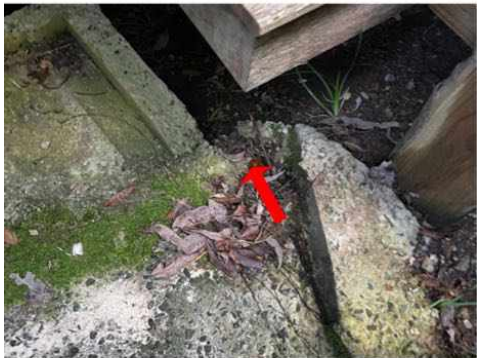
### Finding 2.06

Information: It was observed that there was no barrier to prevent water running under the house, it was also noted that there was no drainage at the front of the house to capture surface or subsoil water. It is recommended that a plumber install a sub soil agg drain to collect all water before it gets to the house and retaining walls, this work should be completed as soon as possible.

Damp soil under the house has the potential to attract termites and cause mould.

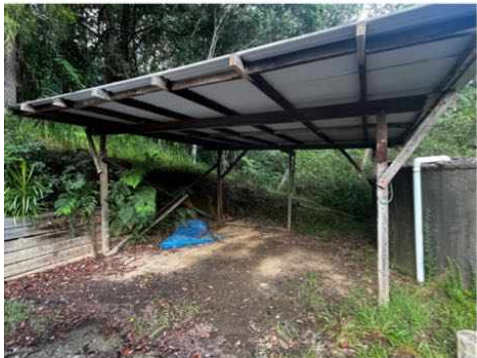
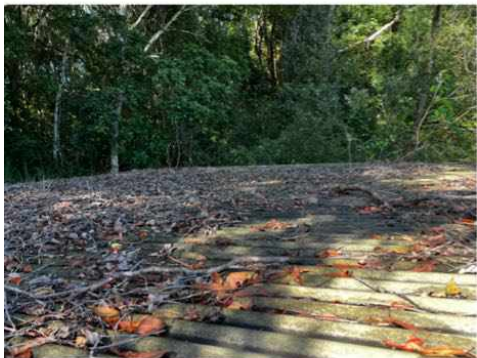
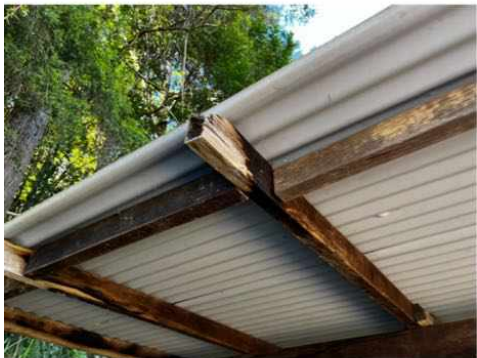
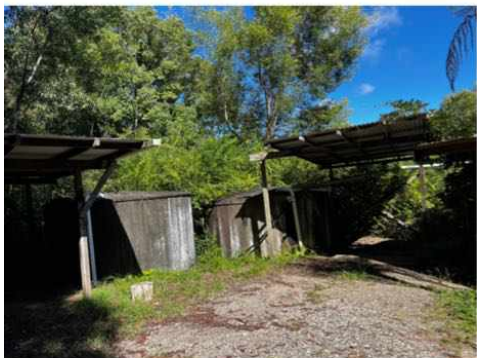
**Finding 3.01**

Building: Main Building  
Location: Carport  
Finding: Carport - defects  
Information: At the time of this inspection it was observed that the two carports at the front of the house were in poor condition and should be repaired or replaced.

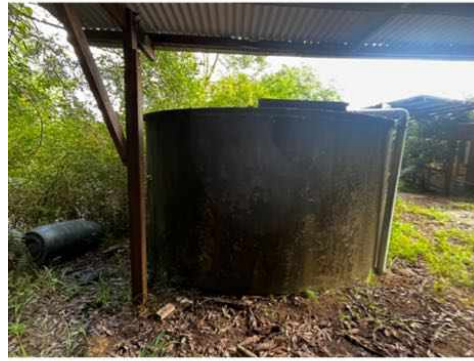
**Finding 3.02**

Building: Main Building  
Location: Water tanks  
Finding: Concrete water tanks - defects  
Information: It was observed at the time of this inspection that the concrete water tanks had excessive mould and fungus growth evident to the external areas, also noted was a water leak to the one tank where the pipe joins the tank. It is recommended that the vegetation around the tanks be cleared and tanks cleaned for inspection and repair.

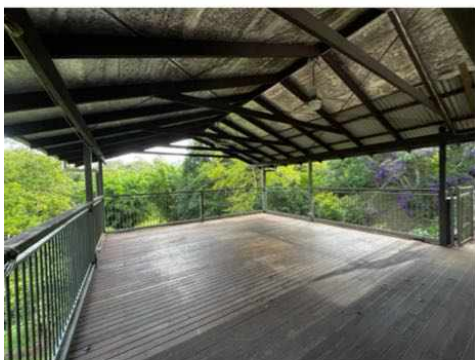
### Finding 3.03

Building:	Main Building
Location:	Rear covered deck
Finding:	Rear covered deck - defects
Information:	It was observed at the time of this inspection that the rear covered deck and rear wall area was in poor condition.

It was also observed that the steel balustrade elements were severely rusted in areas, it is recommended that a steel worker grind off the rust make any required repairs and re prime and paint the steel elements as soon as possible.

It was also observed that the rear eaves sheets and sarking to the underside of the deck roof were mouldy and should be pressure cleaned and repainted.

Maintenance is required to a number of items in this area, decking, timber balustrade, timber wall cladding, timber fascias and timber window and door frames all require repairing, sanding and re coating, it is recommended that a carpenter and painter complete these work as soon as possible.

The guttering should be cleaned of leaf litter.

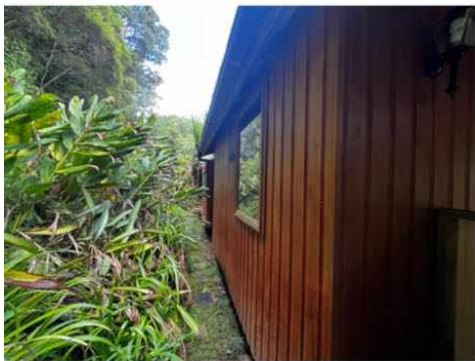
Finding 3.04

Building: Main Building  
Location: Exterior walls - front  
Finding: Exterior area front - defects  
Information: It was observed at the time of this inspection that there were a number of defects at the front of the house,

It was also observed that the front eaves sheets were mouldy and should be pressure cleaned and repainted.

It was observed that the front down pipe bracket was broken, a plumber should re fit the bracket as soon as possible.

Maintenance is required to a number of items in this area, timber wall cladding, timber fascias and timber window and door frames all require repairing, sanding and re coating, it is recommended that a carpenter and painter complete these work as soon as possible.

The guttering should be cleaned of leaf litter.

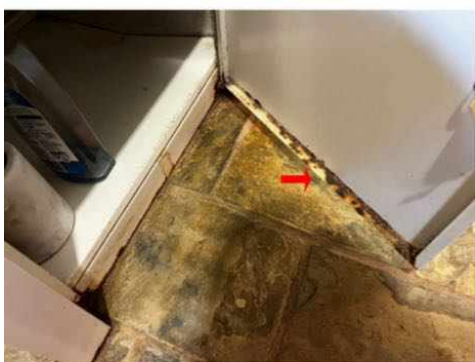
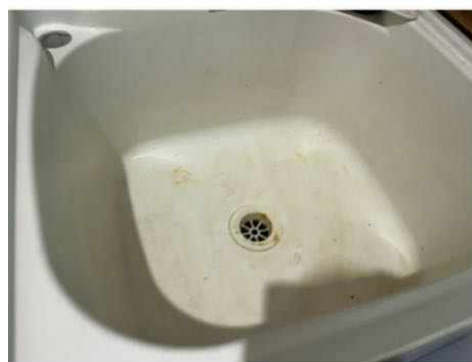
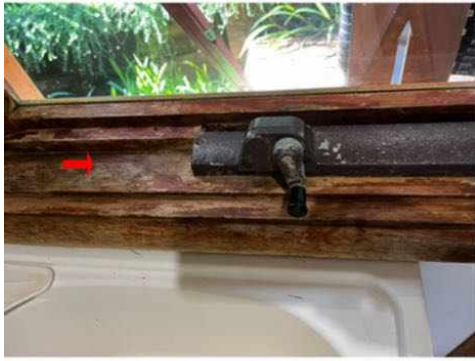
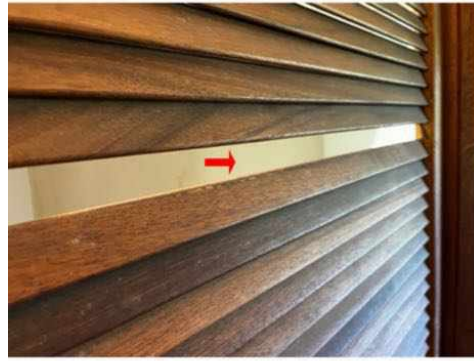
Finding: Laundry - defects

Information: At the time of this inspection it was noted that there were a number of minor defects in the laundry.

1 - It was observed that the laundry tub and cabinet require replacement, the steel cabinet was rusted and the plastic tub stained.

2 - It was observed that there was damage to one linen cupboard door with a timber slat missing, a carpenter should repair the door.

3 - It was also observed that the timber to the window and door frames was weathered with minor damage, it is recommended that a painter prepare and repaint the entire room.

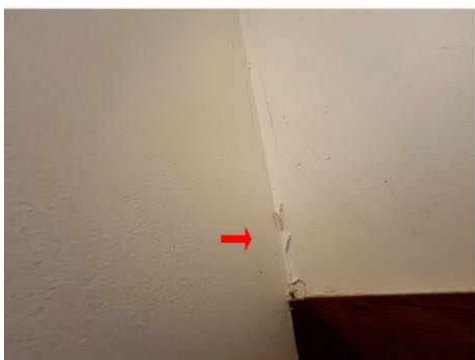
### Finding 3.07

Finding: Toilet - defects

Information: It was observed at the time of this inspection, it was observed that there was minor damage to the timber passage door, wall sheeting and timber architrave, it is recommended that a painter should prepare all surfaces and repaint the entire room.

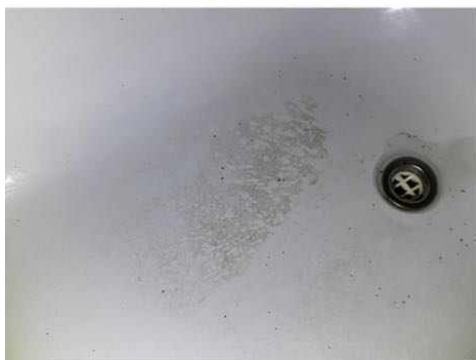
Building: Main Building  
 Location: Bathroom  
 Finding: Bathroom - defects  
 Information: At the time of this inspection it was observed that there were a number of defects in the bathroom area,

1 - It was observed that the timber vanity bench was water affected, it is recommended that a painter sand and re coat the timber top.

2 - It was also observed that the timber window and frame was weathered and should be sanded and repainted.

3 - The bath tub had staining, this should be cleaned if possible.

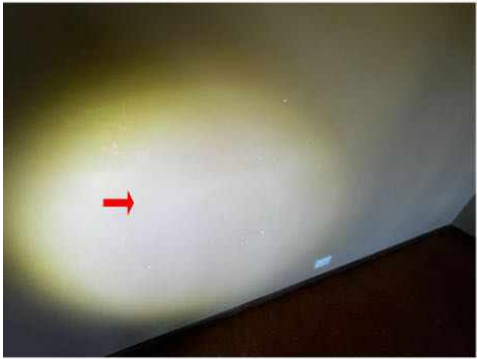
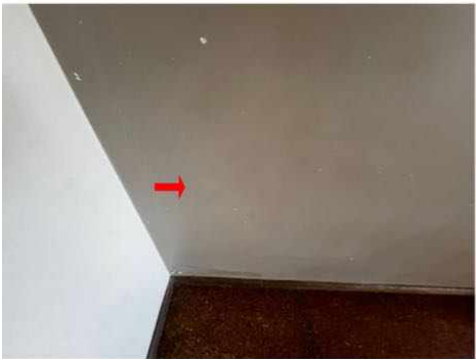
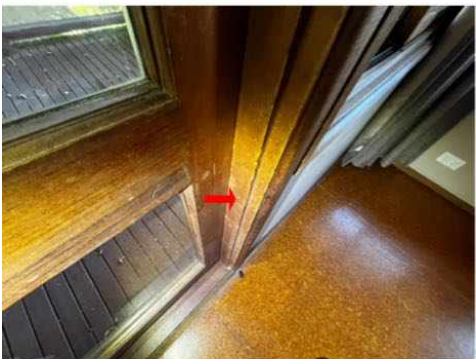
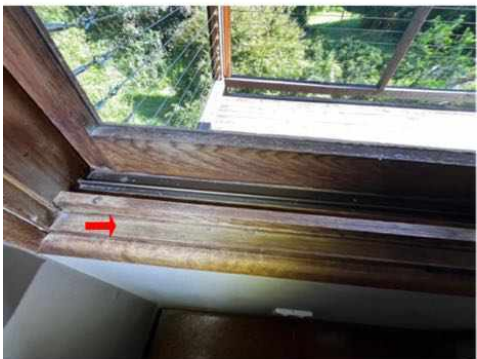
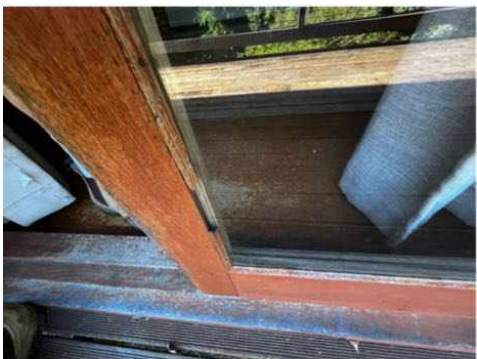
Finding: Bedroom 1 - defects

Information: At the time of this inspection several defects were observed in bedroom 1,

1 - It was observed that there was minor cracking and damage to the wall sheeting, all areas should be patched and repainted.

2 - Minor marking was observed to the ceiling in one area, this area should be repainted at your discretion.

3 - It was observed that all timber windows and doors were weathered and should be prepared and repainted.

4 - It was observed that a trim was broken to the external door, a carpenter should repair the door and all surfaces be repainted.

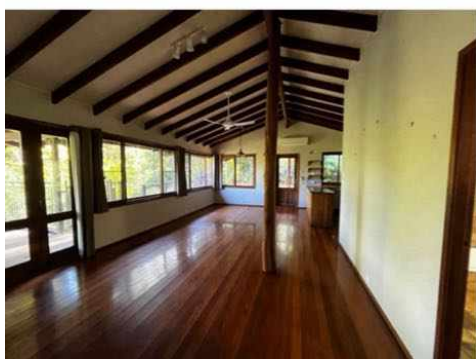
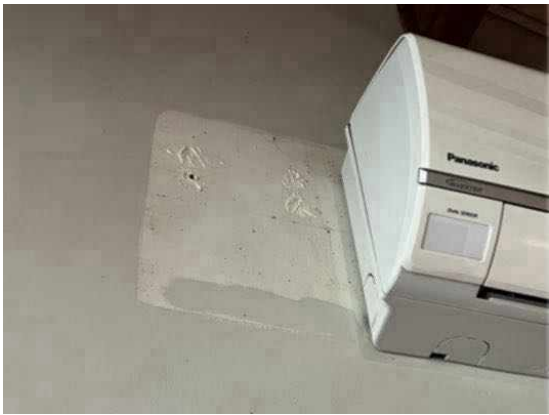
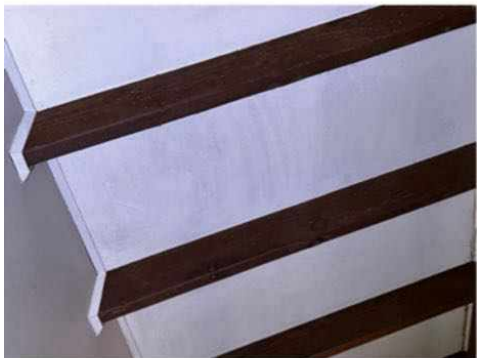
Building: Main Building  
 Location: Lounge Room  
 Finding: Lounge room - defects  
 Information: At the time of this inspection it was observed that there were a number of defects in the lounge room,

1 - It was observed that there was minor damage to the wall sheeting and ceiling sheeting where replacement items have been fitted, these unpainted areas should be prepared and painted.

2 - It was observed that there was mould growth and marking evident to areas of the ceiling, the ceiling should be cleaned and repainted.

3 - All timber windows and doors were weathered and require preparing and re coating. Also observed were a number of minor areas of maintenance required and should be provided by a glazier.

4 - It was observed that there was minor damage and scratching to the timber flooring, a flooring expert should sand and re coat the floor at your discretion.

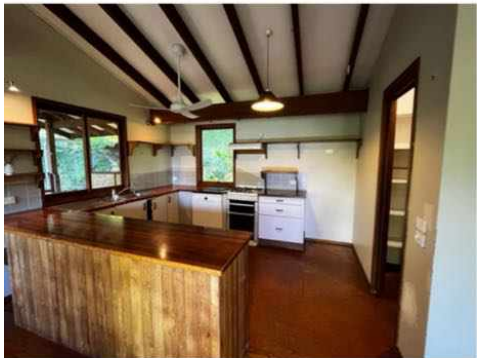
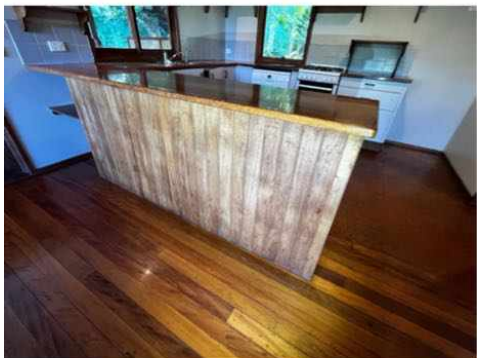
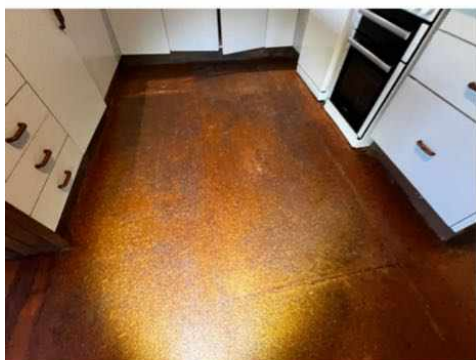
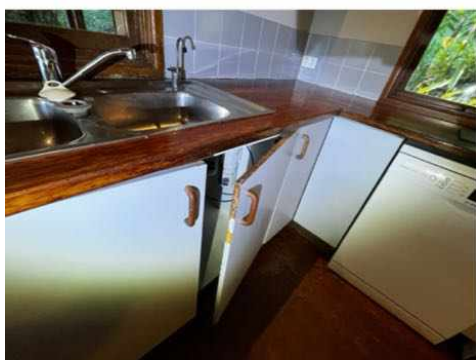
**Finding 3.17**

Building: Main Building  
Location: Kitchen  
Finding: Kitchen - minor defects  
Information: At the time of this inspection, it was observed that the kitchen and pantry were in poor condition, it is recommended that the areas be renovated as soon as possible.

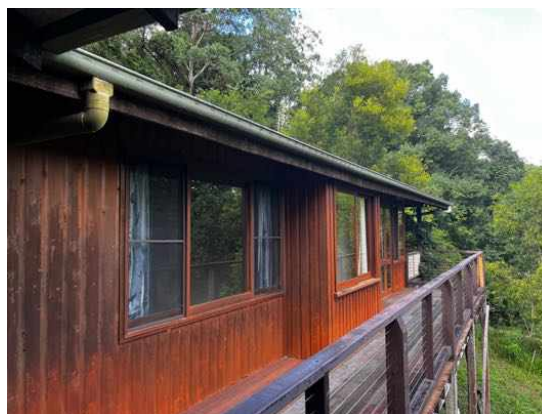
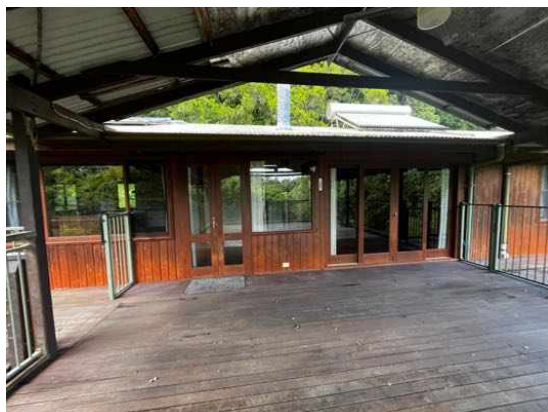
External timber structures are also constantly exposed to weather elements and can deteriorate in an accelerated manner, ongoing assessments are required.

It is highly recommended that a Structural Engineer further assess the external timber balcony or deck to inform the client of its load capacity. Regular maintenance inspections by competent practitioners is needed.

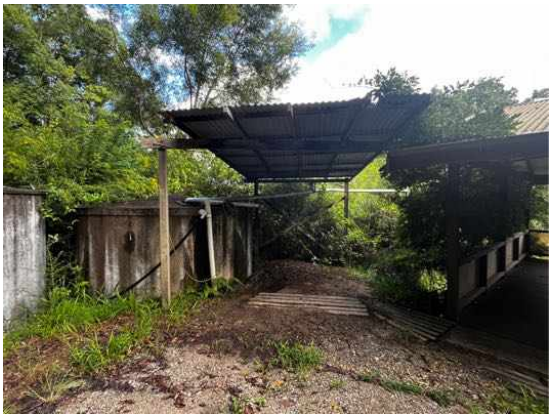
Building: Main Building  
Location: All External Areas  
Finding: Overgrown vegetation  
Information: Extensive and overgrown vegetation was observed to all areas of the house and yard, this vegetation should be thinned out or removed and all areas reinspected.

In areas the vegetation is causing damage to the building.

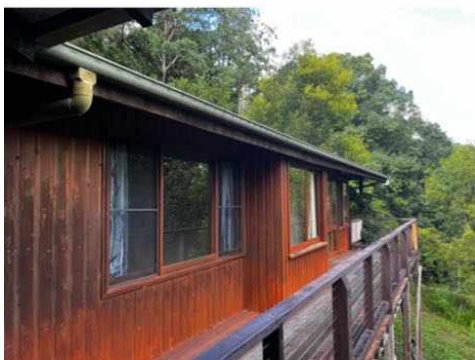
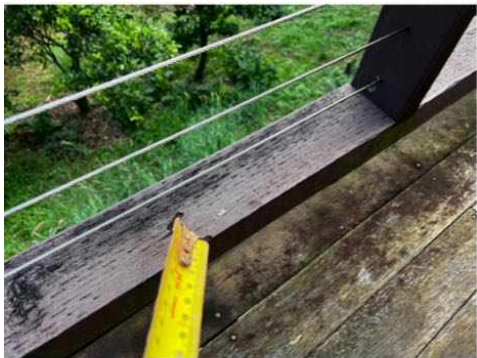
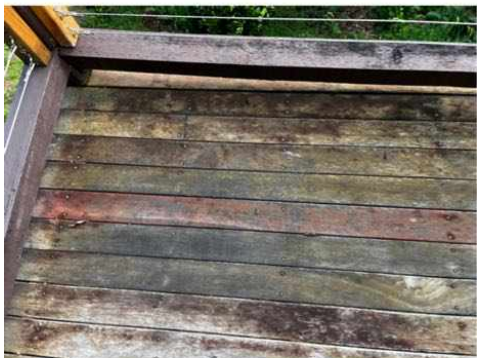
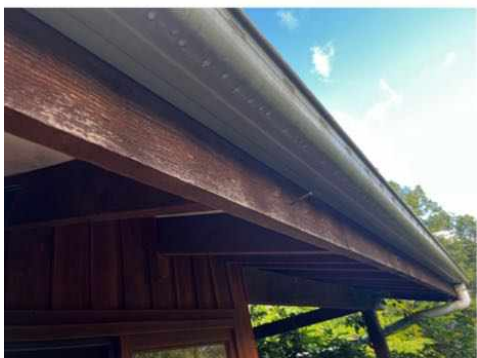
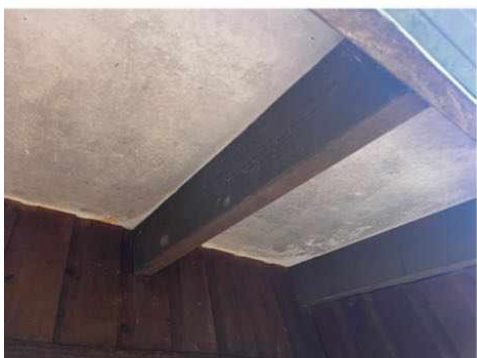
### Finding 7.02

Building:	Main Building
Location:	Rear uncovered deck
Finding:	Rear uncovered deck - defects
Information:	It was observed at the time of this inspection that the rear uncovered deck and rear wall area was in poor condition.

It was observed that the timber balustrade was non compliant under current regulations, however the balustrade may have been compliant when constructed. It is recommended that the balustrade be made compliant in the interests of safety.

The guttering should be cleaned of leaf litter.

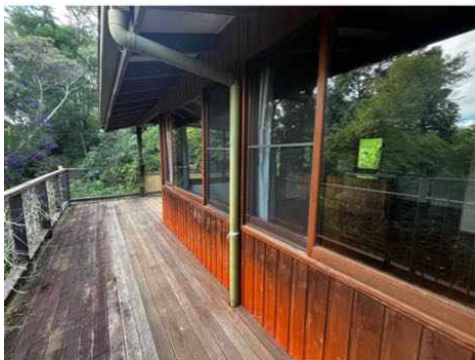
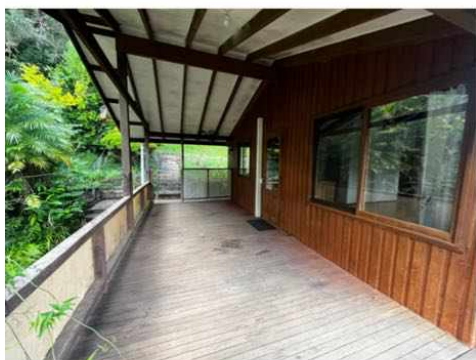
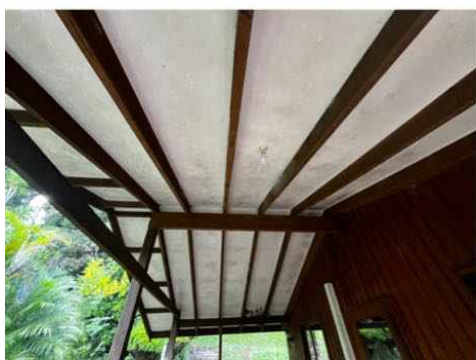
Finding 7.03

Building: Main Building  
Location: Rear covered deck  
Finding: East deck and wall area - defects  
Information: It was observed at the time of this inspection that the eastern wall and deck area was in poor condition.

It was observed that the timber balustrade was non compliant under current regulations, however the balustrade may have been compliant when constructed. It is recommended that the balustrade be made compliant in the interests of safety.

All vegetation should be removed from this area as soon as possible.

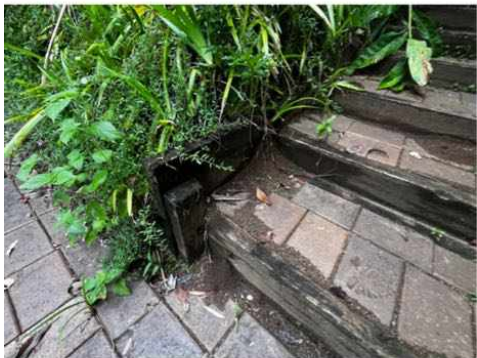
### Finding 7.04

Building:	Main Building
Location:	All External Areas
Finding:	Landscaping Timbers and retaining wall - defects
Information:	At the lke of this inspection it was observed that there was numerous timber elements used in the landscaping, these elements were garden edging, garden featured and retaining walls timbers.

It is recommended that all vegetation be thinned out or removed and a landscaper is engaged to provide maintenance (repair or replace damaged elements) to all retaining walls and landscaping Timbers as soon as possible.

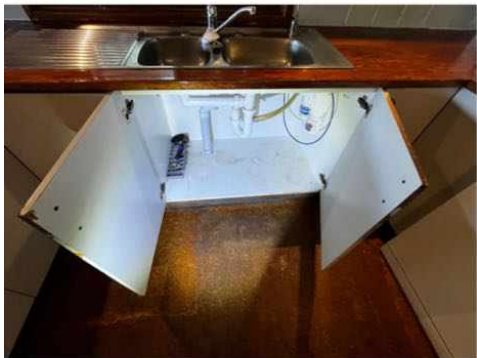
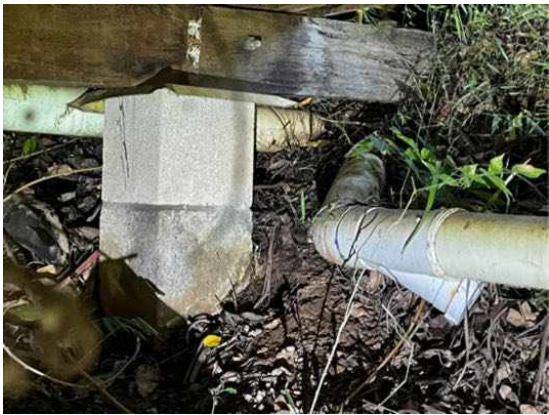
There was no evidence of any further inspections or treatments additional to that.

As a consequence of the conducive conditions that exist around the external of the building for the attack or infestation of timber pests, especially the sub floor area, it is highly recommended that a professional timber pest practitioner be engaged to complete a timber pest inspection to all areas of the property, including landscaping and all areas of the building. Then provide and implement a Timber Pest Management Plan as soon as possible.
