# Building and Timber Pest Inspection Report

Inspection Date: Fri, 20 Mar 2026

Property Address: 426 Union Rd, Lavington NSW 2641,  
Australia

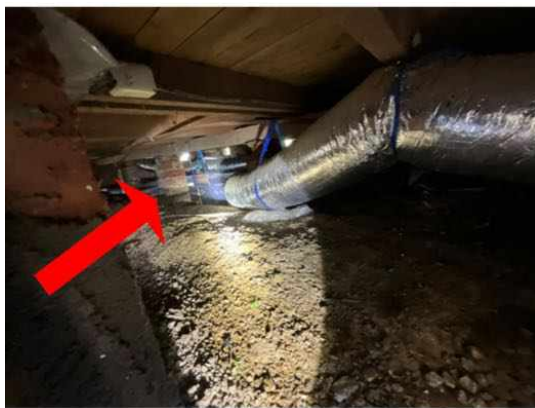
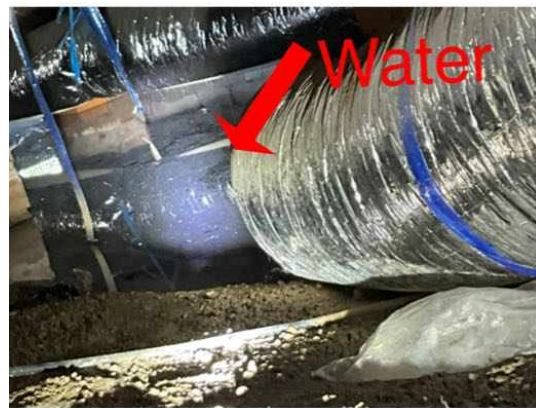
Building: Building 1  
Location: Subfloor  
Finding: Water leak - Active  
Information: Generally, water leaks occur when a particular area of the property is not weather or water tight. As the surrounding area was found to be damp at the time of inspection, the leak is considered ongoing and hence requires urgent action.

Regardless of the location, even minor leaks that are left unmanaged can lead to serious damage of associated building elements and result in the need for replacement of building materials. Mould and other hazards such as electrical hazards may also arise if the leak is left to develop.

A major defect is noted. The sub floor has excessive water pooling in large areas. An active leak must be assumed. A plumber should be contacted immediately to find the leak and make all needed repairs to prevent further deterioration.

It is highly advised that the cause of the leak be identified and resolved immediately by a licensed plumber to prevent any further damage. Depending on the extent of the damage previously sustained, repair and/or replacement of any affected building materials may be required.

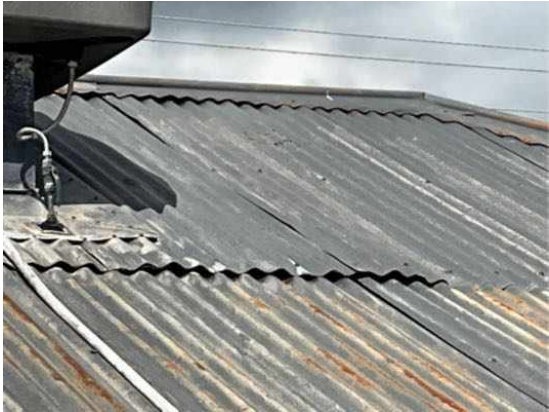
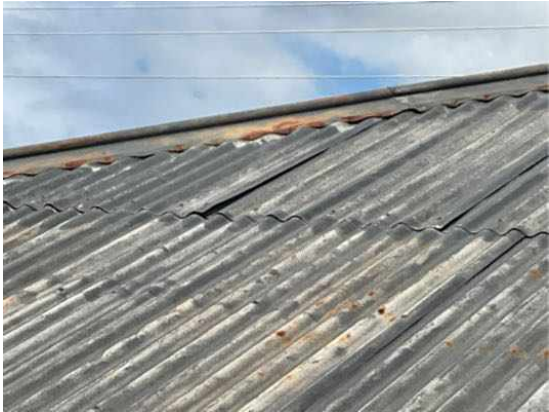
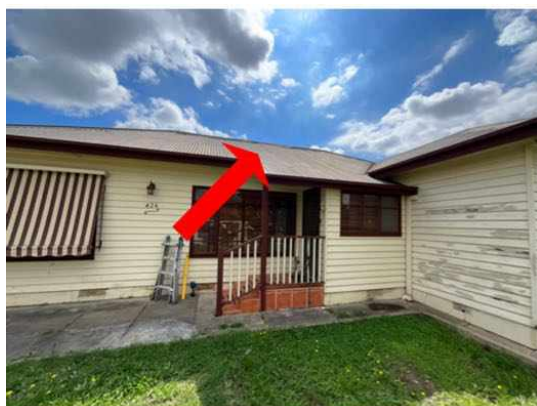
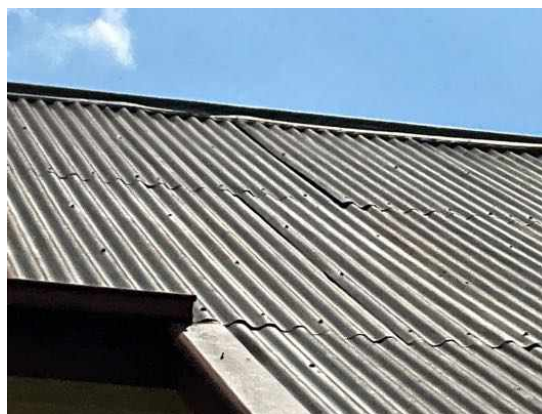
#### Finding 3.01

Finding: Roof sheets - Loose

Information: Upon inspection of the exterior roof covering, it was noted that numerous roof sheets have become loose from their original fixings. It is suspected that this defect has developed as a result of a lack of adequate maintenance, but may also have been caused by inappropriate fixings being used in the construction process.

Loose roof sheeting detracts from the weather tightness of the roof covering, making the internal roofing structure susceptible to water penetration and subsequent damage. If left unaddressed, it is likely that secondary damage to associated building elements will develop, potentially necessitating remedial works to these structures.

A roofing restoration contractor should be appointed to advise on rectification options and on the cost of repair. It is advised that remedial works be performed as soon as possible to prevent any further damage.

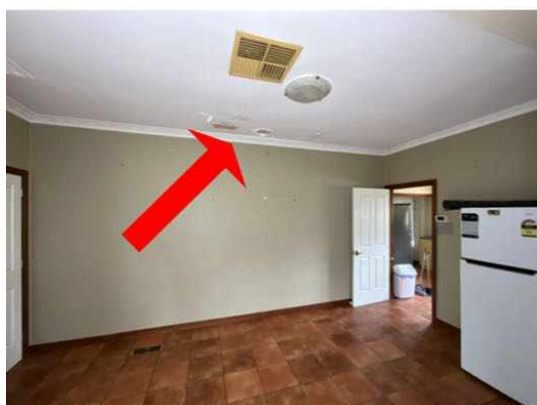
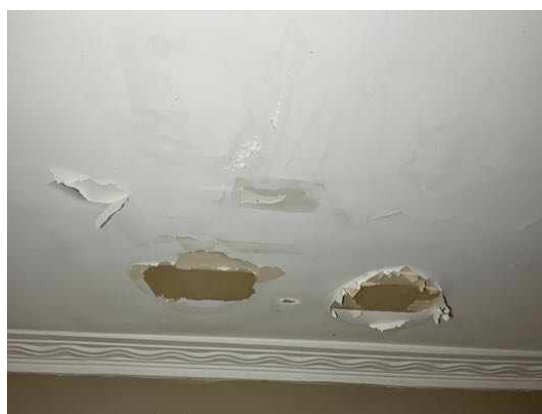
### Finding 3.02

Building:	Building 1
Location:	Family Room
Finding:	Ceiling - Water damaged
Information:	Water damage to the ceiling lining is generally an indication of excessive moisture being present in the roof void, usually via a leak to the roof covering.

Where water damage is evident to the ceiling, the primary requirement is to identify and rectify the source of the leak. A roofing plumber should be appointed as soon as possible to identify the leak and perform rectification works as necessary, ensuring the water damage is restricted.

Once the leak is repaired, consultation with relevant tradespeople, including plasterers and painters, is advised. Rectification works may include replacement of ceiling lining or minor repainting, depending on the extent of the damage.

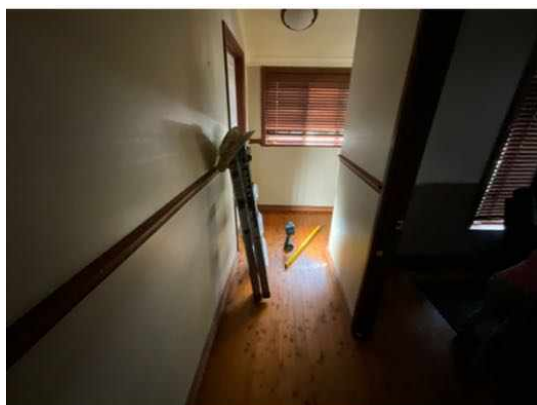
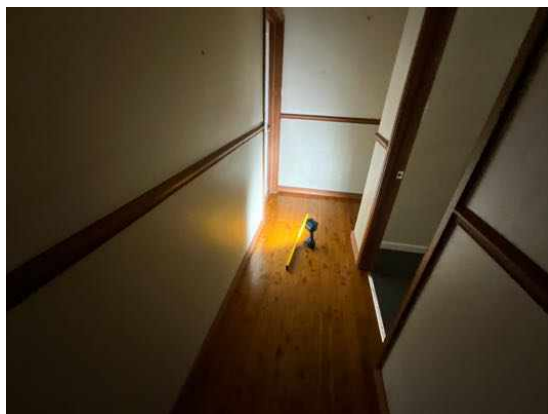
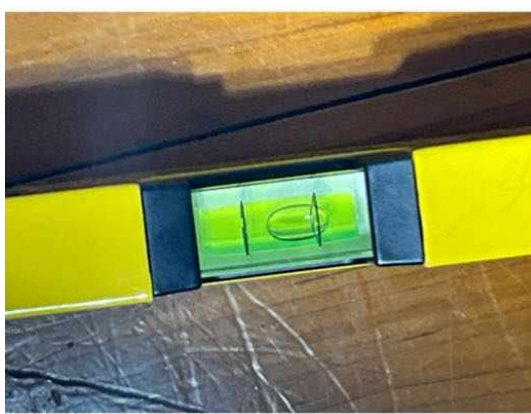
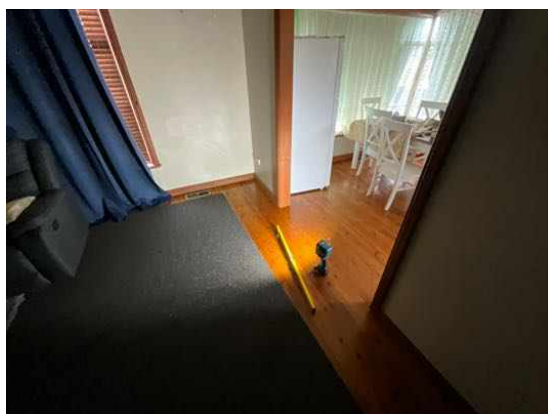
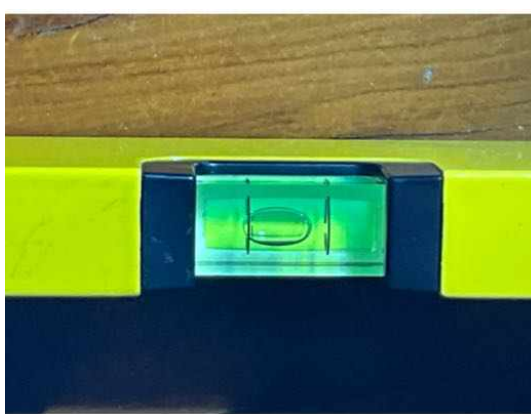
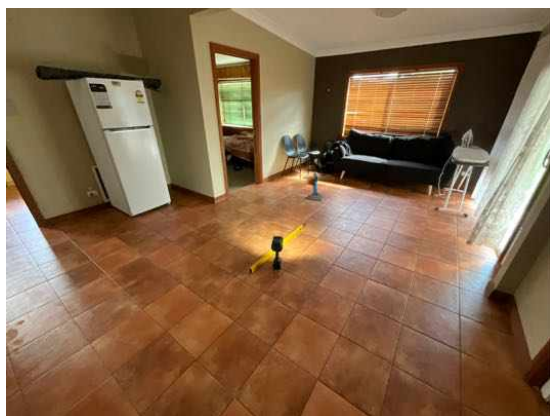
### Finding 3.03

Building:	Building 1
Location:	All Internal Areas
Finding:	Flooring - Uneven
Information:	The internal flooring in this area is out of level and uneven. Uneven flooring is likely to

indicate minor defects such as expected movement of the foundations of the property, but may also indicate subsidence of the associated subfloor stumps.

It is advised that the flooring be closely monitored to identify any further movement. Where flooring remains relatively unchanged for an extended period of time (i.e. several months), it is likely that this defect has been caused by expected movement of the foundations of the property.

However, where flooring is uneven further, potentially invasive inspection of the subfloor structures and stumps in this area is required. In this case, works to repair are likely to be required, and would be carried out by a registered builder specialising in re-stumping.

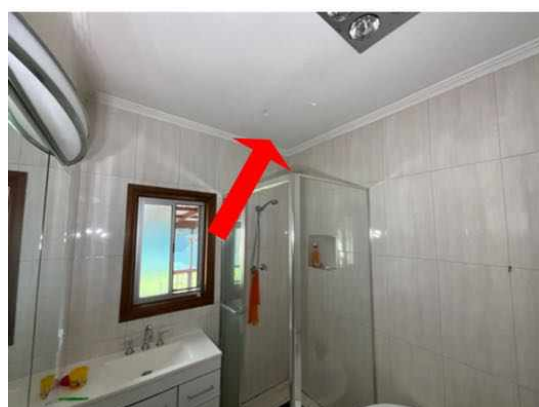
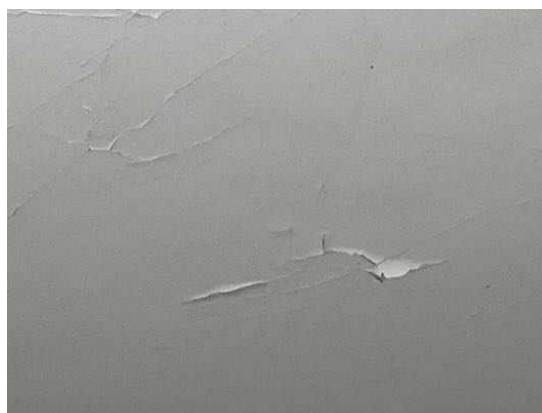
### Finding 3.04

Information: Sections of paint in this area was found to have deteriorated. Paint flaking is generally an indication of excessive moisture in the area, that is currently hidden by the painted surface.

The presence of excessive moisture can have major implications on associated building elements if left unattended. While only seemingly minor at this stage, the damage cannot be determined due to the paint obstructing any further inspection of the damage.

A qualified Painter should be contacted at the Owner's discretion to re-paint the ceiling.

Monitoring is recommended to ensure that a leak is not present in the ceiling when rain occurs. If a leak is suspected then a roofing plumber should be contacted immediately to make any needed repairs.

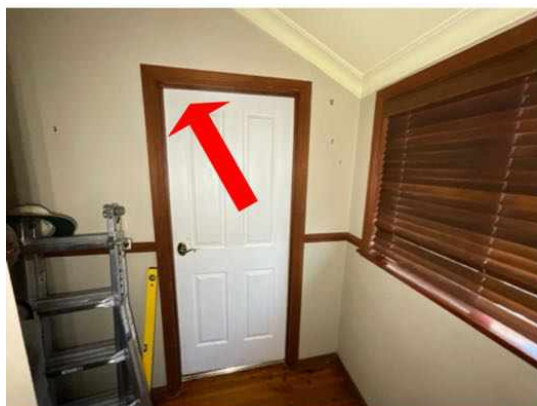
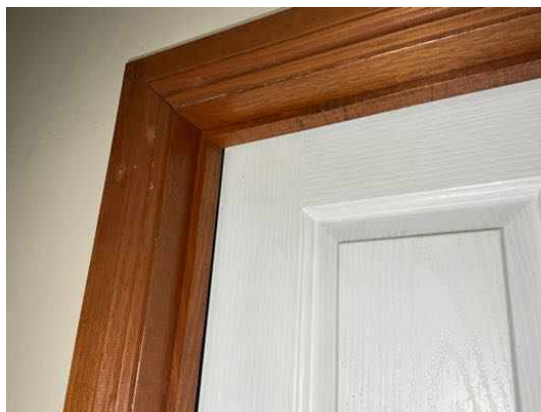
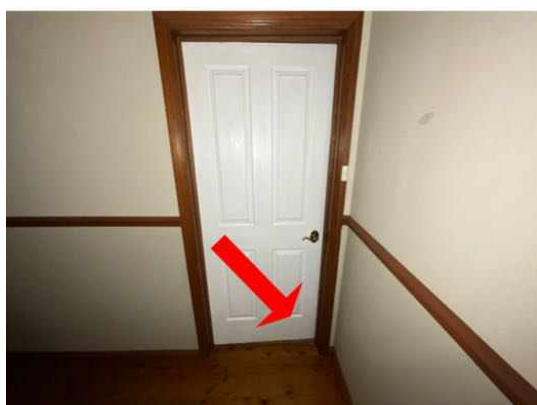
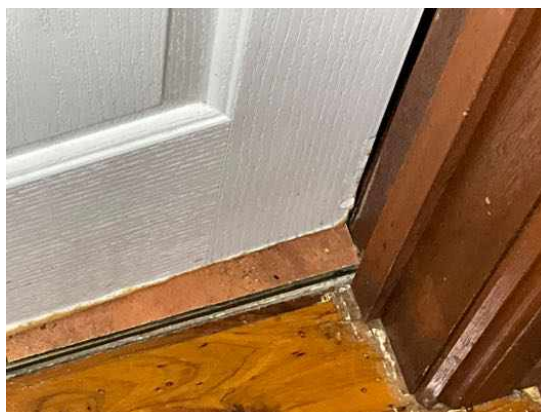
### Finding 3.05

Building: Building 1  
 Location: Bedroom - Master, hall  
 Finding: Door- Binding/jamming  
 Information: Binding and/or jamming of this door is evident during standard operation. This defect inhibits the functionality of the affected door as well as creating potential for secondary defects to associated building elements, such as damage to the floor covering.

A qualified carpenter or general handyperson should be appointed to perform minor rectification works at client discretion.

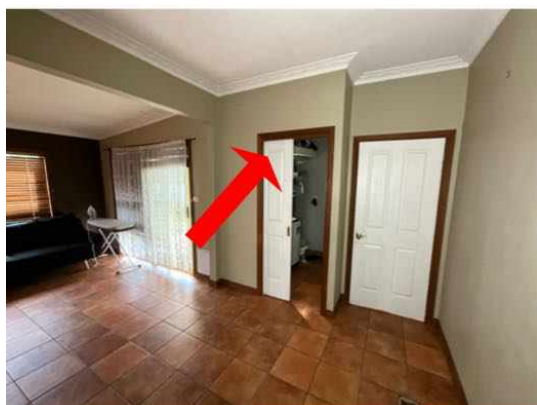
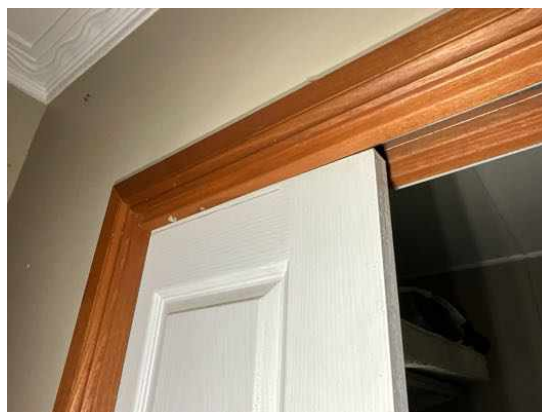
### Finding 3.06

Building: Building 1  
 Location: Laundry  
 Finding: Door- Stiff to slide  
 Information: The door in this area was jammed and difficult to slide along the associated tracks at the time of the inspection. Restricted function of the affected door may pose as a potential safety hazard if required for emergency egress from the building.

Generally, factors such as general age of the building element and a lack of maintenance are the usual causes for this type of defect.

Replacement of door hardware or tracks may be required, as well as minor repairs

and cleaning. A registered builder or general handy person will be required to repair the affected doors.

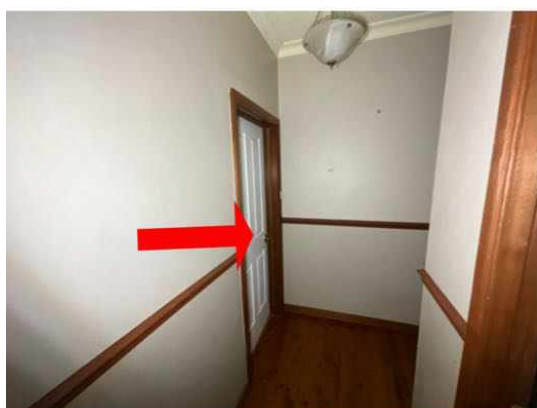
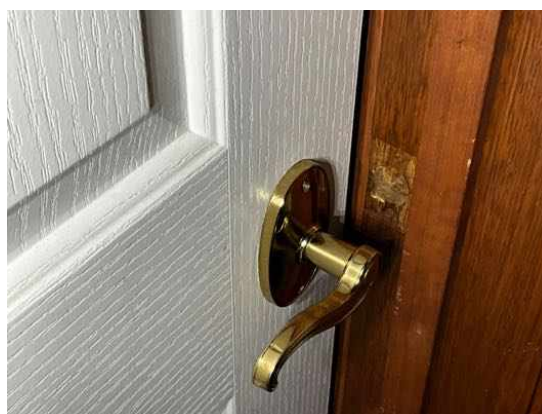
### Finding 3.07

Building:	Building 1
Location:	Hall
Finding:	Door - Striker plate misaligned
Information:	The striker plate to this door appears to have become misaligned and has consequently resulted in the door's operation being compromised.

This is a common defect and is expected in a property of this age, whether being due to substandard installation or general deterioration of the door hardware.

Readjustment of the striker plate is recommended at client discretion. Works such as these can be completed by a general handyman or qualified carpenter.

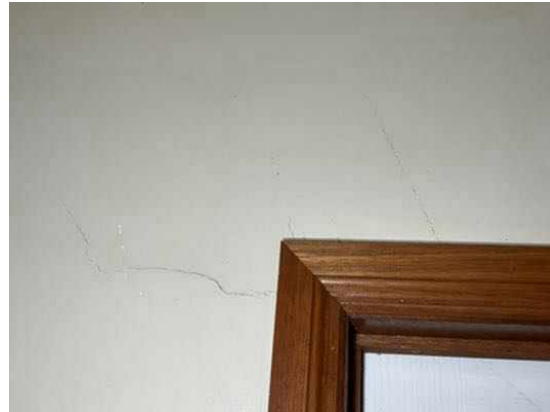
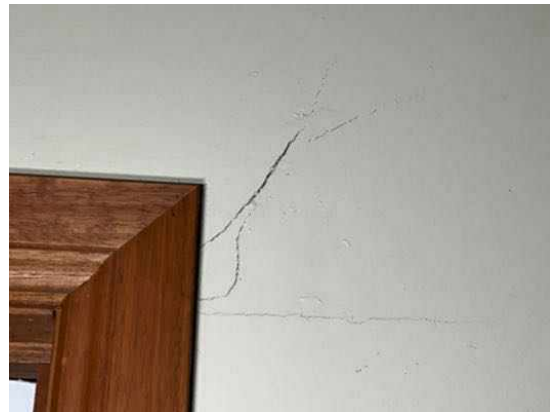
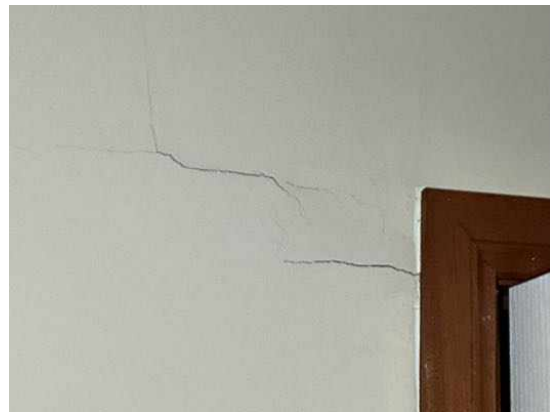
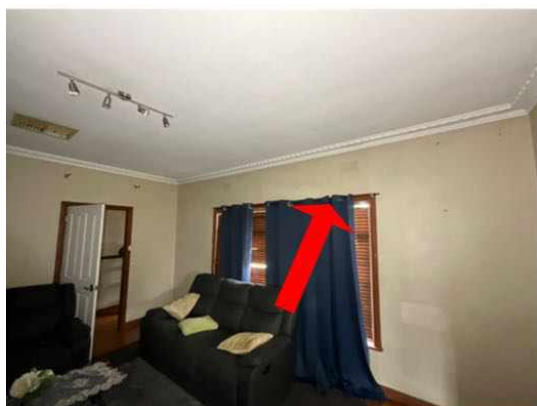
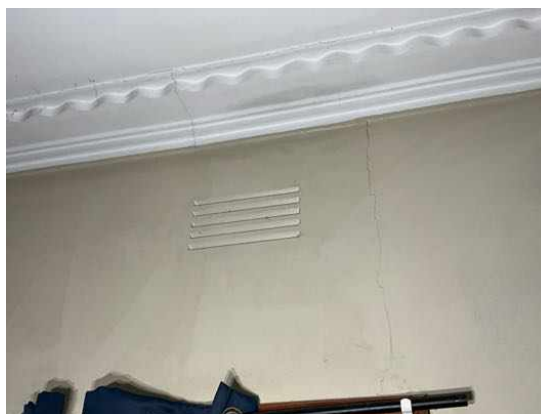
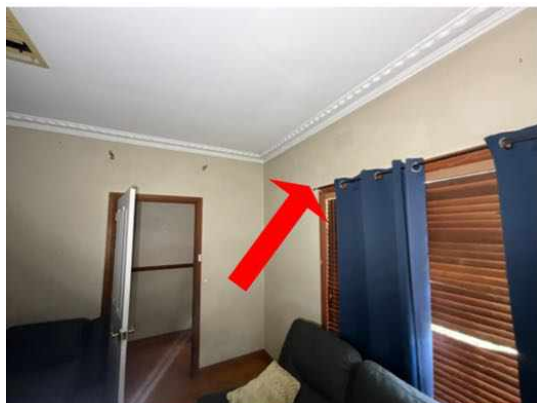
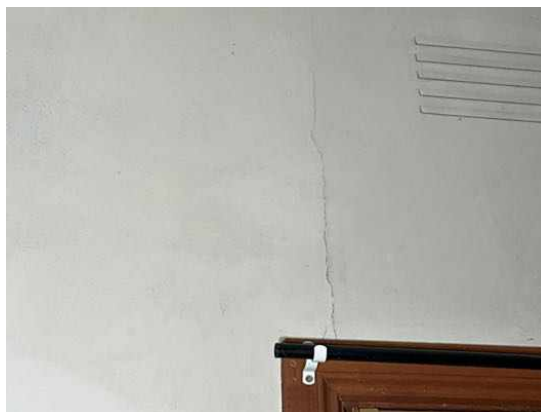
### Finding 3.08

Building:	Building 1
Location:	Hall, bed 2, living
Finding:	Cracking - Damage Category 1 - Fine (up to 1mm)
Information:	Although fine cracks are quite noticeable, they are often only considered to be an

appearance defect, and usually do not indicate any structural damage. Generally, the cause of a fine crack is indicative of a separation between building materials and finishes (e.g. paint, plaster, etc.) along joints.

Cracking of this nature can generally be repaired with minor sanding, filling and/or repainting. Such works should be performed by a qualified painter or a general handyman.

Monitoring of all cracking should be conducted frequently. Always contact a building inspector should cracks widen, lengthen, or become more numerous.

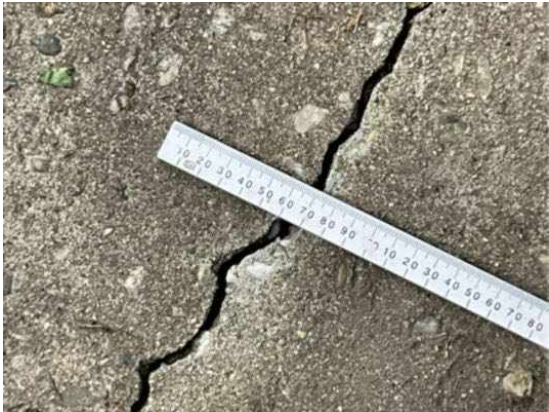
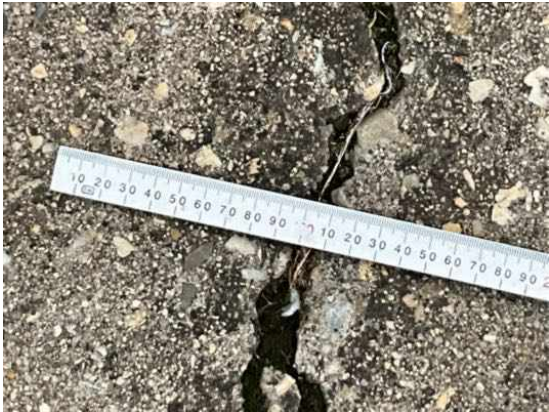
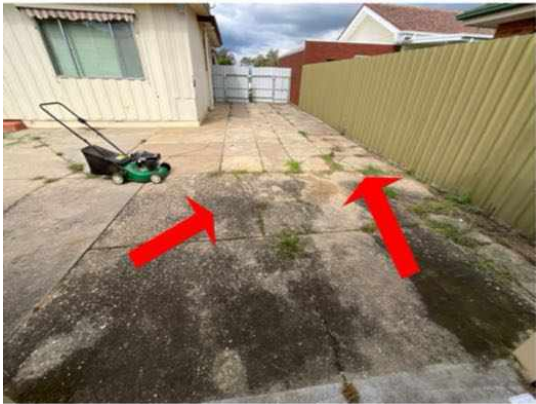
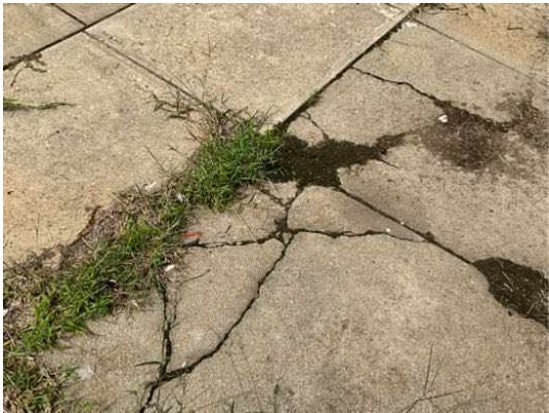
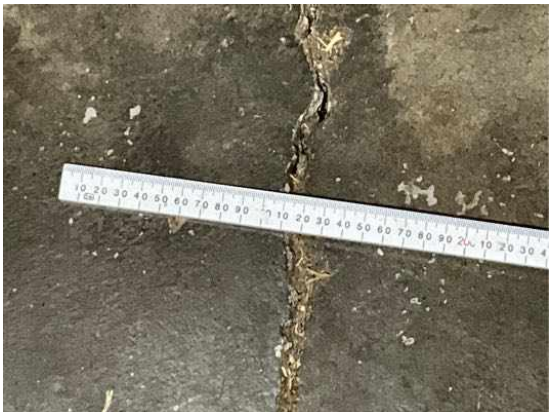
### Finding 3.09

Building:	Building 1
Location:	Yard - Back, driveway, garage
Finding:	Cracking - External Concrete Paving Damage Category 3 - Wide Cracks (2mm - 4mm)
Information:	Wide cracks were identified in external concrete paving. Wide cracks are significant and are likely to lead to the development of safety hazards and secondary defects if left unmanaged.

General age and expected deterioration of the paved areas is a common cause of this type of cracking. However, expansion and contraction of the slab may also have occurred due to environmental factors. Such factors include variable moisture and weather conditions, the presence of trees and their roots having a settling or lifting affect on the soil, or the effect of load bearing, e.g. heavy vehicles over a sustained period of time.

Cracking to this degree may also be due to poor original installation of the concrete. Factors such as poor compaction of the sub surface and/or inadequate reinforcing of the slab may create cracking and other secondary defects. Wide cracks may also have a more significant structural cause, such as subsidence of soils.

Where the crack is located adjacent to structural elements of the building, the advice of a Structural Engineer is advisable before undertaking repairs. Significant repair and likely replacement of the concrete paving is probable.

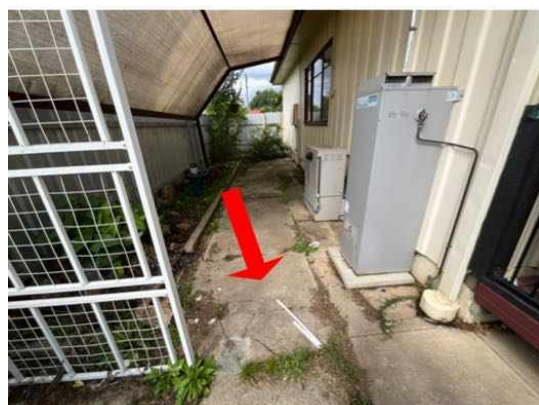
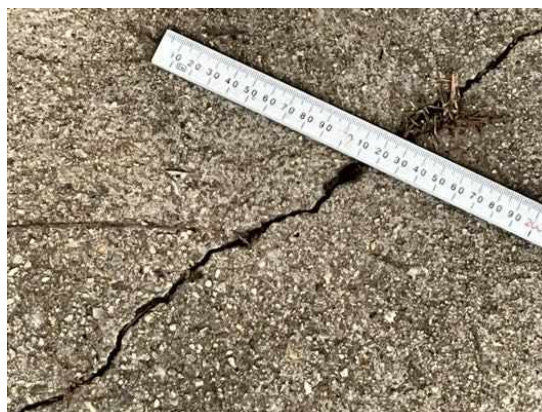
### Finding 3.10

Building:	Building 1
Location:	Yard - Back
Finding:	Cracking - External Concrete Paving Damage Category 1 - Fine (less than 2mm)
Information:	Fine cracks were identified in external concrete paving. Although fine cracks are quite noticeable, they are often only considered to be an appearance defect, and usually do not indicate any structural damage. To be considered a Category 1 or fine crack, the crack is found to be less than 2mm in width.

Generally the cause of a hairline crack in existing concrete paving such as driveways and pathways is indicative of the expansion and contraction of the concrete. Such causes are generally due to environmental factors, such as moisture levels, weather conditions, root systems of nearby trees or the soil types on which they are laid.

Fine cracks may also be due to poor original installation of the concrete. Factors such as poor compaction of the sub surface and/or inadequate reinforcing of the slab may create cracking and other secondary defects.

Monitoring of all cracking should be conducted frequently. Always contact a building inspector should cracks widen, lengthen, or become more numerous.

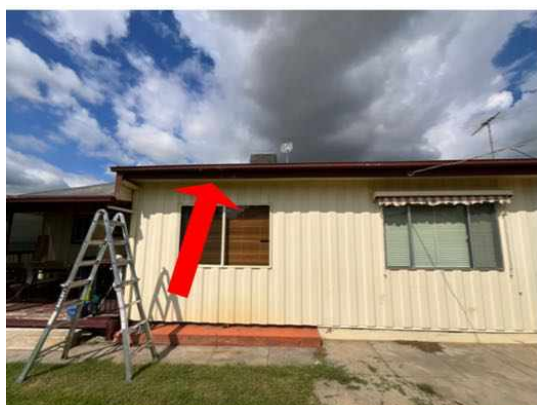
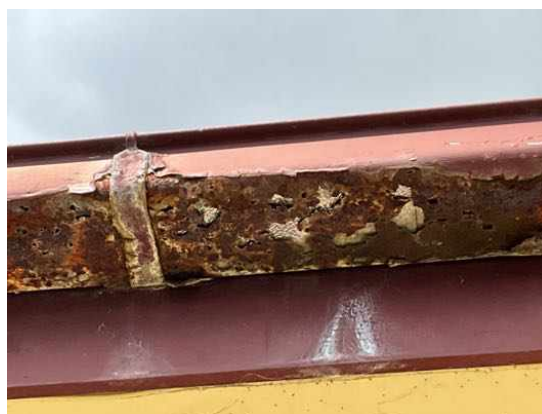
Building: Building 1  
 Location: Eaves  
 Finding: Gutters- Deteriorated  
 Information: The guttering and some downpipes have deteriorated.

Although not a major problem now, they will deteriorate further if left for an extended period.

Sagging can be seen in the gutter.

A Licensed Plumber should be engaged as soon as possible to advise on any repairs or maintenance that may be required.

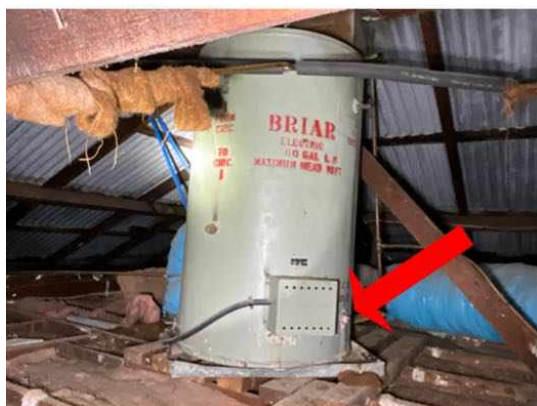
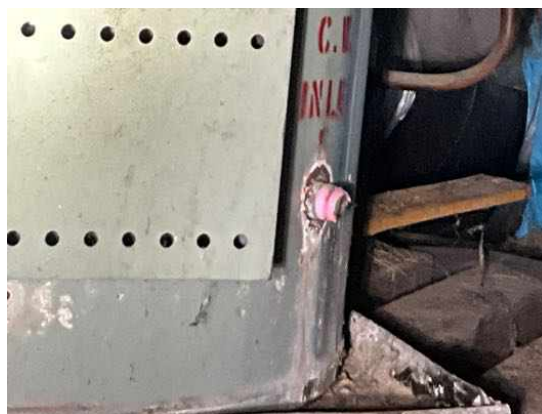
### Finding 6.02

Building: Building 1  
 Location: Roof Void  
 Finding: Gravity-Fed HWS - Disconnected  
 Information: It was noted at the time of inspection that a disconnected gravity-fed hot water system (HWS) remains in this area.

Despite this plumbing structure being unused, it is likely to be storing residual water, and is therefore susceptible to rust and corrosion. If allowed to continue, rust and corrosion is likely to lead to damage to adjoining building elements, and may also make the area susceptible to termite or timber pest activity.

While it is a costly exercise to remove the disused gravity-fed HWS, it is advisable in the short-term future to prevent any further damage to the area. Further consultation with a licensed plumber is required to gain further advice on removal of the structure.

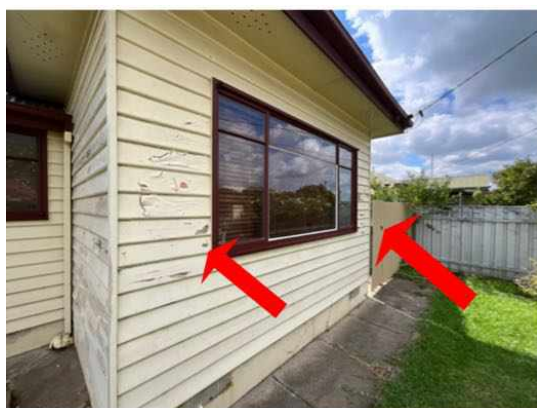
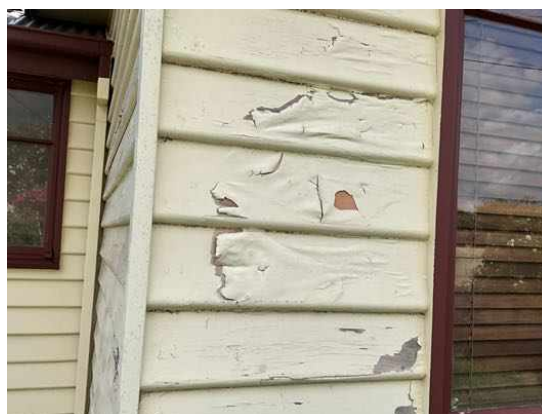
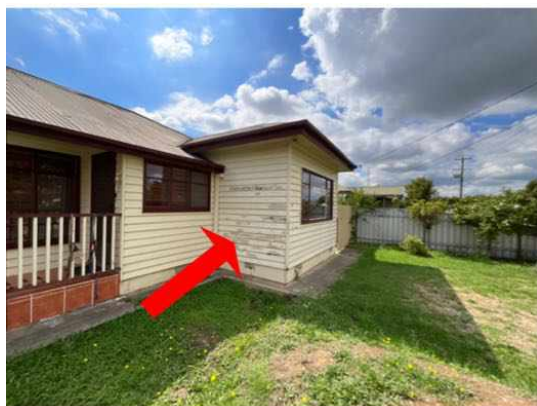
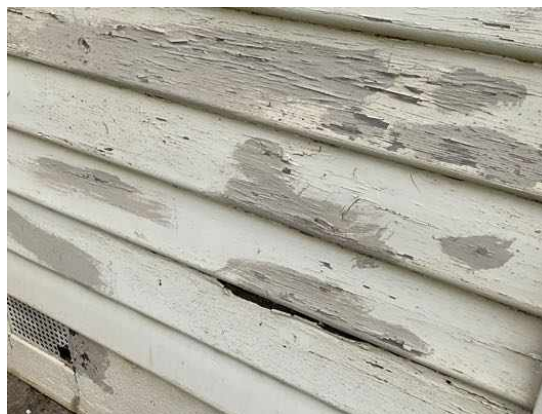
### Finding 6.03

Building:	Building 1
Location:	All External timber
Finding:	External painting deteriorated
Information:	Much of the external paintwork including but not limited to windows, fascias, guttering, veranda and other external fitments have been neglected and require attention to prepare and re-paint.

Whilst incomplete or missing paint finish is generally an appearance defect, it can also lead to the development of secondary building defects over time. Incomplete areas of paint finish expose the area to moisture, potentially accelerating the deterioration of underlying building materials.

Degraded paint finishes should be sanded back, filled, leveled and painted, as applicable. Where inadequate or missing paint protection has led to the deterioration of the associated building element, repair and/or replacement of this building element may be required.

A painting contractor should be appointed as soon as possible to perform necessary works to aid the appearance of the affected area and to ensure the area is protected against further deterioration. Alternatively, the homeowner following manufacturer instructions may perform these works.

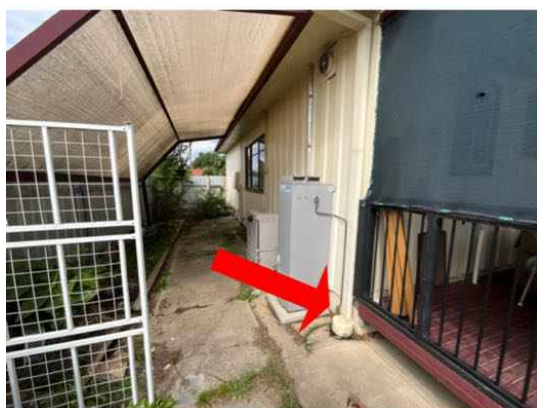
### Finding 6.04

Building: Building 1  
 Location: Yard - Back  
 Finding: HWS Overflow - Not Connected  
 Information: The Hot Water System (HWS) overflow was found to be disconnected from storm water drainage and is creating excessive moisture in the surrounding area.

These damp conditions can lead to secondary defects such as rot, rust or corrosion of associated building elements, the formation of fungal decay, or even the creation of potential slip hazards. When coupled with poor site drainage, pooling of water may also attract termite activity to this area.

It is highly recommended that a licensed plumber be appointed to connect the HWS overflow in order to prevent such an environment from being created. These minor works should be carried out as soon as possible.

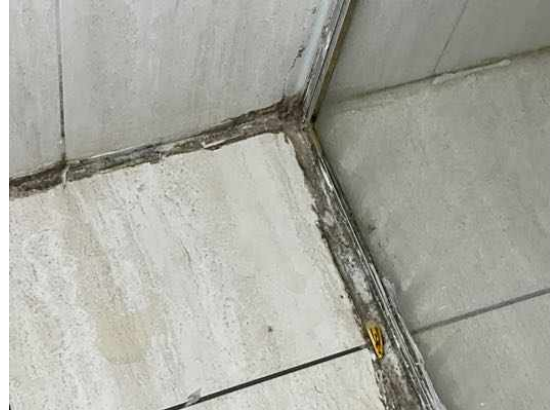
### Finding 6.05

Building: Building 1  
 Location: Bathroom  
 Finding: Inadequate sealant or Grout  
 Information: This area has a lack of effective Sealant or Grout. This is allowing the ingress of water

The presence of water encourages Termite attack, Mould and Fungal Decay.

A Tiler or General Handy person must be contacted as soon as possible to effect repairs and prevent further deterioration.

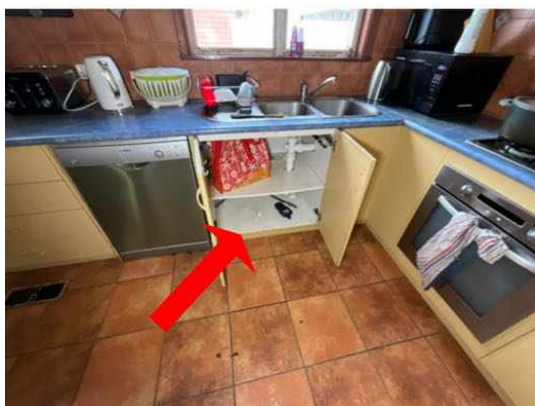
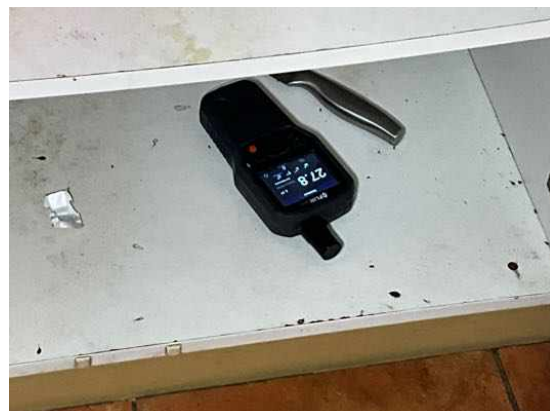
### Finding 6.06

Building:	Building 1
Location:	Kitchen
Finding:	Evidence of moisture- present
Information:	Excessive moisture can attract termites and produce conditions that promote termite attack, fungal growth and wood decay.

In this case the trap may be leaking.

This area should be monitored for any increase in moisture levels.

If mould or cracking damage increases, appropriate trades should be contacted to make all needed repairs/ restoration.

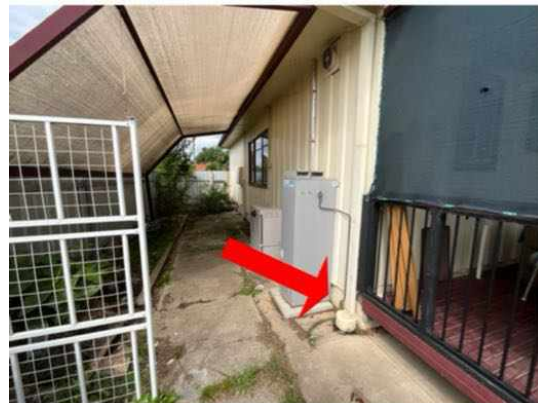
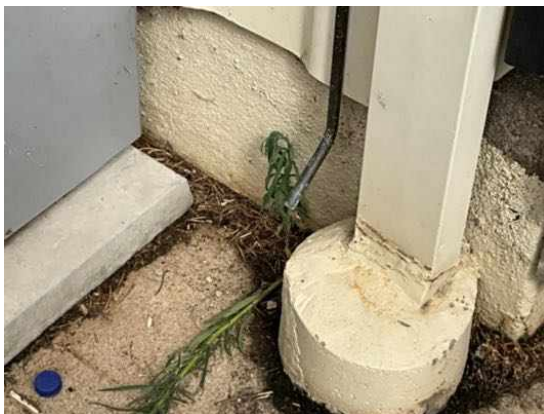
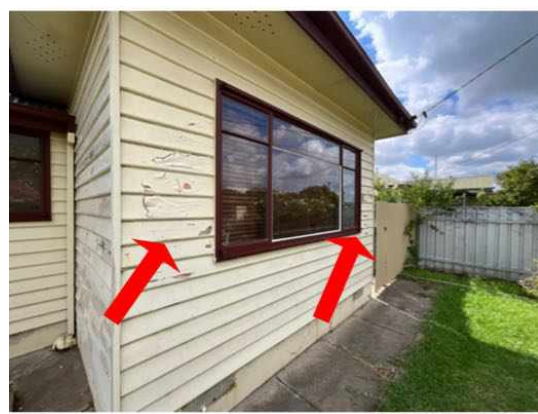
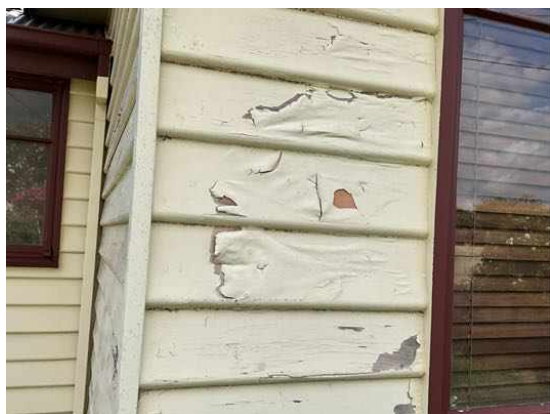
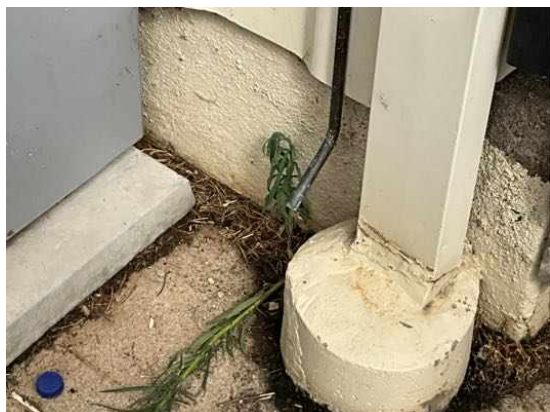
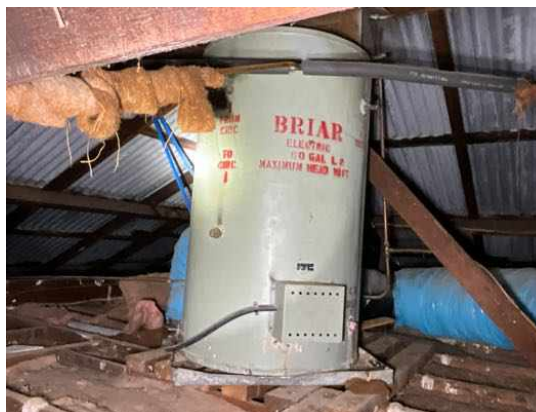
### Finding 6.07

Building: Building 1  
Location: All External Areas  
Finding: Termite Management System - no evidence of a chemical installation  
Information: The application of a post-construction chemical termite barrier is highly recommended for all properties, particularly if live termite activity has been found on the site previously. Such barriers are highly effective in preventing termite attack on any timber building elements throughout the property.

A durable notice should be placed in the switchboard unit to indicate current termite barriers. At the time of inspection, it appeared as though no termite management system has been installed, with no evidence to suggest preventative works taking place.

There is no evidence of previous Termite Management services. The property has factors that are Conducive to Termite attack. A Licensed Pest controller should be contacted soon to advise on a Termite Management Plan and avoid potentially costly repairs.

The client may consider gaining further advice from a pest controller as to the costs and procedures involved with this application. It is recommended that obtaining such advice be a short-term priority.

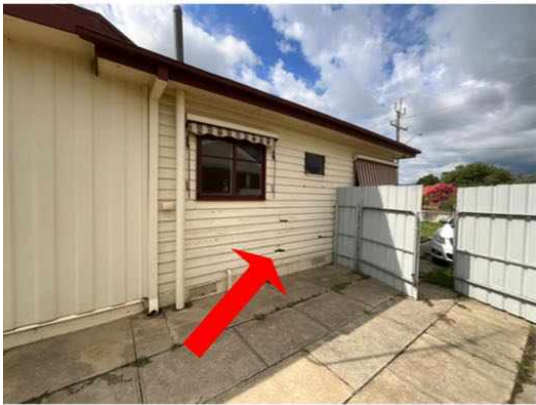
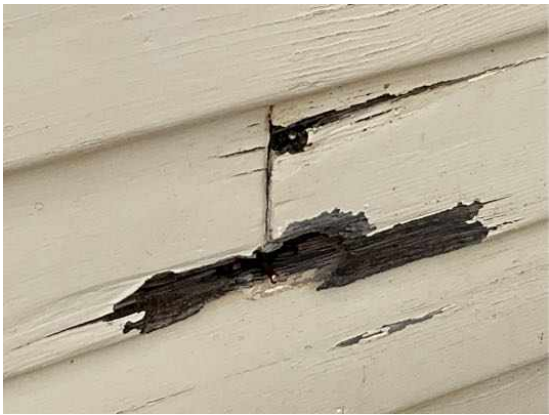
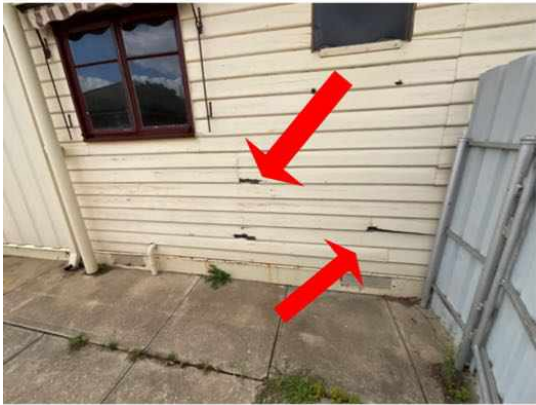
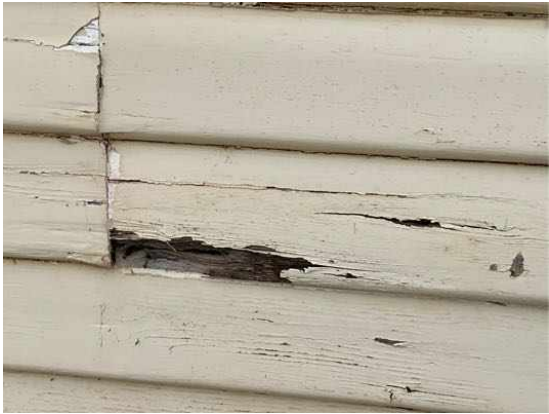
### Finding 7.01

Building:	Building 1
Location:	Weatherboards
Finding:	Fungal decay - present (localised)
Information:	Fungal decay also known as wood decay or wood rot generally refers to the deterioration of timber elements when in contact with excessive levels of moisture for a prolonged period of time.

The development of fungal decay is accelerated by temperatures in the range of 5degreeC to 40degreeC as well as the presence of oxygen. Generally fungal decay develops on timber elements that are in use in an external environment which are exposed to rain penetration.

In this case although the affected timber element is in a decaying state the extent of any visible damage appears to be localised to a specific area and is yet to spread to other parts of the building element or affect adjoining structures. The fungal decay is therefore likely to be of a relatively superficial nature with minimal impact on the structural integrity or tensile strength of the timber element.

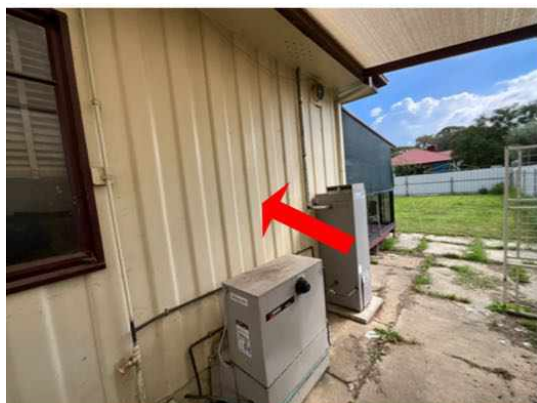
The presence of potentially Asbestos containing material is noted. Asbestos testing is outside the scope of this inspection. An Asbestos testing specialist should be contacted if confirmation is required. In the interim, care should be taken if any renovation work is undertaken.

Building: Building 1  
Location: All Areas  
Finding: Asbestos - Suspected ACM Identified on Site  
Information: Reporting on Asbestos is outside the Scope of this Report. This suspected defect is highlighted as a caution only. We suspect, based on our experience in the building industry, that there is a higher risk of the identified building element containing asbestos.

As Asbestos Reporting is outside the scope of this report, we advise that you consider a separate Asbestos Inspection and Condition Audit, which can include the taking of samples for definitive confirmation of the presence of Asbestos.

In the interim, the client is advised to act with caution, especially when considering any damage to building materials general wear and tear renovations extensions demolition and general maintenance activities due to the suspected presence of Asbestos.

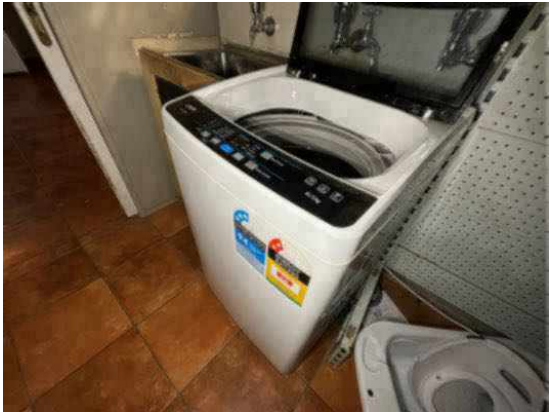
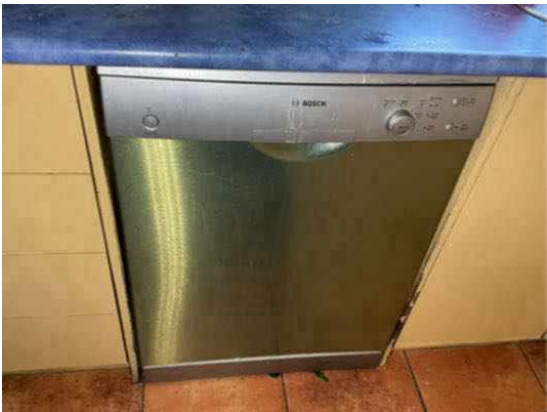
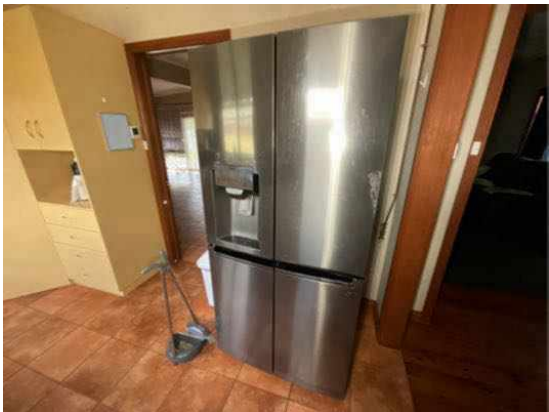
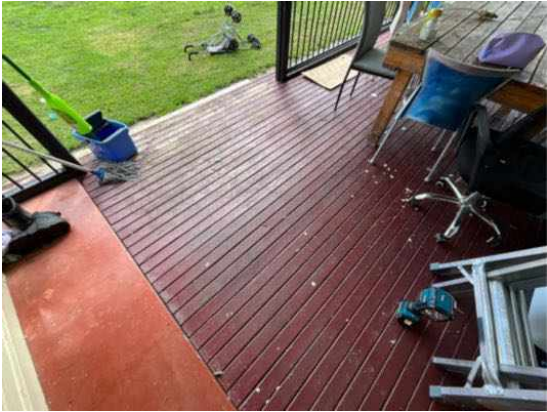
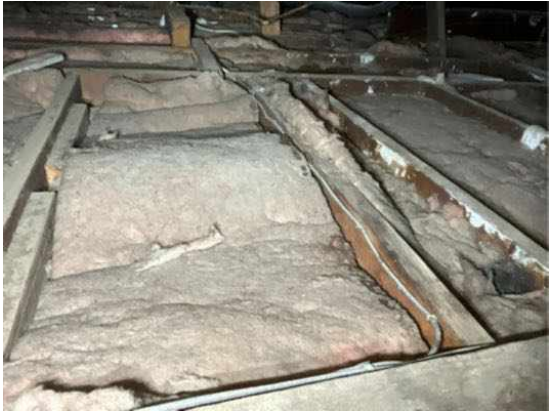
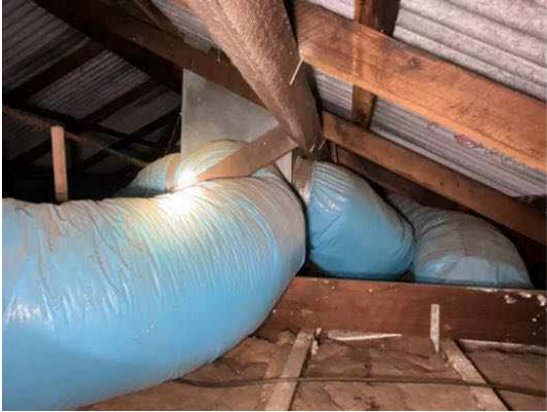
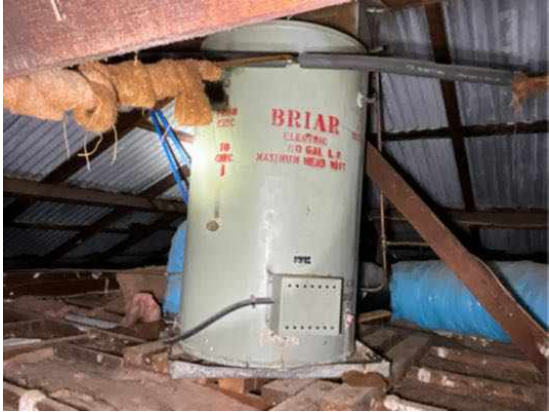
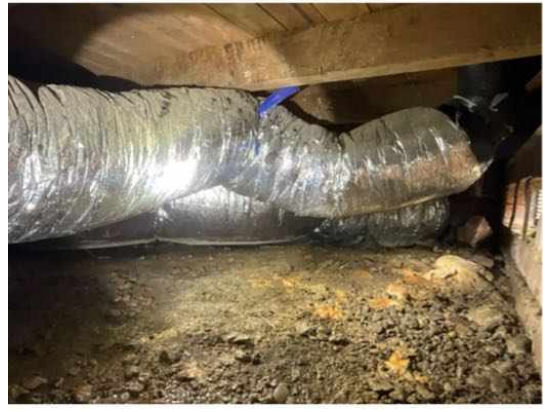
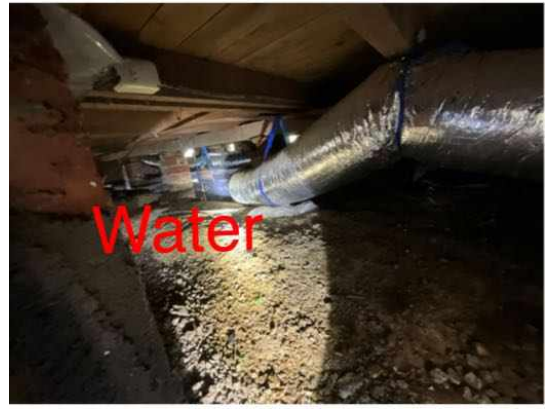
Building: Building 1  
Location: All Areas  
Finding: Additional Photos - Obstructions and Limitations  
Information: These photographs are an indication of the obstructions and limitations which impeded full inspection of the property at the time of inspection. These obstructions can hide an array of defects and should be removed to allow full inspection to be carried out. A re-inspection is recommended once the areas are made accessible.
