## Building Inspection Report

Inspection Date: Fri, 27 Mar 2026

Property Address: 1/68 Heyington Ave, Thomastown VIC 3074,  
Australia

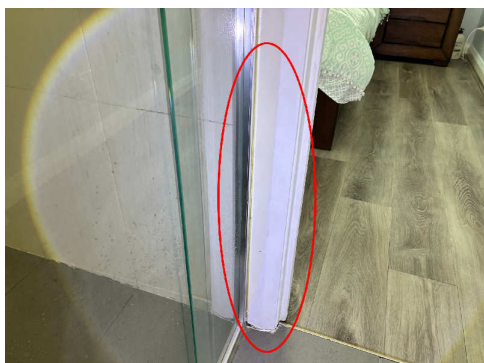
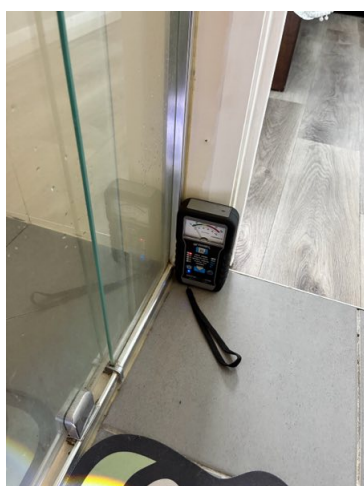
#### Defects 3.01

Location: Ensuite - Master

Finding: Shower external - Water damage

Information: At the time of inspection, water damage was apparent to the door architrave side of the shower. The shower did not appear to be currently leaking and damage could be pre-existing. It is suspected that the leaking could have occurred as a result of shower not being sealed correctly.

Water leaking from the shower, where left unattended, is likely to lead to water damage to adjoining flooring and walls. Such damage can lead to water damage and necessitate extensive remedial works being required. Active water leaks may also create an environment that is susceptible to the formation and development of mould.

Flexible and mould resistant materials should be applied to affected areas to prevent any subsequent water damage that is likely to occur. Regular maintenance and replacement of damage or missing or damaged sealant and grout is highly recommended to the wet areas, as this is a regular wear and tear defect.

It is advised that these areas be monitored and if there is signs of water leaking, a sealant specialist or shower screen contractor should be appointed to complete these works immediately. It is also advisable that a qualified carpenter or general handyperson be engaged to repair damaged materials.

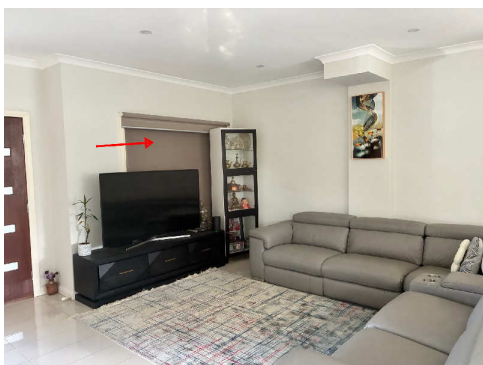
### Defects 3.02

Location: Lounge Room

Finding: Flyscreens - Missing

Information: At the time of inspection the flyscreen was found to be missing to the top Lounge room window. Whether the flyscreens has not been installed or have been removed post-installation, this missing building element detracts from the operational state of the window.

Where not replaced, missing flyscreens allow pest and insect ingress into the adjoining room/s.

It is advised that all missing building elements be replaced in order to ensure the full function of all building structures.

A general handyperson may be appointed to replace flyscreens at the discretion of the client.

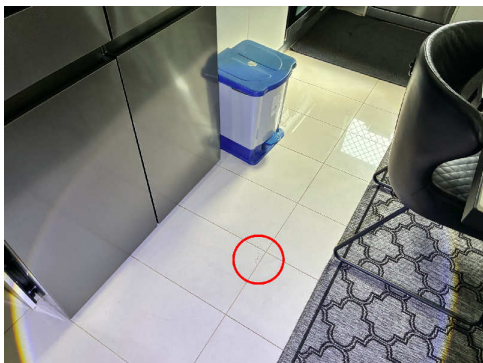
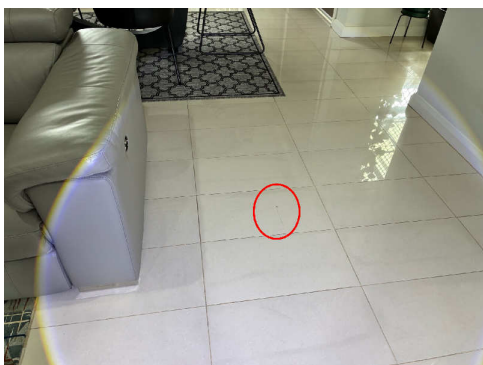
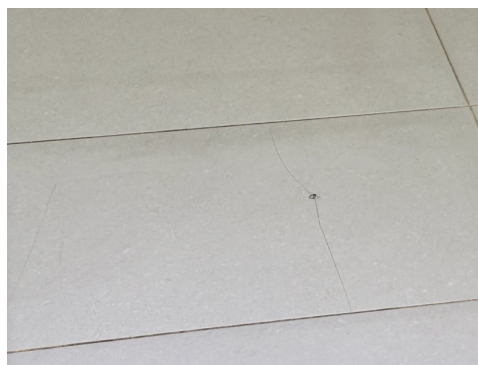
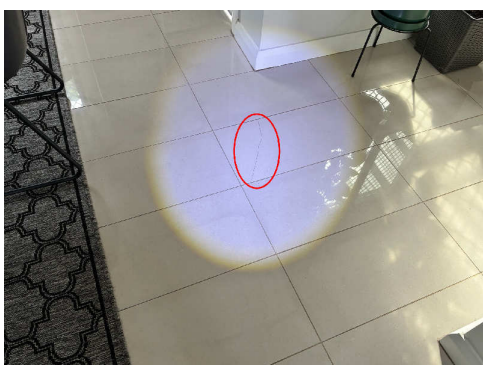
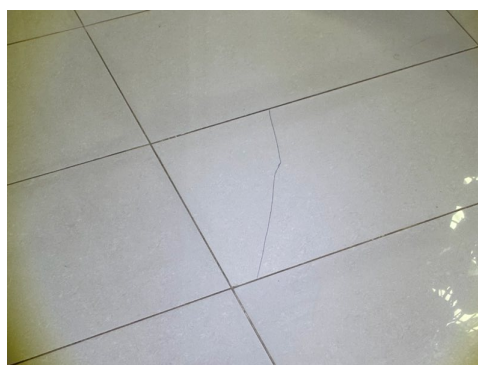
### Defects 3.03

Location: Lounge Room, Kitchen Area

Finding: Cracked floor tiles

Information: At the time of inspection cracking in the floor tiles was evident Lounge and Kitchen area. It is suspected that this cracking has occurred as a result of minor impact damage.

Cracked tiles throughout the household detract from the overall appearance of the affected areas however it is unlikely to create or lead to any secondary defects.

While not considered a matter of urgency, replacement of cracked floor tiles is recommended at the clients discretion.

A tiling contractor may be appointed to perform these works. Where cracks become more numerous, contact a licensed building inspector for further investigation.

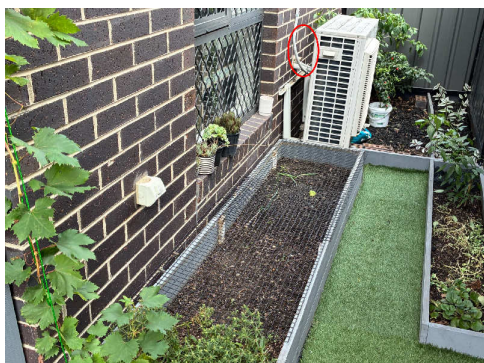
### Defects 3.04

Location: Rear Yard

Finding: Air conditioner - Disconnected overflow

Information: The Air Conditioner (A/C) overflow to the A/C unit in the rear yard was found that the overflow is not connected to a storm water drainage point and is creating excessive moisture in the surrounding area.

Such leaking creates an environment which is conducive to an array of defects, including water damage to associated building elements and the attraction of termite or timber pest infestation.

It is highly recommended that a licensed plumber be appointed to connect the A/C overflow in order to prevent such an environment from being created. These minor works should be carried out as soon as possible.

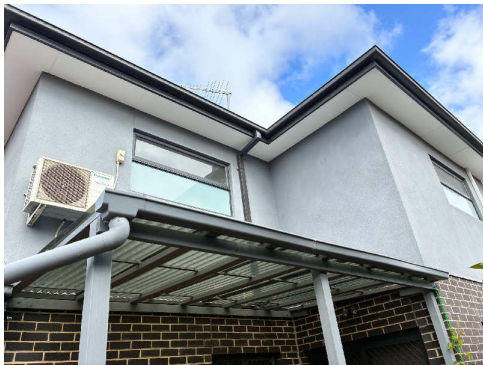
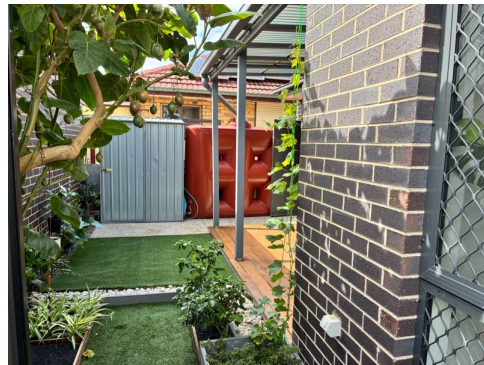
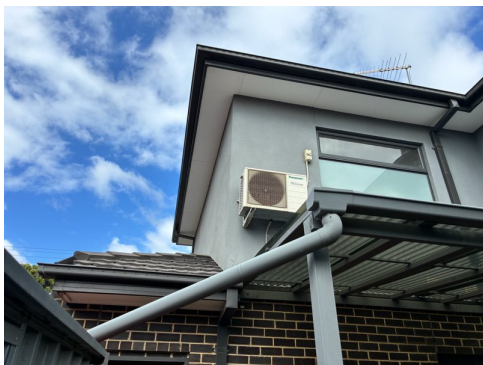
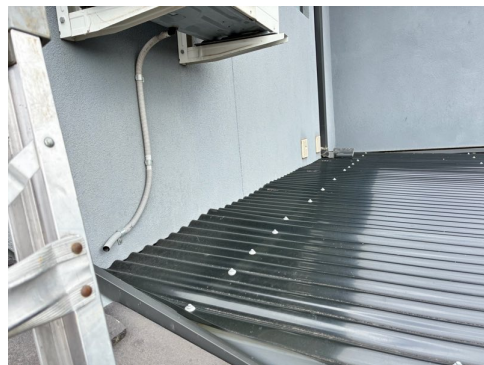
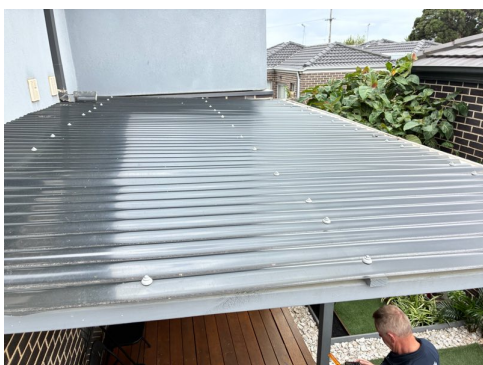
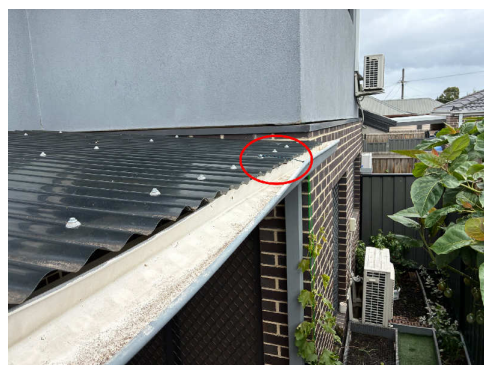
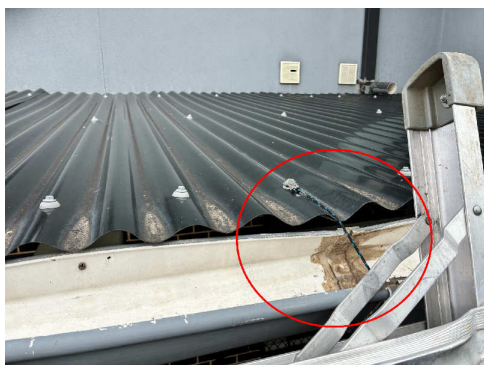
### Defects 3.05

Location: Rear Yard

Finding: Pergola Structure is Suspected to be Constructed Post handover

In addition, the guttering servicing the pergola was observed to have inadequate fixing brackets securing it to the main structure.

The lack of sufficient fixings increases the likelihood of the guttering becoming loose or collapsing, particularly during heavy rainfall or high wind conditions, which may result in damage or pose a safety risk.

☒ It is recommended that a licensed roofing plumber be engaged as a matter of priority to assess and rectify the guttering installation.

Works should include installing adequate fixing brackets in accordance with standard practice and manufacturer requirements to ensure the guttering is securely supported and able to function as intended.

The purchaser may wish to seek further information from the vendor or the relevant authority to confirm whether a building permit was required for the pergola and whether appropriate approvals were obtained.

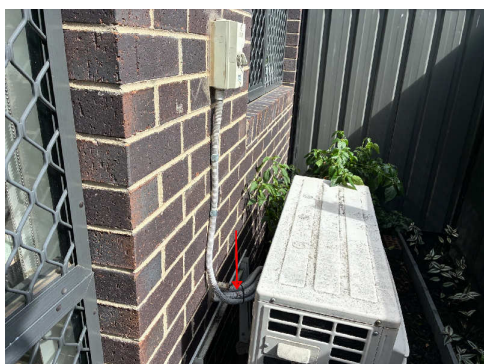
### Defects 3.06

Location: Rear Yard

Finding: Ground floor Condenser Electrical Conduit Deteriorated

Information: At the time of inspection, external cabling was observed to be enclosed within flexible corrugated conduit; however, sections of the conduit and protective sleeving appear to be deteriorated. The installation does not appear to provide consistent mechanical protection along the full length of the cabling.

Where conduit or sleeving is damaged, unsupported, or degraded, the underlying cables may be exposed to physical damage, UV degradation, and moisture ingress.

☒ It is recommended that a licensed electrician or air conditioner contractor inspect and where necessary, damaged or deteriorated conduit and sleeving should be replaced.

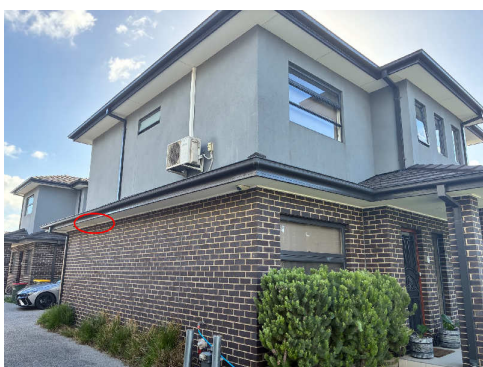
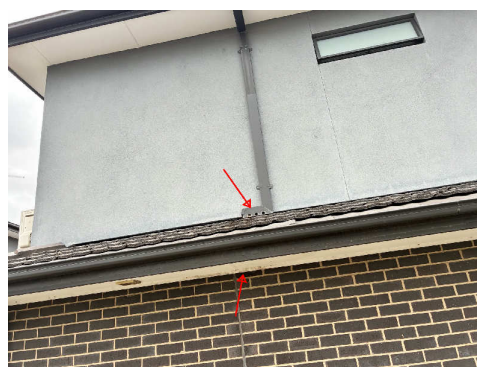
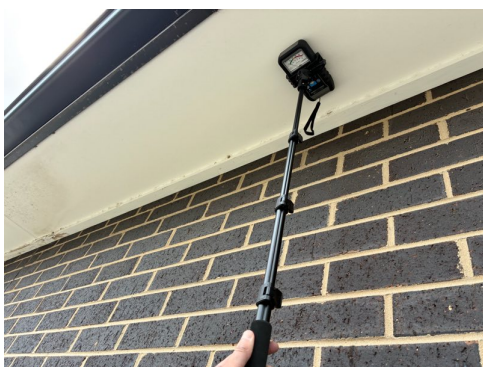
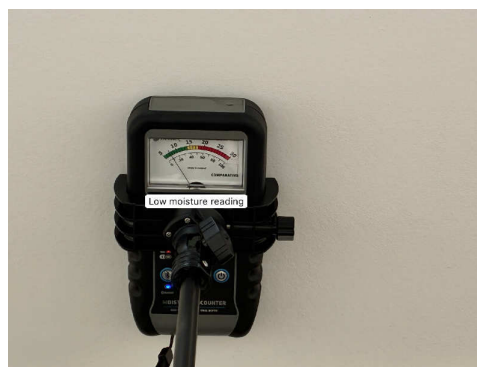
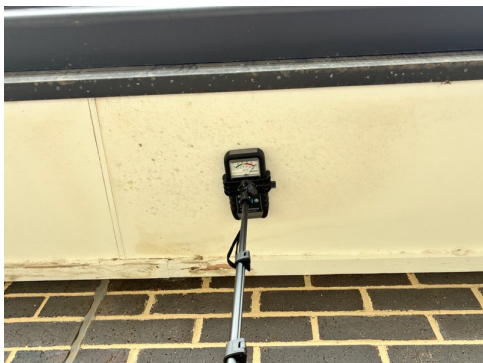
### Defects 3.07

Finding: Eave Linings - Water stained

Information: At the time of inspection water staining to eave linings to the left hand side of the dwelling was evident. Water staining indicates that surfaces have been exposed to excessive moisture over time. The minerals and other elements in the water lead to staining, which may graduate to corrosion and deterioration if left unmanaged.

It is suspected that the downpipe spreader above when raining may have caused water to get in under the roof tiles. While mostly an appearance defect, water staining can be indicative of more serious defects, which may be currently concealed by interior ceilings.

It is suspected that water staining is active and highly advise a licensed roof plumber consulted as soon as possible to identify the cause of the staining and to provide advice on any reparation works that may be required.

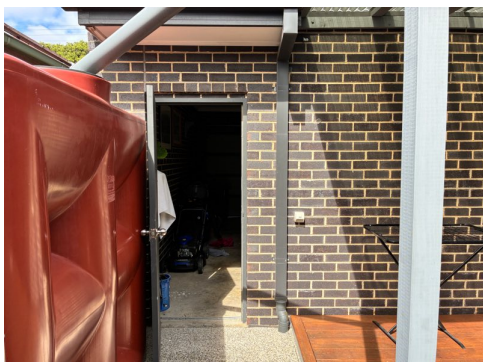
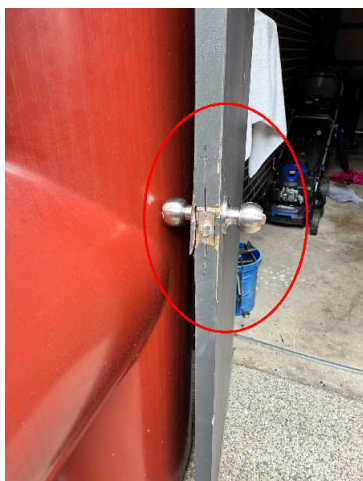
### Defects 3.08

Information: At the time of inspection the Rear Garage access door is Binding and jamming during standard operation. This defect inhibits the functionality of the affected door as well as creating potential for secondary defects to associated building elements, such as damage to the door frame.

It is suspected the door has been damaged due to weather and moisture has affected the door.

It is recommended that a qualified carpenter or general handyperson should be appointed to replace the door at client discretion.

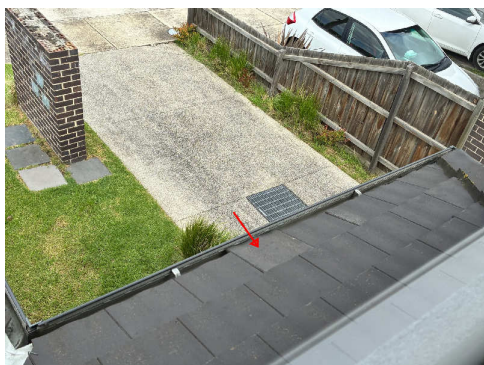
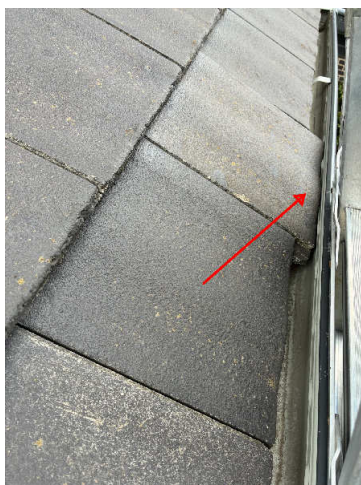
### Defects 3.09

Information: Upon inspection of the exterior roof covering, it was noted that a tile have slipped from their original fixing front of house below Bed room 2 . Tiles may slip over time due to a number of minor causes, including breakage of tiles, failings in the adjoining battens, or fixings that may have failed.

Roof tiles that have moved from their original position are very likely to allow water penetration into the roof void, exposing roofing structures to excessive moisture.

This creates an environment that is conducive to water damage and accelerated deterioration of all associated building elements.

Replacement of loose or missing roofing tiles is recommended immediately to prevent the development of any secondary defects. A roofing restoration specialist should be appointed to complete such works as necessary.

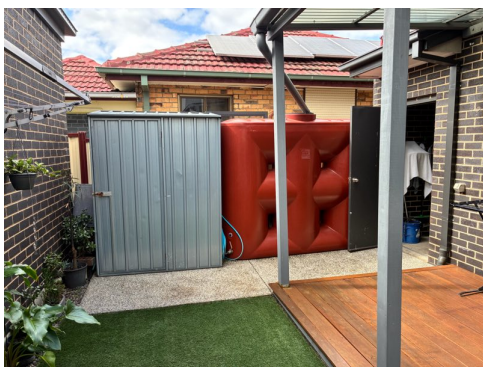
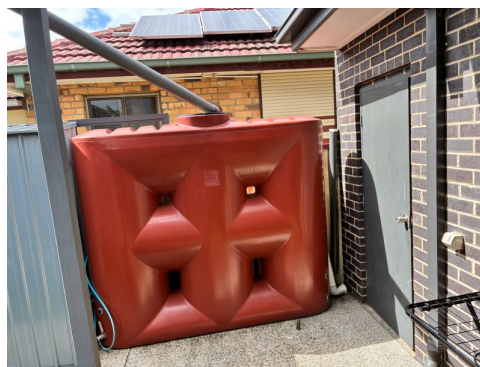
### Defects 3.10

Water tanks connected to a dwelling are required to be fitted with an overflow arrangement to safely manage excess water during periods of heavy rainfall. The absence of a visible or identifiable overflow raises concern that excess water may discharge in an uncontrolled manner, potentially causing localised flooding, or moisture issues near building elements and footings.

☑ It is recommended that a licensed plumber be engaged as soon as possible to confirm whether an overflow has been installed and whether it is connected to a suitable and approved discharge point.

If no overflow is present, a compliant overflow pipe should be installed and directed to an appropriate stormwater connection or other approved discharge location to prevent uncontrolled water release and potential property damage.

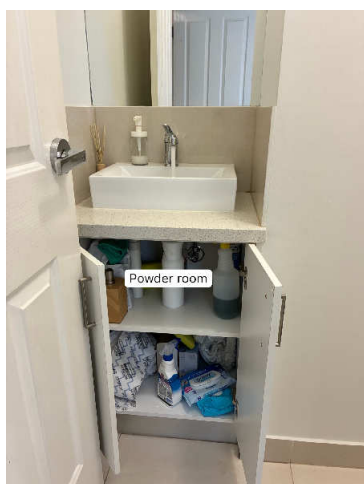
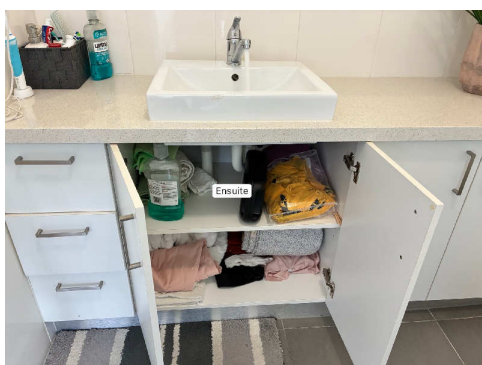
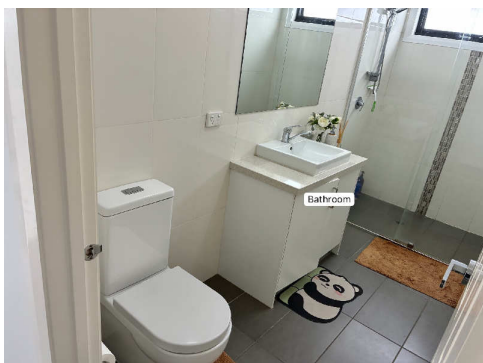
Information: The basins drains in the Ensuite, Bathroom and Powder room appeared to be slow draining at the time of inspection. If left unmanaged, a lack of general maintenance may lead to the development of more significant defects, such as water damage to surrounding building materials.

It is advised that any possible blockage be removed as required.

A licensed plumber or handyperson should be appointed as soon as possible to perform any remedial works where required.

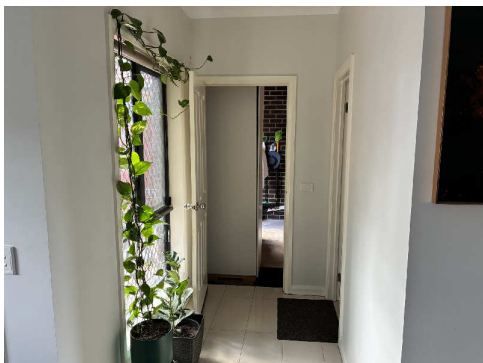
Building:	Main Building
Location:	House Garage access door
Finding:	External Door Seals - Missing
Information:	At the time of inspection the internal access door between house and garage did not have a door seal around the perimeter edges of the door frame.

Sealing external doors is a requirement of the Building Code of Australia which may not be applicable to this particular property however missing seals adversely affect the energy efficiency of the structure.

Where external door seals are missing the area is no longer weather-tight. Insulation of the area against external weather conditions will also be compromised.

It is recommended that all missing weather seals be installed by a general handyperson or a licensed carpenter to prevent any damage and to restore the external door seals to a fully functional level.

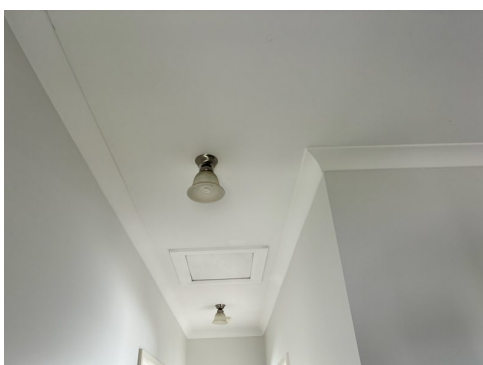
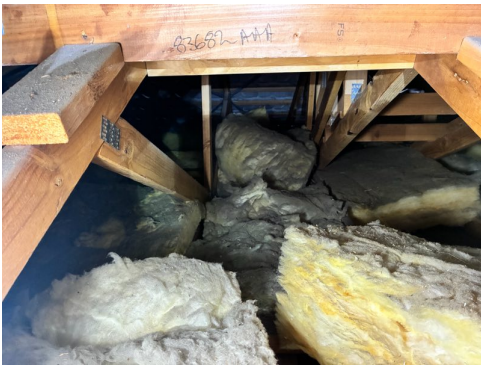
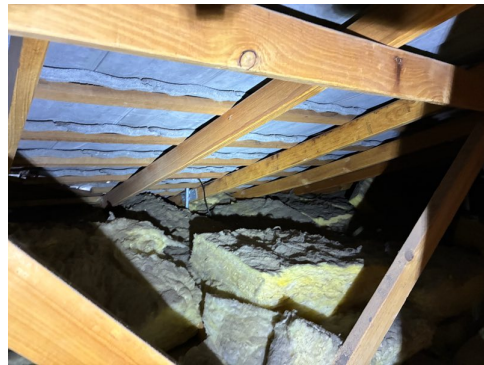
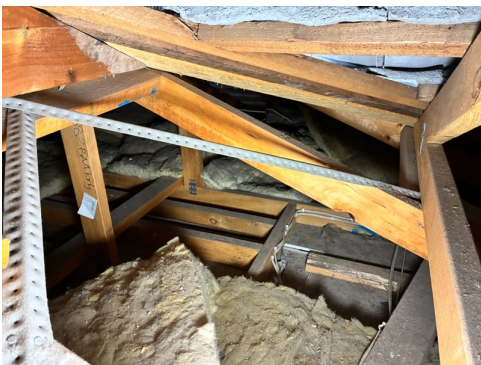
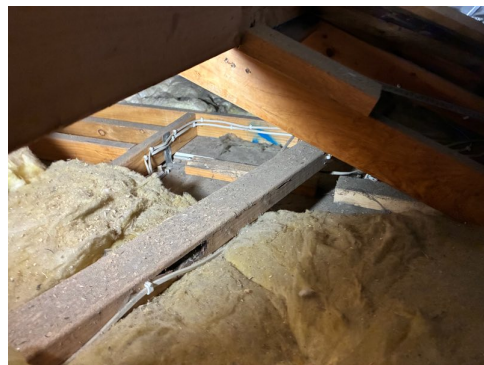
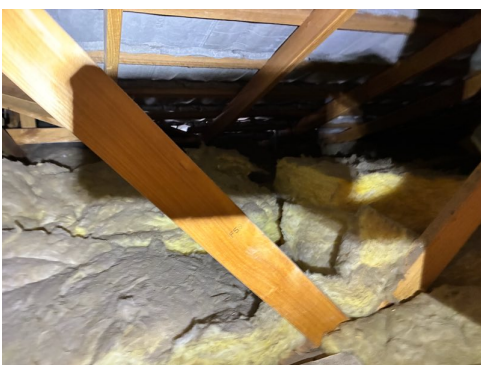
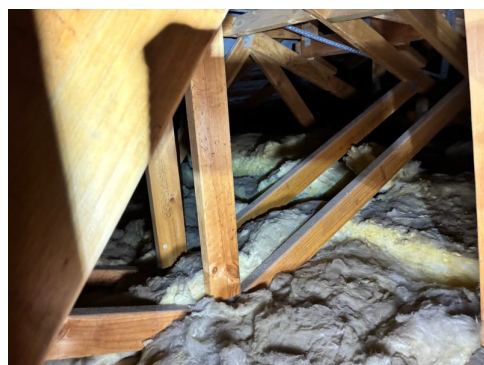
- Ceiling insulation batts have been moved in areas and not replaced.
- Limited access due to roof trusses

A re-inspection is recommended once the area are made accessible.
