Building and Timber Pest Inspection Report

Inspection Date: Fri, 23 Jan 2026

Property Address: 21 Govett St, Randwick NSW 2031,
Australia

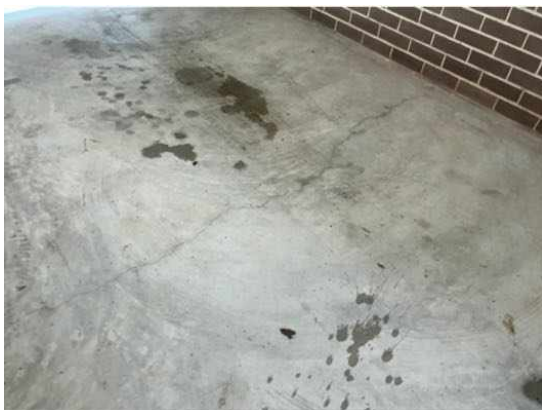
Finding 3.01

Building: Main Building
Location: Garage
Finding: Cracking Fine - Concrete
Information: Fine cracks have been identified in the garage concrete slab. While these cracks are quite noticeable, they are generally considered aesthetic defects and do not indicate any structural damage.

Typically, hairline cracks in concrete are caused by the expansion and contraction of the material.

No repairs are necessary at this time; however, it is important to monitor all cracking over the next 12 months to detect any further damage in the area.

Frequent monitoring of the cracks is essential. Always consult a building inspector if any cracks widen, lengthen, or increase in number.

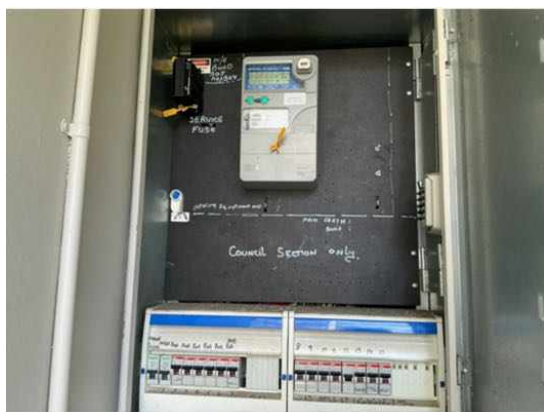
Finding 6.01

Building:	Main Building
Location:	Electrical circuit box
Finding:	Termite Management System No Evidence of Installation
Information:	The application of a post-construction termite barrier is highly recommended for all properties. Such barriers are highly effective in preventing termite attack on any timber building elements throughout the property.

A durable notice should be placed in the switchboard unit to indicate current termite barriers. At the time of inspection, it appeared as though no termite management system has been installed, with no evidence to suggest preventative works taking place.

The client may consider gaining further advice from a pest controller as to the costs and procedures involved with this application. It is recommended that obtaining such advice be a short-term priority.

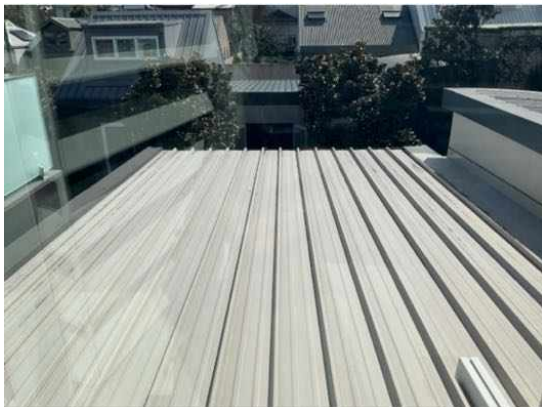
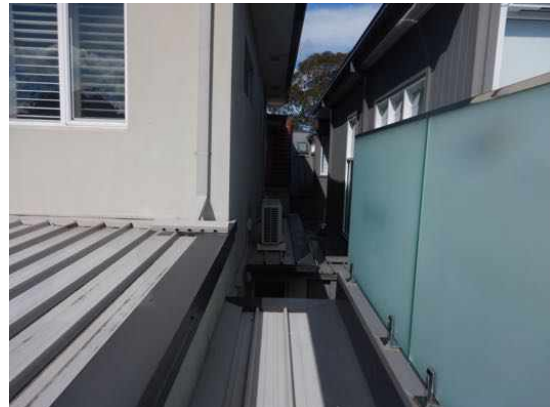
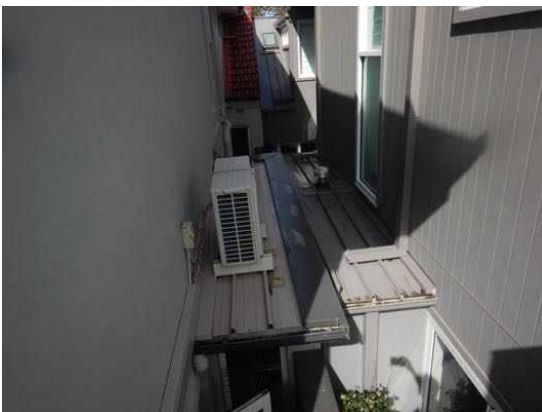
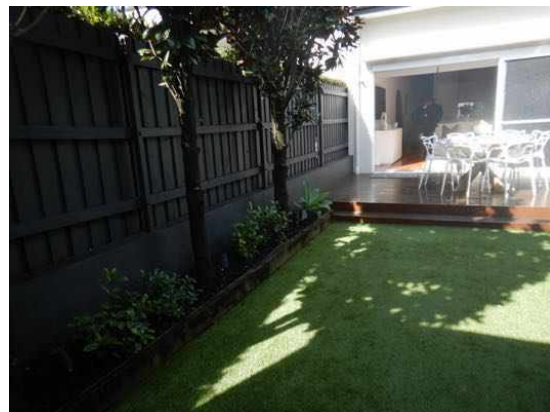
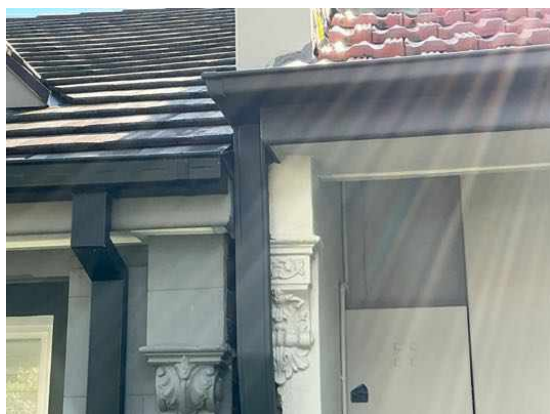
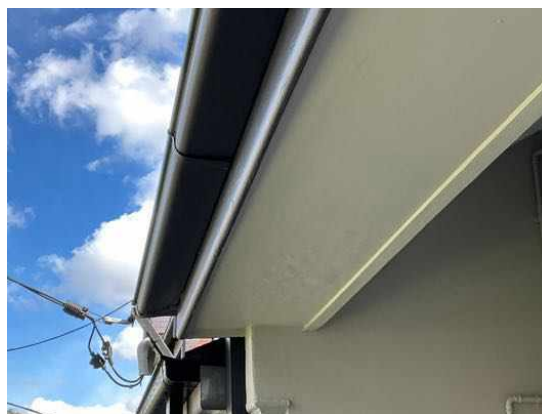
Building: Main Building
Location: All External Areas
Finding: Roof plumbing & site drainage
Information: At the time of inspection the roof plumbing and drainage site drainage appeared to be in good condition. There was no signs of drainage issues, internal leaks, or site drainage issues with the property.

It is recommended to maintain the roof plumbing and any drainage points around the property over the life of the house. This includes removal of debris and leaf litter.

Consultation with a plumber is advised on any plumbing or drainage elements and maintenance schedules.

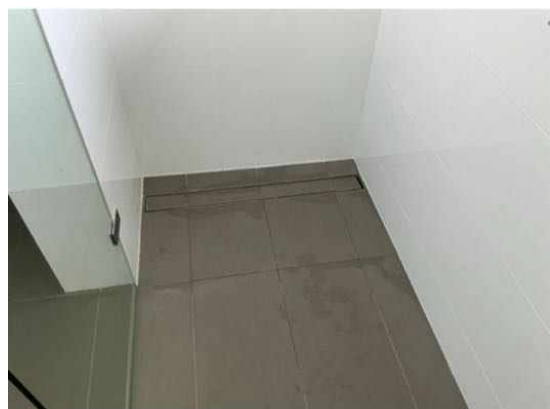
Building:	Main Building
Location:	Bathroom
Finding:	Water Proofing Membrane - No damp detected
Information:	During the inspection, a moisture meter was used to evaluate the dampness levels in the bathrooms and other wet areas. The readings showed no evidence of moisture or damp, indicating that these areas are functioning properly and do not exhibit any signs of leakage. This result provides reassurance regarding the integrity of the plumbing and waterproofing in these important spaces.

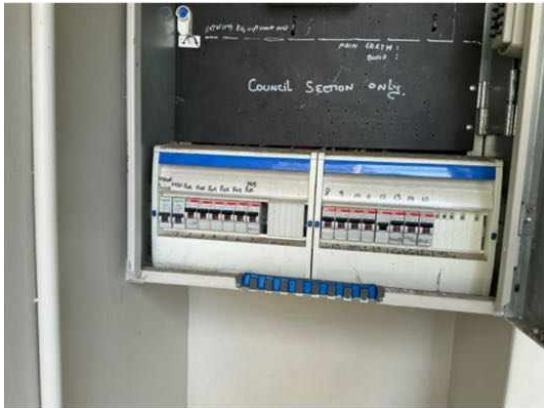
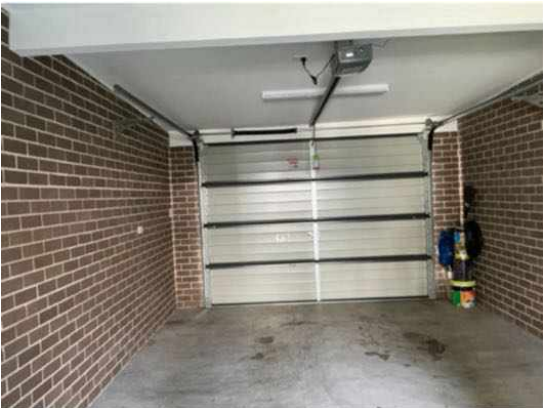
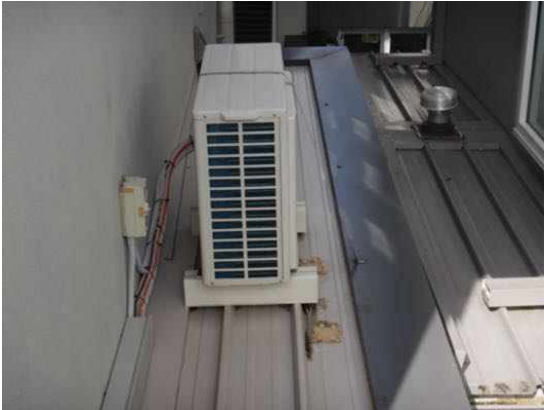
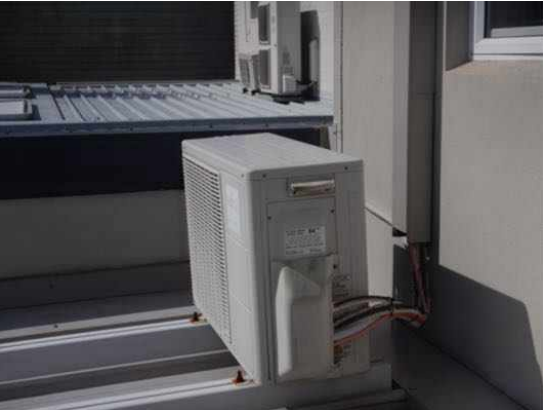
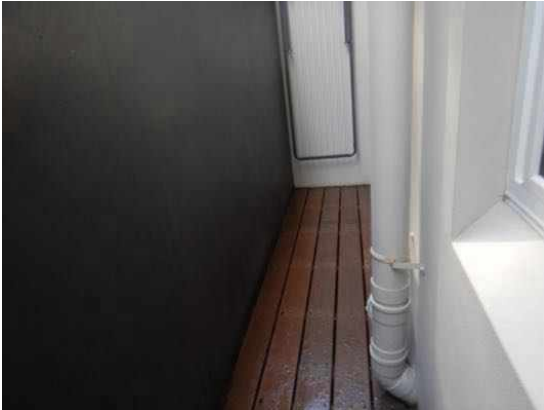
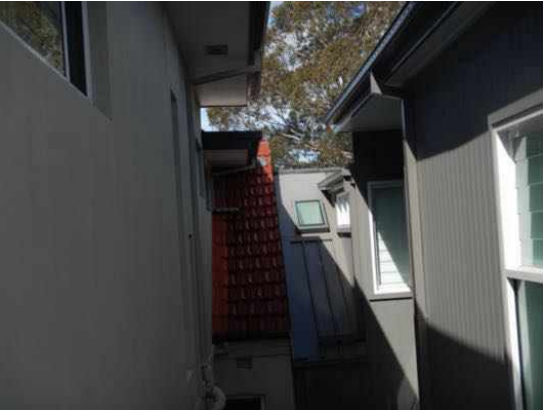
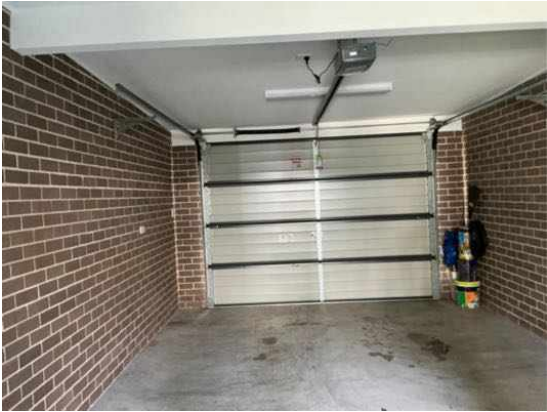
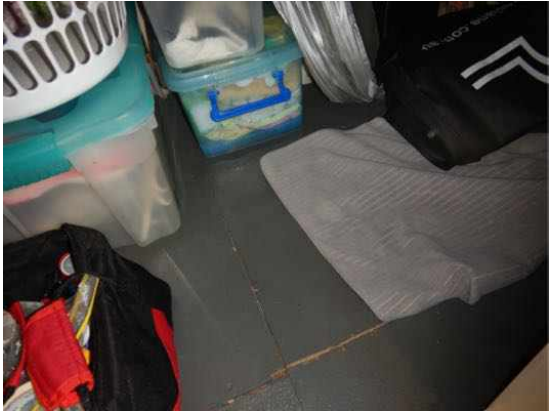
Building:	
Location:	All Areas
Finding:	Additional Photos & Information
Information:	Additional photos are provided for your general reference. These show areas that were inspected, but may not have necessarily had defects.

Some photos may also show obstructions and limitations which impeded full inspection of the property at the time of inspection. Additional photos also show other elements such as hot water systems, air conditioning units and RCD switches (electrical safety switches) on power boxes.

Readings were taken with the moisture meter throughout the interior of the property and no issues such as damp or rising damp were detected at the time of inspection.

The subfloor access point could not be opened as the hatch was sealed shut.
