Building Inspection Report

Inspection Date: Tue, 27 Jan 2026

Property Address: 5 Hazlewood St, New Norfolk TAS 7140,
Australia

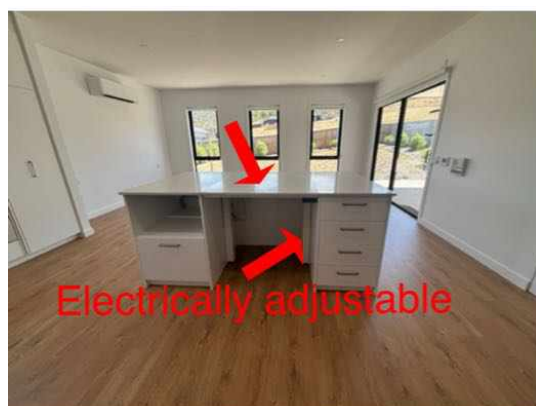
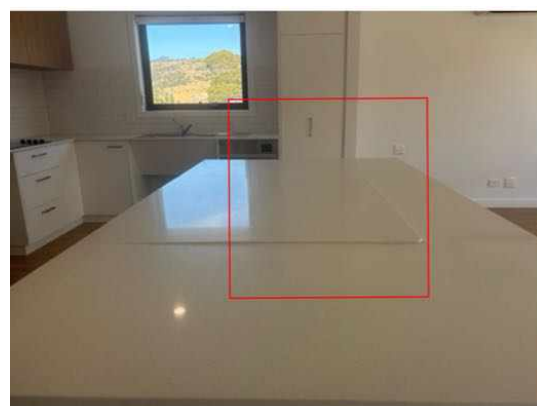
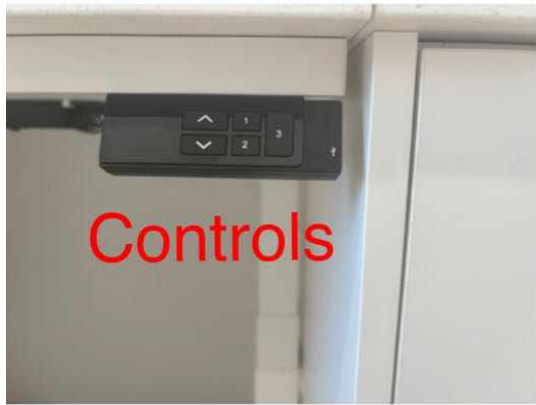
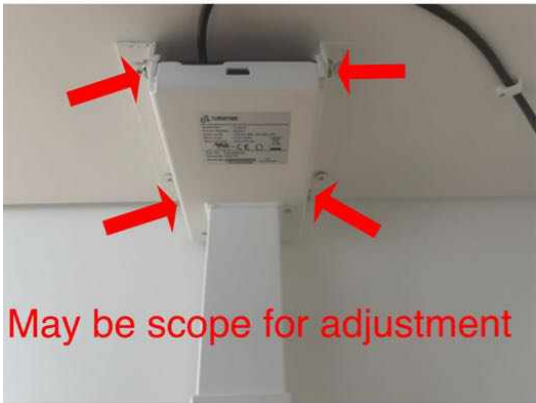
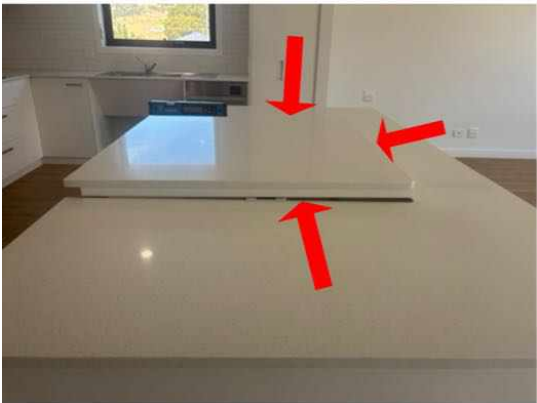
Defects 3.01

Finding: Height adjustable bench

Information: In the kitchen the height adjustable bench is not level. It cannot be made flush with the surrounding bench. It is out of level by approximately 8mm. The gaps are even, however the levels are out. The screws in the brackets may be able to be adjusted or slotted to rectify. I think the best persons to rectify this issue would be the original kitchen installers.

Failure to rectify could lead to damage to the adjustable bench and surrounding bench top.

Moveable section
8mm/m out of level

Recommend client request if the agent can liaise with the builder to identify the kitchen installers. They may have greater experience with this system as it is not common.

If kitchen installers decline, recommend client engage a Handy Person to rectify as soon as possible.

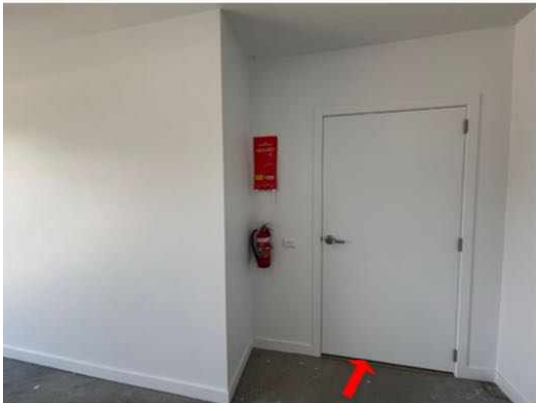
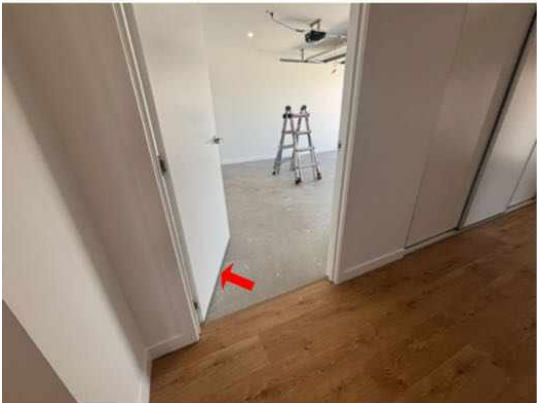
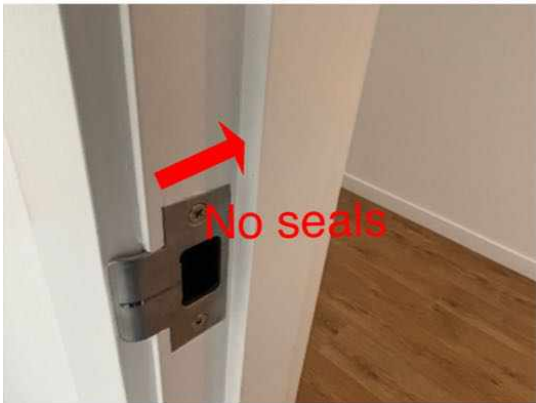
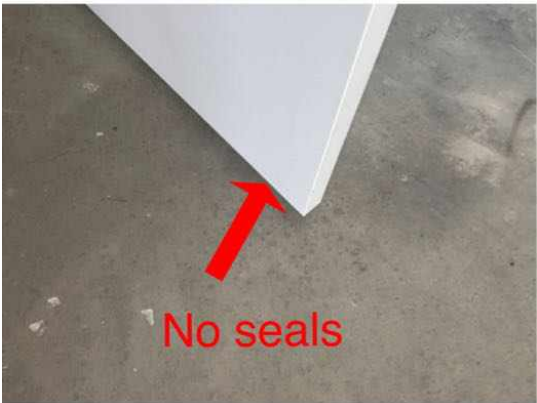
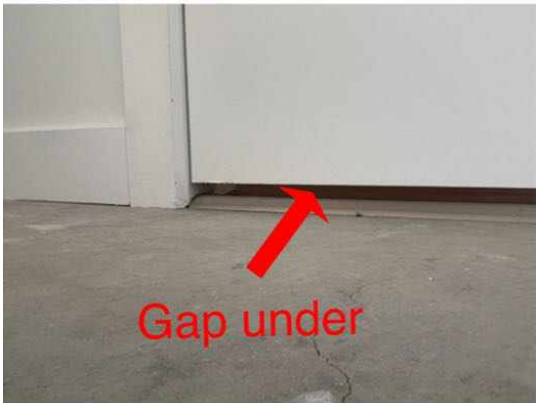
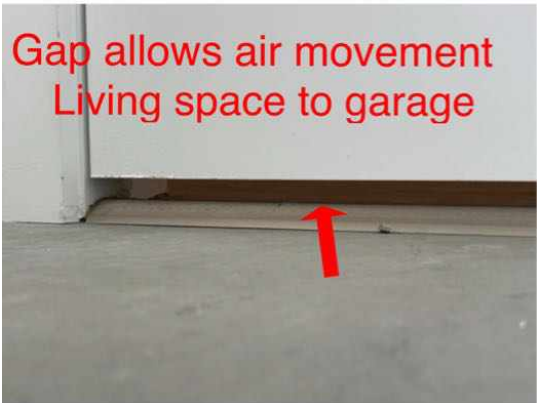
Defects 3.02

Building: Main Building
Location: Garage
Finding: Weather Seals
Information: The garage door to the hallway is missing the weather seals.

If not rectified the heating/cooling will be less efficient.

Recommend client engage Handy Person to rectify as soon as practicable.

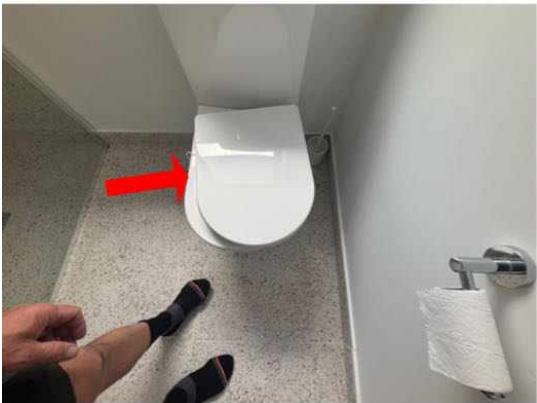
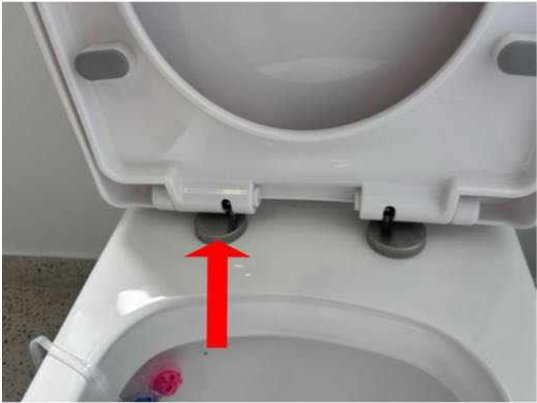
Defects 3.03

Building: Main Building
Location: Ensuite
Finding: Toilet seat loose
Information: The toilet seat in the ensuite is loose.

If not rectified it could be a safety hazard for persons using the toilet if it tips sideways.

Recommend client engage Lic Plumber to rectify when attending for other plumbing items.

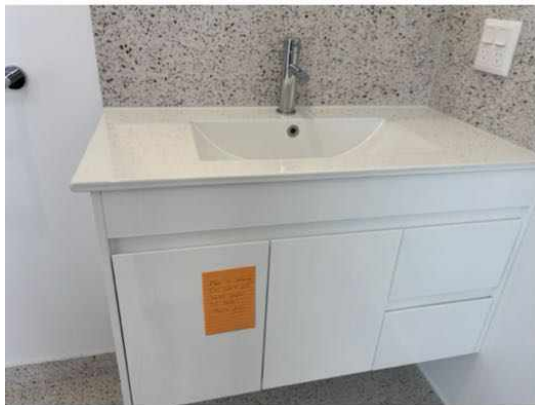
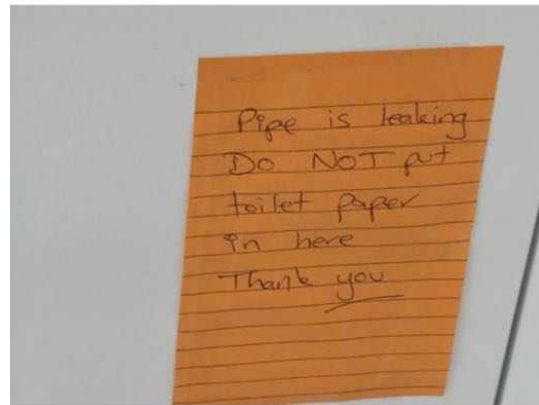
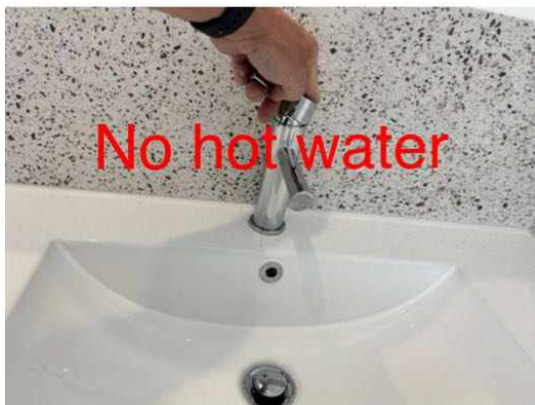
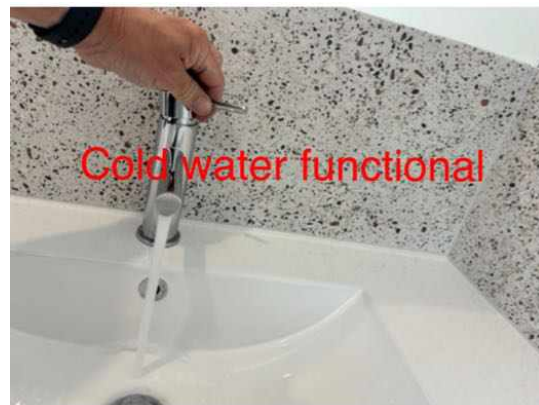
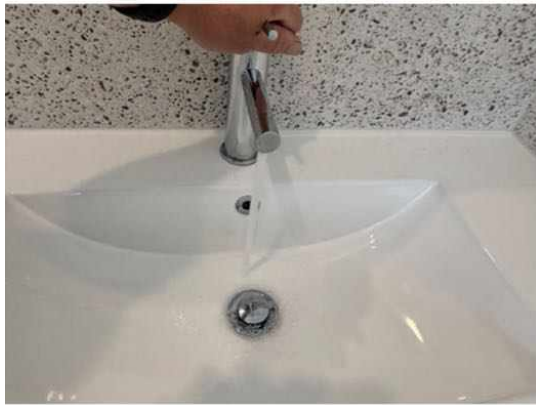
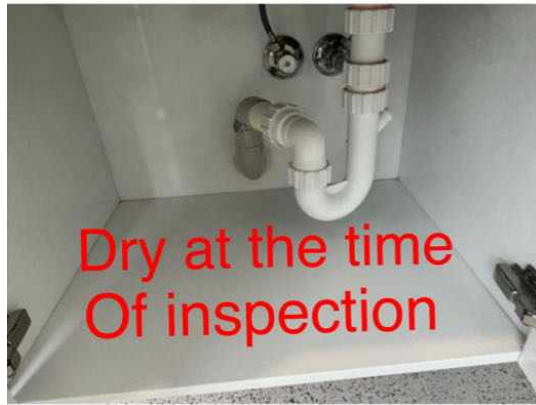
Defects 3.04

Finding: Water leak

Information: In the ensuite the vanity hot water would not operate as it has been turned off at the stop cock. There is also a notice on the door regarding a leak.

I ran the tap briefly and did not observe a leak, however this may be related to the hot water which was turned off.

Internal water leaks can be detrimental to surrounding building elements. Rust, corrosion, decay and water damage are potential outcomes where a water leak is left unattended. In extreme cases, structural damage/subsidence may develop due to a prolonged water leak.

Recommend client engage a Lic Plumber to rectify as soon as possible.

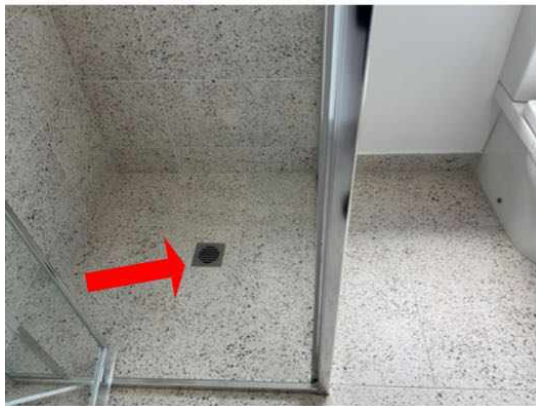
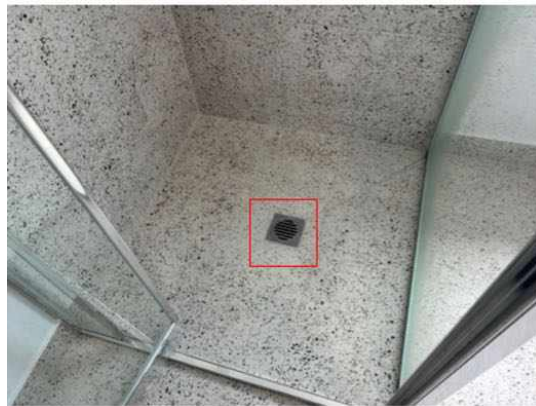
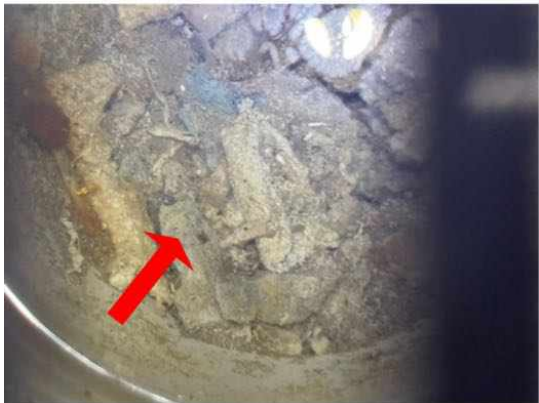
Defects 3.05

Finding: Drain obstructed

Information: The drain to the ensuite shower has debris in it. I ran the shower for a few minutes and the water was draining. However this partial obstruction may make it easier to become clogged and overflow.

Blockages prevent building elements from operating as intended. If left unmanaged, a lack of general maintenance may lead to the development of more significant defects such as flooding and water damage to surrounding building materials.

Recommend client engage a Lic Plumber to rectify as soon as possible.

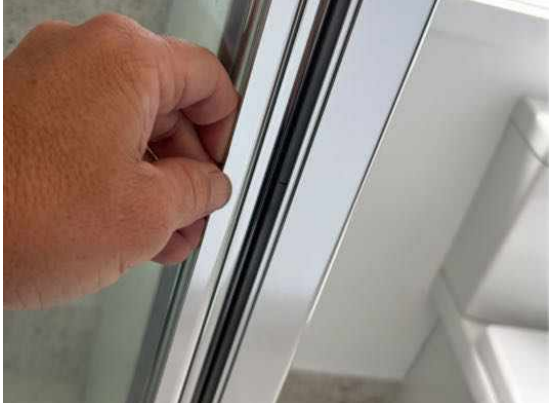
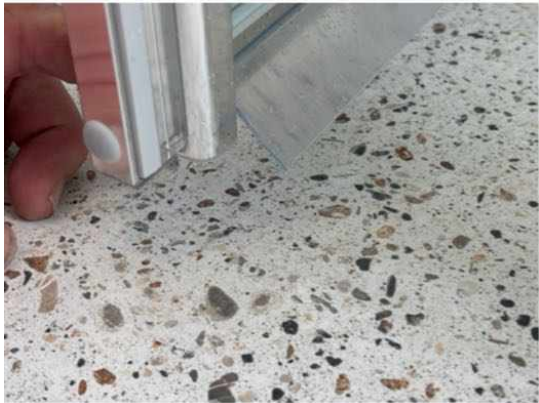
Defects 3.06

Finding: Shower door binding

Information: The bathroom shower door is slightly binding on the bottom of the door. This defect inhibits the functionality of the affected door. If left as is, it will likely cause some wear marks and/or damage to the door frame.

Failure to rectify will lead to further deterioration to the building elements.

Recommend client engage a Handy Person to rectify as soon as practicable.

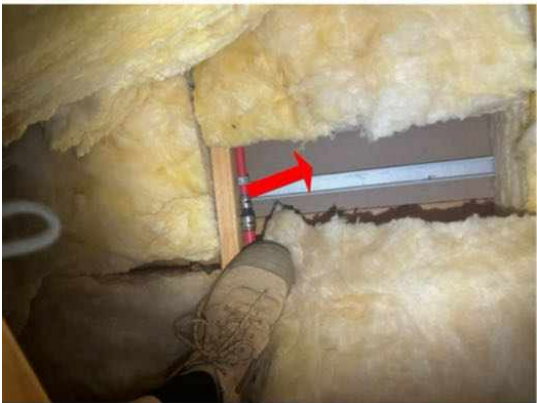
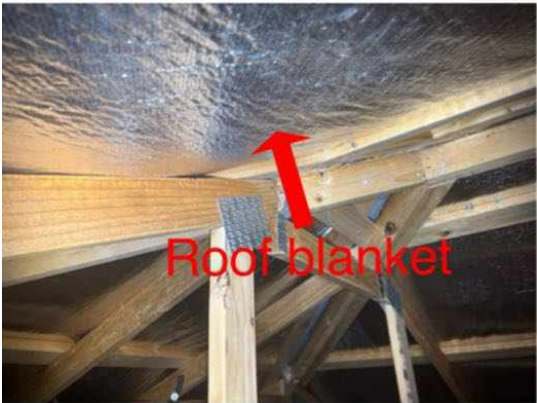
Defects 3.08

Building: Main Building
Location: Roof void
Finding: Insulation displaced
Information: In the roof void, a small amount of insulation batts have been displaced. Most likely they were moved by trades persons carrying out various jobs in the roof void.

Insufficient insulation will result in a comparatively higher cost to heat and cool a property. Insulation works as a barrier to heat transfer. This helps to keep out unwanted heat in summer and preserves warmth inside your home in winter. It can also help soundproof your home from unwanted airborne noise transfer.

Recommend client engage a Handy Person to rectify at clients convenience.

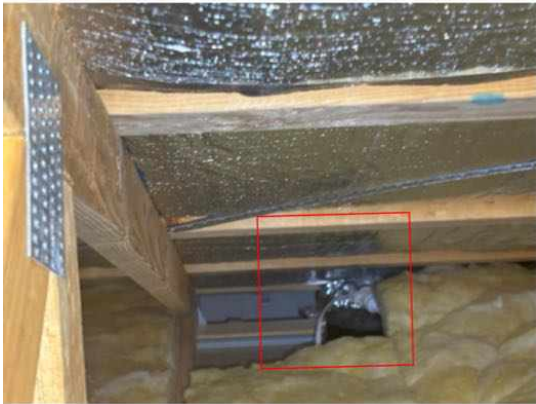
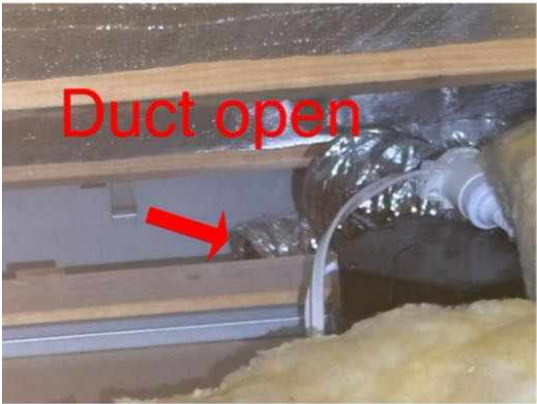
Defects 3.09

Building: Main Building
 Location: Roof void
 Finding: Exhaust fan not ducted to the exterior
 Information: In the roof void, (possibly the small exhaust fan to the ensuite) is not ducted to the eave outlet. Without ducting evaporative moisture can cause mould in the roof void.

Recommend client engage a Handy Person to rectify as soon as practicable.

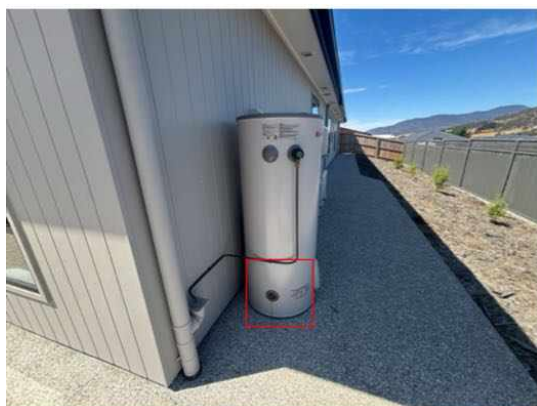
Defects 3.10

Building: Main Building
 Location: Hot Water System
 Finding: Hot Water System - corrosion to fitting
 Information: On the hot water system there is some corrosion to a fitting.

Failure to rectify could lead to further deterioration.

Recommend client engage a Lic Plumber to inspect and rectify if necessary as when attending for other items.

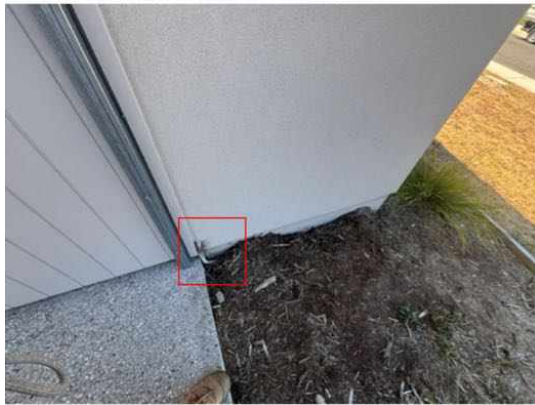
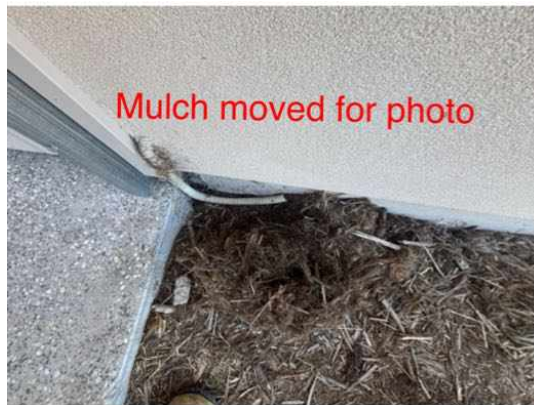
Defects 3.11

Building: Main Building
 Location: Left hand side of house
 Finding: Heat Pump - not plumbed for drainage
 Information: The heat pump outside the front bedroom, has not been plumbed to drainage. It has the hose buried in the mulch. Over time, this could lead to blockage of house by debris or insects and cause the water to overflow into the dwelling.

If the heat pump is not plumbed it may result in the surrounding area becoming excessively damp. These damp conditions can lead to secondary defects such as rot, rust or corrosion of associated building elements, the formation of fungal decay or mould and has the potential to create slip hazards. These works will ensure that the area remains dry and free of any secondary defects.

Recommend client engage Lic Plumber to rectify as soon as practicable.

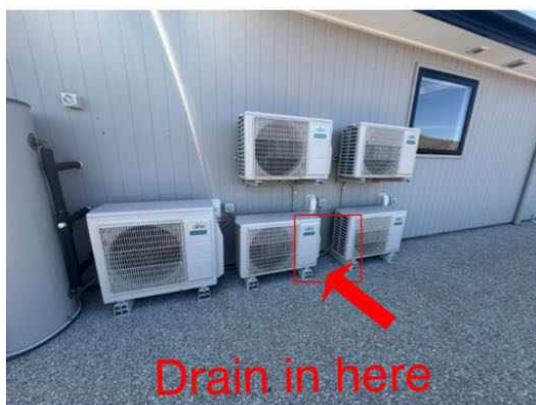
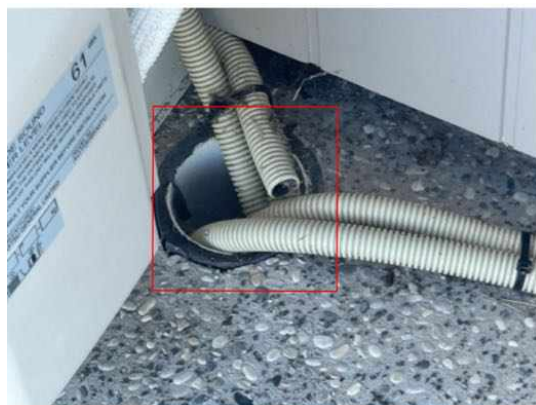
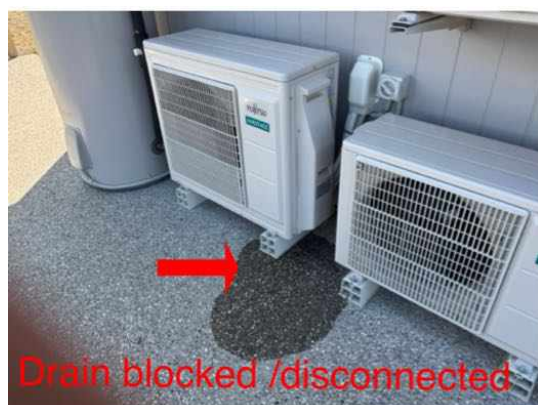
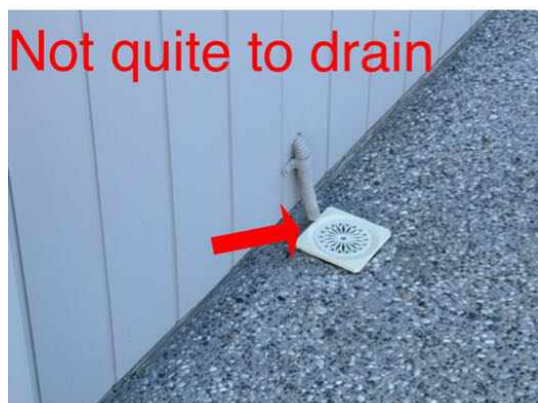
Defects 3.12

Building: Main Building
 Location: Left hand side of house
 Finding: Heat pumps
 Information: Two of the heat pump drains on the gate side are not connecting to the water connection (drain). Also one heat pump outdoor unit is not connected to drainage and is spilling onto the concrete.

If the heat pump is not plumbed it may result in the surrounding area becoming excessively damp. These damp conditions can lead to secondary defects such as rot, rust or corrosion of associated building elements, the formation of fungal decay or mould and has the potential to create slip hazards. These works will ensure that the area remains dry and free of any secondary defects.

Recommend client engage Lic Plumber to rectify as soon as practicable.

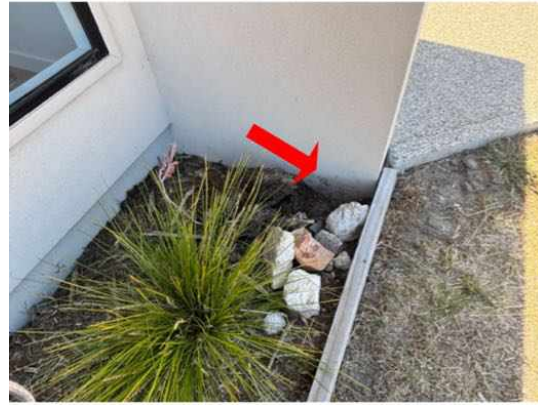
Defects 3.13

Building:	Main Building
Location:	Front of house
Finding:	Cladding in ground contact
Information:	The decorative wall to the front of the house is light weight cement sheet cladding, that has been rendered. When I tapped it, it sounded like it is timber framed. Other similar houses that I have inspected that have these decorative walls have a timber frame. However this wall is embedded into the landscaping fairly deeply. These materials are not designed for in ground use. Failure to rectify could lead to water damage, due to the result capillary action getting into the wall cavity. This can cause damage over the long term to the timber framing. I used a moisture meter, however there were no elevated moisture levels were detected at this time.

This wall appears primarily to be a decorative element, but there may be some structural support provided by the wall.

This style of cement sheet cladding over timber framed, creates the appearance of a masonry wall, without the durability of a masonry wall.

Failure to rectify could lead to the accelerated decay of these building materials.

Recommend client engage a Lic Builder to inspect and rectify, as soon as practicable, to prevent long term damage to the wall framing.

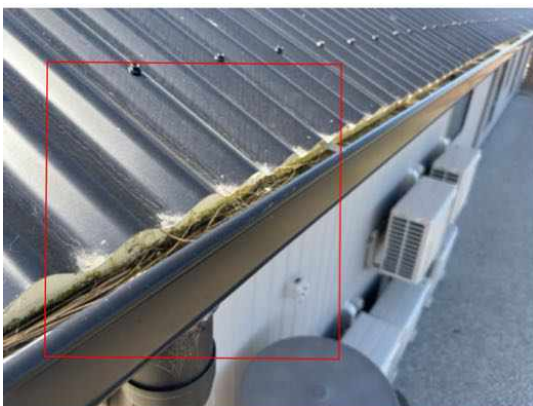
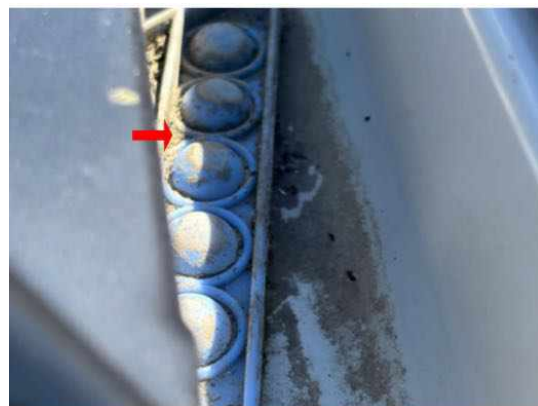
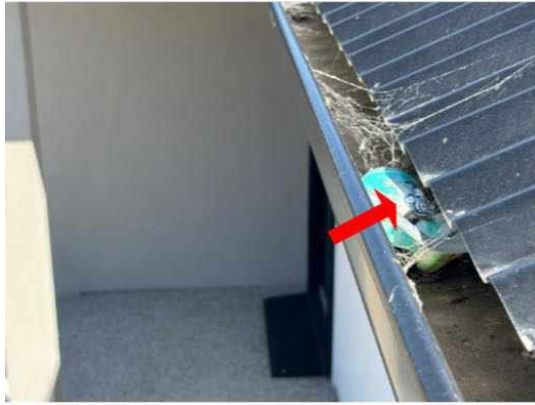
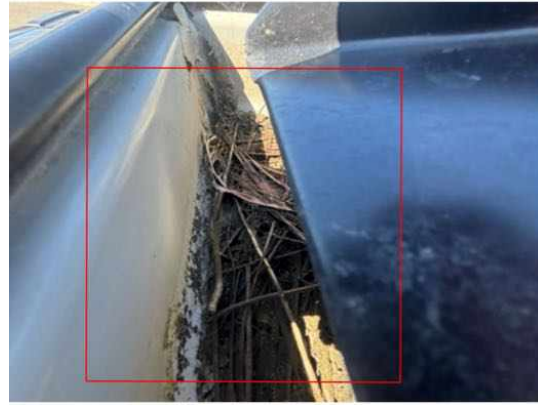
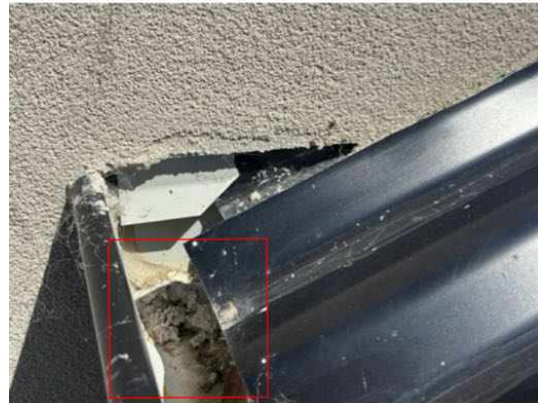
Defects 3.14

Building:	Main Building
Location:	Multiple locations
Finding:	Gutters - debris
Information:	There is some debris in the gutters.

Roof plumbing structures, such as guttering and downpipes, should be free of all debris to prevent blockages. Blockages of the guttering and downpipes will lead to pooling and accumulated water overflows, which is likely to subsequently flood eaves and exterior walls.

Blocked gutters are likely to lead to high levels of moisture in the affected areas. Such moisture can cause rust and decay of the associated building materials. Blockages in gutters should therefore be removed immediately to ensure dry conditions are maintained.

Recommend client engage a Handy Person to clean the gutters as soon as possible.

Recommend client ensure that all gutters be maintained on a frequent basis to ensure the condition of roof plumbing.

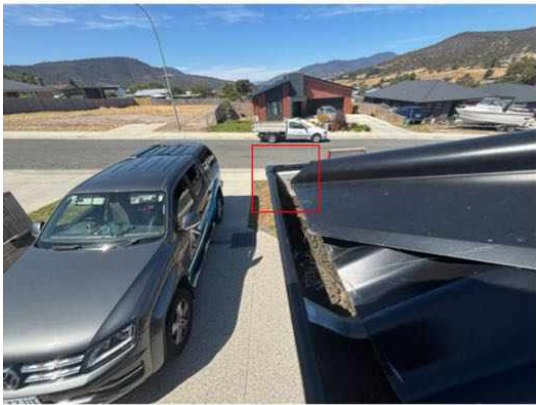
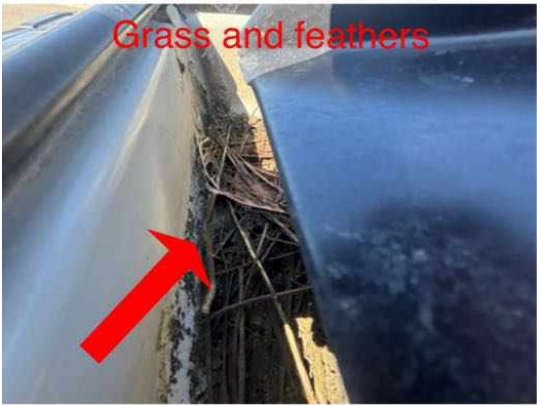
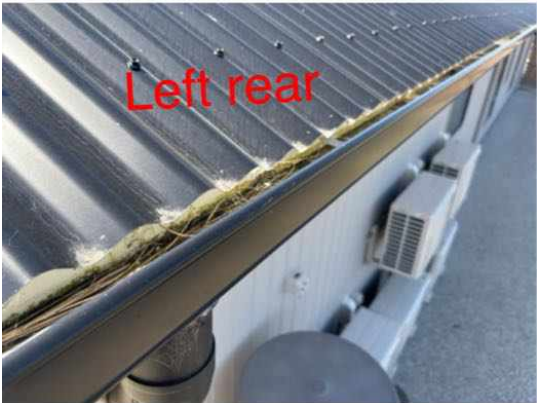
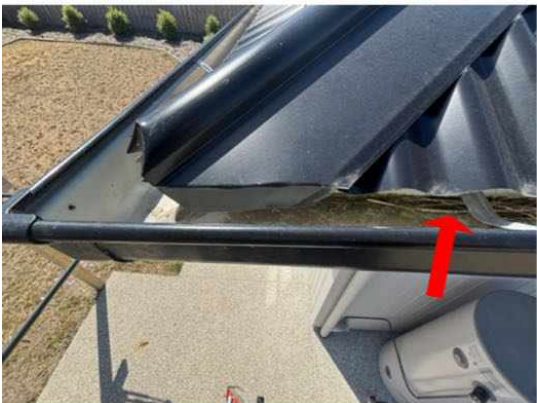
Defects 3.15

Building:	Main Building
Location:	Multiple locations
Finding:	Bird nesting materials
Information:	There are bird nesting materials in the gutters on the front right hand corner and rear left hand corner. I did not see or hear any birds in the roof void, however they tend to be out in the eaves where there is restricted visibility. Also the activity is usually seasonal.

Failure to exclude the birds may cause secondary damage via their waste, and potential damage to building elements and disruption to occupants due to the noise.

Recommend client engage a Handy Person as soon as possible, to remove nesting material and the block any entry ways to prevent birds re-entering.

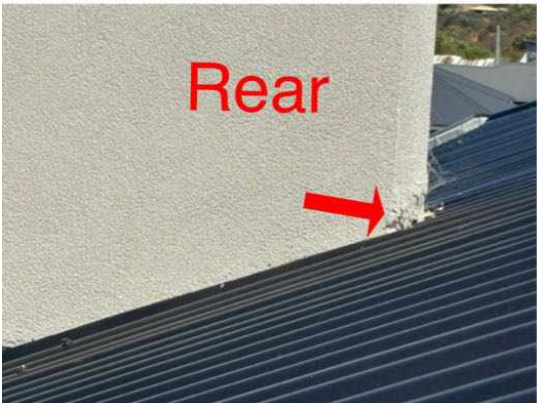
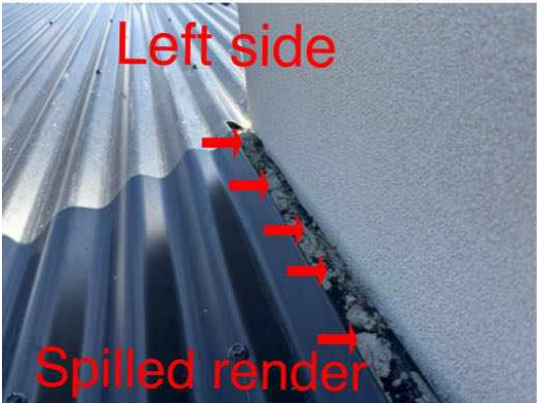
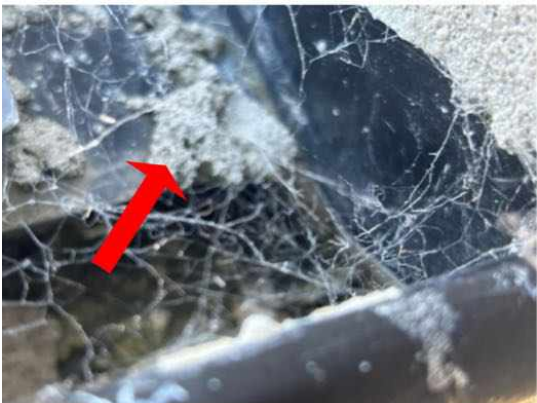
Defects 3.16

Building: Main Building
 Location: Left hand side of the decorative wall
 Finding: Rendering
 Information: On the left hand side of the decorative wall on the roof, the render has dropped down onto the flashing. This will restrict water flow. The rear of the wall looked a little messy as well.

Recommend client engage a Handy Person to inspect and rectify as soon as practicable.

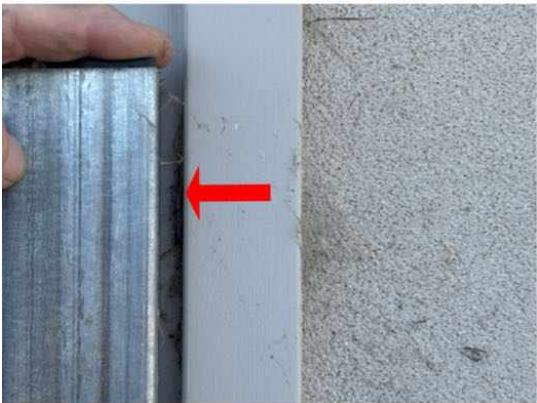
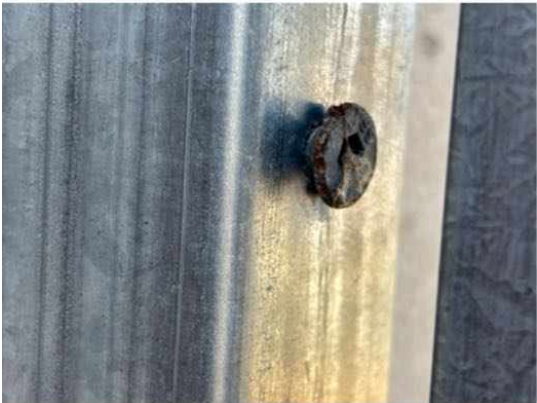
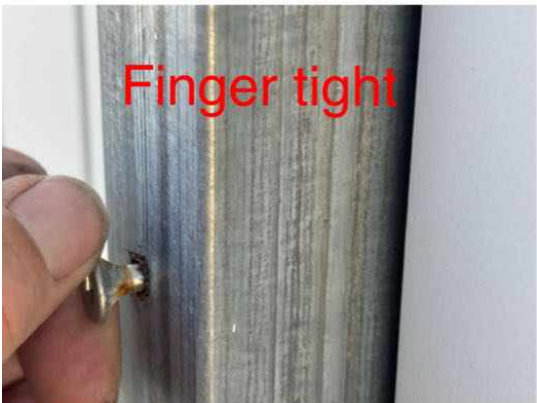
Defects 3.17

Building: Main Building
 Location: Left hand side of house
 Finding: Gate
 Information: The gate post on the left hand side of the house, has been screwed to the cladding. There appears to be no supporting timber behind the post and it is loose.

Failure to rectify could cause the gate post to dislodge and damage the cladding.

Recommend client engage a Handy Person to rectify as soon as practicable.

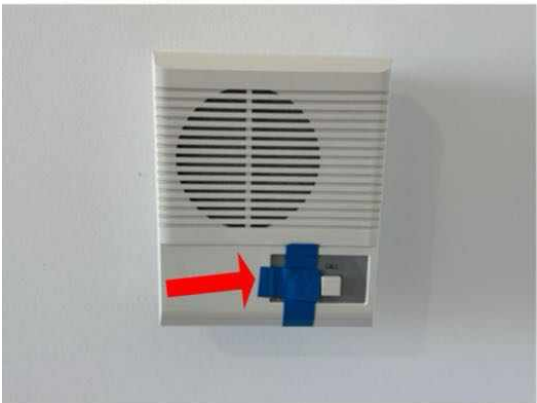
Finding: Intercom taped
Information: FYI there is tape on the intercom. Recommend engage a Handy Person to rectify as soon as practicable.

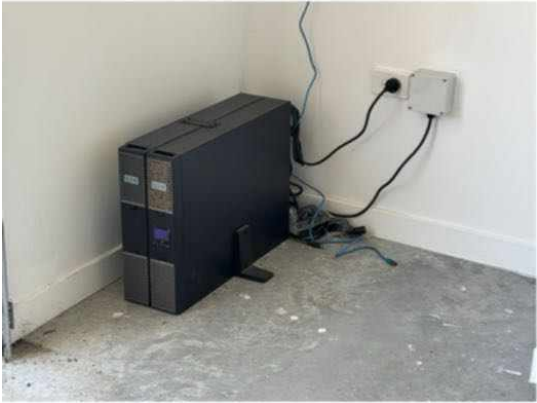
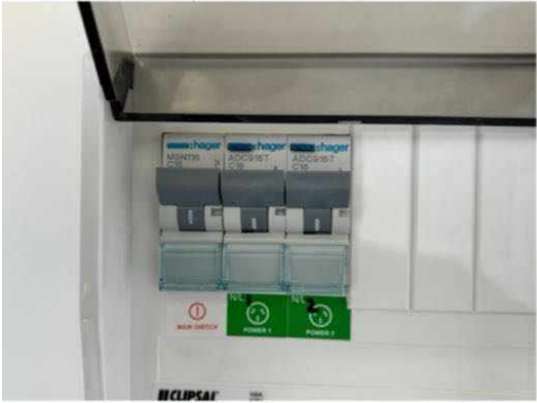
Building: Main Building
Location: Garage
Finding: Uninterruptible Power Supply
Information: FYI there is an Uninterruptible Power Supply (UPS) fitted in the garage. My understanding is that some power points are fed from this and are typically labelled.

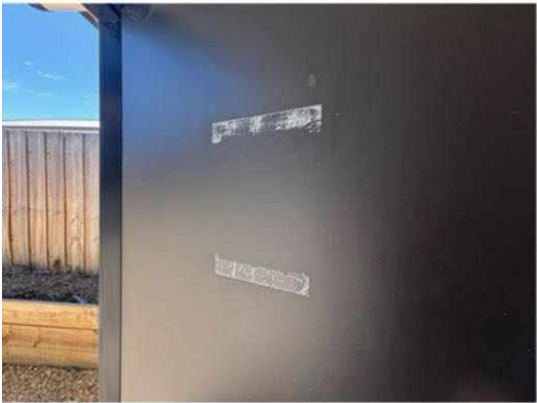
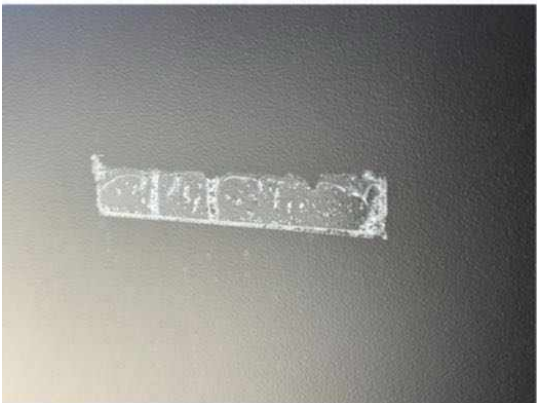
Building: Main Building
 Location: Garage
 Finding: Personal access door
 Information: FYI the exterior personal access door to the garage has some tape residue on it, most likely from having a notice taped to it. Recommend client engage a Handy Person to rectify as soon as practicable.
