Building and Timber Pest Inspection Report

Inspection Date: Wed, 25 Feb 2026

Property Address: 79 Holden drive Oran park

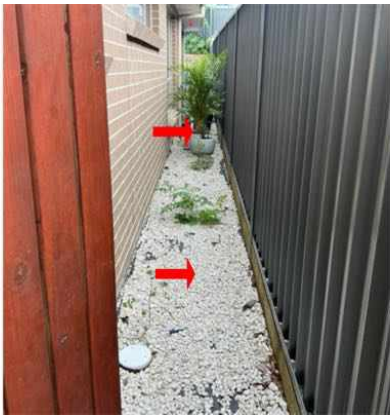
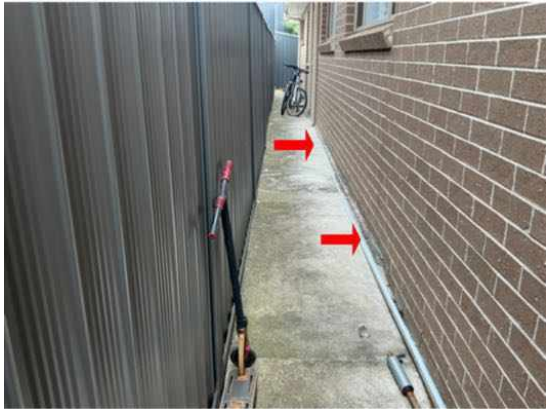
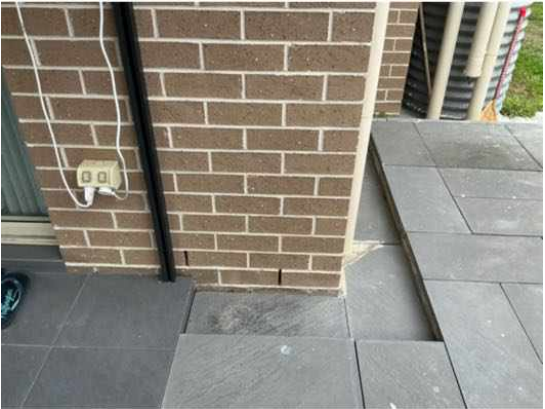
Finding 3.03

Building: Main Building
Location: All External Areas
Finding: Surface Drainage - Gravel and uneven pavement
Information: The setback is finished with loose aggregate. While gravel can assist with surface dispersion of water, it is not a controlled drainage system. The adequacy of falls and stormwater connection could not be confirmed at the time of inspection. Monitoring during rainfall is recommended to ensure no ponding or water discharge occurs toward the slab edge. recommended a licensed plumber to further access for grading to all exterior areas including uneven paved surfaces to ensure water is diverted away from the building in accordance with good building practice.

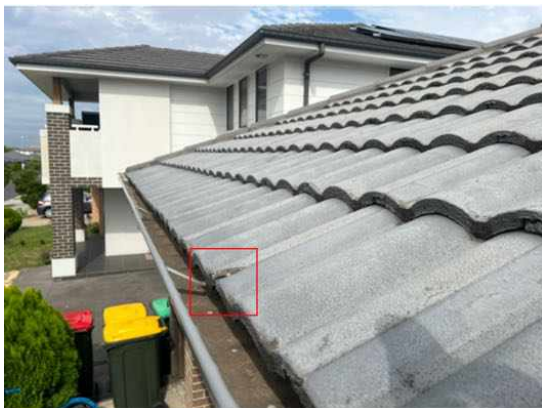
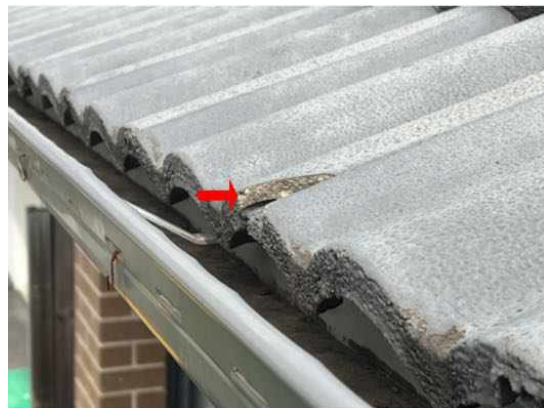
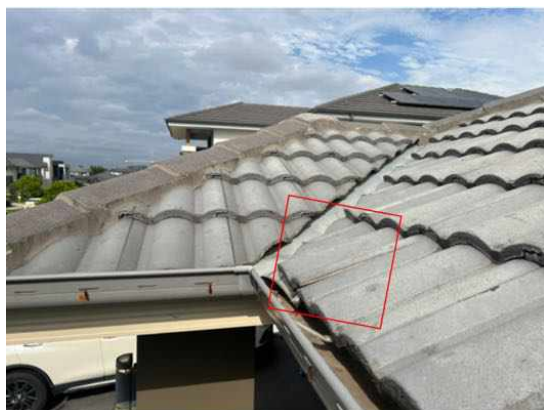
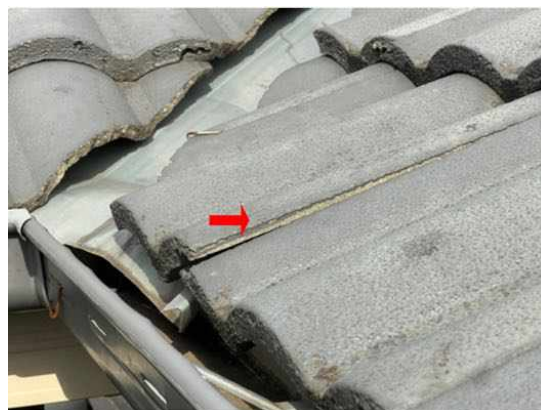
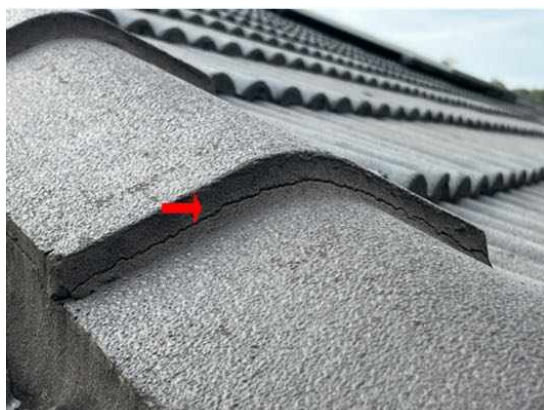
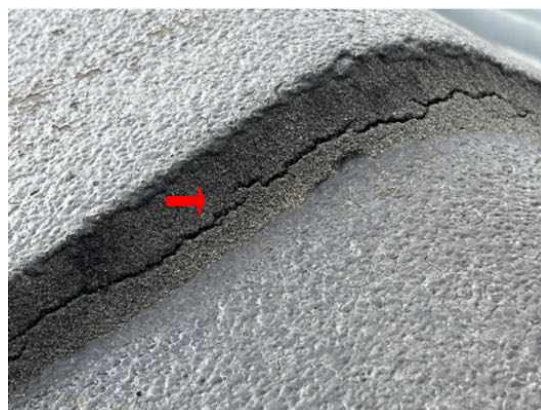
Finding 3.04

Building:	Main Building
Location:	Roof Exterior
Finding:	Roof tiles - Broken/lifting and damaged mortar
Information:	Upon inspection of the exterior roof covering, broken/lifting roofing tiles were identified. Broken and friable roof tiles are generally the result of ageing and weathering of what is essentially a porous material.

If left to further deteriorate, broken and brittle roof tiles are likely to lead to water penetration via the roof into the ceiling space, causing secondary damage to ceiling linings, insulation and roof structures. Broken roof tiles are also likely to detract from the effectiveness of the roof drainage system, creating potential for secondary damage to the exterior roof covering and roof plumbing.

Replacement and alignment of broken tiles is required and should be performed by a roofing contractor as soon as possible.

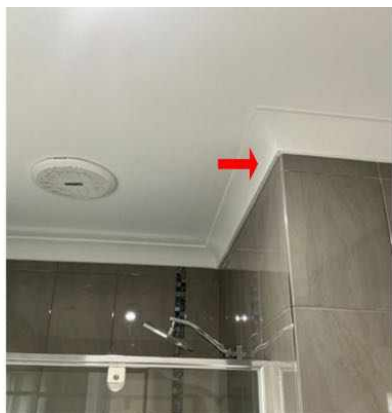
Finding: Painted surface - Bubbling - possible humidity

Information: Sections of paint in this area was found to have bubbled and deteriorated. Paint bubbling is generally an indication of excessive moisture in the area, that is currently hidden by the painted surface.

The presence of excessive moisture can have major implications on associated building elements if left unattended. While only seemingly minor at this stage, the damage cannot be determined due to the paint obstructing any further inspection of the damage.

It is highly advised that the affected paint be cleaned to allow a further, more invasive inspection by a licensed plumber. Failure to act on this defect may necessitate major works in the future.

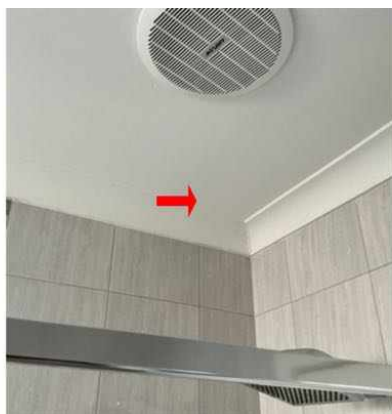
Finding 3.07

Building:	Main Building
Location:	Bathroom, ensuite
Finding:	Water Staining - Humidity or Ventilation
Information:	The ceiling surface shows faint darkened spotting or shadowing, commonly consistent with surface mould or humidity-related staining, often found in bathroom or wet area ceilings with insufficient ventilation. While there is no visible sagging or major water damage, the pattern suggests prolonged moisture exposure, possibly due to steam accumulation or minor condensation issues. According to AS 4349.1-2007 (Appendix C), this would be classified as a minor defect unless further deterioration or active leaks are found. Recommend improving mechanical or natural ventilation, cleaning the surface with mould treatment, and monitoring for recurrence.

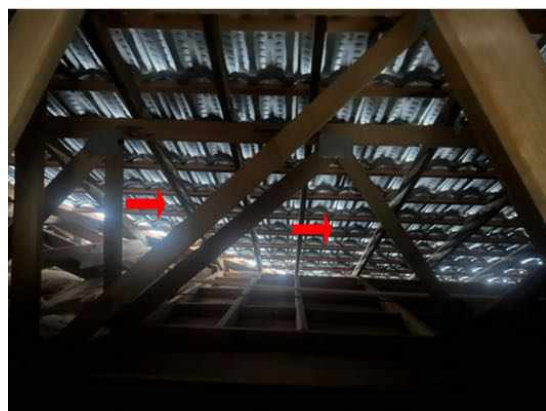
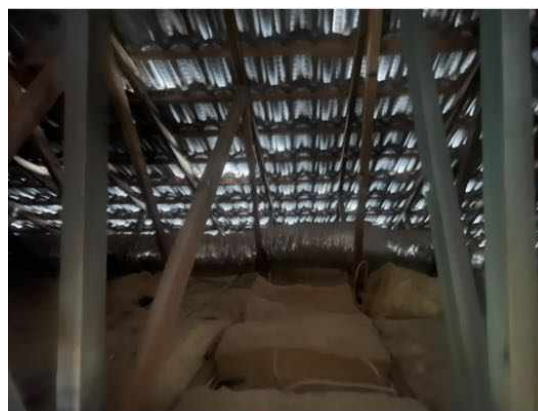
Finding 3.08

Building:	Main Building
Location:	Roof Void
Finding:	Roof Void – No Sarking & Light Ingress
Information:	Light ingress is visible through multiple roof tile laps, which is typical of older tile roofs without sarking and may allow minor wind-driven moisture or dust into the space, though no active leaks were observed.

Consider retrofitting sarking or roof wrap in the future to improve thermal and moisture performance.

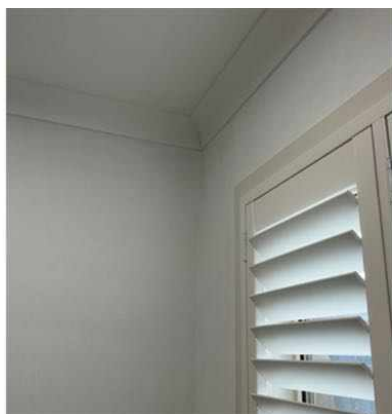
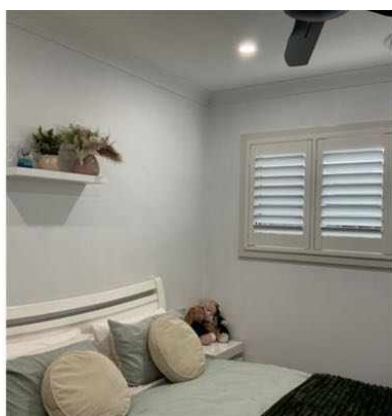
Finding 3.09

Building:	Main Building
Location:	Bedroom 1
Finding:	Water staining - Minor
Information:	Water staining was evident in this area at the time of inspection. Water staining indicates that surfaces have been exposed to excessive moisture over time. The minerals and other elements in the water lead to staining, which may graduate to corrosion and deterioration if left unmanaged.

While mostly an appearance defect, water staining can be indicative of more serious

defects, which may be currently concealed by other building elements.

Where water staining is active, a licensed plumber must be consulted to identify the cause of the staining and to provide advice on any reparation works that may be required. Replacement of any broken or damaged structures is advised.

Conversely, where water staining is old and inactive, affected building materials may be repaired or replaced at client discretion. A qualified carpenter or registered builder may be appointed to perform these works.

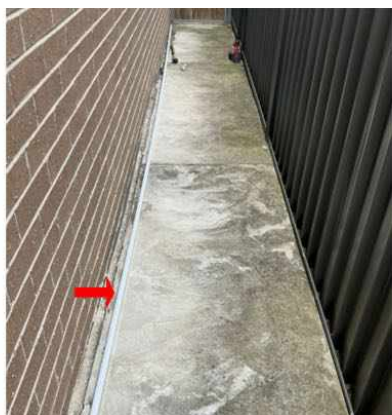
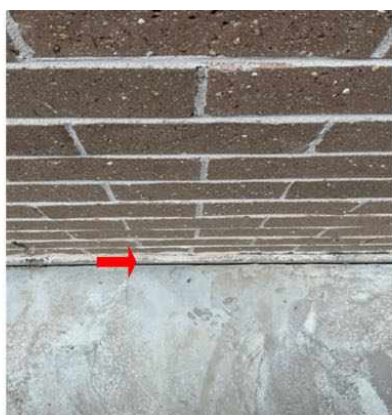
Finding 3.10

Building:	Main Building
Location:	All External Areas
Finding:	Gap Between Concrete and External Wall - to some areas
Information:	Visible gaps were observed between the external masonry wall and adjacent concrete slab at the pathway.

This separation may permit water ingress and contribute to concealed moisture-related damage, pest ingress, or slab movement if left unsealed.

The defect appears consistent with common differential settlement or poor sealant detailing at the slab-to-wall junction. Recommend a licensed contractor seal the gap with an appropriate flexible, UV-stable exterior-grade sealant to prevent moisture entry

and pest intrusion.

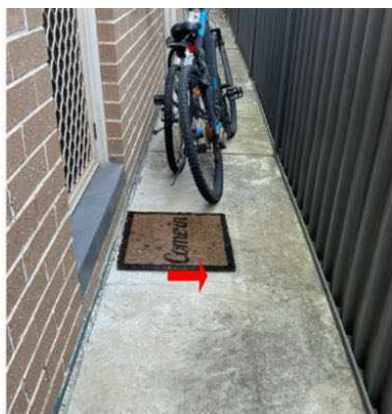
Finding 3.11

Building:	Main Building
Location:	All External Areas
Finding:	Cracking - External Concrete Paving Damage Category 2 - Distinct (less than 3mm) to some areas
Information:	Distinct cracks were identified in external concrete paving. Distinct cracks are generally found in older concrete paving, and may also present as a trip hazard as consequence of an uneven or curved surface.

General age and expected deterioration of the paved areas is a common cause of this type of cracking. However, expansion and contraction of the slab may also have occurred due to environmental factors. Such factors include variable moisture and weather conditions, the presence of trees and their roots having a settling or lifting affect on the soil, or the effect of load bearing, e.g. heavy vehicles over a sustained period of time.

Cracking to this degree may also be due to poor original installation of the concrete. Factors such as poor compaction of the sub surface and/or inadequate reinforcing of the slab may create cracking and other secondary defects.

Repairs are likely to be required to prevent further cracking and to reduce hazards

associated with cracking, such as tripping. Monitoring of all cracking should be conducted frequently. Always contact a building inspector should cracks widen, lengthen, or become more numerous.

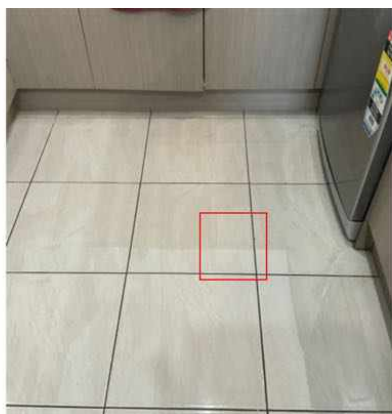
Finding 3.12

Building:	Main Building
Location:	Kitchen, hallway
Finding:	Tiles - Cracked or damaged (Minor chips or hairline)
Information:	Cracking was evident to the tiling in this area at the time of inspection. While the cracking appears to be minor, this area is frequently exposed to water, allowing potential for water penetration into adjoining sections of walls or flooring.

If left unmanaged, water penetration to these areas may lead to subsequent water damage, which is likely necessitate repair work to affected building elements.

A tiling contractor should be appointed to ensure that no further water damage occurs. The re-application of silicone and grouting throughout remaining tile work is also advised, to further protect the area against water penetration.

Where water penetration has led to water damage, appointment of a relevant tradesperson may be required to repair damaged building elements.

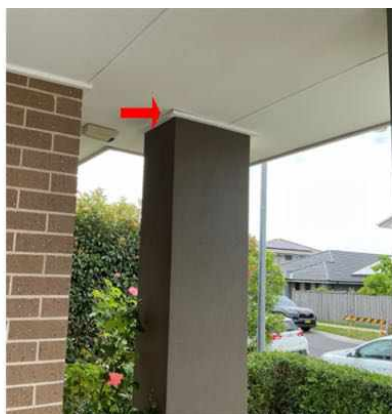
Finding 3.13

Building:	Main Building
Location:	All External Areas
Finding:	Eave Trim Separation - to some areas
Information:	The external timber trim at the eaves corner displays a visible separation crack, likely due to minor building movement or timber shrinkage over time. While not structurally significant on its own, the gap may allow moisture ingress and should be sealed with a flexible exterior-grade sealant to prevent further deterioration.

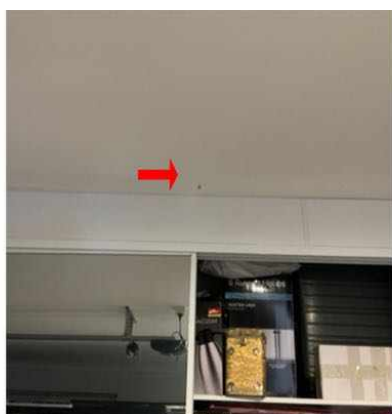
Finding 3.14

Building: Main Building
 Location: All Internal Areas - Garage , bathroom
 Finding: Ceiling nails - Popping To some areas
 Information: Numerous popped nails were identified in the internal ceiling at the time of inspection. Nails and screws hold simply by the friction between them and the surface they are applied to. Over time, the nails and screws can back out, which is often a result of general ageing and deterioration of the building structure.

If left unmanaged, the ceiling sheets may become loose and unstable, increasing the rate of deterioration of the internal ceiling and creating potential for the development of secondary defects.

Re-fastening of popped nails will help to maintain the stability of the internal ceiling and associated building elements. Such minor works will also help to improve the appearance of the affected area and secure the ceiling sheets, so as to prevent the onset of ceiling sagging. These works should be performed by a qualified carpenter or plasterer at client discretion.

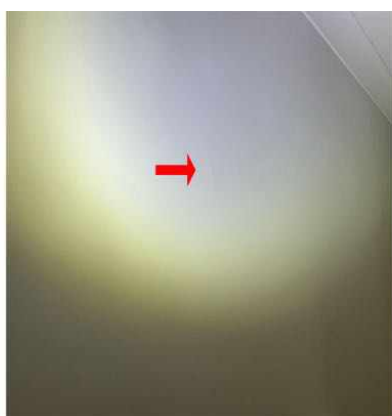
Finding 3.15

Information: Numerous popped nails were identified in the wall sheets at the time of inspection. Nails and screws are held by the friction between them and the surface that they are applied to. Over time, the nails and screws can back out, which is often a result of general ageing and deterioration of the building structure.

If left unmanaged, the wall sheets may become loose and unstable, increasing the rate of deterioration of the wall sheeting and creating potential for the development of secondary defects.

Re-fastening of popped nails will help to maintain the stability of the internal walls and associated building elements. Such minor works will also help to improve the appearance of the affected area and secure the wall sheets. These works should be performed by a qualified carpenter or plasterer at client discretion.

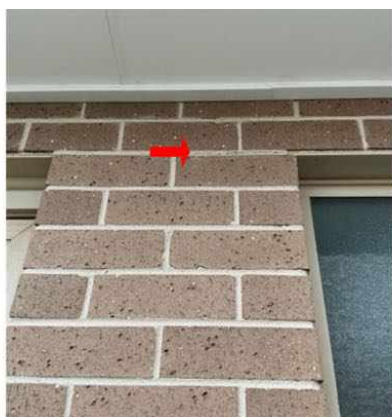
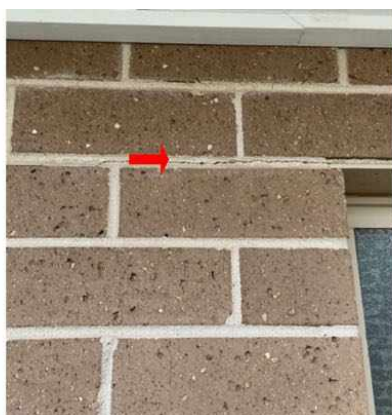
Finding 3.16

Finding: Brickwork - Deteriorated mortar
Information: Mortar, or 'bedding', is the material which fills joints and intersections between bricks in masonry walls and structures. Sections of mortar in this brickwork were identified as having deteriorated, which is generally expected for a property of this age and condition.

Mortar may deteriorate as a result of age of building materials, minor movement of bricks, or frequent exposure to weathering. Mortar should be replaced to ensure that bricks remain in their intended location and to prevent gaps, which would allow water or moisture ingress and secondary damage as a result.

Mortar deterioration can be addressed by a bricklayer where areas of deterioration are localised and easily accessible. Alternatively, appointment of a registered builder is advised, to repoint large areas of decaying mortar. Where secondary structural defects have become evident, consultation with a structural engineer may be required.

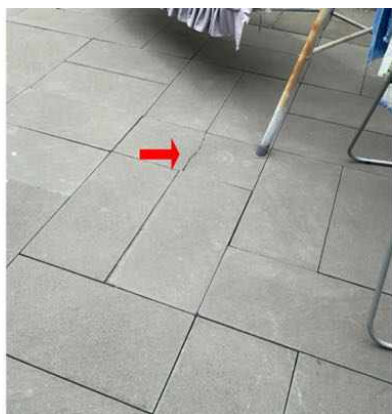
Building:	Main Building
Location:	All External Areas
Finding:	Building element - Damaged - Render damaged front , paver cracked , masonry brick damaged rear
Information:	Breakage occurs generally when the building materials have either aged and decayed, or as a result of damage (accidental or deliberate).

Repair and/or replacement of broken elements is advised to ensure that additional secondary defects do not arise as a consequence. Such works are necessary, as all building elements play a key role in the operation and function of the overall structure and its performance.

A relevant tradesperson should be appointed to repair or replace the affected building element prior to any subsequent damage being caused.

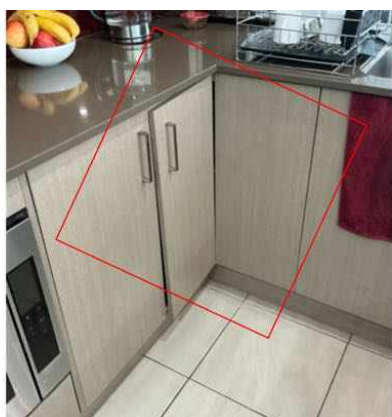
Repair and/or replacement of broken elements is advised to ensure that additional secondary defects do not arise as a consequence. Such works are necessary, as all building elements play a key role in the operation and function of the overall structure and its performance.

A relevant tradesperson should be appointed to repair or replace the affected building element prior to any subsequent damage being caused.

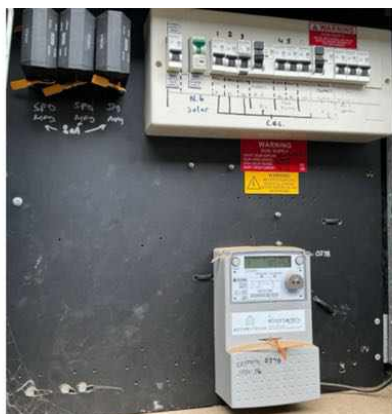
A durable notice should be placed in the switchboard unit to indicate current termite barriers. At the time of inspection, it appeared as though no termite management system has been installed, with no evidence to suggest preventative works taking place.

The client may consider gaining further advice from a pest controller as to the costs and procedures involved with this application. It is recommended that obtaining such advice be a short-term priority.

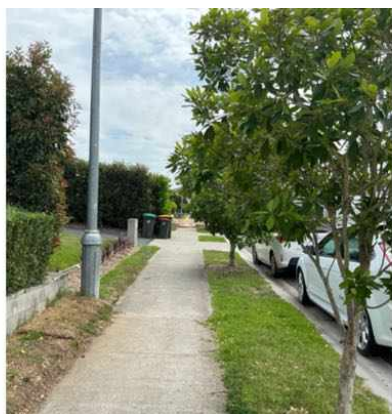
Finding 6.02

- Building: Main Building
- Location: All External Areas
- Finding: Trees within 50m
- Information: Trees within 50m of the property can be conducive to termite activity. It is recommended an invasive inspection of all trees with 50m to the property be carried out by a qualified pest control expert.

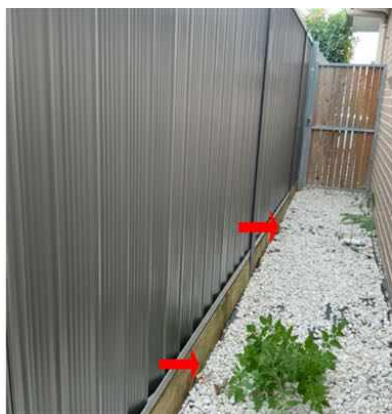
Building:	Main Building
Location:	All External Areas
Finding:	In ground contact - Timber
Information:	Any timbers in direct ground contact provide opportunity for concealed termite entry and are likely to be subject to premature rot and decay as the soil retains moisture or damp conditions against the timbers.

Remove untreated timber that is in direct contact with external grounds. Consider replacement with more durable materials i.e. treated timber or non timber elements. Frequent pest inspections are advised to readily identify any termite activity in these areas.

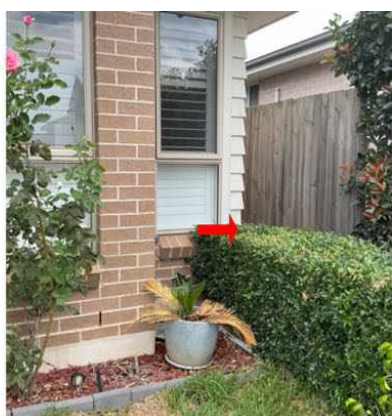
The removal and replanting of species that do not provide "cover" or cutting back of existing vegetation will assist greatly in preventing Bridging from occurring.

The removal of any such materials that may be conducive to termite activity should be carried out as soon as possible and arrange re inspection to minimize the risk of termite attack.

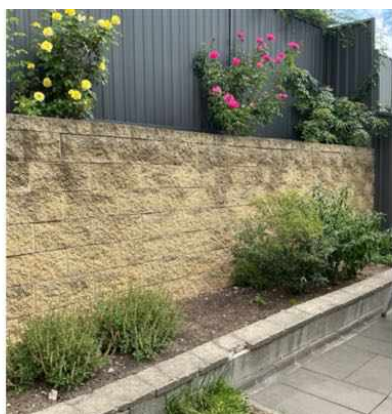
Building:	Main Building
Location:	All External Areas
Finding:	Retaining Wall Drainage
Information:	Drainage provisions could not be confirmed during visual inspection. Recommend inspection by a licensed landscaper to ensure adequate drainage provisions have been provided.

Retaining walls require ongoing maintenance to ensure stability and drainage performance. Regularly check for signs of cracking, movement, or leaning, and ensure that weep holes or subsoil drains remain unobstructed to prevent water pressure buildup. Vegetation should be kept clear from the wall face and upper edge to avoid root pressure or added moisture. Periodic inspection and maintenance will help extend the wall's service life and prevent structural deterioration.
