Building and Timber Pest Inspection Report

Inspection Date: Tue, 17 Feb 2026

Property Address: 1 Sherridon Cres, Quakers Hill NSW 2763,
Australia

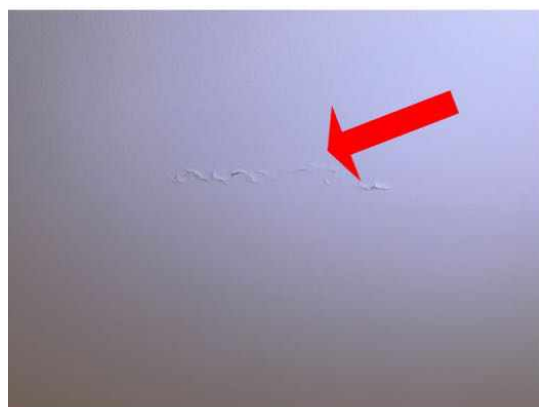
Building: Main Building
 Location: Living Room
 Finding: Ceiling - Water damaged
 Information: Water damage to the ceiling lining is generally an indication of excessive moisture being present in the roof void, usually via a leak to the roof covering.

Where water damage is evident to the ceiling, the primary requirement is to identify and rectify the source of the leak. A roofing plumber should be appointed as soon as possible to identify the leak and perform rectification works as necessary, ensuring the water damage is restricted.

Once the leak is repaired, consultation with relevant tradespeople, including plasterers and painters, is advised. Rectification works may include replacement of ceiling lining or minor repainting, depending on the extent of the damage.

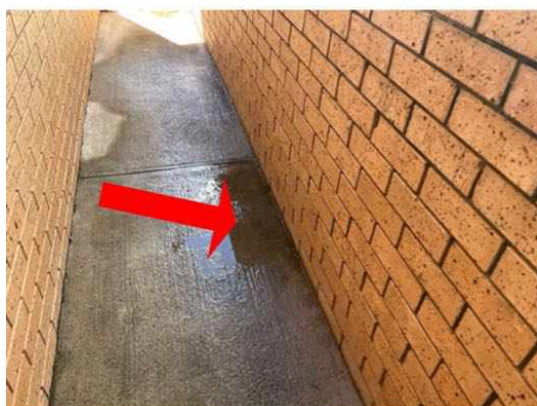
Building: Main Building
 Location: All External Areas
 Finding: Evidence of Water Ponding and Possible Moisture Ingress
 Information: Water ponding was observed on the concrete surface adjacent to the boundary retaining wall. The moisture appears to be accumulating along the base of the wall and does not appear to be draining adequately away from the structure.

The source of the water could not be confirmed at the time of inspection. Possible causes include:

- Inadequate surface drainage and fall toward a suitable stormwater outlet

- Failure or lack of subsoil drainage behind the retaining wall
- Water ingress from the neighbouring property
- Concealed plumbing leak within the vicinity

Prolonged moisture accumulation in this area may contribute to deterioration of masonry, mortar joints, footing movement, rising damp, or structural issues over time.

An invasive inspection is strongly recommended to determine the source of the moisture. This may include:

- Pressure testing of nearby plumbing services by a licensed plumber
- Investigation of subsoil drainage behind the retaining wall
- Moisture testing of adjacent wall surfaces
- Lifting sections of concrete (if required) to inspect drainage conditions

A licensed plumber and/or drainage specialist should be engaged as soon as possible to identify the source and carry out rectification works as necessary.

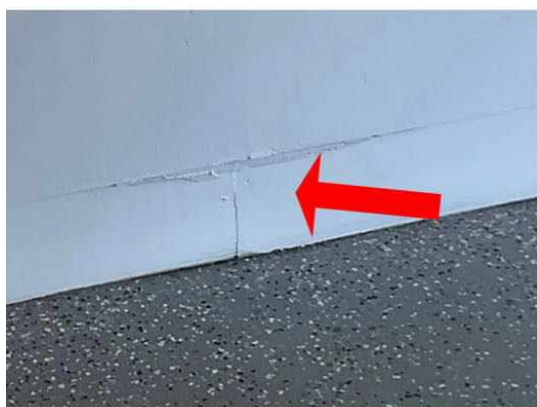
Finding 3.02

Building:	Main Building
Location:	Garage
Finding:	Garage – Wall Lining (Evidence of Possible Moisture Damage)
Information:	Evidence of previous plasterboard replacement was observed to the lower section of the garage walls. The wall lining has been cut approximately 200mm above slab level around the perimeter and patched with replacement sections.

This type of repair is commonly associated with previous moisture or damp-related damage at slab level. The presence of perimeter cutting suggests the lower wall lining may have been affected by moisture ingress or rising damp. The workmanship of the repair is uneven.

If the underlying moisture source has not been rectified, further deterioration of wall lining and potential corrosion to steel framing components may occur.

An invasive inspection is recommended to:

- Remove sections of wall lining as required
- Inspect the slab edge, bottom track and wall cavity for moisture, corrosion or ongoing damp issues
- Identify the source of moisture (if present)

Moisture monitoring is also recommended to confirm whether the condition is active or historical.

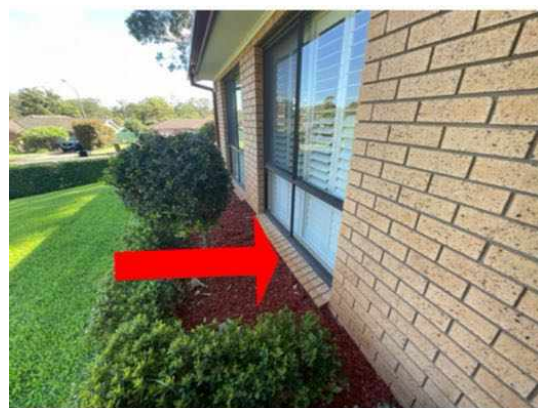
Finding 3.03

Building:	Main Building
Location:	All External Areas
Finding:	Site drainage - Inadequate
Information:	The site drainage in this area was found to be inadequate at the time of inspection, creating potential for subsequent water damage to associated building elements.

It is important that water does not lie against the base of walls; surrounding paths and ground levels should be sloped to drain water away from walls. Downpipes should not discharge stormwater onto lower walls or plinths. Stormwater should be carried away by large, regularly cleaned drains. Ground levels may need to be lowered to expose a buried DPC.

Where site drainage is inadequate, installation of an Agricultural (Aggie) Drain may be required. A qualified plumber should be appointed to further inspect the property and perform any remedial works as necessary. Water damage and secondary defects are likely to occur if left unmanaged.

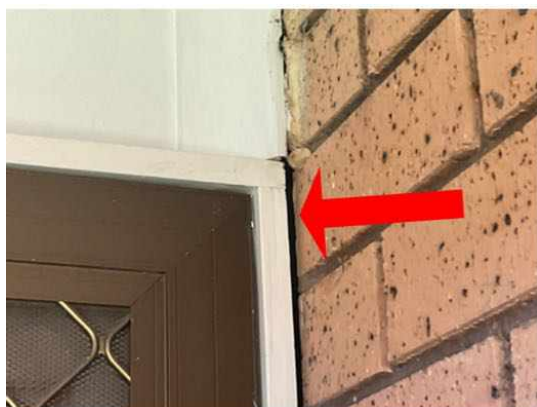
Building:	Main Building
Location:	Exterior walls - front
Finding:	Window / Door - Gap
Information:	A significant gap was identified between the brick and window / door frame in this area. Where large gaps to the head / side appear, it may indicate a variety of defects, ranging from uneven framework, sagging hinges or uneven flooring.

A gap to the head of the window may also indicate movement of the foundation of the property, which is a common occurrence and does not indicate structural damage.

A qualified tradesmen should be appointed to perform remedial works to restore the window to a fully operational level.

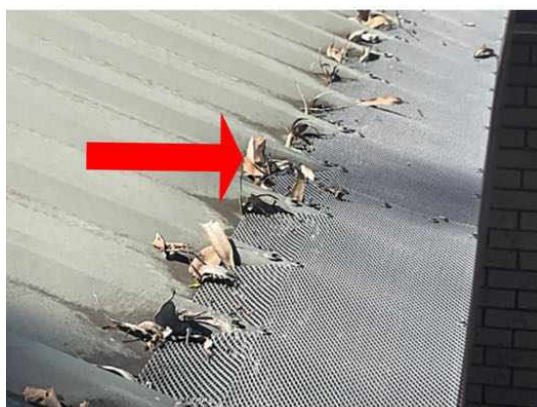
Finding 3.10

Building:	Main Building
Location:	Roof Exterior
Finding:	Gutters - Blocked
Information:	Roof plumbing structures, such as guttering and downpipes, should be free of all debris to prevent blockages. Blockages of the guttering and downpipes will lead to pooling and accumulated water overflows, which is likely to subsequently flood eaves

Blocked gutters are likely to lead to high levels of moisture in the affected areas. Such moisture will not only cause rust and decay of the associated building materials, but can also provide conditions that are conducive to termite and timber pest activity. Blockages in gutters should therefore be removed immediately to ensure dry conditions are maintained.

Consult a Licensed Plumber for further specific advice on remedial works that may be required. In the interim, it is highly advised that blocked gutters be removed by the homeowner or a general handyperson as a matter of urgency.

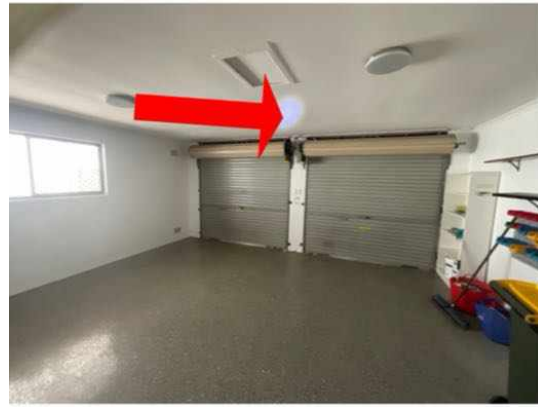
Information: Sections of the ceiling were found to be sagging at the time of inspection. Sagging to the fixed ceiling structure generally indicates that the building materials have swollen, due to contact with water, or that fixings (e.g. nails or glue) have become loose and require reattachment.

Where minor sagging is evident, comparatively minor works, such as re-gluing of ceiling sheets, may be required. Such works may be performed by relevant tradespeople, such as plasterers and painters. Where excessive moisture has caused the roofing structure to swell and sag, the source of the water leak should primarily be identified prior to any remedial works being performed.

In some cases, sagging ceiling linings may also indicate that there are structural issues, causing surfaces to warp, twist or sag. Where sagging appears to be major, appointment of a structural engineer is advised to further inspect the property and identify the source and rectification works required.

The appropriate action should be taken by the client as soon as possible to ensure that any potential further damage is limited.

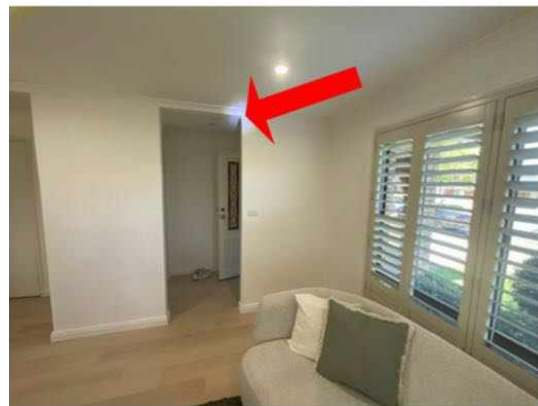
Finding 3.14

Building:	Main Building
Location:	Living Room
Finding:	Cornices - Sagging
Information:	Sagging and uneven cornices generally indicate that the building materials have swollen, due to contact with water, or the movement of the ceiling joints or that fixings (e.g. nails or glue) have become loose and require reattachment. In some cases, sagging and uneven surfaces may also indicate that there are structural issues causing surfaces to warp, twist, or sag.

Where sagging appears to be major, appointment of a structural engineer is advised to further inspect the property. Otherwise, minor works such as re-gluing of wall/ceiling sheets may be required and should be performed by an aptly qualified plasterer or carpenter.

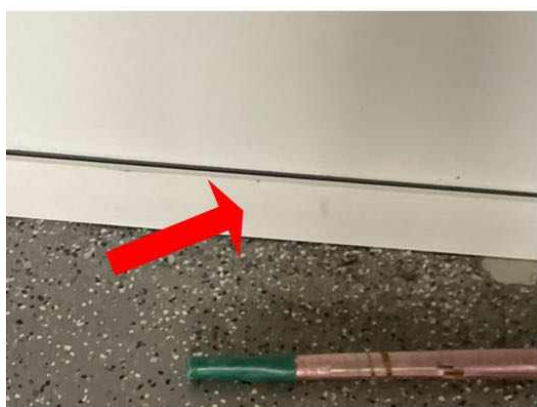
Building:	Main Building
Location:	Garage
Finding:	Skirting board / Architraves - Loose or missing or damaged
Information:	The skirting board / architraves in this area is loose / missing / damaged and requires adjustment to tighten.

If left unmanaged, the timber skirting / architraves may further deteriorate, causing potential for the development of other minor secondary defects.

A relevant tradesperson should be appointed to perform these rectification works at discretion of the client.

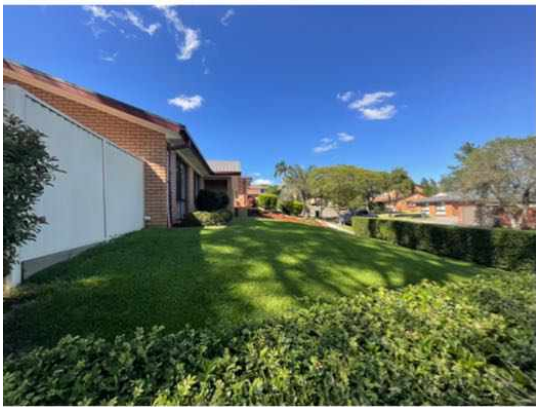
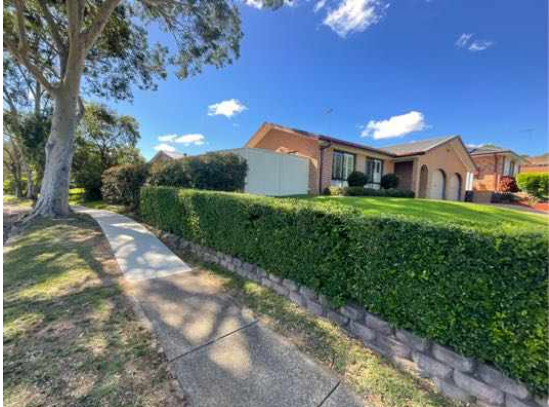
Finding 6.01

Building: Main Building
Location: All Areas
Finding: Garden Beds - Conditions Conducive to Termites
Information: Garden beds were found to be evident in the garden area. These garden beds can include untreated timber, and with a combination of moisture from watering hosing can make conditions conducive to termite activity and termite ingress.

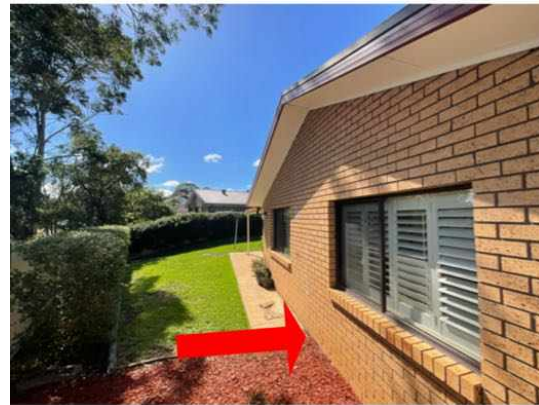
Additionally build-up of moisture is likely to occur if weep holes are covered further attracting termite activity to these areas.

It is highly recommended that weep holes are left exposed in all areas throughout the external property. Therefore if any termite activity leading into weep holes becomes easily detectable during frequent pest inspections.
