# Building and Timber Pest Inspection Report

Inspection Date: Mon, 23 Mar 2026

Property Address: 1 Hawthorn Av, Kialla VIC 3631, Australia

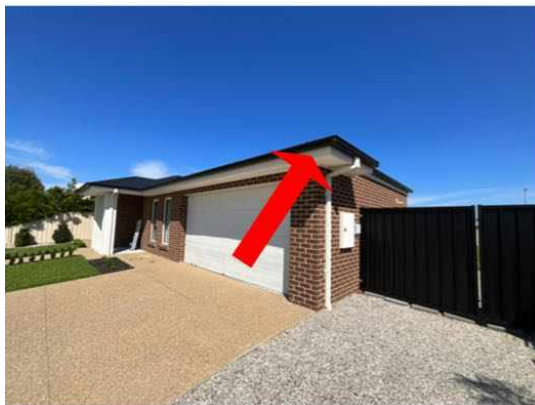
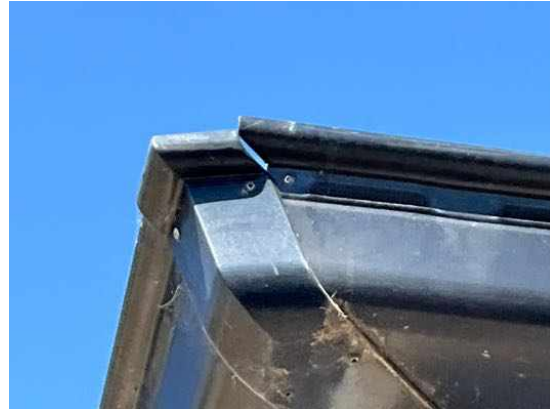
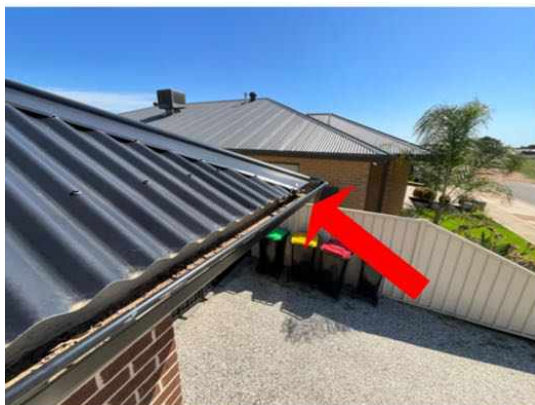
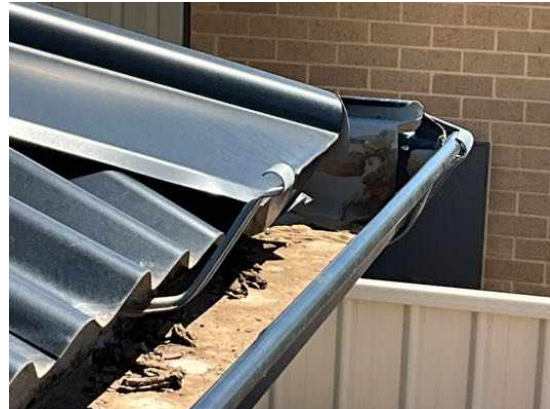
#### Finding 3.01

Building: Building 1  
Location: Eaves  
Finding: Gutter- damaged  
Information: The gutter in this area shows damage. This negatively affects the stormwater drainage.

A licensed plumber should be contacted as soon as possible to restore the area and prevent further deterioration.

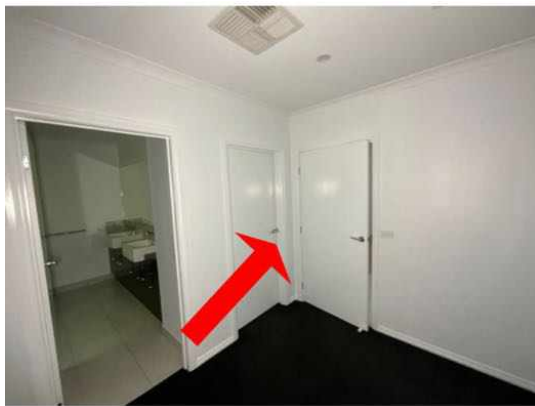
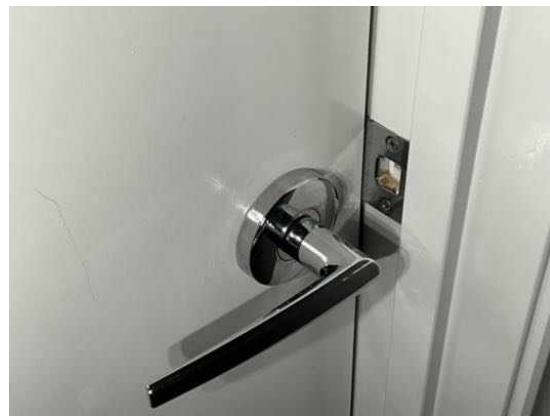
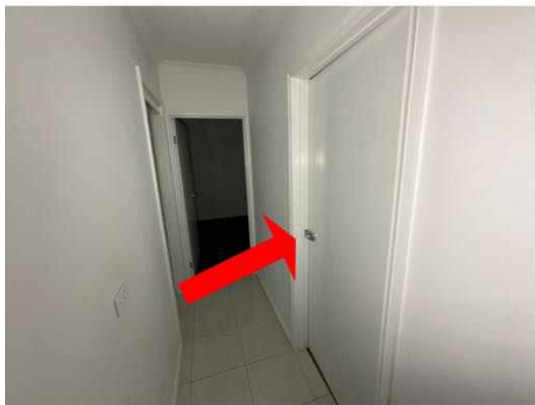
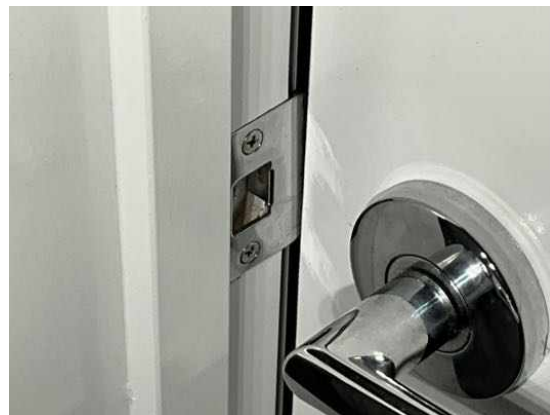
### Finding 3.02

Building: Building 1  
 Location: Walk In Robe laundry  
 Finding: Door - Striker plate misaligned  
 Information: The striker plate to this door appears to have become misaligned and has consequently resulted in the door's operation being compromised.

This is a common defect and is expected in a property of this age, whether being due to substandard installation or general deterioration of the door hardware.

Readjustment of the striker plate is recommended at client discretion. Works such as these can be completed by a general handyman or qualified carpenter.

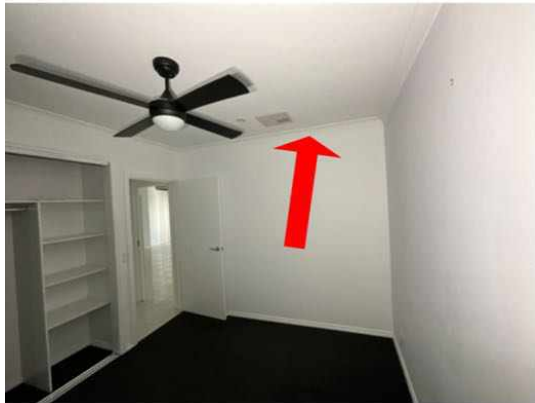
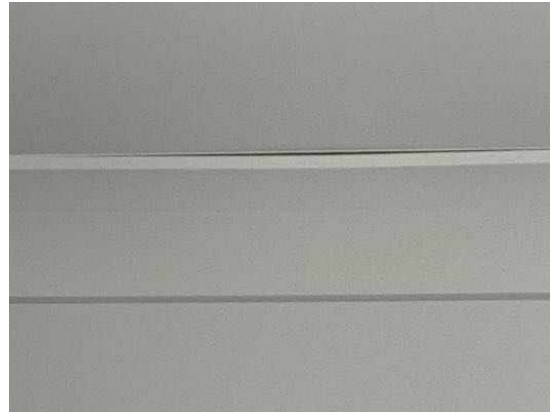
### Finding 3.03

Building: Building 1  
 Location: Bedroom 2  
 Finding: Cornice- sagging  
 Information: The cornice in this area is sagging. This may be due to age or poor initial installation.

A plasterer or handyman should be contacted soon to restore the area and prevent further deterioration.

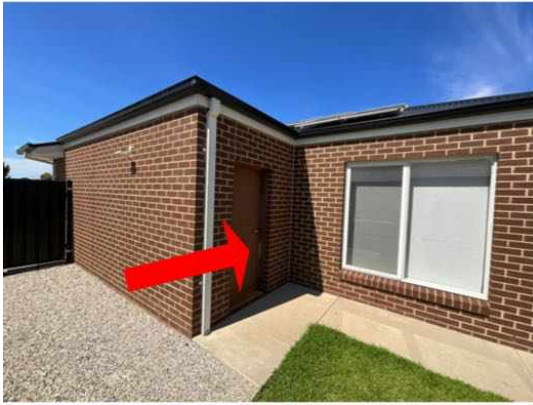
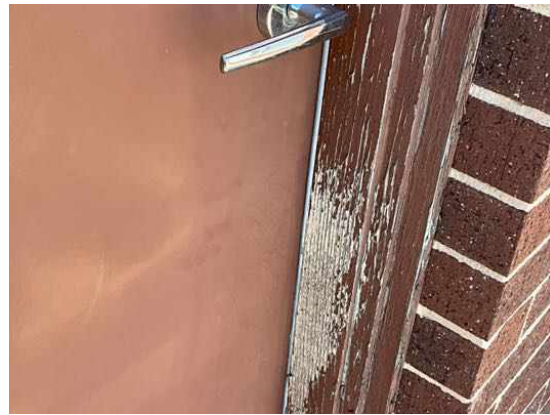
#### Finding 6.01

Building: Building 1  
Location: Garage  
Finding: Timber - exposed to weather  
Information: External timbers that are frequently exposed to harsh weather conditions require adequate protection in order to maintain their condition. Where timbers have not been painted or treated adequately, general deterioration is likely to occur at an accelerated rate.

If left unattended, replacement of these timbers is likely to be necessary in the short-term future. Adequate treatment of these timbers is required as soon as possible by a painting contractor or general handyman.

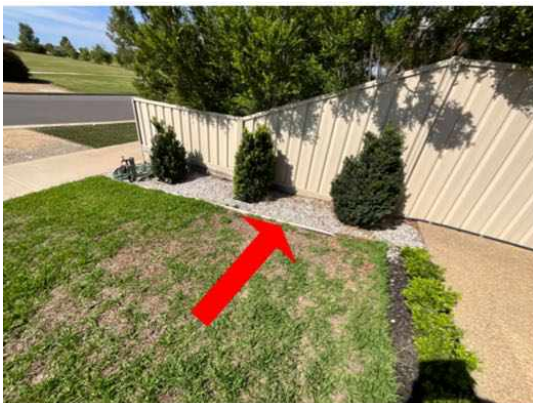
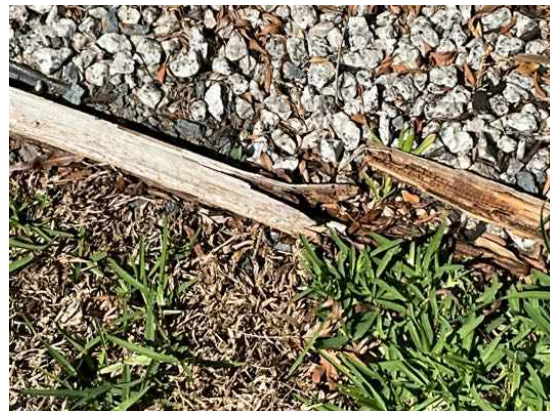
### Finding 6.02

Building:	Building 1
Location:	Yard - Front
Finding:	Untreated or non-durable timbers in a hazardous environment
Information:	To reduce the risk of timber pest attack it is essential that timber used in a hazardous environment (e.g. in direct contact with the ground or frequently exposed to damp conditions) is of sufficient durability and/or is adequately preservative treated.

Untreated timbers in direct contact with the ground are likely to develop severe wood rot and/or fungal decay if left unattended creating attraction for subterranean termites to infest the timbers from surrounding areas.

If untreated or non-durable timbers are found to be in a hazardous environment it is highly advised that replacement of these building elements be performed as soon as possible to aid the protection of the property against termite / timber pest attack.

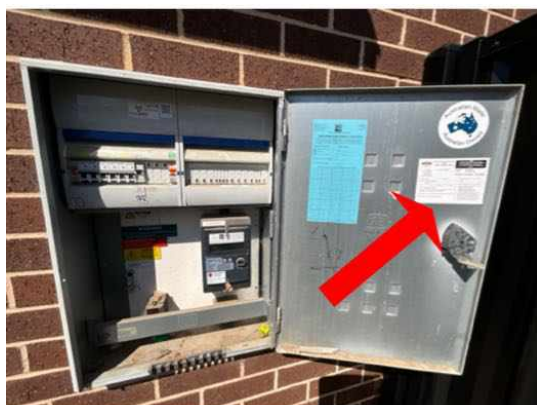
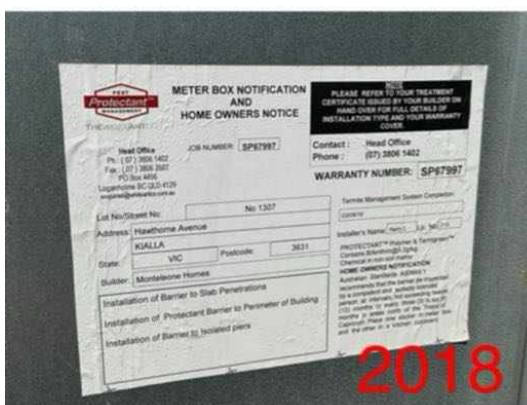
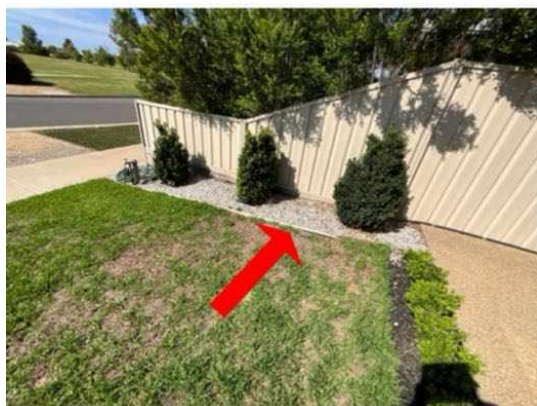
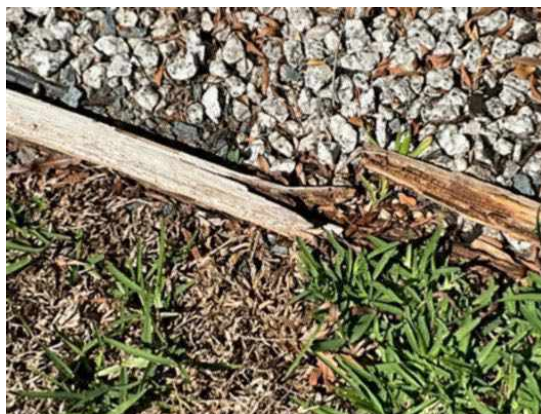
### Finding 6.03

Building:	Building 1
Location:	All External Areas
Finding:	Termite Management System - no evidence of a chemical installation
Information:	The application of a post-construction chemical termite barrier is highly recommended

for all properties, particularly if live termite activity has been found on the site previously. Such barriers are highly effective in preventing termite attack on any timber building elements throughout the property.

A durable notice should be placed in the switchboard unit to indicate current termite barriers. At the time of inspection, it appeared as though no termite management system has been installed, with no evidence to suggest preventative works taking place.

The client may consider gaining further advice from a pest controller as to the costs and procedures involved with this application. It is recommended that obtaining such advice be a short-term priority.

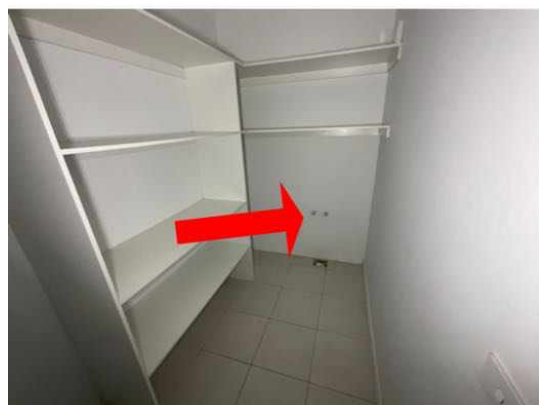
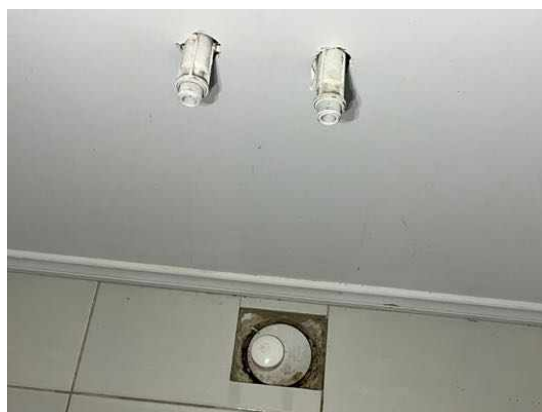
Building: Building 1  
 Location: Pantry - Walk In  
 Finding: Installation - substandard or incomplete  
 Information: The installation of this building element appears to have been completed to a substandard level of workmanship or is incomplete. Generally substandard repairs or installation are related to poor workmanship, the use of inappropriate materials, or a failure to complete installation to a suitable standard.

Where installation is substandard and/or incomplete, the client should contact the responsible trade to undertake rectification. Unfinished and substandard building works are likely to degrade more quickly and may create potential for secondary defects to associated building elements.

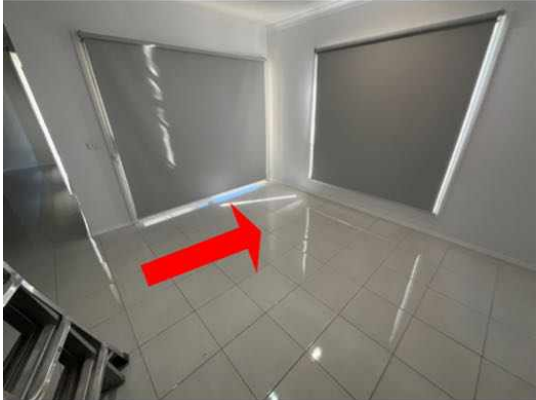
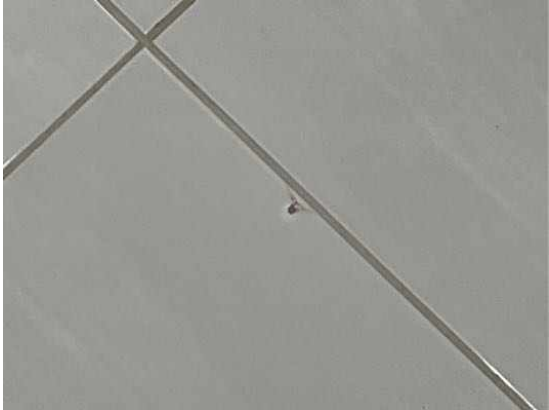
Building: Building 1  
 Location: Dining Room  
 Finding: Cracked floor tile  
 Information: Cracking in a floor tile was evident in this area at the time of inspection. It is suspected that this cracking has occurred as a result of minor settlement or impact damage.

Cracked tiles throughout the household detract from the overall appearance of the affected areas however it is unlikely to create or lead to any secondary defects.

While not considered a matter of urgency, replacement of cracked floor tiles is recommended at the clients discretion. A tiling contractor may be appointed to perform these works. Where cracks become more numerous, contact a licensed building inspector for further investigation.

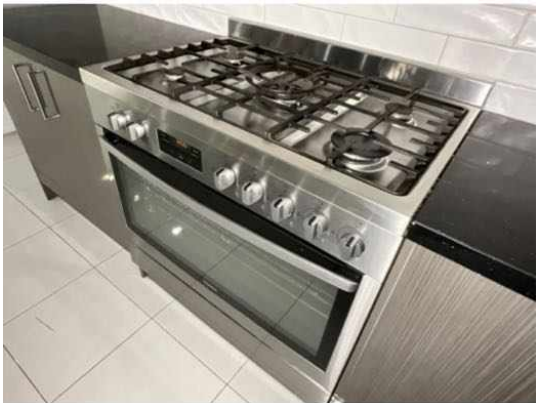
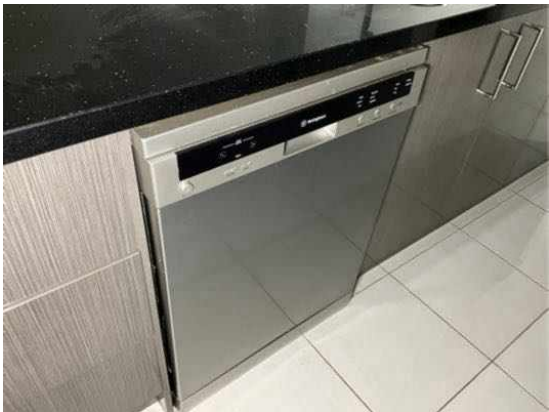
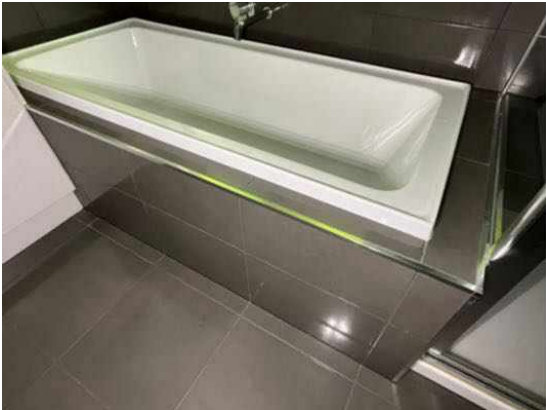
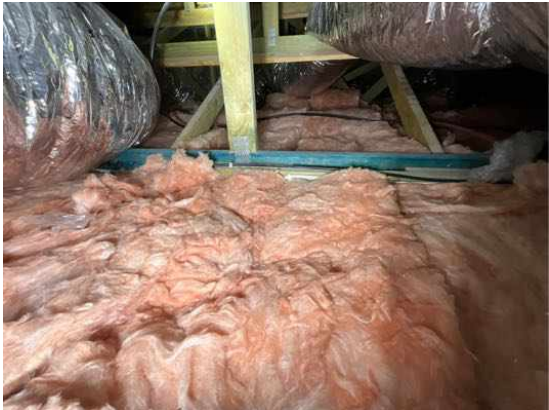
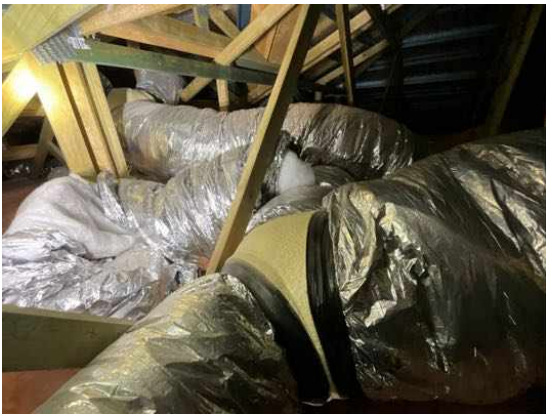
Building: Building 1  
Location: All Areas  
Finding: Additional Photos - Obstructions and Limitations  
Information: These photographs are an indication of the obstructions and limitations which impeded full inspection of the property at the time of inspection. These obstructions can hide an array of defects and should be removed to allow full inspection to be carried out. A re-inspection is recommended once the areas are made accessible.
