Building and Timber Pest Inspection Report

Inspection Date: Wed, 25 Mar 2026

Property Address: 484 Beach Rd, Sunshine Bay NSW 2536,
Australia

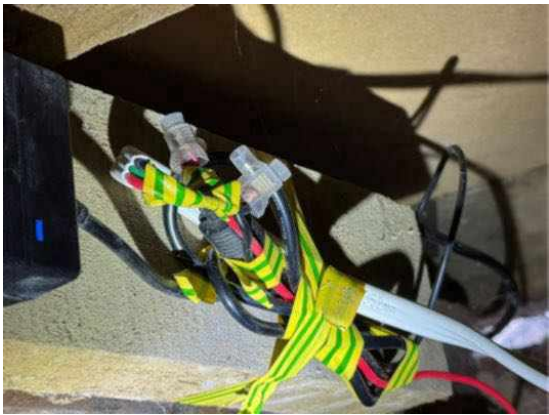
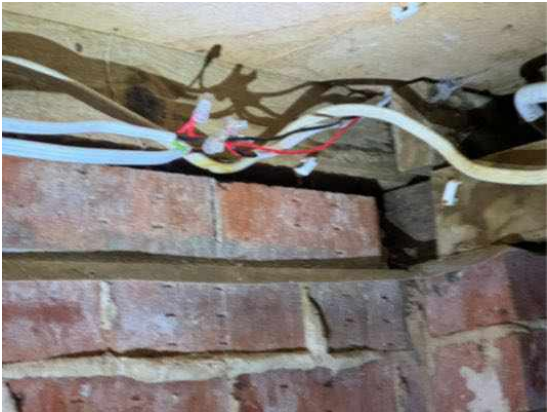
Building: Main Building
Location: All Areas
Finding: Electrical Defect Suspected
Information: At the time of inspection it appeared that there were suspected defects with the electricals. This includes;

- loose expose wiring was identified on the front power pole requiring urgent repairs.
- loose exposed electrical connections and terminations in the subfloor require immediate repairs.
- expose wiring connections in the house require urgent repairs.

Faulty wiring, switches and damaged outlets can cause shorting out of areas of the house, damage appliances and possibly cause electrocution or fires. It is advised all suspect issues be inspected by a licensed electrician before use.

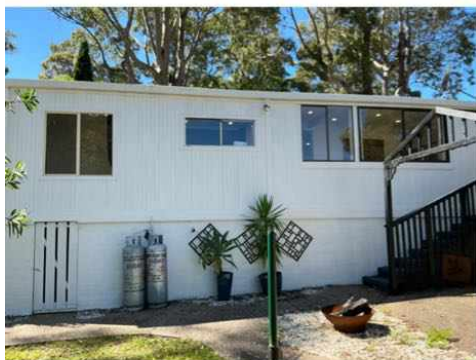
Finding 1.02

Building: Main Building
 Location: Exterior walls - rear
 Finding: Items - Non-compliant
 Information: This structure, whilst appearing to be adequate, does not comply with contemporary building practices and current Australian Standards. This includes:

All windows higher than 2000mm from the external ground/floor level must NOT be able to open wider than 125mm. It is highly recommended that permanent locks be fitted at 125mm open ASAP.

Gaps between open stair treads must not exceed 125mm.

These items should be repaired by the relevant tradesman as soon as possible.

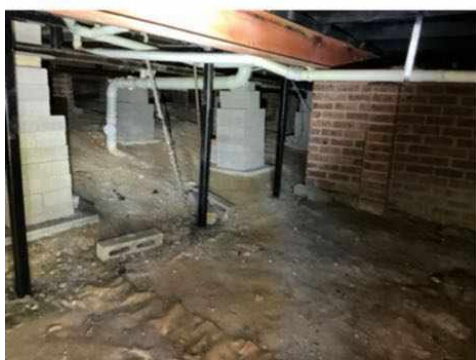
Building:	Main Building
Location:	Subfloor
Finding:	Support or Bearing - Inadequate
Information:	At the time of inspection it was evident that these subfloor structural building elements had insufficient support to take the surrounding building loads.

- these dry stacked masonry peers appear in adequate for their intended purpose. It is unknown if there are concrete footings underneath these peers. It is recommended an engineer be consulted for further instructions.

- The side decking centre pier post appears loose. It is unknown if this is sitting on a concrete footing.

Structural piers, bearers, braces and fittings are the strength of the building. If any of these components are compromised, damaged, deteriorated or missing this creates significant weakness in the buildings integrity. Repairs to any structural building members should be undertaken with urgency. Failure to do so will result in further damage possibly progressing to major safety hazards and even partial collapse.

It is advised you contact a licensed Builder as soon as possible to discuss repair works based on engineers instructions.

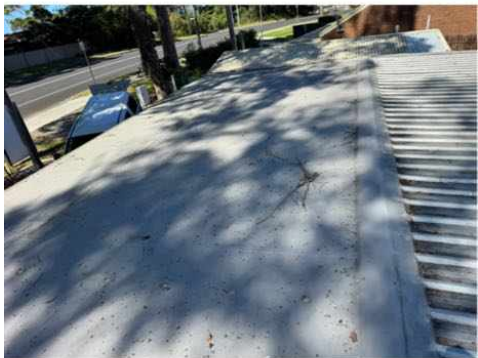
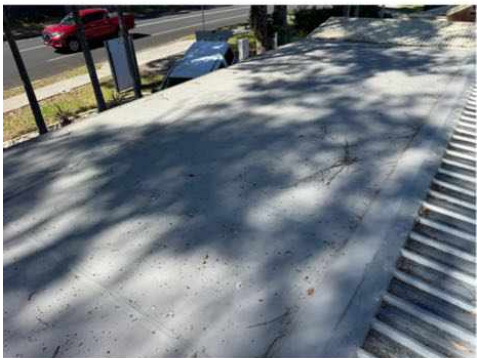
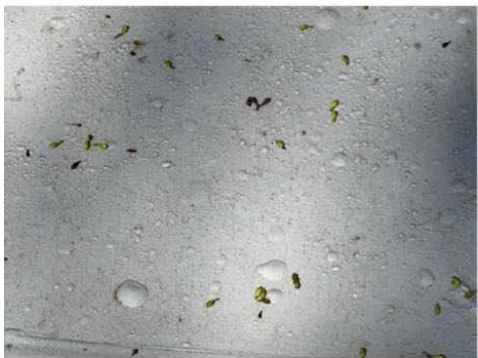
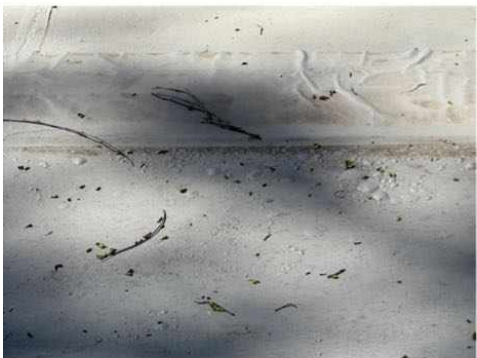
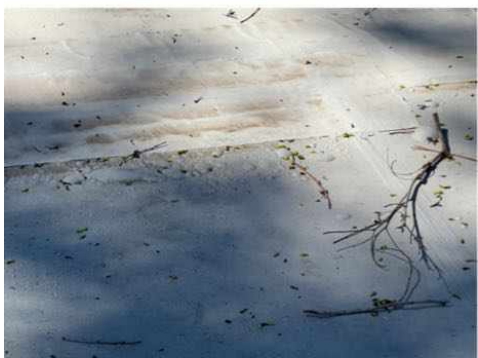
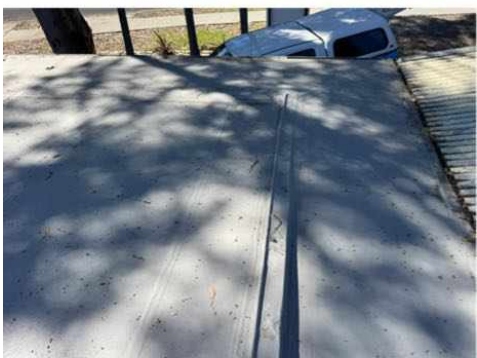
Finding 2.04

Building:	Main Building
Location:	Roof Exterior
Finding:	Unconventional Works
Information:	This work appears to have been completed to a level that does not comply with regular building practices. This includes;

Where work is not completed satisfactorily, accelerated deterioration of the associated building elements is likely to occur and secondary defects to surrounding structures may develop. It is highly recommended that the substandard work be rectified by professional services. Works to improve this area are likely to increase the safety and the operation of the associated building elements.

The client should exercise care when coming into the immediate vicinity of these issues. Rectification works are advised by the appropriate trades.

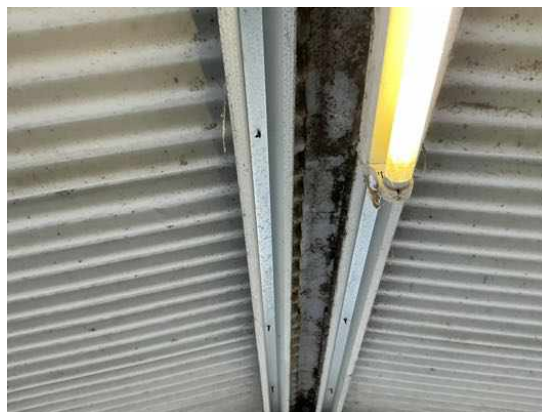
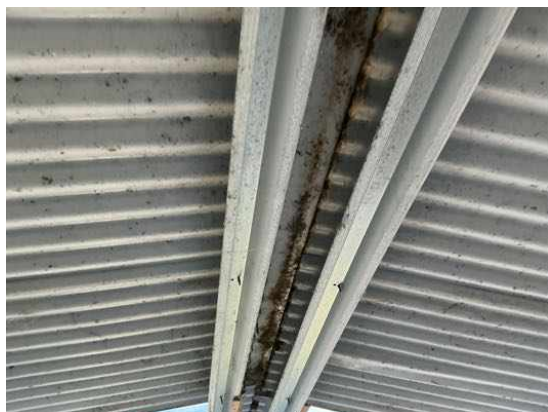
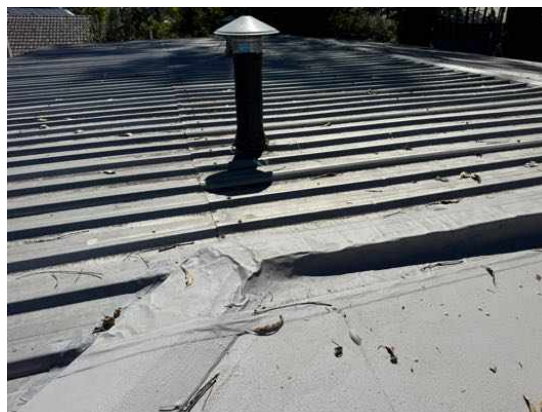
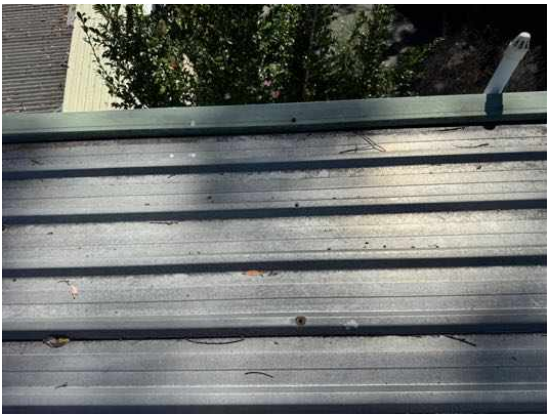
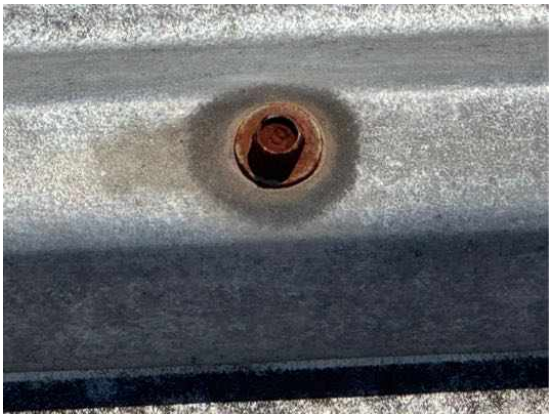
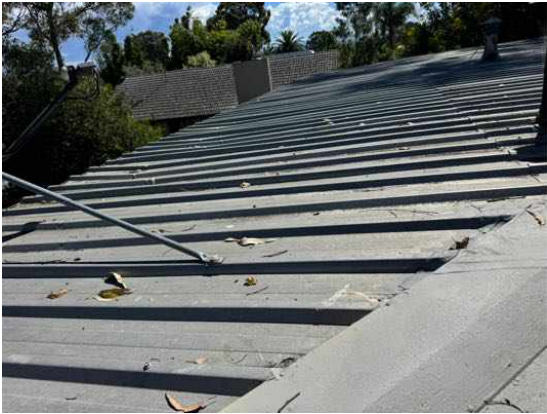
Location: All Areas
Finding: Building element - Rusted or corroded
Information: This building element shows evidence of rusting and corrosion, which is likely to have developed as a result of excessive exposure to moisture and or inadequate coatings. Rusted items include;

- The Apex end of garage roof sheets required treatment.
- some roofing screws require replacement before their rust begins to affect the roof sheets.
- What's the latest sections of the garden shed required treatment?

As surface rust provides no protection to the underlying iron, the deteriorating condition is likely to worsen if not addressed in the short-term future. Where possible, the use of galvanized (treated) metals or aluminium coated metals aid in rust prevention, as does regular general maintenance. Rust formation can be controlled with coatings, such as paint, that isolate the iron from the environment.

Rusting and corrosion should be managed by ideally removing or limiting the affected surface from exposure to moisture. A registered builder may be appointed to replace any building elements that have been severely affected by rust or water damage.

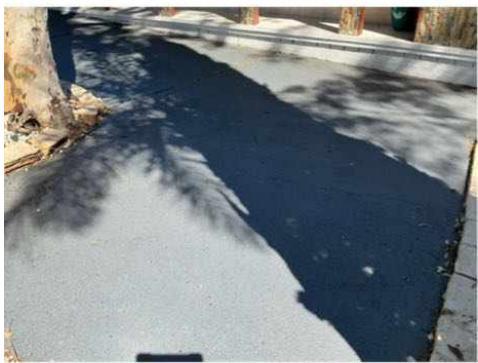
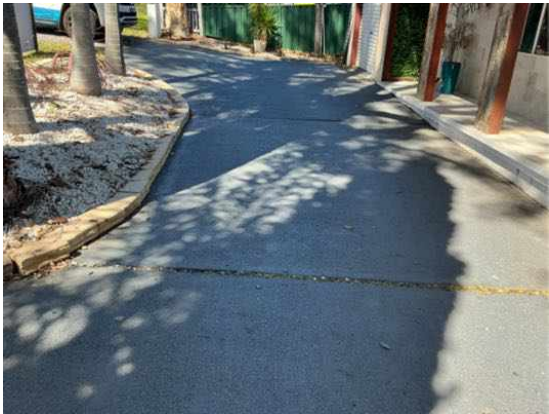
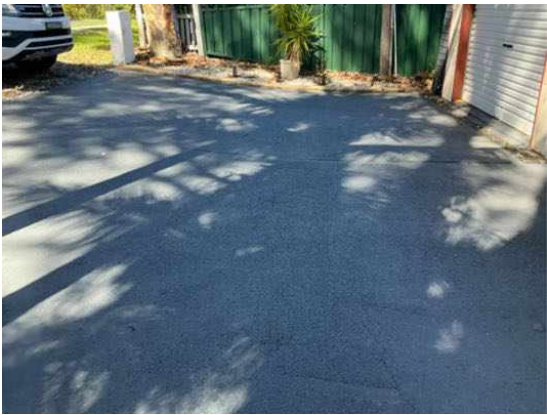
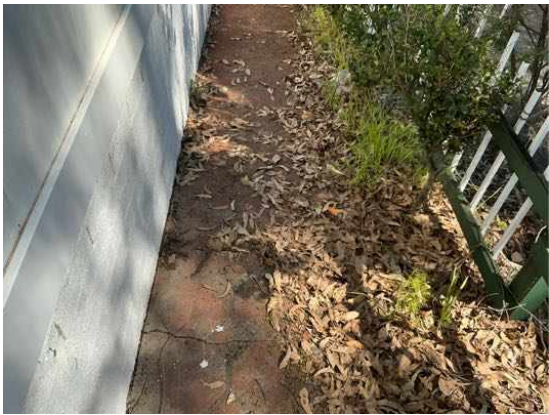
Finding 3.02

Building: Main Building
Location: All Areas
Finding: Crack in concrete slab - Category 1
Information: A crack coded as Category 1 was identified in the slab. A Category 1 crack is described as a fine but noticeable crack, with the slab at an otherwise reasonable level.

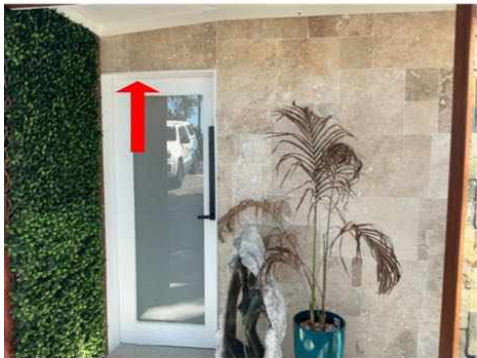
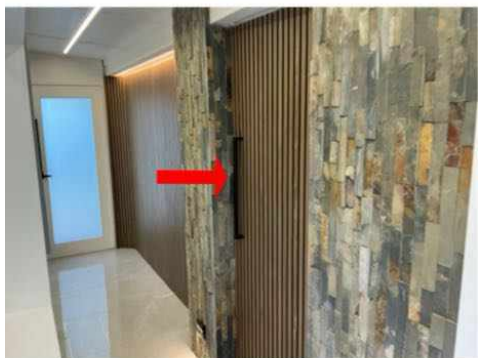
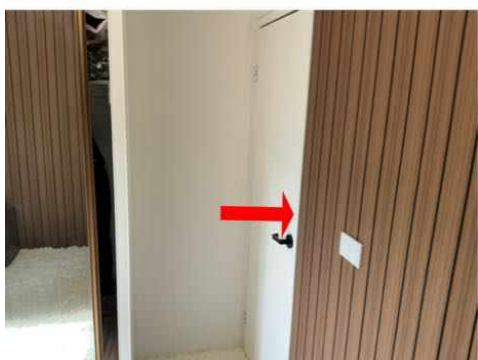
Finding 3.03

Building: Main Building
Location: All Areas
Finding: Door - Binding/jamming
Information: Binding and/or jamming of this door is evident during standard operation.

This defect inhibits the functionality of the affected door as well as creating potential for secondary defects to associated building elements, such as damage to the floor covering. A door that binds to flooring or to the associated door frame may have several causes, ranging from minor defects, such as poor installation of the door or deteriorated hardware.

For minor causes, a qualified carpenter or general handyperson should be appointed to perform minor rectification works at client discretion.

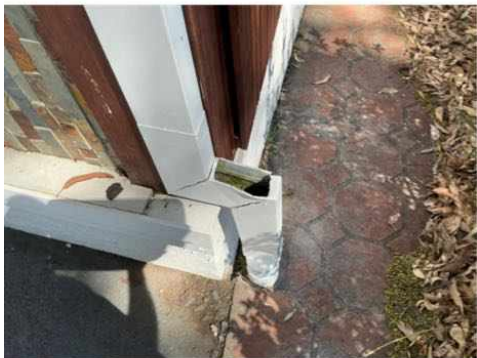
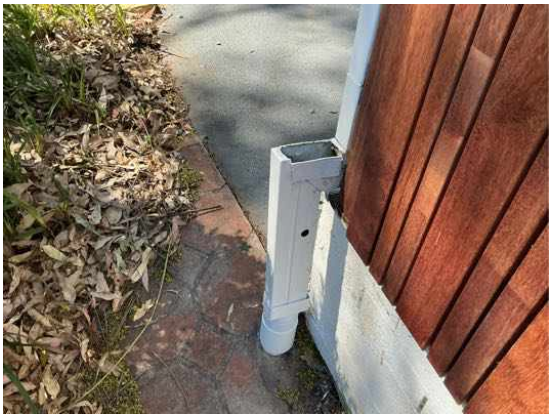
Finding 3.04

Building:	Main Building
Location:	All Areas
Finding:	Gutters and Down Pipes Leaking
Information:	The gutters and down pipes were found to be leaking creating excessive moisture in the surrounding areas.

These damp conditions can lead to secondary defects such as rot, rust or corrosion of associated building elements, the formation of fungal decay, or even the creation of potential slip hazards. When coupled with poor site drainage, pooling of water may also attract termite activity to this area.

It is highly recommended that a licensed plumber be appointed to connect the gutters and down pipes in order to prevent such an environment from being created. These minor works should be carried out as soon as possible.

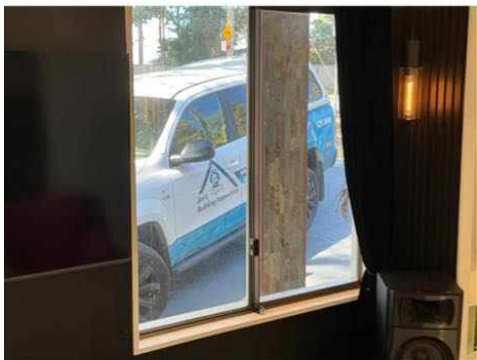
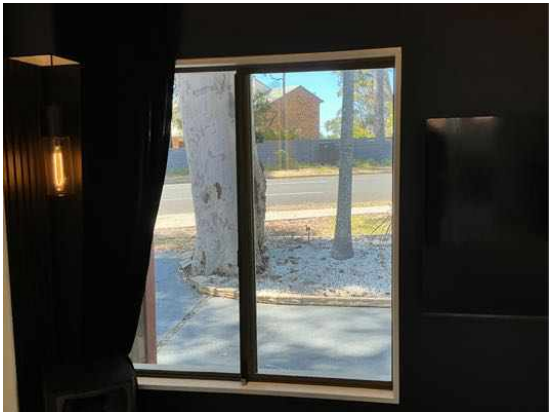
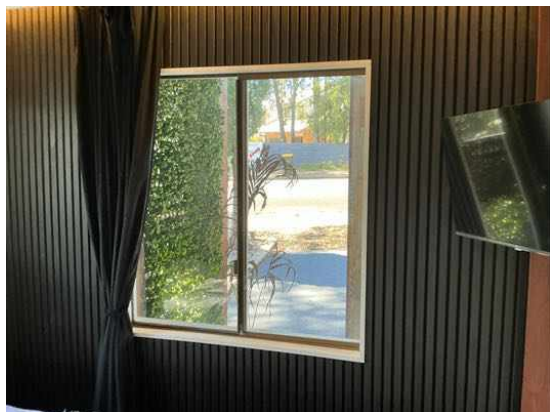
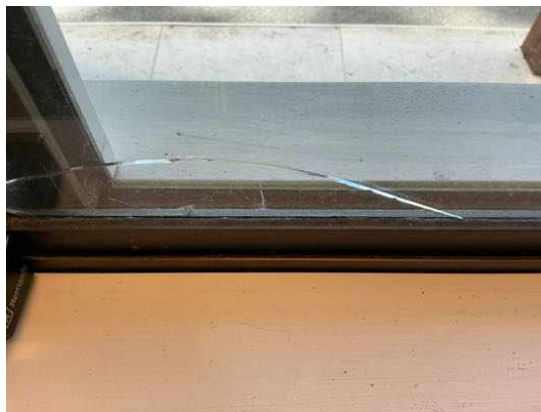
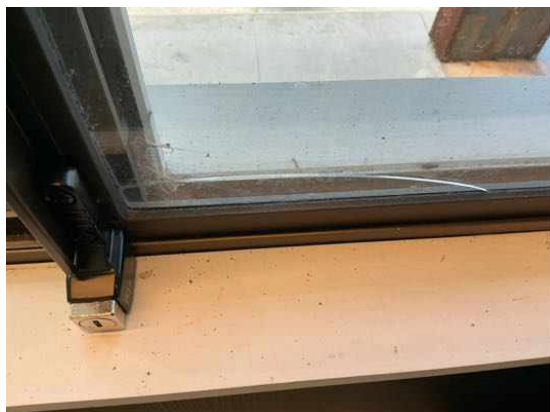
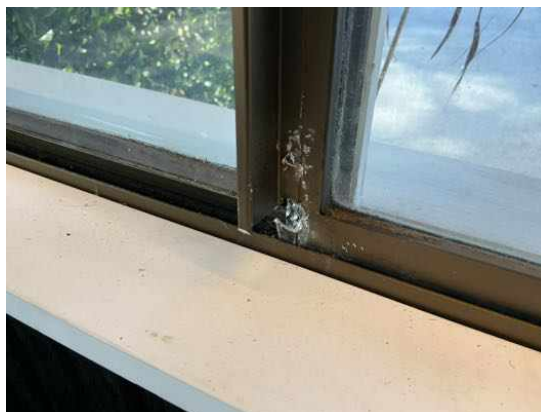
Finding 3.05

Building: Main Building
Location: All Areas
Finding: Building element - Damaged
Information: Breakage occurs generally when the building materials have either aged and decayed, or as a result of damage (accidental or deliberate). This includes;

Repair and/or replacement of broken elements is advised to ensure that additional secondary defects do not arise as a consequence. Such works are necessary, as all building elements play a key role in the operation and function of the overall structure and its performance.

A relevant tradesperson should be appointed to provide a quote to repair or replace the affected building element prior to purchase.

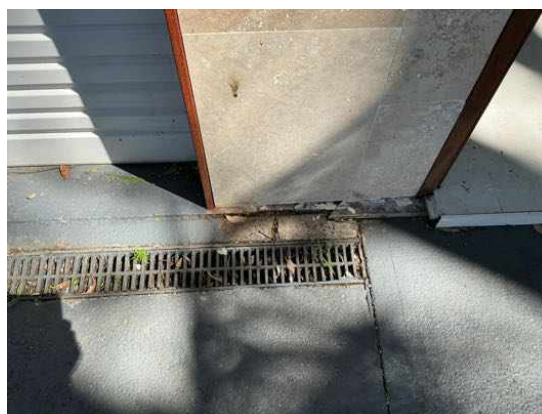
Building:	Main Building
Location:	Driveway
Finding:	Building element - Blocked
Information:	Blockages prevent building elements from operating as intended, detracting from the overall function of the affected building elements. Additionally, the lack of general maintenance may lead to the development of more significant defects, such as damage to surrounding building materials.

Blockages should be removed and addressed promptly, as they will lead to the development of secondary building defects. The blockage should be removed as the primary rectification works. Secondly, check for any secondary or concealed damage, and then attempt to address the cause of the blockage to prevent recurrence or any water damage to associated structures.

Depending on the location of the blockage and the building elements affected, a licensed plumber may be required to perform necessary remedial works.

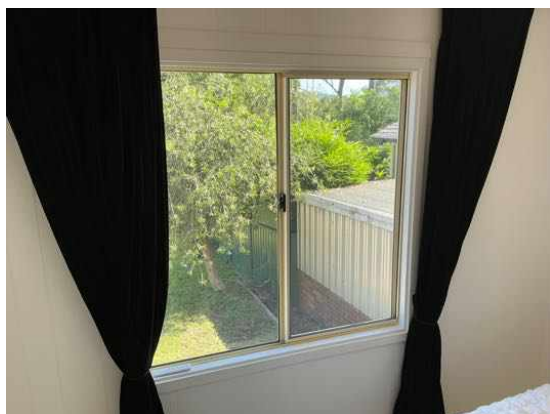
Building:	Main Building
Location:	Exterior walls - front
Finding:	Window handle - Not latching
Information:	It was noted that the window in this area was not latching during operation at the time of inspection.

Whilst detracting from the functionality of this building element, this minor defect may also be a security risk, and may therefore have serious implications if left unattended. Such damage is identified as general wear and tear, which is expected for building elements of this age.

A qualified carpenter or general handyperson may be appointed to perform rectification works as necessary. If left unattended, further functional impairment is likely to occur.

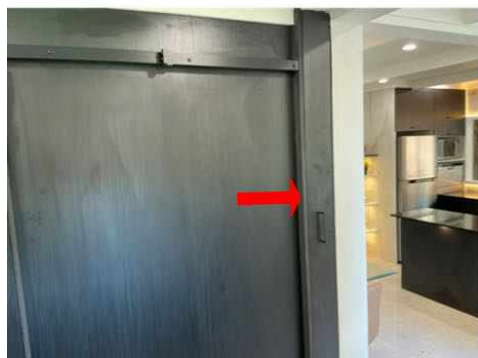
Finding 3.10

Building:	Main Building
Location:	All Areas
Finding:	Fitting or fixture - Loose
Information:	The fitting in this area is loose and requires adjustment to tighten.

If left unmanaged, the fitting may further deteriorate, causing potential for the development of other minor secondary defects.

A relevant tradesperson should be appointed to perform these rectification works at discretion of the client.

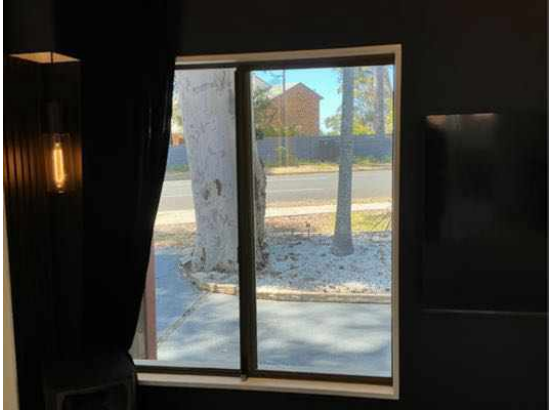
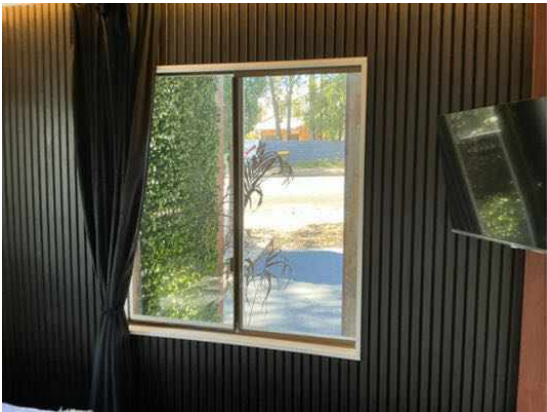
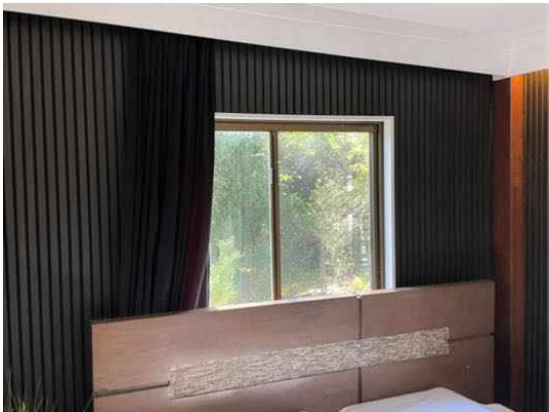
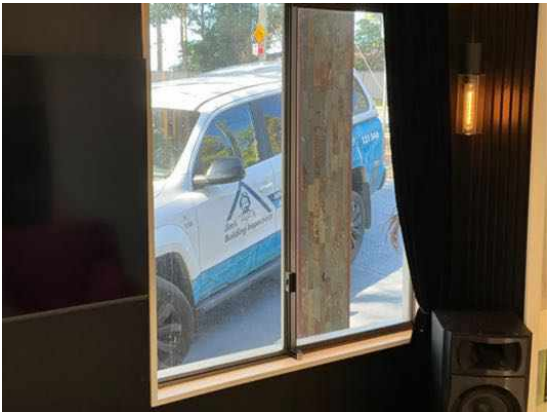
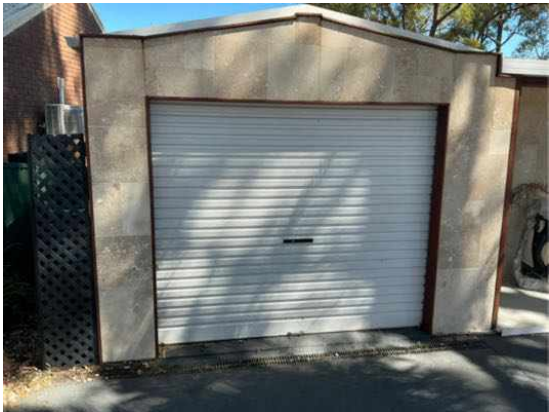
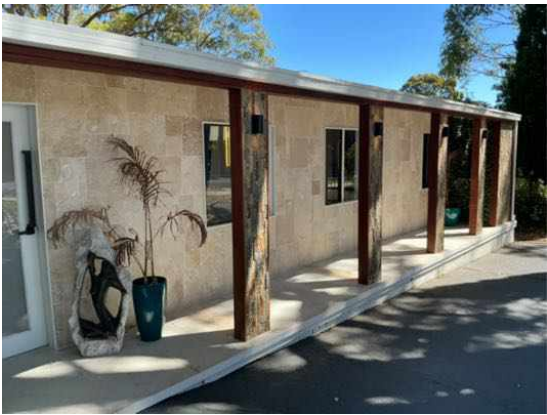
Finding 3.11

Building:	Main Building
Location:	All Areas
Finding:	Incomplete and Substandard Works
Information:	The works to this area appear to be incomplete and substandard. Including;

development of building defects and may impede on the safety and integrity of the overall structure.

It is highly recommended that the relevant trades be appointed to complete these works and ensure the safety of the area and the longevity of all associated building elements.

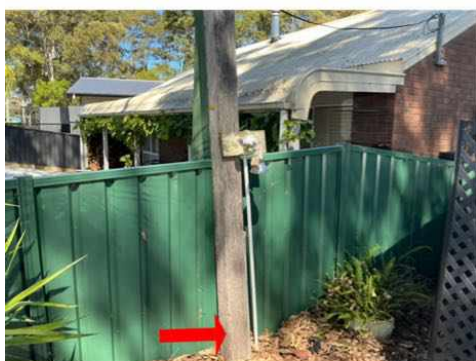
Information: Termite activity was found to have affected this area. Any affected building components should be replaced by the relevant tradesmen. It is advised that the area be visually inspected frequently to ensure that the condition of affected building materials does not reoccur.

Please note that although no evidence of live termite activity was found, because of obstructions and access restrictions the extent of any activity in the wall cavity and roof space areas is unknown. A building contractor may be appointed to provide a more invasive inspection.

It is strongly recommended that a licensed Timber Pest Controller is consulted for further information regarding a termite management system. Quotes for repairs and treatment should be sorted before purchase.

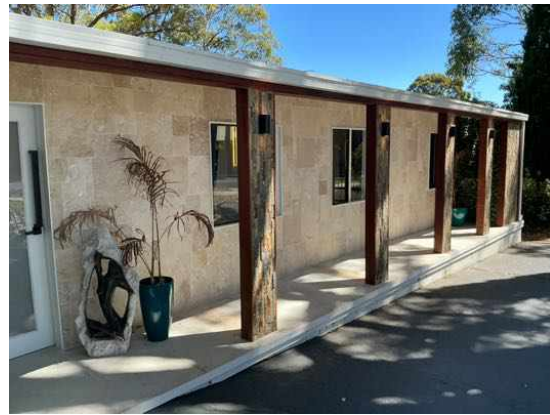
Generally this takes the form of finished ground levels external paving, concrete, fencing posts, gardens, vegetation, plumbing, stored items etc being retrospectively installed above the ant cap level or weep and ventilation holes.

Where bridging of the termite management system has occurred full inspection is prevented and termites may enter a property in a concealed or undetectable manner.

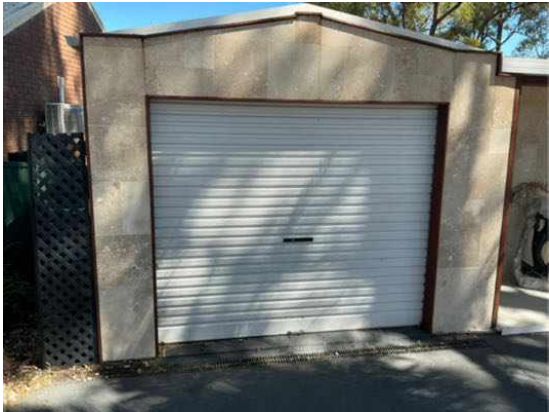
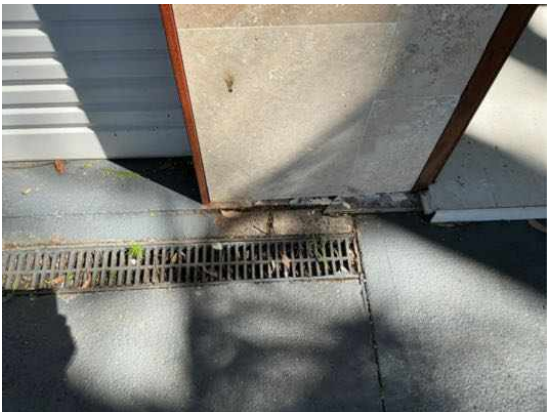
Building:	Main Building
Location:	All Areas
Finding:	Fungal decay - present (localised)
Information:	Fungal decay also known as wood decay generally refers to the deterioration of timber elements when in contact with excessive levels of moisture for a prolonged period of time. Generally fungal decay develops on timber elements that are in use in an external environment which are exposed to rain penetration.

In this case although the affected timber element is in a decaying state the extent of any visible damage appears to be localised to a specific area. The fungal decay is therefore likely to be of a relatively superficial nature with minimal impact on the structural integrity or tensile strength of the timber element.

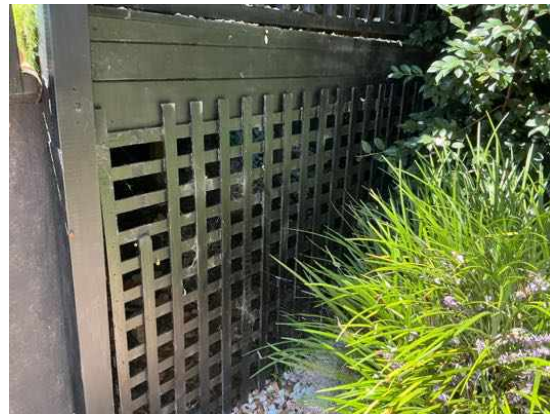
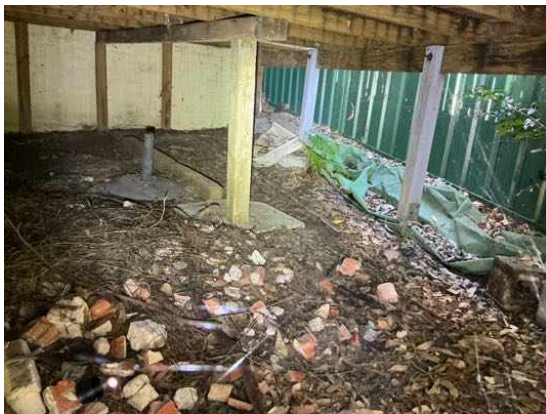
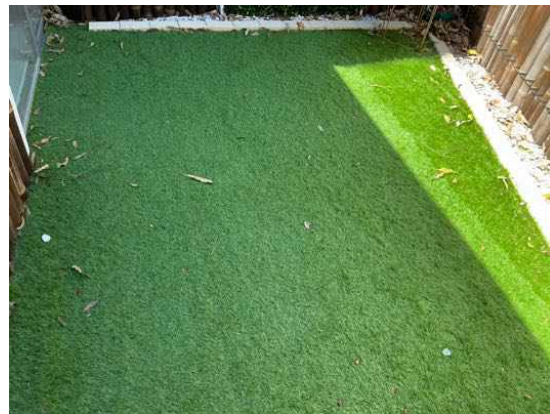
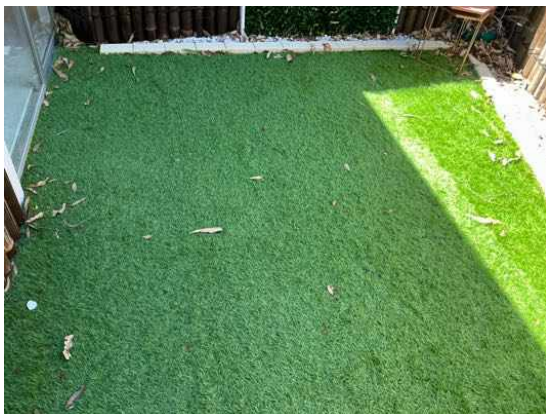
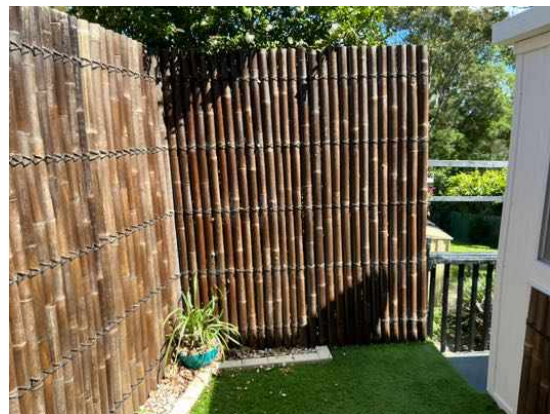
External timber structures and fixings are also constantly exposed to weather elements and can deteriorate in an accelerated manner, ongoing assessments are required.

It is highly recommended that a Structural Engineer further assess the external timber balcony or deck to inform the client of its load capacity. Regular maintenance inspections by competent practitioners is needed.

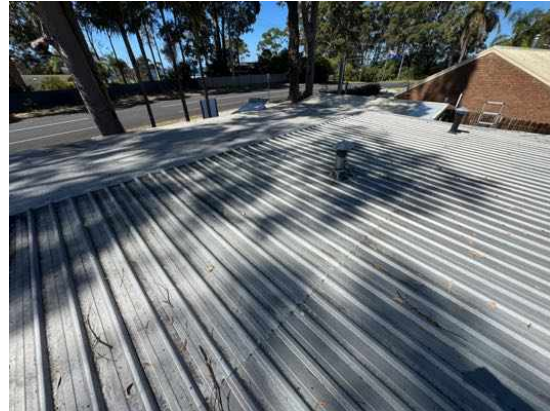
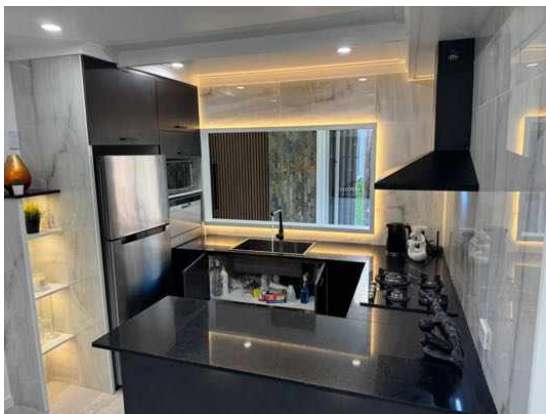
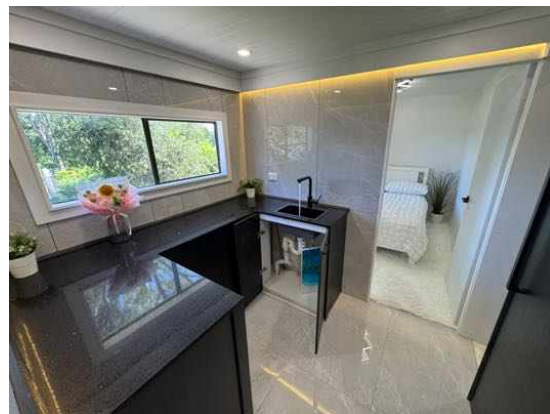
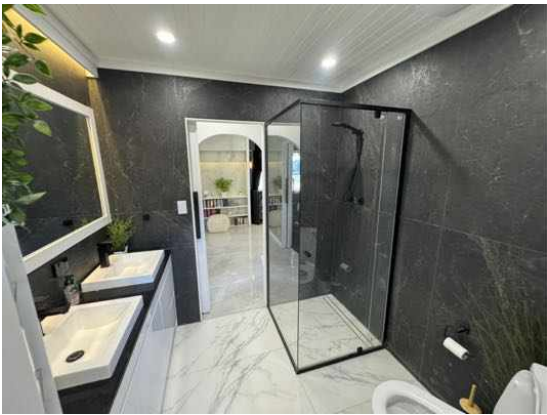
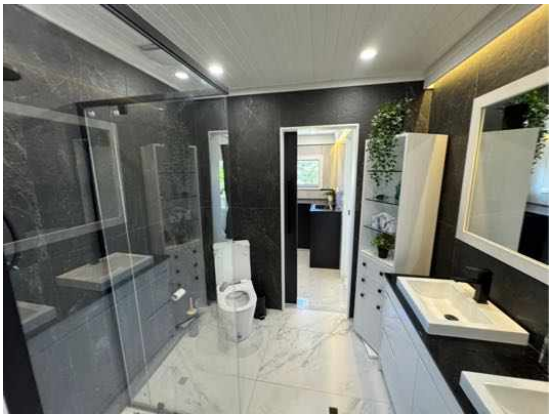
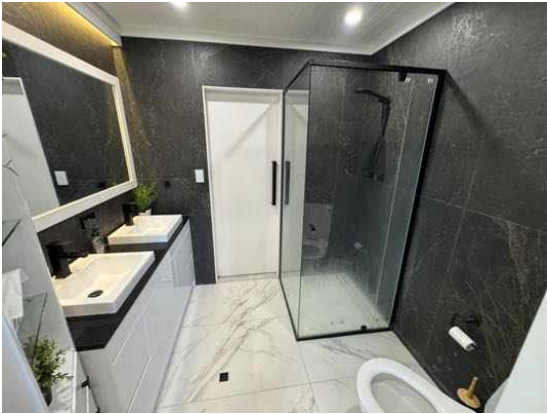
Building:	Main Building
Location:	All Areas
Finding:	Additional Photos - Obstructions and Limitations
Information:	These photographs are an indication of the obstructions and limitations which impeded full inspection of the property at the time of inspection. These obstructions can hide an array of defects and should be removed to allow full inspection to be carried out. A re-inspection is recommended once the areas are made accessible.

- decking.
- stored items.
- furniture.
- rubbish and debris.
- obstructions from other building materials.
- finished concrete and paving levels.
- finished ground levels.
- vegetation.

A further invasive inspection is recommended to these areas immediately.
