Building and Timber Pest Inspection Report

Inspection Date: Thu, 8 Jan 2026

Property Address: 15 Hazel Pl, Glenview QLD 4553, Australia

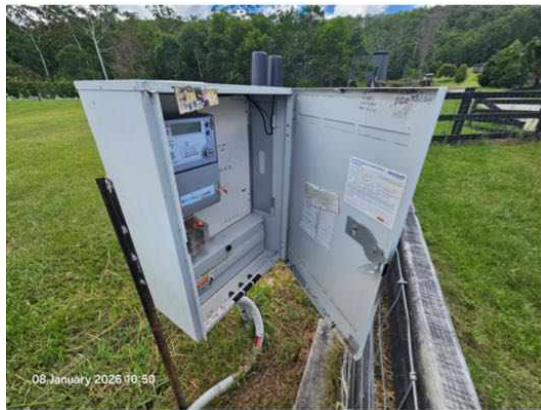
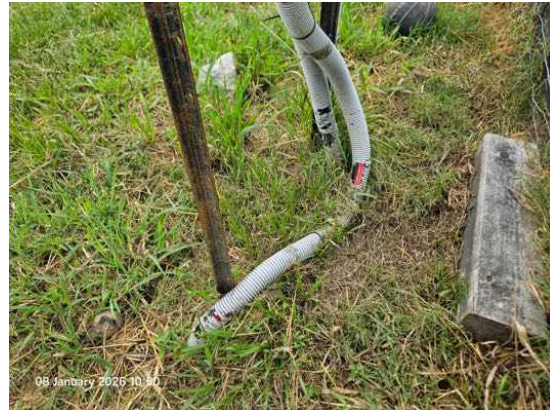
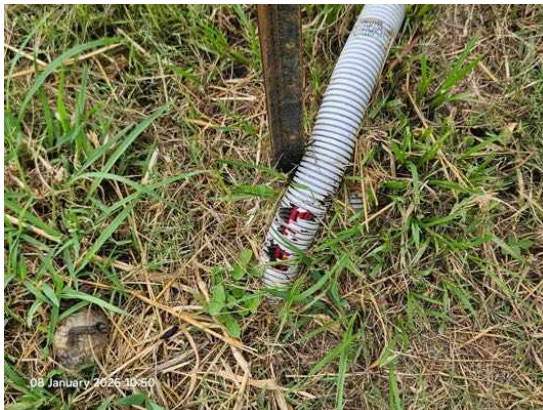
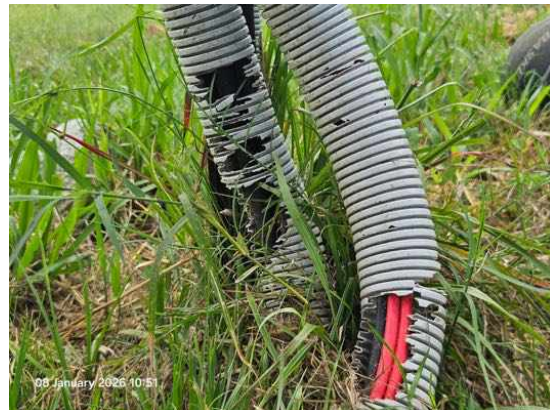
Finding 1.01

Building: Yard
 Location: Meter Box
 Finding: Electrical conduit - damaged
 Information: On the day of inspection the electrical supply conduit at the meter box was noted as damaged.

The cable internally was not able to be assessed or viewed. It would be advisable to have the supply cable checked and the conduit repaired by a licensed electrician.

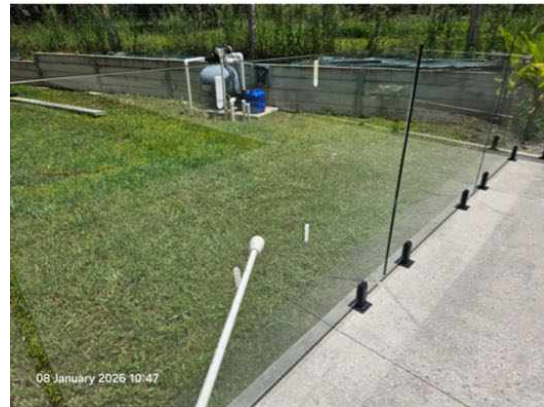
Finding 1.02

Building: Yard
 Location: Pool Area
 Finding: Pool Safety - CPR signage
 Information: During the inspection it was noted that the pool safety CPR sign was missing. According to the pool safety guidelines, pool safety signage must be readily readable and visible.

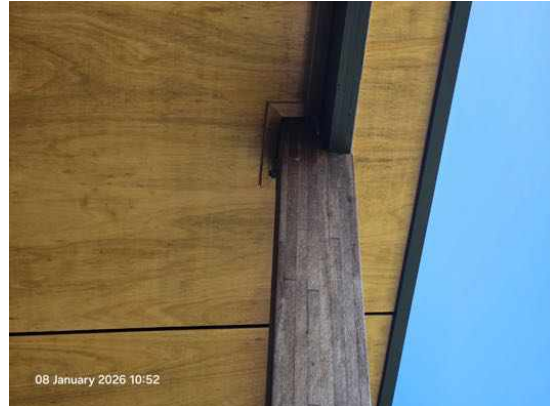
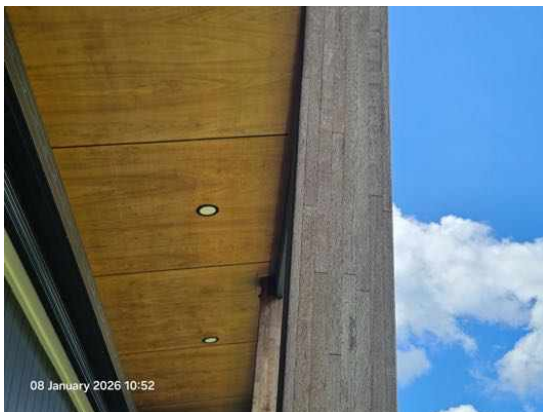
Finding 3.01

Location: Front patio
 Finding: Timber - exposed to weather
 Information: External timbers that are frequently exposed to harsh weather conditions require adequate protection in order to maintain their condition. Where timbers have not been painted or treated adequately, general deterioration is likely to occur at an accelerated rate.

Adequate treatment of these timbers is required as soon as possible by a painting contractor or general handyman.

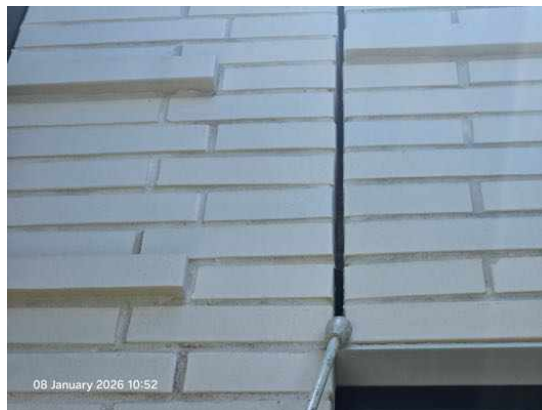
Finding 3.02

Building: Main Building
 Location: Front elevation
 Finding: Expansion / Control joints - unsealed.
 Information: At the front of the building, there is a control / expansion joint in the brick work. This joint is unsealed and requires filling with correct sealant to prevent moisture and vermin from entering the building via these joints.

This can be done at the clients discretion, by the client or a general handyman.

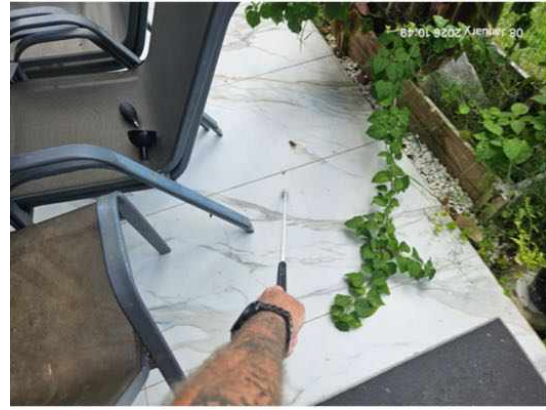
Finding 3.03

Building:	Main Building
Location:	As shown
Finding:	Tiles - Drummy
Information:	Drummy tiled areas were identified at the time of inspection. Please see the attached photos for locations.

The term 'drummy' refers to tiles that have become detached from their fixing, despite otherwise being in relatively good condition. Such defects are generally caused by physical or moisture damage to the area. Drummy tiled areas may also be a direct result of poor workmanship during the construction process.

Tiled areas may swell and shrink with changes in air humidity if the area has sustained moisture damage. Any exposure to moisture is capable of causing tiled areas to become drummy and/or cracked over a prolonged period of time. Drummy tiled areas generally require removal and replacement of affected tiles.

Specialist trades are available for these types of services. A licensed builder may be required to undertake works if damage is extensive or if secondary building defects have resulted. Otherwise, it is advised that a tiling contractor or a tile adhesive injection service may be appointed to perform works as necessary.

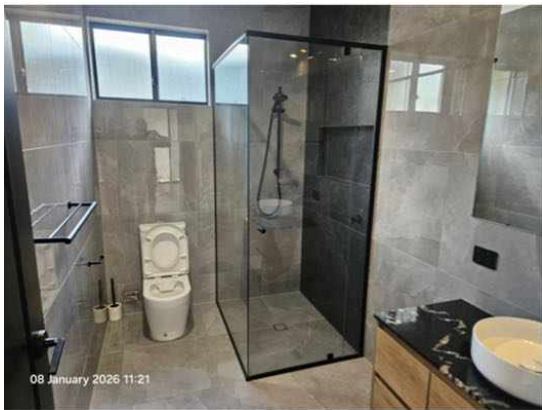
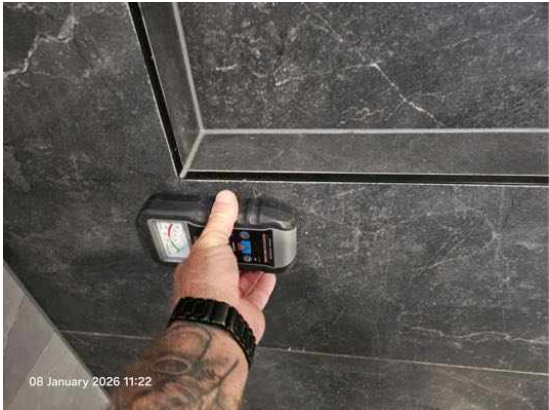
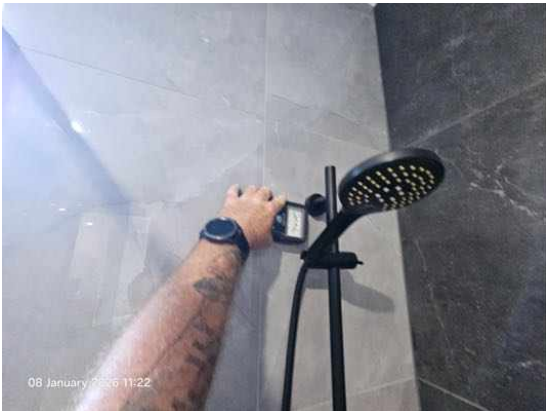
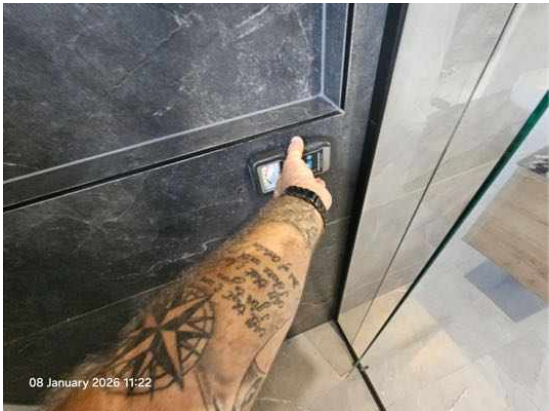
Building: Main Building
Location: Bathroom, ensuite
Finding: No moisture detected in bathroom / ensuite
Information: On the day of inspection the showers in the bathroom/s and ensuite are measure for moisture using a "Tramex" moisture meter. During this inspection no moisture was detected in these areas and the tiled / sheeted surfaces appear to be in good order.

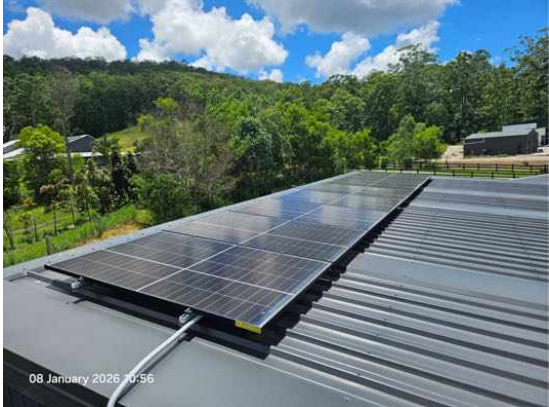
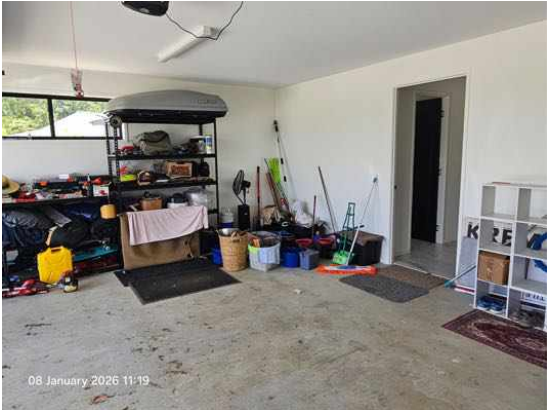
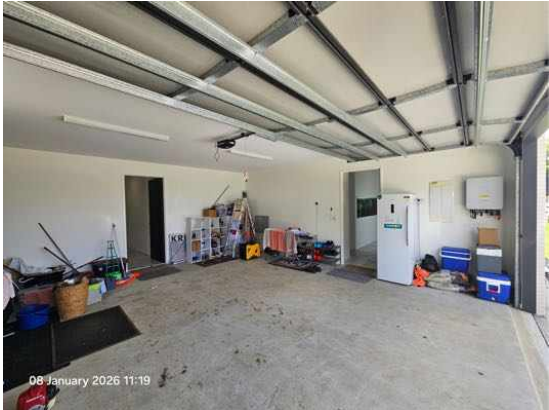
Building: Main Building
Location: All Areas
Finding: Additional Photos - Obstructions and Limitations
Information: These photographs are an indication of the obstructions and limitations which impeded full inspection of the property at the time of inspection. These obstructions can prevent full inspections of the areas shown.
