# Building and Timber Pest Inspection Report

Inspection Date: Fri, 20 Feb 2026

Property Address: 9 Percival Ct, Glenroy NSW 2640, Australia

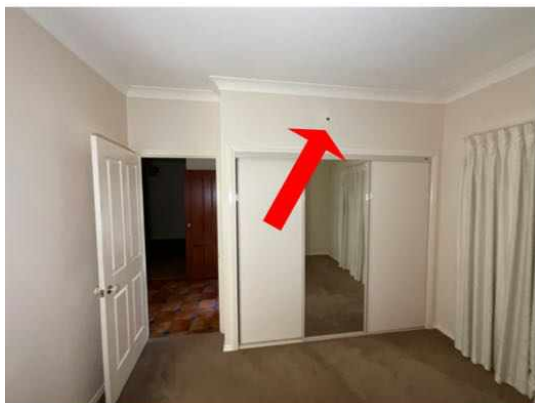
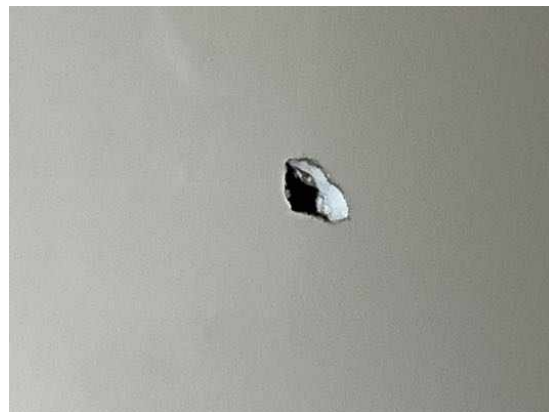
#### Finding 3.01

Building: Building 1  
 Location: Bedroom - Master  
 Finding: Impact damage  
 Information: This area appears to show impact damage. This has compromised the structure. This damage has also compromised the moisture barrier.

Appropriate trades should be contacted soon to restore this area to full function.

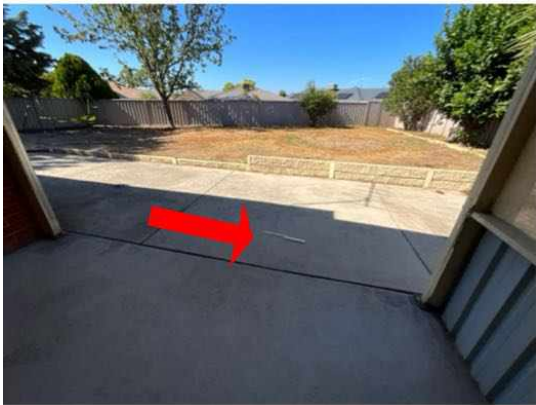
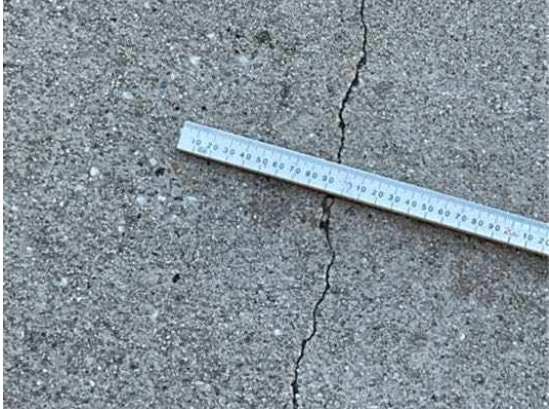
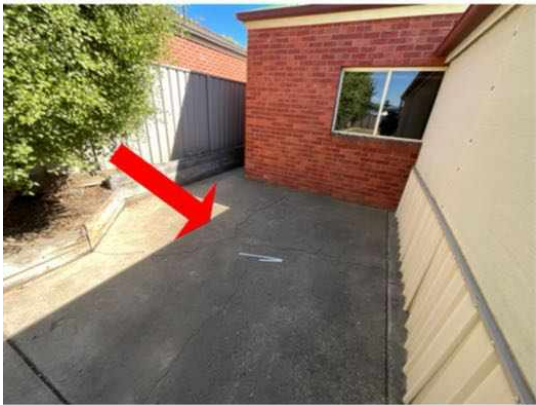
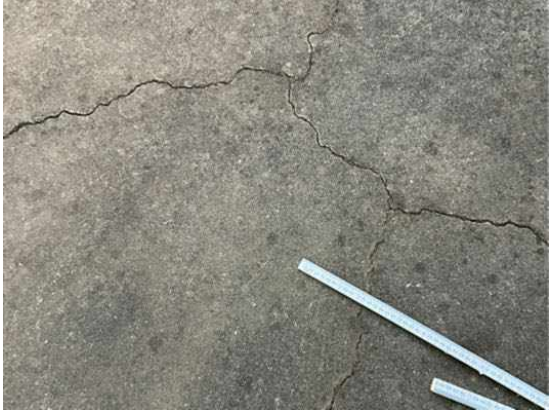
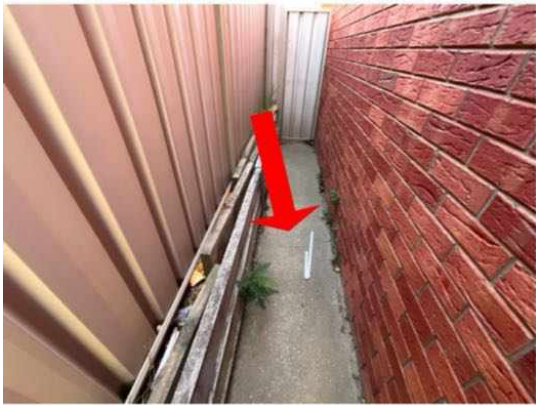
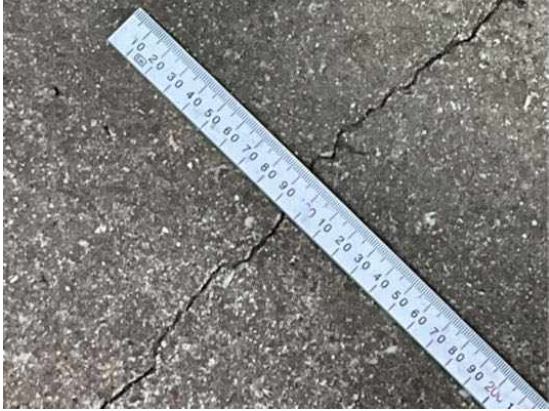
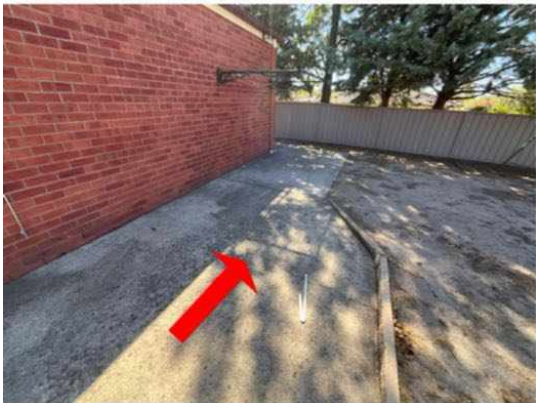
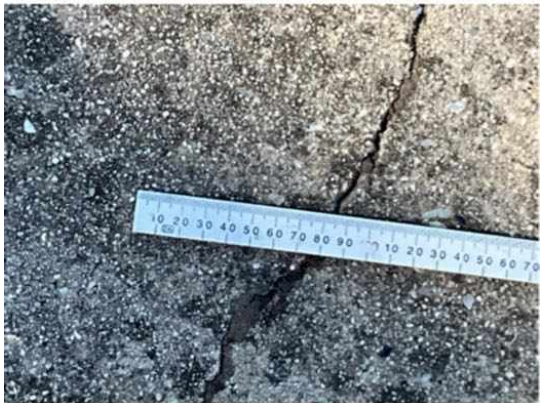
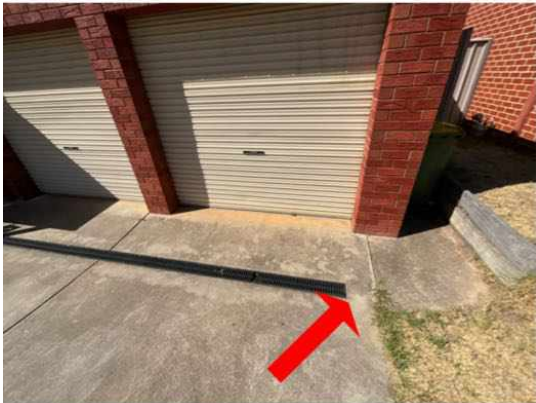
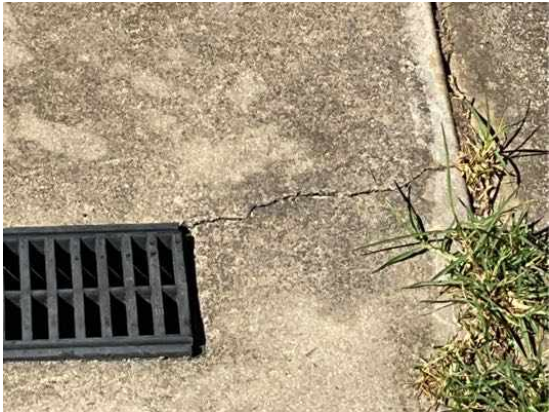
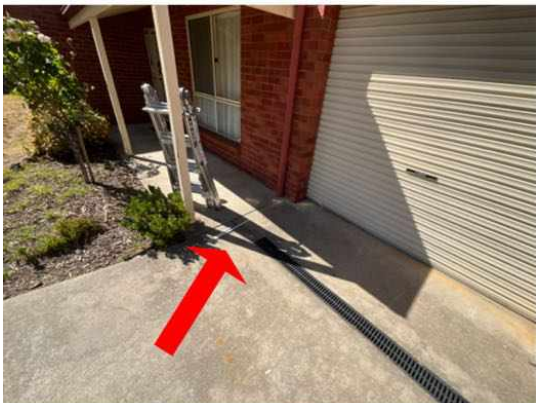
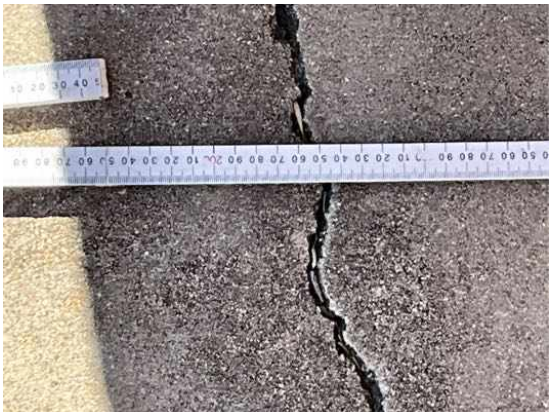
#### Finding 3.02

Building: Building 1  
 Location: Yard - Back, front  
 Finding: Cracking - External Concrete Paving Damage Category 1 - Fine (less than 2mm)  
 Information: Fine cracks were identified in external concrete paving. Although fine cracks are quite noticeable, they are often only considered to be an appearance defect, and usually do not indicate any structural damage. To be considered a Category 1 or fine crack, the crack is found to be less than 2mm in width.

Generally the cause of a hairline crack in existing concrete paving such as driveways and pathways is indicative of the expansion and contraction of the concrete. Such

causes are generally due to environmental factors, such as moisture levels, weather conditions, root systems of nearby trees or the soil types on which they are laid.

Fine cracks may also be due to poor original installation of the concrete. Factors such as poor compaction of the sub surface and/or inadequate reinforcing of the slab may create cracking and other secondary defects.

Monitoring of all cracking should be conducted frequently. Always contact a building inspector should cracks widen, lengthen, or become more numerous.

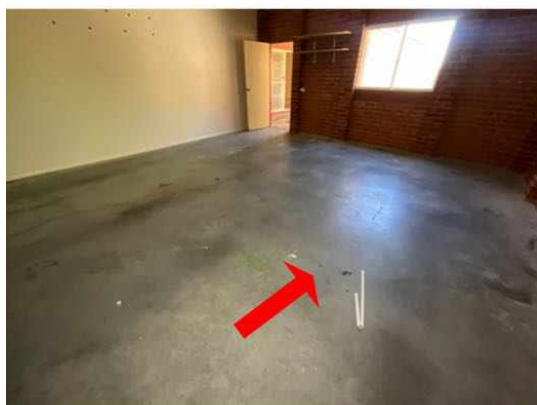
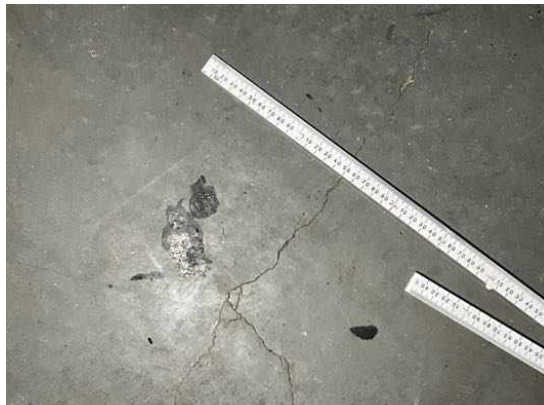
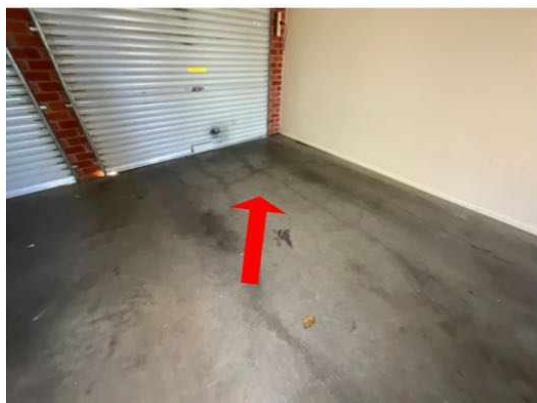
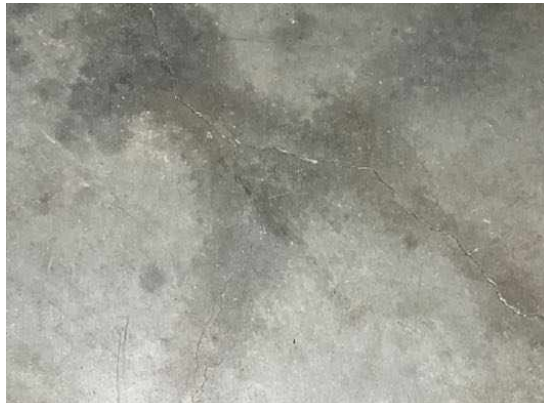
**Finding 3.03**

Building: Building 1  
 Location: Garage  
 Finding: Crack in concrete slab - Category 1  
 Information: A crack coded as Category 1 was identified in the slab. A Category 1 crack is described as a fine but noticeable crack, with the slab at an otherwise reasonable level.

To be considered Category 1, the approximate width of the crack is less than 1.0mm, or a less than 10mm change in offset when a 3m straight edge is placed over the defect.

Category 1 cracks should be monitored for a period of 12 months. At the end of the monitoring period, identified cracks that are rated greater than Category 2 are considered defects, and require rectification.

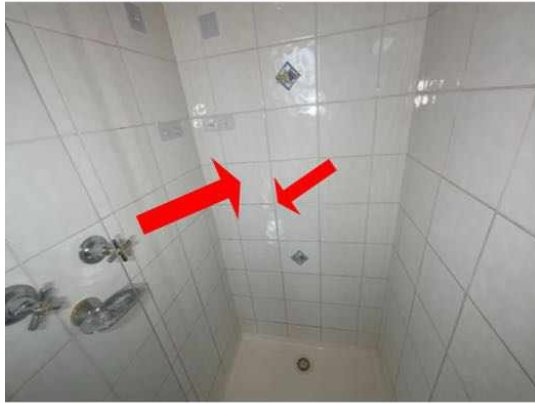
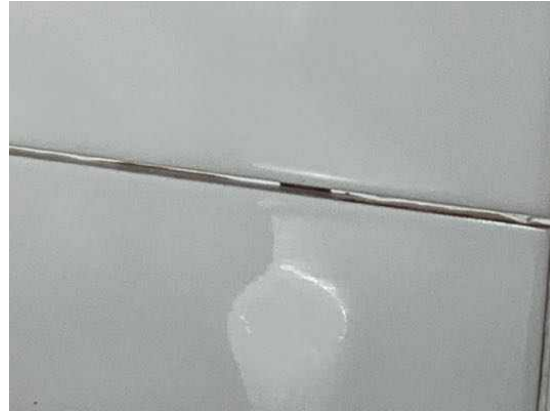
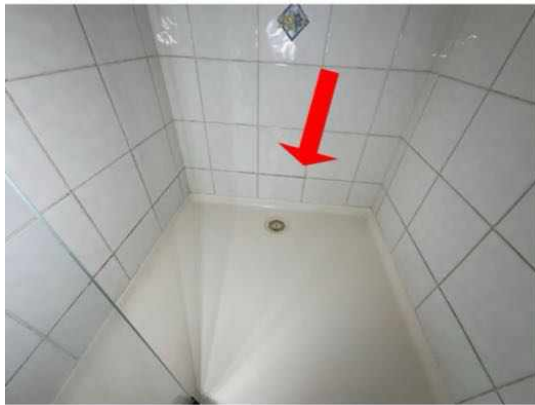
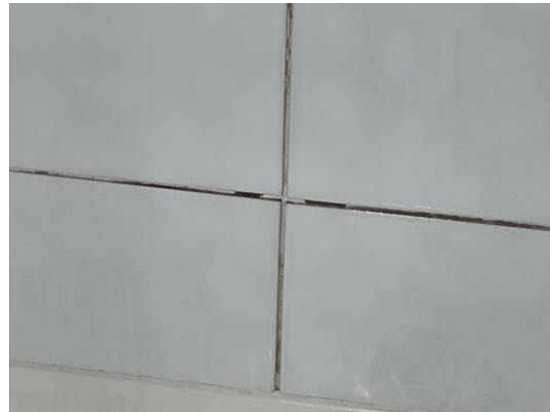
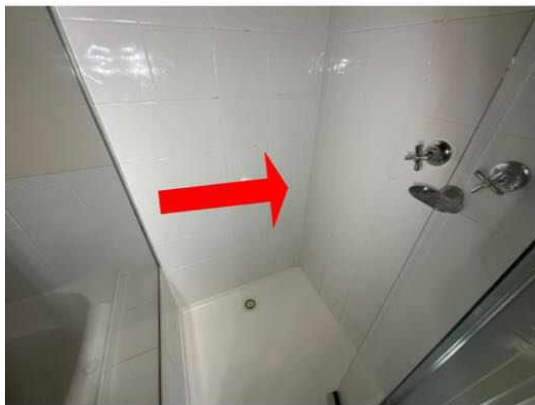
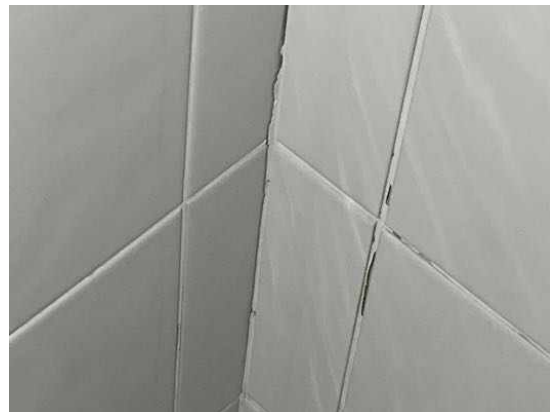
### Finding 6.01

Building:	Building 1
Location:	Ensuite, bathroom
Finding:	Inadequate sealant or Grout
Information:	This area has a lack of effective Sealant or Grout. This is allowing the ingress of water to the structure inside the wall.

The presence of water encourages Termite attack, Mould and Fungal Decay.

A Tiler or General Handy person must be contacted as soon as possible to effect repairs and prevent further deterioration.

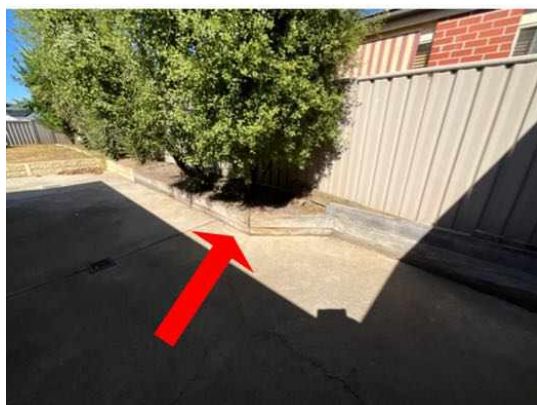
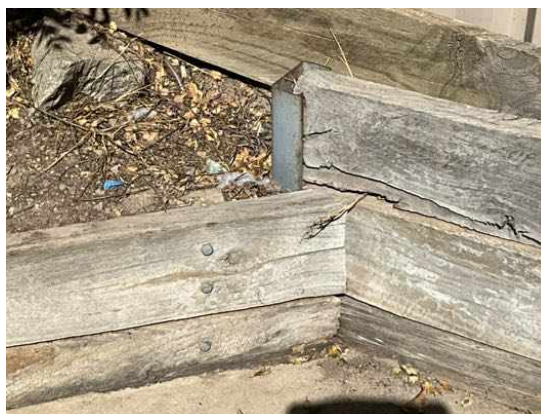
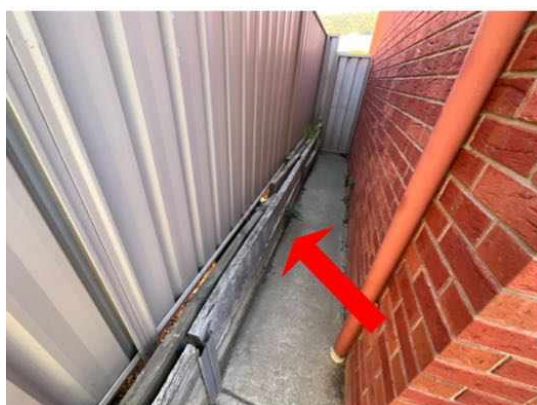
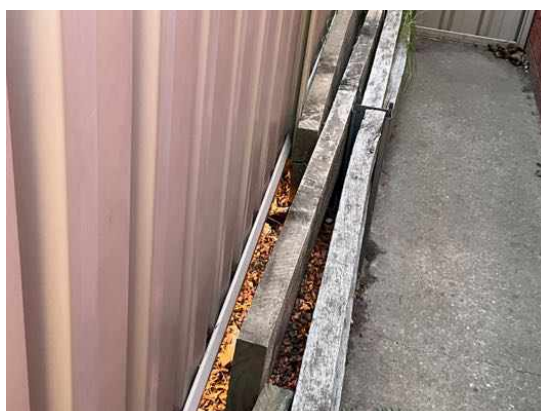
### Finding 6.02

Building:	Building 1
Location:	Yard - Back
Finding:	Untreated or non-durable timbers in a hazardous environment
Information:	To reduce the risk of timber pest attack it is essential that timber used in a hazardous environment (e.g. in direct contact with the ground or frequently exposed to damp

conditions) is of sufficient durability and/or is adequately preservative treated.

Untreated timbers in direct contact with the ground are likely to develop severe wood rot and/or fungal decay if left unattended creating attraction for subterranean termites to infest the timbers from surrounding areas.

If untreated or non-durable timbers are found to be in a hazardous environment it is highly advised that replacement of these building elements be performed as soon as possible to aid the protection of the property against termite / timber pest attack.

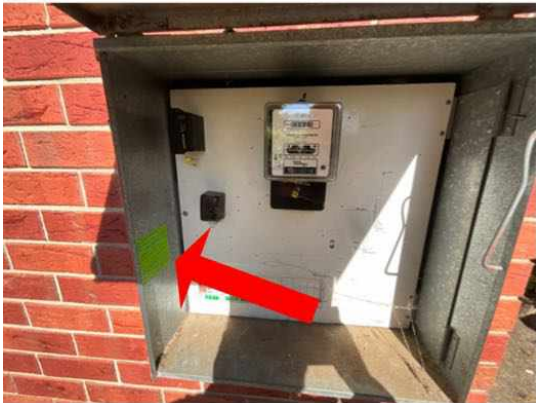
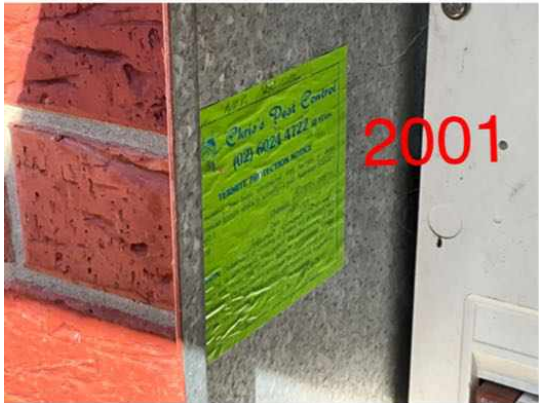
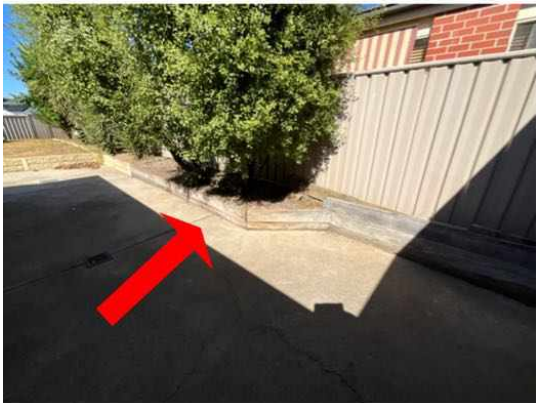
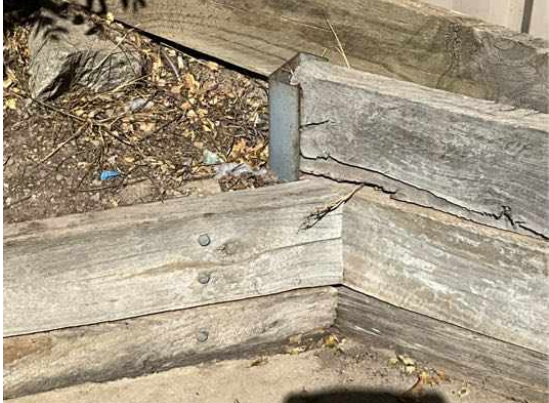
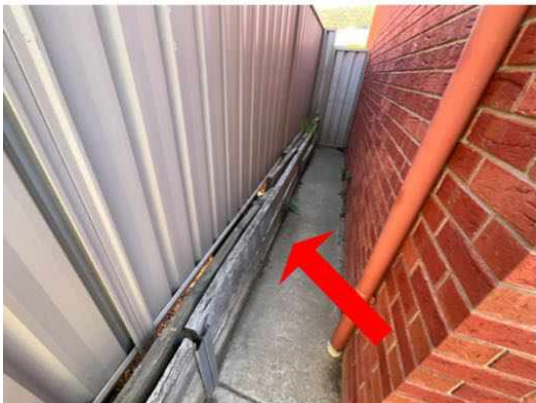
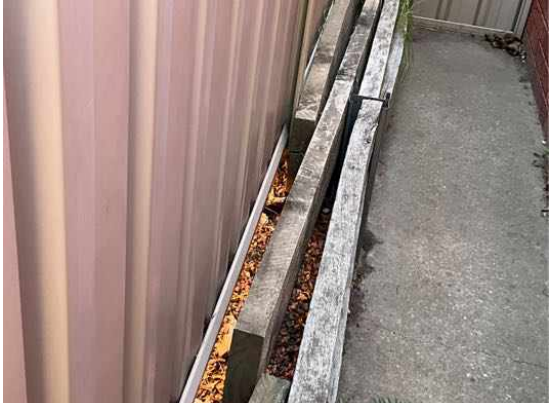
### Finding 6.03

Building:	Building 1
Location:	All External Areas
Finding:	Termite Management System- evidence of a chemical installation
Information:	The application of a post-construction chemical termite barrier is highly recommended for all properties, particularly if live termite activity has been found on the site previously. Such barriers are highly effective in preventing termite attack on any timber building elements throughout the property.

A durable notice has been placed in the switchboard unit to indicate current termite barriers. At the time of inspection, it appeared as though a termite management system has been installed. The recency of any treatment cannot be determined.

The client may consider gaining further advice from a pest controller as to the costs and procedures involved with this application. It is recommended that obtaining such advice be a short-term priority.

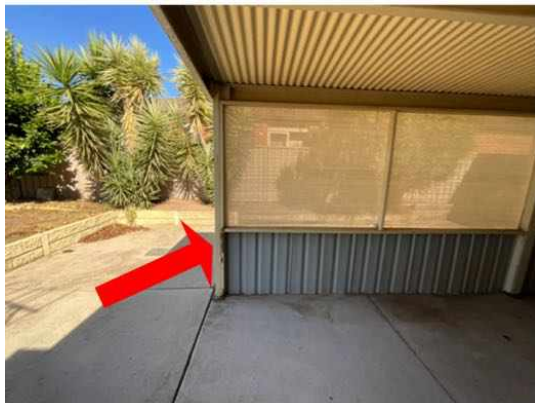
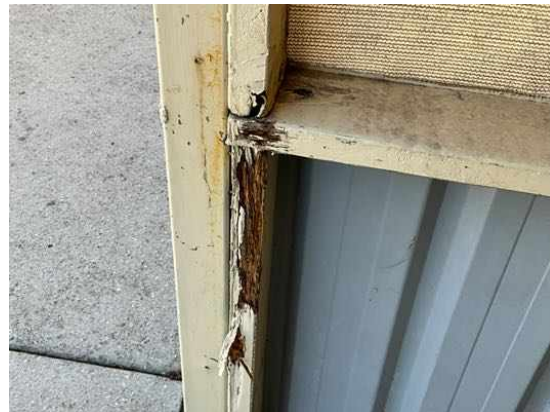
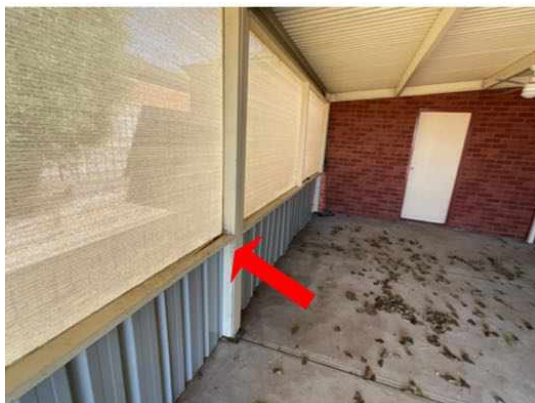
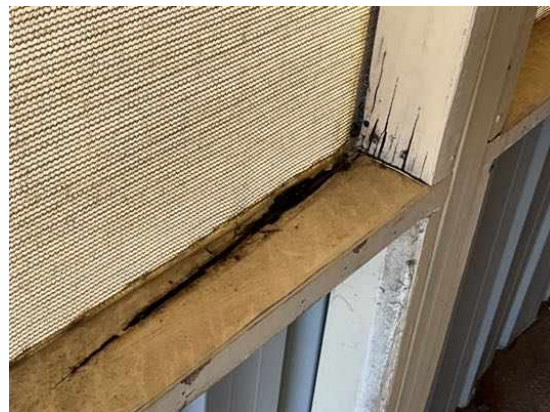
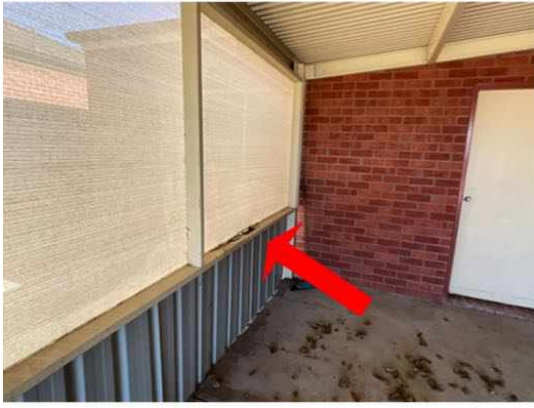
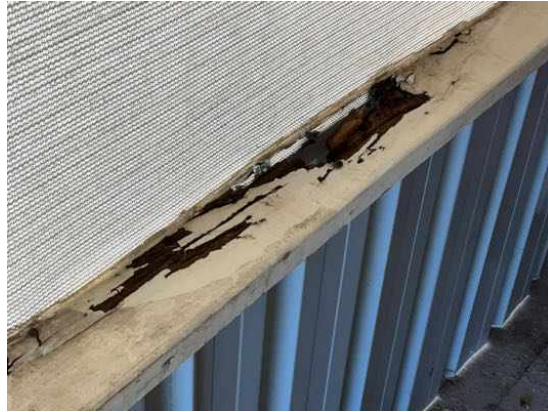
**Finding 7.01**

Building: Building 1  
Location: Alfresco  
Finding: Fungal decay - present (widespread)

Information: Fungal decay is also known as wood decay or wood rot generally refers to the deterioration of timber elements when in contact with excessive levels of moisture for a prolonged period of time.

The development of fungal decay is accelerated by temperatures in the range of 5degreeC to 40degreeC as well as the presence of oxygen. Generally fungal decay develops on timber elements that are in use in an external environment which are exposed to rain penetration.

In this case, fungal decay appears to have become widespread and is likely to have affected any adjoining timber elements/structures. The widespread development of fungal decay is likely to have heavily impacted the structural integrity and tensile strength of the affected timber elements and the associated structure.

Timbers affected by widespread fungal decay should be replaced immediately. The cause of the moisture that has led to the development of such decay should also be identified and dealt with in an appropriate manner.

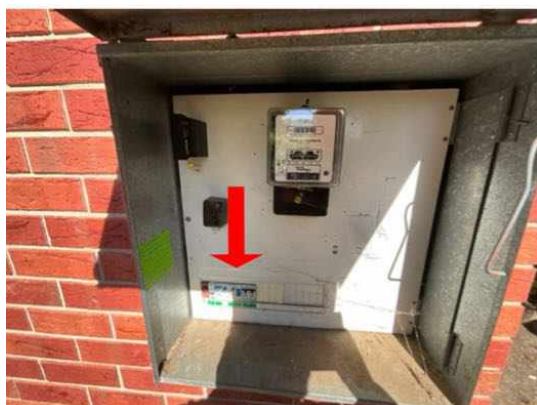
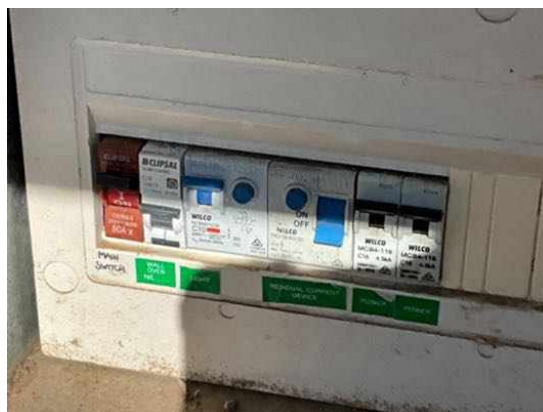
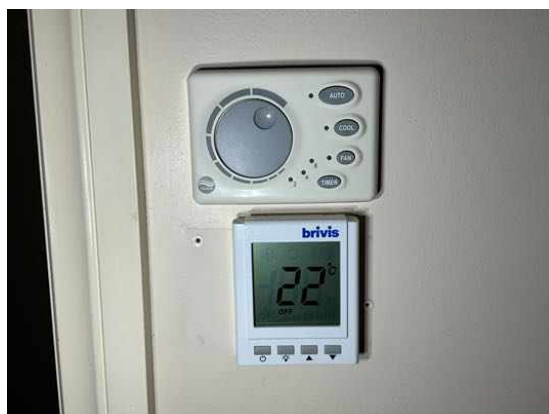
Building: Building 1  
 Location: All Areas  
 Finding: Appliance checks  
 Information: The oven and dishwasher could not be operated at the time of inspection. The air conditioning systems could also not be tested.

An electrical safety circuit would activate at every attempt to operate these appliances.

An electrician should be contacted immediately to ensure no safety issues exist. This will prevent potential injury and allow testing of the appliances.

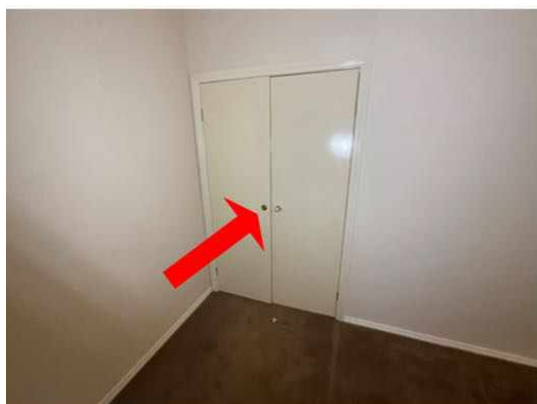
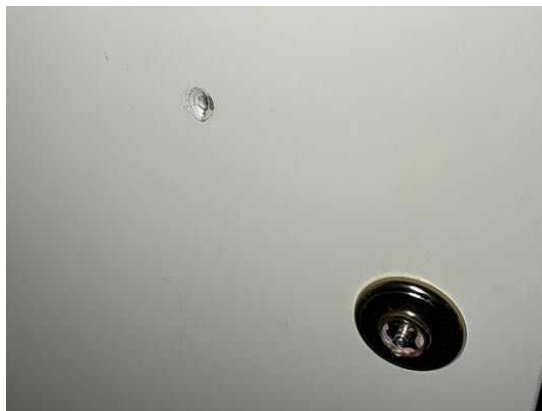
Building: Building 1  
 Location: Bedroom 2  
 Finding: Cabinet handles missing  
 Information: During the visual inspection it was found that there are handles missing from the

cabinetry. This negatively effects their operation.

A General handy person or cabinetmaker should be appointed at the discretion of the client to replace the handles and restore full operation.

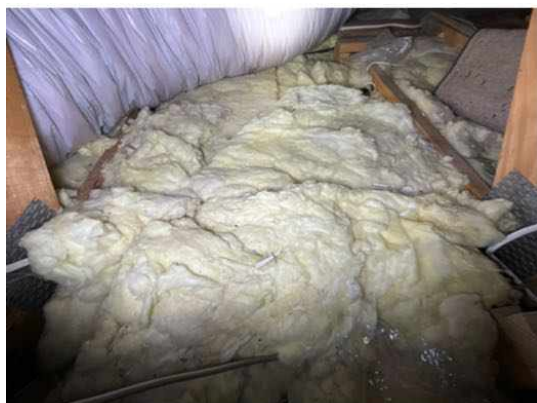
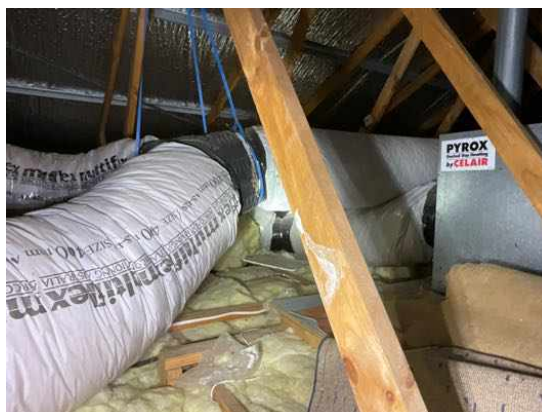
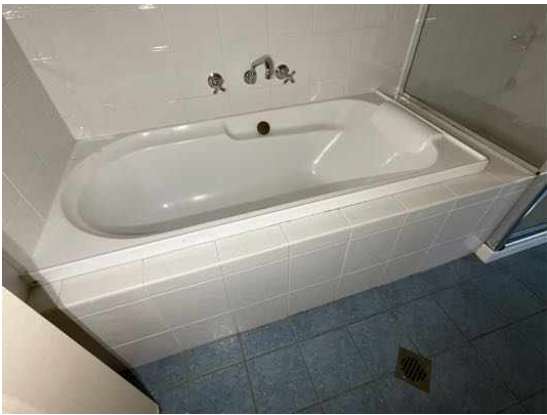
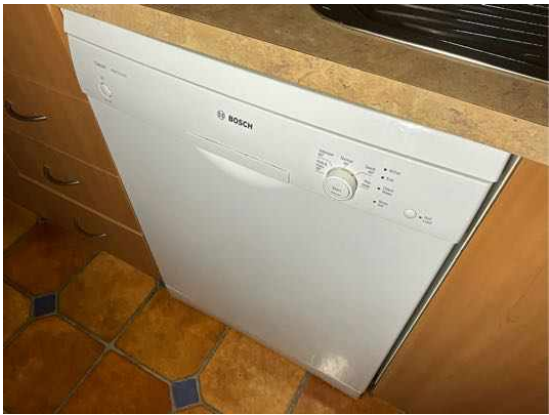
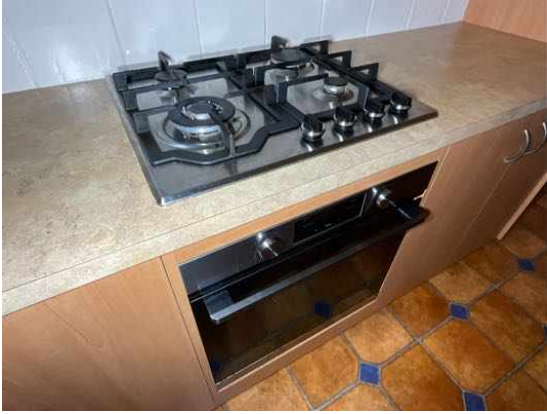
Building: Building 1  
 Location: All Areas  
 Finding: Additional Photos - Obstructions and Limitations  
 Information: These photographs are an indication of the obstructions and limitations which impeded full inspection of the property at the time of inspection. These obstructions can hide an array of defects and should be removed to allow full inspection to be carried out. A re-inspection is recommended once the areas are made accessible.
