Building and Timber Pest Inspection Report

Inspection Date: Thu, 26 Mar 2026

Property Address: 39 Bartlett Ave, Nerang QLD 4211,
Australia

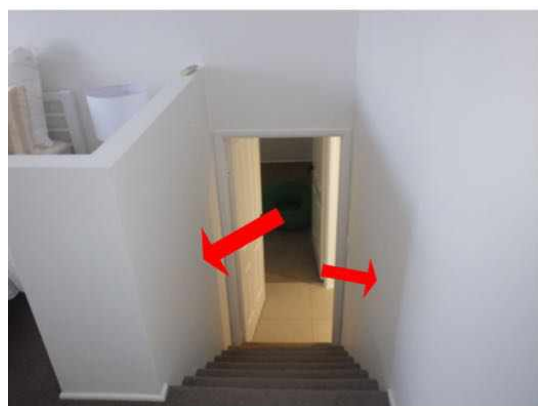
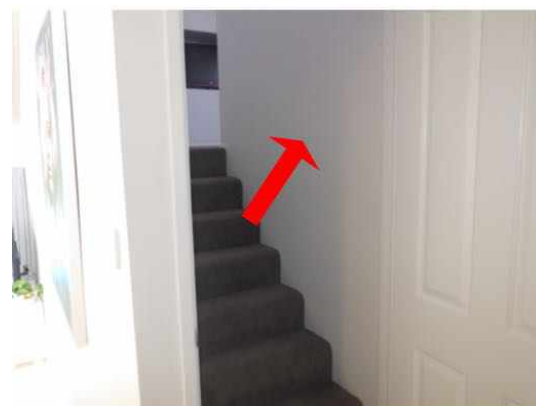
Building: Main Building
 Location: Bedroom 4 > Front
 Finding: Stairs - Handrail
 Information: At the time of inspection it was noted there was no handrail in the bedroom 4 stairway. The absence of a handrail in the stairway compromises the safety and accessibility of the stairs for all users.

According to AS1657-2018, every stairway must have at least one handrail, and a handrail on each side for stairways wider than 1000mm.

A licensed builder could be consulted for further information on stairway requirements.

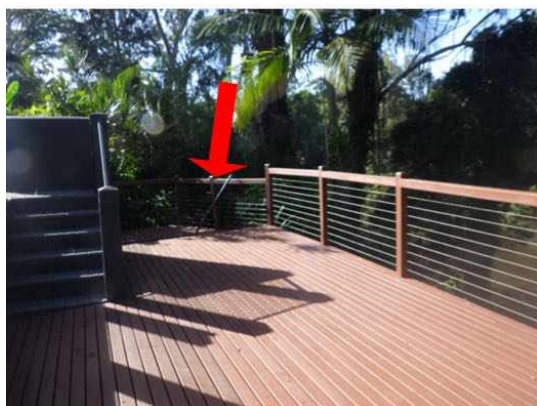
Finding 3.02

Building:	Main Building
Location:	Deck > Rear Left
Finding:	Deck
Information:	It was noted at the time of inspection that a section of the timber deck hand railing to the rear of the property showed signs of movement or deterioration. Typically timber decking or balustrade deteriorates due to age and or wear, rot and or rust which is generally expected for a structure of this age, due to prolonged exposure to weather conditions. Sometimes inadequate installation or maintenance can be to blame.

It is suspected that repair of several elements of the decking handrail may be required.

A licensed carpenter could be engaged to perform rectification works as necessary.

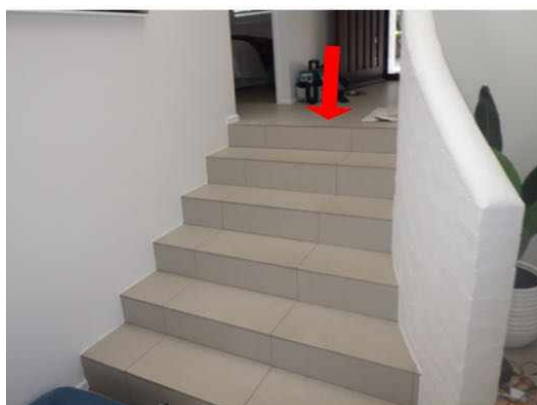
Finding 3.03

Building:	Main Building
Location:	Stairs - Internal > Front
Finding:	Tiles - Chipped
Information:	Chipped tiles to the internal stairs floor area were identified at the time of inspection. Chipped tiles are generally caused by impact.

A tiling contractor could be appointed to perform repair works at the clients discretion.

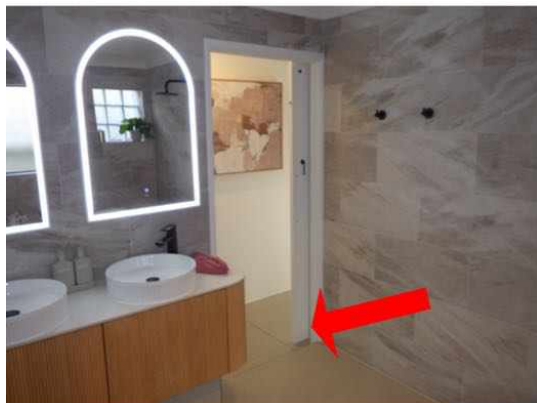
Finding 3.04

Building:	Main Building
Location:	Bathroom > Front
Finding:	Door Guide
Information:	It was noted that the door guide to the bathroom area sliding door was missing at the time of inspection.

This is noted as a minor defect that you need to be aware of.

A licensed carpenter or general handyman could be engaged to adjust or replace the door guide at the clients discretion.

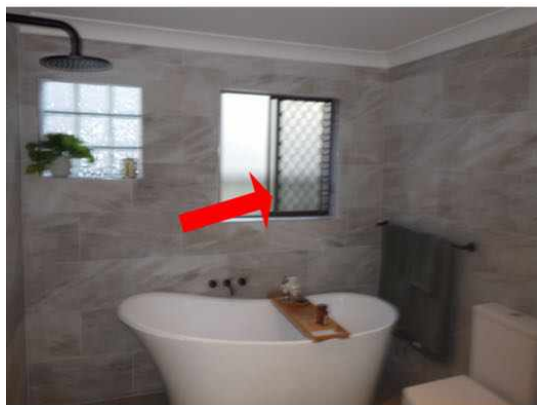
Finding 3.05

Building: Main Building
 Location: Bathroom > Rear Right
 Finding: Window Catch - missing
 Information: It was noted that the window handle/catch to the bathroom area aluminium sliding window was missing at the time of inspection. Whilst detracting from the functionality of the window, this minor defect may also be a security risk.

It is suspected that this defect has occurred due general wear and tear, which is expected for building elements of this age.

An aluminium sliding window service agent or general handyperson may be appointed to perform rectification works as necessary, at client discretion.

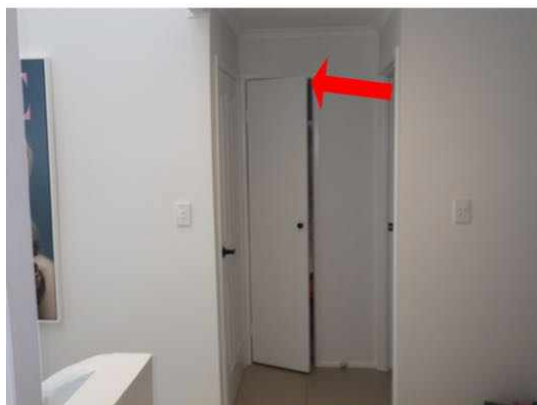
Finding 3.06

Building: Main Building
 Location: Storage Cupboard > Front
 Finding: Door - Broken latch
 Information: The door latch to the linen cupboard door was found to be broken at the time of inspection. Breakage occurs generally when the building materials have aged and decayed, but may be indicative of impact damage (accidental or deliberate).

A general handyman could be appointed to replace the door latch at the client's discretion.

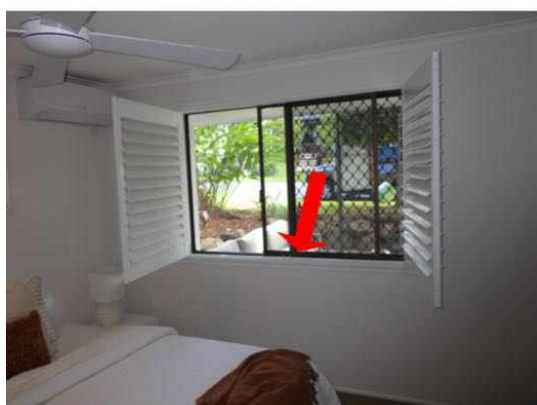
Finding 3.07

Building:	Main Building
Location:	Bedroom 2 > Rear
Finding:	Window - Stiff to Slide
Information:	The aluminium sliding window in bedroom 2 was stiff to operate at the time of the inspection. Windows provide ventilation to the adjoining area and should be at a fully operational level to ensure user comfort. Restricted function of the window may also pose as a potential safety hazard if required for emergency egress from the building.

Generally, factors such as general age of the building element and a lack of maintenance are the usual causes for this type of defect.

An aluminium window service agent will be required to repair the affected windows.

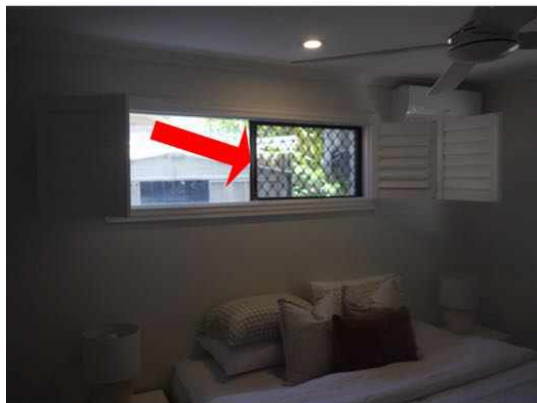
Finding 3.08

Building:	Main Building
Location:	Bedroom 2 > Centre Left
Finding:	Window Catch - missing

Information: It was noted that the window handle/catch to the bedroom 2 aluminium sliding window was missing at the time of inspection. Whilst detracting from the functionality of the window, this minor defect may also be a security risk.

It is suspected that this defect has occurred due general wear and tear, which is expected for building elements of this age.

An aluminium sliding window service agent or general handyperson may be appointed to perform rectification works as necessary, at client discretion.

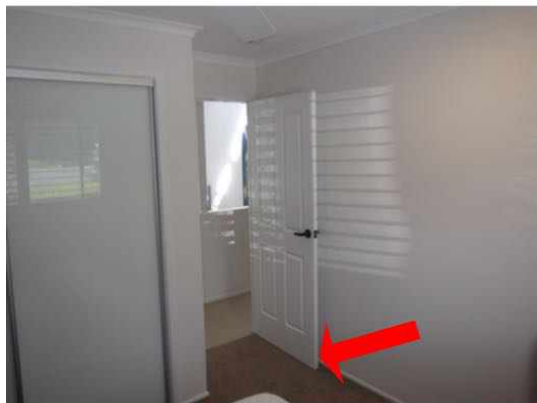
Finding 3.09

Building: Main Building
 Location: Bedroom 3 > Front
 Finding: Door stop - Missing
 Information: The bedroom 3 door stop is missing or is inadequate to stop the door handle from impacting the wall.

Re-installation or replacement of the door stop is advised to prevent any subsequent damage to the wall linings or associated structures.

A general handyman may be appointed to perform these works at client discretion.

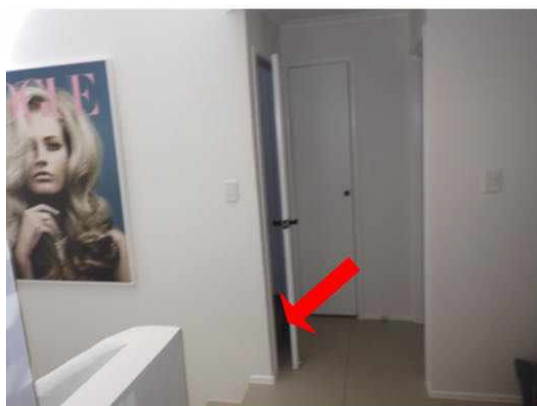
Finding 3.10

Building: Main Building
 Location: Bedroom 4 > Front
 Finding: Door - Binding/Jamming
 Information: Binding and/or jamming of the bedroom 4 door on the door frame or stair tread carpet was evident during standard operation. This defect inhibits the functionality of affected door as well as creating potential for secondary defects to associated building elements, such as damage to the door framing.

A door that binds on the door frame or adjoining stairs may have several causes, such as poor installation of the door or deteriorated hinges.

A qualified carpenter or general handyman could be appointed to perform minor rectification works at client discretion.

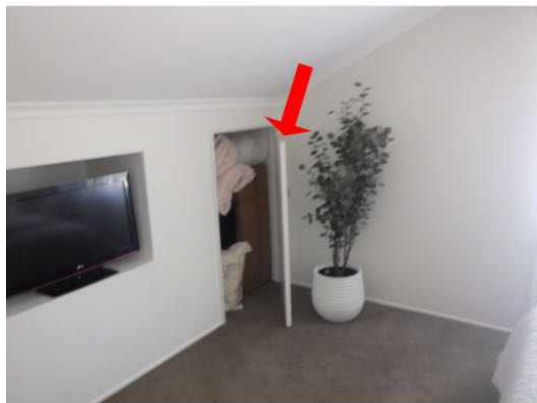
Finding 3.11

Building: Main Building
 Location: Bedroom 4 > Rear Right
 Finding: Door - Paint
 Information: At the time of inspection it was noted the bedroom 4 right side cupboard door had not been fully painted along the top edge. It is important that all door surfaces and edges are painted or sealed as per the manufactures specifications to preserve the life of the door.

A qualified painter or general handyman could be engaged to undertake minor painting works.

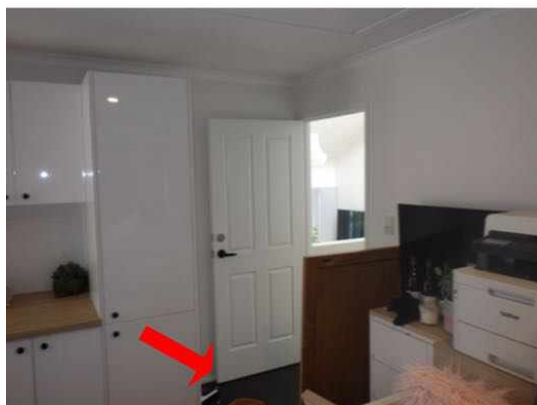
Finding 3.12

Building: Main Building
 Location: Garage > Front
 Finding: Door stop - Missing
 Information: The garage interior door stop is missing or is inadequate to stop the door handle from impacting the wall.

Re-installation or replacement of the door stop is advised to prevent any subsequent damage to the wall linings or associated structures.

A general handyman may be appointed to perform these works at client discretion.

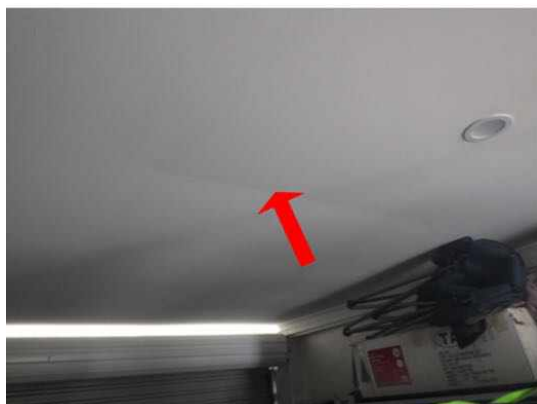
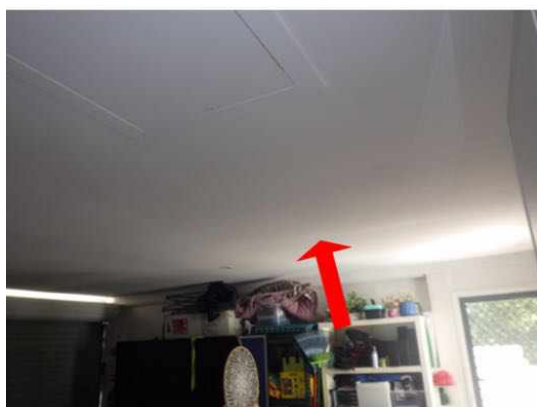
Finding 3.13

Building: Main Building
 Location: Garage > Centre
 Finding: Ceiling - Sagging
 Information: The ceiling linings in the garage showed signs of minor sagging at the time of inspection. Sagging to the fixed ceiling structure generally indicates that the building materials have swollen, due to exposure to moisture, or that fixings (e.g. nails or glue) have become loose and require reattachment.

screwing of ceiling sheets, may be required.

Such works may be performed by relevant tradespeople, such as plasterers and painters.

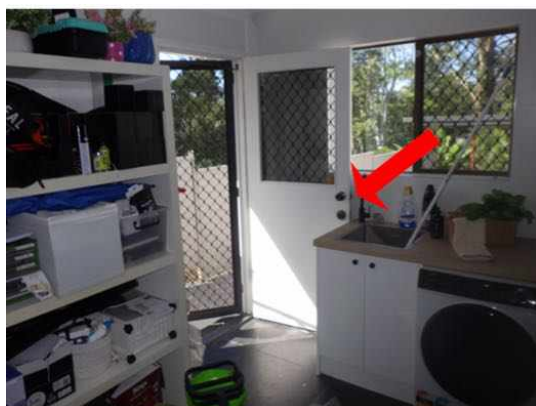
Finding 3.14

Building:	Main Building
Location:	Garage > Rear Left
Finding:	Door stop - Missing
Information:	The garage/laundry exterior door stop is missing or is inadequate to stop the door handle from impacting the wall.

Re-installation or replacement of the door stop is advised to prevent any subsequent damage to the wall linings or associated structures.

A general handyman may be appointed to perform these works at client discretion.

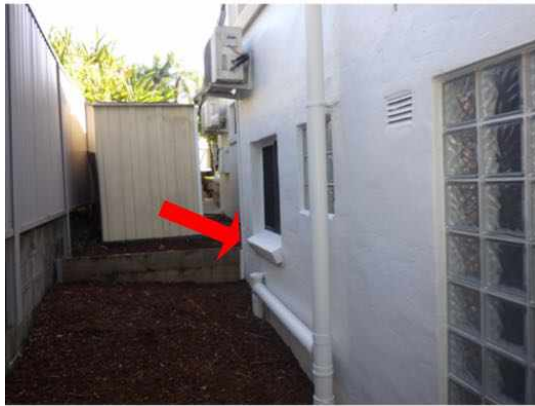
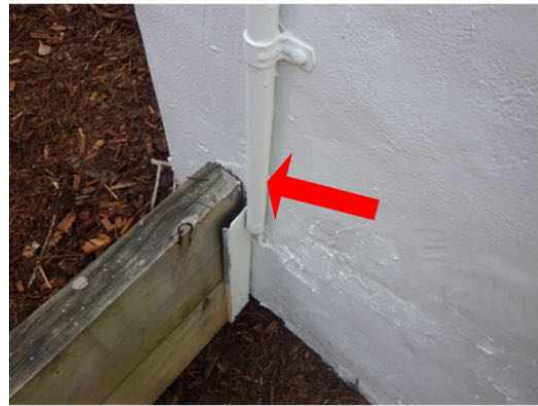
Finding 6.02

Building:	Main Building
Location:	Exterior walls - right side > Centre Right
Finding:	Overflow - Not plumbed for drainage
Information:	The air conditioning unit overflow is not plumbed or connected to suitable drainage, which can result in the surrounding area becoming excessively damp. These damp conditions can lead to secondary defects such as rot, rust or corrosion of associated building elements, the formation of fungal decay, or even the creation of potential slip hazards. When coupled with poor site drainage, pooling of water may also attract termite activity to this area. It is highly recommended that a qualified plumber be appointed to install adequate drainage to the overflow. These works will ensure that

the area remains dry and free of any secondary defects.

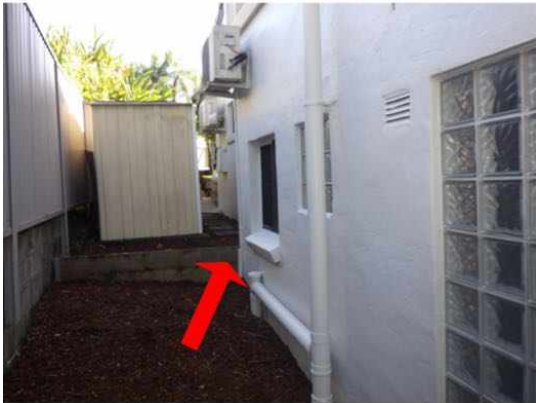
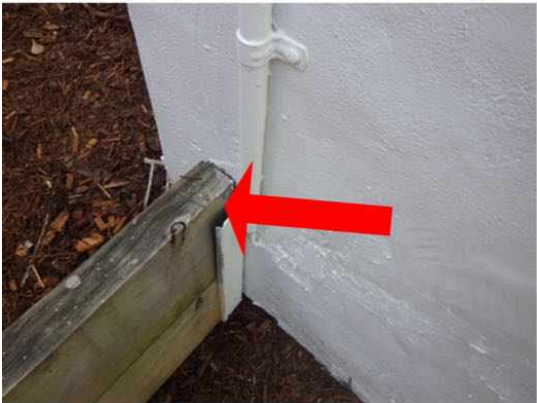
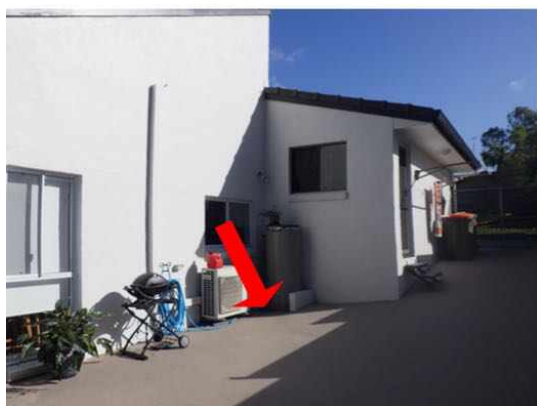
Any timbers in direct ground contact provide opportunity for concealed termite activity and are likely to be subject to premature rot and decay as the soil retains moisture or damp conditions against the timbers.

Removal of any untreated timber or tree stumps which are in direct contact with external ground is recommended. Frequent pest inspections are advised to readily identify any termite activity in these areas.

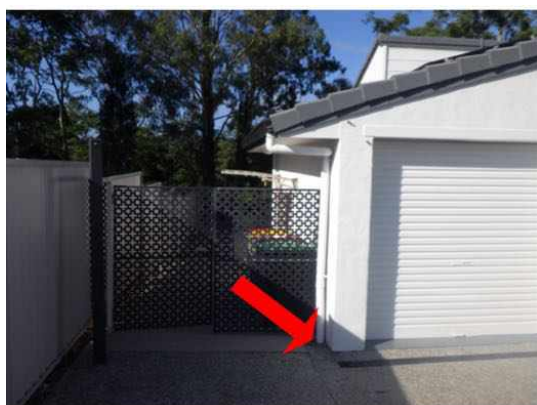
Finding 6.05

Building:	Main Building
Location:	Exterior walls - left side > Front Left
Finding:	Stormwater downpipes
Information:	The down pipe to the front right side of the property is not connected directly to the stormwater drainage on the site. This disconnection can negatively impact the functional capacity of the downpipe and the surrounding ground area.

Where roof plumbing doesn't drain as required, the area at the base perimeter can become excessively damp, potentially creating an environment that is susceptible to flooding and rust or corrosion of surrounding building elements, as well as attracting termites and other pests.

It is recommended that a licensed plumber be appointed to further inspect and to extend the down pipes to the properties stormwater line as necessary.

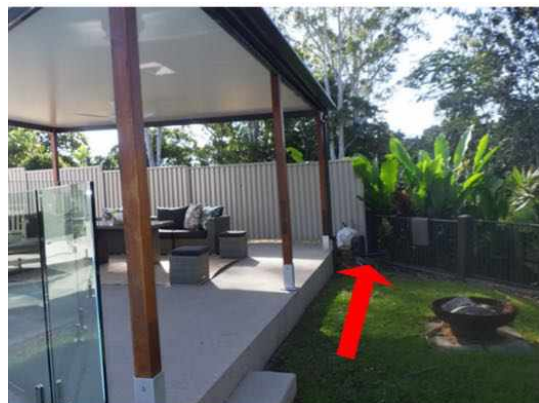
Finding 6.06

Building:	Main Building
Location:	Cabana > Rear Left
Finding:	Stormwater downpipes
Information:	The down pipe to the cabana roof area at the rear of the property is not connected to

Where roof plumbing doesn't drain as required, the area at the base perimeter can become excessively damp, potentially creating an environment that is susceptible to flooding and rust or corrosion of surrounding building elements, as well as attracting termites and other pests.

It is recommended that a licensed plumber be appointed to further inspect and to extend the down pipes to the properties stormwater line as necessary.

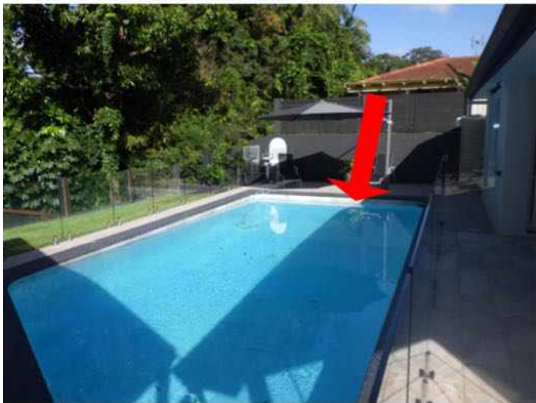
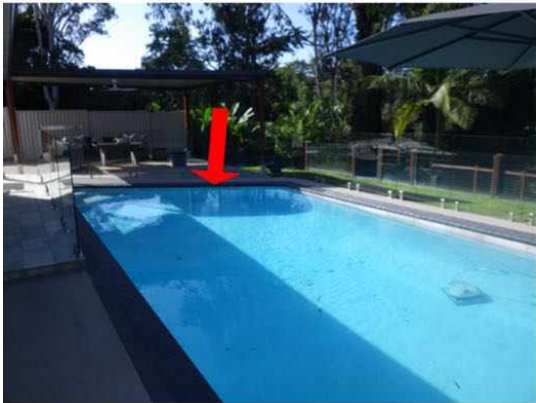
Building: Main Building
 Location: Swimming Pool - Below Ground > Existing
 Finding: Swimming Pool
 Information: At the time of inspection it was observed there is a noticeable difference in the water height - pool coping tile margins to each end of the pool.

Additionally as there is no obvious signs of ground erosion, cracking or damage to the pool shell, it is assumed the pool shell structure has been constructed approximately 100mm off level.

Monitoring the pool area is advised to identify any signs of movement or damage in the area.
