Building and Timber Pest Inspection Report

Inspection Date: Wed, 21 Jan 2026

Property Address: 82 Waratah Rd, Huntly VIC 3551, Australia

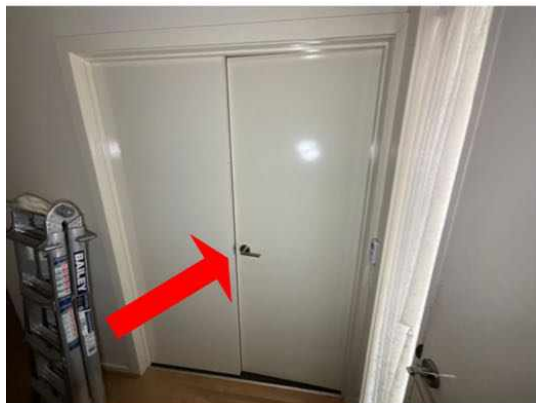
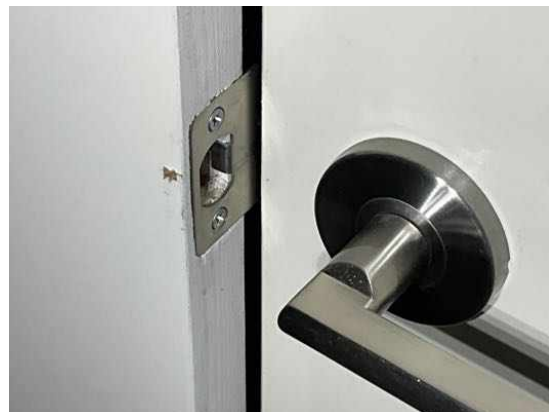
Finding 3.01

Building: Building 1
 Location: Cinema
 Finding: Door - Striker plate misaligned
 Information: The striker plate to this door appears to have become misaligned and has consequently resulted in the door's operation being compromised.

This is a common defect and is expected in a property of this age, whether being due to substandard installation or general deterioration of the door hardware.

Readjustment of the striker plate is recommended at client discretion. Works such as these can be completed by a general handyman or qualified carpenter.

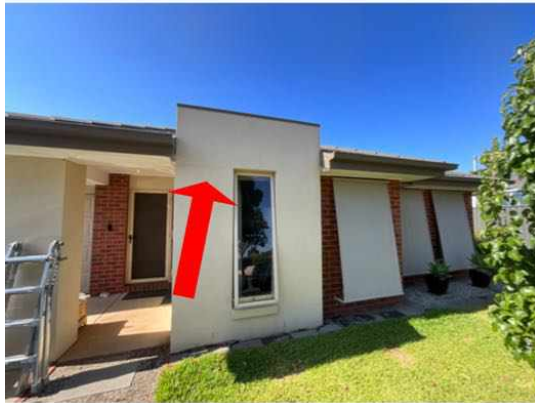
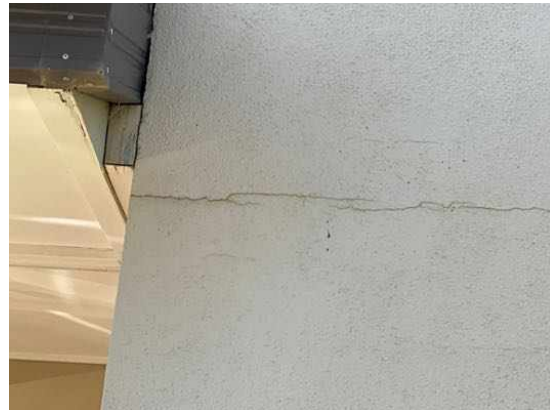
Finding 3.02

Building: Building 1
 Location: Front wall
 Finding: Render- Cracking
 Information: Cracking to the render in this area was identified at the time of inspection.

This type of cracking is often consistent with general dilapidation of the property, and

may continue to develop if left unmaintained.

Frequent monitoring should be carried out to identify any further damage.

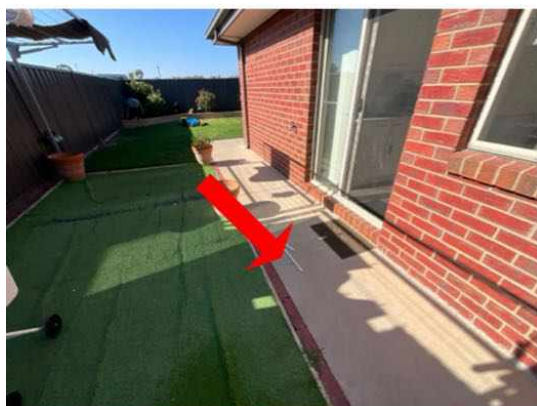
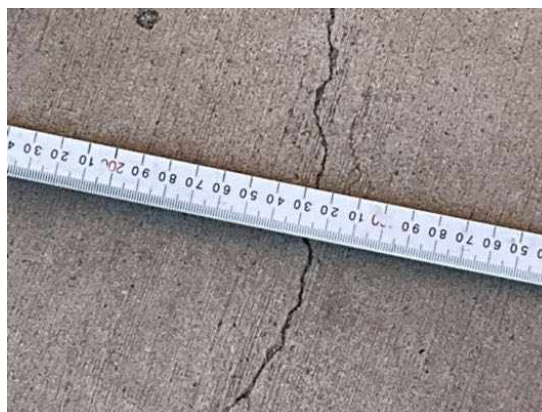
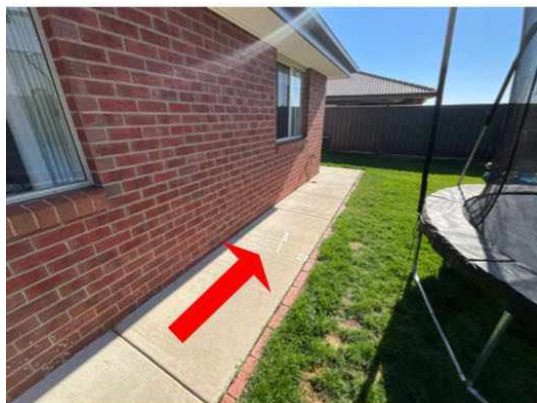
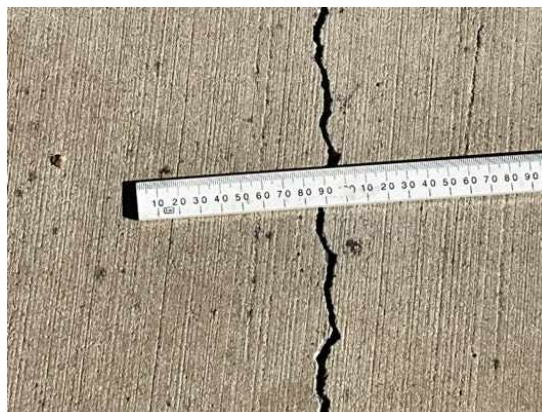
Finding 3.03

Building:	Building 1
Location:	Yard - Side, back
Finding:	Cracking - External Concrete Paving Damage Category 1 - Fine (less than 2mm)
Information:	Fine cracks were identified in external concrete paving. Although fine cracks are quite noticeable, they are often only considered to be an appearance defect, and usually do not indicate any structural damage. To be considered a Category 1 or fine crack, the crack is found to be less than 2mm in width.

Generally the cause of a hairline crack in existing concrete paving such as driveways and pathways is indicative of the expansion and contraction of the concrete. Such causes are generally due to environmental factors, such as moisture levels, weather conditions, root systems of nearby trees or the soil types on which they are laid.

Fine cracks may also be due to poor original installation of the concrete. Factors such as poor compaction of the sub surface and/or inadequate reinforcing of the slab may create cracking and other secondary defects.

Monitoring of all cracking should be conducted frequently. Always contact a building inspector should cracks widen, lengthen, or become more numerous.

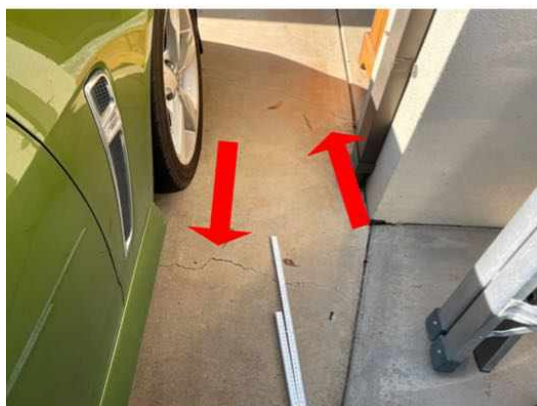
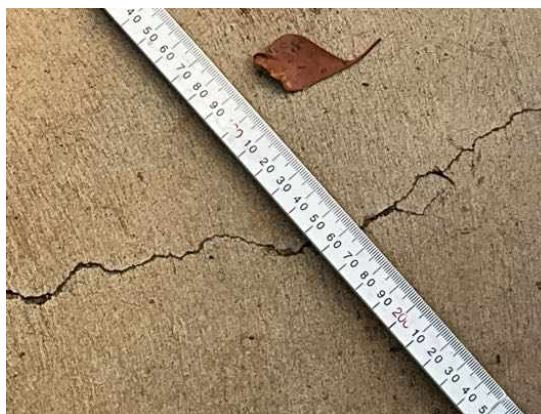
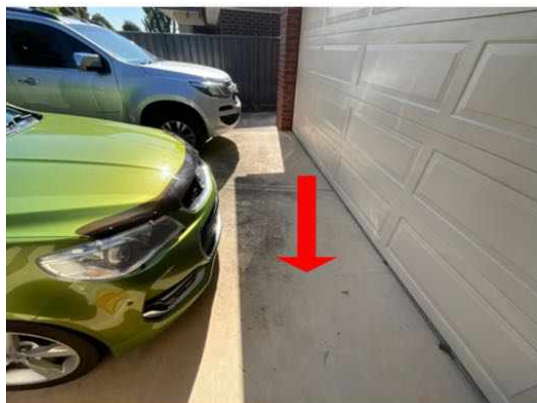
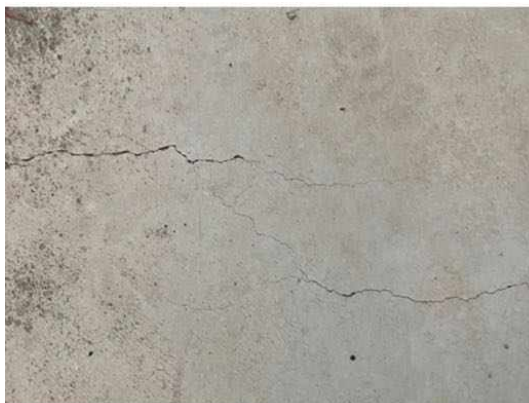
Finding 3.04

Building:	Building 1
Location:	Driveway
Finding:	Cracking - External Concrete Paving Damage Category 1 - Fine (less than 2mm)
Information:	Fine cracks were identified in external concrete paving. Although fine cracks are quite noticeable, they are often only considered to be an appearance defect, and usually do not indicate any structural damage. To be considered a Category 1 or fine crack, the crack is found to be less than 2mm in width.

Generally the cause of a hairline crack in existing concrete paving such as driveways and pathways is indicative of the expansion and contraction of the concrete. Such causes are generally due to environmental factors, such as moisture levels, weather conditions, root systems of nearby trees or the soil types on which they are laid.

Fine cracks may also be due to poor original installation of the concrete. Factors such as poor compaction of the sub surface and/or inadequate reinforcing of the slab may create cracking and other secondary defects.

Monitoring of all cracking should be conducted frequently. Always contact a building inspector should cracks widen, lengthen, or become more numerous.

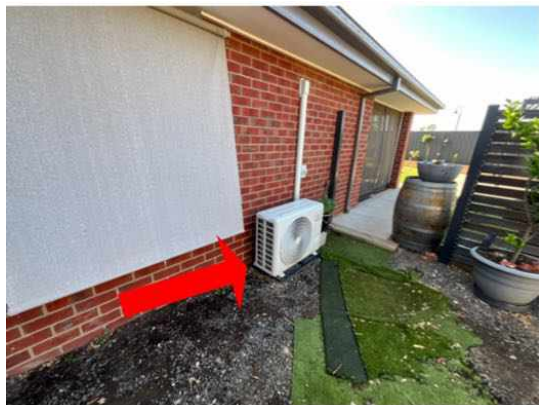
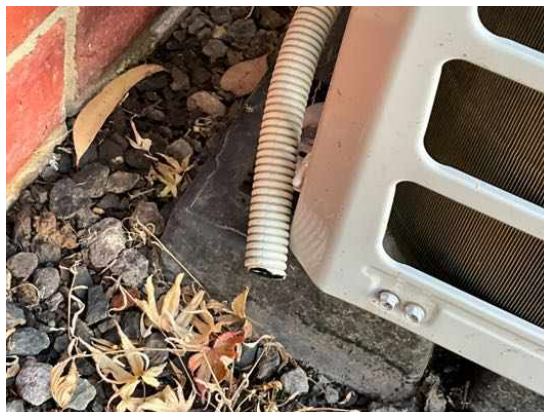
Finding 6.01

Building: Building 1
 Location: Yard - Side
 Finding: Air conditioner - Disconnected overflow
 Information: The Air Conditioner (A/C) overflow was found to be disconnected from storm water drainage and is creating excessive moisture in the surrounding area.

Such leaking creates an environment which is conducive to an array of defects, including water damage to associated building elements and the attraction of termite or timber pest infestation.

It is highly recommended that a licensed plumber be appointed to connect the A/C

overflow in order to prevent such an environment from being created. These minor works should be carried out as soon as possible.

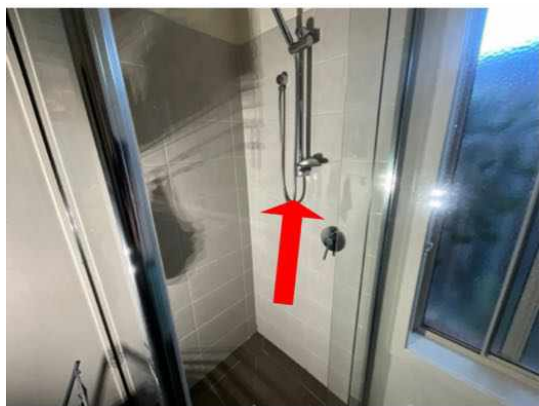
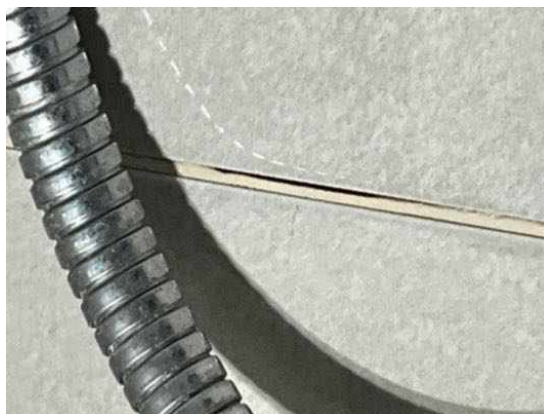
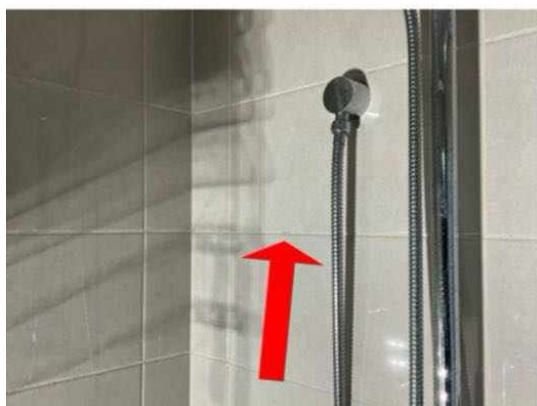
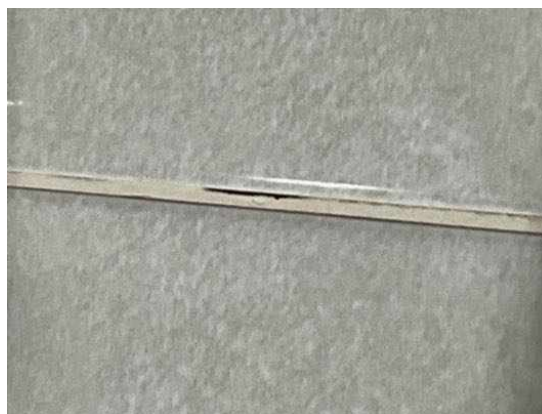
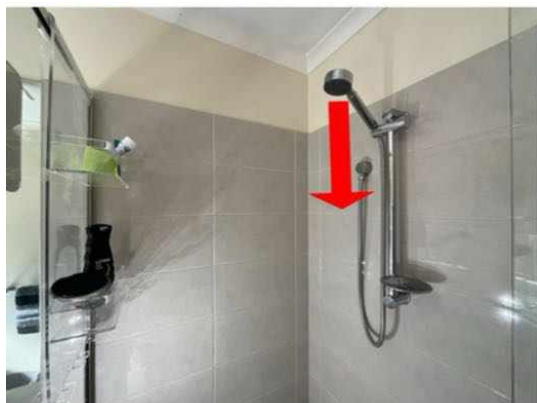
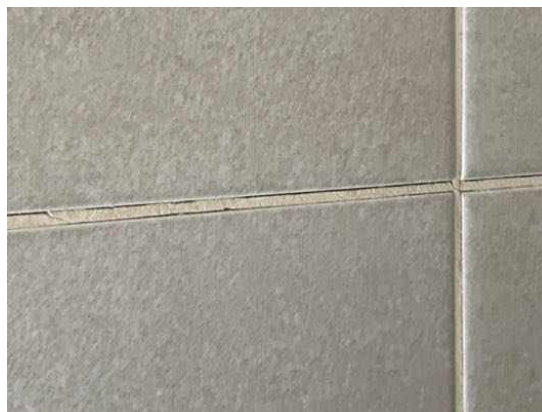
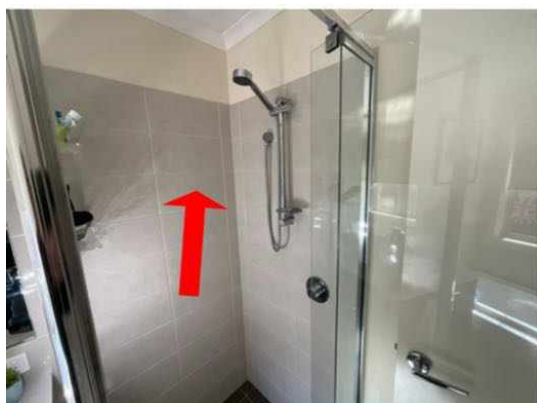
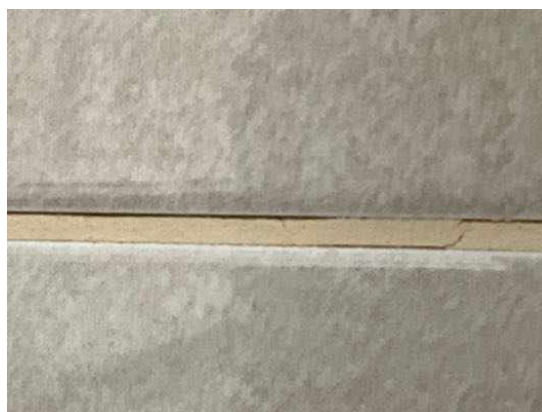
Finding 6.02

Building: Building 1
 Location: Ensuite, bathroom
 Finding: Inadequate sealant or Grout
 Information: This area has a lack of effective Sealant or Grout. This is allowing the ingress of water to the structure inside the wall.

The presence of water encourages Termite attack, Mould and Fungal Decay.

A Tiler or General Handy person must be contacted as soon as possible to effect repairs and prevent further deterioration.

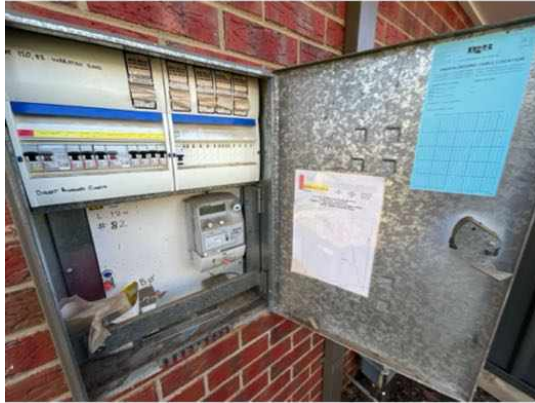
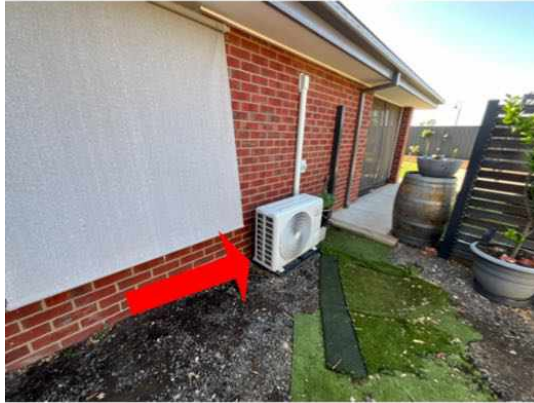
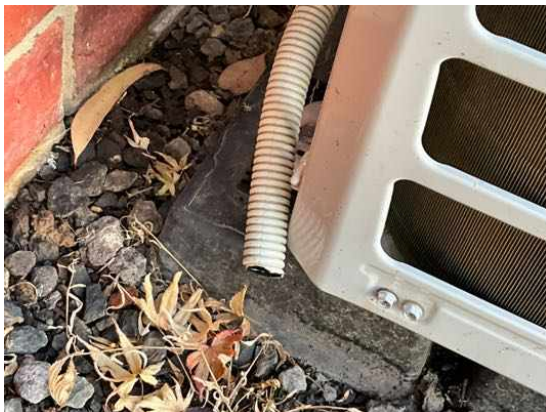
Finding 6.03

Building:	Building 1
Location:	All External Areas
Finding:	Termite Management System - no evidence of a chemical installation
Information:	The application of a post-construction chemical termite barrier is highly recommended for all properties, particularly if live termite activity has been found on the site previously. Such barriers are highly effective in preventing termite attack on any timber building elements throughout the property.

A durable notice should be placed in the switchboard unit to indicate current termite barriers. At the time of inspection, it appeared as though no termite management system has been installed, with no evidence to suggest preventative works taking

place.

The client may consider gaining further advice from a pest controller as to the costs and procedures involved with this application. It is recommended that obtaining such advice be a short-term priority.

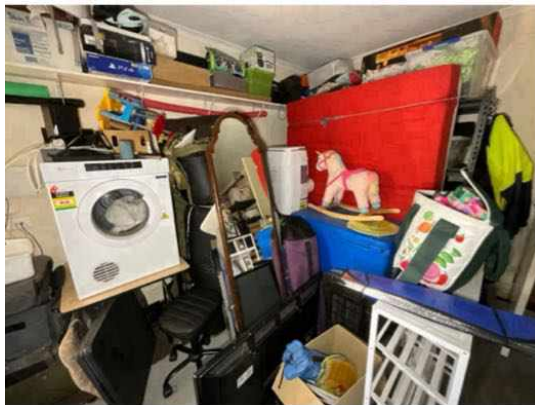
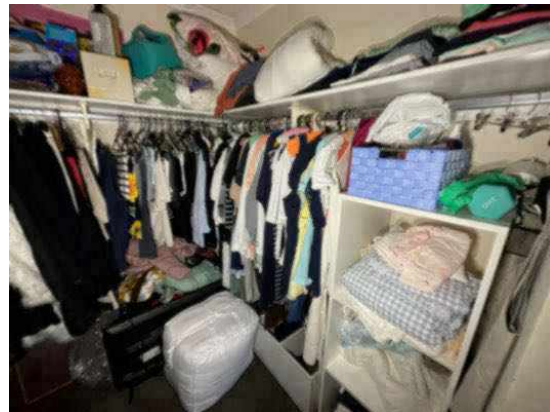
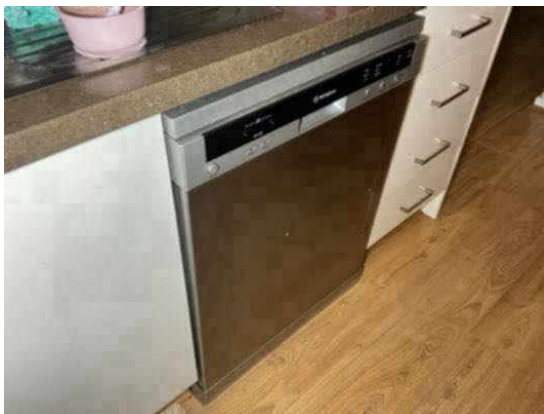
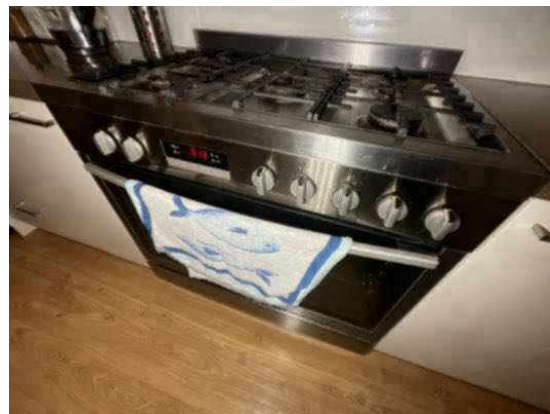
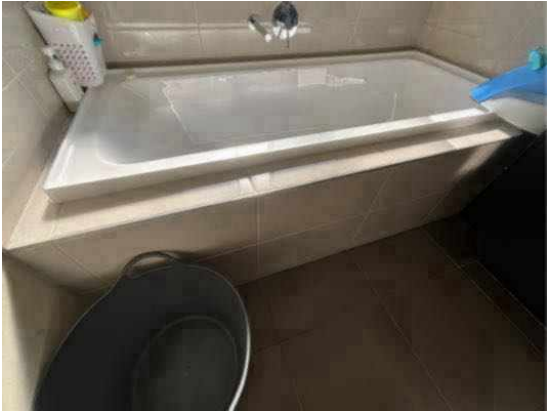
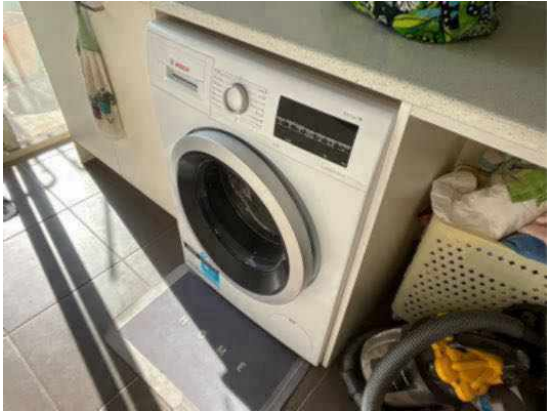
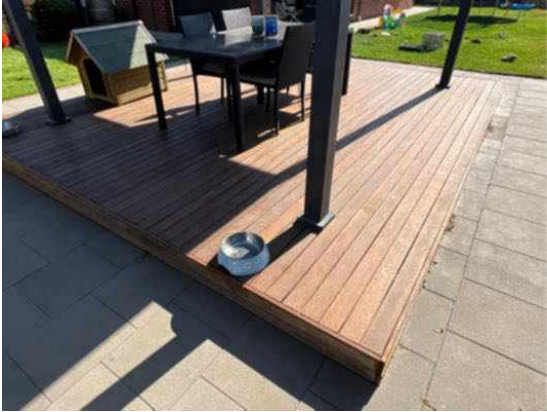
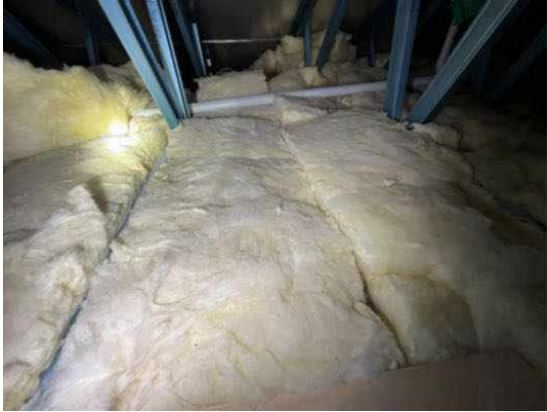
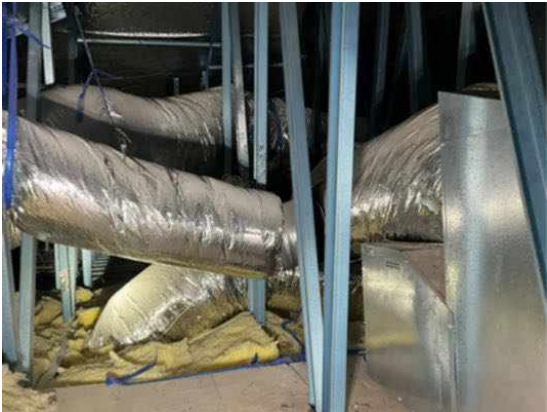
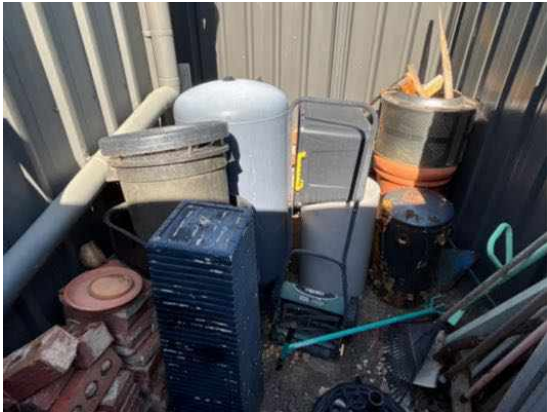
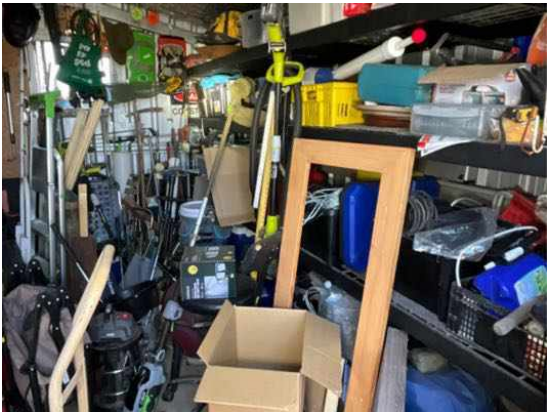
Noted Item

Building: Building 1
Location: All Areas
Finding: Additional Photos - Obstructions and Limitations
Information: These photographs are an indication of the obstructions and limitations which impeded full inspection of the property at the time of inspection. These obstructions can hide an array of defects and should be removed to allow full inspection to be carried out. A re-inspection is recommended once the areas are made accessible.
