## Building and Timber Pest Inspection Report

Inspection Date: Mon, 9 Feb 2026

Property Address: 20 McLeod Ct, Wyreema QLD 4352,  
Australia

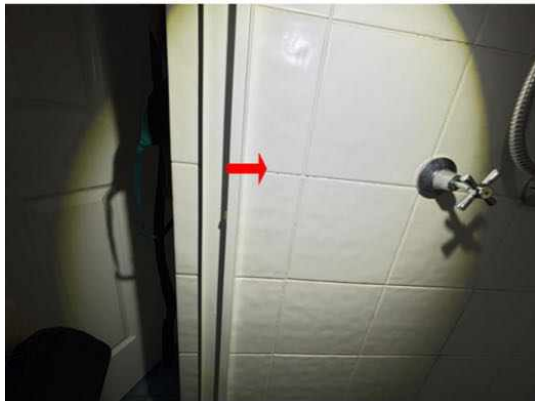
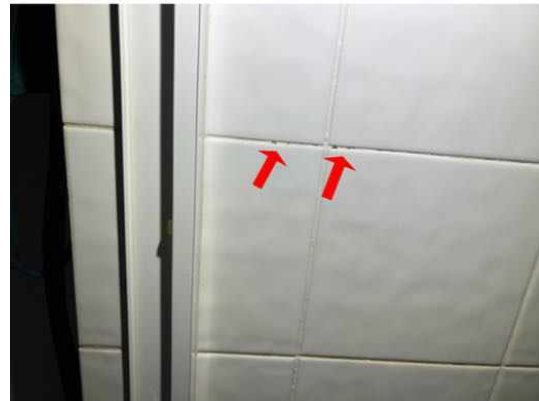
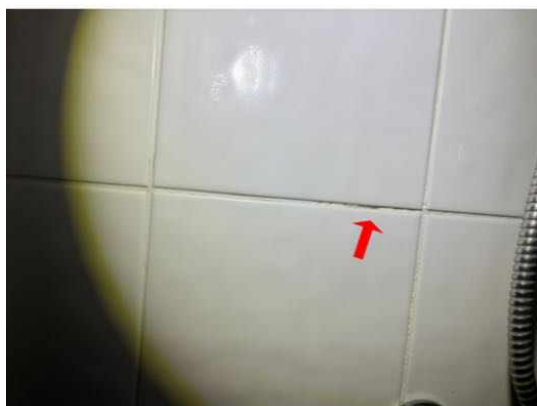
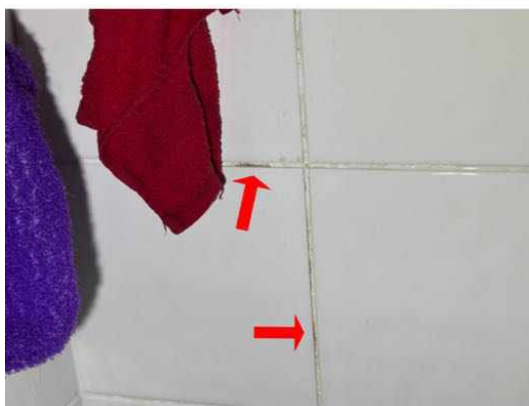
#### Finding 3.01

Building: Main Building  
Location: Bathroom  
Finding: Bathroom - grout deteriorating  
Information: At the time of time of the inspection, it was noted that the grout for the wall tiles in the shower cubicle has deteriorated and in some sections, there are holes in the grout. This may be due to normal wear and tear. Grout replacement is recommended to prevent moisture getting behind the tiles. Normal moisture readings were recorded in the shower cubicle.

A bathroom specialist should be engaged to assess the shower and provide a solution for this issue. This should be done as a short term priority.

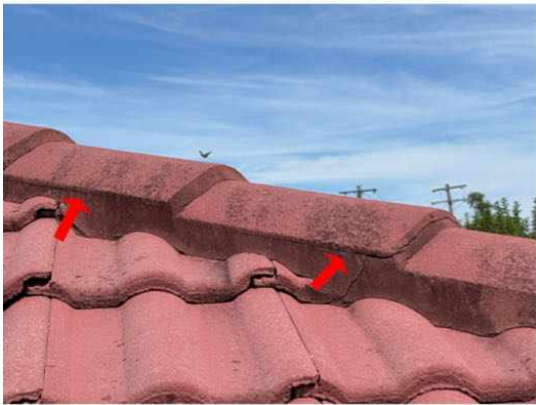
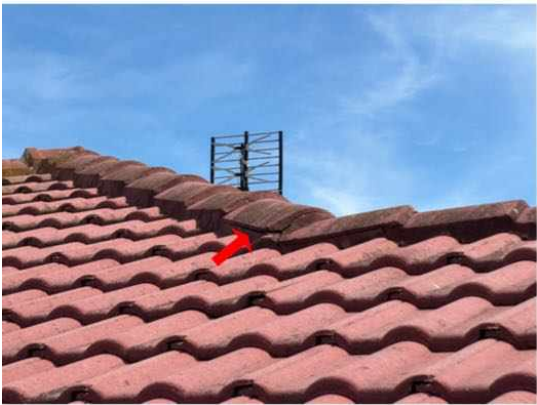
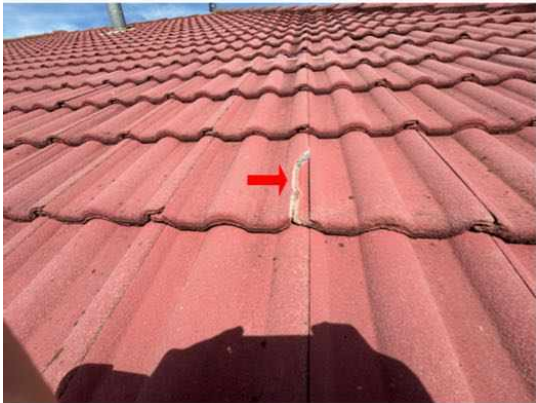
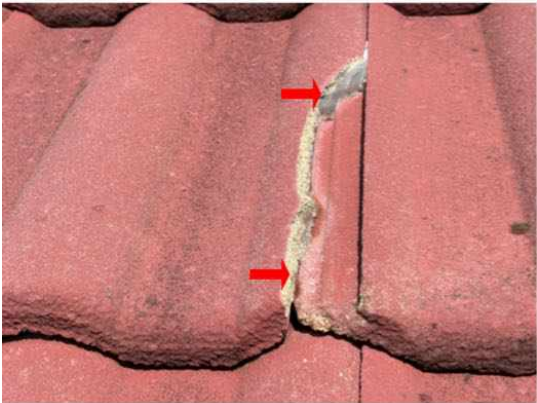
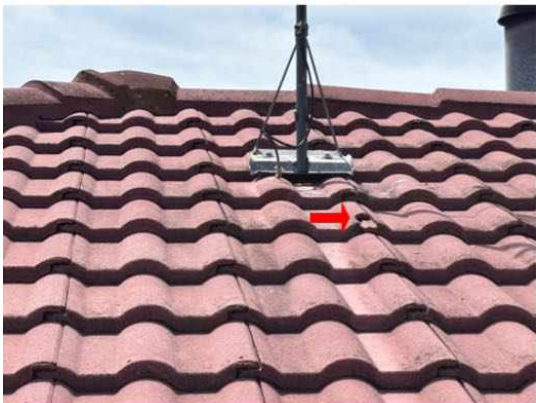
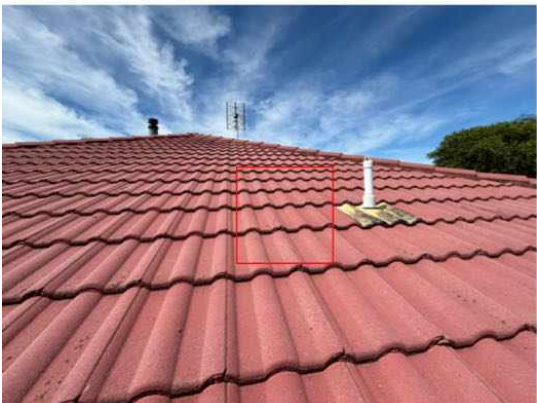
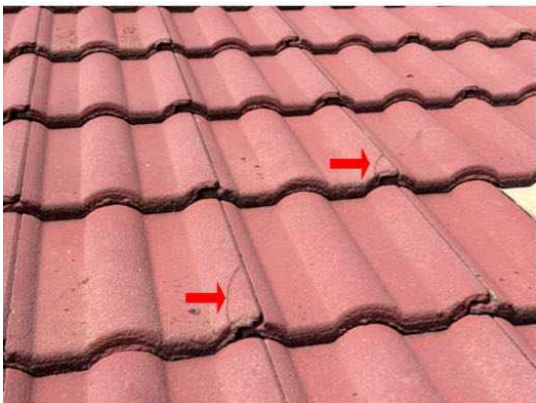
### Finding 3.02

Building:	Main Building
Location:	Roof Exterior
Finding:	Roof tiles - Weathered
Information:	Upon inspection of the exterior roofing, the majority of roof tiles were considered to be in a good condition. While weathering of the tiles is consistent with the age of the property, maintenance works are required.

Four roof tiles were found to be cracked or broken. The tile at the front of the dwelling with the largest piece broken off, has been repaired with sealant that has deteriorated. Sealant on a roof can only be seen as a temporary repair. Replacement of the cracked/broken tiles is recommended to prevent moisture entering the roof void. Some cracking, consistent with the age of the dwelling, was found to the ridge capping mortar.

Where left unmanaged, deteriorating roof tiles are likely to lead to a number of secondary defects, including minor water leaks and weather exposure to internal roofing structures.

Re-pointing and re-sealing the may be considered as an interim solution by the client to help preserve and extend the life span of the tiles.

Consultation with a roofing contractor is highly advised to gain advice on cost of remedial works that may be required in the short to medium term. Remedial works are likely to increase the longevity of the exterior roofing structure. If left unaddressed, this minor defect may become a major defect.

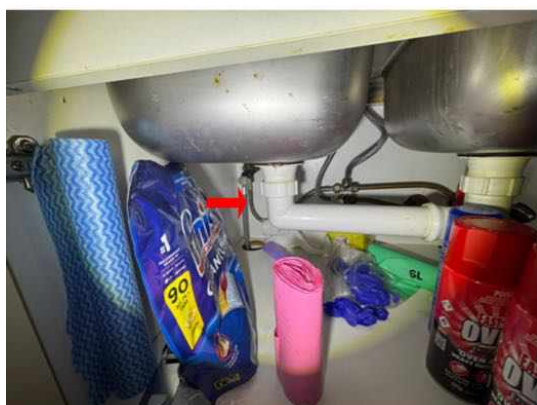
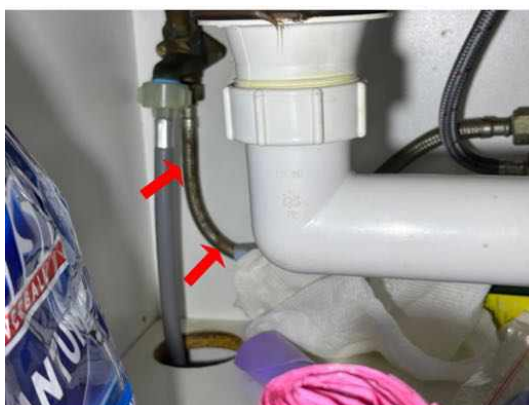
Finding 3.03

Building:	Main Building
Location:	Kitchen
Finding:	Kitchen - flexible hose has signs of rust
Information:	At the time of the inspection, it was noted that a flexible hose in the kitchen sink cabinet had signs of rusting. This may be due to the age of the hose. Flexible hoses typically have a 5 - 10 year lifespan. It is recommended that they be changed if they have signs of bulging, fraying, kinking or rust.

A licensed plumber should be engaged to replace the affected flexible hose in the kitchen sink cabinet. This should be done as a matter of urgency.

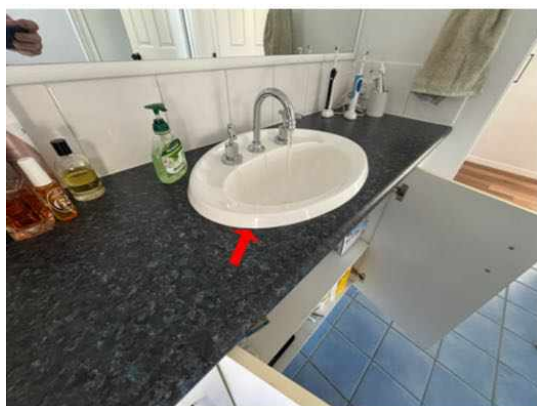
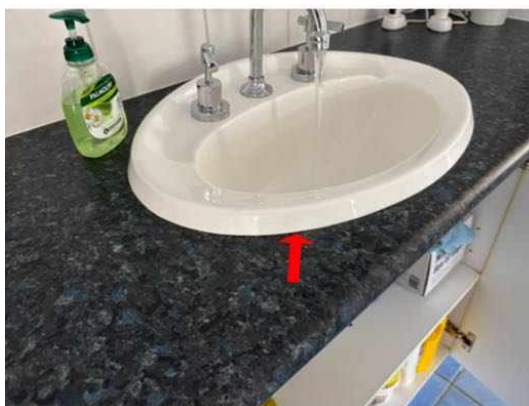
### Finding 3.04

Building:	Main Building
Location:	Bathroom area
Finding:	Bathroom area - no sealant to basin
Information:	At the time of the inspection, it was noted that there was no sealant around the vanity basin. The basin can be moved by hand. No sealant around the basin allows moisture to get under the basin which could result in damage to the bench top or the vanity cabinet.

A building maintenance professional or bathroom specialist should be engaged to apply sealant to the vanity basin. This should be done as a short term priority.

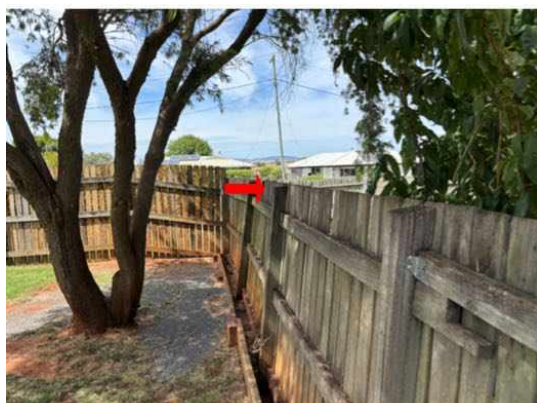
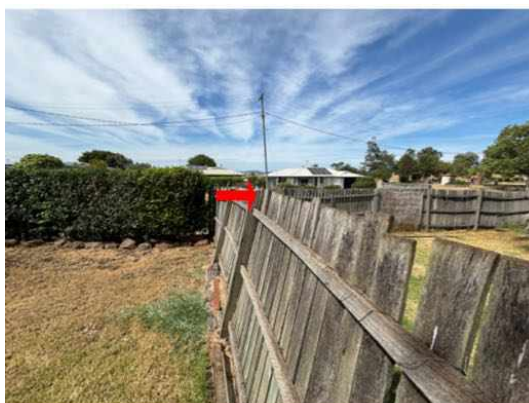
### Finding 3.05

Building: Main Building  
 Location: Back yard  
 Finding: Boundary fence - falling over  
 Information: At the time of the inspection, it was noted that the rear boundary timber fence was falling over. This may be due to the age of the materials and general weathering.

The client should engage a fencing contractor to replace the rear boundary timber fence. This can be done at the clients discretion.

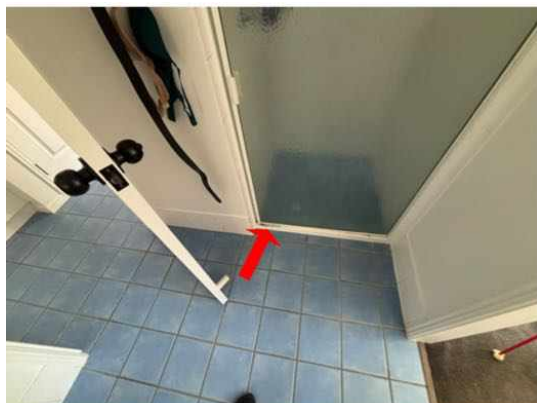
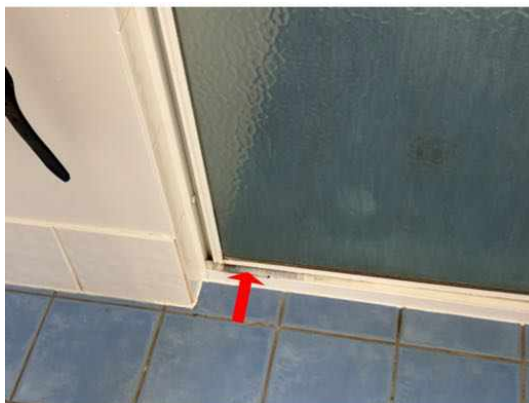
### Finding 3.06

Building: Main Building  
 Location: Bathroom  
 Finding: Bathroom - shower screen door binding  
 Information: At the time of the inspection, it was noted that the shower screen door was binding on the frame sill. This may be due to general wear and tear. If left unaddressed, deterioration of the shower screen may occur.

A building maintenance professional or shower screen specialist should be engaged to carry out the necessary repairs to restore full functionality to the shower screen door. This can be done at the clients discretion.

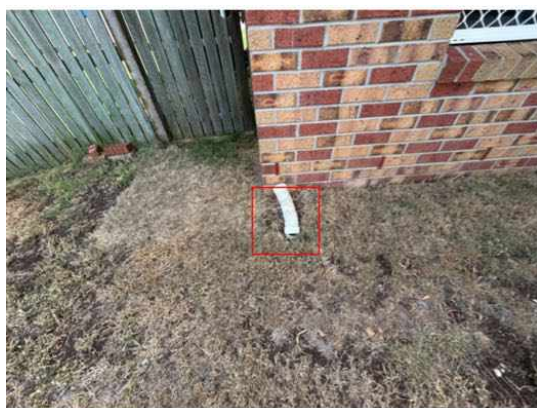
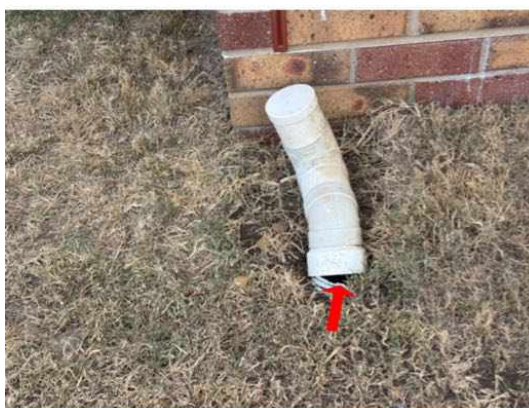
### Finding 3.07

Finding: Storm water - capping loose

Information: At the time of the inspection, it was noted that the capping for the down pipe on the rear left hand side of the dwelling was loose. The down pipe has been diverted to the water tank in the back yard. The hole created by the loose capping will allow dirt and debris to fall into the storm water system potentially causing a blockage.

A licensed plumber should be engaged to re-secure the capping to the storm water system. This should be done as a short term priority.

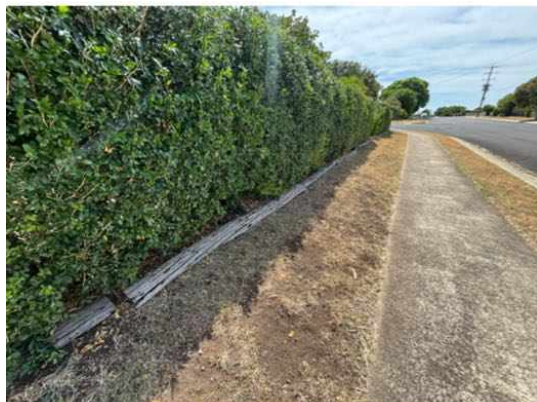
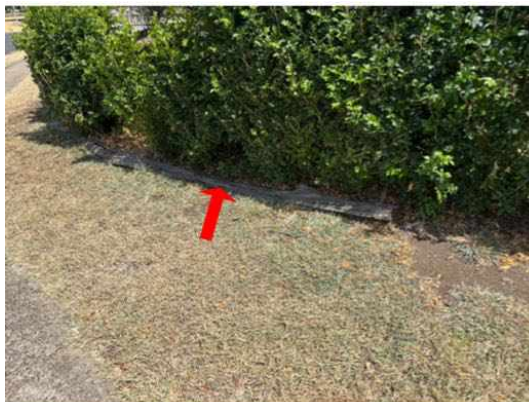
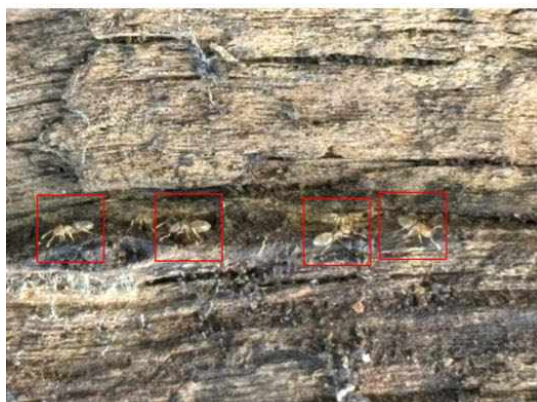
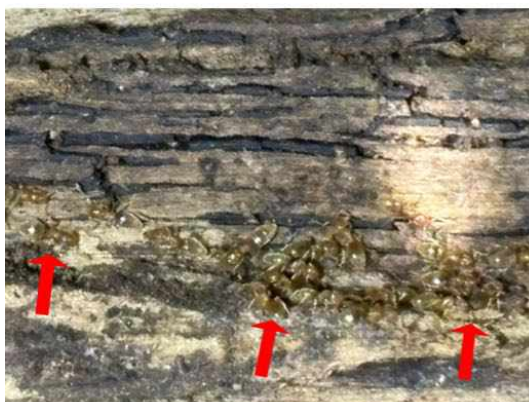
### Finding 4.01

Finding: Evidence of live termite activity was identified (species unknown)

Information: At the time of the inspection, it was noted that there was live termite activity on the

property.

Live termites were found in sections of the timber garden edging on the left hand side of the dwelling. The species of the termites could not be identified at the time of inspection which may impact on the mode of eradication.

Works to eradicate live termites should be undertaken immediately to prevent any further damage that will inevitably ensue. It is recommended that that the timber garden edging be removed.

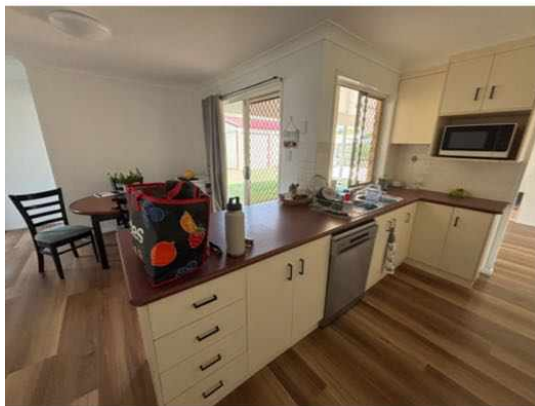
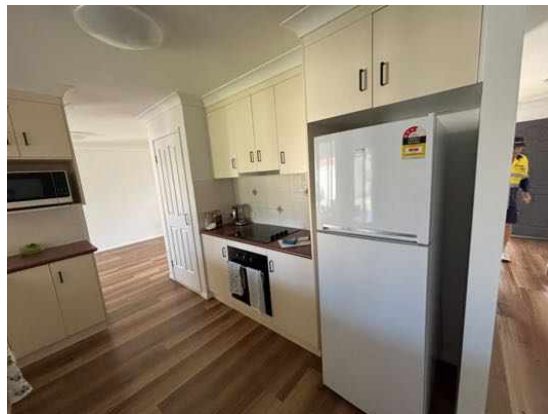
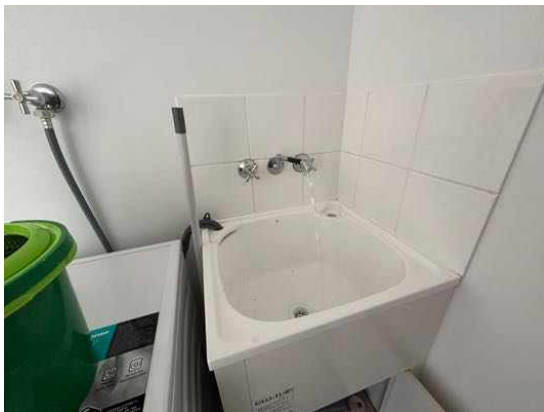
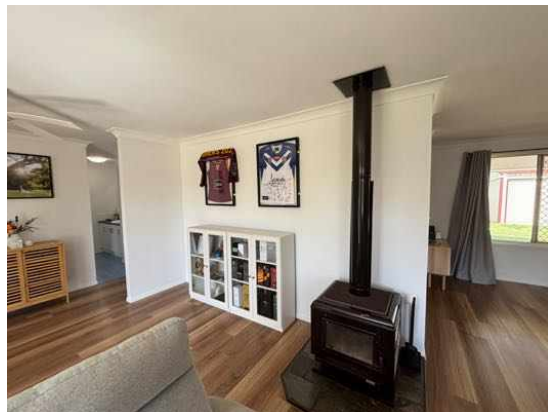
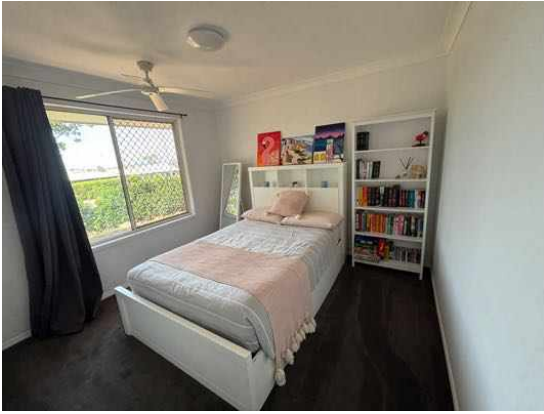
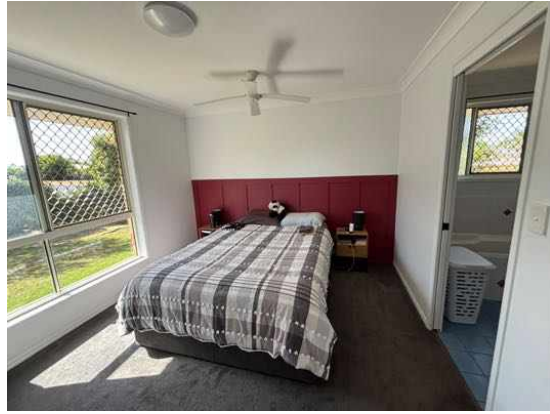
Building: Main Building  
Location: All Internal Areas  
Finding: Obstructions and Limitations - Internal areas  
Information: These photographs are an indication of the obstructions and limitations which impeded full inspection of the property of the internal areas at the time of inspection. These obstructions can hide an array of defects and should be removed to allow full inspection to be carried out. A re-inspection is recommended once the areas are made accessible.

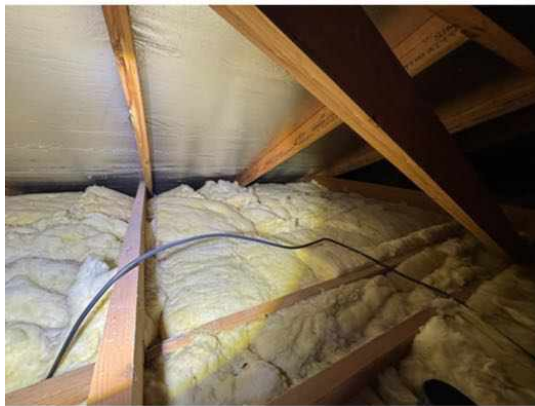
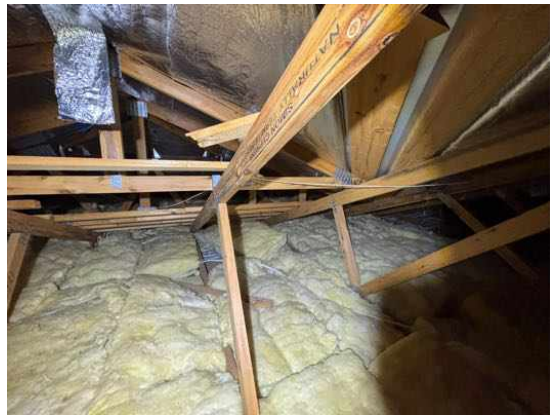
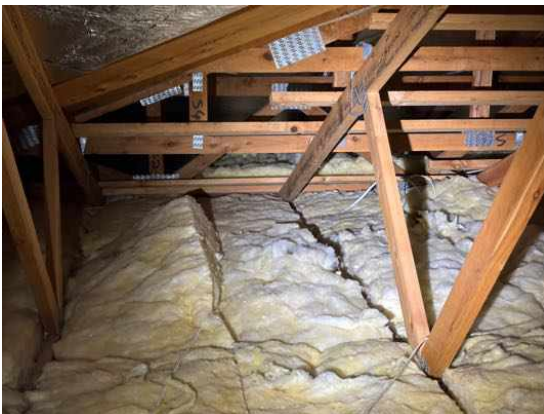
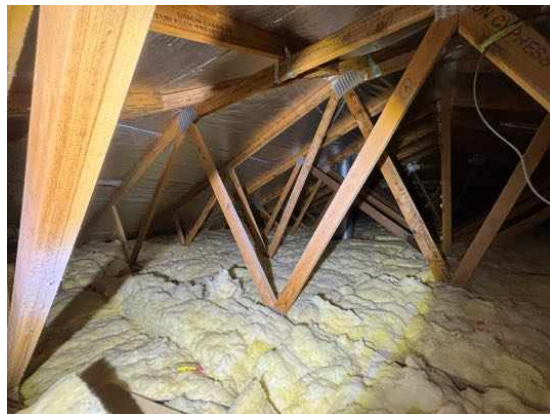
Finding: Obstructions and Limitations - Roof cavity

Information: These photographs are an indication of the obstructions and limitations which impeded full inspection of the property of the roof cavity

at the time of inspection. These obstructions can hide an array of defects and should be removed to allow full inspection to be carried out. A re-inspection is recommended once the areas are made accessible.

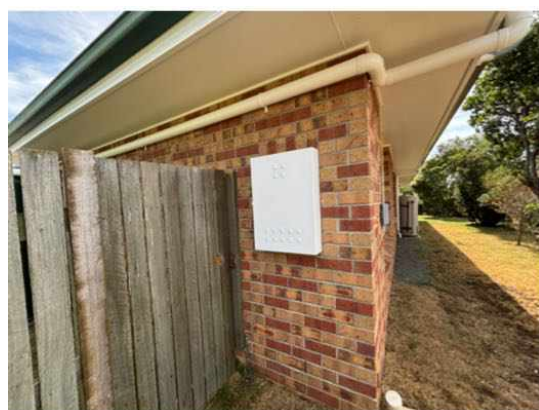
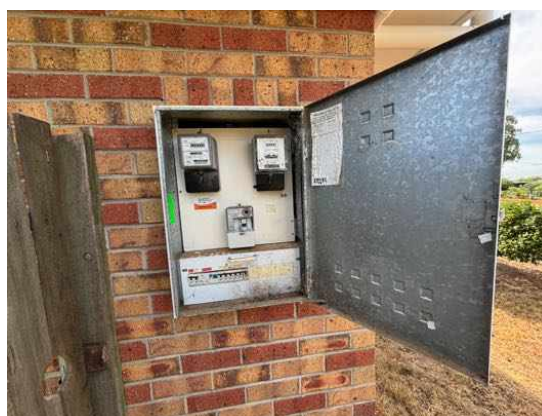
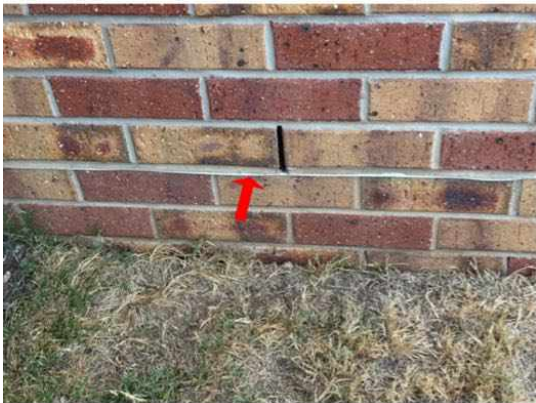
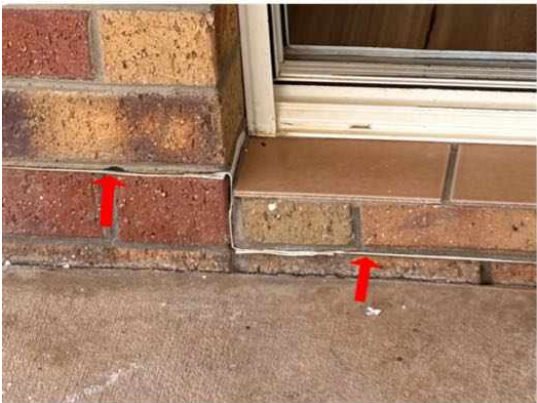
Building: Main Building  
Location: All External Areas  
Finding: Evidence of a physical termite management system was identified.  
Information: At the time of the inspection, evidence of a physical termite management system was found by way of a visual sighting at the damp course level of the brickwork. No durable notice was found in the electricity meter box or in the kitchen sink cabinet.

A physical termite barrier would normally be installed to the slab penetrations, perimeter and construction joints during construction. Due to the lack of a durable notice, full details of the physical termite barrier could not be determined.

A termite and timber pest technician should be engaged to carry out annual termite inspections as per AS 3660 in order to further protect the dwelling. Annual termite inspections must be carried out in partnership with any termite treatment system, physical or chemical, as no termite treatment system can be expected to be 100% effective.

A physical termite barrier does not stop or eliminate termites, it is designed to expose concealed termite activity. A chemical termite treatment system would add an extra layer of protection against termites.
