Building and Timber Pest Inspection Report

Inspection Date: Mon, 23 Mar 2026

Property Address: 14 Cressy St, Goulburn NSW 2580,
Australia

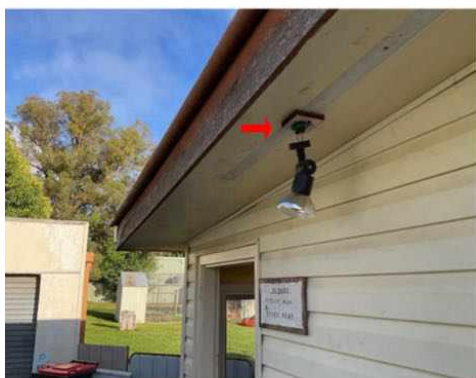
Building:	Building 1
Location:	Exterior walls - left side
Finding:	Light fittings - Damaged or missing
Information:	The light fitting in the driveway area were found to be damaged at the time of inspection creating a safety issue. The front left bedroom has no light and the garage light is missing a tube.

Damage occurs generally when the building materials have aged and decayed, but may also be indicative of impact damage to the building element (accidental or deliberate).

Left unmanaged, the driveway fitting is unlikely to cause further damage to surrounding building elements. However, the broken light fitting may expose electrical works, and may create a minor safety hazard if there is potential contact with persons in the area.

Repair and/or replacement of the damaged fitting is advised. A Licensed electrician should be appointed to repair/replace the light fitting at the client's discretion.

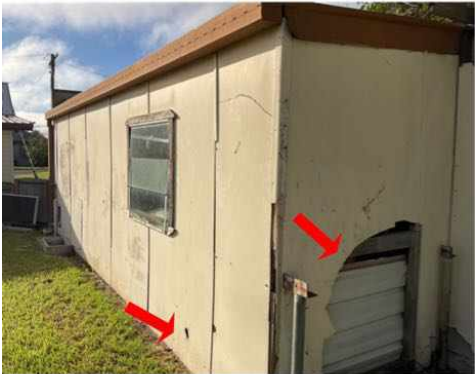
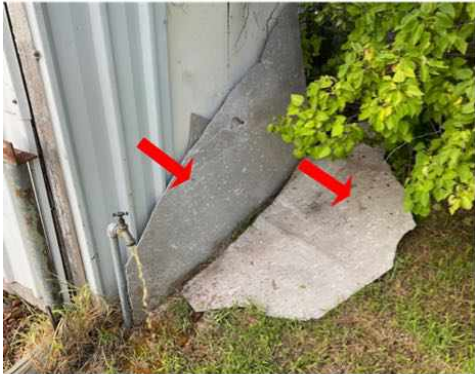
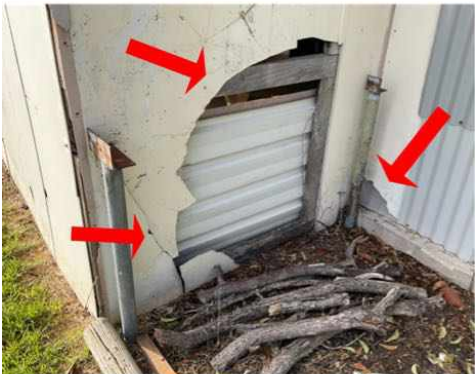
Finding 1.02

Building: Building 2
Location: Exterior garage walls
Finding: Cladding damaged
Information: Evidence of damage was identified to the garage walls where the cladding has minor damage. A carpenter would be the trade responsible for rectification of this wall area.

See also asbestos in "for your information".

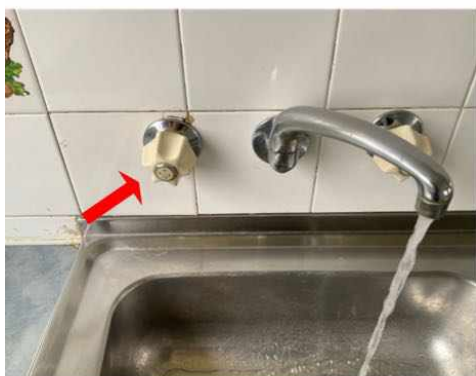
The relatives that were onsite stated they thought the hot water was not functioning.

These items should be rechecked and repaired to a working state by a licensed plumber or gasfitter.

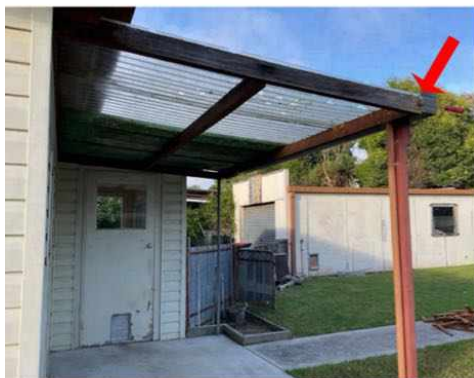
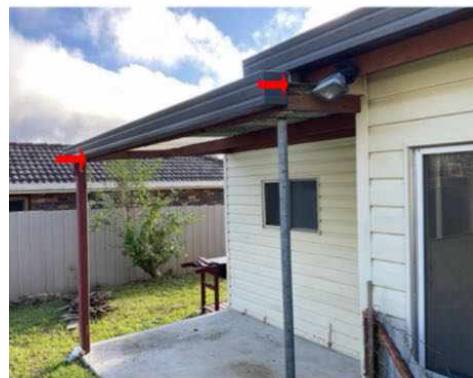
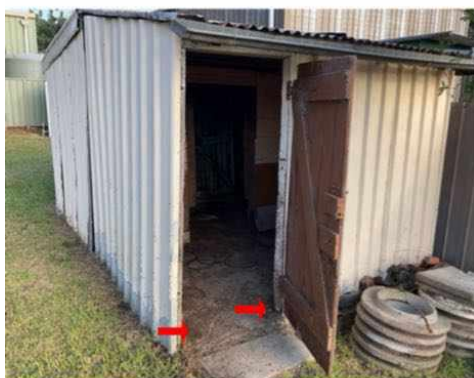
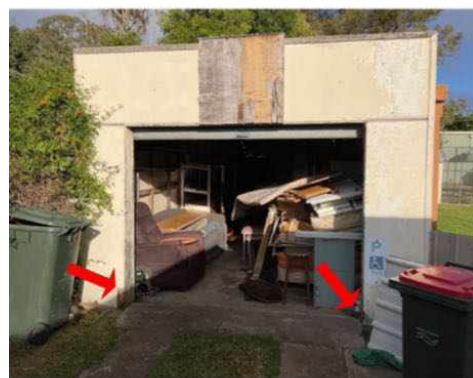
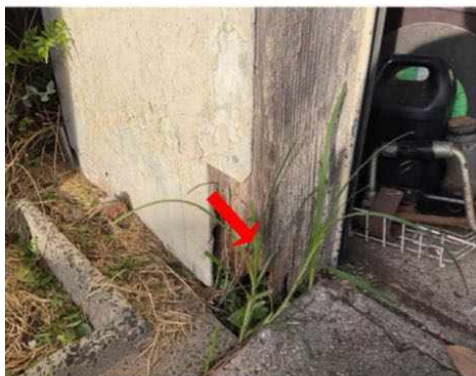
Finding 3.02

Building: Building 1
 Location: All buildings
 Finding: Wood rot
 Information: The buildings shows evidence of wood rot. The wood rot in the pergola posts appears

to need immediate replacement to support the roof.

Wood rot, also known as Fungal Decay, occurs when timbers and other cellulose building materials are exposed to damp conditions on an ongoing basis. This could be the result of exposure to weathering over a prolonged period of time, or the attraction of excessive moisture from other abutting building materials.

Early intervention and regular maintenance, particularly of exterior timbers, will prolong the useful life of these building elements. Prior to any works being performed, the cause of the moisture that has created the visible wood rot should be identified and addressed in a suitable manner. Replacement of affected timbers may then be a necessary step in protecting surrounding building elements from such deterioration.

A qualified carpenter or registered builder may also be required to replace affected pergola posts.

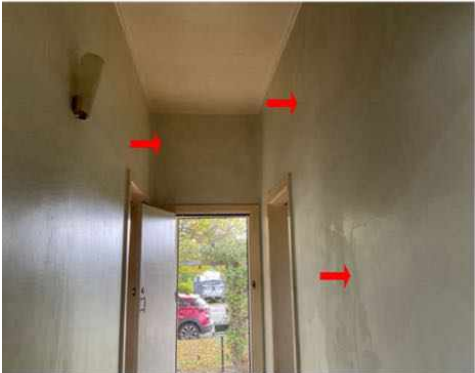
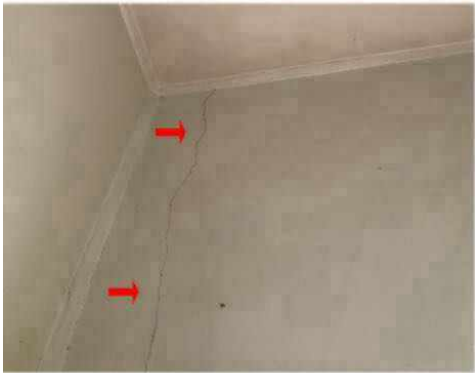
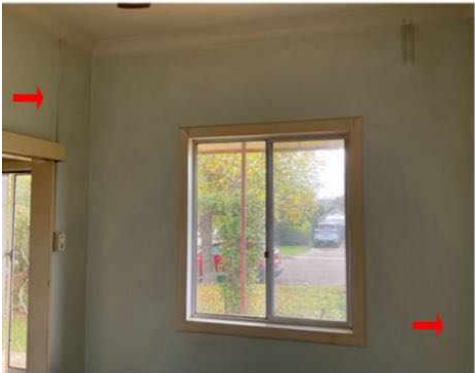
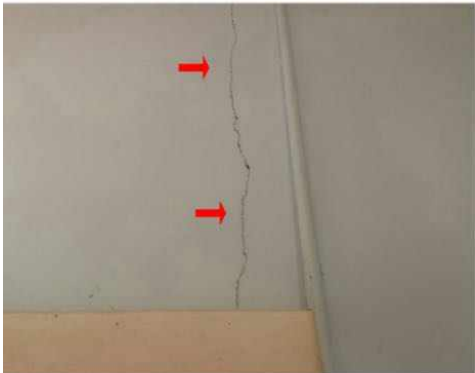
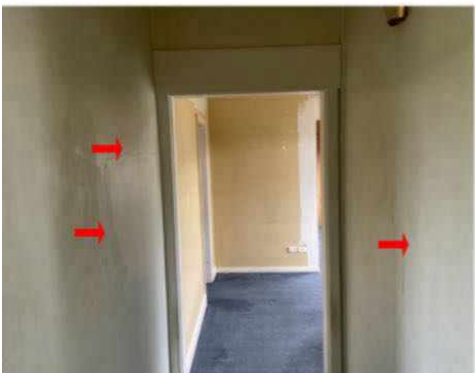
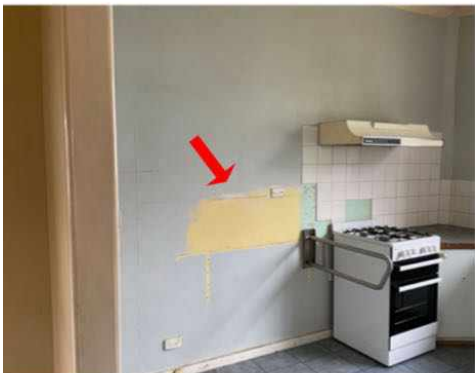
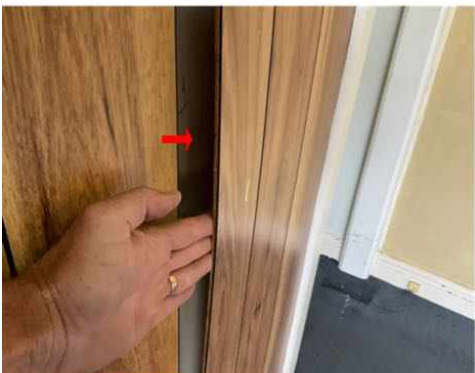
Finding 3.03

Building:	Building 1
Location:	Pictured areas
Finding:	Cracking - Damage Category 2 - Noticeable (up to 5mm)
Information:	Noticeable cracks are a common occurrence as a result of many primary defects. Such causes may include age, general wear and tear, expected building movement, general expansion/contraction of building materials in different weather conditions, and/or minor failings in the installation or application of building materials.

Noticeable cracks may result in minor sticking or jamming of associated doors and windows, which require easement. However, noticeable cracks are easily filled and repaired. A plasterer can be consulted to install an expansion joint at this point to allow for this movement during different weather conditions.

The added internal timber loungeroom cladding needs removal to check for further cracking which is suspected.

Monitoring of all cracking should be conducted frequently. Always contact a building inspector should cracks widen, lengthen, or become more numerous. Additionally, your building inspector should also be contacted if associated building elements such as doors and windows become more difficult to operate over time.

The loungeroom wall cladding should also be removed as it appears this may have been installed to hide further cracking.

Relevant tradespeople, such as carpenters, painters and plasterers, should be appointed to perform remedial works, as deemed necessary.

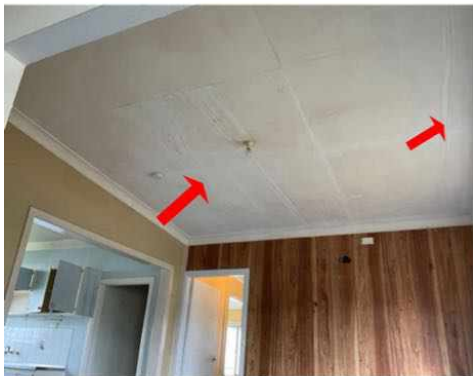
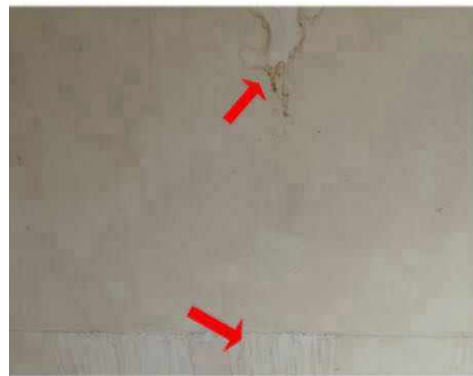
Finding 3.04

Building: Building 1
Location: Kitchen & lounge areas
Finding: Ceiling - Water stained
Information: Water staining to ceiling linings in these areas was evident at the time of inspection. Water staining indicates that surfaces have been exposed to excessive moisture over time. The minerals and other elements in the water lead to staining, which may graduate to corrosion and deterioration if left unmanaged.

While mostly an appearance defect, water staining can be indicative of more serious defects, which may be currently concealed by interior ceilings.

Minor moisture readings of up to 13.4 were recorded with rain falling in the previous 7 days.

Where water staining is active, a licensed plumber must be consulted to identify the cause of the staining and to provide advice on any reparation works that may be required. Replacement of any damaged structures is advised. It is suspected the join between the different sloping rooves requires sealing and 6 monthly inspection for further leaks.

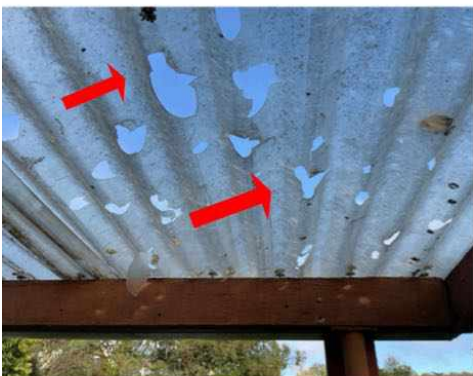
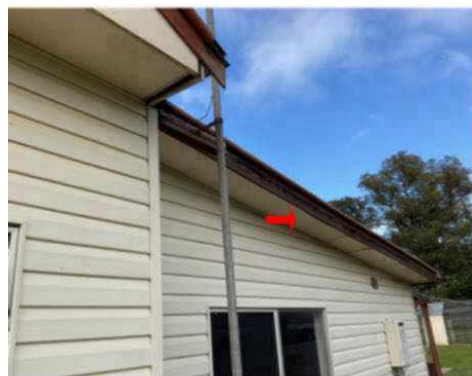
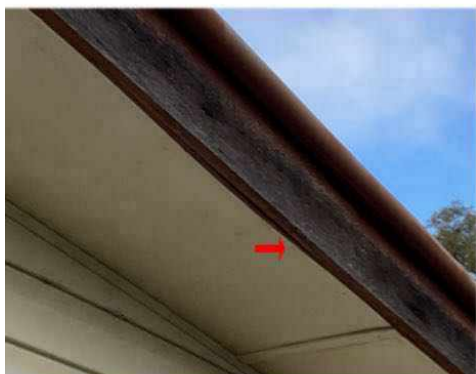
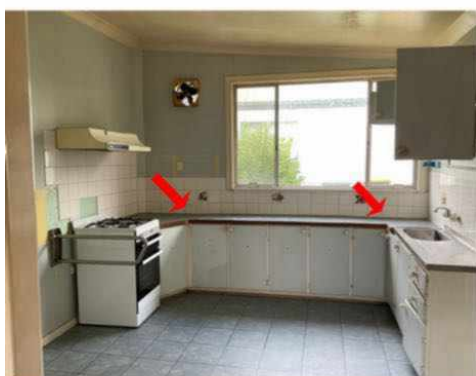
Building:	Building 1
Location:	Pictured external areas
Finding:	Building elements - Damaged
Information:	Evidence of minor missing or damaged areas was identified at the time of the inspection. These include -

1. The rear pergola roof is disintegrating and requires replacement.
2. The right rear eave shows minor sagging requiring refixing in place by a handyperson.
3. Some internal wall panelling is loose requiring a carpenter to refix this in place. It is suspected this is covering plaster cracking.
4. The kitchen bench is made of chipboard and is bowing, sagging and not level.

A carpenter would be the trade responsible for rectification of these areas when convenient.

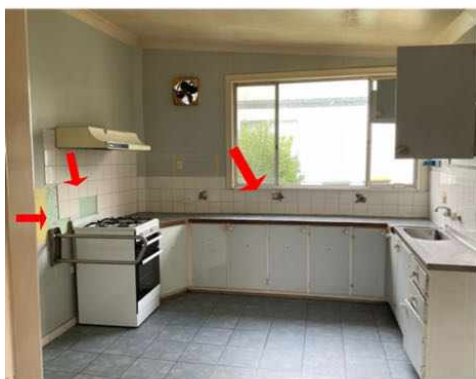
Building: Building 1
 Location: Bathroom
 Finding: Tiles cracked

Information: Cracked tiles were evident in these pictured kitchen areas at the time of inspection. It is suspected that this cracking has occurred as a result of both minor settlement or impact damage. Cracked tiles throughout the household detract from the overall appearance of the affected areas. In wet areas of kitchens, it can lead to water damage of adjoining walls.

Replacement of cracked tiles is recommended as soon as possible. A tiling contractor may be appointed to perform these works. Where cracks become more numerous, contact a licensed building inspector for further investigation.

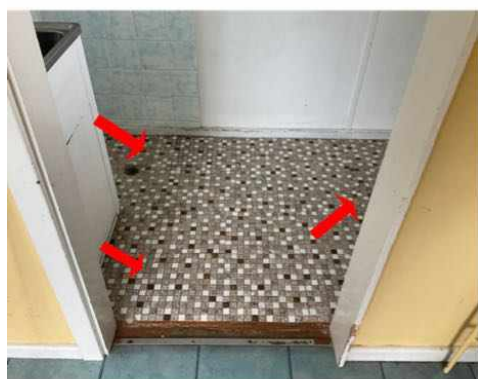
Finding 3.11

Building: Building 1
 Location: Laundry
 Finding: Tiles - Drummy

Information: Drummy tiled areas were identified at the time of inspection. The term 'drummy' refers to tiles that have become detached from their fixing, despite otherwise being in relatively good condition. Such defects are generally caused by physical or moisture

damage to the area. Drummy tiled areas may also be a direct result of poor workmanship during the construction process.

Tiled areas may swell and shrink with changes in air humidity if the area has sustained moisture damage. Any exposure to moisture is capable of causing tiled areas to become drummy and/or cracked over a prolonged period of time. Drummy tiled areas generally require removal and replacement of affected tiles, with adequate sealant and grouting.

Specialist trades are available for these types of services. A registered builder may be required to undertake works if damage is extensive or if secondary building defects have resulted. Otherwise, it is advised that a tiling contractor be appointed to perform works as necessary. Immediate action is recommended to ensure that no further damage is sustained in the affected area.

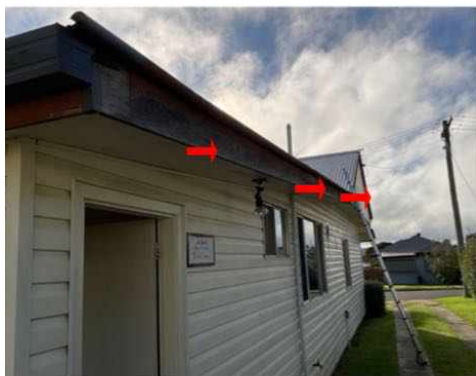
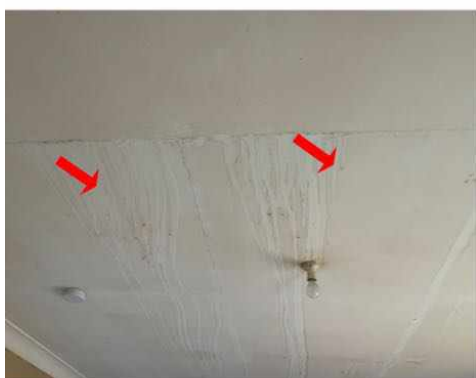
Finding 3.12

Building:	Building 1
Location:	Internal and external areas
Finding:	External painting deteriorated
Information:	Some of the external paintwork has been neglected and require attention to prepare and re-paint.

Whilst incomplete or missing paint finish is generally an appearance defect, it can also lead to the development of secondary building defects over time. Incomplete areas of paint finish expose the area to moisture, potentially accelerating the deterioration of underlying building materials.

Degraded paint finishes should be sanded back, filled, leveled and painted, as applicable. Where inadequate or missing paint protection has led to the deterioration of the associated building element, repair and/or replacement of this building element may be required.

A painting contractor should be appointed as soon as possible to perform necessary works to aid the appearance of the affected area and to ensure the area is protected

against further deterioration. Alternatively, the homeowner following manufacturer instructions may perform these works.

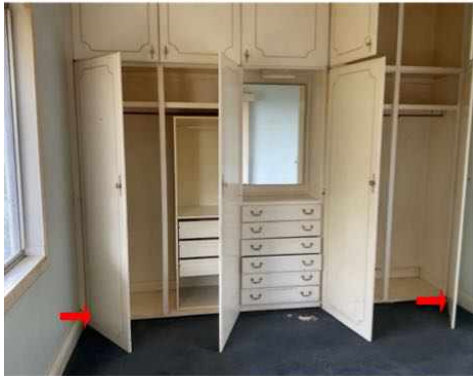
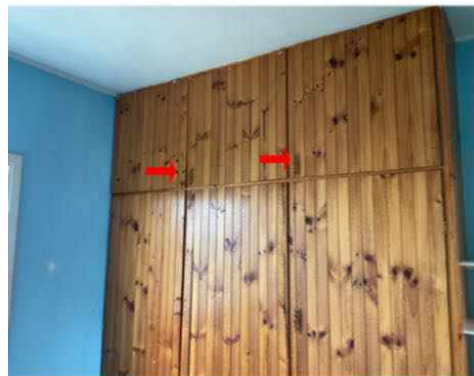
Finding 3.13

Building:	Building 1
Location:	Pictured Areas
Finding:	Doors - Binding and damaged
Information:	Binding and/or jamming of these doors is evident during standard operation. This defect inhibits the functionality of the affected doors as well as creating potential for secondary defects to associated building elements, such as damage to the floor covering or the adjoining door jamb. The rear door is delaminating and may need redo, a cement in a few years.

A door that binds to flooring or to the associated door frame may have several causes, ranging from minor defects, such as poor installation of the door or deteriorated hinges, through to major structural issues, such as damage to subfloor structures.

For minor causes, a qualified carpenter or general handyperson should be appointed

to perform minor rectification works at client discretion.

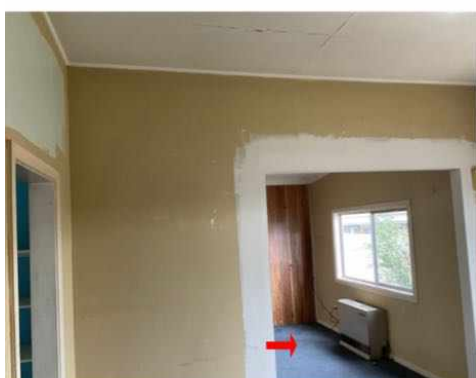
Finding 3.14

Building:	Building 1
Location:	Many Areas
Finding:	Flooring - Uneven
Information:	The internal flooring in some areas is out of level and uneven. Uneven flooring is likely to indicate minor defects such as expected movement of the foundations of the property, but may also indicate subsidence of the associated subfloor stumps.

Where flooring remains relatively unchanged for an extended period of time (i.e. several months), it is likely that this defect has been caused by expected movement of the foundations of the property.

However, where flooring is uneven further, potentially invasive inspection of the subfloor structures and stumps in this area is required. In this case, works to repair are likely to be required, and would be carried out by a registered builder specialising in re-stumping.

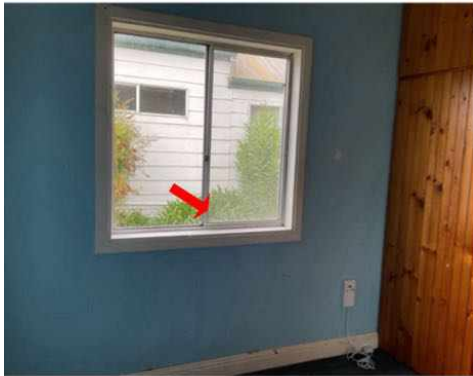
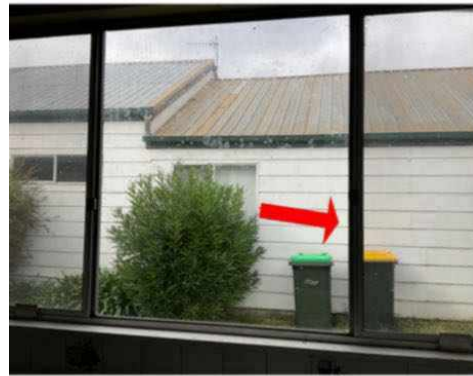
Finding 3.15

Building:	Building 1
Location:	Pictured Areas
Finding:	Windows - Stiff to slide and rear window areas damaged.
Information:	The windows in these areas were jammed and difficult to operate at the time of the inspection. Some sills are not level. Windows provide ventilation to the adjoining area and should be at a fully operational level to ensure comfort. The rear window has a damaged latch and window seal.

Generally, factors such as general age of the building element and a lack of maintenance are the usual causes for this type of defect.

Replacement of window hardware or frame may be required, as well as minor repairs and cleaning. A registered builder or general handy person will be required to repair

the window.

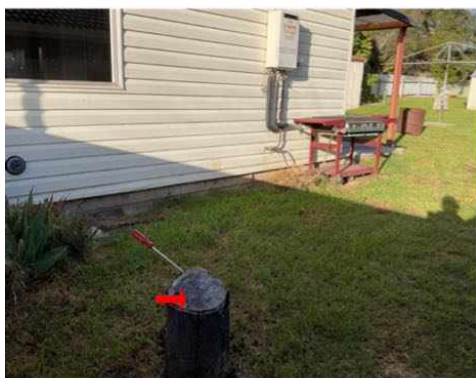
Building:	Building 1
Location:	Pictured tree
Finding:	Evidence of wood borer activity identified
Information:	Wood borers small beetles that colonise in exposed timber elements are a common timber pest that are regularly mistaken for termites. Although wood borer activity is generally not detrimental to the affected timber they may lead to serious damage and necessitate replacement of certain building elements if left unattended.

The other commonly known borer the Anobium borer is more likely to attack floorboards and may cause severe structural damage to flooring areas.

As no live wood borer activity was identified treatment is not required at this time.

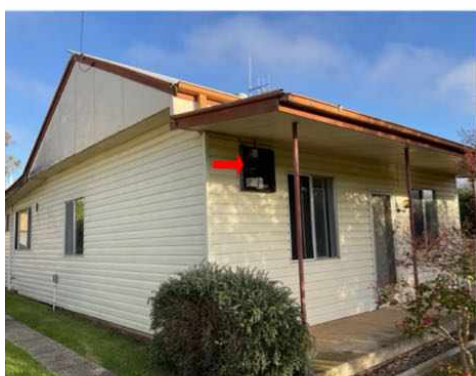
Finding 6.01

Building:	Building 1
Location:	Meter Box
Finding:	Termite Management System - no evidence of a chemical installation
Information:	The application of a post-construction chemical termite barrier is highly recommended for all properties. Such barriers are highly effective in preventing termite attack on any timber building elements throughout the property.

A durable notice should be placed in the switchboard unit to indicate current termite barriers. At the time of inspection, no durable notice was evident and it appeared as though no chemical termite management system has been installed, with no evidence to suggest preventative works taking place since the property was built.

The client may consider gaining further advice from a pest controller as to the costs and procedures involved with a 'chemical' application. It is recommended that obtaining such advice be a short-term priority.

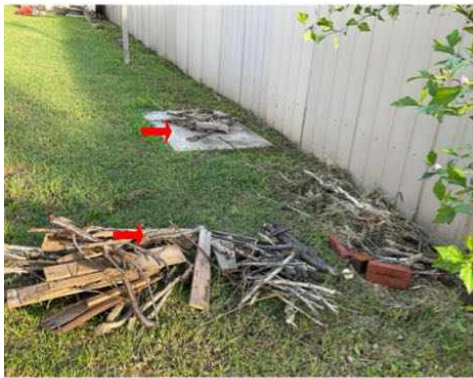
Finding 6.02

Location: Yard - Back
 Finding: Timber in contact with the ground
 Information: Any timbers in direct ground contact provide opportunity for concealed termite entry and are likely to be subject to premature rot and decay as the soil retains moisture or damp conditions against the timbers.

Removal of all waste timber that is in direct contact with ground is highly advised. This timber is promoting mould and wood rot and is very attractive to termites.

Frequent pest inspections are advised to readily identify any termite activity in these areas.

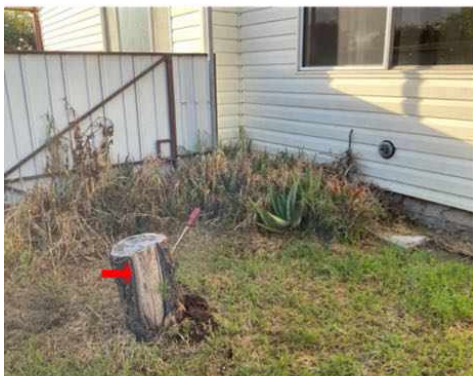
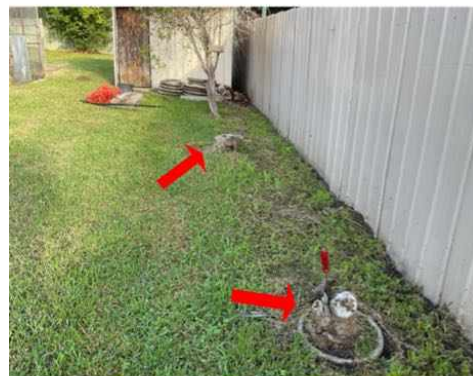
Finding 6.03

Building: Building 1
 Location: Many yard areas
 Finding: Tree stumps - left in ground
 Information: Tree stumps left in ground provide opportunity for termite attack as they are likely to be subject to rot and decay providing an attractive food source. Treatment and/or Removal of the stumps is highly recommended. A pest controller and tree removalist should be engaged to perform such works.

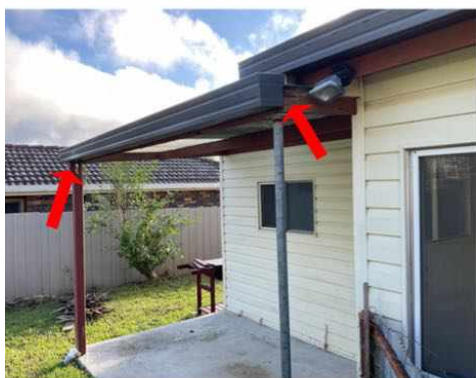
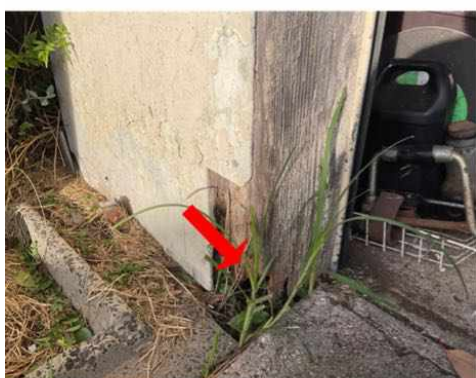
In this case, the affected timber element is in a decaying state and will need replacement by a carpenter or licensed builder.

Note - See ALL wood rot photos, all these show fungal decay.

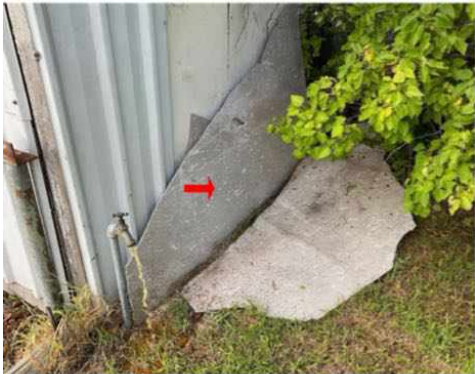
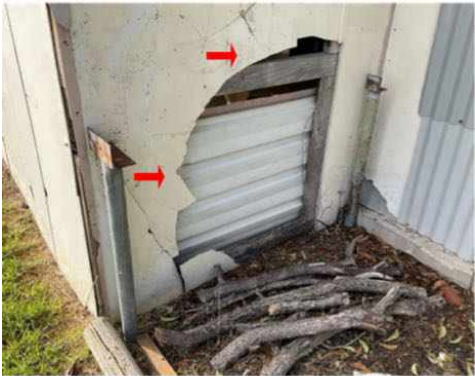
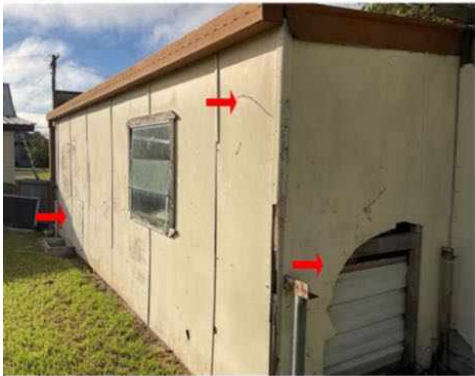
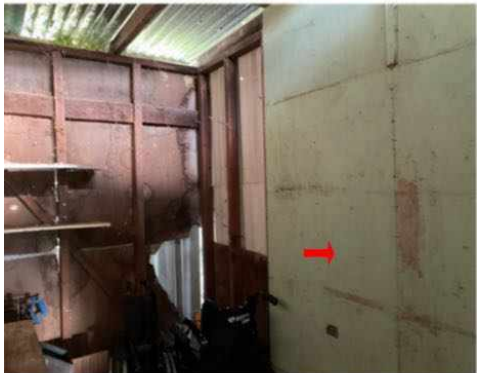
As Asbestos Reporting is outside the scope of this report, we advise that you consider a separate Asbestos Inspection and Condition Audit, which can include the taking of samples for definitive confirmation of the presence of Asbestos.

In the interim, the client is advised to act with caution, especially when considering any damage to building materials general wear and tear renovations extensions demolition and general maintenance activities due to the suspected presence of Asbestos.

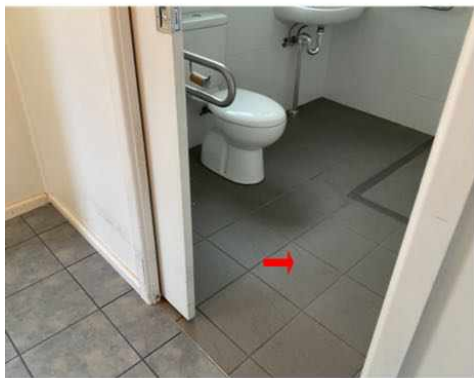
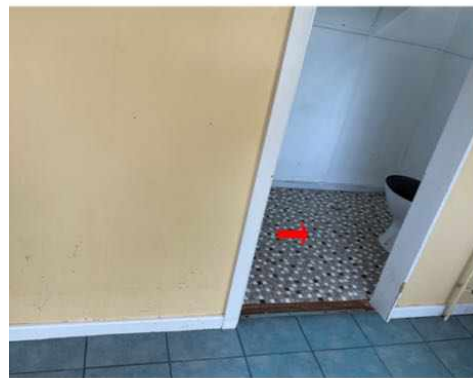
Building: Building 1
Location: Bathrooms and laundry
Finding: Waterproofing membranes - Information Only
Information: Internal Water Proofing Membranes, are crucial in preventing water ingress into the property is important to know that the Membrane System used is to Australian Standards and has been installed correctly.

With older property's where this information is unavailable all wet areas should be monitored. If any leaks, water staining, peeling or bubbling of the paint become evident to any adjacent walls or ceilings below a licensed builder or waterproofing specialist is recommended to investigate further.
