Building and Timber Pest Inspection Report

Inspection Date: Thu, 2 Apr 2026

Property Address: 45 Neill St, Rushworth VIC 3612, Australia

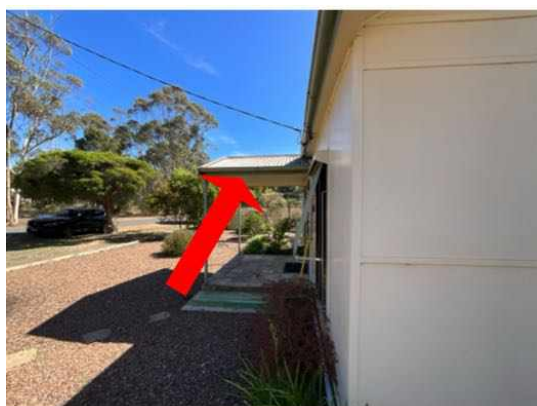
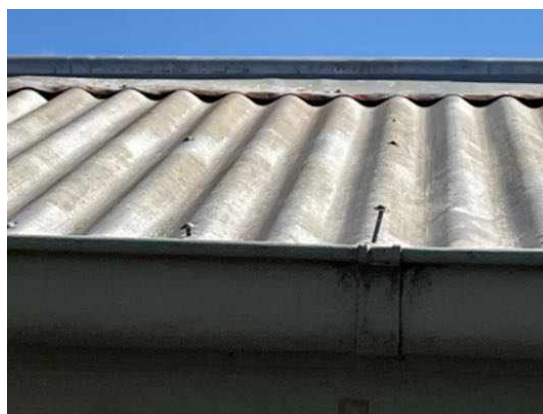
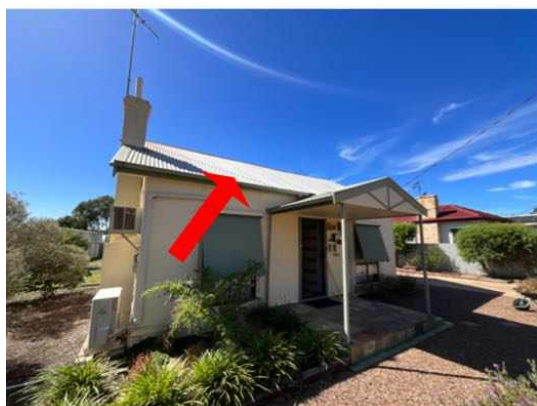
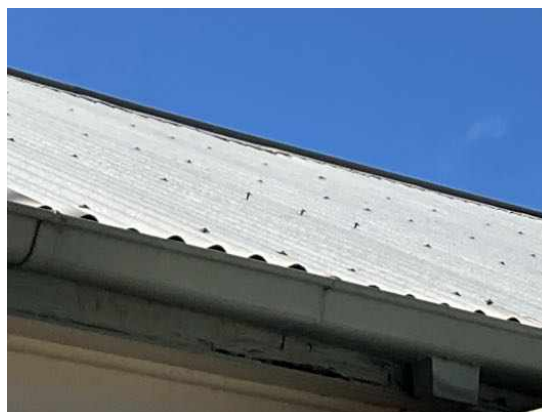
Finding 3.01

Building:	Building 1
Location:	Roof Exterior
Finding:	Roof sheets - Loose
Information:	Upon inspection of the exterior roof covering, it was noted that numerous roof sheets have become loose from their original fixings. It is suspected that this defect has developed as a result of a lack of adequate maintenance, but may also have been caused by inappropriate fixings being used in the construction process.

Loose roof sheeting detracts from the weather tightness of the roof covering, making the internal roofing structure susceptible to water penetration and subsequent damage. If left unaddressed, it is likely that secondary damage to associated building elements will develop, potentially necessitating remedial works to these structures.

A roofing restoration contractor should be appointed to advise on rectification options and on the cost of repair. It is advised that remedial works be performed as soon as possible to prevent any further damage.

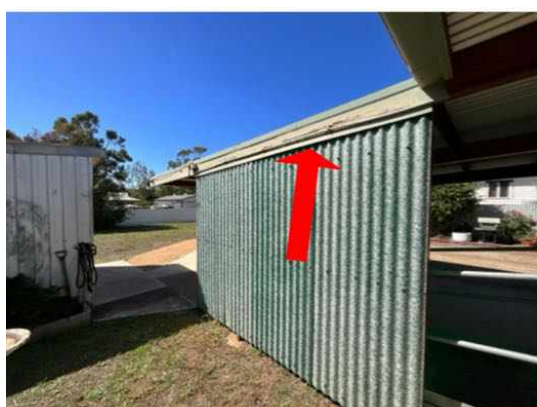
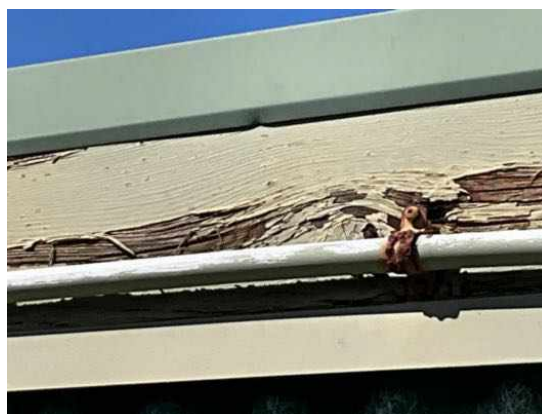
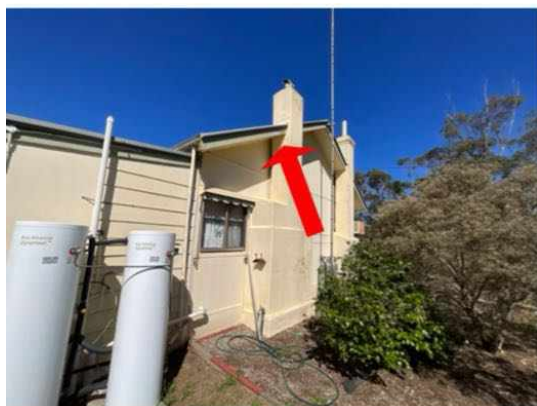
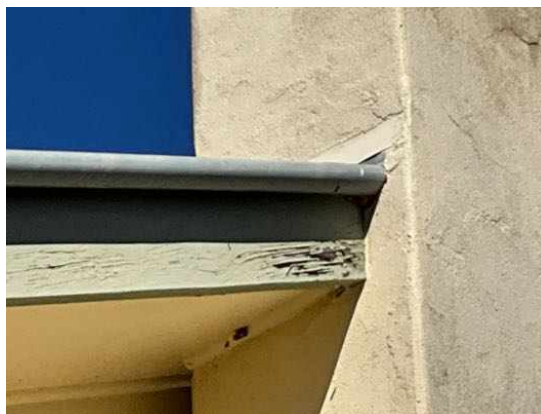
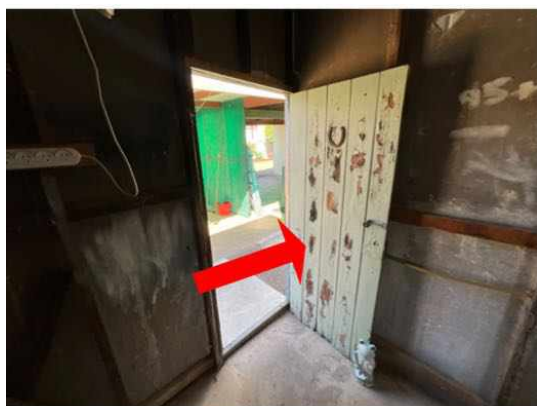
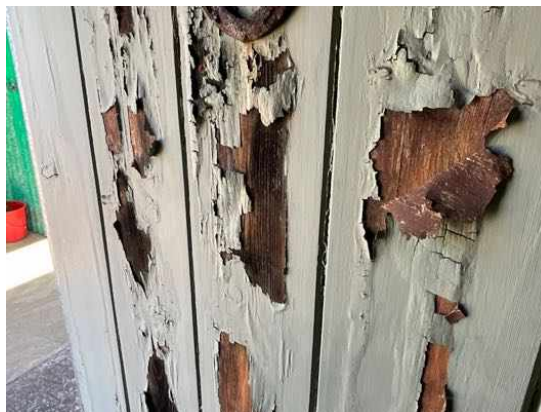
Finding 3.02

Building:	Building 1
Location:	All External Areas
Finding:	External painting deteriorated
Information:	Much of the external paintwork including but not limited to windows, fascias, guttering, veranda and other external fitments have been neglected and require attention to prepare and re-paint.

Whilst incomplete or missing paint finish is generally an appearance defect, it can also lead to the development of secondary building defects over time. Incomplete areas of paint finish expose the area to moisture, potentially accelerating the deterioration of underlying building materials.

Degraded paint finishes should be sanded back, filled, leveled and painted, as applicable. Where inadequate or missing paint protection has led to the deterioration of the associated building element, repair and/or replacement of this building element may be required.

A painting contractor should be appointed as soon as possible to perform necessary works to aid the appearance of the affected area and to ensure the area is protected against further deterioration. Alternatively, the homeowner following manufacturer instructions may perform these works.

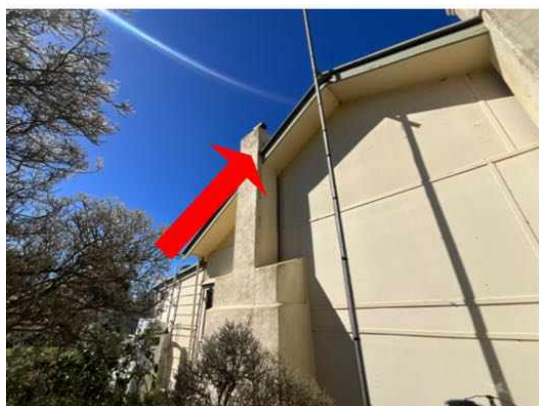
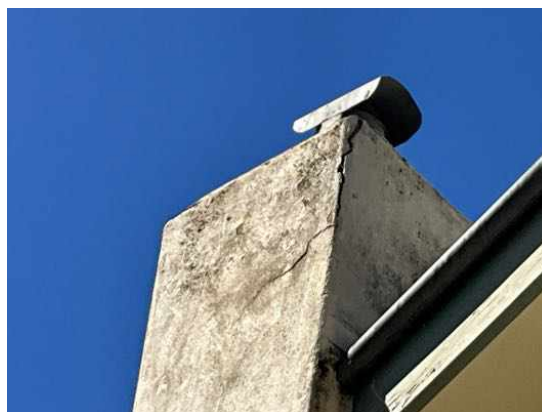
Finding 3.03

Building:	Building 1
Location:	Chimney
Finding:	Brickwork- Step cracking
Information:	Step cracking was identified to the brickwork in this area at the time of inspection. Step cracking, which is similar to other forms of cracking, has a variety of possible causes. However, the most common is the subsidence of adjacent footings.

Step cracking is a relatively common defect, and is most likely to occur adjacent to windows, doors and other openings. Mortar failure in the gaps between affected bricks indicates the stresses and tensions affecting the wall.

Minor step cracking can be used as a warning sign to address factors causing stress to the wall, which can include the effect of surrounding trees, water leaks, soil erosion, or even the presence of reactive soils in the surrounding area.

If cracks increase in size or number contact a Licensed builder immediately to make all needed repairs.

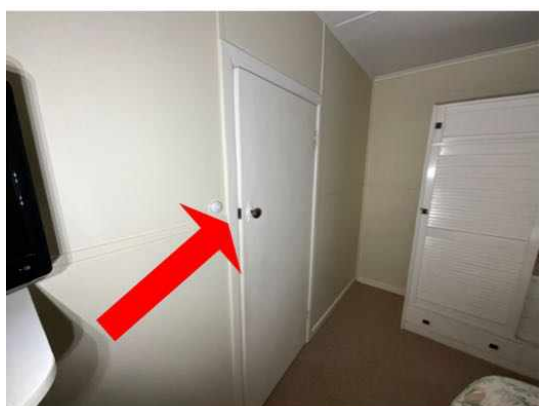
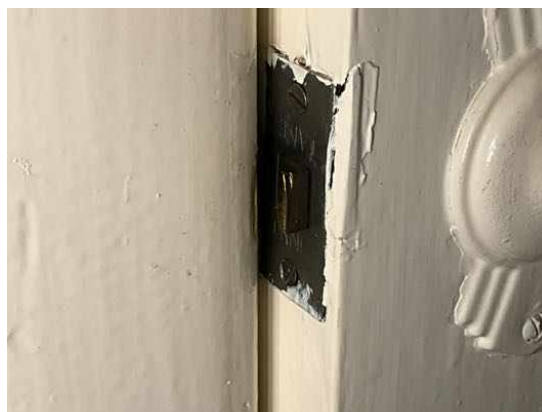
Finding 3.04

Building:	Building 1
Location:	Bedroom 1
Finding:	Door - Striker plate misaligned
Information:	The striker plate to this door appears to have become misaligned and has consequently resulted in the door's operation being compromised.

This is a common defect and is expected in a property of this age, whether being due to substandard installation or general deterioration of the door hardware.

Readjustment of the striker plate is recommended at client discretion. Works such as these can be completed by a general handyman or qualified carpenter.

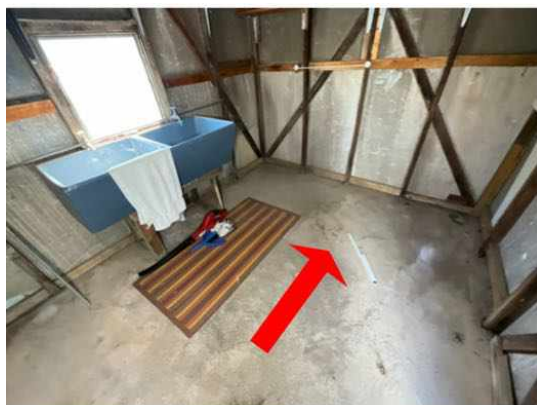
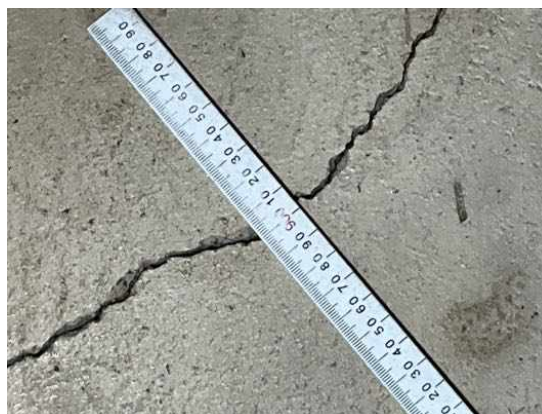
Finding 3.05

Building:	Building 1
Location:	Laundry/ wash house
Finding:	Cracking - External Concrete Paving Damage Category 3 - Wide Cracks (2mm - 4mm)
Information:	Wide cracks were identified in external concrete paving Wide cracks are significant and are likely to lead to the development of safety hazards and secondary defects if left unmanaged.

General age and expected deterioration of the paved areas is a common cause of this

type of cracking. However, expansion and contraction of the slab may also have occurred due to environmental factors. Such factors include variable moisture and weather conditions, the presence of trees and their roots having a settling or lifting affect on the soil, or the effect of load bearing, e.g. heavy vehicles over a sustained period of time.

Cracking to this degree may also be due to poor original installation of the concrete. Factors such as poor compaction of the sub surface and/or inadequate reinforcing of the slab may create cracking and other secondary defects. Wide cracks may also have a more significant structural cause, such as subsidence of soils.

Where the crack is located adjacent to structural elements of the building, the advice of a Structural Engineer is advisable before undertaking repairs. Significant repair and likely replacement of the concrete paving is probable.

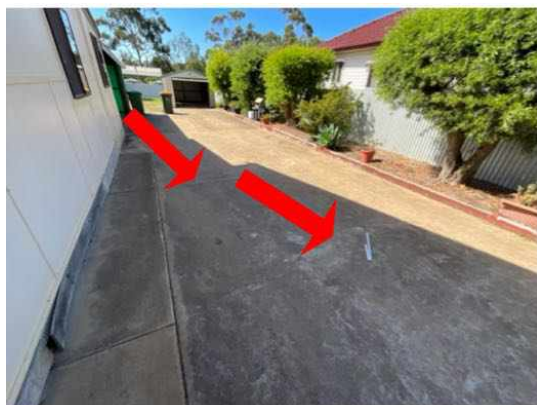
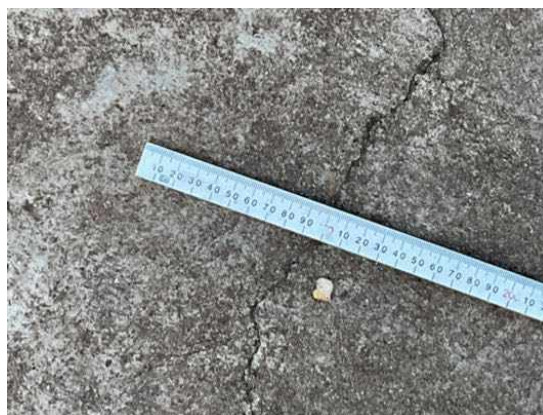
Finding 3.06

Building:	Building 1
Location:	Driveway
Finding:	Cracking - External Concrete Paving Damage Category 1 - Fine (less than 2mm)
Information:	Fine cracks were identified in external concrete paving. Although fine cracks are quite noticeable, they are often only considered to be an appearance defect, and usually do not indicate any structural damage. To be considered a Category 1 or fine crack, the crack is found to be less than 2mm in width.

Generally the cause of a hairline crack in existing concrete paving such as driveways and pathways is indicative of the expansion and contraction of the concrete. Such causes are generally due to environmental factors, such as moisture levels, weather conditions, root systems of nearby trees or the soil types on which they are laid.

Fine cracks may also be due to poor original installation of the concrete. Factors such as poor compaction of the sub surface and/or inadequate reinforcing of the slab may create cracking and other secondary defects.

Monitoring of all cracking should be conducted frequently. Always contact a building

inspector should cracks widen, lengthen, or become more numerous.

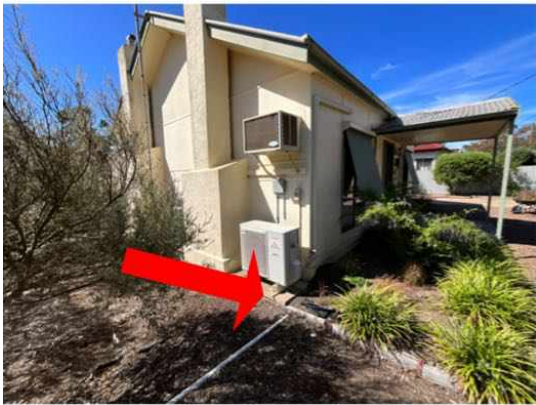
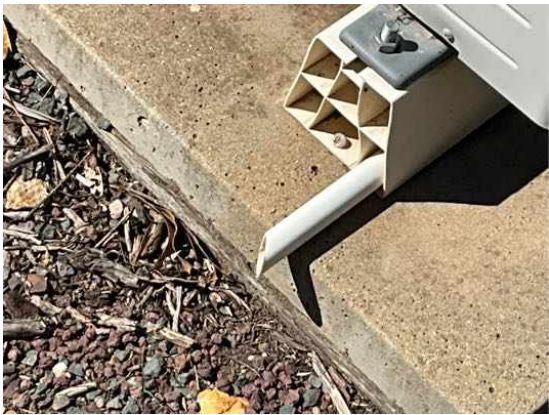
Finding 6.01

Building:	Building 1
Location:	Yard - Side
Finding:	Air conditioner - Disconnected overflow
Information:	The Air Conditioner (A/C) overflow was found to be disconnected from storm water drainage and is creating excessive moisture in the surrounding area.

Such leaking creates an environment which is conducive to an array of defects, including water damage to associated building elements and the attraction of termite or timber pest infestation.

It is highly recommended that a licensed plumber be appointed to connect the A/C overflow in order to prevent such an environment from being created. These minor works should be carried out as soon as possible.

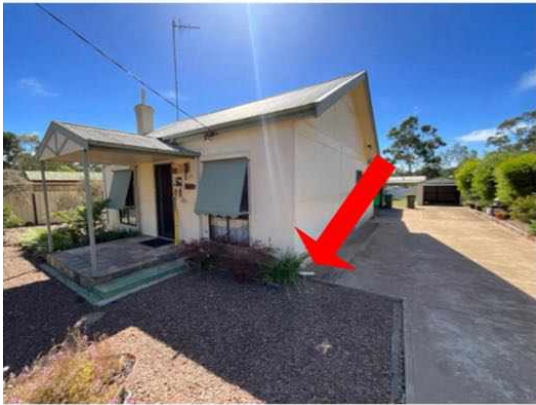
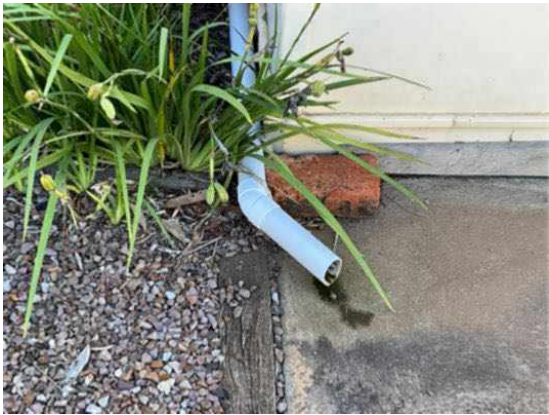
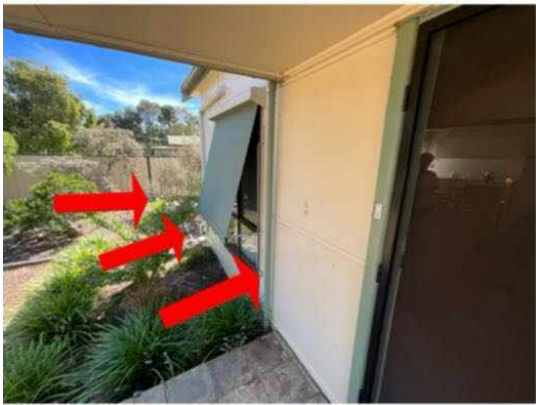
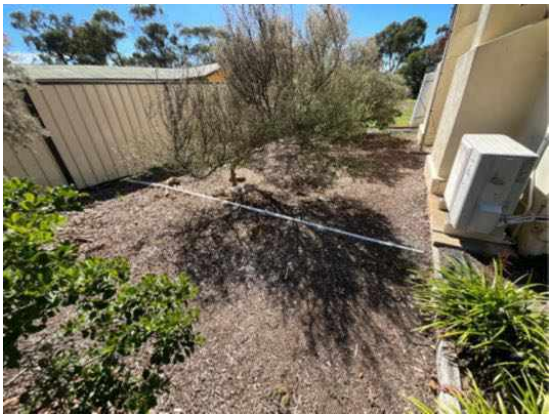
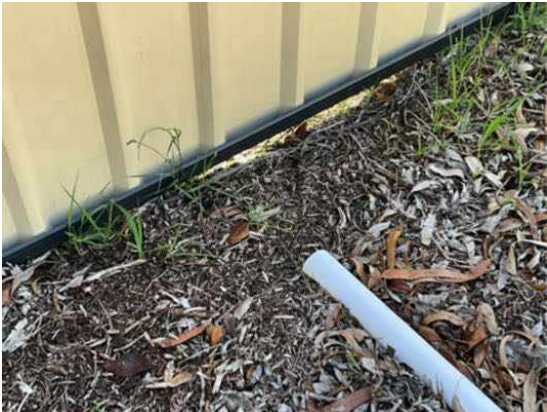
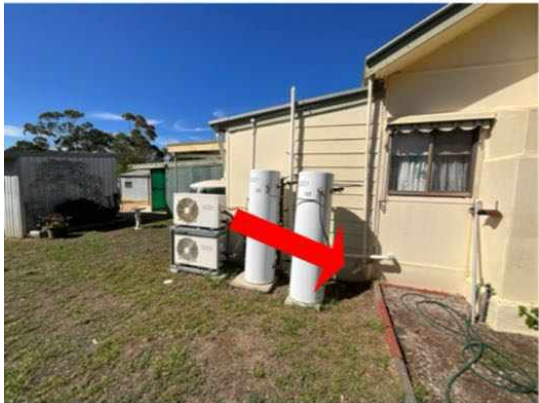
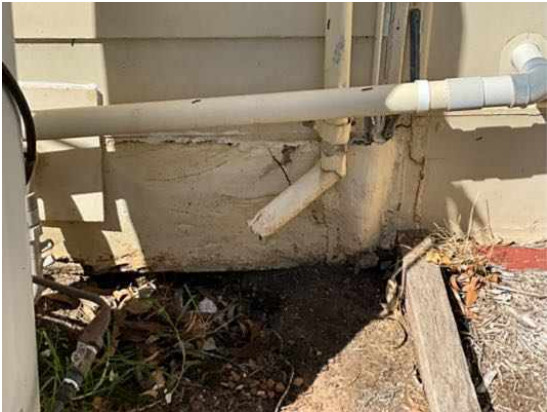
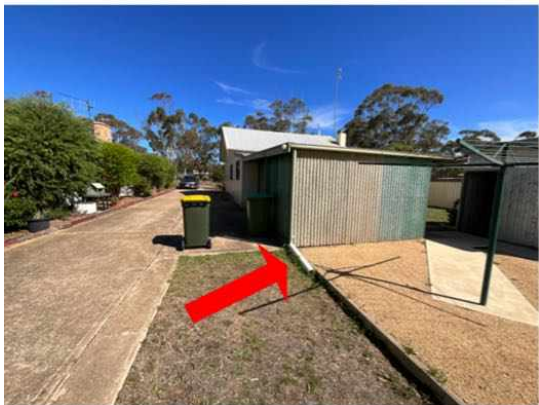
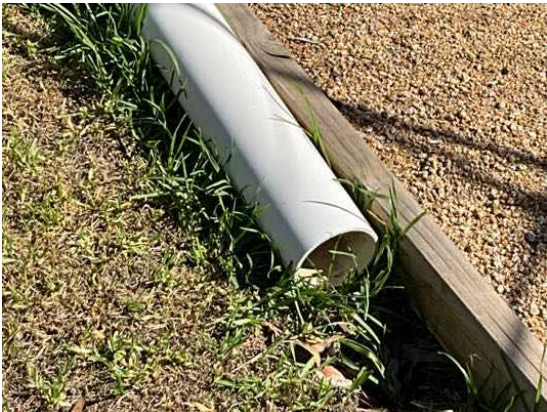
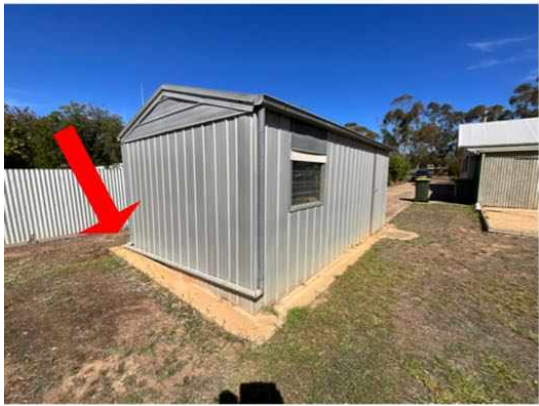
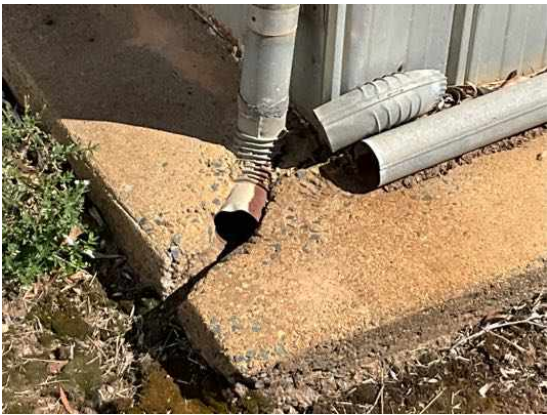
Finding 6.02

Building: Building 1
Location: Driveway, side and back yard
Finding: Stormwater drain - Not connected
Information: The roof plumbing is not adequately connected to stormwater drainage on the site. This disconnection negatively impacts the functional capacity of the roof plumbing.

Where roof plumbing doesn't drain adequately, the area at the base perimeter can become excessively damp, potentially creating an environment that is susceptible to rust and corrosion of surrounding building elements, as well as attracting termites and other pests.

It is highly recommended that a plumber be appointed to further inspect the area and to install adequate drainage equipment where necessary.

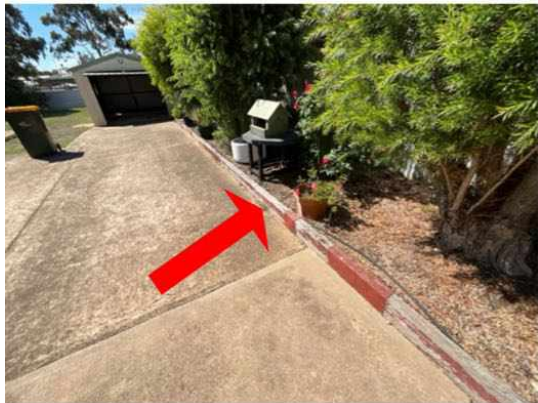
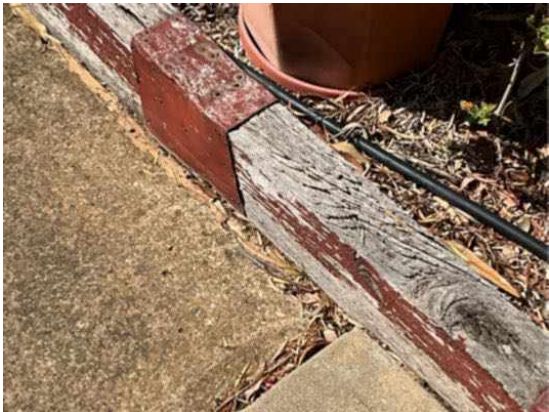
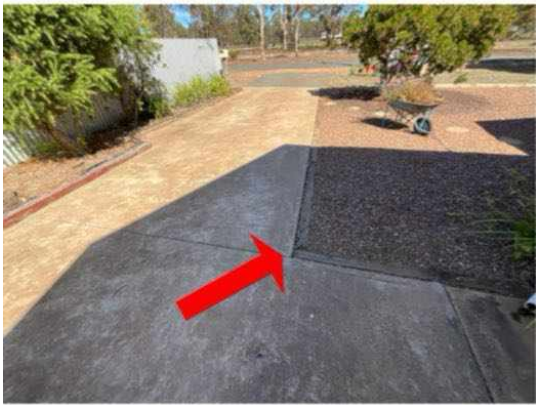
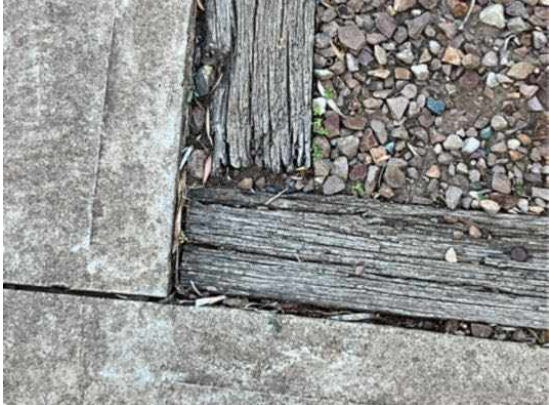
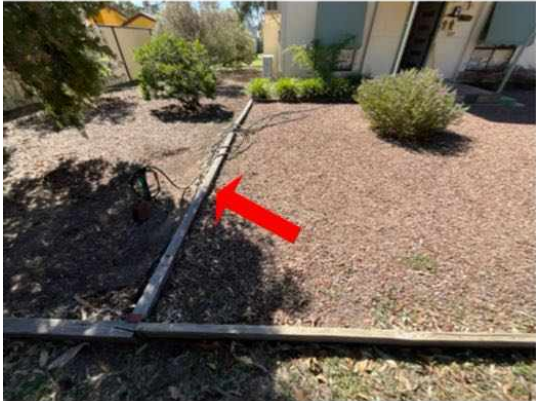
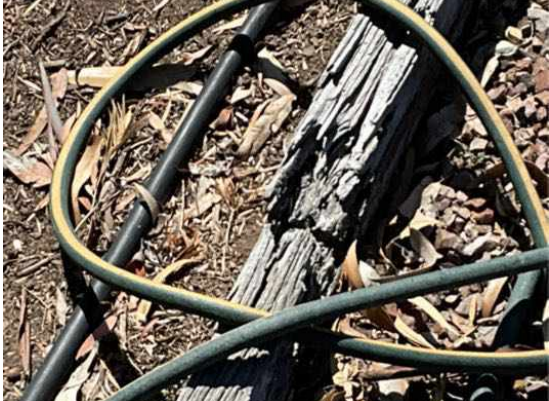
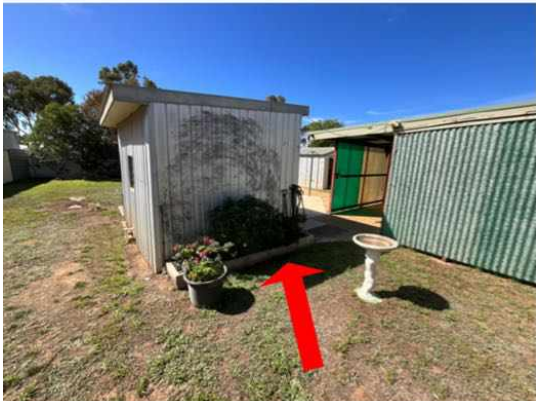
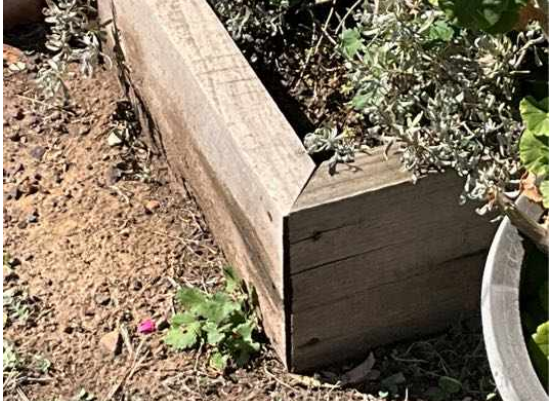
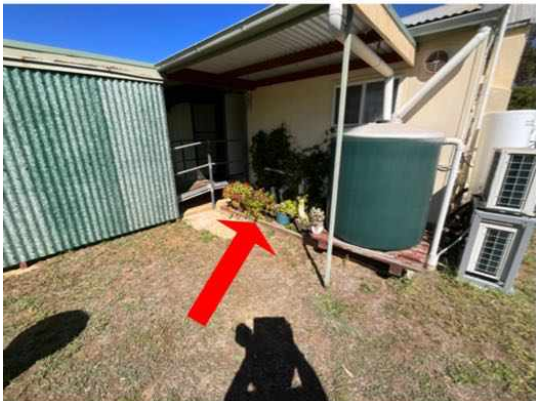
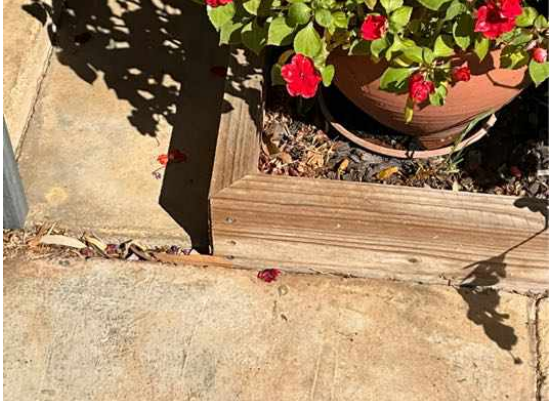
Finding 6.03

Building: Building 1
Location: Yard - Back, front
Finding: Untreated or non-durable timbers in a hazardous environment
Information: To reduce the risk of timber pest attack it is essential that timber used in a hazardous environment (e.g. in direct contact with the ground or frequently exposed to damp conditions) is of sufficient durability and/or is adequately preservative treated.

Untreated timbers in direct contact with the ground are likely to develop severe wood rot and/or fungal decay if left unattended creating attraction for subterranean termites to infest the timbers from surrounding areas.

If untreated or non-durable timbers are found to be in a hazardous environment it is highly advised that replacement of these building elements be performed as soon as possible to aid the protection of the property against termite / timber pest attack.

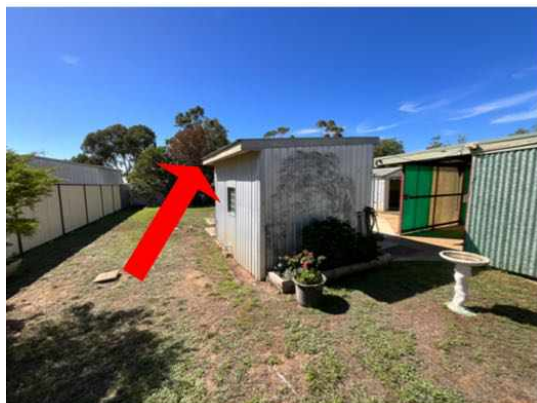
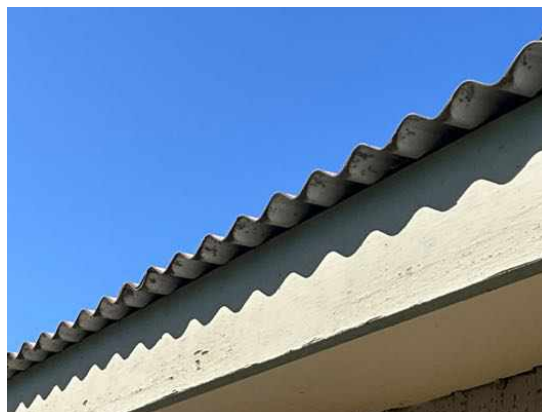
Finding 6.04

Building: Building 1
 Location: Shed
 Finding: Guttering Missing
 Information: The Guttering in this area was missing at the time of inspection. Guttering, Downpipes and Stormwater drainage are vital to protect the integrity of the structure and to prevent an environment conducive to Timber Pest attack.

A Plumber should be contacted as soon as possible to replace and connect to drainage the missing Guttering.

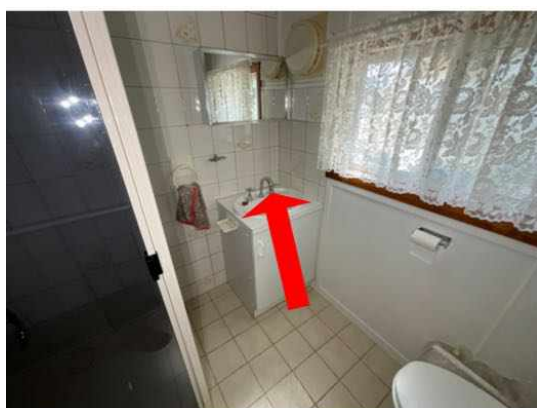
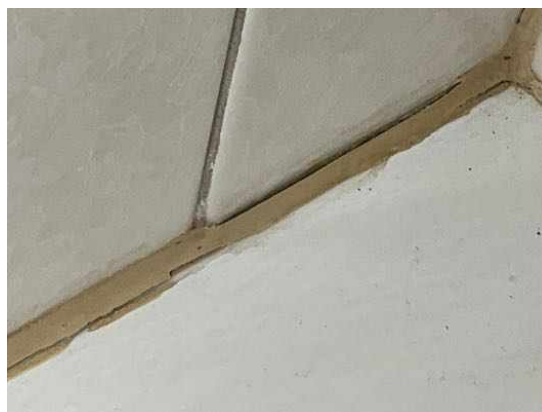
Finding 6.05

Building: Building 1
 Location: Bathroom
 Finding: Inadequate sealant or Grout
 Information: This area has a lack of effective Sealant or Grout. This is allowing the ingress of water to the structure inside the wall.

The presence of water encourages Termite attack, Mould and Fungal Decay.

A Tiler or General Handy person must be contacted as soon as possible to effect repairs and prevent further deterioration.

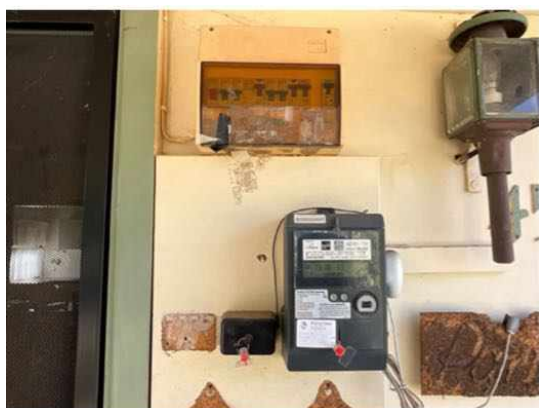
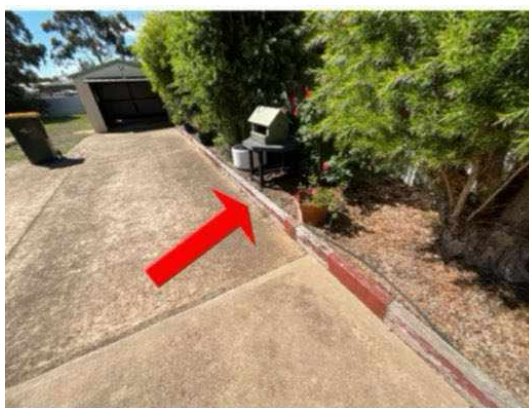
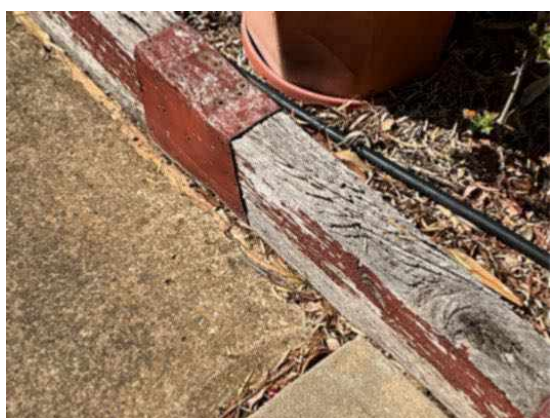
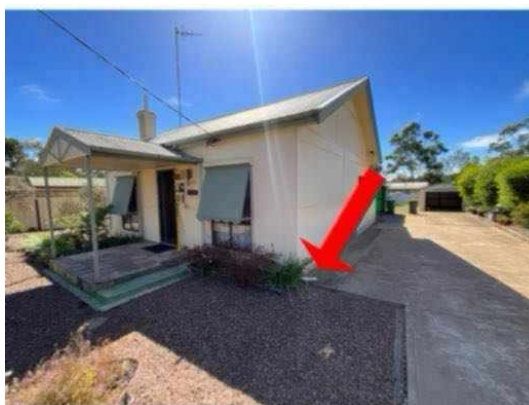
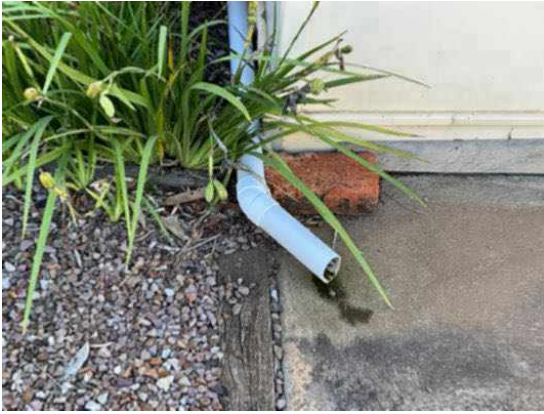
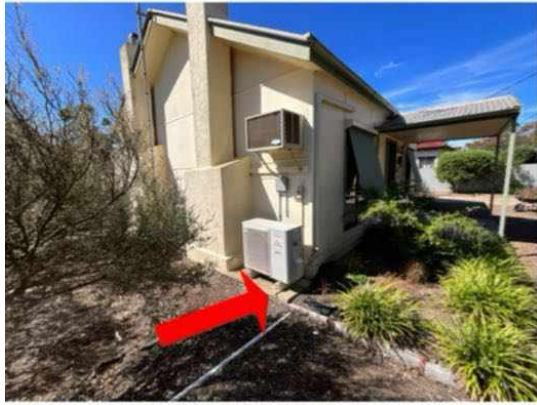
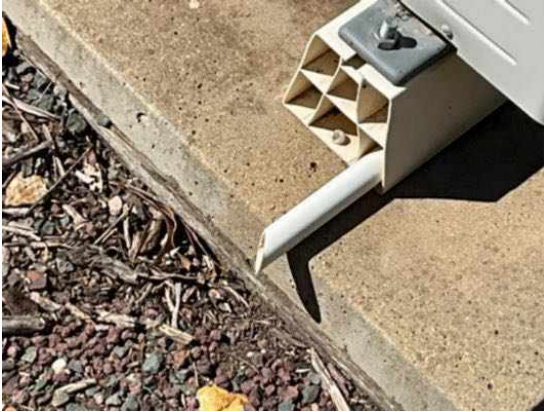
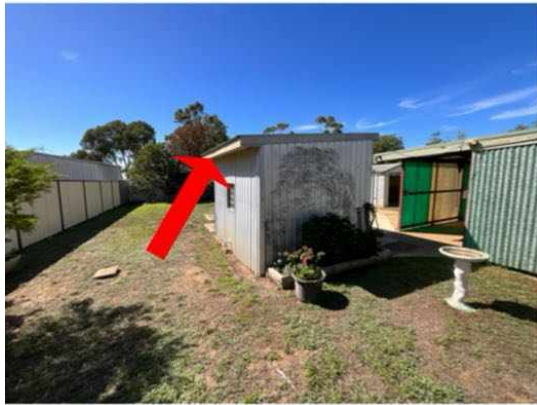
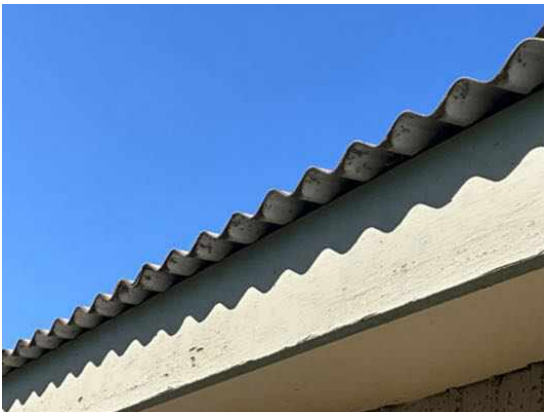
Finding 6.06

Building:	Building 1
Location:	All External Areas
Finding:	Termite Management System - no evidence of a chemical installation
Information:	The application of a post-construction chemical termite barrier is highly recommended for all properties, particularly if live termite activity has been found on the site previously. Such barriers are highly effective in preventing termite attack on any timber building elements throughout the property.

A durable notice should be placed in the switchboard unit to indicate current termite barriers. At the time of inspection, it appeared as though no termite management system has been installed, with no evidence to suggest preventative works taking place.

The client may consider gaining further advice from a pest controller as to the costs and procedures involved with this application. It is recommended that obtaining such advice be a short-term priority.

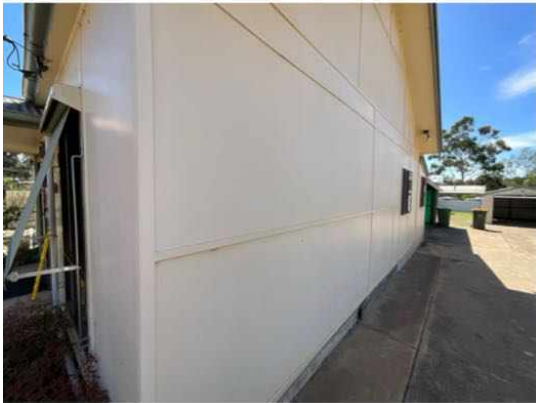
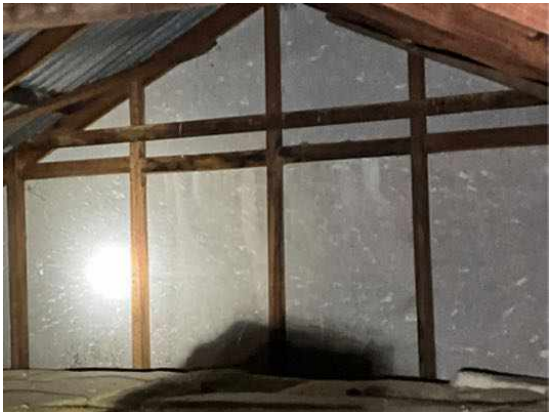
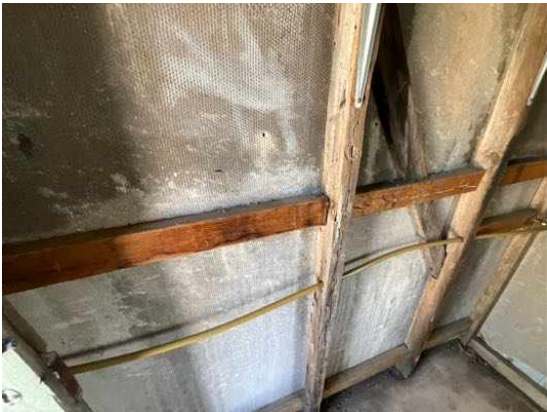
Building: Building 1
Location: All Areas
Finding: Asbestos - Suspected ACM Identified on Site
Information: Reporting on Asbestos is outside the Scope of this Report. This suspected defect is highlighted as a caution only. We suspect, based on our experience in the building industry, that there is a higher risk of the identified building element containing asbestos.

As Asbestos Reporting is outside the scope of this report, we advise that you consider a separate Asbestos Inspection and Condition Audit, which can include the taking of samples for definitive confirmation of the presence of Asbestos.

In the interim, the client is advised to act with caution, especially when considering any damage to building materials general wear and tear renovations extensions demolition and general maintenance activities due to the suspected presence of Asbestos.

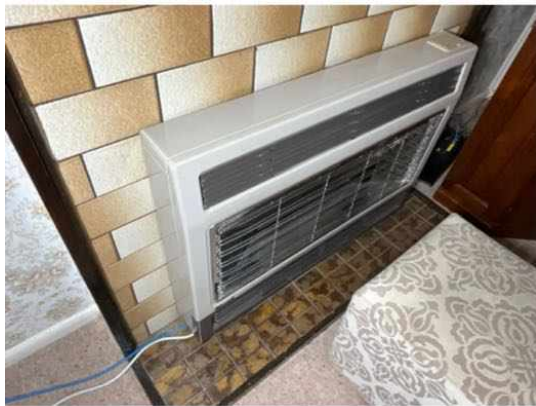
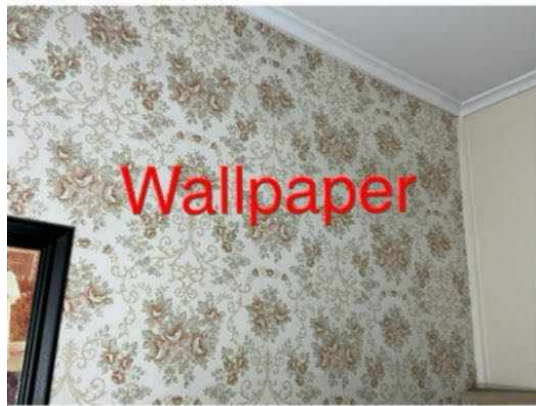
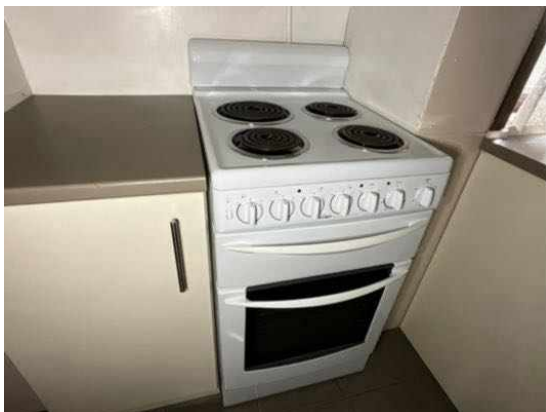
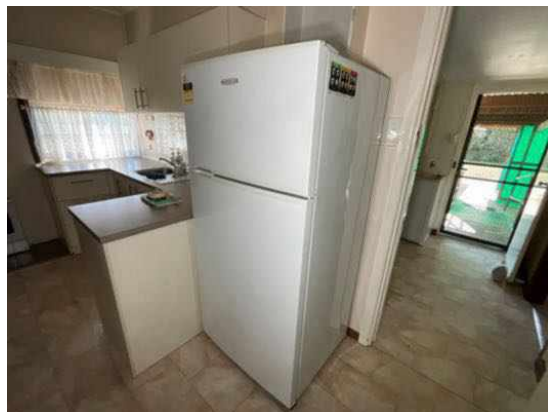
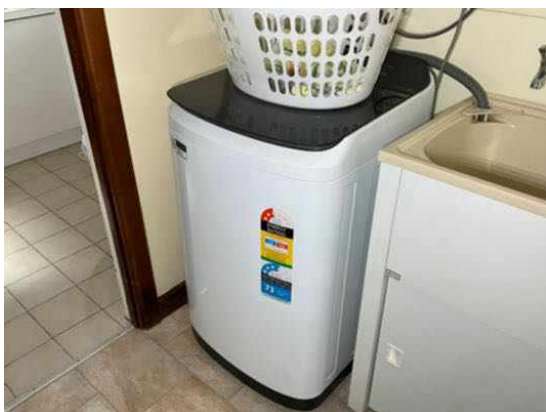
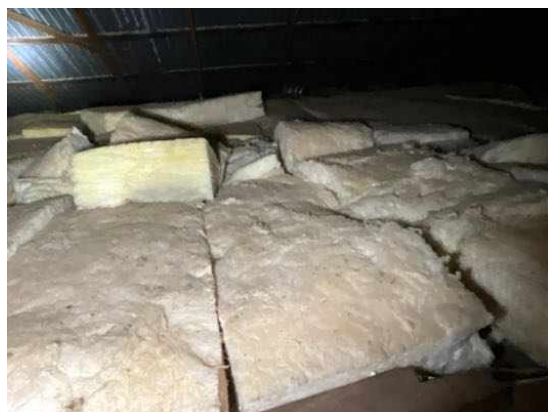
Building: Building 1
Location: All Areas
Finding: Additional Photos - Obstructions and Limitations
Information: These photographs are an indication of the obstructions and limitations which impeded full inspection of the property at the time of inspection. These obstructions can hide an array of defects and should be removed to allow full inspection to be carried out. A re-inspection is recommended once the areas are made accessible.
