Building and Timber Pest Inspection Report

Inspection Date: Fri, 20 Mar 2026

Property Address: 64 Rangeview Dr, Skye VIC 3977, Australia

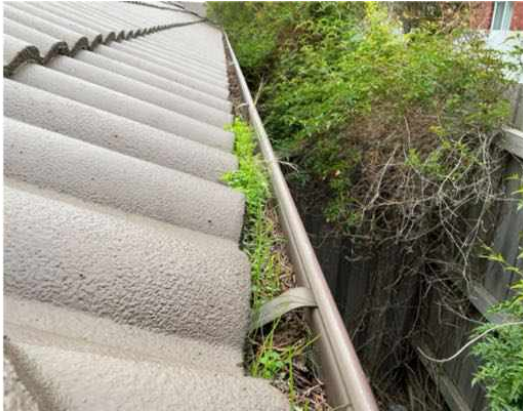
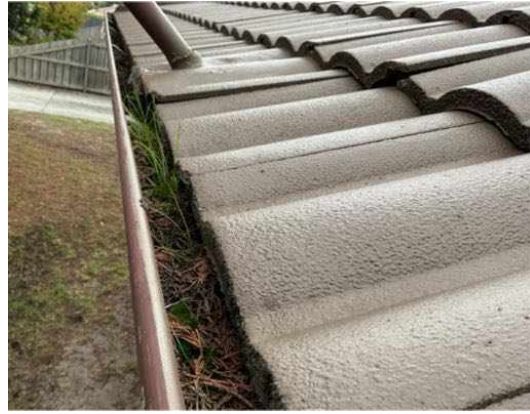
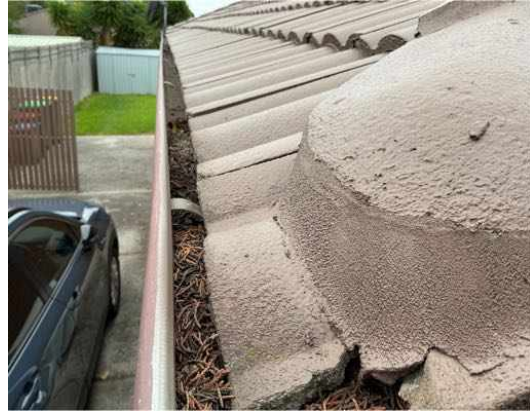
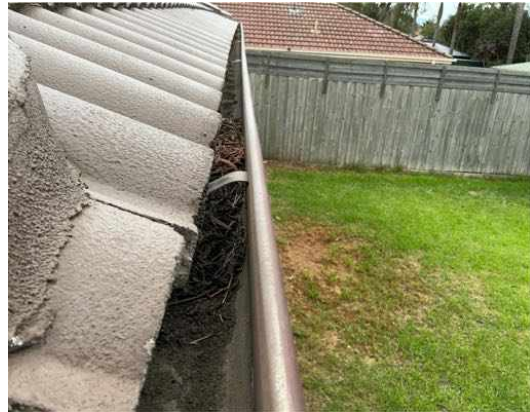
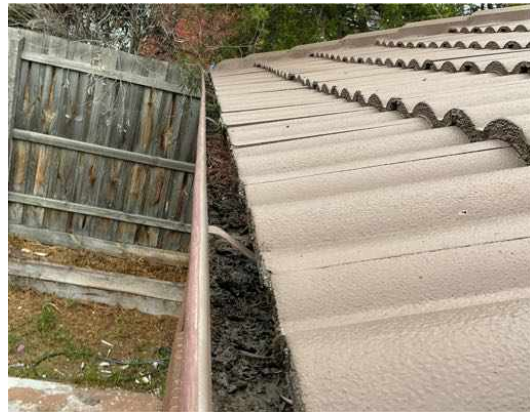
Blocked gutters are likely to lead to high levels of moisture in the affected areas. Such moisture will not only cause rust and decay of the associated building materials, but can also provide conditions that are conducive to termite and timber pest activity. Blockages in gutters should therefore be removed immediately to ensure dry conditions are maintained.

Consult a Licensed Plumber for further specific advice on remedial works that may be required. In the interim, it is highly advised that blocked gutters be removed by the homeowner or a general handyperson as a matter of urgency.

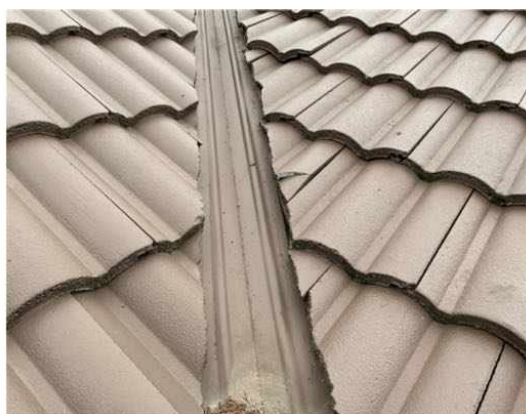
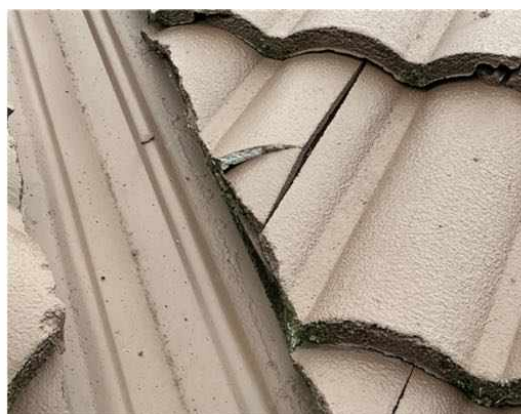
Finding 3.02

Building:	Main Building
Location:	Roof Exterior
Finding:	Roof tile - Broken
Information:	Upon inspection of the exterior roof covering, a broken roofing tile was identified. Broken tiles are generally the result of ageing and weathering of what is essentially a porous material.

If left to further deteriorate, broken and brittle roof tiles are likely to lead to water penetration via the roof into the ceiling space, causing excessive moisture and secondary damage to ceiling linings, insulation and roof structures. Broken roof tiles are also likely to detract from the effectiveness of the roof drainage system, creating potential for secondary damage to the exterior roof covering and roof plumbing. Excessive moisture could attract termites.

Replacement of broken tiles is required and should be performed by a roofing contractor as soon as possible.

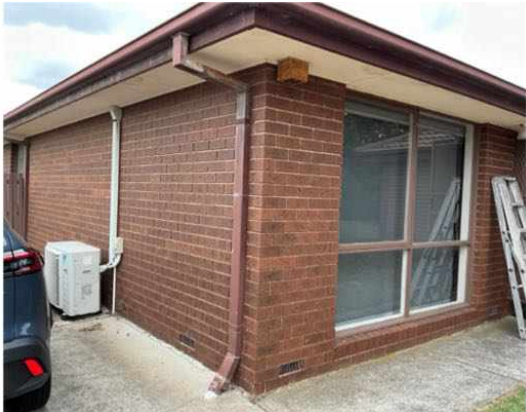
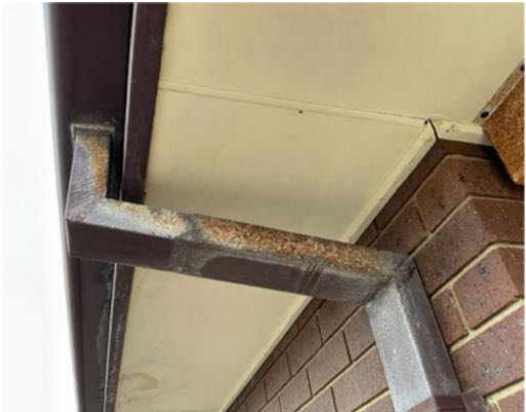
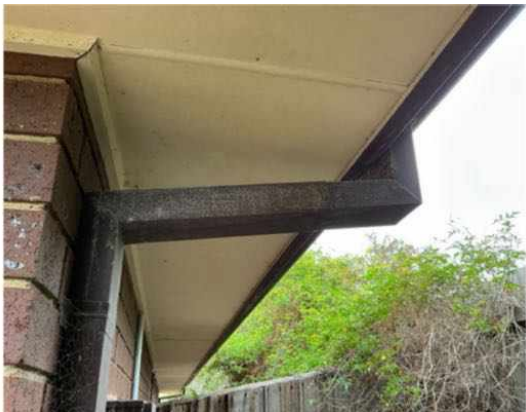
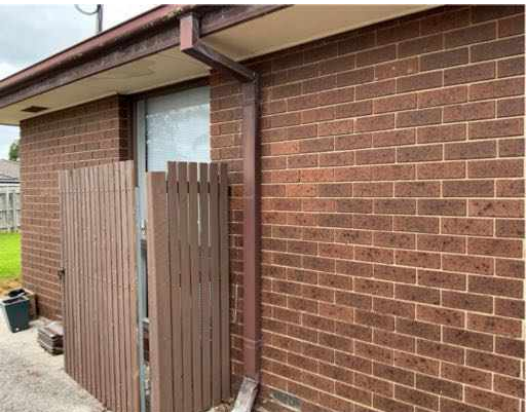
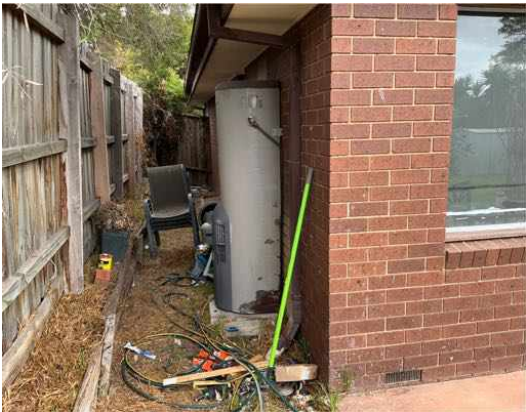
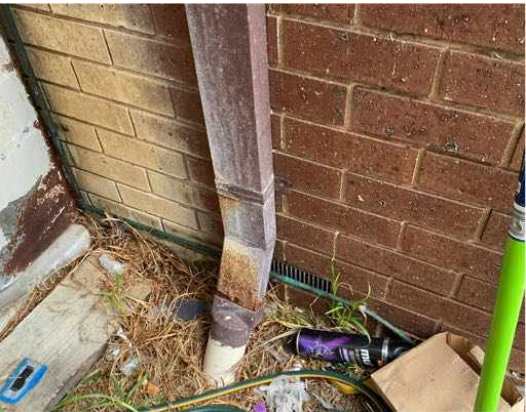
Finding 3.03

Building:	Main Building
Location:	Exterior walls
Finding:	Downpipes Rusted or corroded
Information:	The down pipes to the building shows evidence of rusting and corrosion, which is likely to have developed as a result of excessive exposure to moisture and or inadequate coatings.

As surface rust provides no protection to the underlying iron, the deteriorating condition is likely to worsen if not addressed in the short-term future.

Where possible, the use of galvanized (treated) metals or aluminium coated metals aid in rust prevention, as does regular general maintenance. Rust formation can be controlled with coatings, such as paint, that isolate the iron from the environment.

Rusting and corrosion should be managed by ideally removing or limiting the affected surface from exposure to moisture. A registered builder may be appointed to replace

any building elements that have been severely affected by rust or water damage.

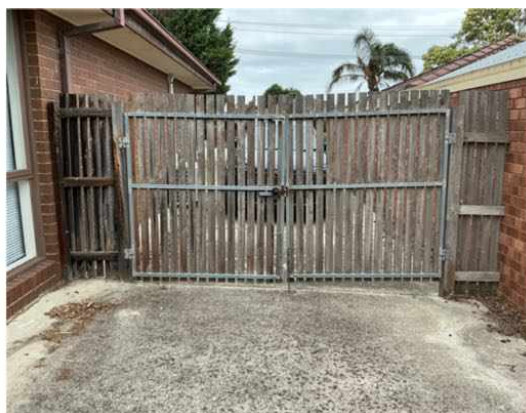
Finding 3.04

Building: Main Building
 Location: Yard - Back
 Finding: Gates - Binding/jamming
 Information: Binding and/or jamming of the gates was evident during standard operation. This defect inhibits the functionality of the affected gate as well as creating potential for secondary defects to associated building elements.

A gate that binds to the associated frame may have several causes, ranging from

minor defects, such as poor installation of the gate or deteriorated hinges.

For minor causes, a qualified carpenter or general handyman should be appointed to perform minor rectification works at client discretion.

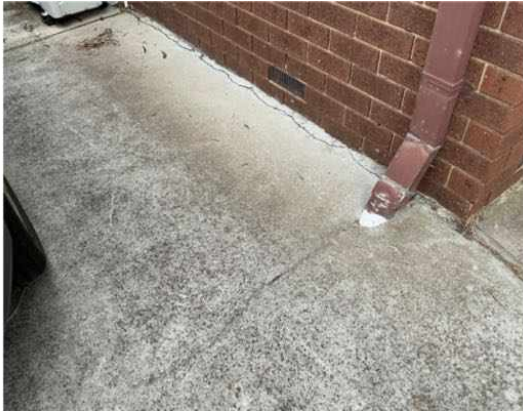
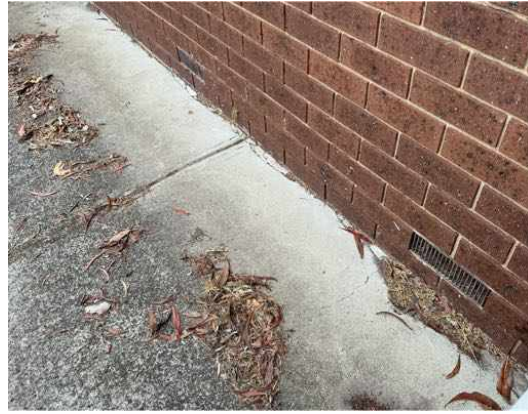
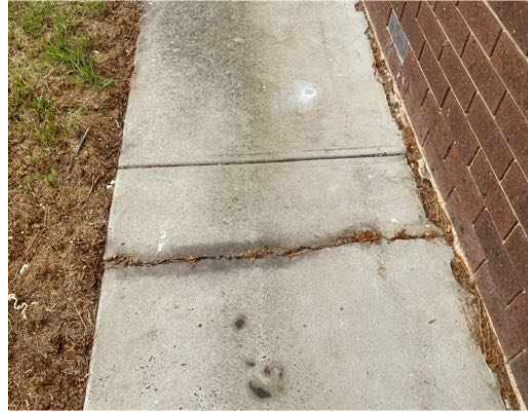
Finding 3.05

Building:	Main Building
Location:	Driveway and pathway
Finding:	Driveway/pathway Cracking
Information:	Cracks were identified in the driveway and pathways external concrete paving. Although cracks are quite noticeable, they are often only considered to be an appearance defect, and usually do not indicate any structural damage.

Generally the cause of the cracks in existing concrete paving such as driveways and pathways is indicative of the expansion and contraction of the concrete. Such causes are generally due to environmental factors, such as moisture levels, weather conditions, root systems of nearby trees or the soil types on which they are laid.

Cracks may also be due to poor original installation of the concrete. Factors such as poor compaction of the sub surface and/or inadequate reinforcing of the slab may create cracking and other secondary defects.

Monitoring of all cracking should be conducted frequently. Always contact a building inspector should cracks widen, lengthen, or become more numerous.

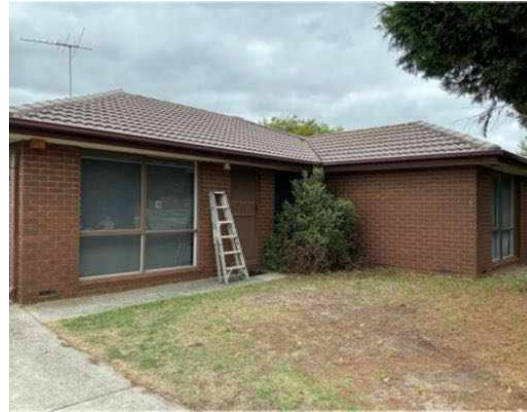
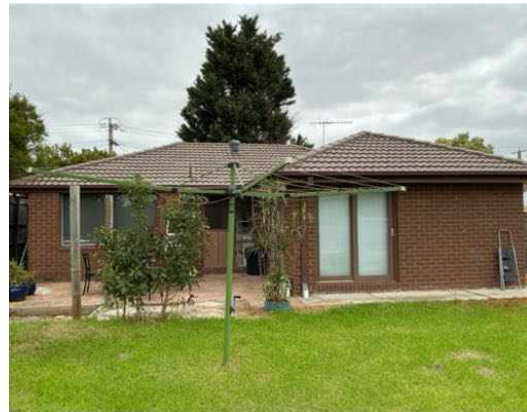
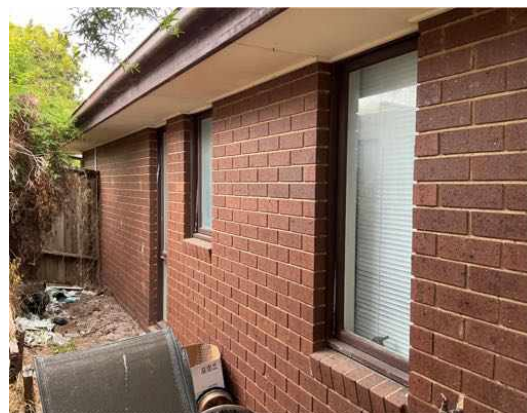
Finding 3.06

Building:	Main Building
Location:	Various parts of the building
Finding:	External painting deteriorated
Information:	Much of the external paintwork has been neglected and requires attention to prepare and re-paint.

Whilst incomplete or missing paint finish is generally an appearance defect, it can also lead to the development of secondary building defects over time. Incomplete areas of paint finish expose the area to moisture, potentially accelerating the deterioration of underlying building materials.

Degraded paint finishes should be sanded back, filled, leveled and painted, as applicable. Where inadequate or missing paint protection has led to the deterioration of the associated building element, repair and/or replacement of this building element may be required.

A painting contractor should be appointed as soon as possible to perform necessary works to aid the appearance of the affected area and to ensure the area is protected against further deterioration. Alternatively, the homeowner following manufacturer instructions may perform these works.

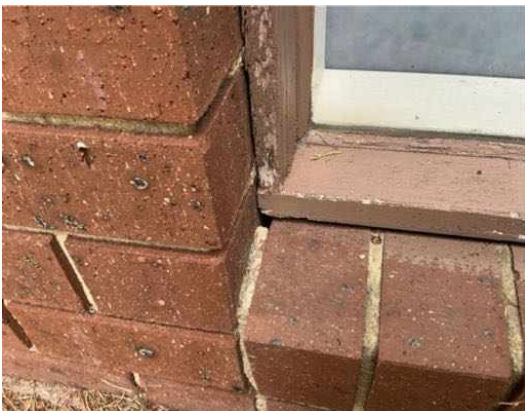
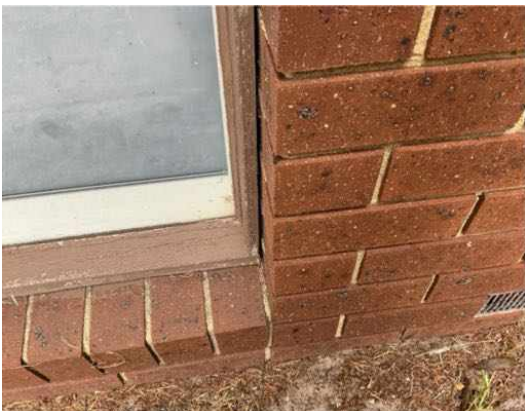
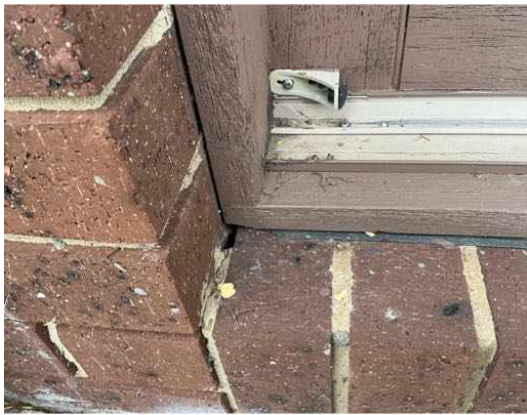
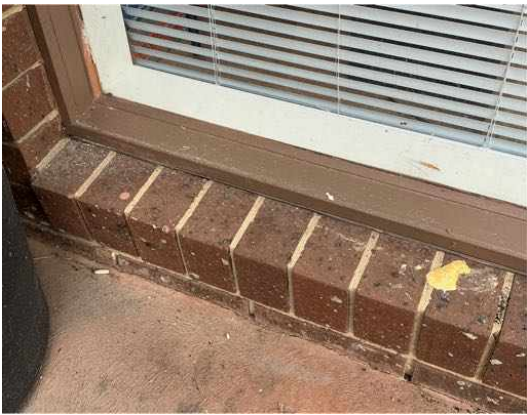
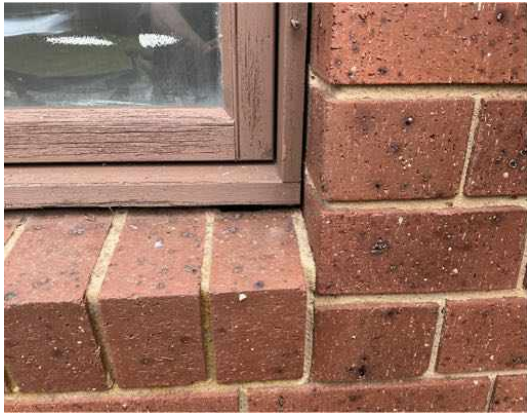
Finding 3.07

Building: Main Building
Location: Various parts of the building
Finding: A few gaps to the exterior walls/windows
Information: A few gaps were noticed to some of the exterior walls/windows to the building. These gaps can let in water, drafts, and pests. Overtime moisture ingress may cause damage to internal walls, mould growth, or structural issues. Gaps also reduce the energy efficiency of the property. Recommend engaging a caulker to seal gaps with an exterior grade flexible sealant that is UV and weather resistant to reduce the risk of pest/water penetration to the building as soon as possible.

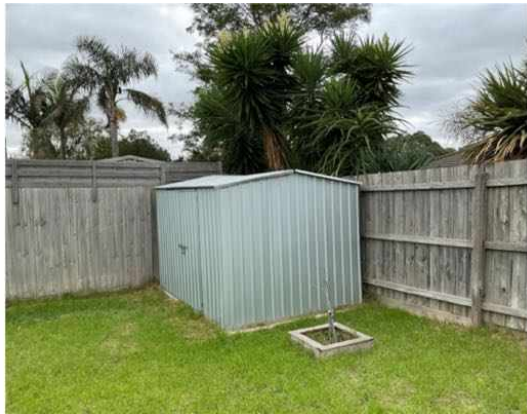
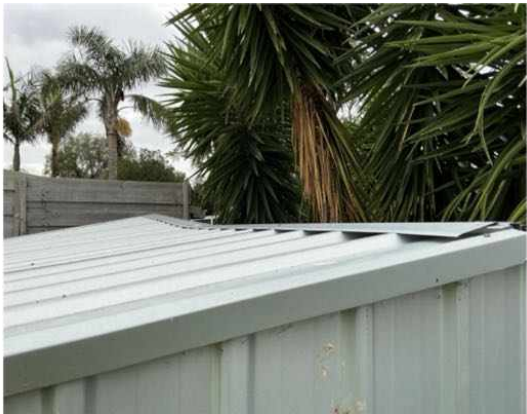
Finding 3.08

Building: Main Building
Location: Yard - Back
Finding: Damage to shed roof
Information: On inspection of the shed, it was noticed that the roof line is dented down/damaged. Recommend repair/replacement by a handyman or carpenter to reduce the risk of future deterioration at the owners discretion.

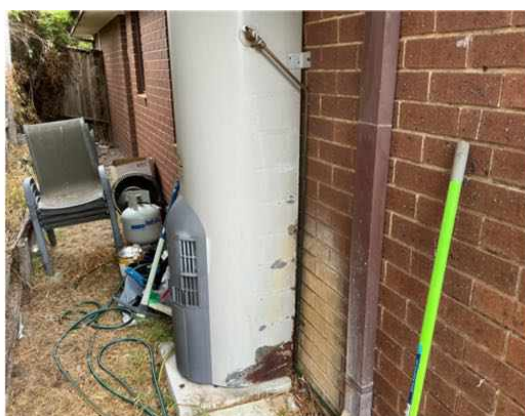
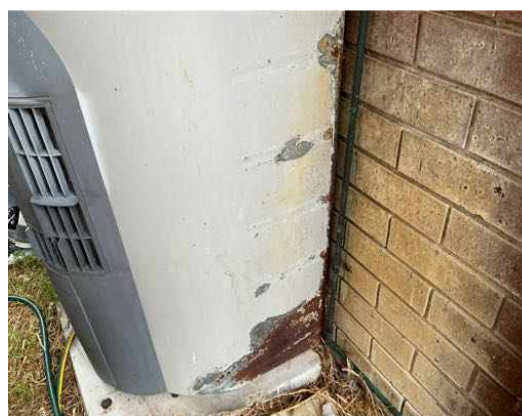
Finding 3.09

Location: Yard - Back
 Finding: Hot water unit - Rusted
 Information: The external hot water unit shows evidence of rust and general deterioration. This rust is likely to have developed due to minor leaks in the unit, providing excess moisture to affected areas. Such damage is expected of a building element of this age and with this level of exposure to excessive moisture.

While the hot water unit is still fully operational, any leaks should be identified and rectified by a licensed plumber as soon as possible. Prevention of further deterioration will delay the need for replacement of the unit in the near future.

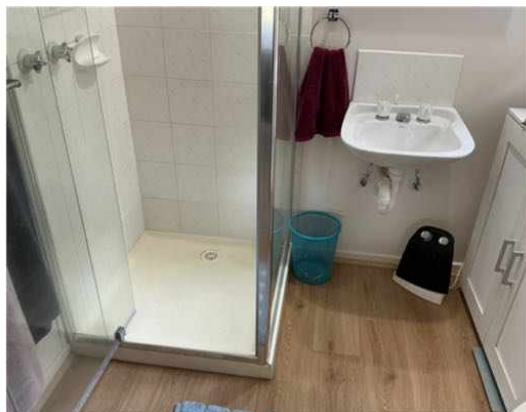
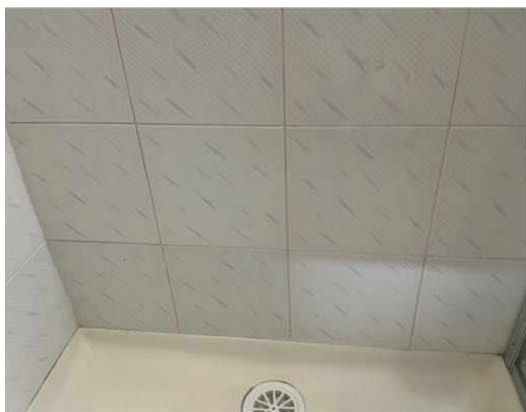
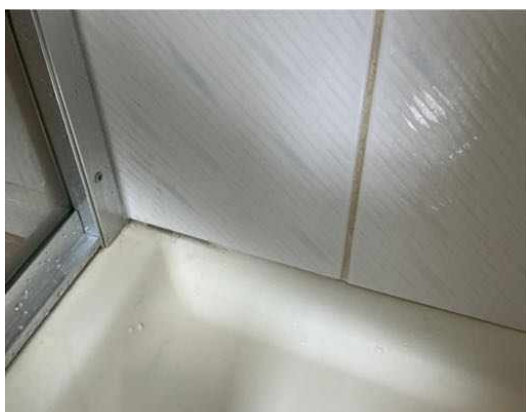
Finding 3.10

Building: Main Building
 Location: Ensuite - Master
 Finding: Bathroom Sealant and grouting - Missing or damaged
 Information: It was noted on inspection that sealant or grout is degraded to the tiled shower alcove and or other areas of the bathroom.

Different materials and floor areas move at different rates, generally causing cracking to grout or sealant at this point. A flexible sealant is required to allow for expected expansion and contraction, while keeping the joint water tight and protective of all associated building materials.

Flexible and mould resistant materials should be applied to affected areas to prevent any subsequent water damage that is likely to occur. Regular maintenance and replacement of damage or missing or damaged sealant and grout is highly recommended to the wet areas, as this is a regular wear and tear defect. Sealant and grouting in areas that come into regular contact with water should be maintained for the long term care of your property.

A sealant specialist or tiling contractor should be appointed to complete these works as soon as possible

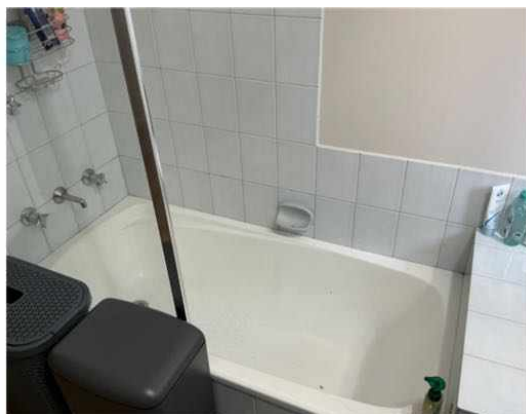
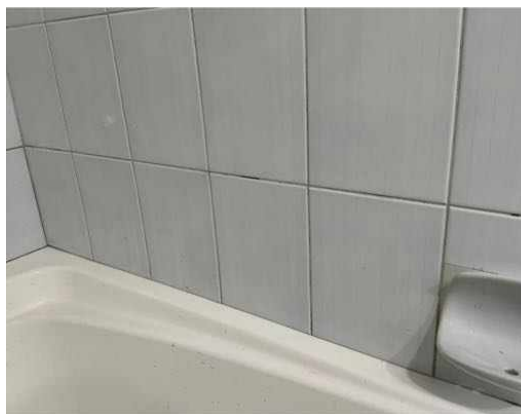
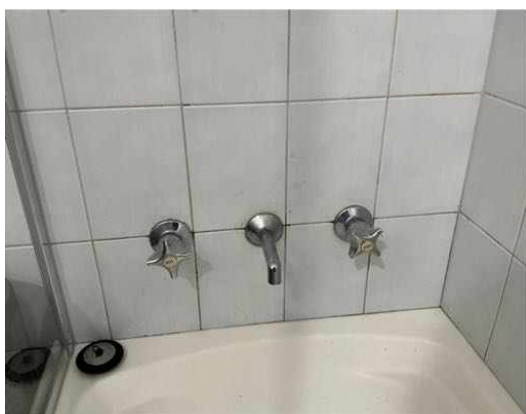
Finding 3.11

Building: Main Building
 Location: Bathroom
 Finding: Bathroom Sealant and grouting - Missing or damaged
 Information: It was noted on inspection that sealant or grout is degraded to the tiled shower alcove and or other areas of the bathroom.

Different materials and floor areas move at different rates, generally causing cracking to grout or sealant at this point. A flexible sealant is required to allow for expected expansion and contraction, while keeping the joint water tight and protective of all associated building materials.

Flexible and mould resistant materials should be applied to affected areas to prevent any subsequent water damage that is likely to occur. Regular maintenance and replacement of damage or missing or damaged sealant and grout is highly recommended to the wet areas, as this is a regular wear and tear defect. Sealant and grouting in areas that come into regular contact with water should be maintained for the long term care of your property.

A sealant specialist or tiling contractor should be appointed to complete these works as soon as possible

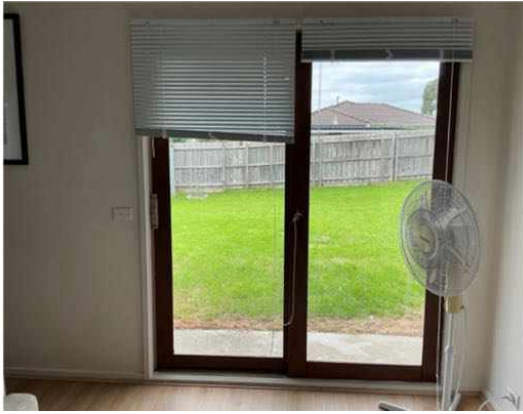
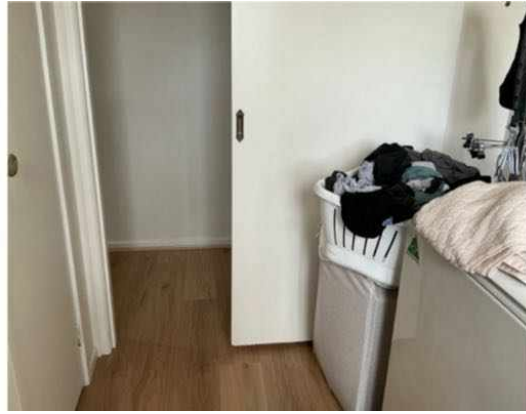
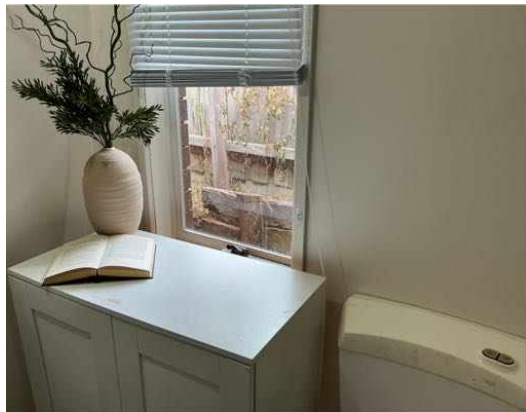
Finding 3.12

Building:	Main Building
Location:	Various parts of the building
Finding:	Doors and windows required maintenance
Information:	Some of the doors and windows to the building require some maintenance to make them operate more smoothly. This can happen overtime with deterioration or lack of maintenance. Recommend engaging a carpenter to repair/maintain windows and doors at the owners discretion.

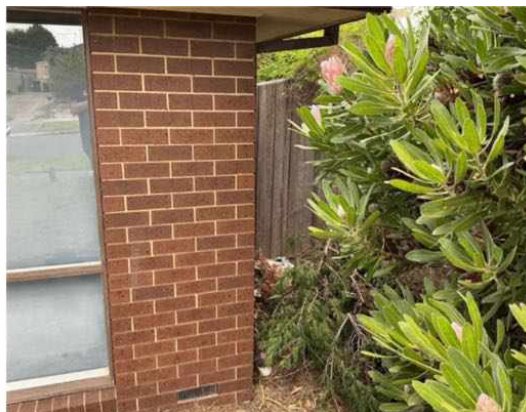
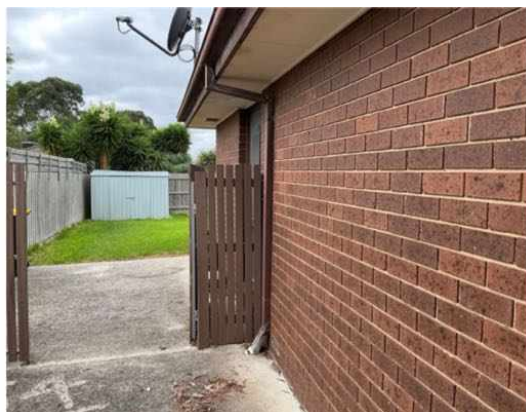
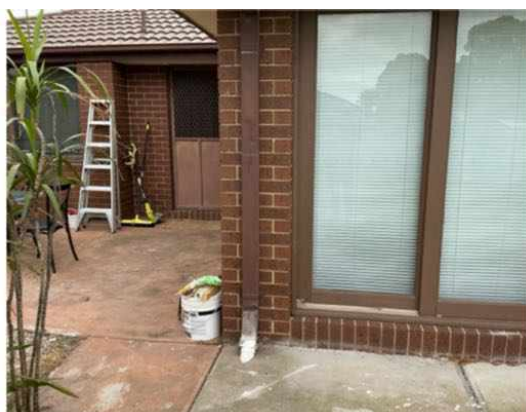
Building:	Main Building
Location:	Exterior walls
Finding:	downpipes damaged
Information:	Some of the down pipes are damaged. This disconnection negatively impacts the functional capacity of the plumbing.

Where plumbing doesn't drain adequately, the area at the base perimeter can become excessively damp, potentially creating an environment that is susceptible to rust and corrosion of surrounding building elements, as well as attracting termites and other pests.

It is highly recommended that a plumber be appointed to further inspect the area and to install adequate drainage equipment where necessary.

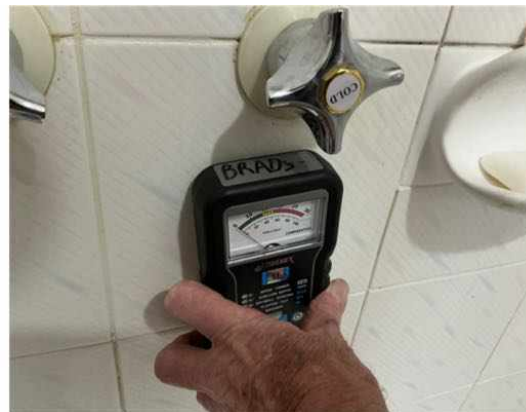
Finding 6.03

Building: Main Building
 Location: Ensuite - Master
 Finding: Shower - Damp
 Information: Damp is evident to parts of the ensuite bathroom shower alcove found using using a moisture meter. This defect is quite common, and is suspected to have been caused by moisture permeating through the grouting in this area, which shows evidence of deterioration creating moist conditions. Leaking pipes within the adjoining wall is also a possible cause. Excessive moisture can attract termites.

Damp (or structural damp) refers to the presence of unwanted moisture in the structure of a building, either as the result of intrusion from outside, or condensation

from within the structure. In the shower area, internal water leaks or other sources of excessive moisture are generally the cause of damp.

Unmanaged damp in the shower recess is likely to facilitate the formation and development of mould and fungi growth, decaying associated building materials and compromising their structural integrity. It is important to address damp conditions, as the World Health Organisation notes that excess moisture leads - on almost all indoor materials - to growth of microbes such as moulds, fungi and bacteria, which subsequently emit spores and other matter into the indoor air. Exposure to these contaminants is associated with a wide range of respiratory and other health-related problems.

Consultation with a qualified plumber or bathroom specialist is advised immediately to identify the cause of damp and to perform remedial works as required. Where excessive mould growth is present, further inspection by a specialist environmental health inspector should also be considered.

Always ensure that sealant and grout is in good condition to prevent any moisture issues occurring in the future.

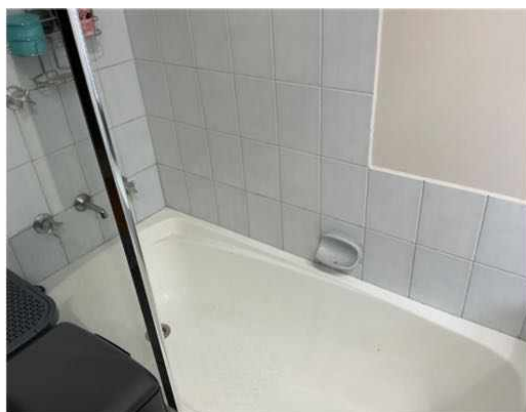
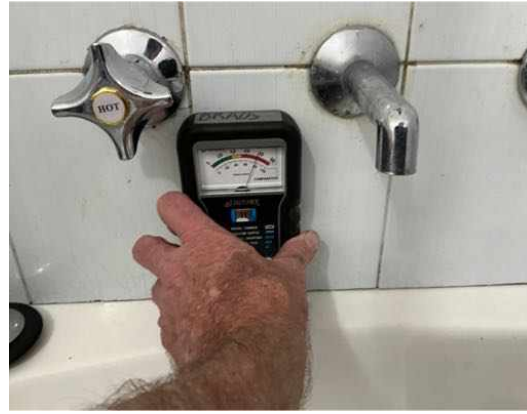
Finding 6.04

Information: Damp is evident to parts of the bathroom shower alcove found using using a moisture meter. This defect is quite common, and is suspected to have been caused by moisture permeating through the grouting in this area, which shows evidence of deterioration creating moist conditions. Leaking pipes within the adjoining wall is also a possible cause. Excessive moisture can attract termites.

Damp (or structural damp) refers to the presence of unwanted moisture in the structure of a building, either as the result of intrusion from outside, or condensation from within the structure. In the shower area, internal water leaks or other sources of excessive moisture are generally the cause of damp.

Unmanaged damp in the shower recess is likely to facilitate the formation and development of mould and fungi growth, decaying associated building materials and compromising their structural integrity. It is important to address damp conditions, as the World Health Organisation notes that excess moisture leads - on almost all indoor materials - to growth of microbes such as moulds, fungi and bacteria, which subsequently emit spores and other matter into the indoor air. Exposure to these contaminants is associated with a wide range of respiratory and other health-related problems.

Consultation with a qualified plumber or bathroom specialist is advised immediately to identify the cause of damp and to perform remedial works as required. Where excessive mould growth is present, further inspection by a specialist environmental health inspector should also be considered.

Always ensure that sealant and grout is in good condition to prevent any moisture issues occurring in the future.

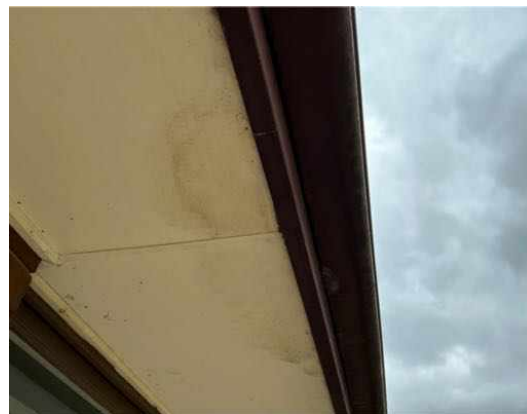
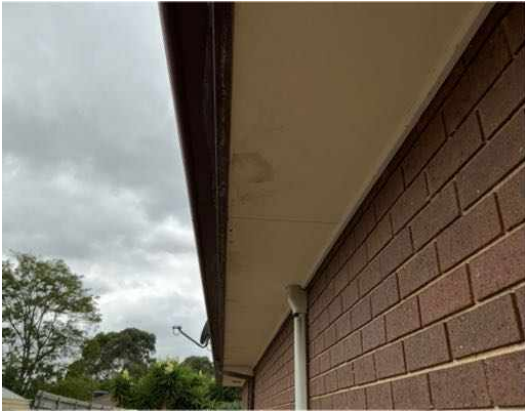
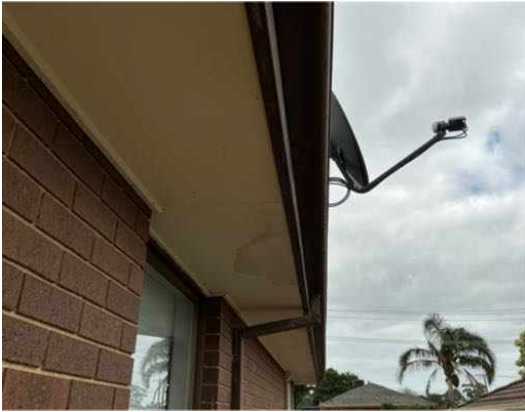
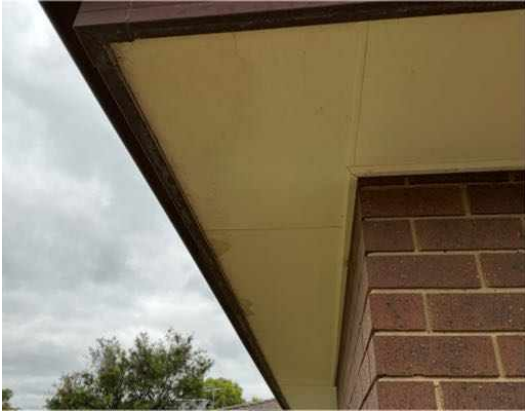
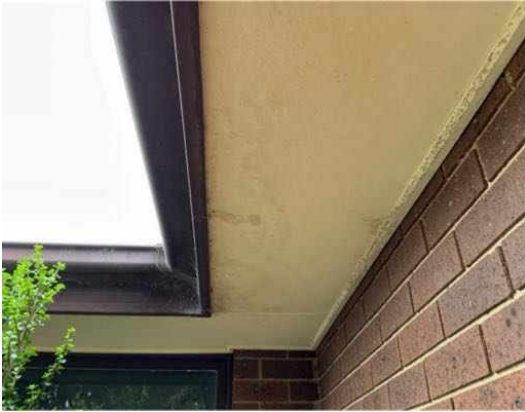
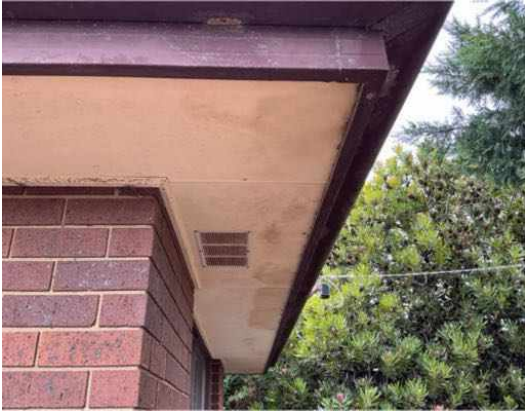
Finding 6.05

Building:	Main Building
Location:	Eaves
Finding:	Evidence of moisture stains but tested dry- eaves
Information:	Evidence of moisture stains was found to the parts of the eaves but tested dry using a moisture meter. It is suspected these stains have come from blocked gutters at one time. Recommend cleaning and maintaining gutters regularly. Recommend monitoring and if further stains are noticed contact a licensed plumber straight away. Excessive moisture can attract termites and produce conditions that promote termite attack, fungal growth and wood decay. Excessive moisture is generally caused by deteriorated, inadequate or missing roof drainage, leaking plumbing pipes or fixtures, poorly plumbed HWS overflows or condenser units and poor site drainage. It is highly recommended that all plumbing and drainage fixtures and fittings be maintained regularly in order to prevent excessive moisture being present in the external / internal property.

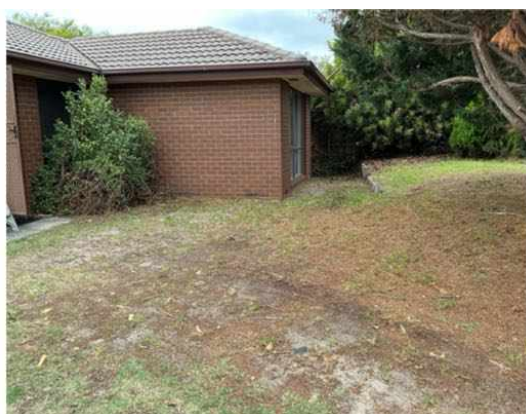
Finding 6.06

Building:	Main Building
Location:	Yards
Finding:	Site drainage - poor/inadequate
Information:	The site drainage to parts of the yards was found to be inadequate at the time of inspection, creating potential for subsequent water damage to associated building elements. Excessive moisture will attract termites.

It is important that water does not lie against the base of walls; surrounding paths and ground levels should be sloped to drain water away from walls. Downpipes should not discharge stormwater onto lower walls or plinths. Stormwater should be carried away by large, regularly cleaned drains. Ground levels may need to be lowered to expose a buried DPC.

Where site drainage is inadequate, installation of an Agricultural (Aggie) Drain may be required. A qualified plumber should be appointed to further inspect the property and perform any remedial works as necessary. Water damage and secondary defects are likely to occur if left unmanaged.

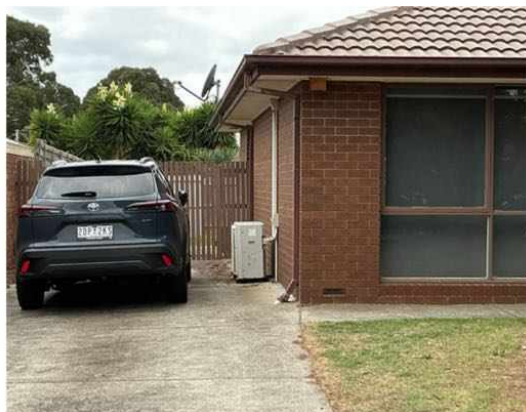
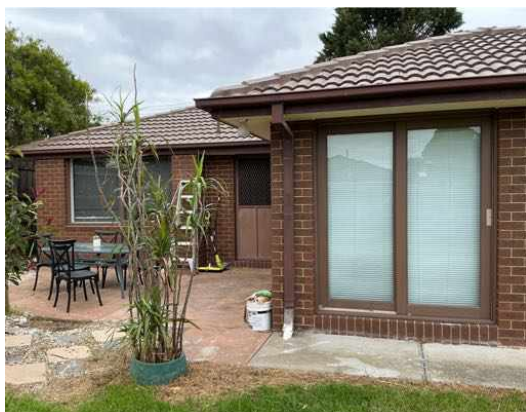
Finding 6.07

Building:	Main Building
Location:	Various parts of the building
Finding:	Bridging attachments to buildings
Information:	Bridging occurs when items against a building provide a concealed entry point for termites into the building or by passing around a termite management system.

Where any part of an attachment to a building is not isolated and is not provided with a clear gap of not less than 25mm from building, bridging occurs. Attachments to buildings such as hot water services, downpipes, verandahs, decks, steps, fences, service conduits and the like provide the opportunity for concealed entry.

Building attachments of this nature need to be frequently inspected for termite activity by a qualified inspector.

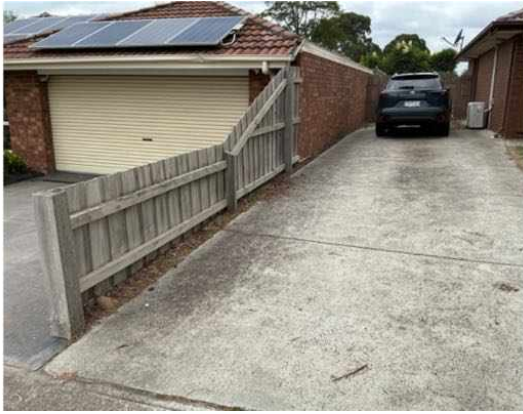
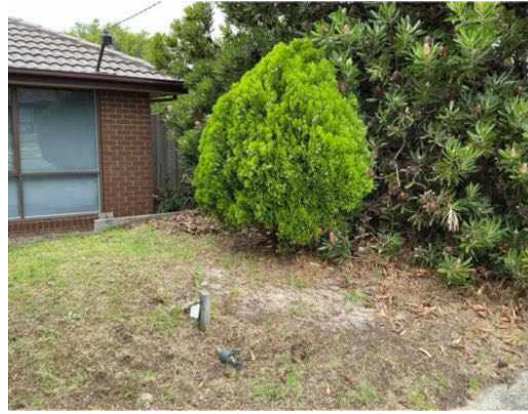
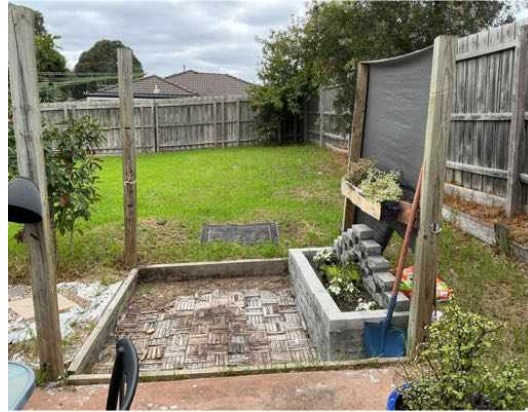
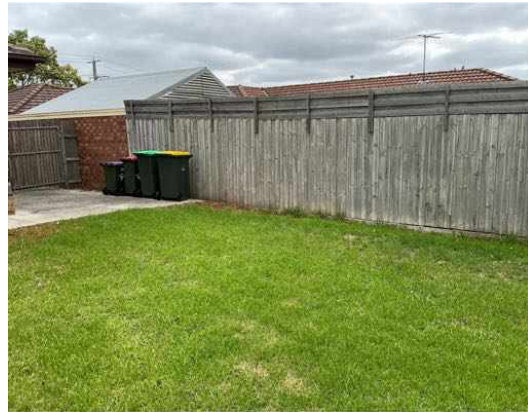
Finding 6.08

Building:	Main Building
Location:	Various parts of the building
Finding:	In ground contact
Information:	<p>Any timbers in direct ground contact provide opportunity for concealed termite entry and are likely to be subject to premature rot and decay as the soil retains moisture or damp conditions against the timbers.</p> <p>Remove untreated timber that is in direct contact with external grounds. Consider replacement with more durable materials i.e. treated timber or non timber elements. Frequent pest inspections are advised to readily identify any termite activity in these areas.</p>

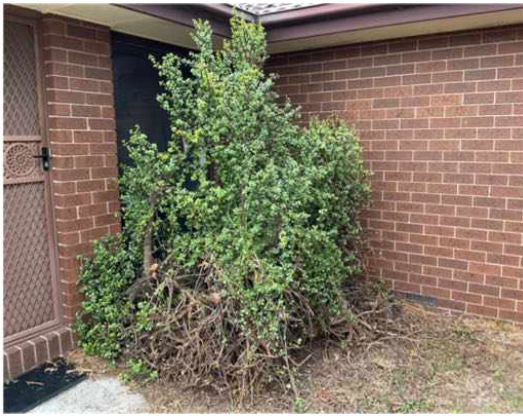
Finding 6.09

Building:	Main Building
Location:	Yard - Front
Finding:	Garden Beds Conditions Conducive to Termites
Information:	Garden beds were found to be evident in close proximity to the building. Garden beds immediately adjacent to the perimeter of the building block the visual inspection of these areas, providing a concealed termite entry point.

These garden beds can include untreated timber, and with a combination of moisture from watering hosing can make conditions conducive to termite activity and termite ingress.

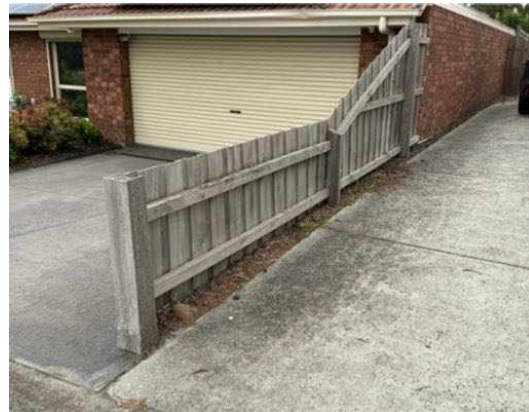
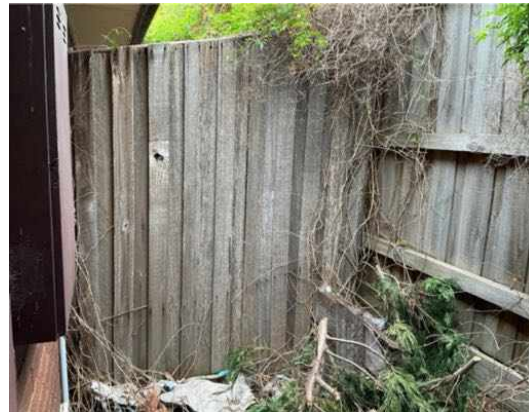
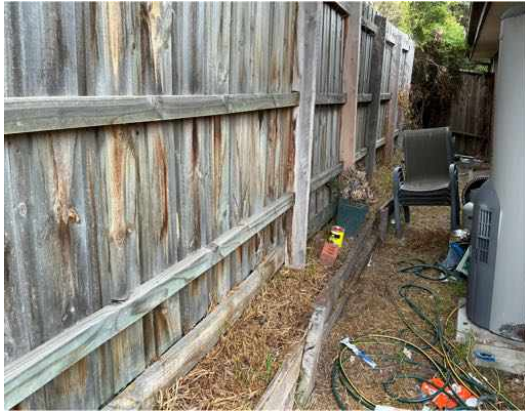
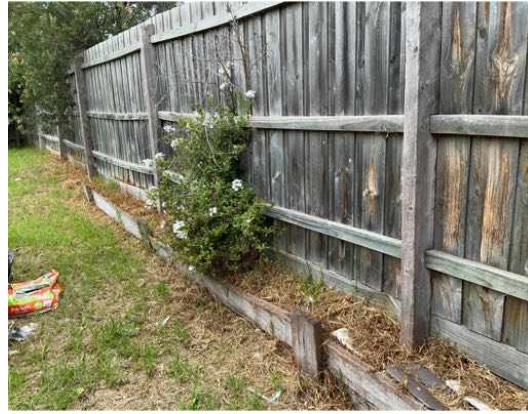
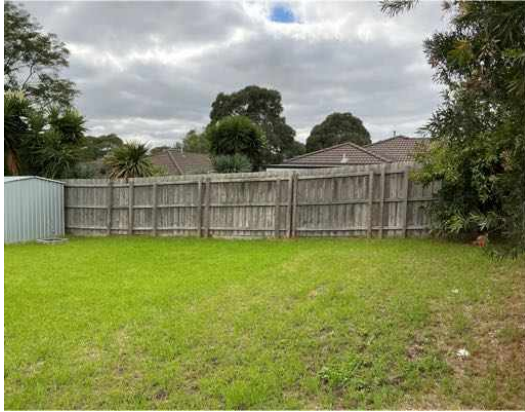
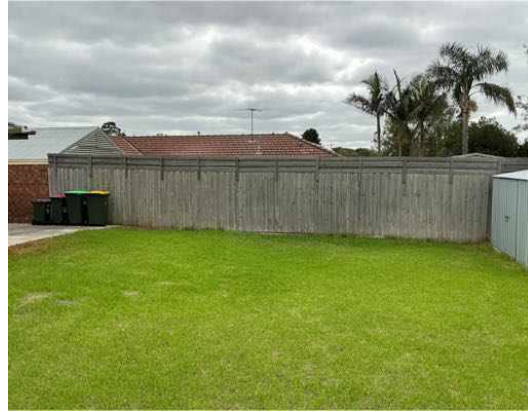
Finding: Fencing and retaining walls - wood rot-fungal decay

Information: It was noted at the time of inspection that sections of the fencing and retaining walls to the property have deteriorated and have fungal decay/wood rot present. Typically fencing deteriorates due to age and or wear, rot and or rust which is generally expected for a structure of this age, due to prolonged exposure to weather conditions. Sometimes inadequate installation or maintenance can be to blame.

If left unattended, it is likely that further damage will occur. It is suspected that repair of several elements of the fencing may be required however replacement may be a consideration of the client also.

A licensed fencing contractor should be appointed to provide further advice and perform rectification works as necessary.
