Building Inspection Report

Inspection Date: Fri, 20 Mar 2026

Property Address: 3/1 Merrilong St, Ringwood East VIC 3135,
Australia

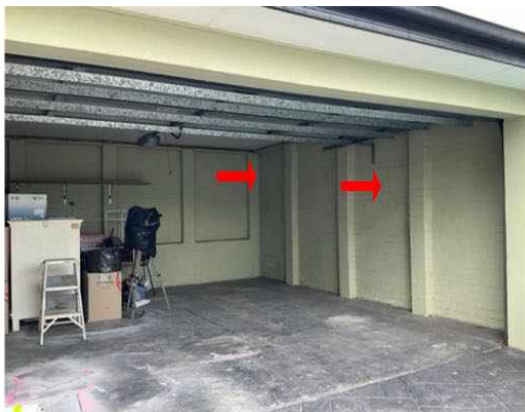
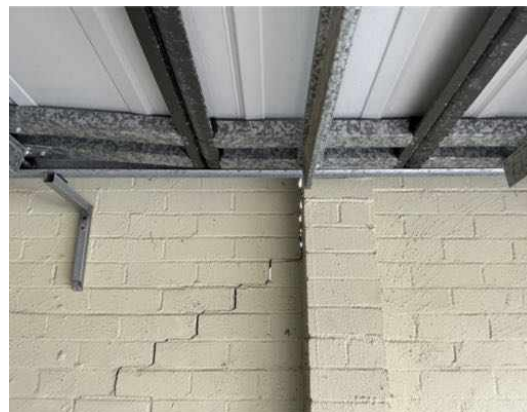
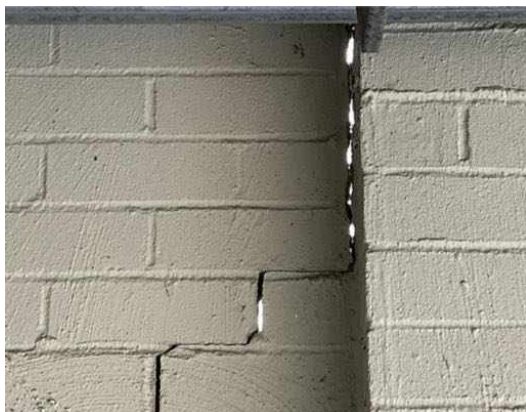
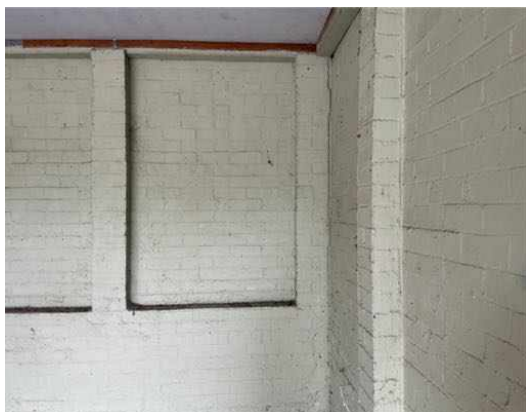
Defects 2.01

Building: Garage
Location: Garage
Finding: Brickwork - Step cracking
Information: Step cracking was identified to the brickwork in this area at the time of inspection. Step cracking, which is similar to other forms of cracking, has a variety of possible causes. However, the most common is the subsidence of adjacent footings.

Step cracking is a relatively common defect, and is most likely to occur adjacent to windows, doors and other openings. Mortar failure in the gaps between affected bricks indicates the stresses and tensions affecting the wall.

The brickwork cracking to the garage is considered a major defect for rectification. A qualified bricklayer should be engaged immediately to repair this brickwork.

Where step cracking is extensive or severe, the client is advised to consult a structural engineer. Minor step cracking can be used as a warning sign to address factors causing stress to the wall, which can include the effect of surrounding trees, water leaks, soil erosion, or even the presence of reactive soils in the surrounding area.

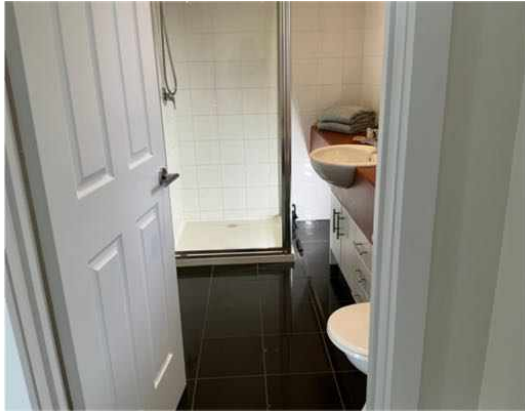
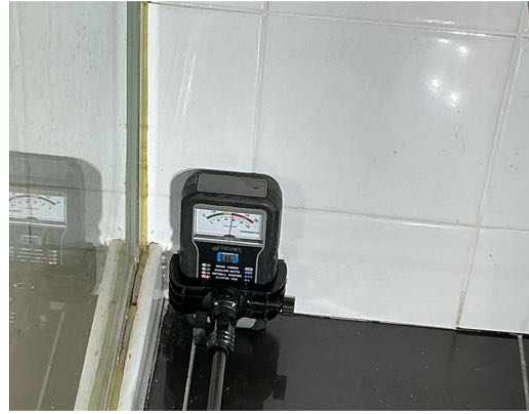
Defects 2.02

Building:	Main Building
Location:	Ensuite - Master
Finding:	Shower - Leaking
Information:	Leaking was evident to the shower area at the time of inspection as shown in photos with the moisture meter. It is suspected that the leaking has occurred as a result of general ageing of the building elements.

Leaking from the shower base, where left unattended, is likely to lead to water damage to adjoining flooring and walls. Leaking can lead to water damage and necessitate extensive remedial works being required. Active water leaks may also create an environment that is susceptible to the formation and development of mould.

The Shower in the ensuite was found to be leaking with broken tiles and missing grout also found. This bathroom will need to be renovated with new waterproofing and tiling required. This bathroom should not be used until these works are completed.

Appointment of a tiling contractor is required to replace the shower the bathroom waterproofing and tiling. Such works should be performed as soon as possible to ensure that no further damage occurs.

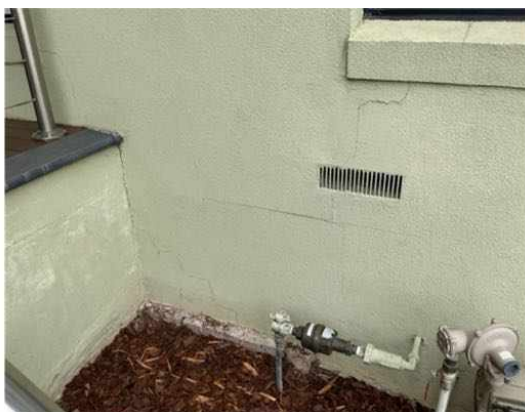
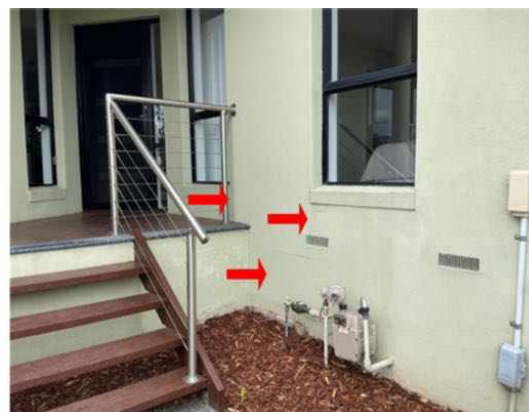
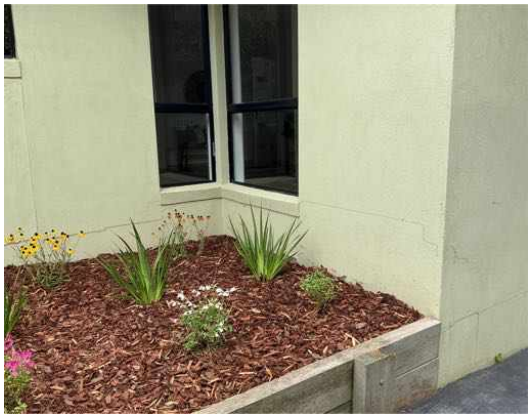
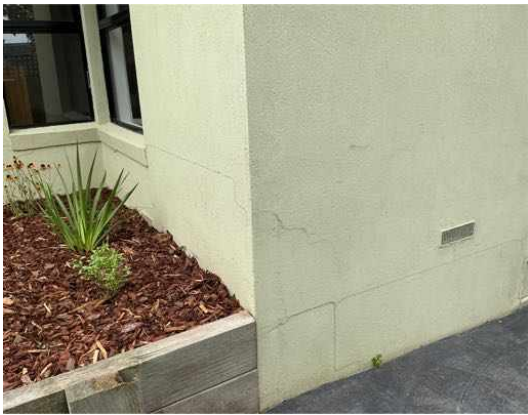
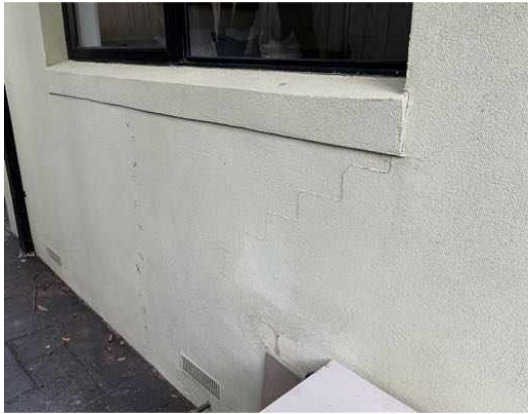
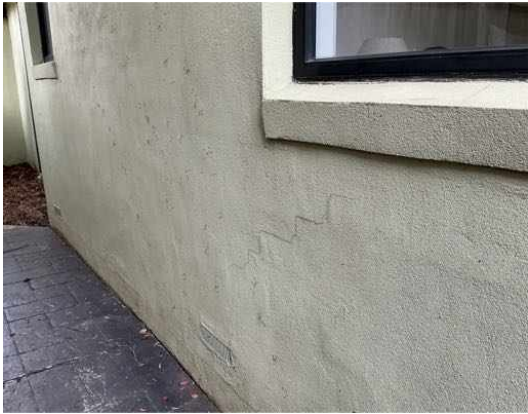
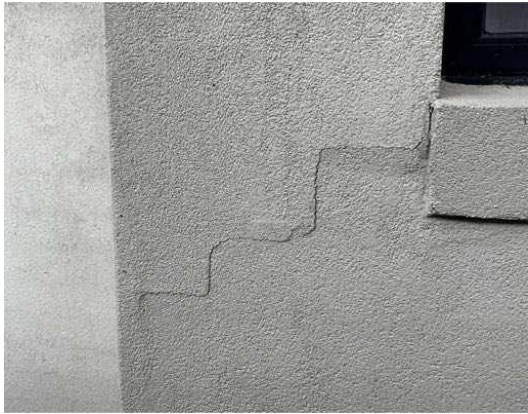
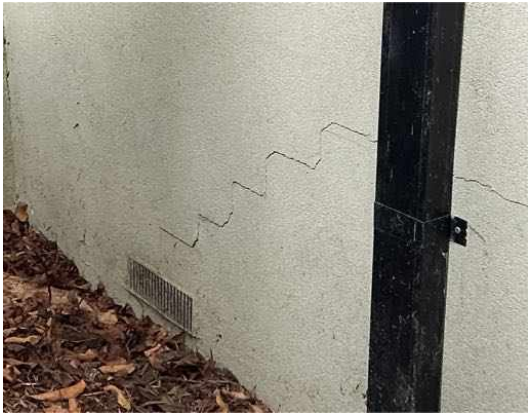
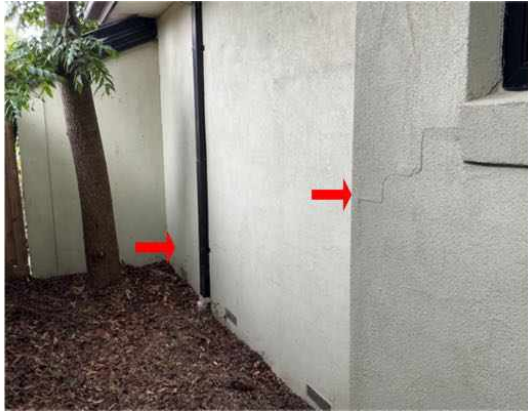
Defects 3.01

Building:	Main Building
Location:	All Areas
Finding:	Brickwork - Step cracking
Information:	Step cracking was identified to the brickwork in this area at the time of inspection. Step cracking, which is similar to other forms of cracking, has a variety of possible causes. However, the most common is the subsidence of adjacent footings.

Step cracking is a relatively common defect, and is most likely to occur adjacent to windows, doors and other openings. Mortar failure in the gaps between affected bricks indicates the stresses and tensions affecting the wall.

Uneven flooring throughout that was found to be beyond tolerance for a building of this construction method. Cracking to brickwork was extensive and many doors were found to be binding.

Where step cracking is extensive or severe, the client is advised to consult a structural engineer. Minor step cracking can be used as a warning sign to address factors causing stress to the wall, which can include the effect of surrounding trees, water leaks, soil erosion, or even the presence of reactive soils in the surrounding area.

A specialist Restumping and underpinning expert will be able to assess the subfloor structures and recommend and quote on any Restumping/stabilization and underpinning works required.

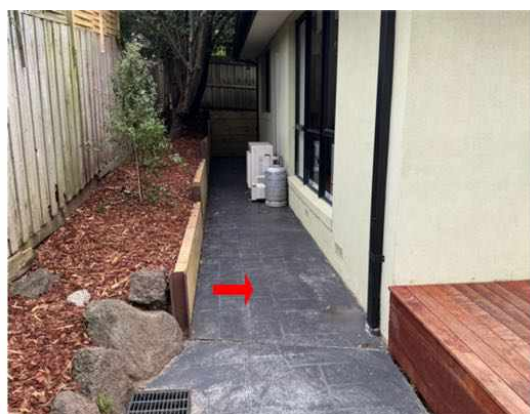
Defects 3.02

Building:	Main Building
Location:	Rear Elevation
Finding:	Perimeter Paving - Insufficient Fall
Information:	The perimeter paving or ground levels were found to have an inadequate slope away from the adjoining building structure, creating potential for water pooling in this area.

Perimeter paving is required to fall from the building by a minimum of 25mm in the first metre and bare ground should fall away from the house by 50mm in the first meter. This standard ensures that excessive moisture does not pool around the base of building structures, which creates potential for water and structural damage, as well as making the area susceptible to termite and timber pest activity.

Where paving or ground levels do not have adequate fall, a licensed paving contractor should be appointed to install or remove and re-level pavement.

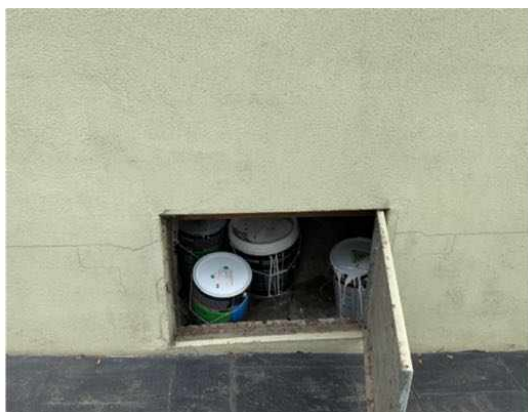
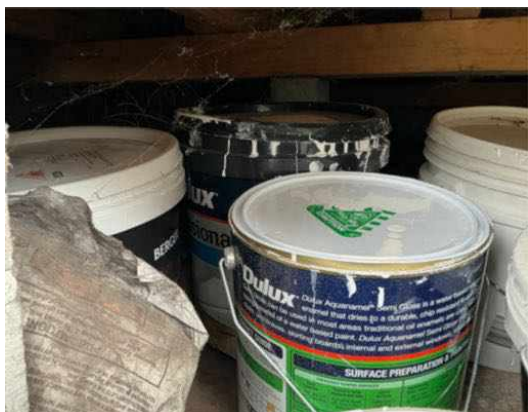
Defects 3.03

Building:	Main Building
Location:	Subfloor
Finding:	Subfloor - Debris
Information:	An array of debris was found in the subfloor area at the time of inspection. Debris in this area restricts subfloor ventilation and creates potential for concealed pest entry. Stored timbers and other materials may also make the area susceptible to termite activity and wood rot.

A clear and empty subfloor will be better ventilated and easier to maintain in a dry condition. The removal of any timber debris is vital in minimising the risk of termite or wood borer activity.

Debris in the subfloor should be removed as soon as possible. Depending on the location and amount of debris and stored items, the homeowner may elect to undertake this task. Alternatively there are a large number of rubbish removal subcontractors that could undertake these works.

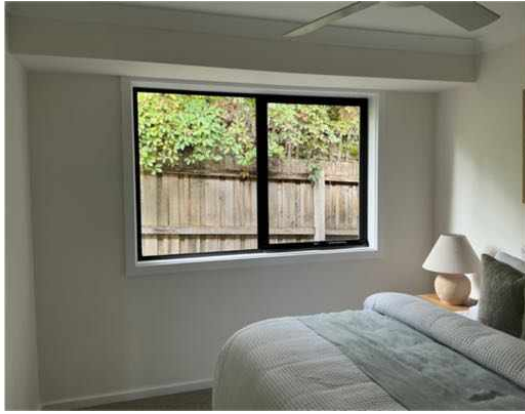
Defects 3.04

Building:	Main Building
Location:	Windows
Finding:	Windows- stiff to open
Information:	The windows to this area was difficult to operate at the time of inspection.

Windows provide ventilation and exits to the adjoining area and should be at a fully operational level to ensure user comfort and safety. Restricted function may also pose as a potential safety hazard if required for emergency egress from the building.

Generally, factors such as general age of the building element and a lack of maintenance are the usual causes for this type of defect.

Replacement of windows running hardware may be required, as well as minor repairs and cleaning. A registered builder or general handy person will be required to repair the windows

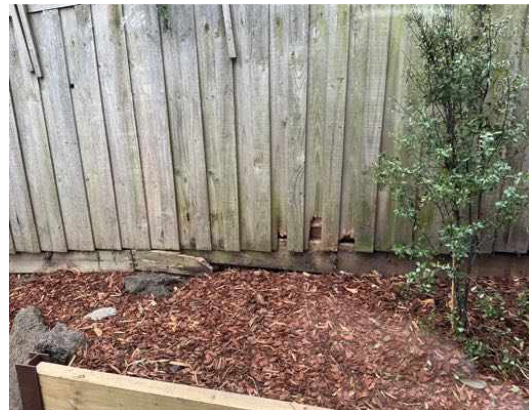
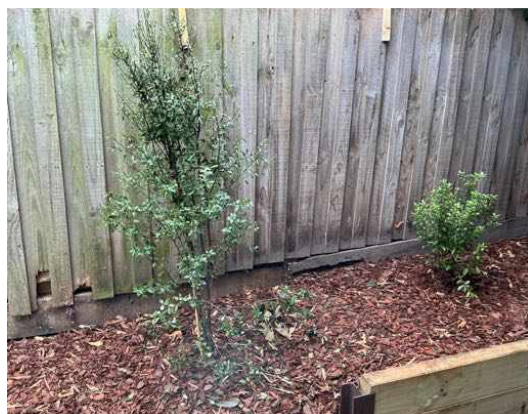
Defects 3.05

Finding: Fencing - Deteriorated

Information: It was noted at the time of inspection that sections of the fencing throughout the property have deteriorated. Typically fencing deteriorates due to age and or wear, rot and or rust which is generally expected for a structure of this age, due to prolonged exposure to weather conditions. Sometimes inadequate installation or maintenance can be to blame.

If left unattended, it is likely that further damage will occur. It is suspected that repair of several elements of the fencing may be required however replacement may be a consideration of the client also.

A licensed fencing contractor should be appointed to provide further advice and perform rectification works as necessary.

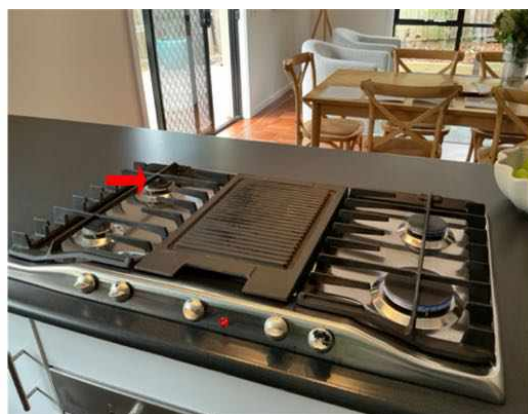
Defects 3.06

Building:	Main Building
Location:	Kitchen
Finding:	Building element - Not operating left rear igniter to stove top
Information:	Non-operational items should be addressed to ensure that the full function of the building structure is available. Where some building elements are not operating as intended, it is possible that secondary building defects could arise due to their non-operation.

Repair and/or replacement of the faulty building element is recommended. It is highly recommended that the relevant tradesperson be engaged to perform any necessary works.

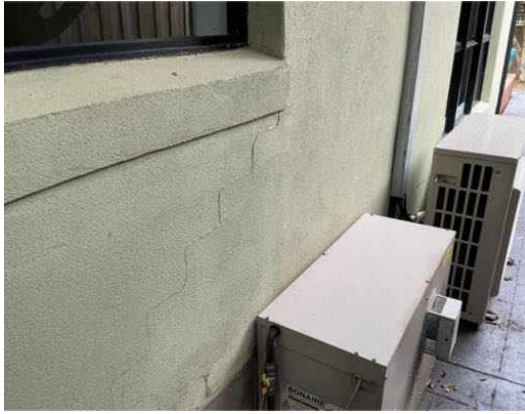
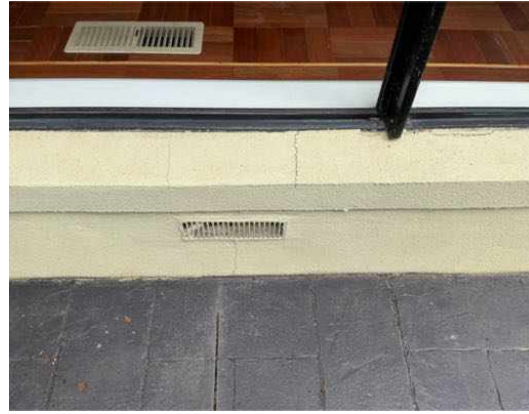
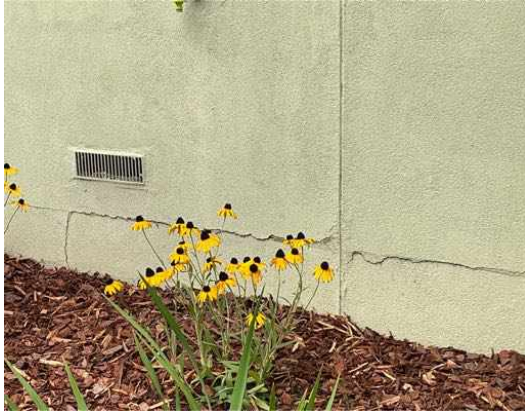
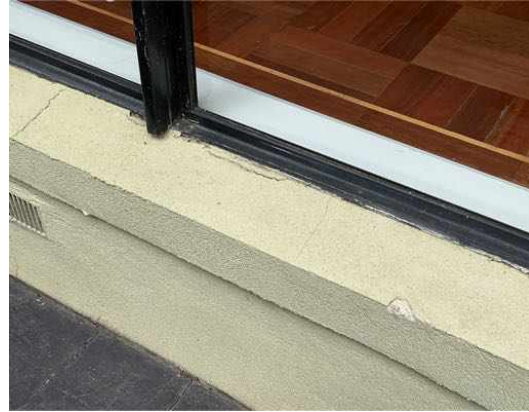
Defects 3.07

Building:	Main Building
Location:	All Areas
Finding:	Cracks to render - Category 2
Information:	It has been observed that cracking to rendered surfaces has occurred. The degree of damage falls within Category 2, described as noticeable cracks which are easily filled. Cracking of this size are generally less than 5mm in width.

Category 2 damage is required to be monitored for a period of 12 months. After the monitoring period, a crack rated at Category 2 or above is considered a defect requiring rectification.

Always contact your building inspector should cracks widen, lengthen, or become more numerous.

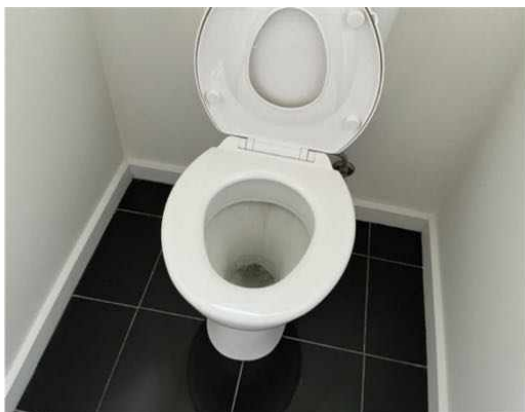
Defects 3.08

Building: Main Building
Location: Toilet (WC)
Finding: Toilet - Continually running
Information: At the time of inspection, the toilet showed evidence of continually running.

It is highly advised that this be addressed by a licensed plumber as soon as possible.

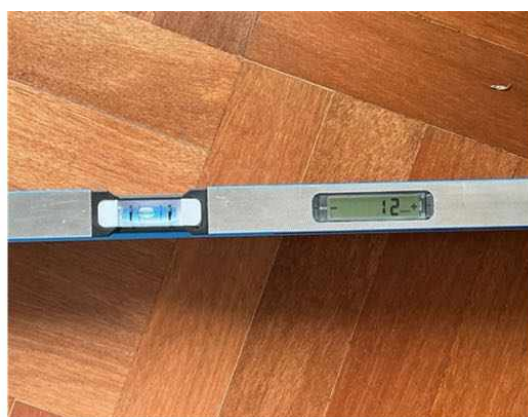
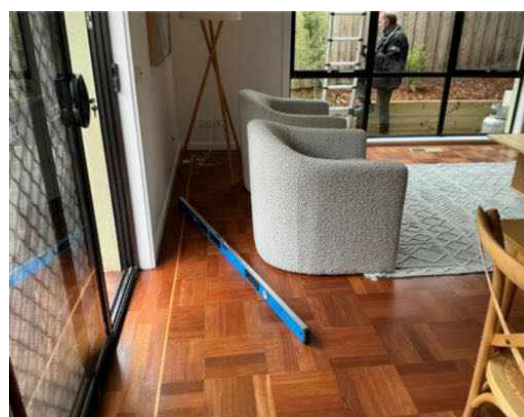
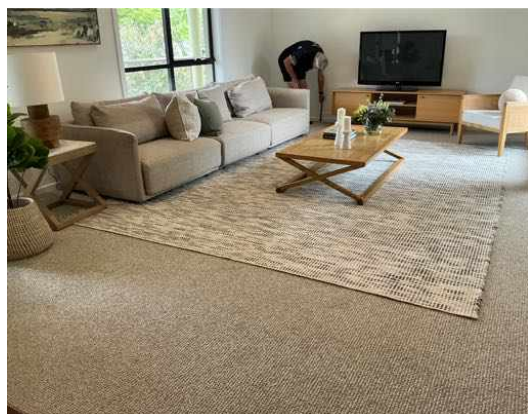
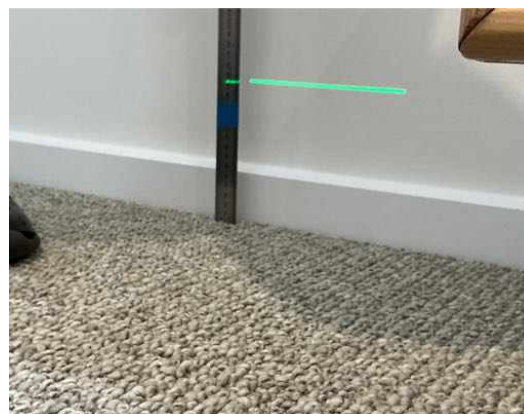
Defects 3.09

Location: Family Room
 Finding: Flooring - Uneven
 Information: The internal flooring in this area is out of level and uneven. Uneven flooring is likely to indicate minor defects such as expected movement of the foundations of the property, but may also indicate subsidence of the associated subfloor stumps.

It is advised that the flooring be closely monitored to identify any further movement. Where flooring remains relatively unchanged for an extended period of time (i.e. several months), it is likely that this defect has been caused by expected movement of the foundations of the property.

However, where flooring is uneven further, potentially invasive inspection of the subfloor structures and stumps in this area is required. In this case, works to repair are likely to be required, and would be carried out by a registered builder specialising in re-stumping.

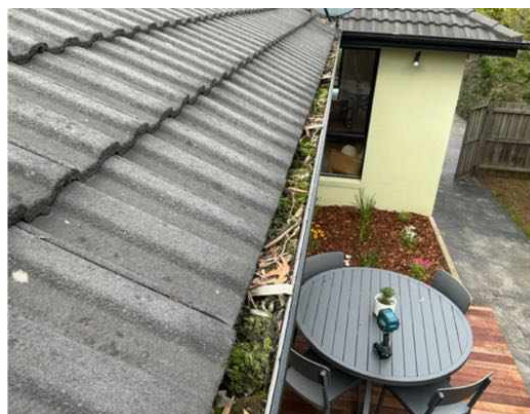
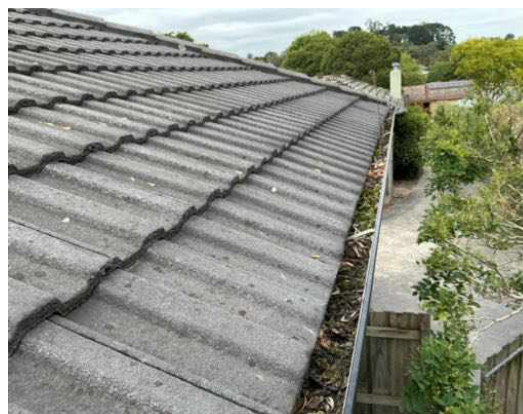
Defects 3.10

Building: Main Building
 Location: Roof Exterior
 Finding: Gutters - Blocked
 Information: Roof plumbing structures, such as guttering and downpipes, should be free of all debris to prevent blockages. Blockages of the guttering and downpipes will lead to

Blocked gutters are likely to lead to high levels of moisture in the affected areas. Such moisture will not only cause rust and decay of the associated building materials, but can also provide conditions that are conducive to termite and timber pest activity. Blockages in gutters should therefore be removed immediately to ensure dry conditions are maintained.

Consult a Licensed Plumber for further specific advice on remedial works that may be required. In the interim, it is highly advised that blocked gutters be removed by the homeowner or a general handyperson as a matter of urgency.

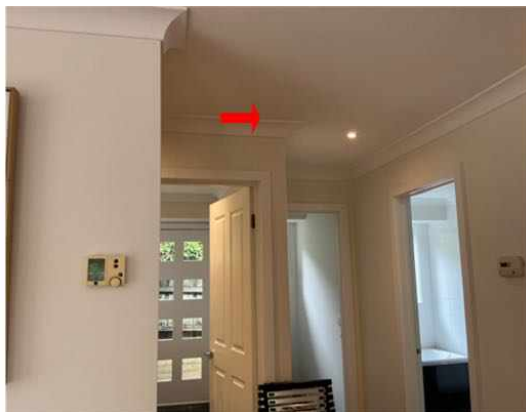
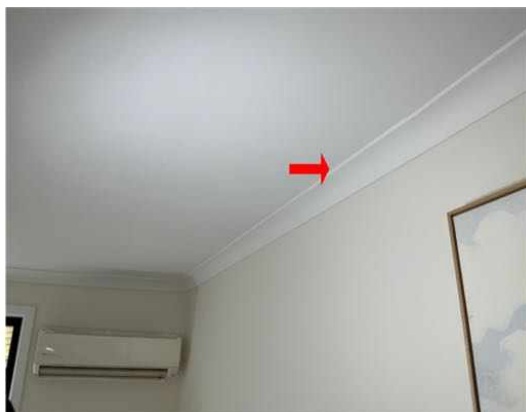
Defects 3.11

Building:	Main Building
Location:	All Areas
Finding:	Cornice - Cracking
Information:	The cornice has separated and cracking is apparent in this area.

This area should be carefully monitored to identify any further damage.

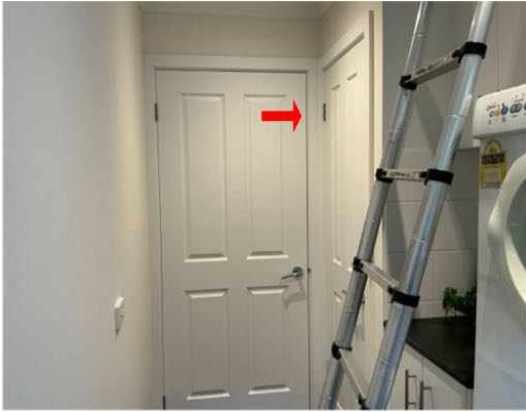
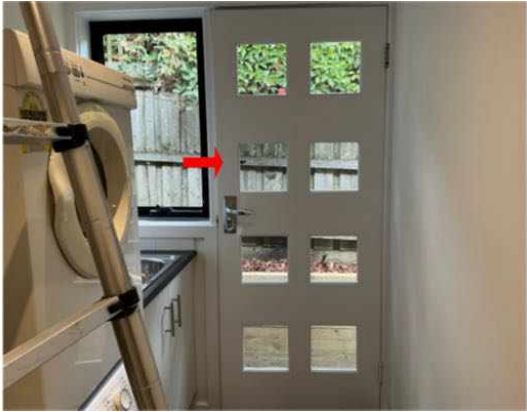
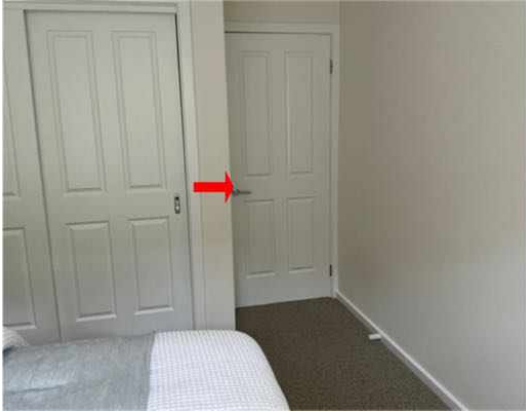
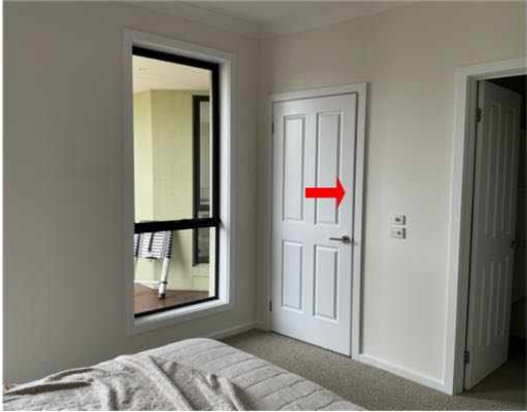
Defects 3.12

Building:	Main Building
Location:	All Areas
Finding:	Door - Binding/jamming
Information:	Binding and/or jamming of this door is evident during standard operation. This defect inhibits the functionality of the affected door as well as creating potential for secondary defects to associated building elements, such as damage to the floor covering.

A door that binds to flooring or to the associated door frame may have several causes, ranging from minor defects, such as poor installation of the door or deteriorated hinges, through to major structural issues, such as damage to subfloor structures.

Where several doors are binding/jamming it may indicate major structural issues, a registered builder specialising in re-stumping should be appointed to provide an estimate on the cost of rectification.

For minor causes, a qualified carpenter or general handyman should be appointed to perform minor rectification works at client discretion.

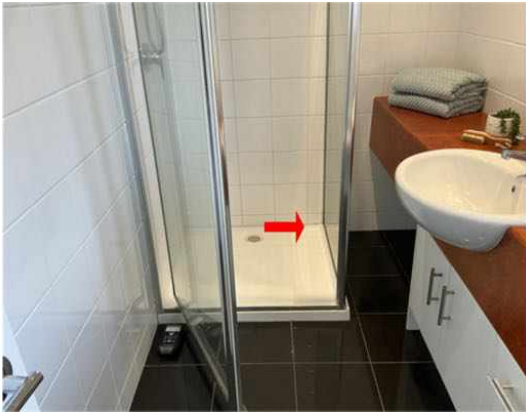
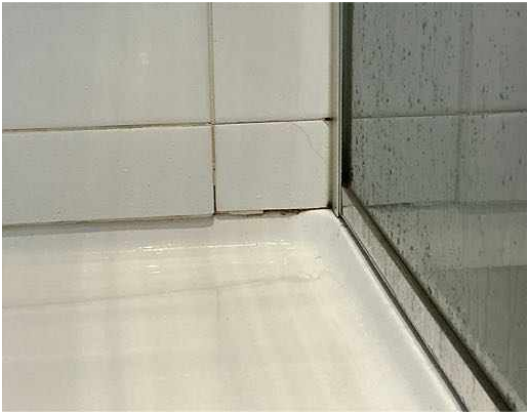
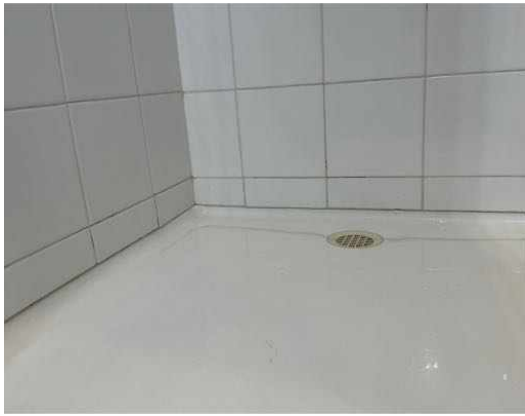
Defects 3.13

Building: Main Building
Location: Ensuite - Master
Finding: Grout - Missing
Information: Grout is missing in this area. Grout is used to protect gaps and crevices in building materials to ensure that they are water-tight and prevent water penetration to the associated structures.

Where grout is missing, a tiling contractor should be appointed immediately to apply grout and re-apply any silicone where necessary. Failure to do so is likely to lead to water damage to the surrounding area.

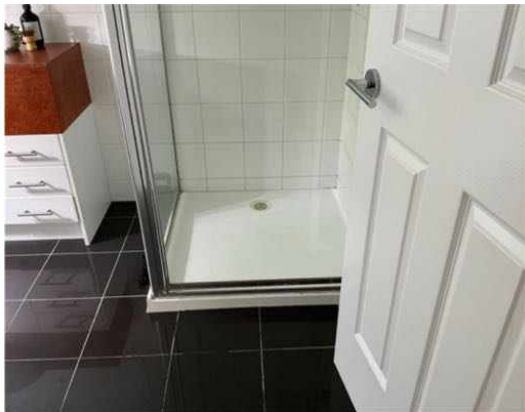
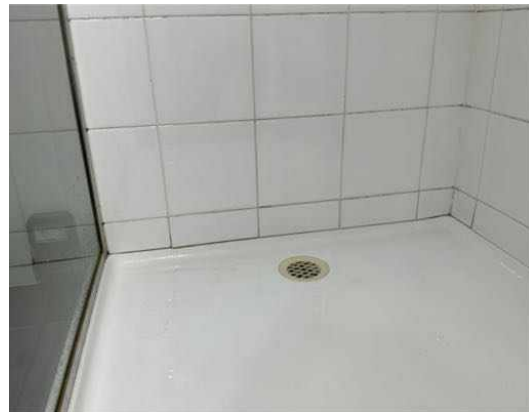
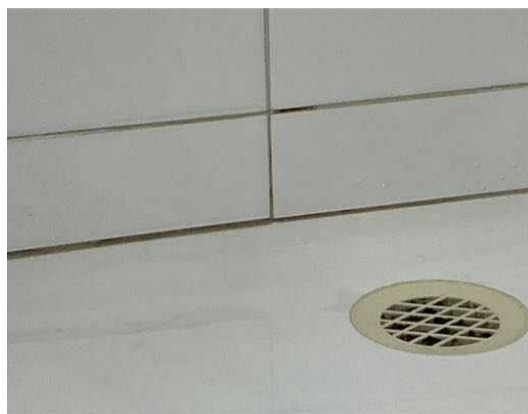
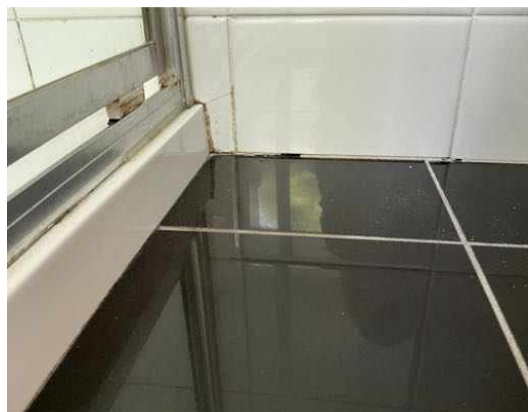
Defects 3.14

Finding: Grout - Missing

Information: Grout is missing in this area. Grout is used to protect gaps and crevices in building materials to ensure that they are water-tight and prevent water penetration to the associated structures.

Where grout is missing, a tiling contractor should be appointed immediately to apply grout and re-apply any silicone where necessary. Failure to do so is likely to lead to water damage to the surrounding area.

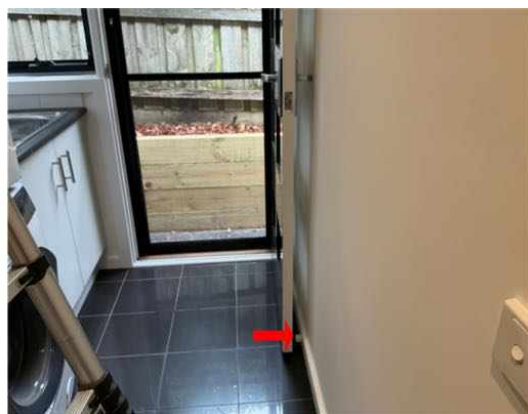
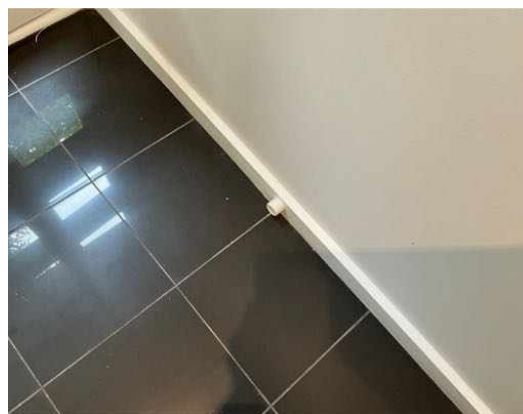
Defects 3.15

Building:	Main Building
Location:	Laundry
Finding:	Door stop - Missing
Information:	The door stop is missing or is inadequate to stop the door handle from damaging the wall. Although some building elements may seem irrelevant or unnecessary, all building elements play a key role in the operation and function of the overall structure and its performance.

Re-installation or replacement of the door stop is advised as soon as possible to prevent any subsequent damage to the door or associated structures. A general handyman may be appointed to perform these works at client discretion.

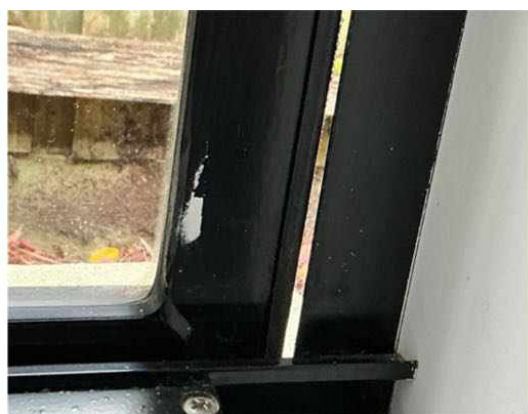
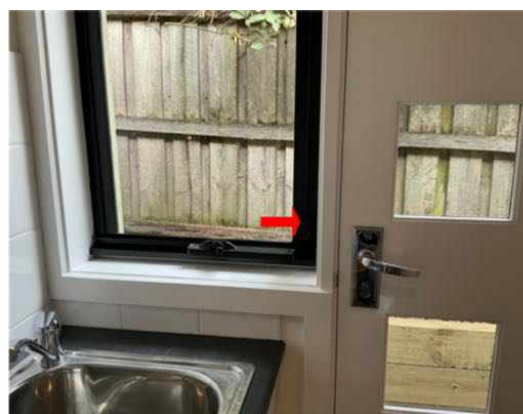
Defects 3.16

Building:	Main Building
Location:	Laundry
Finding:	Windows not sealed
Information:	Due to frequent exposure to weather conditions and subsequent moisture, windows should be sealed to all edges.

Where window seals have deteriorated or are missing, the window is no longer weather-tight; rain penetration and subsequent water damage is therefore likely to ensue. Insulation of the area against external weather conditions will also be compromised.

It is recommended that all deteriorated windows are sealed by a general handyman or sealant expert to prevent any damage and to restore the window to a fully functional level.

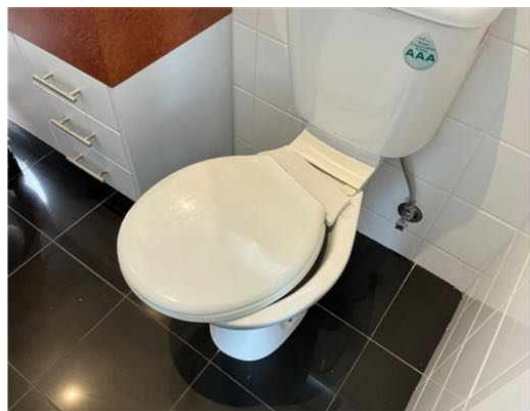
Defects 3.18

Building:	Main Building
Location:	Ensuite - Master
Finding:	Toilet seat - Loose
Information:	The toilet seat was found to be loose and relatively unstable at the time of inspection. It is suspected that this defect has developed due to general aging of the toilet seat and associated materials. However, the loose fixing may also be a result of impact damage.

If left unmanaged, the toilet seat could deteriorate further, leading to greater destabilisation and the potential for accidents.

It is recommended that the seat be refixed by a handyman or registered builder.

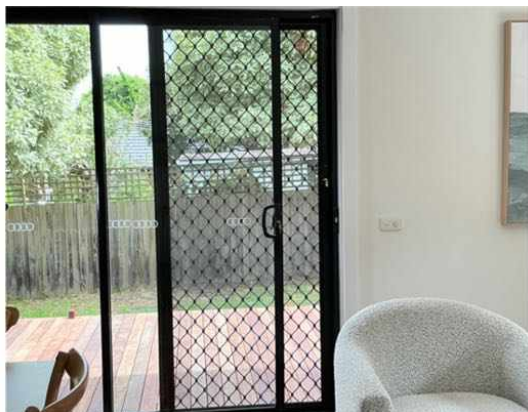
Defects 3.19

Building:	Main Building
Location:	Family Room
Finding:	Lock - Not working
Information:	The lock in this area was not operational at the time of inspection. Where locks have deteriorated to a point where they are no longer usable, the security of the property is immediately compromised.

Repair or replacement of the lock is highly recommended. Consultation with a locksmith or general handyman is required to gain further advice on any added security that may be available for the area.
